NASA/TM—2011–216477

A Damage Tolerance Comparison of Composite Hat-Stiffened and Honeycomb Sandwich Structure for Launch Vehicle Interstage Applications

A.T. Nettles

Marshall Space Flight Center, Huntsville, Alabama

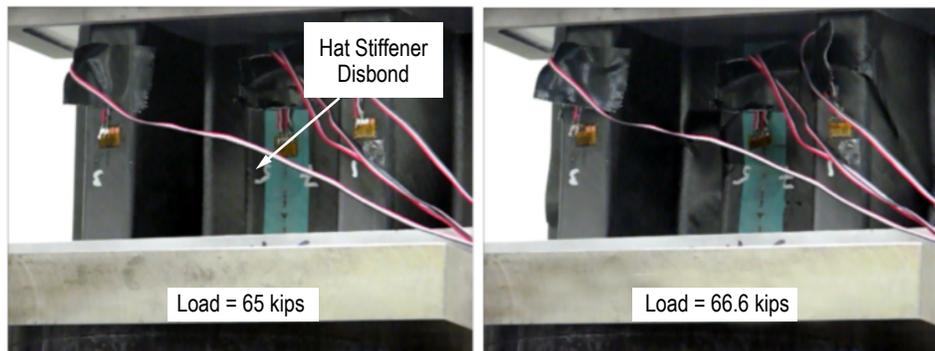
This specimen had hat stiffeners that were precured and then bonded to the face sheet in a secondary bonding operation. This specimen was not impacted. As it was loaded, buckling of the face sheet was noted beginning at ≈ 40 kips. At 55 kips, there appeared to be a disbond between a foot of a hat and the face sheet. Catastrophic failure occurred at 66.6 kips. Figure 5 shows the hat stiffener/face sheet disbond and the specimen just after catastrophic failure.

Figure 5. Hat stiffener/face sheet disbond and total failure of specimen double 1.

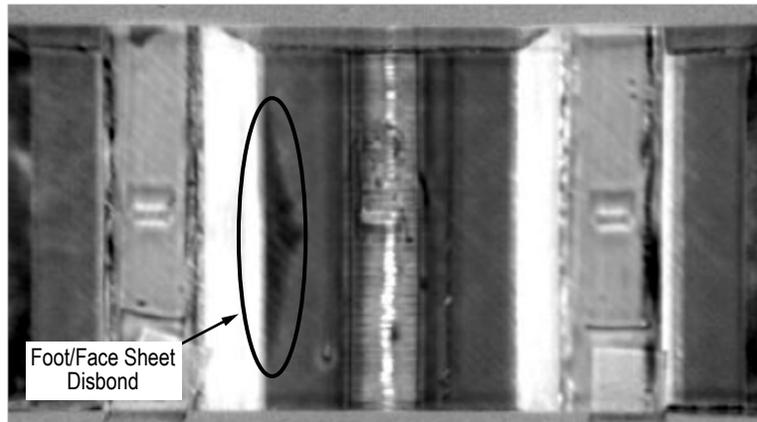
A photograph of an IRT image of the impacted specimen is presented in figure 7. It appears that a 3.4-in length ('length' defined as in the direction of loading) of the foot has disbonded from the face sheet. This disbond does not span the entire width of the foot and has a maximum width of 0.6 in (the foot bond has a width of 0.875 in). Thus, about 70% of the width of one of the feet on one of the hat stiffeners has disbonded due to the impact event.

Figure 7. IRT for specimen double 2.

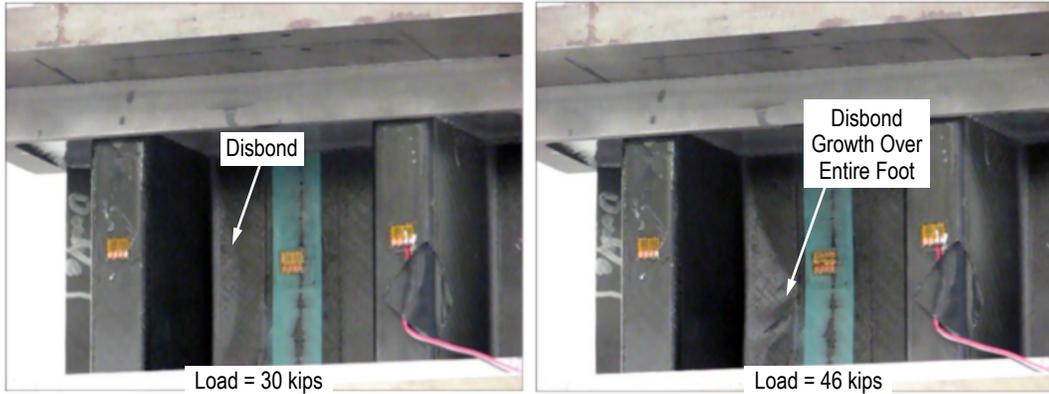
Upon loading, the disbond between the foot and face sheet grew steadily, in a width-wise direction, starting at 30 kips. The disbond grew across the width of the foot, and at 46 kips, an audible pop occurred. Photographs of the specimen near the beginning of the test and at 46 kips are shown in figure 8.

Figure 8. Hat stiffener/face sheet disbond growth on specimen double 2.

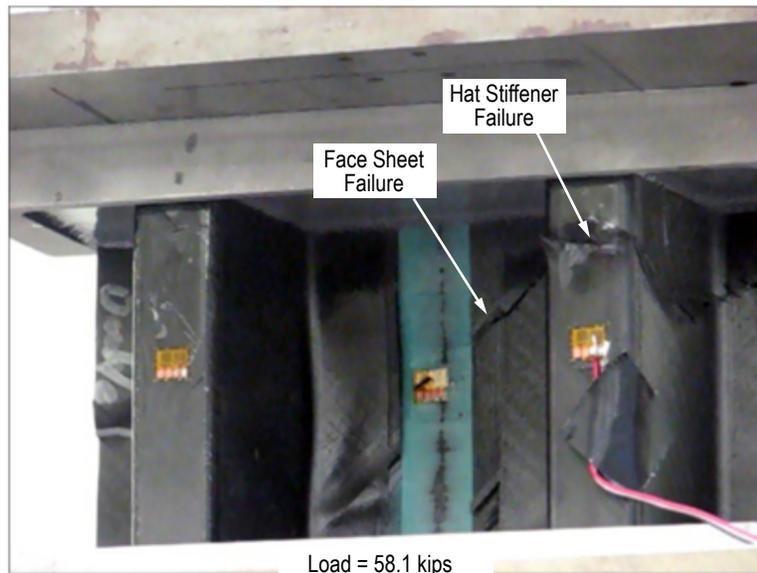
With further loading, catastrophic failure occurred at 58.1 kips. Catastrophic failure is defined in this study as total collapse of the face sheet and both hat stringers with no discernable time between collapse of these components of the structure. Catastrophic failure implies that the specimen could no longer carry any load. A photograph of the specimen just after failure is shown in figure 9.

Figure 9. Failure of specimen double 2.

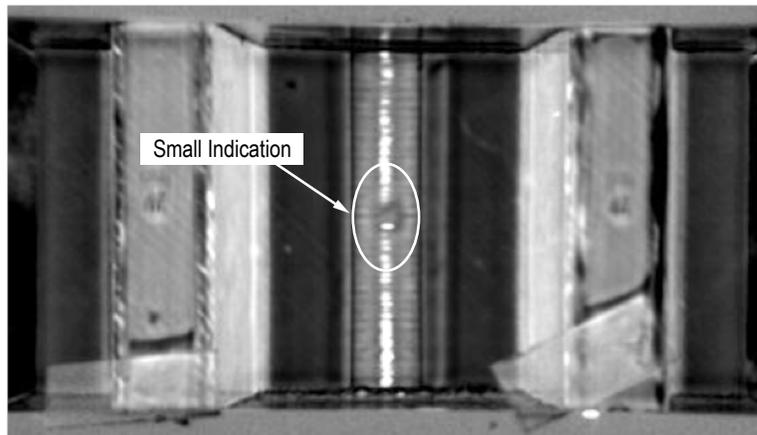
A photograph of an IRT image of the impacted specimen is presented in figure 11. A relatively small indication suggests that there are one or more circular delaminations within the face sheet with an overall size of ≈ 0.5 -in diameter.

Figure 11. IRT for specimen double 3.

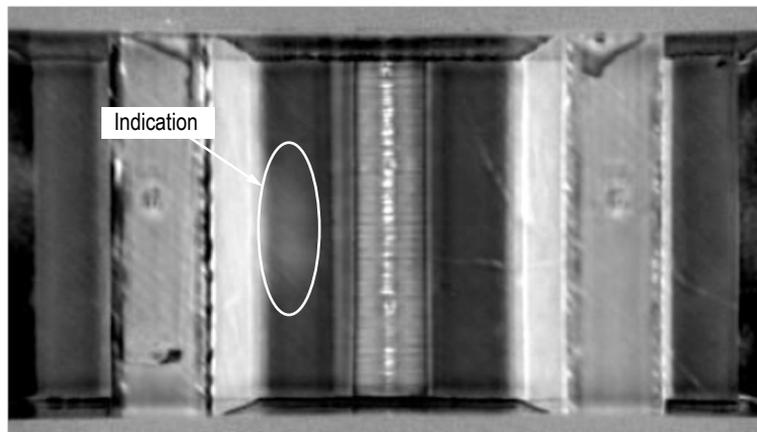
A photograph of an IRT image of the impacted specimen is presented in figure 13. The indication shows damage about 1.6 inches in length and spanning 80% of the width of the foot. Although this specimen was hit with more impact energy than specimen double 2, the length of the disbond between the foot and face sheet was about one-half that of specimen double 2.

Figure 13. IRT for specimen double 4.

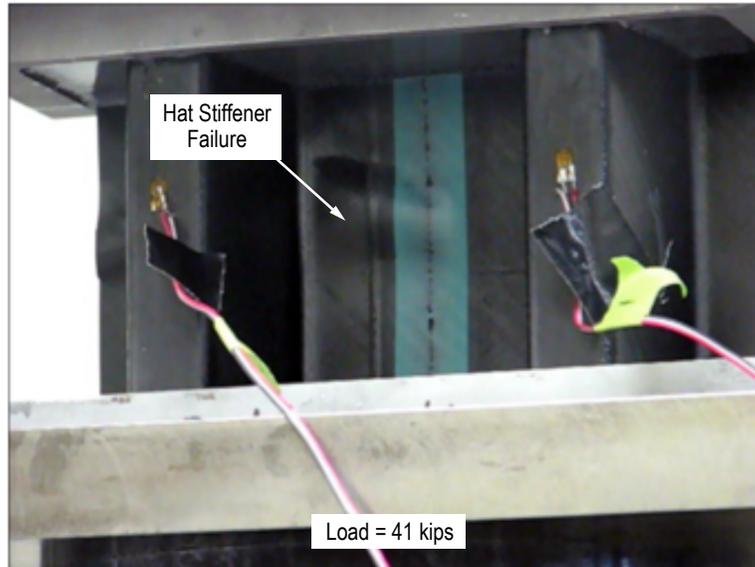
The specimen exhibited disbonding of the impacted foot section from the face sheet at 40 kips. This disbond appears to go beyond the foot of the hat stiffener and extends into the face sheet of the specimen. Figure 14 shows a photograph of the specimen just after this disbond has occurred. Apparently the disbond seen in the IRT image is in the face sheet itself rather than at the hat/face sheet bond as it was in specimen double 2. Thus, the larger diameter impactor perhaps changed the damage morphology.

Figure 14. Hat stiffener disbond of specimen double 4.

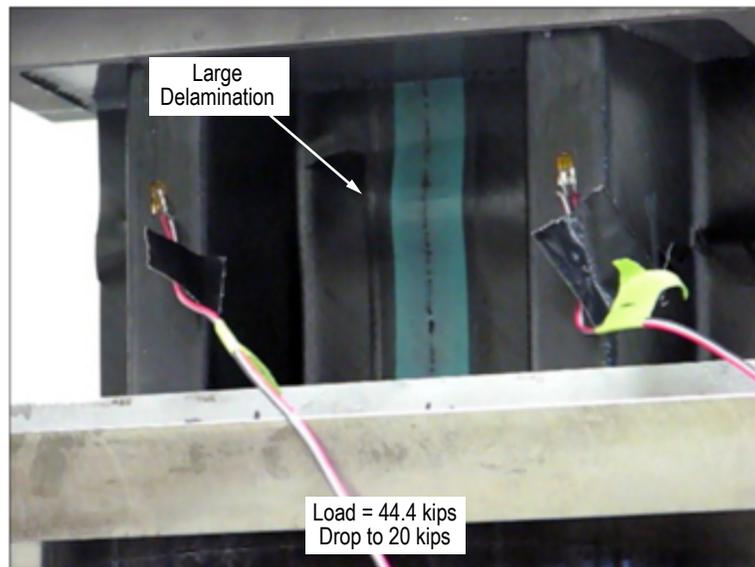
At 44.4 kips, the load fell suddenly to ≈ 20 kips as the large delamination propagated across the face sheet of the specimen from the original delamination that was seen at 40 kips (fig. 14). Testing was stopped at this point. A photograph of the specimen after the large delamination has formed across the entire face sheet is shown in figure 15.

Figure 15. Delamination across entire face sheet of specimen double 4.

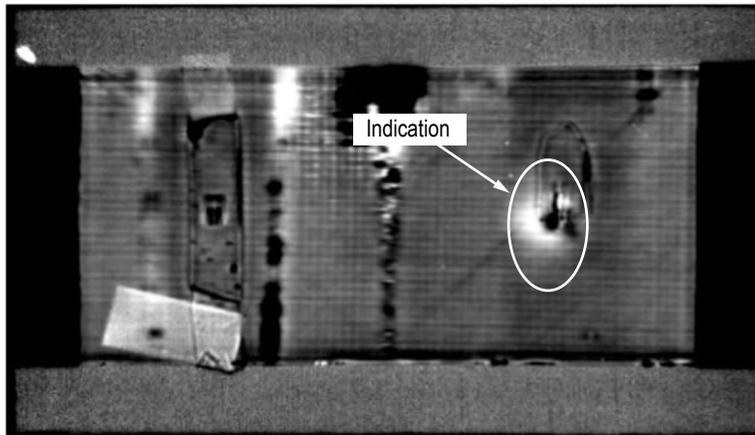
A photograph of an IRT image of the impacted specimen is presented in figure 17. The impact caused a circular area of damage ≈ 1 inch in diameter.

Figure 17. IRT for specimen double 5.

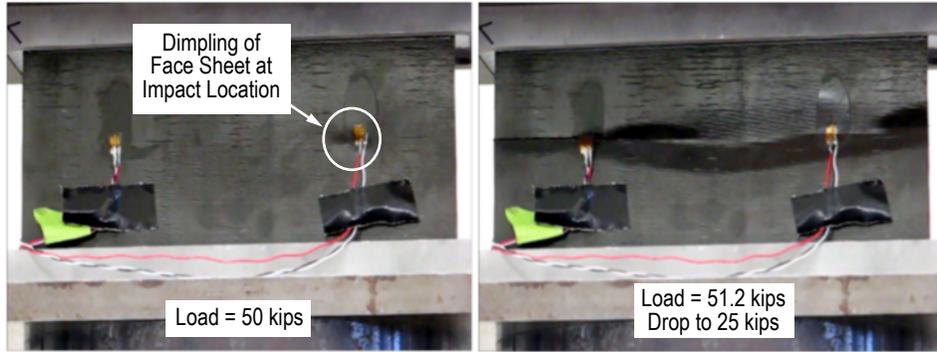
The specimen exhibited dimpling of the face sheet at the impact location beginning at ≈ 45 kips. At a load of 51.2 kips, the face sheet failed from the impact zone but the hat stiffeners remained intact. After failure, the specimen was able to carry a load of 25 kips. The face sheet dimpling and face sheet failure are shown in figure 18.

Figure 18. Dimpling at impact site and face sheet failure of specimen double 5.

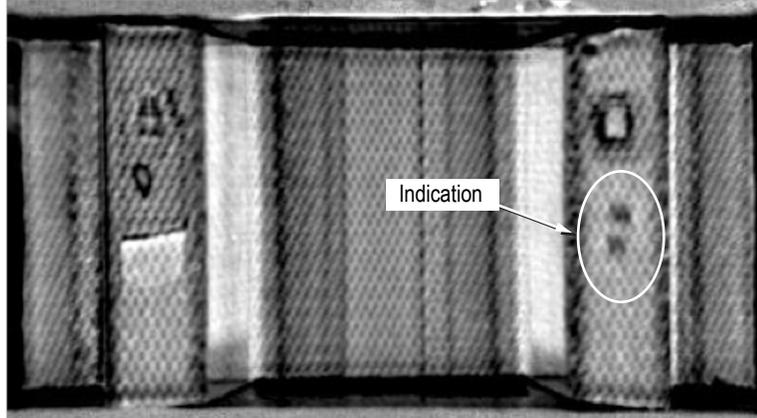
A photograph of an IRT image of the impacted specimen is presented in figure 20. The image suggests damage about 1 in long and spanning 60% of the width of the crown.

Figure 20. IRT for specimen double 6.

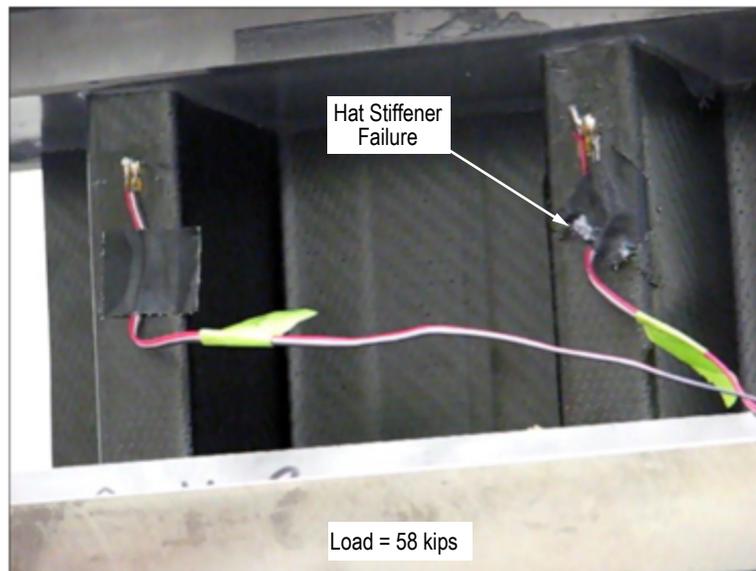
The specimen exhibited a loud pop at 57.9 kips which consisted of failure of the impacted crown as shown in figure 21.

Figure 21. Hat stiffener failure of specimen double 6.

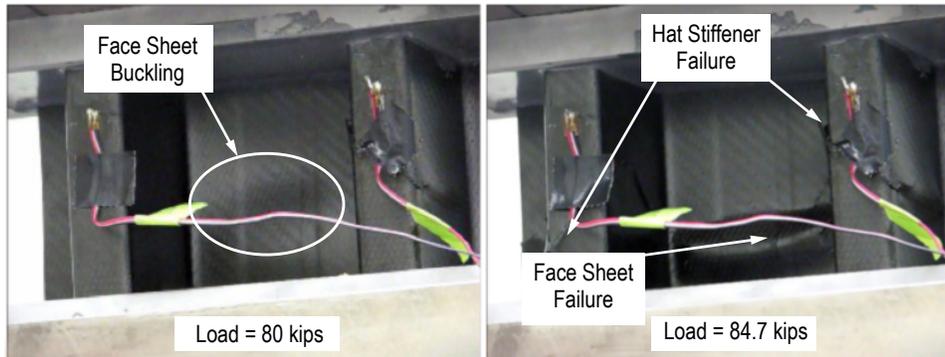
Buckling of the face sheet was apparent at ≈ 70 kips and the specimen failed in a catastrophic manner at 84.7 kips. Photographs of these two events are shown figure 22.

Figure 22. Buckling and catastrophic failure of specimen double 6.

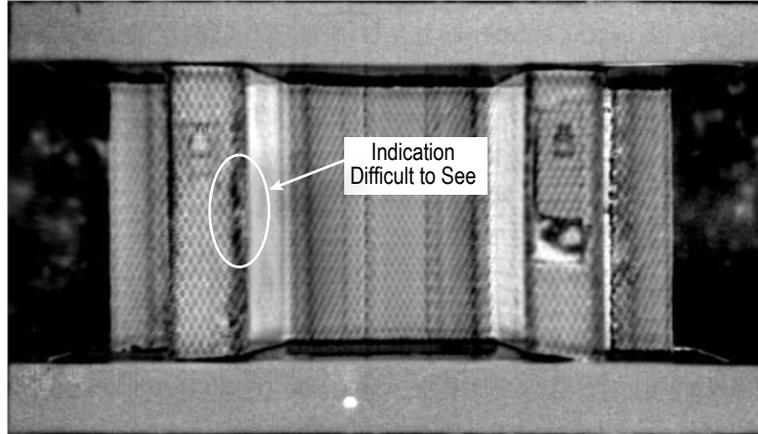
A photograph of an IRT image of the impacted specimen is presented in figure 24. The indication is difficult to see due to the web of the hat stiffener being under the impact site. This changes the damage morphology as well as gives a different IRT signature as can be noted on all of the other specimens that show ‘nonuniformity’ at the edges of the crown.

Figure 24. IRT for specimen double 7.

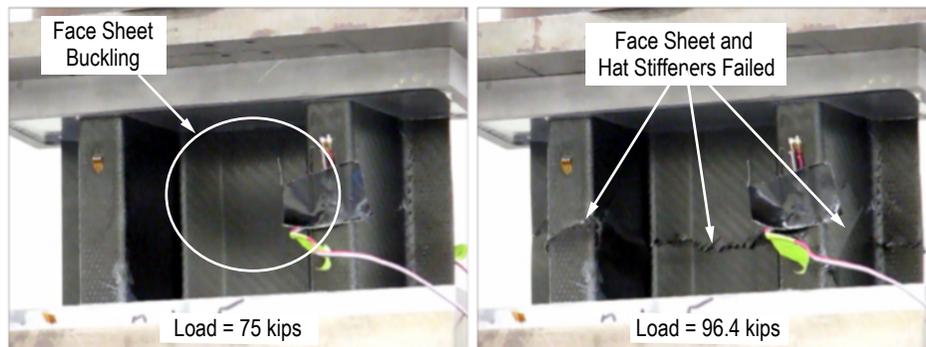
The specimen exhibited buckling of the face sheet beginning at 70 kips and failed catastrophically at 96.4 kips. Pictures of these two events are shown in figure 25. Since the crown did not fail as it did in specimen double 6, it is surmised that an impact at the crown/web interface is not as critical as an impact in the center of the crown. This is probably due to the high stiffness at the crown/web interface.

Figure 25. Buckling and catastrophic failure of specimen double 7.

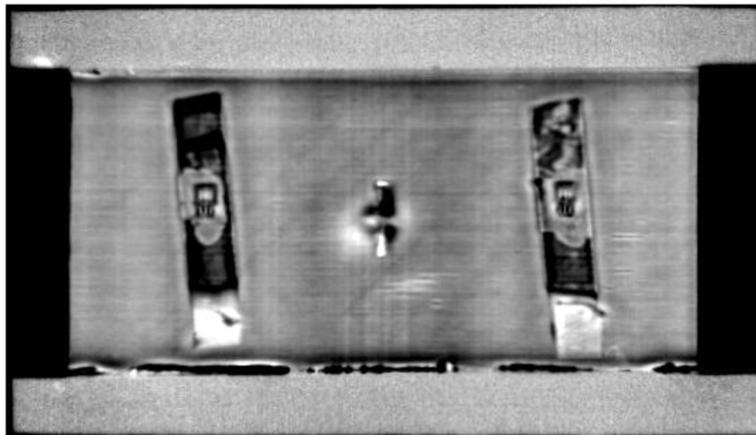
A photograph of an IRT image of the impacted specimen is presented in figure 27. The impact produced a circular area of damage ≈ 1 inch in diameter. This is similar to the damage produced by impacting the face sheet under a hat stiffener (specimen double 5).

Figure 27. IRT for specimen double 8.

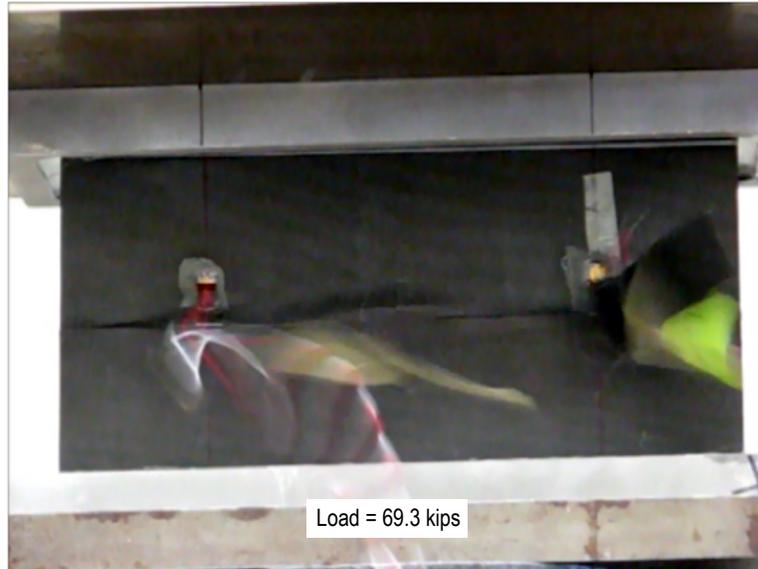
At a load of 69.3 kips, the face sheet of the specimen failed as shown in figure 28. Despite having a similar NDE signature as specimen double 5, this specimen demonstrated more residual compressive load-carrying capability. This is due to the co-cured, hat stiffener specimens demonstrating superior compression strength over the specimens with precured hat stiffeners.

Figure 28. Failure of face sheet of specimen double 8.

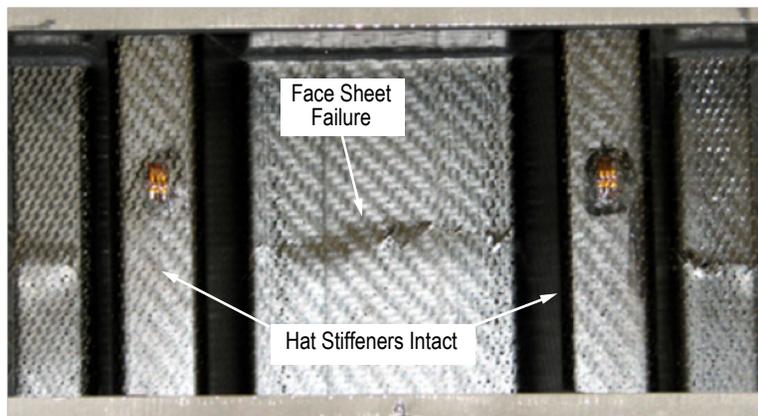
The specimen was still able to carry a load of 36 kips as the hat stiffeners did not fail as shown in the post-testing picture in figure 29.

Figure 29. Specimen double 8 showing intact hat stiffeners after face sheet failure.

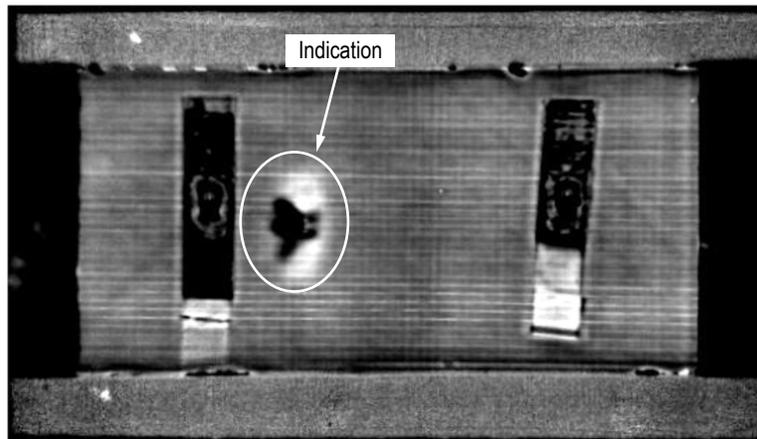
A photograph of an IRT image of the impacted specimen is presented in figure 31. The damage is about twice as long as it is wide, indicating that perhaps the impact caused a disbond of the foot from the face sheet (like specimen double 2).

Figure 31. IRT for specimen double 9.

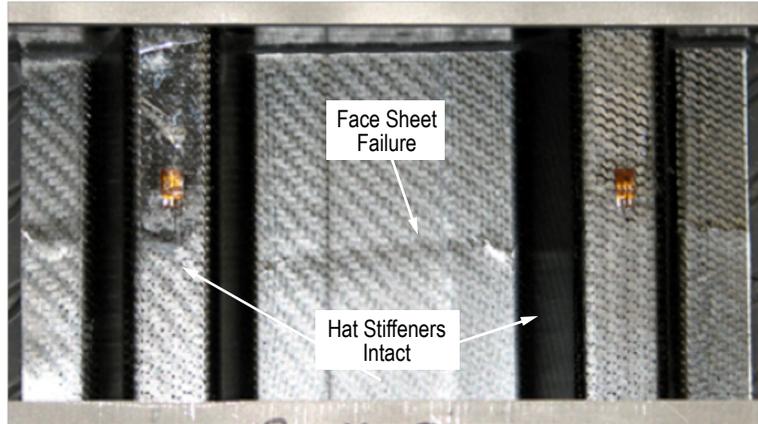
The specimen exhibited debonding of the foot from the face sheet at the impact site beginning at 50 kips. This event was not captured on video since all views during loading were from the impacted side. At a load of 54.1 kips, the specimen face sheet failed and the specimen held a residual load of 31.9 kips. As with specimen double 2, the residual load-carrying capability is due to the fact that the hat stiffeners did not fail and could thus carry load. A post-testing picture of specimen double 9 is shown in figure 32.

Figure 32. Specimen double 9 showing intact hat stiffeners after face sheet failure.

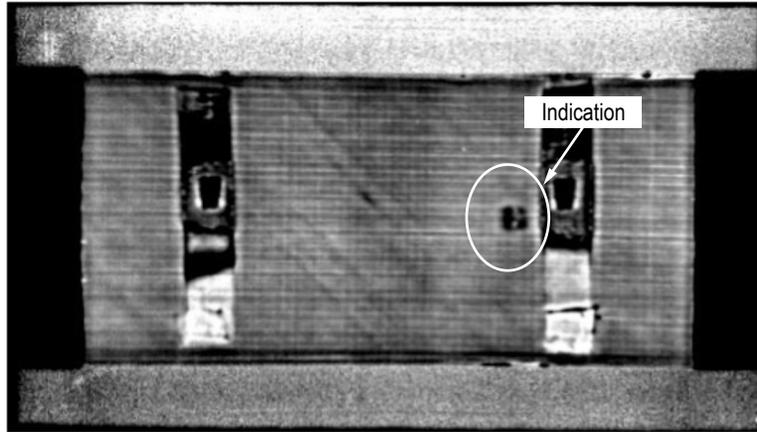
A photograph of an IRT image of the impacted specimen is presented in figure 34. The damage is approximately circular with a diameter of 0.5 in. This damage size is smaller than other impacts of similar energy. This is due to the face sheet being most stiff (transversely) where the hat stiffener meets the face sheet.

Figure 34. IRT for specimen double 10.

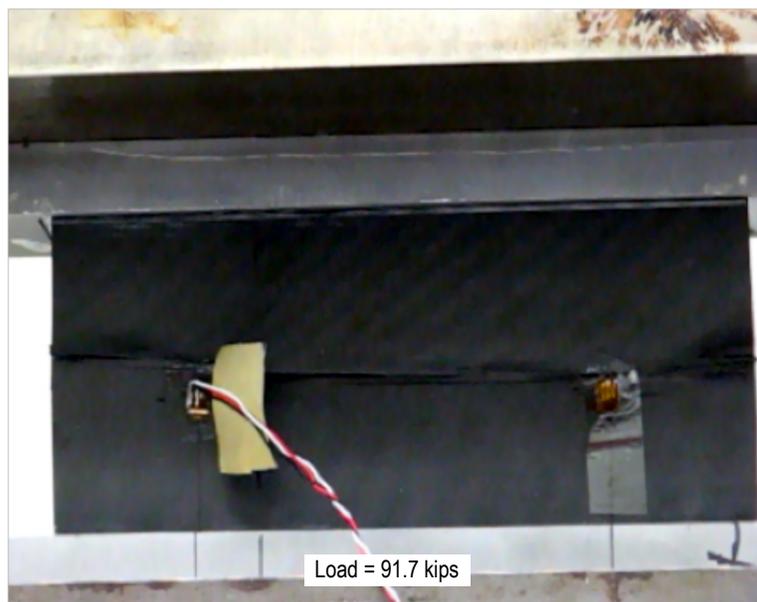
At a load of 91.7 kips, the specimen failed catastrophically. The face sheet did demonstrate buckling at ≈ 70 kips, but this was not as detectable by video when viewed from the face sheet side of the specimen. A photograph of the specimen just after failure is shown in figure 35. Unlike specimens that could carry a residual load after face sheet failure, this specimen demonstrated catastrophic failure as the hat stiffeners broke at the same time as the face sheet. A post-test picture of the specimen is shown in figure 36, showing the failed hat stiffeners in addition to the failed face sheet.

Figure 35. Failure of face sheet of specimen double 10.

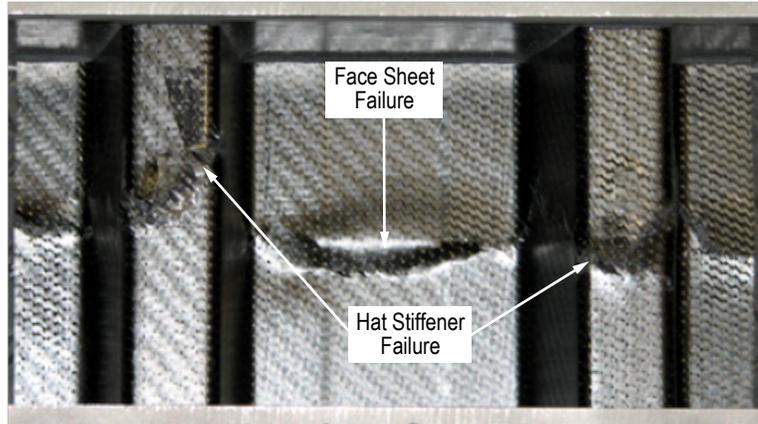
Figure 36. Specimen double 10 showing failed hat stiffeners and face sheet.

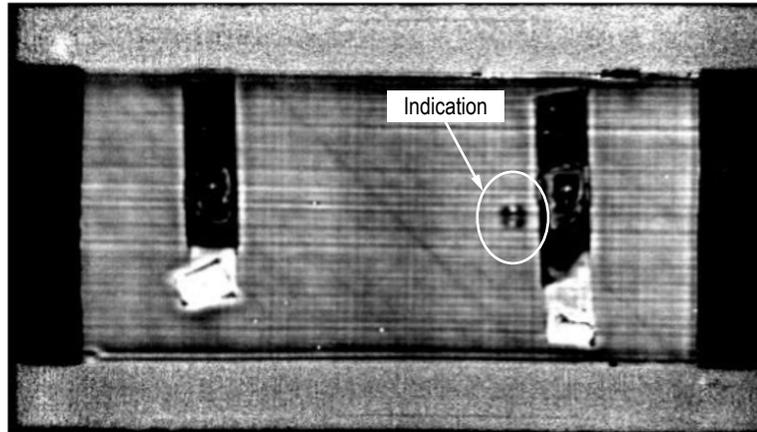
A photograph of an IRT image of the impacted specimen is presented in figure 38. As expected, this IRT image is similar to the IRT image of specimen double 10.

Figure 38. IRT for specimen double 11.

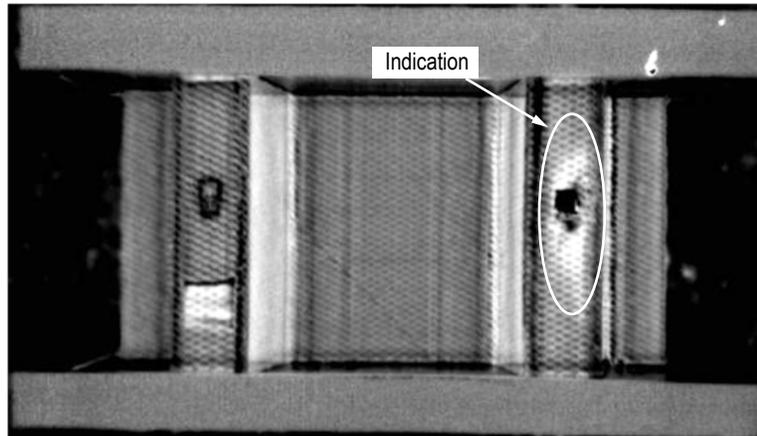
A photograph of an IRT image of the impacted specimen is presented in figure 40. As expected, this IRT image shows more damage in the crown than the impacted crown on specimen double 7. The damage covers the width of the crown and is 2.8 in long compared to 60% of the width of the crown and a length of 1 in.

Figure 40. IRT for specimen double 12.

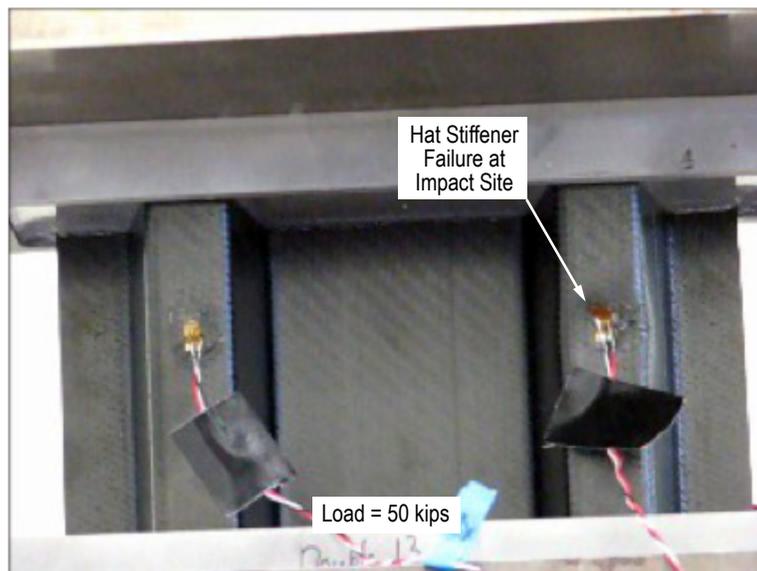
The impacted crown demonstrated a compressive failure at 50 kips. This event is shown in figure 41. The face sheet began a noticeable buckle at ≈ 60 kips and at a load of 77.8 kips, the specimen failed catastrophically. Photographs of these two events are shown in figure 42.

Figure 41. Dimpling at impact site and face sheet failure of specimen double 12.

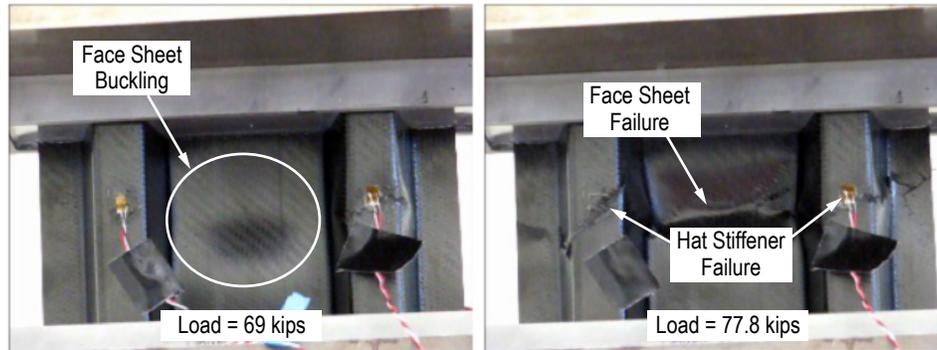
Figure 42. Face sheet buckling and catastrophic failure of specimen double 12.

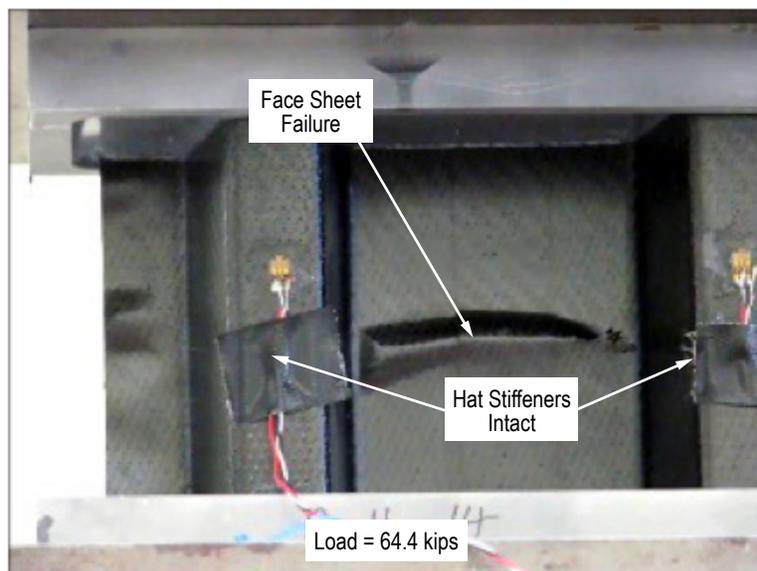
At a load of 64.4 kips, the face sheet failed but the hat stiffeners stayed intact and the specimen carried a residual load of 35 kips. A photograph of specimen double 13 after face sheet failure is shown in figure 45.

Figure 45. Face sheet failure of specimen double 13.

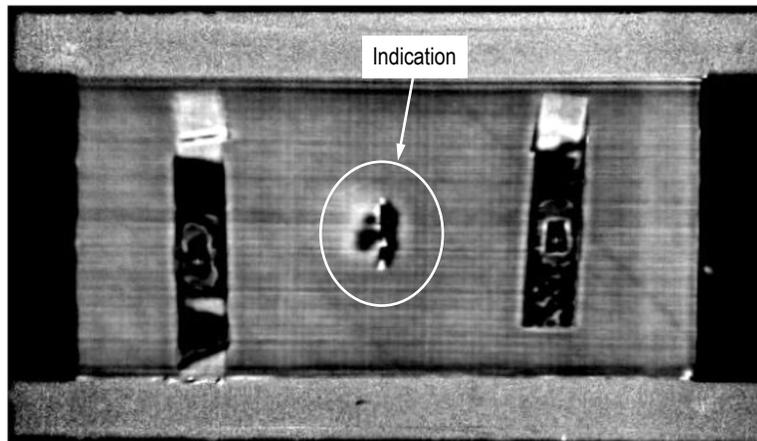
A photograph of an IRT image of the impacted specimen is presented in figure 47. As expected, this IRT image is similar to the IRT image of specimen double 8, though slightly larger. The degree of damage seen in specimen double 14 is 1.1 in wide compared to a 0.9-in width for specimen double 8.

Figure 47. IRT for specimen double 14.

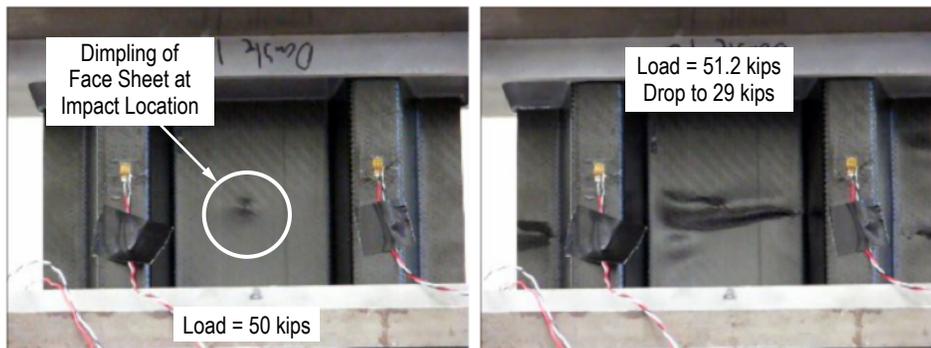
Localized dimpling at the impact zone was noted at 45 kips. At a load of 51.2 kips (26% lower than specimen double 8), the specimen failed, but continued to carry a load of 29 kips. Pictures of these two events are shown in figure 48.

Figure 48. Dimpling at impact site and face sheet failure of specimen double 14.

Upon continued loading, the specimen then reached 37 kips before the load dropped again. This specimen demonstrated a similar failure mode but had less compressive load-carrying capability than specimen double 8. Upon closer inspection of the video recordings, it was noted that specimen double 14 had an audible cracking sound at the onset of the formation of the dimple at the impact site (45 kips). When specimen double 8 failed, there were no audible sounds before the face sheet failure. This indicates that specimen double 14 had less interlaminar strength in its face sheet than specimen double 8. This hypothesis was supported upon continued loading of specimen double 14 in which further delaminations formed in the face sheet rather than the load being effectively transferred to the hat stiffeners.
