Preservation Tech Notes

NUMBER 21

Replacement Wood Sash Utilizing True Divided Lights and An Interior Piggyback Energy Panel

BEATTY'S MILL (CORAL STREET ARTS HOUSE) Philadelphia, Pennsylvania

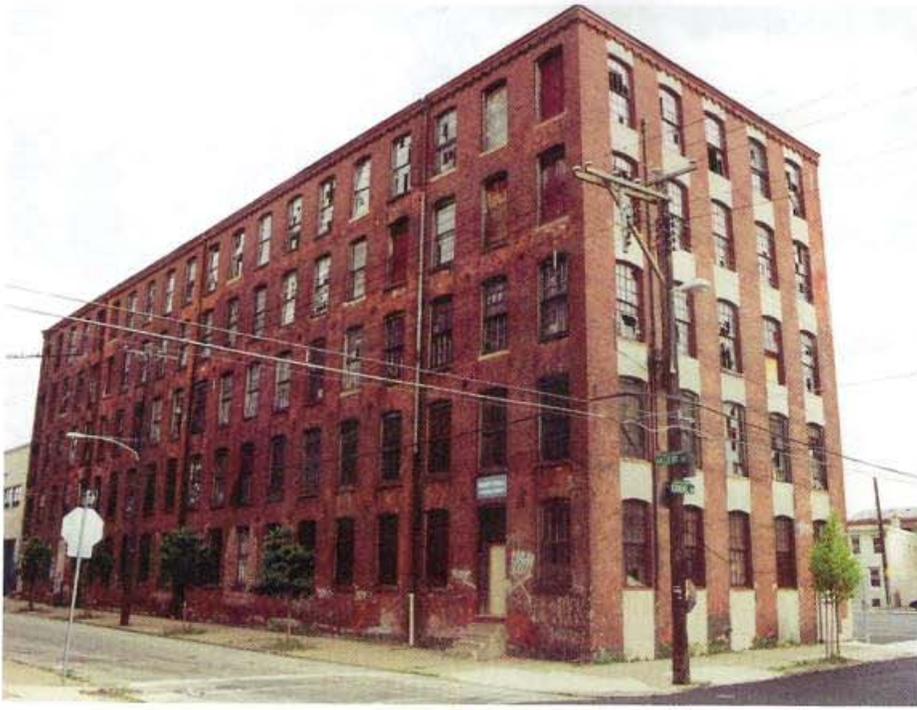
Figure 1. Constructed in 1886, the Beatty's Mill is located at a street intersection. The segmental arched windows are a distinguishing feature of the building.

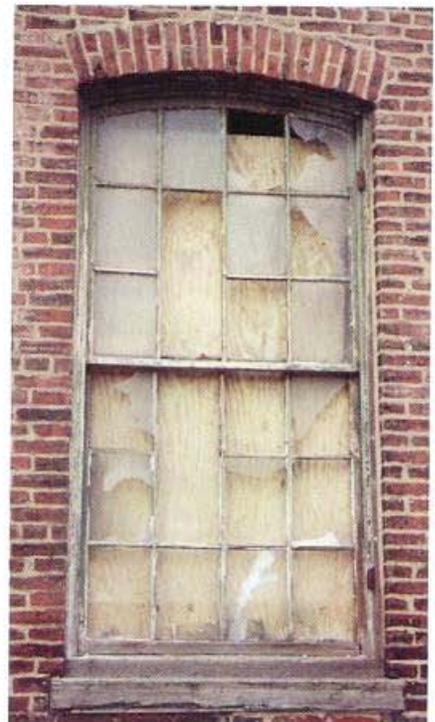
The large double-hung wood windows were one of the most prominent features of the mill. Each measured 48" by 96" with 12 lights of glass in both the upper and lower sash. Characteristic of many mill windows of the time, the sash frames were set in the masonry walls so as to minimize frame exposure on the outside. This provided for more light on the interior. It also enhanced fire safety through minimizing exposed wood on the outside, thus reducing the risk of flames spreading from an adjacent building fire (see figure 2). The outer face of the meeting rail was quite narrow.

Figure 2. The historic double-hung wood windows had narrow sash and frame members that contributed to the distinctive qualities of the windows.

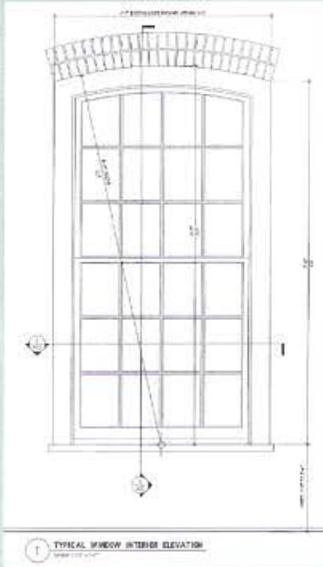
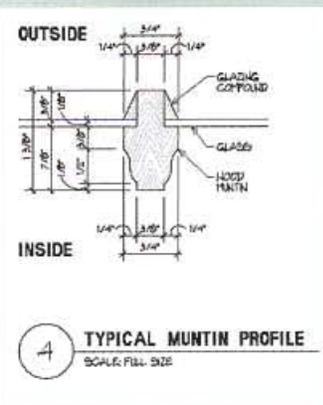
Figure 3. Drawings of the historic windows were prepared by the architectural firm based on field measurements to assist in devising an appropriate replacement window. Drawings: Courtesy of Kitchen & Associates Architectural Services.

The location of this building right on a street corner and the importance of the windows to the historic character of the building led the project team to select a window solution that closely matched both the detail and appearance of the historic windows. By selecting a new custom wood window, the narrow site lines of the historic windows could be closely replicated, the historic glass to wood ratio readily maintained, and other historic details easily reproduced (see figure 3).

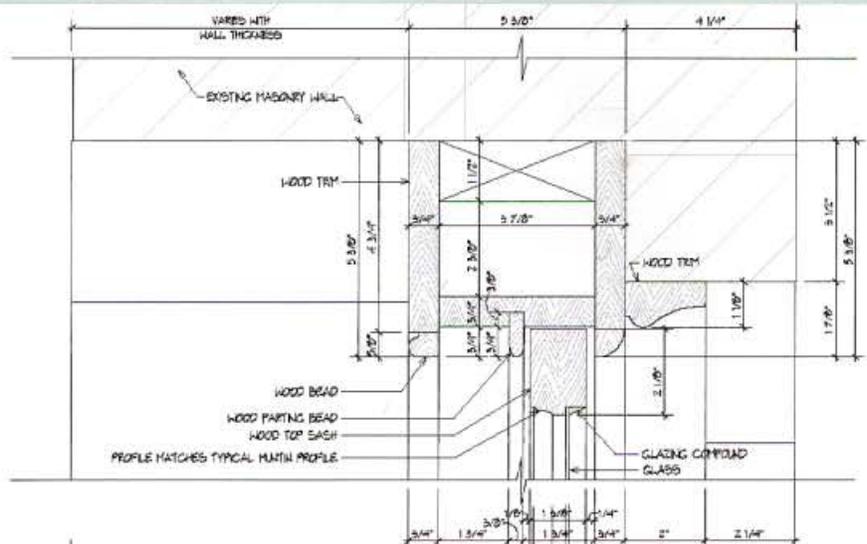
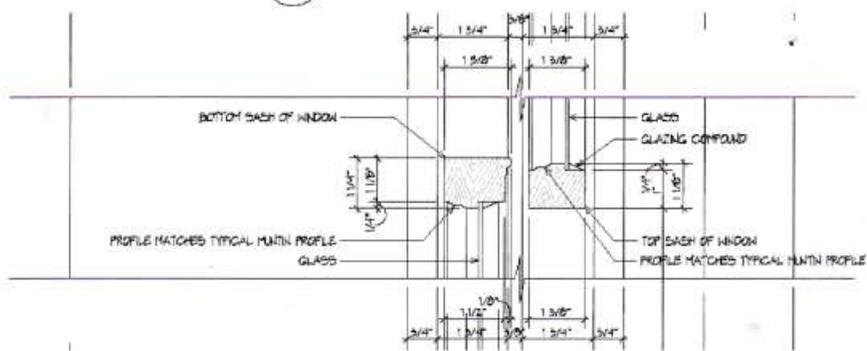
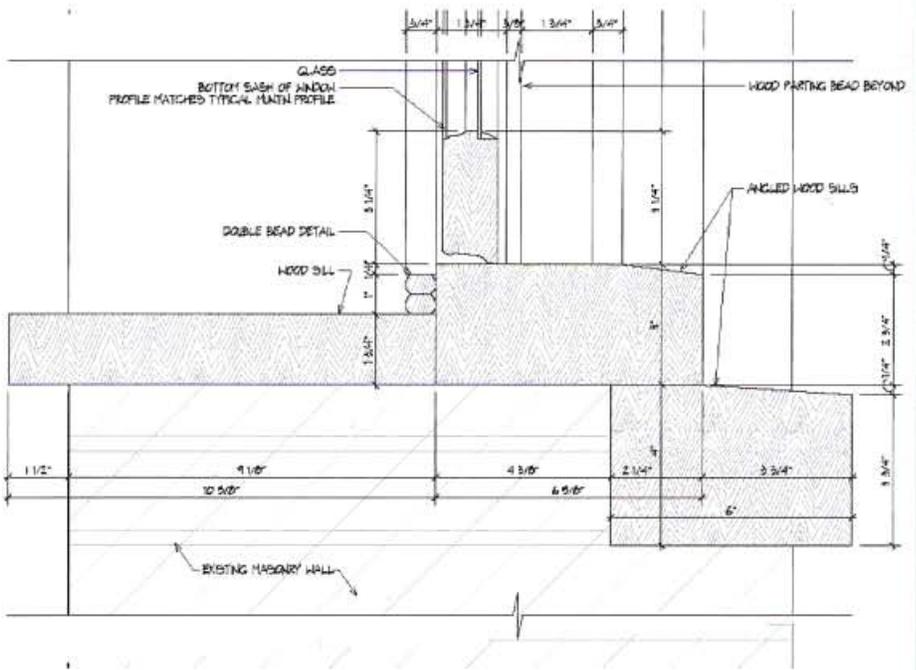
Figure 4. While using contemporary sash balances, the wood replacement windows had many traditional features such as putty glazing for the true wood muntins. Note the sash is rabbeted on the room side to a depth that permits the glazing panel to be set flush. Drawings: Courtesy of Seaquay Architectural Millwork.

To help retain the historic sightlines, the deteriorated frames were removed, permitting the new frames to be set close to the masonry (see figure 4). The alternate approach of retaining the existing frames, abutting new frames to them, and covering the outer face of the exposed portion of the older frames would have resulted in reduced glass exposure and a beefier frame appearance to the finished windows.

Several features of the new window were different than the historic windows in order to accommodate the dual glazing. The inside of the rails and stiles of the sash were rabbeted on the room side to a depth that permits the glazing panel to be set flush. To retain the depth of the original muntin and to accommodate the glazing panel on the inside, the thickness of the sash was increased to 1 3/4". In the bottom rail, weep holes were provided between the glazing panel and the outer glass, to allow water to drain from condensation that might on occasion develop between the two layers of glass.

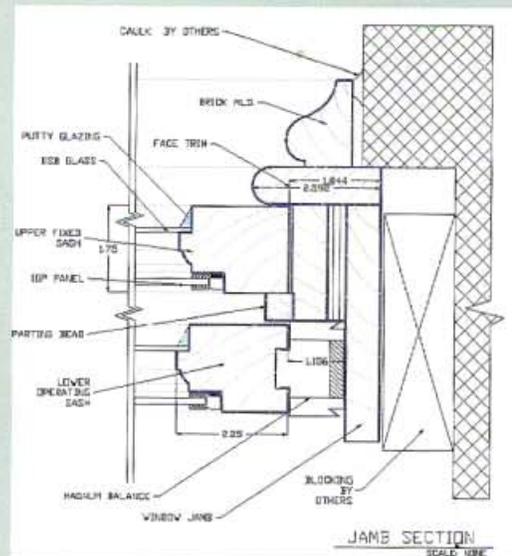
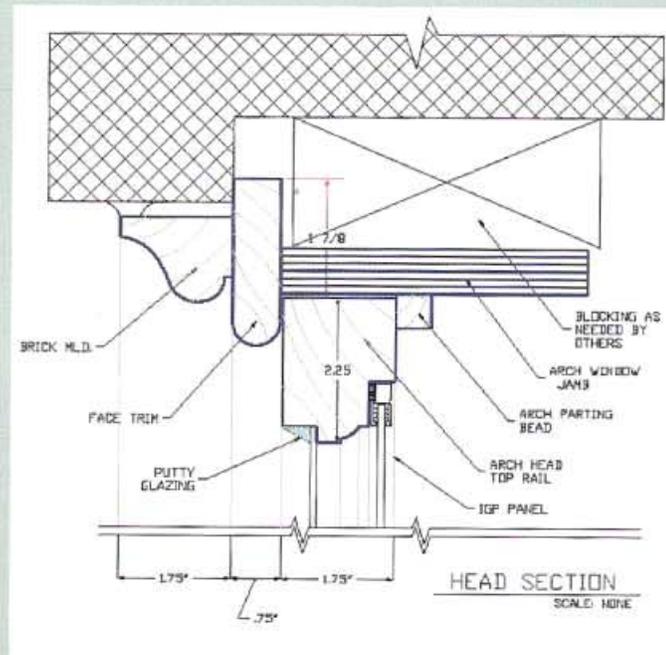
Figure 5. For the new windows to meet ASTM Standards, the face width of the meeting rail was increased 1/2 inch. To both accommodate the piggyback energy panel and match the historic muntins, the thickness of the wood sash was increased from 1 3/8" to 1 3/4". These two changes had minimal visual impact, considering the size of the windows. Drawings: Courtesy of Seaquay Architectural Millwork.

Somewhat more problematic was how close the bottom rail (meeting rail) of the new upper sash could match the narrow width of the existing window. Specifications for the project required that the replacement window meet three ASTM Standards: ASTM E283, the standard test for determining the rate of air leakage through an exterior window; ASTM E331, the test of water penetration; and ASTM E330, the standard test for structural performance of an exterior window. To meet ASTM E330 with the design pressure rating for the window set by the architect, a 1 3/4" wide meeting rail was needed (see figure 5). This was an increase of 1/2 inch over the historic sash. Fortunately because of the size of the window, this increase was considered acceptable, as the meeting rail still appeared relatively narrow even with the 1/2 inch increase.

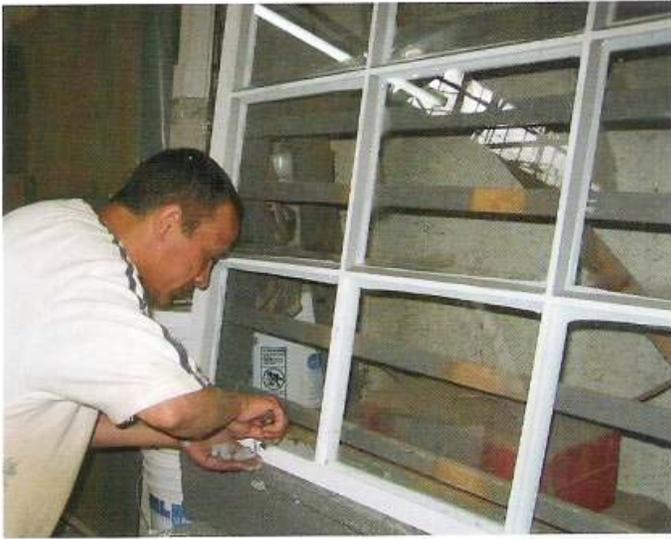
Figure 6. The outer glass was installed in the traditional manner, using exterior glazing putty. Photo: Charles Fisher.

The windows were then assembled and sanded. The outer glass was installed in the factory after the assembled sash were primed. Exterior glazing putty manufactured by C.R. Lawrence was applied in the traditional manner (see figure 6). Since the upper sash were to be fixed in the operable windows, weatherstripping and block and tackle balances were provided only for the lower sash. Each window was provided with two sweep locks and two sash lifts for the operable lower sash. Of the 188 replacement windows, 111 were single hung and 77 were fixed (see figure 7).

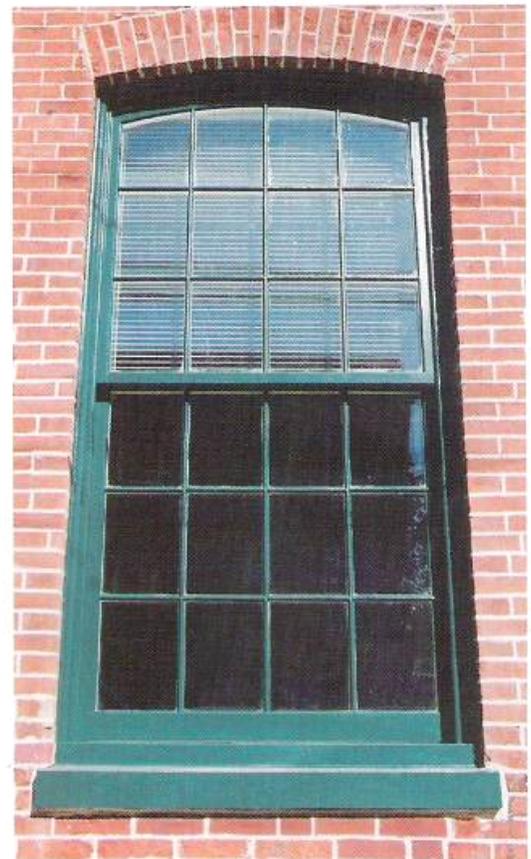
Figure 7. The new window's joinery, individual glass lights, reflective qualities, and painted wood finish all help to capture the appearance of the original units.

The new windows in Beatty's Mill successfully matched the historic units while providing enhanced energy conservation. There is little difference between the new and historic windows in terms of the characteristic features (see figures 2 and 7). The integral wood muntins, individual panes of glass, reflective qualities of the glass, glazing putty, and painted wood surfaces, along with the benefits of using a custom-wood window manufacturer that could duplicate

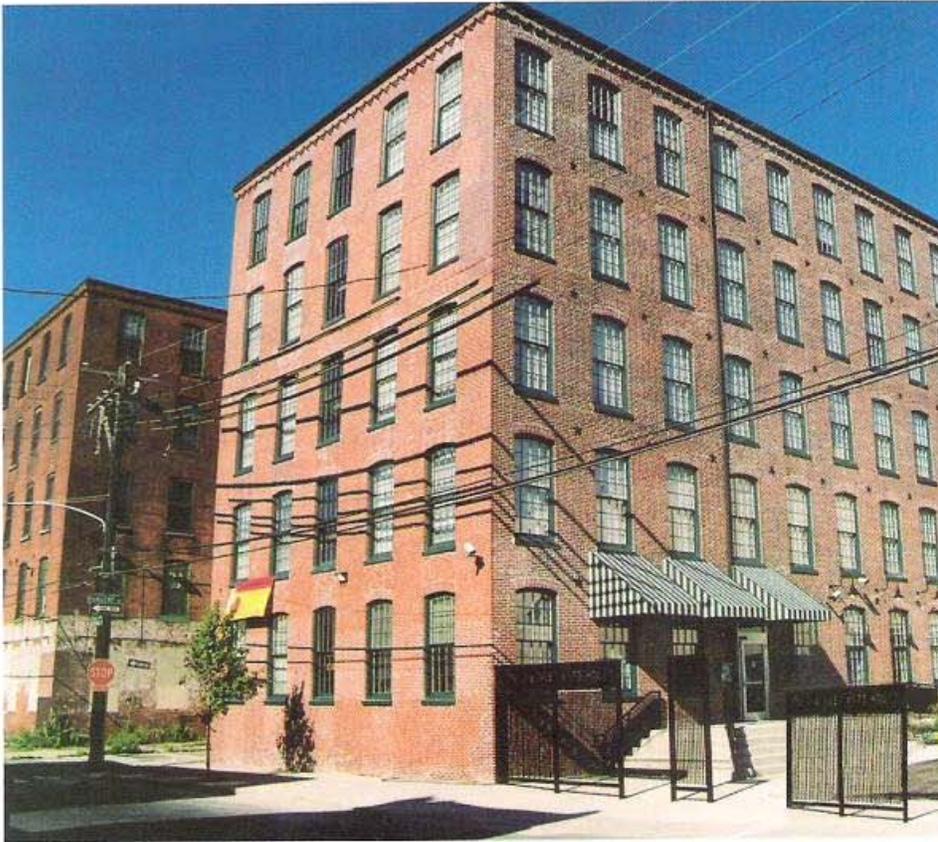
Figure 8. Upon completion of the work, the former mill now serves as low-income housing and artist live/work space. The new wood windows provide improved energy performance and enhance the visual qualities of the historic building.

the traditional true-divided light sash while incorporating dual glazing for energy conservation. Its use at Beatty's Mill and even larger buildings demonstrates that this type of a dual-glazed wood sash can be a viable window solution for projects of varying size (see figure 8).
