**Failure Analysis of OH-58 Kiowa Warrior
Drive Gear Shafts**

ARL-TR-3827

June 2006

U.S. Army Research Laboratory
Weapons and Materials Research Directorate
Aberdeen Proving Ground, MD 21005-5069

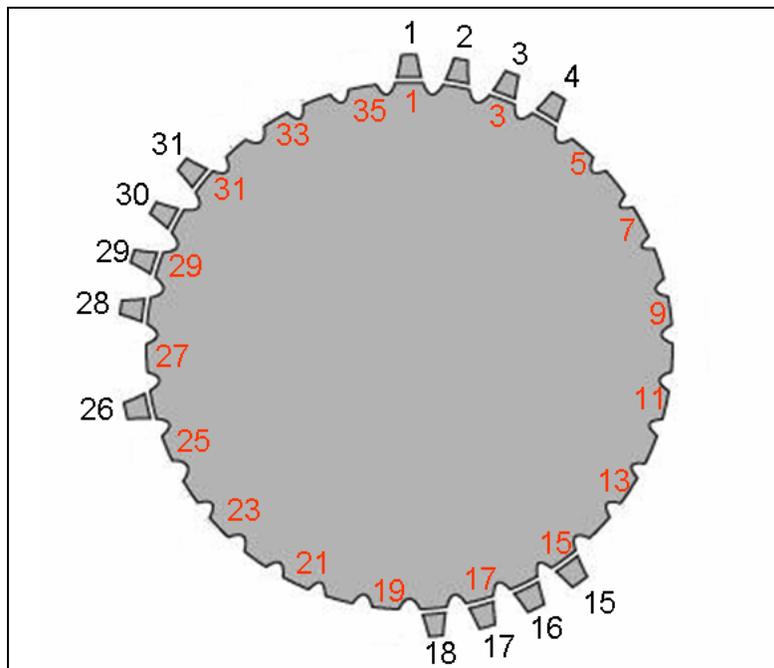
All teeth were stripped or separated from the failed gear; many fracture surfaces were too marred to yield useful information. Thirteen teeth were recovered essentially intact. The recovered teeth were successfully matched to their corresponding location on the gear by examination of the tooth geometry and fracture topography. The location of each tooth relative to the others is shown in figure 1.

Figure 1. Location of recovered teeth on spare drive gear. (Gear is driven counterclockwise.)

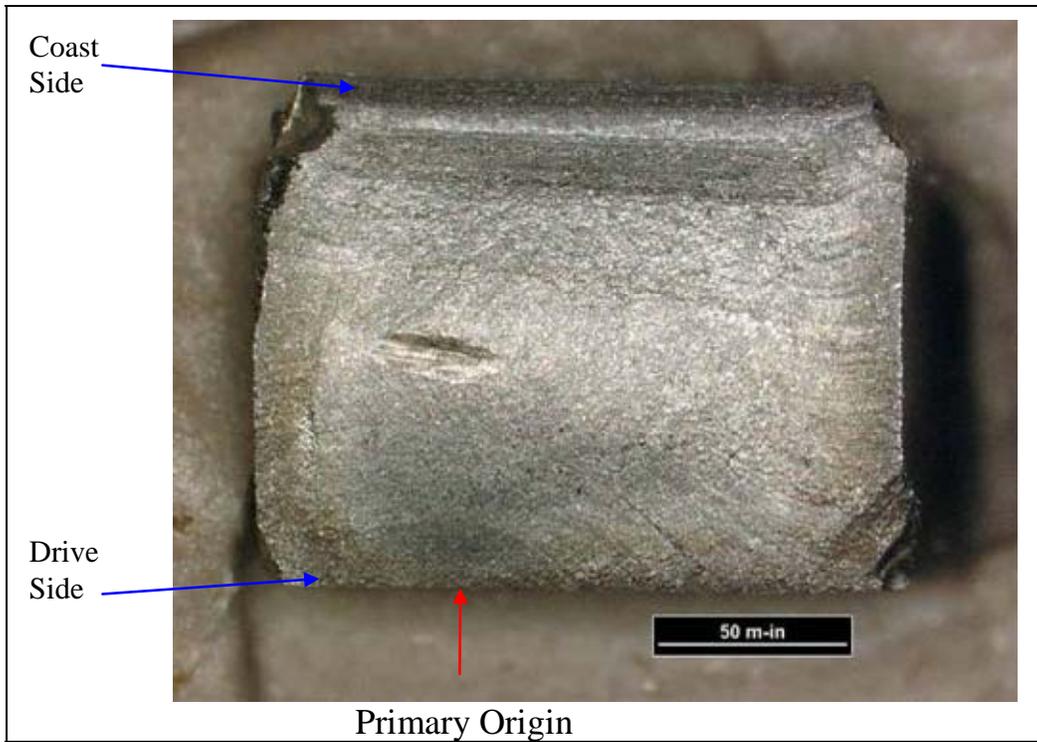
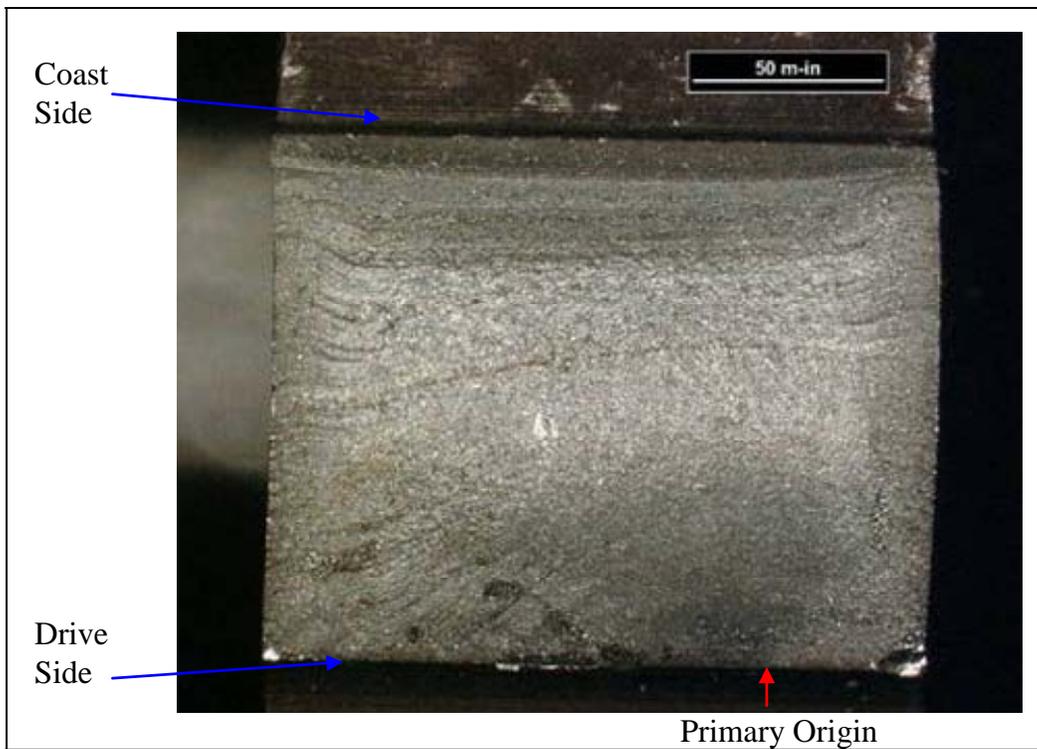
Fracture surfaces for tooth 1 are shown in figures 2–5. The primary origin for this tooth is shown in figure 4. Propagation was by fatigue with a secondary crack initiating on the coast side. A very small overload region was present, as depicted in figure 5.

Figure 2. Tooth 1, tooth fracture half.

Figure 3. Tooth 1, gear fracture half.

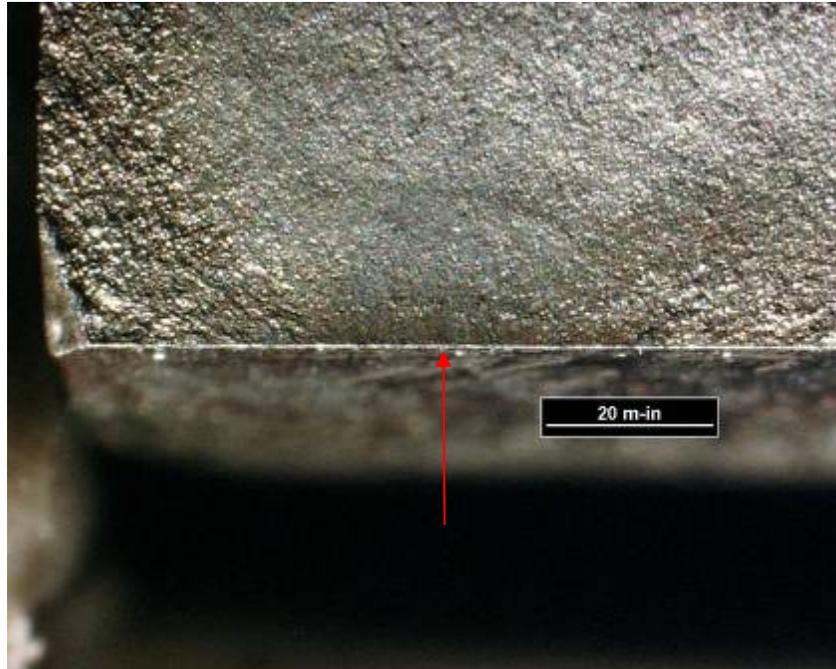
Figure 4. Primary origin, drive side of tooth 1, tooth fracture half.

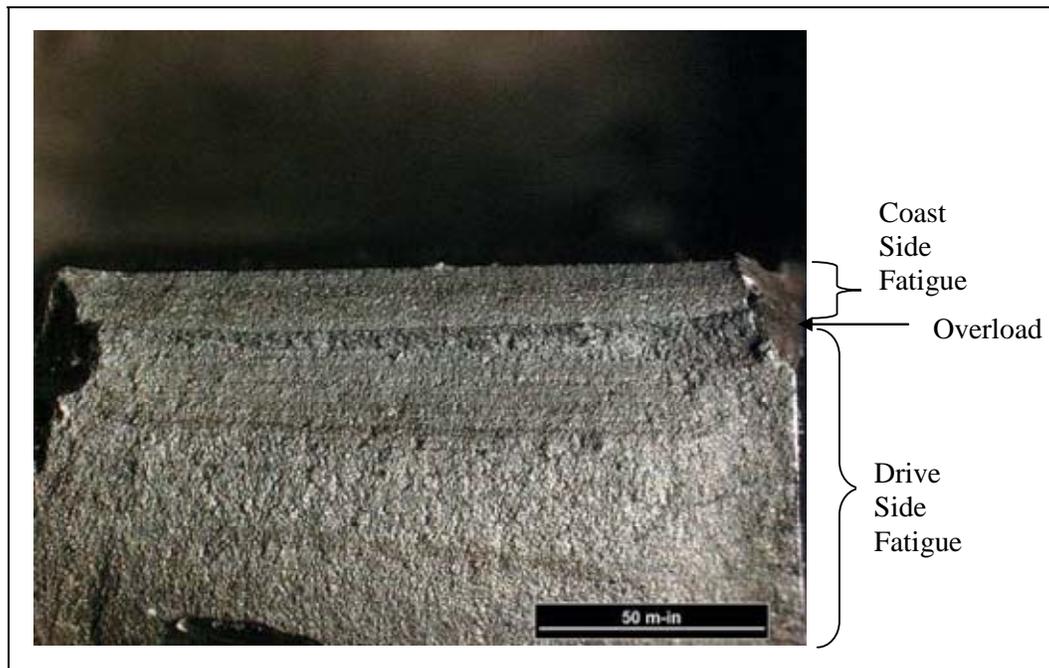
Figure 5. Coast side of tooth 1, tooth fracture half.

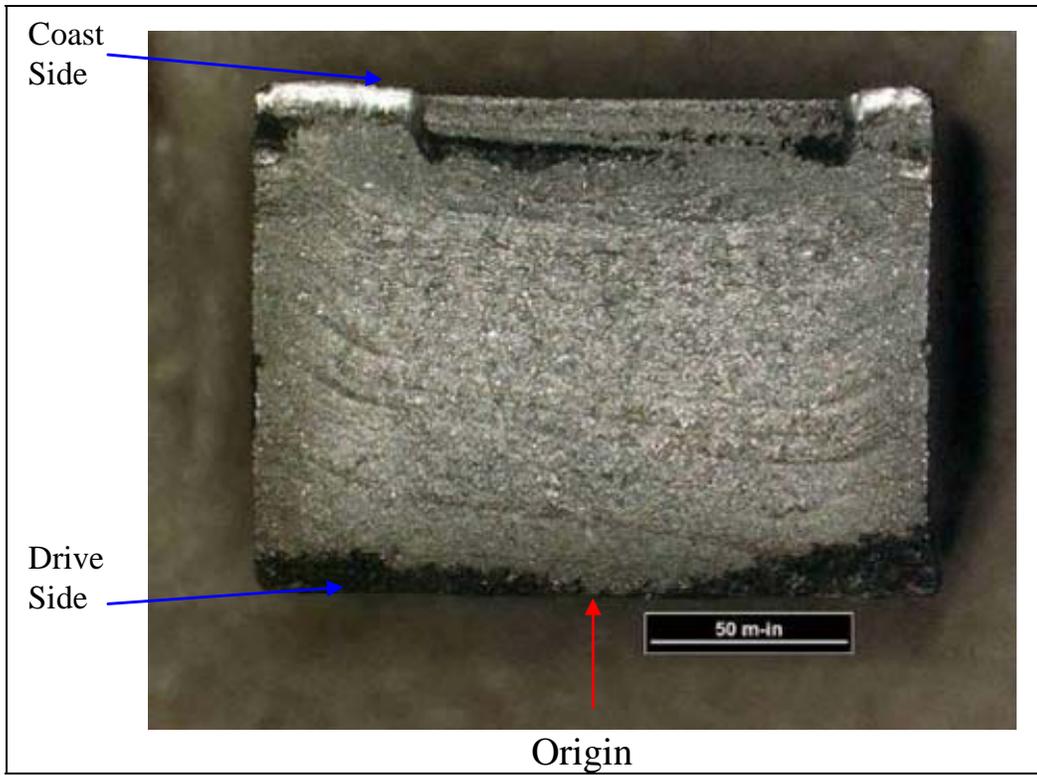
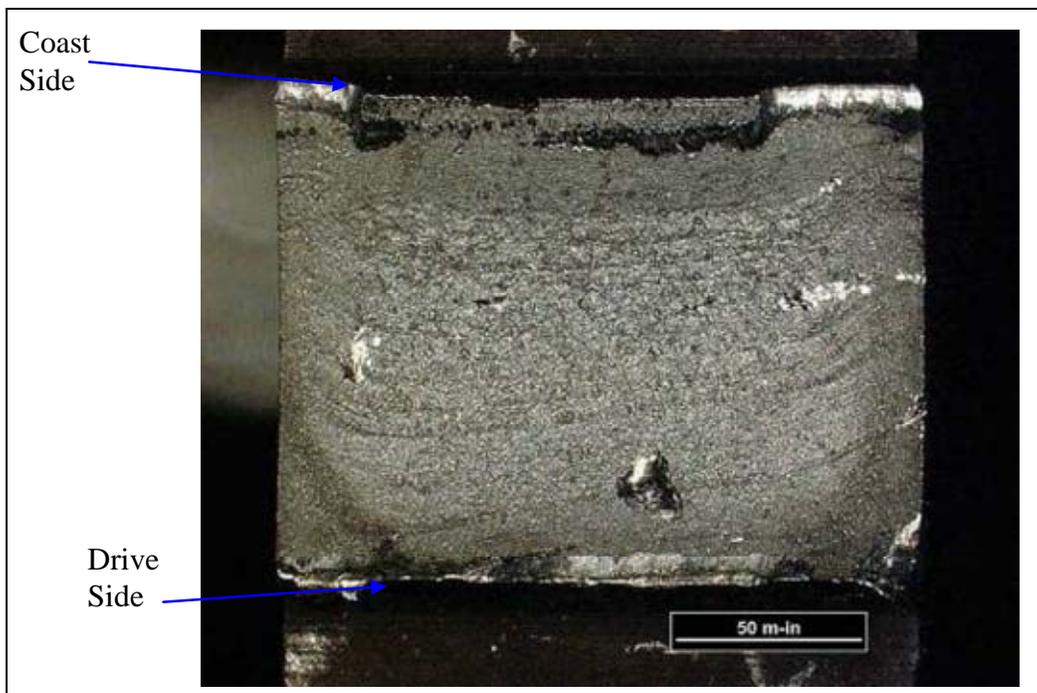
Figures 6 (tooth half) and 7 (gear half) show the fracture surfaces observed on tooth 2. Note the more pronounced beach marks relative to tooth 1.

Figure 6. Tooth 2, tooth fracture half.

Figure 7. Tooth 2, gear fracture half.

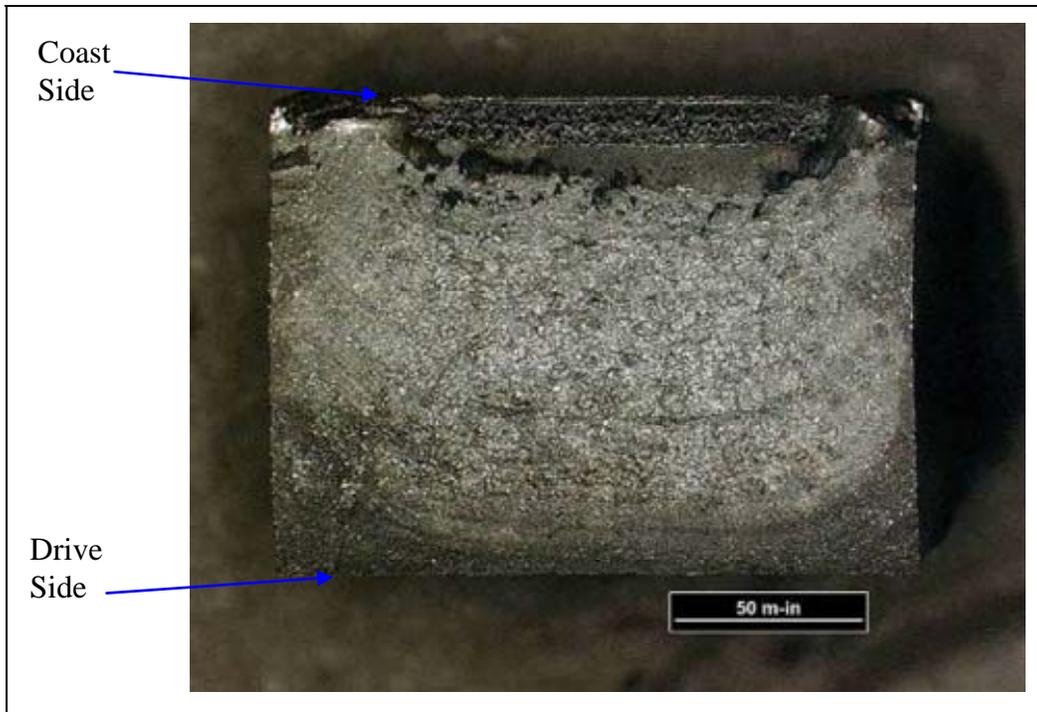
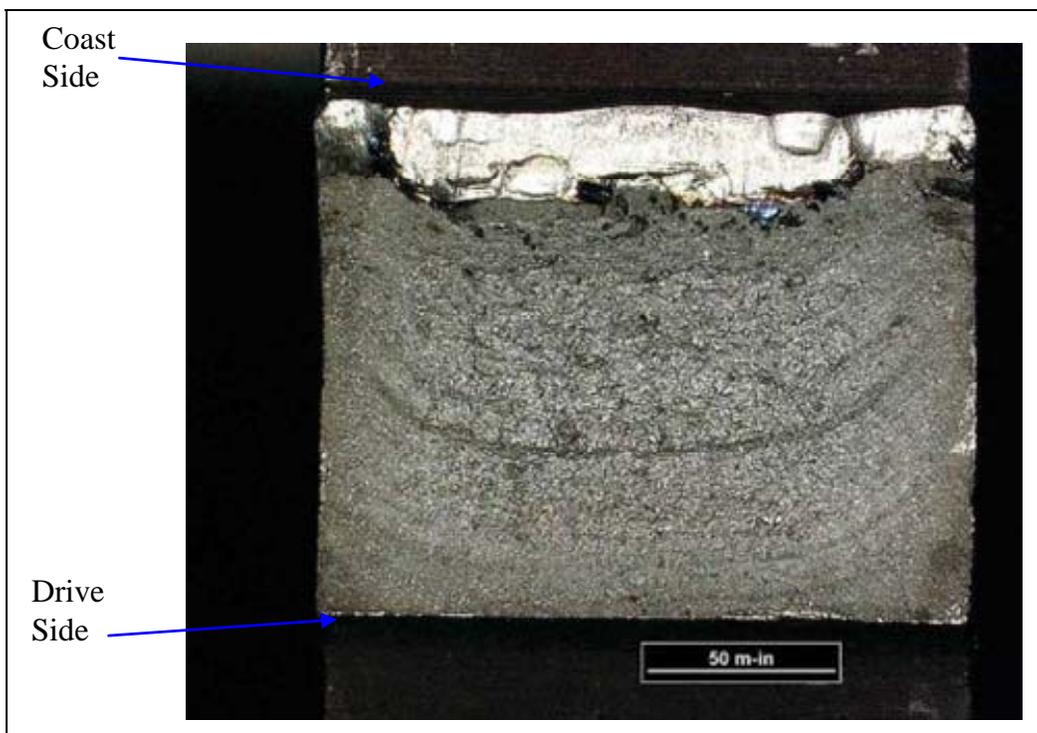
Figures 8 and 9, respectively, present the tooth and gear fracture halves of tooth 3. The overload region was significantly larger than on the preceding teeth.

Figure 8. Tooth 3, tooth fracture half.

Figure 9. Tooth 3, gear fracture half.

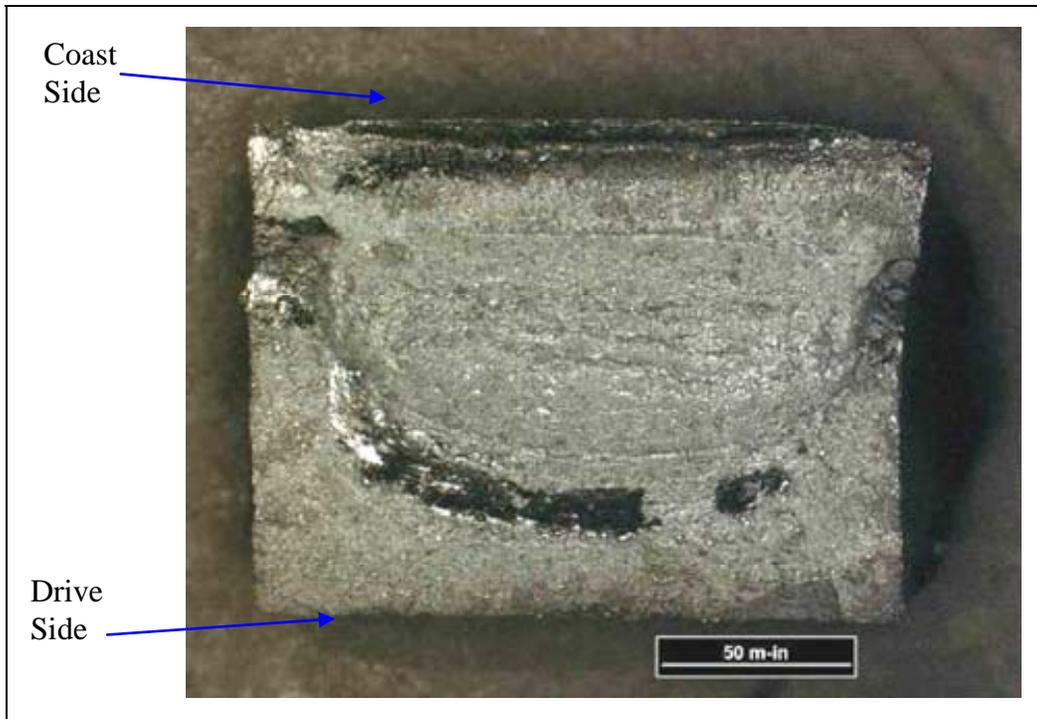
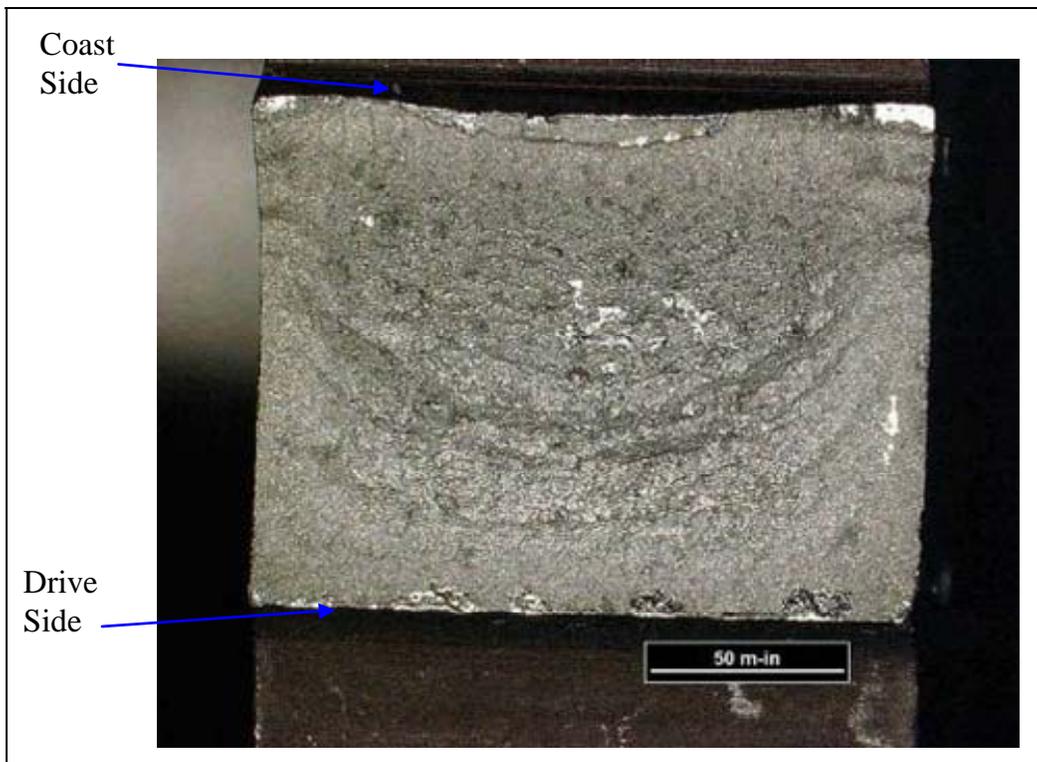
The fracture halves of tooth 4 are presented in figure 10 (tooth half) and figure 11 (gear half). The beachmarks exhibited a “U” or bathtub shape. A large mound can be seen in figure 10; the mating cavity can be seen in figure 11.

Figure 10. Tooth 4, tooth fracture half.

Figure 11. Tooth 4, gear fracture half.

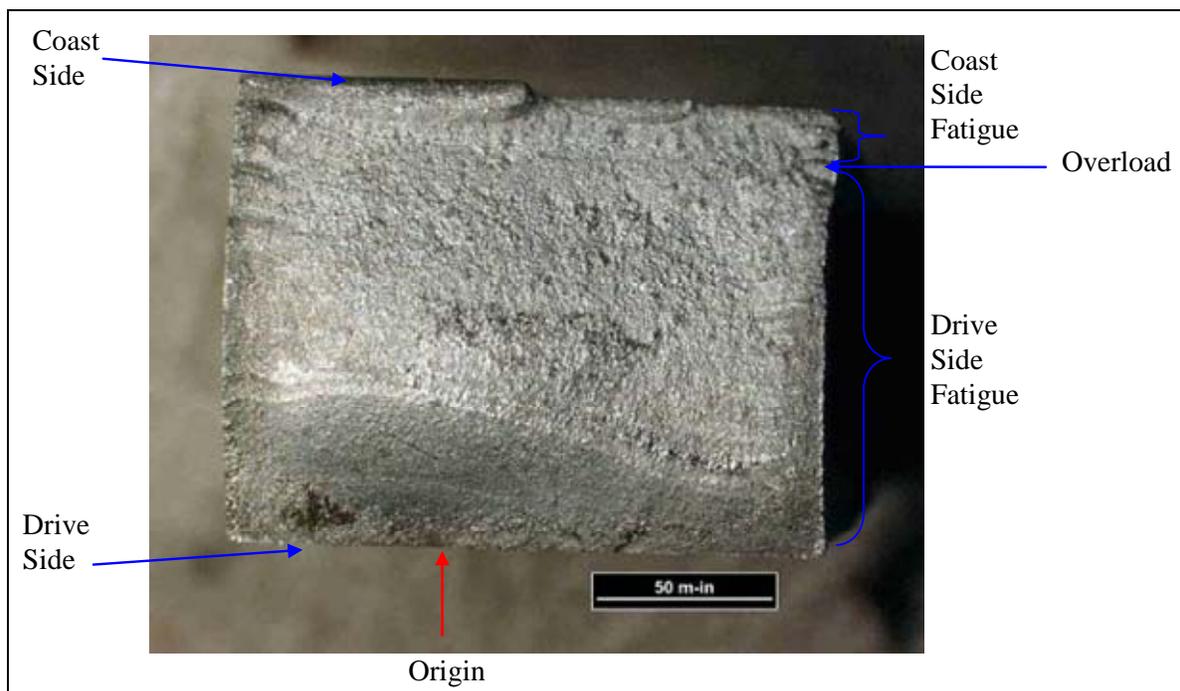
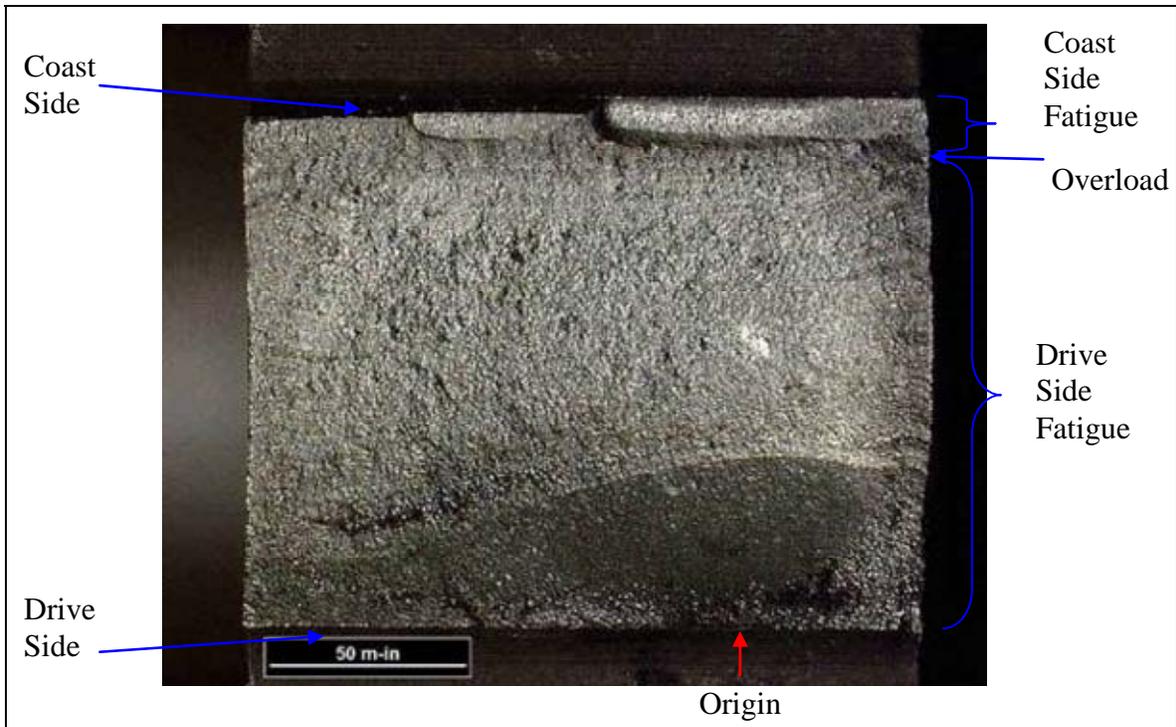
The primary failure for this group was tooth 28. The fracture halves are shown in figures 12 and 13. As in tooth 1, a secondary crack originated on the coast side. A small overload region was present.

Figure 12. Tooth 28, tooth fracture half.

Figure 13. Tooth 28, gear fracture half.

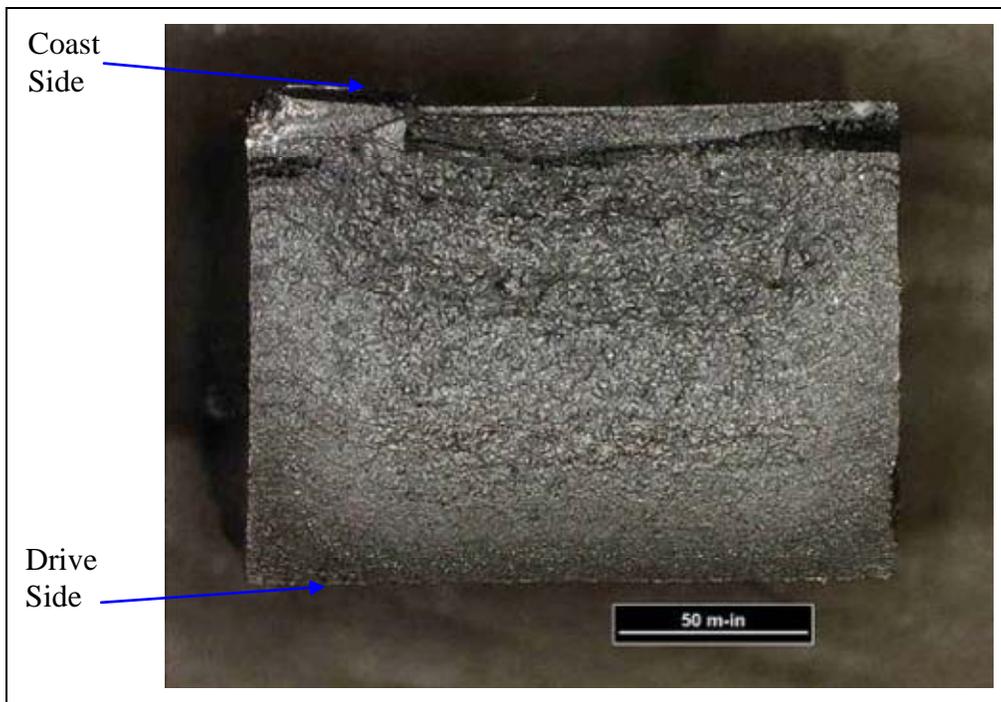
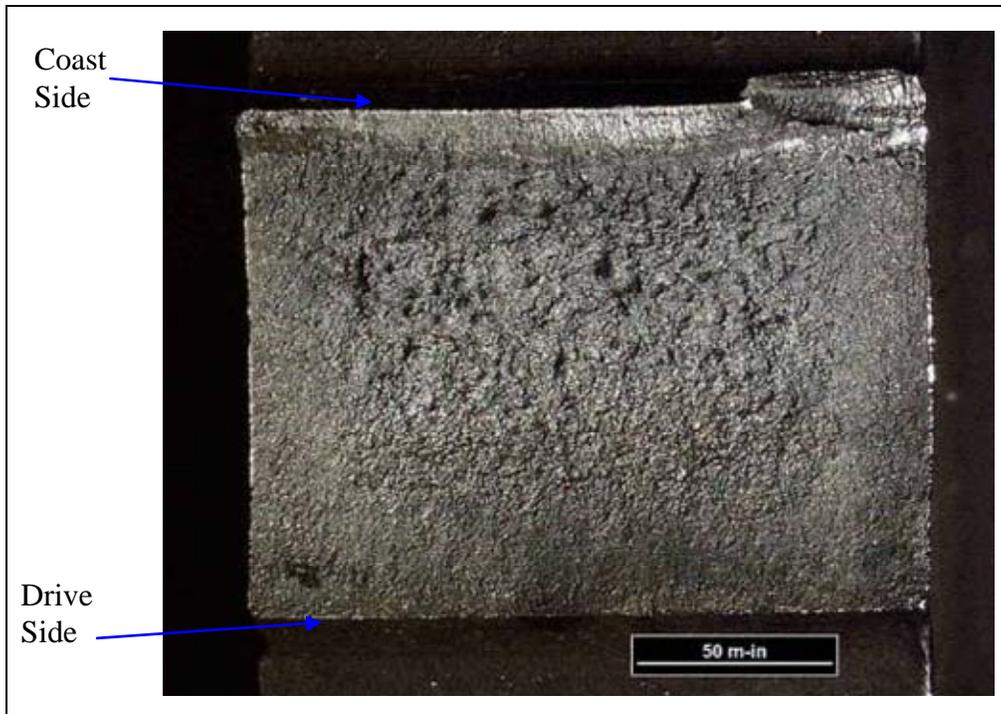
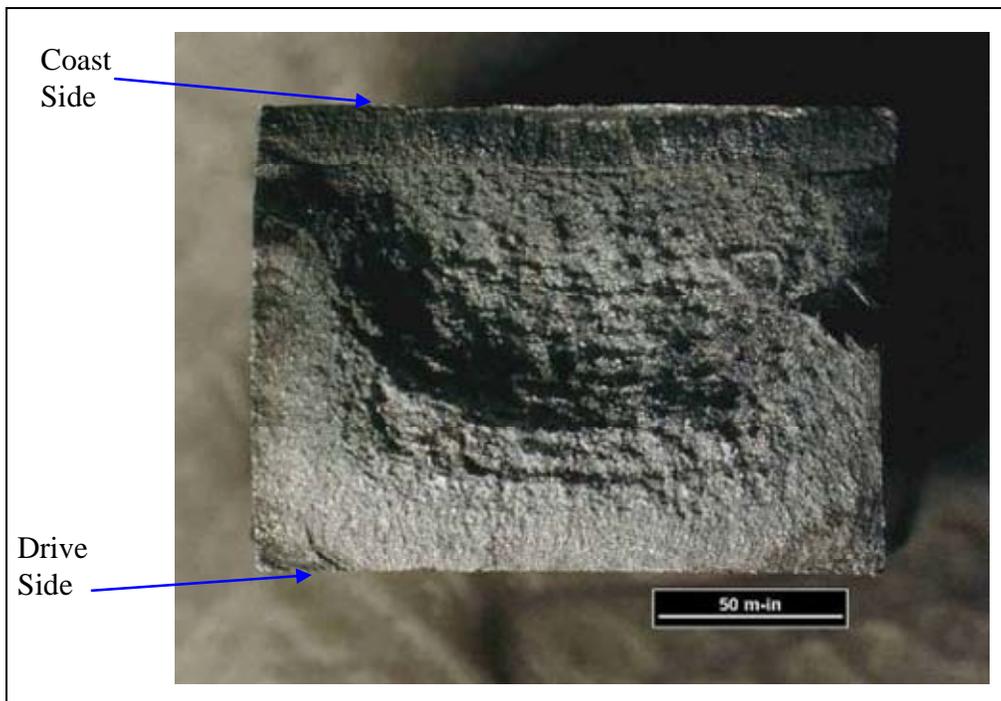
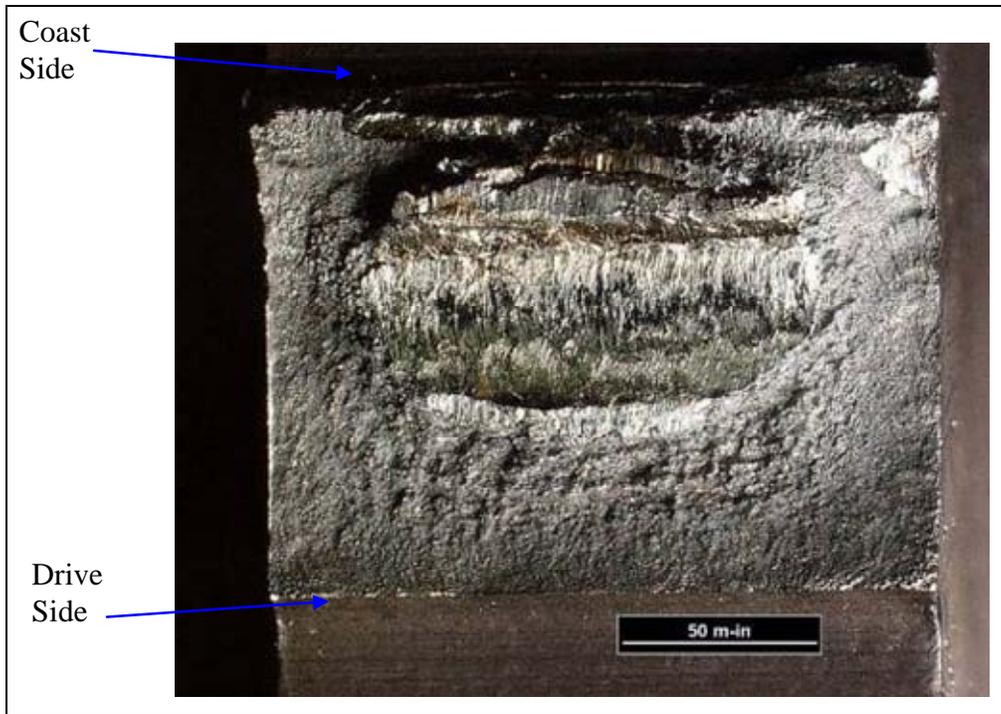
Tooth 29 fracture halves are shown in figures 14 and 15. Fracture halves for tooth 30 are shown in figures 16 and 17.

Figure 14. Tooth 29, tooth fracture half.

Figure 15. Tooth 29, gear fracture half.

Figure 16. Tooth 30, tooth fracture half.

Figure 17. Tooth 30, gear fracture half.

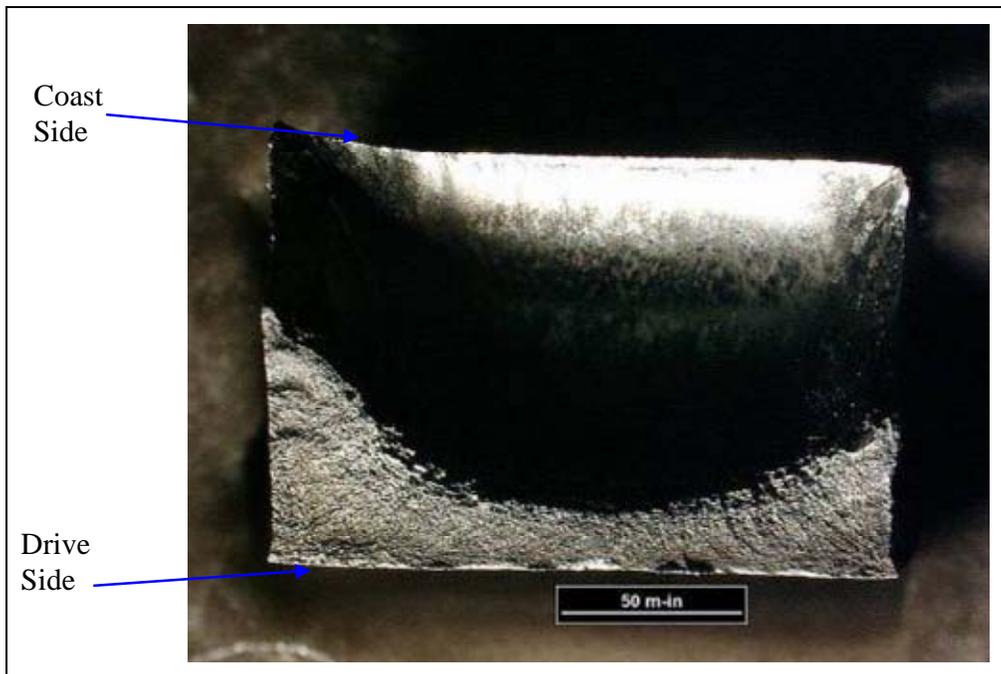
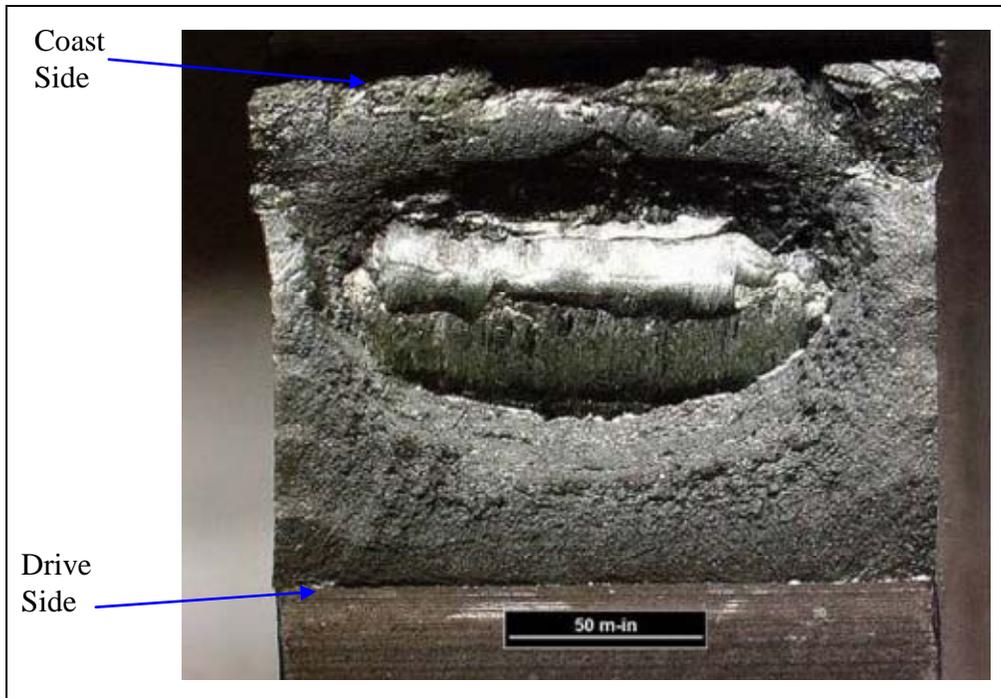
Figures 18 and 19 present the fracture halves for tooth 31. Wear was present at the drive side origin for this tooth (figures 26–28). Note that this was the last tooth in this sequence to fail by bending fatigue.

Figure 18. Tooth 31, tooth fracture half.

Figure 19. Tooth 31, gear fracture half.

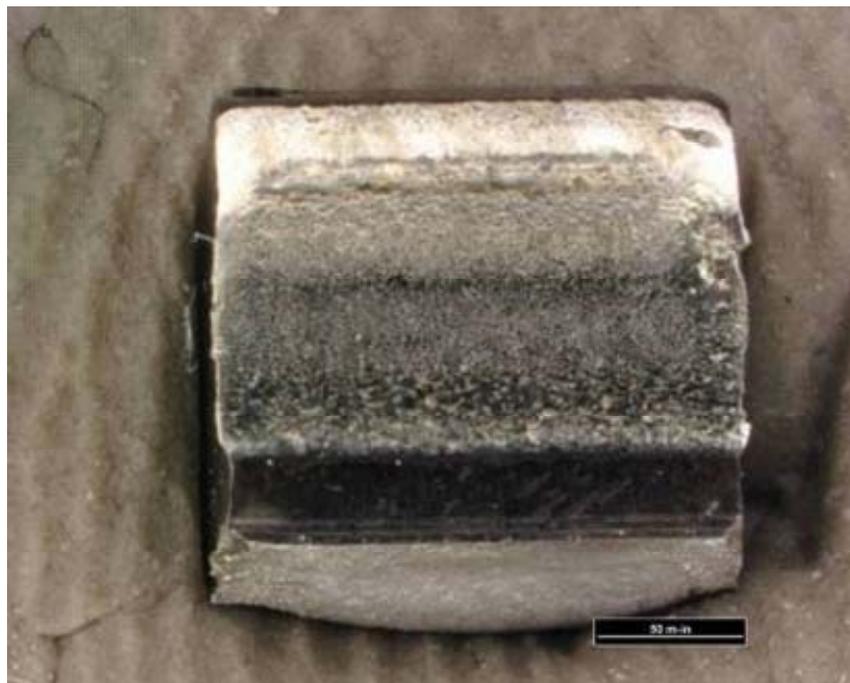
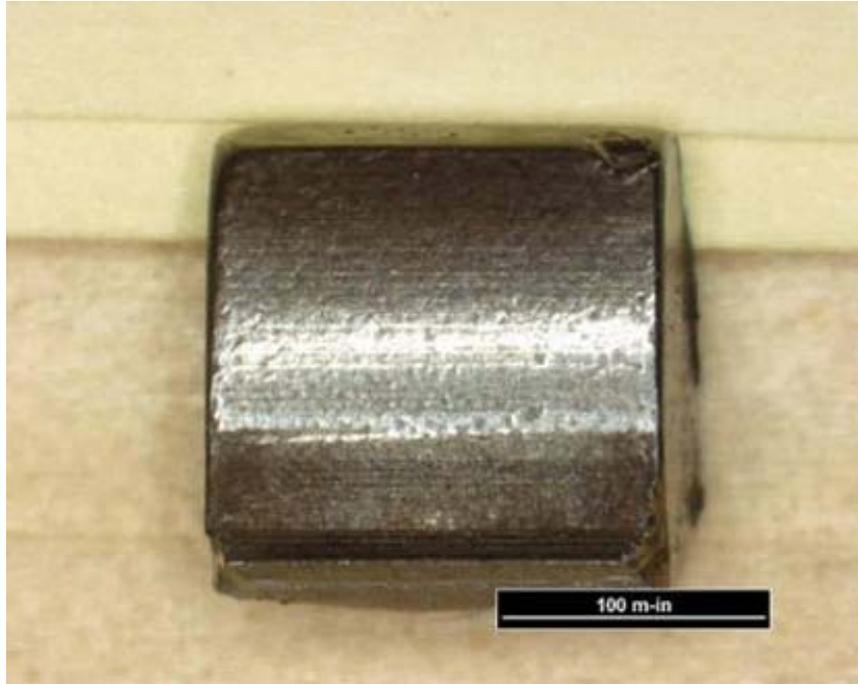
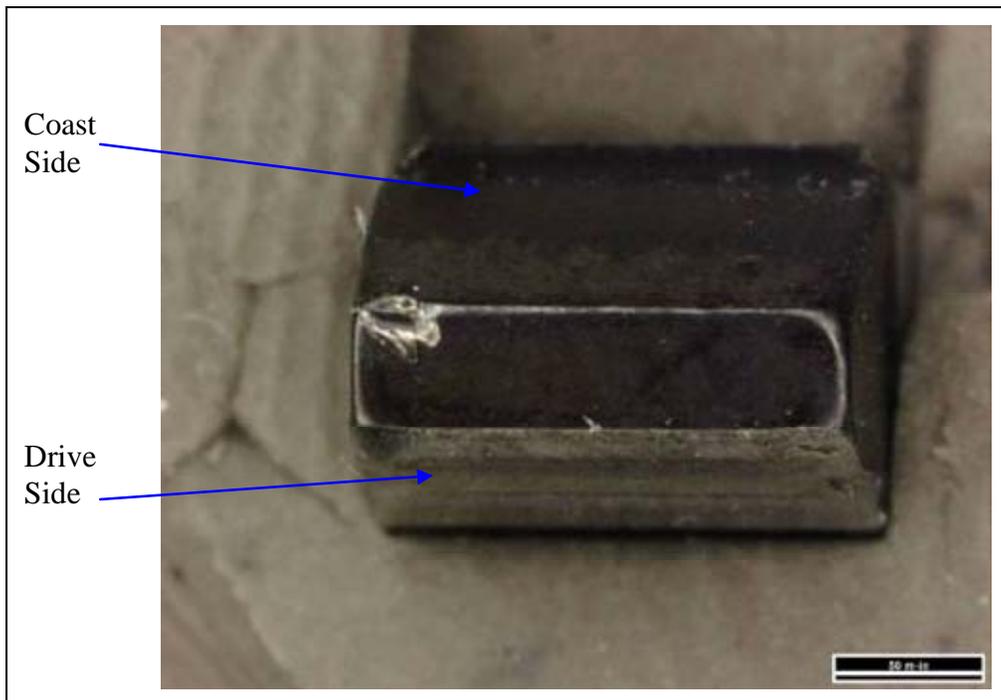
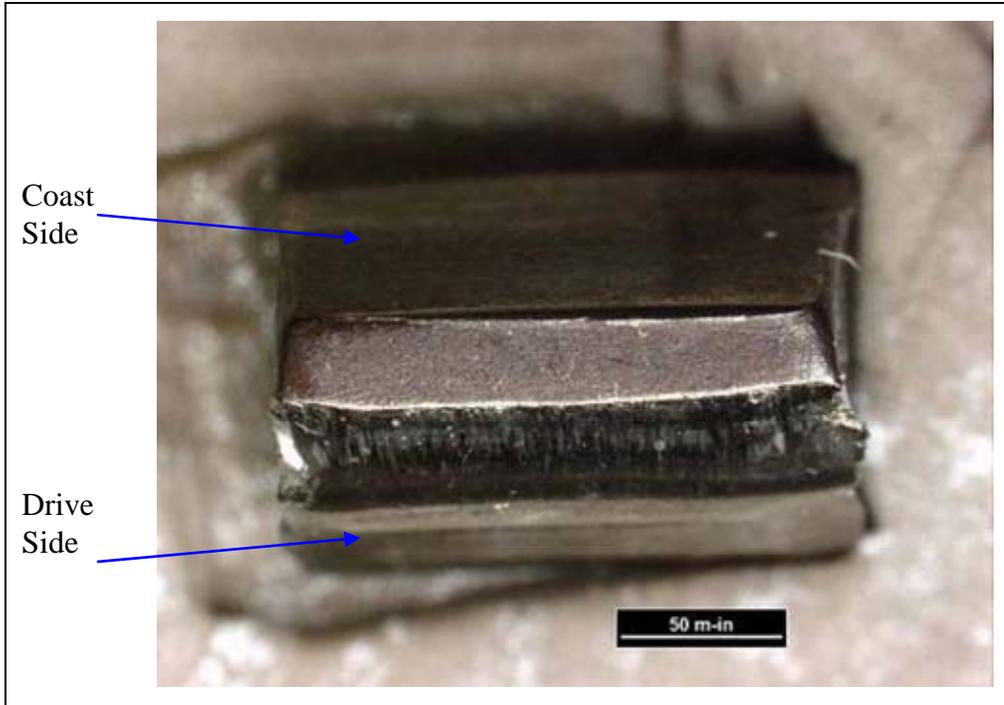
Figures 20–28 are representative of the wear pattern observed on most of the teeth recovered.

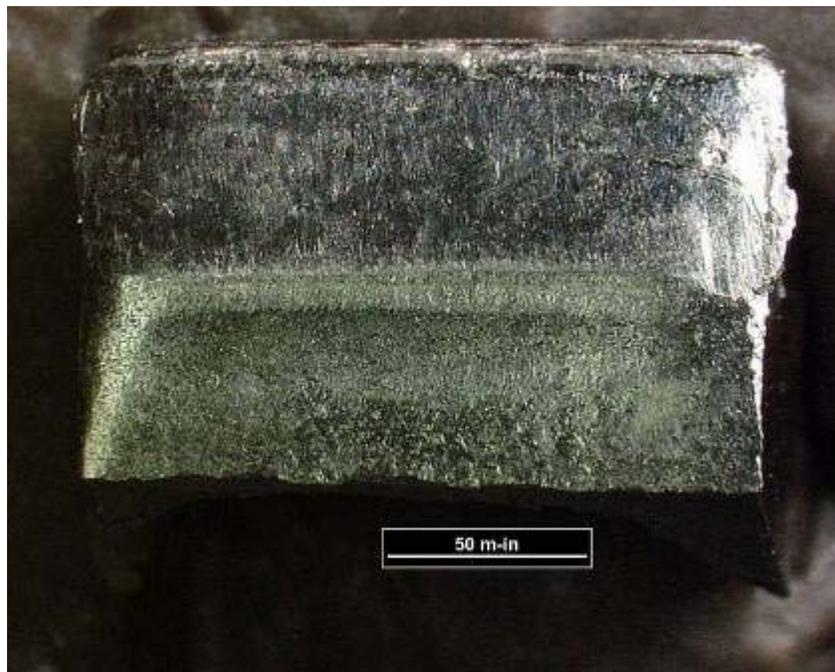
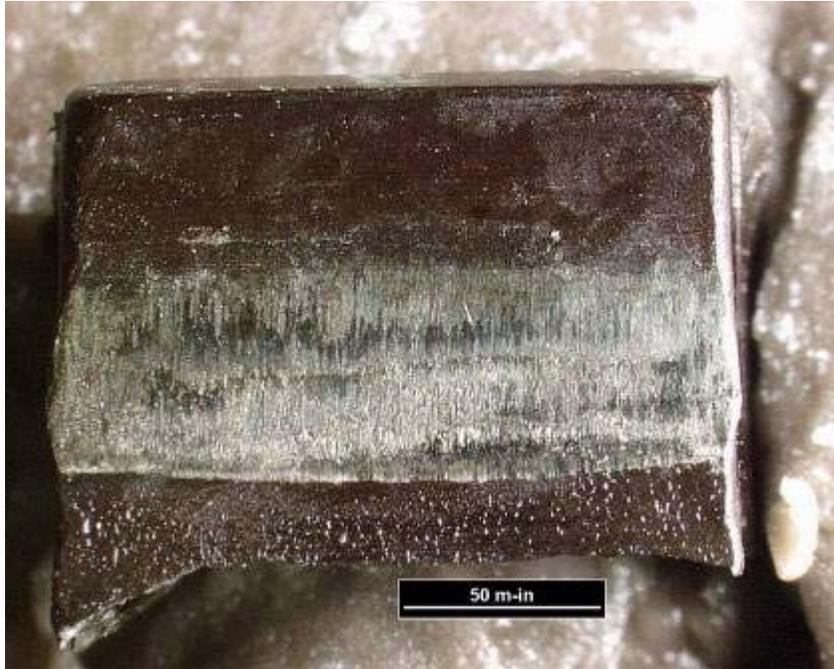
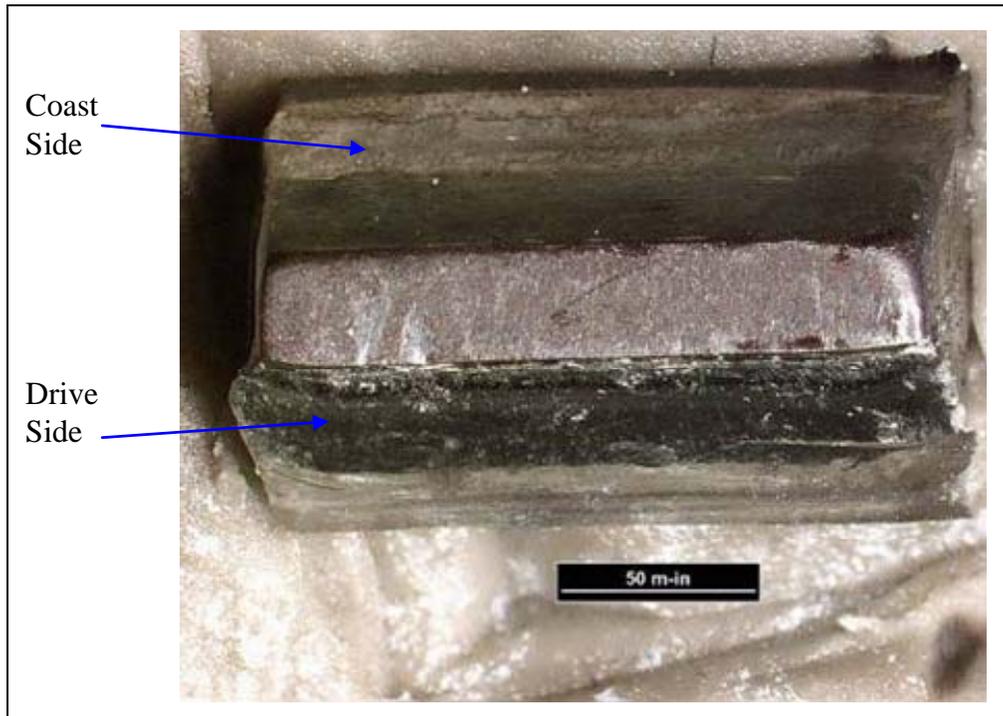
Figure 26. Drive side, tooth 31. (Note: worn adjacent to fracture surface.)
