**Failure Analysis of OH-58 Kiowa Warrior
Drive Gear Shafts**

ARL-TR-3827

June 2006

U.S. Army Research Laboratory
Weapons and Materials Research Directorate
Aberdeen Proving Ground, MD 21005-5069

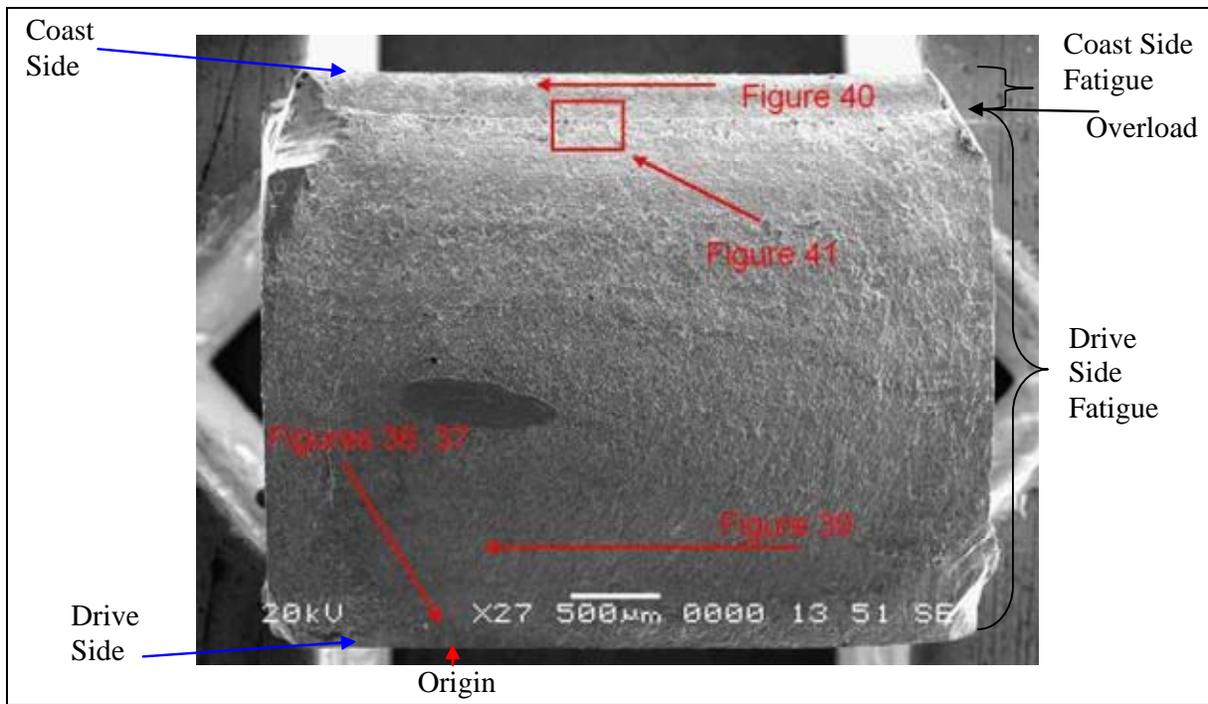
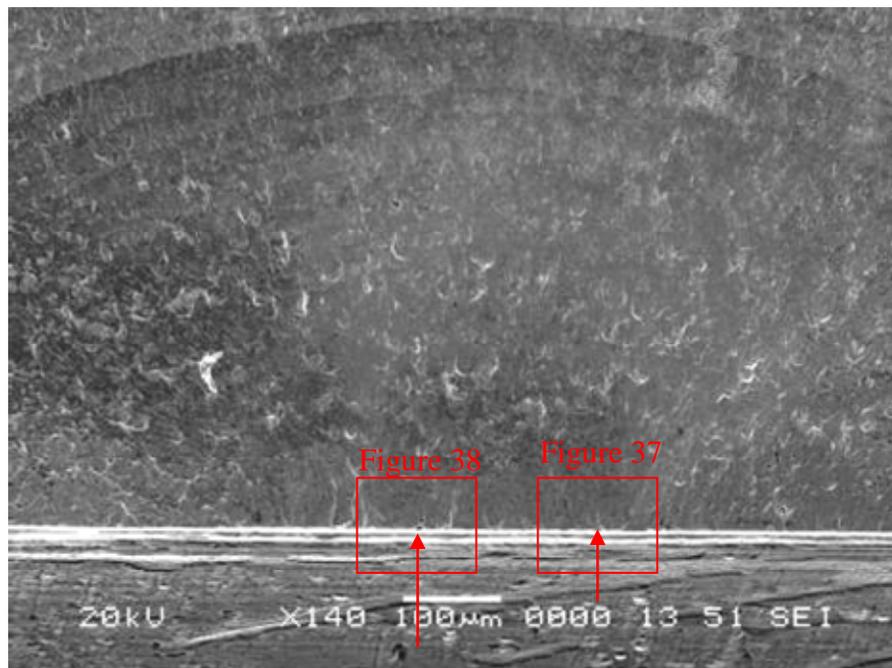
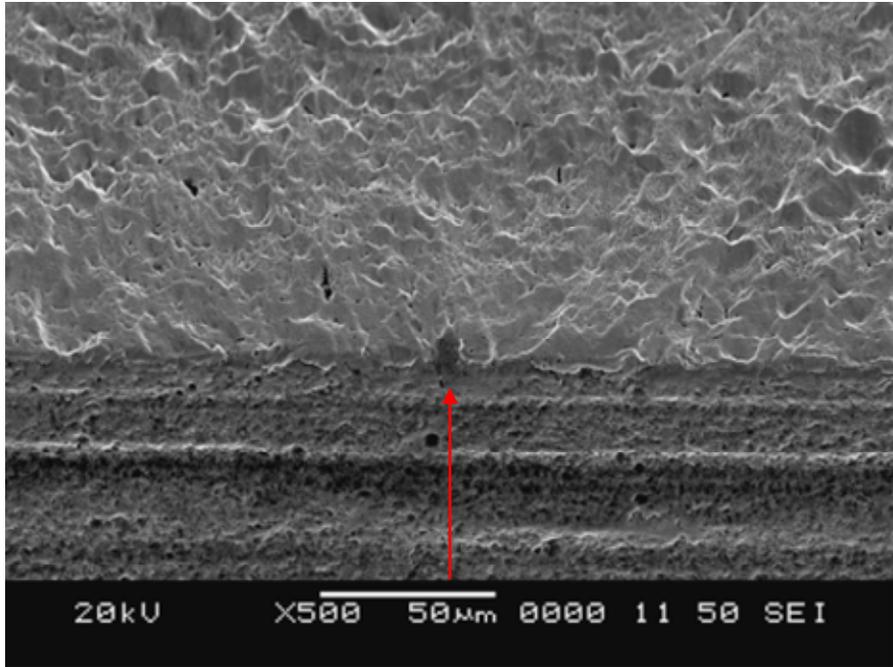
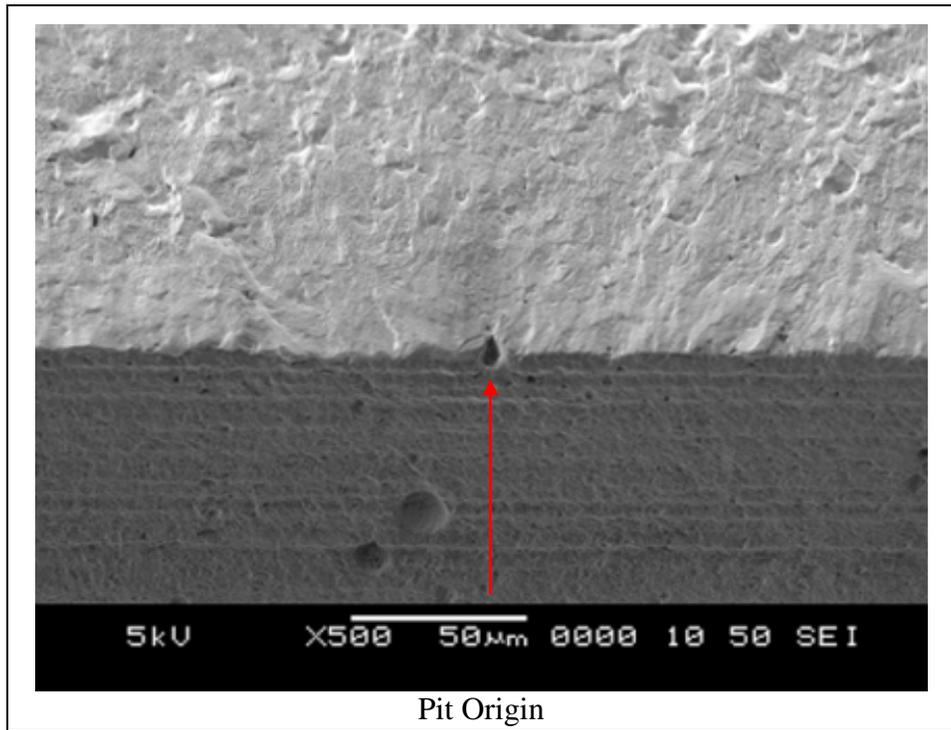
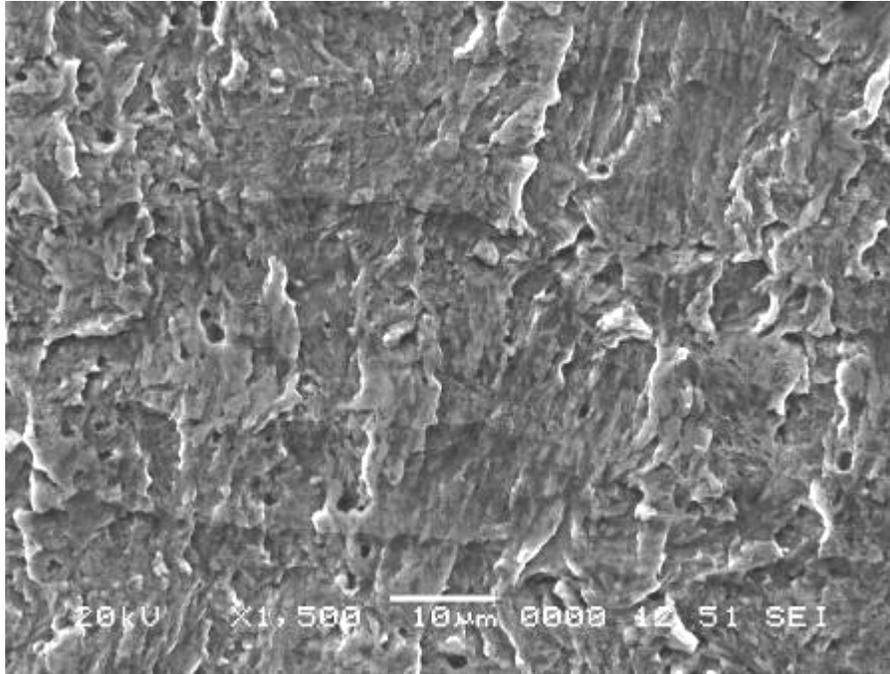
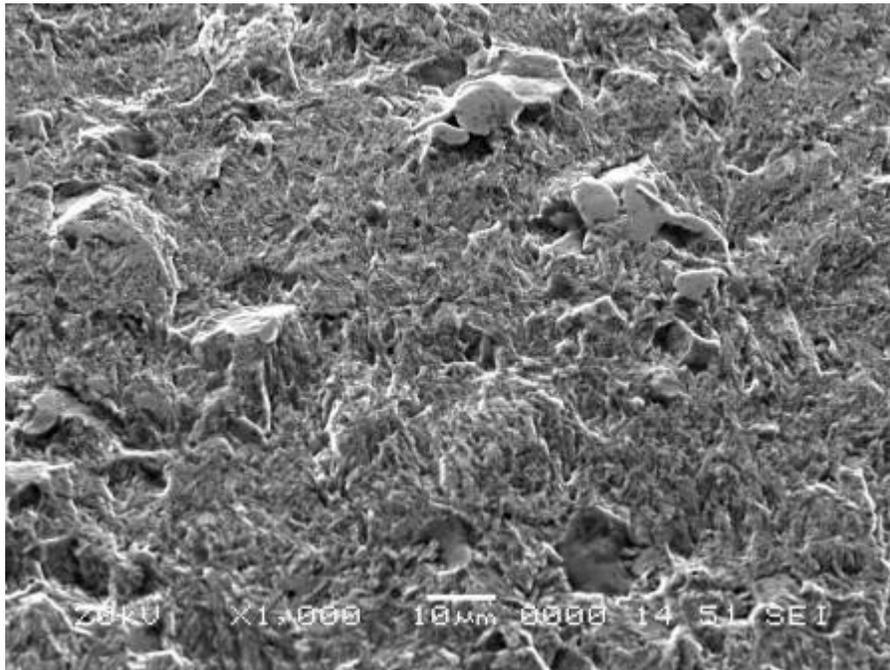
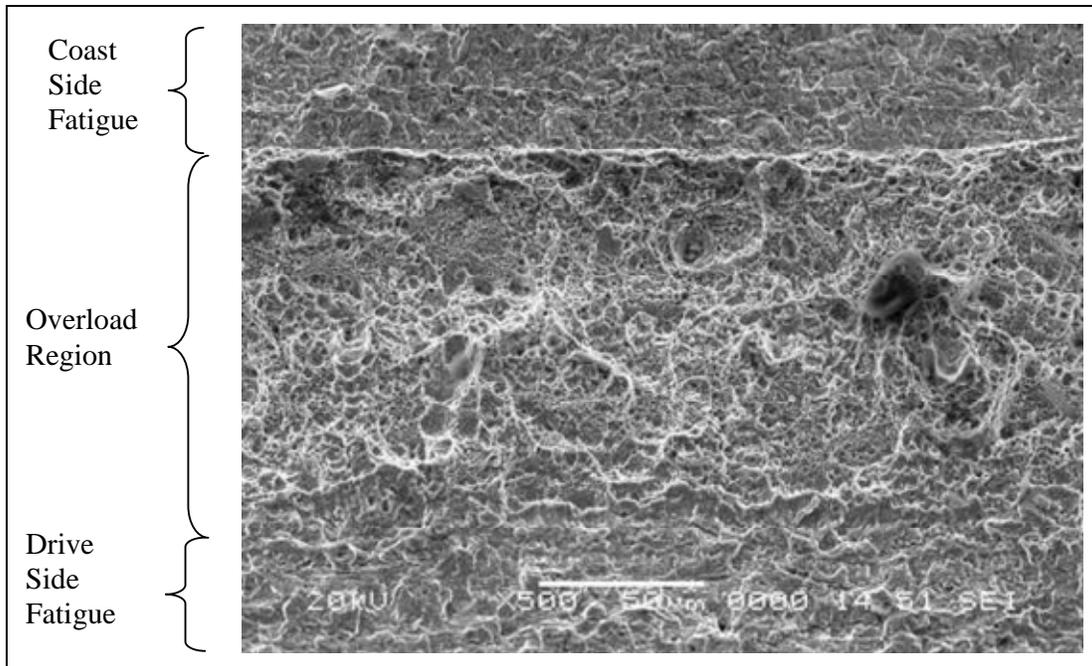
Figures 35–41 show SEM micrographs of tooth 1. Figures 36–38 present the origin for this primary failure. The pit origin can be clearly seen in figure 38. A separate crack originated from the coast side of the tooth and can be observed in figures 35 and 41. The two fractures connected through a small (100–150 μm) overload region as shown in figure 41.

Figure 38. Tooth 1 primary origin, drive side gear fracture half.

Figure 41. Overload transition, tooth 1.

- Identify and eliminate the source of the pitting.
 - Eliminate or reduce the magnitude of the tool marks present in the tooth root fillet.
-

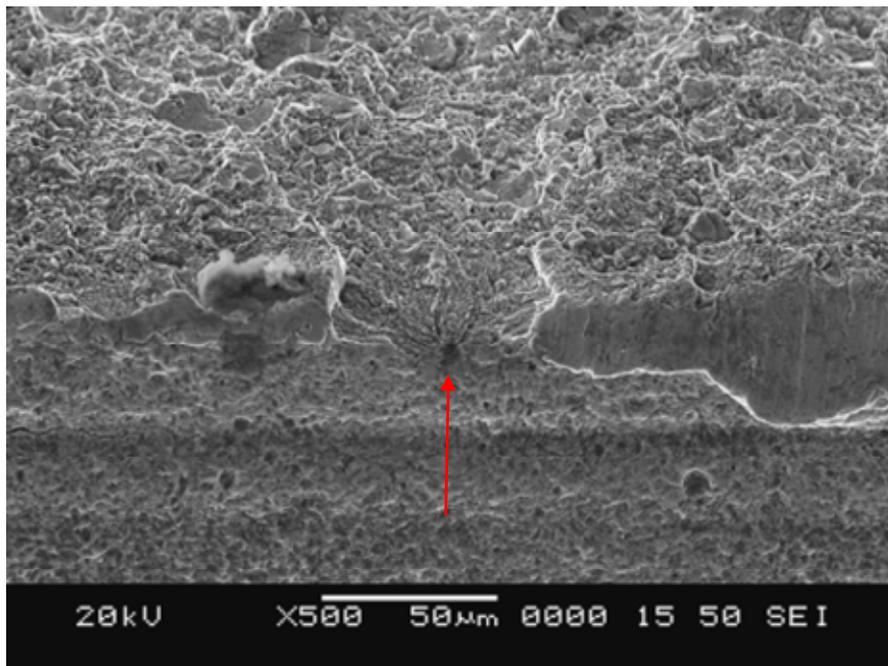
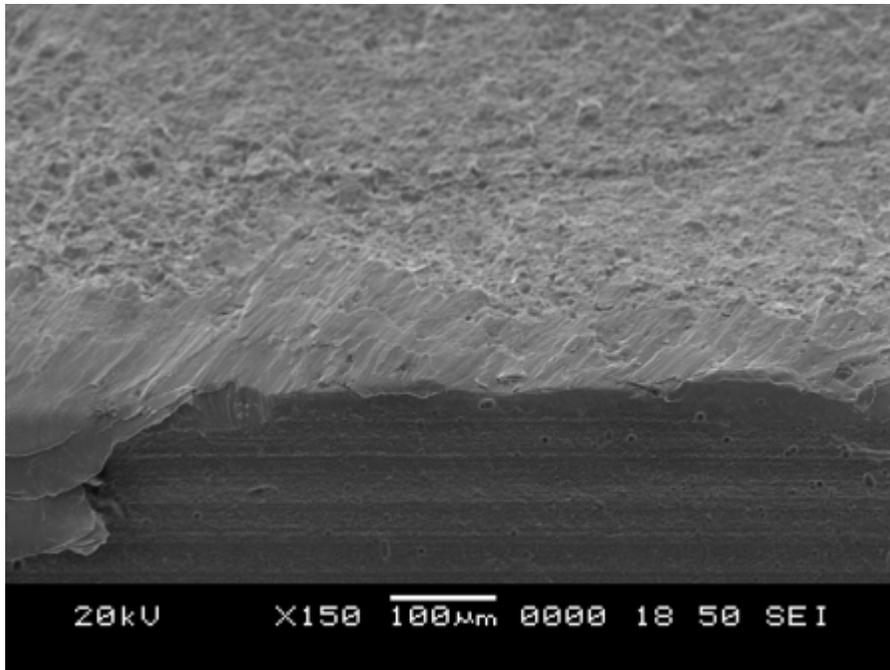
The pit origin for tooth 2 can be clearly seen in figure 42, which shows the tooth half of the fracture. Post fracture damage destroyed the gear half origin, depicted in figure 43.

Figure 42. Tooth 2 drive side primary pit origin, tooth half.

Figure 43. Drive side, tooth 2, gear half, origin location. (Note the damage.)

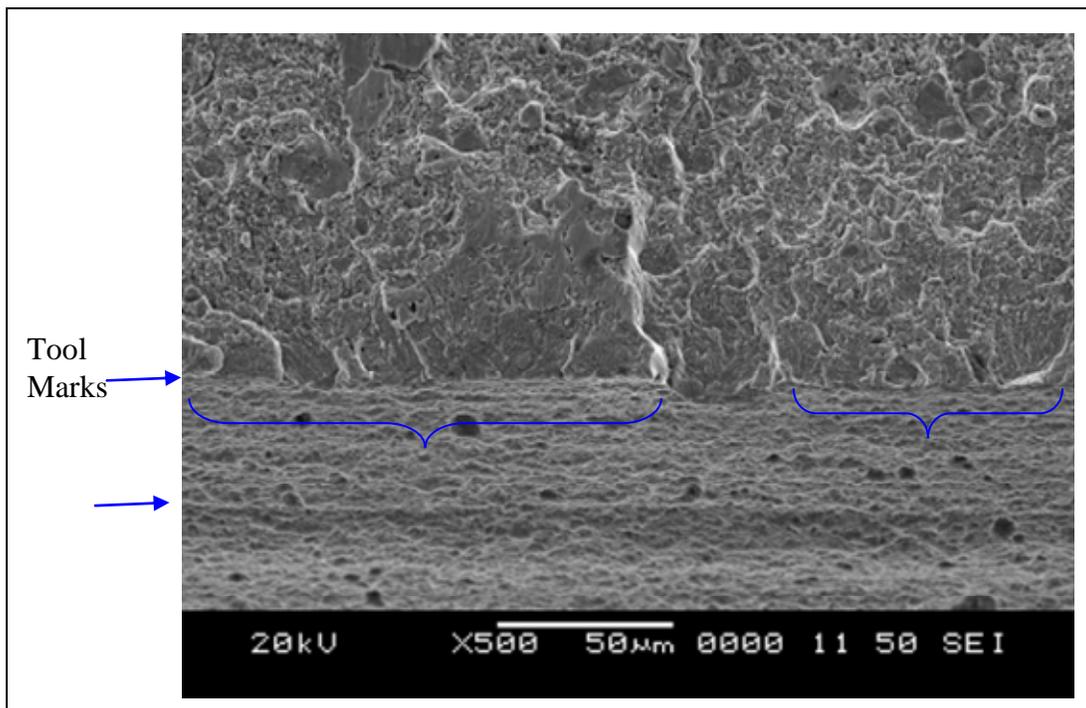
The origin for tooth 3 is shown in figure 44. Initiation appears to occur along a prominent tool mark.

Figure 44. Drive side, tooth 3, primary origin gear half.

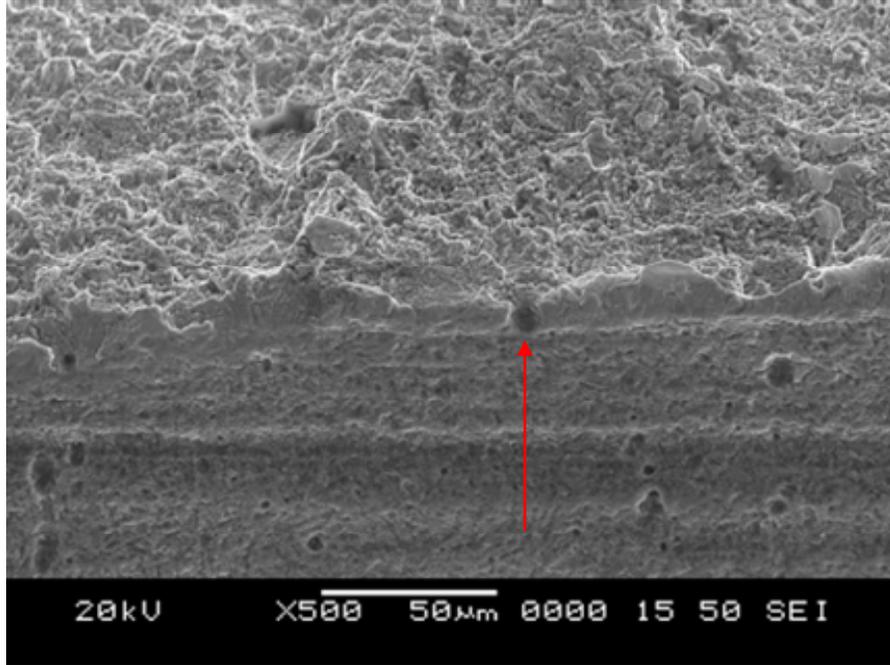
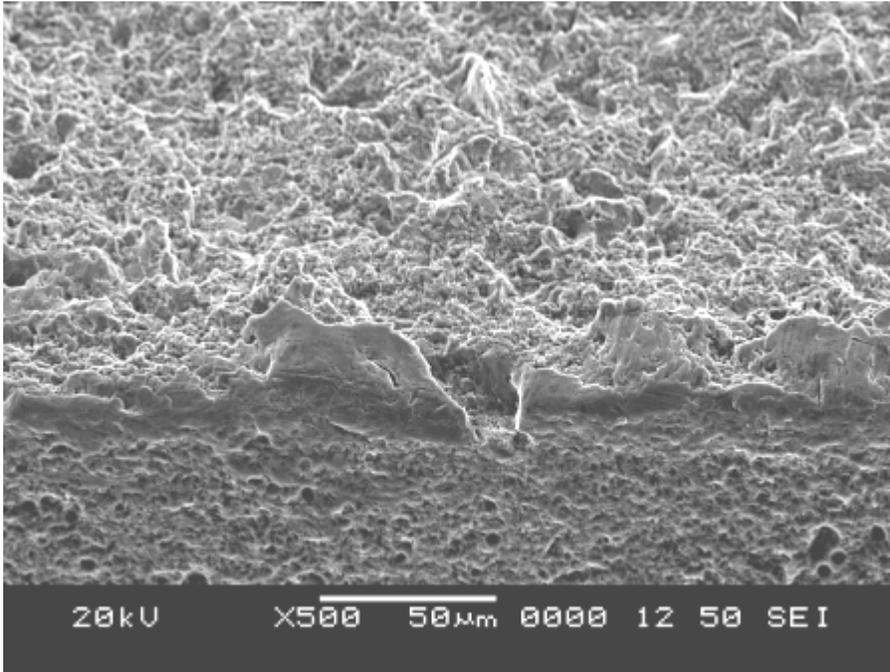
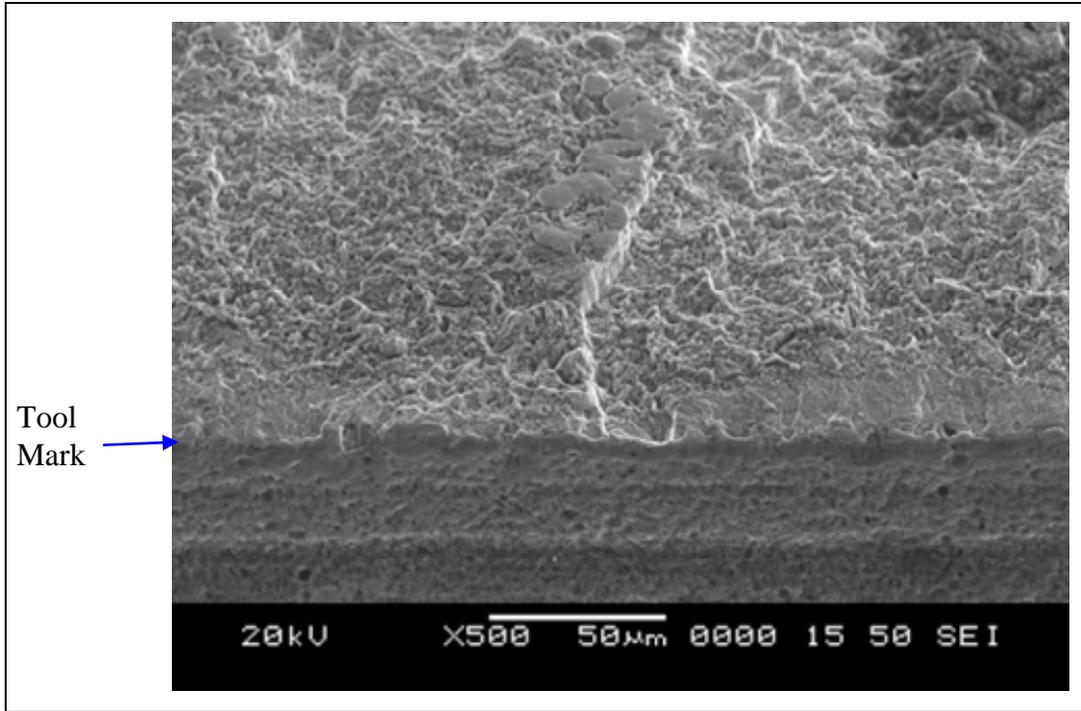
Tooth 4 had multiple origin sites (both pits and tool marks), which are shown in figures 45–47. There was a pit that led to cracking that can be observed on both the tooth and gear fracture halves (figures 45 and 46).

Figure 45. Tooth 4 drive side primary pit origin.

Figure 46. Tooth 4 drive side primary pit origin, gear fracture half.

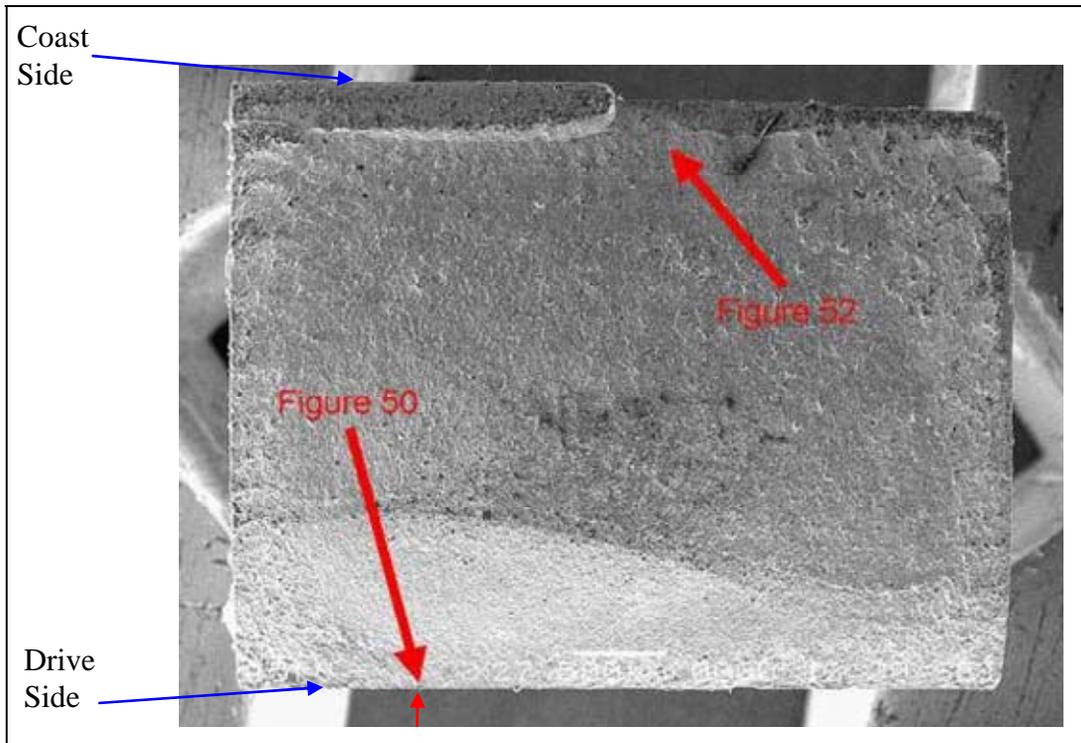
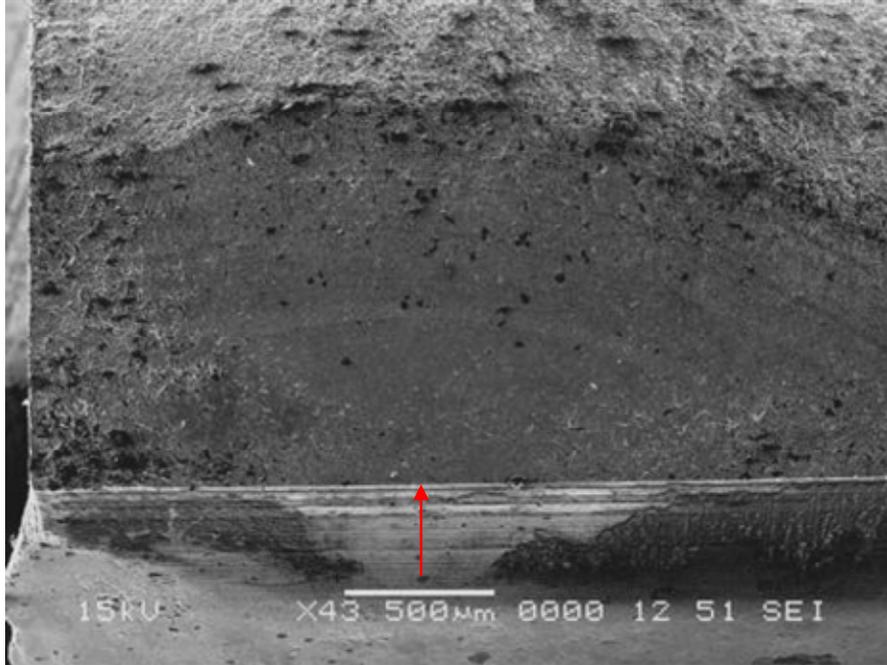
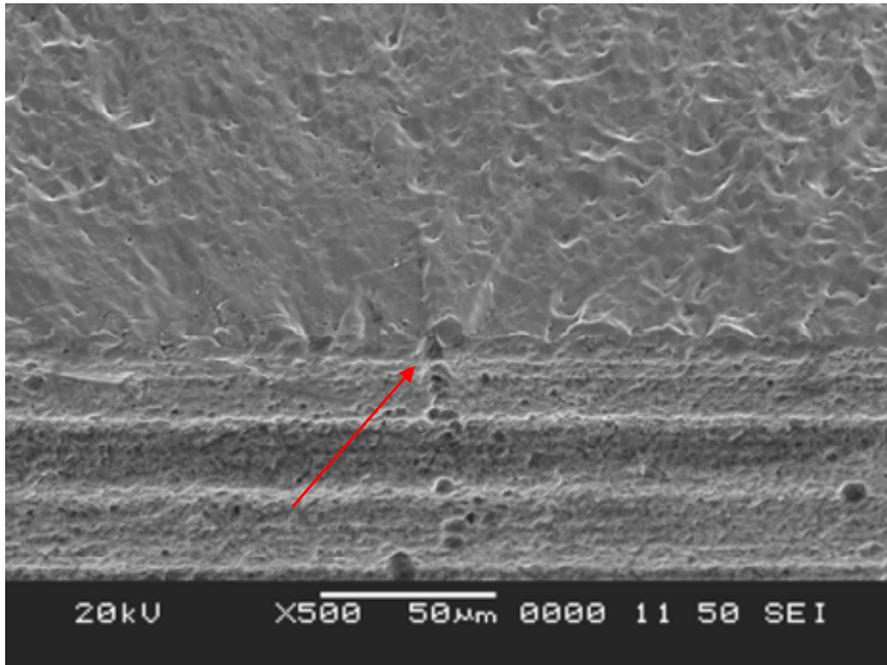
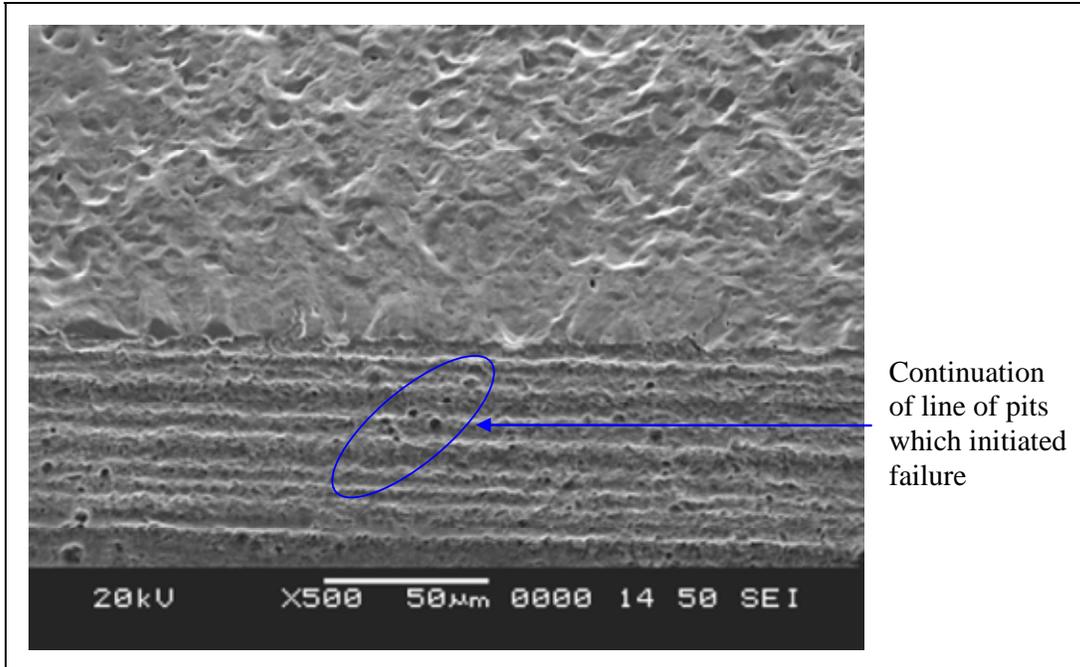
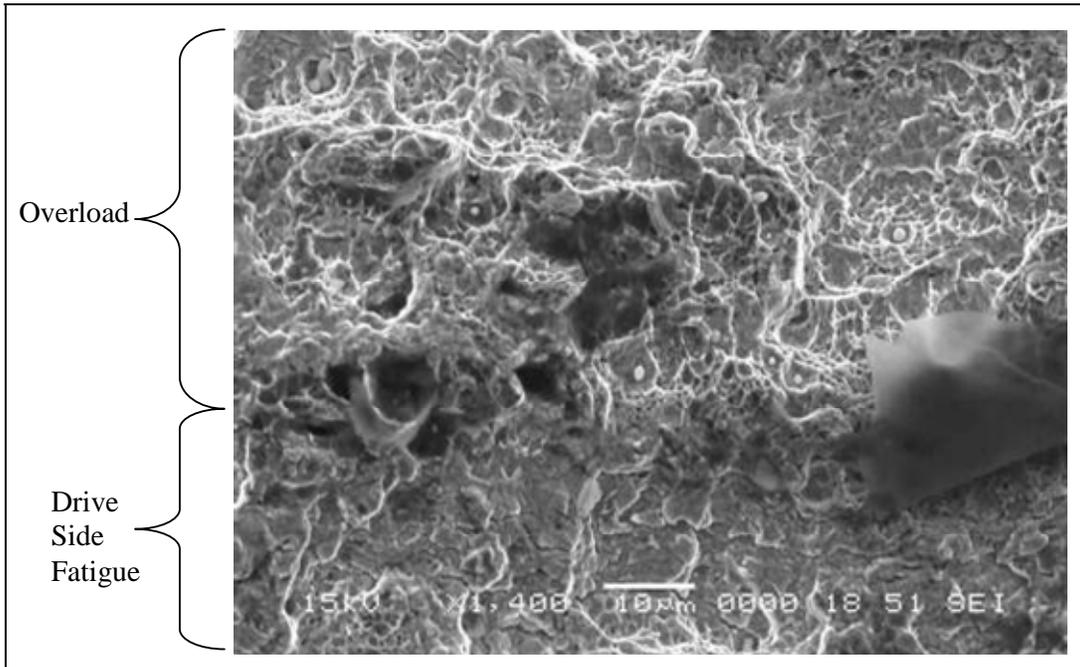
Tooth 28 is shown in figures 48–52. The fracture was remarkably similar to tooth 1; both fractures possessed a primary pit origin (drive side), initiation and propagation from the coast side, and a very small overload region. Figures 49–51 show the origin of fatigue on this primary failure that can be traced to a line of pits including the pit which initiated failure.

Figure 52. Tooth 28 fracture surface, transition to overload at top.

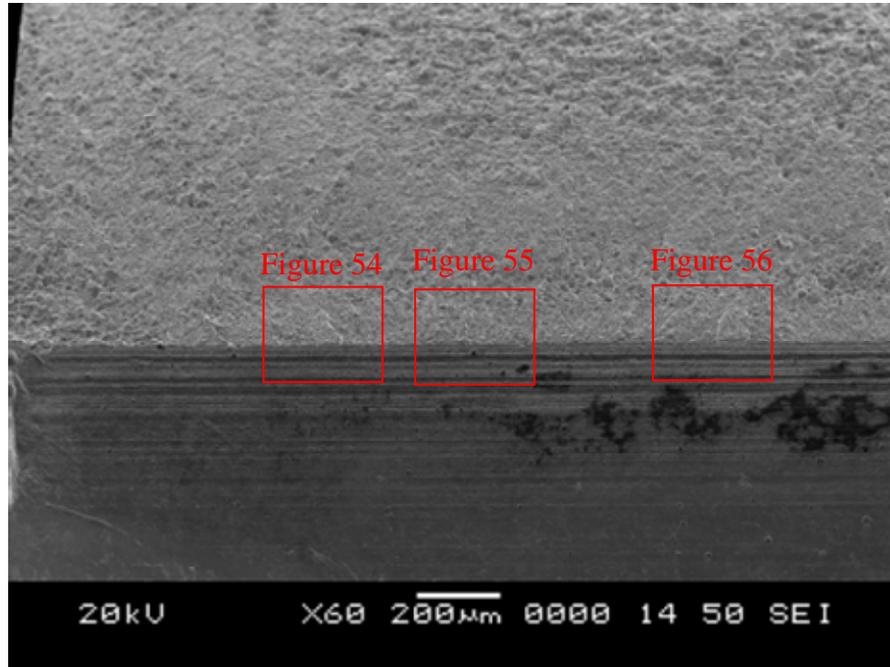
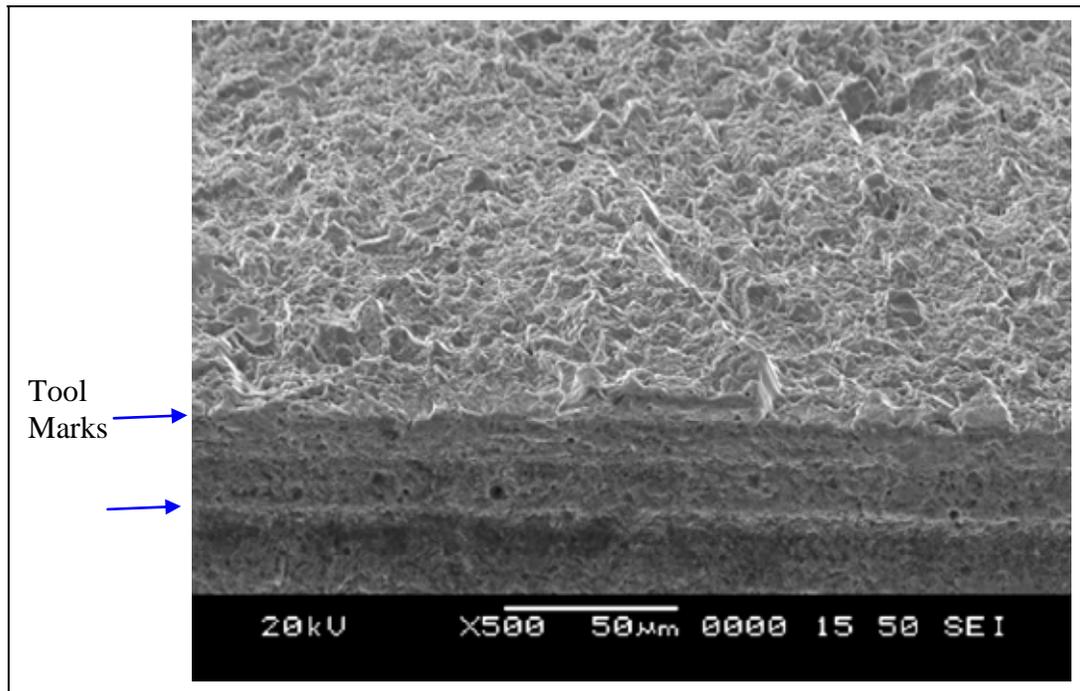
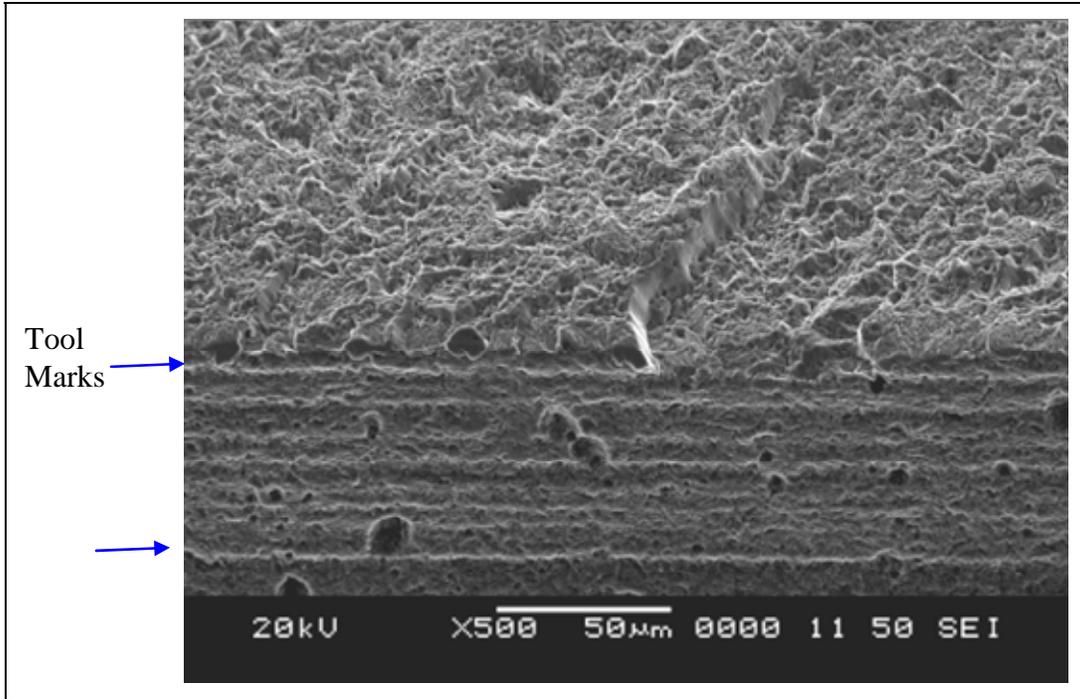
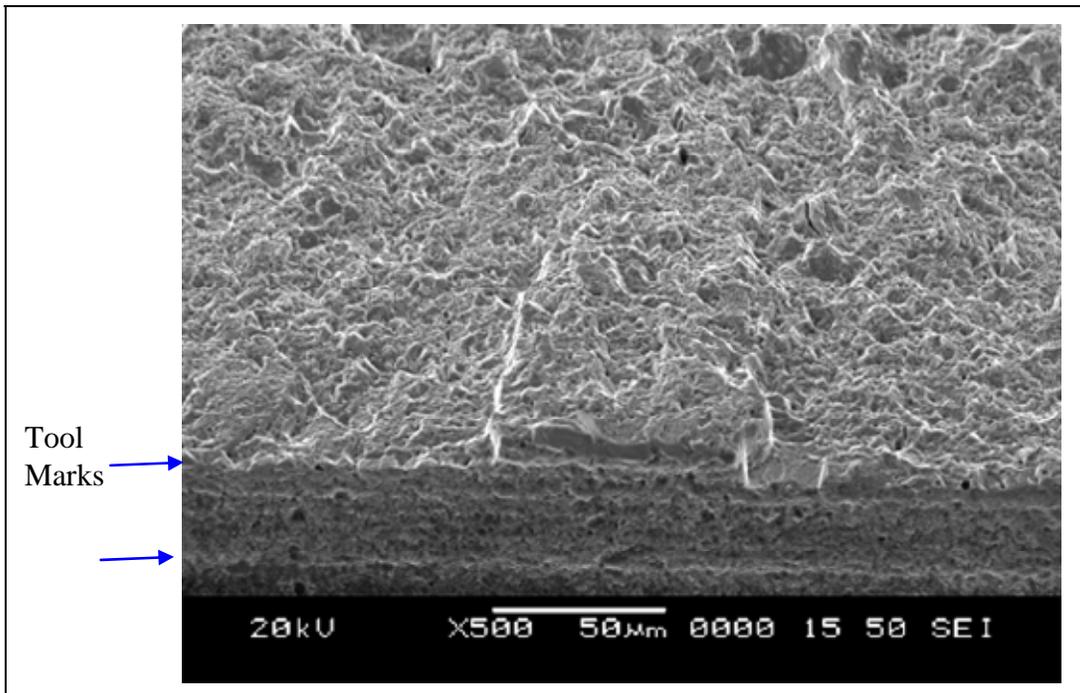
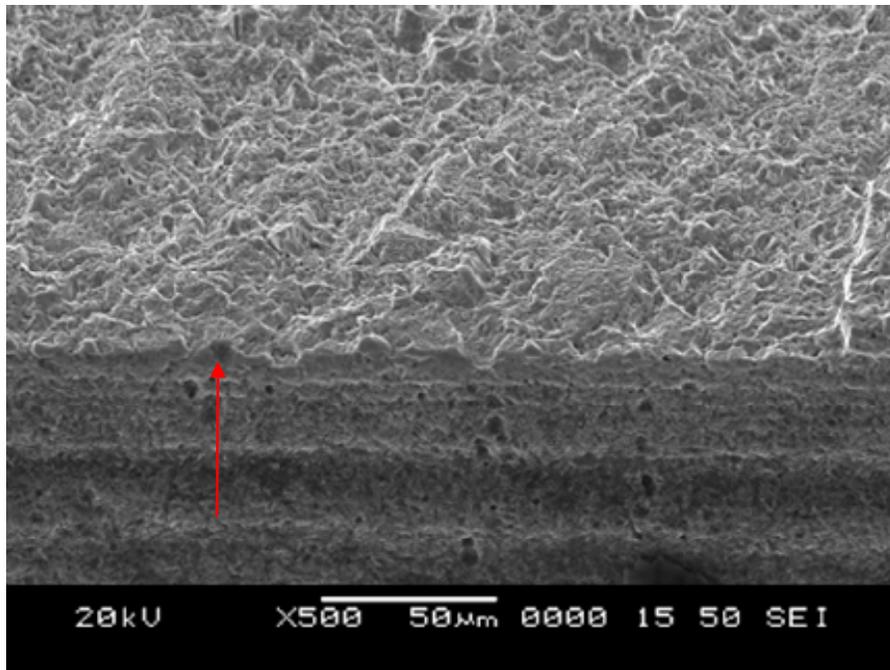
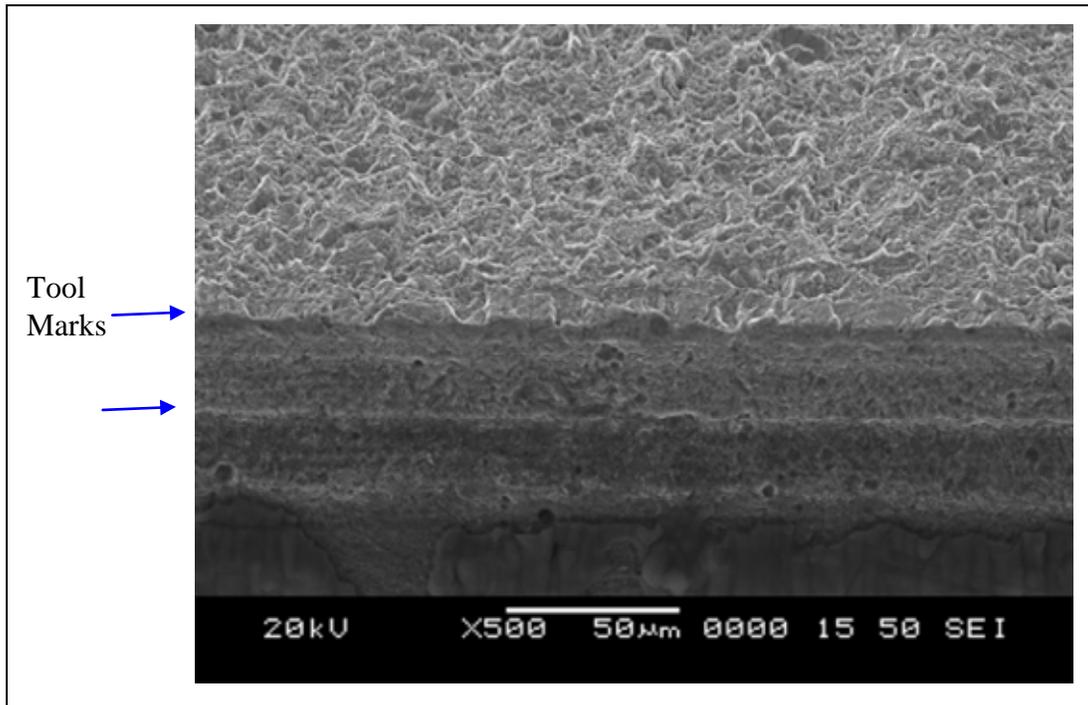
Figures 53–58 show the fracture surfaces associated with tooth 29. Failure originated at multiple points along the drive side, which are seen on both the tooth and gear fracture halves, including both pits and tool marks.

Figure 57. Tooth 29 drive side, primary pit origin.

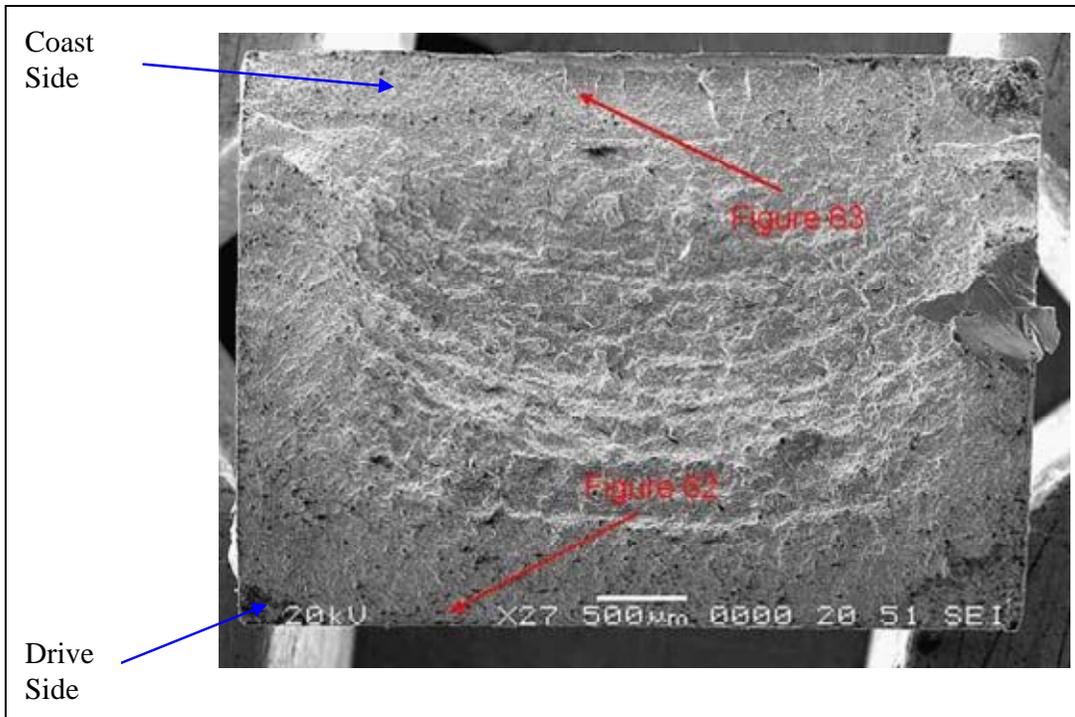
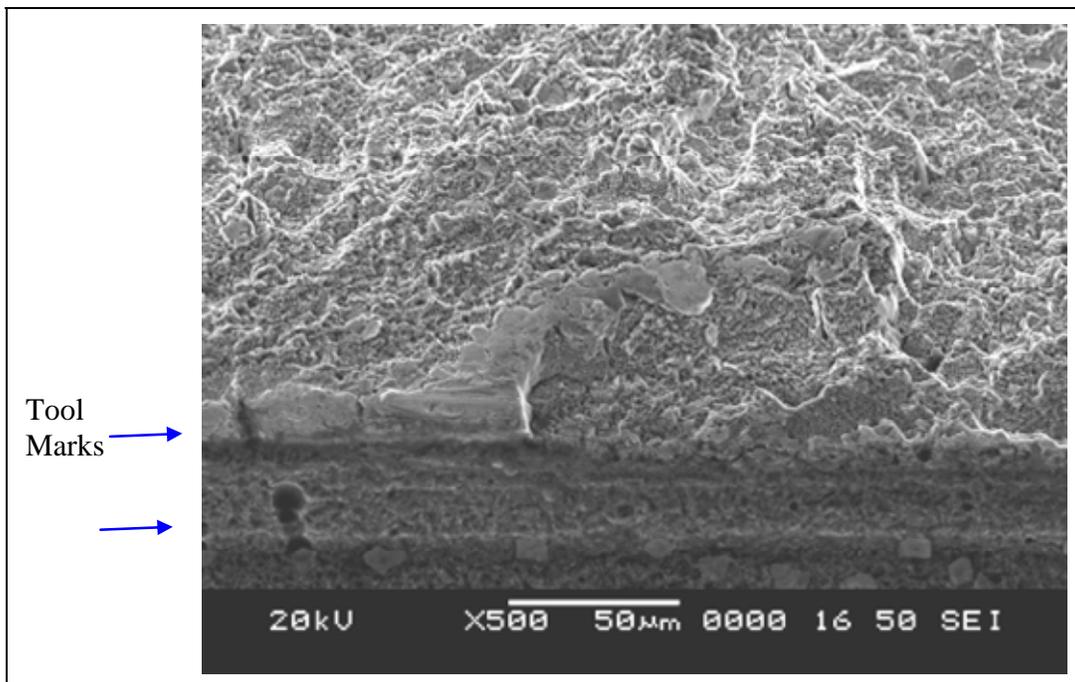
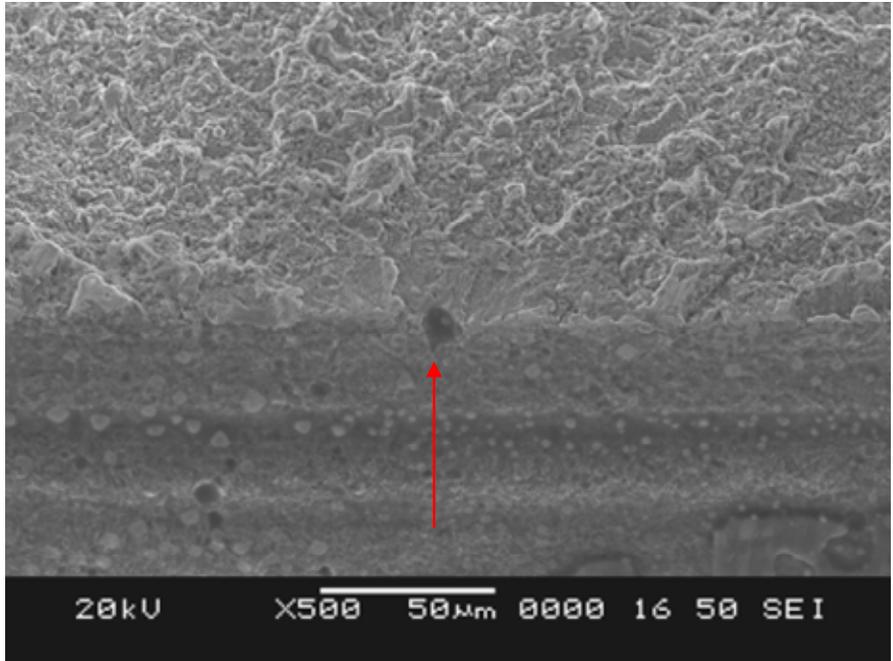
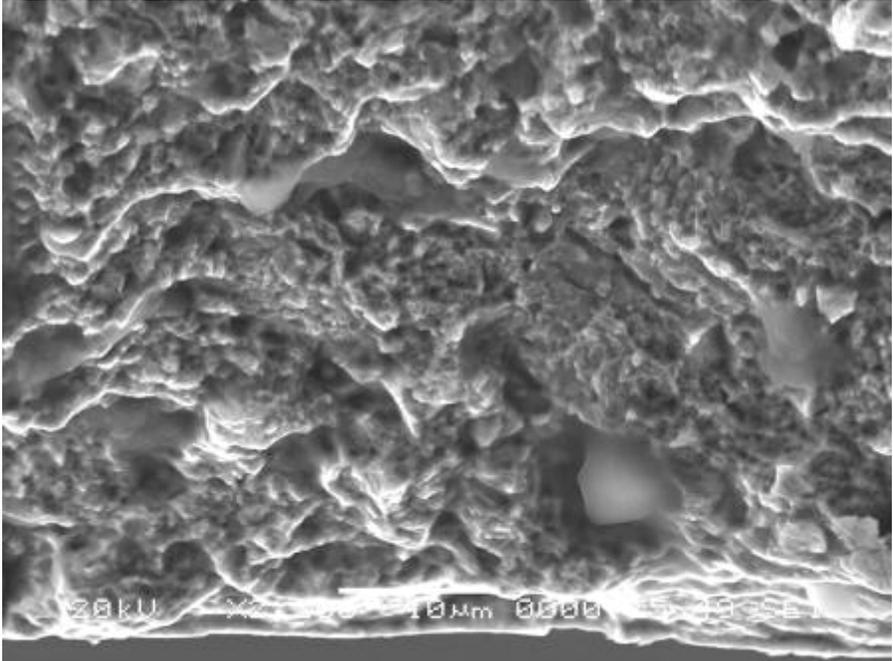
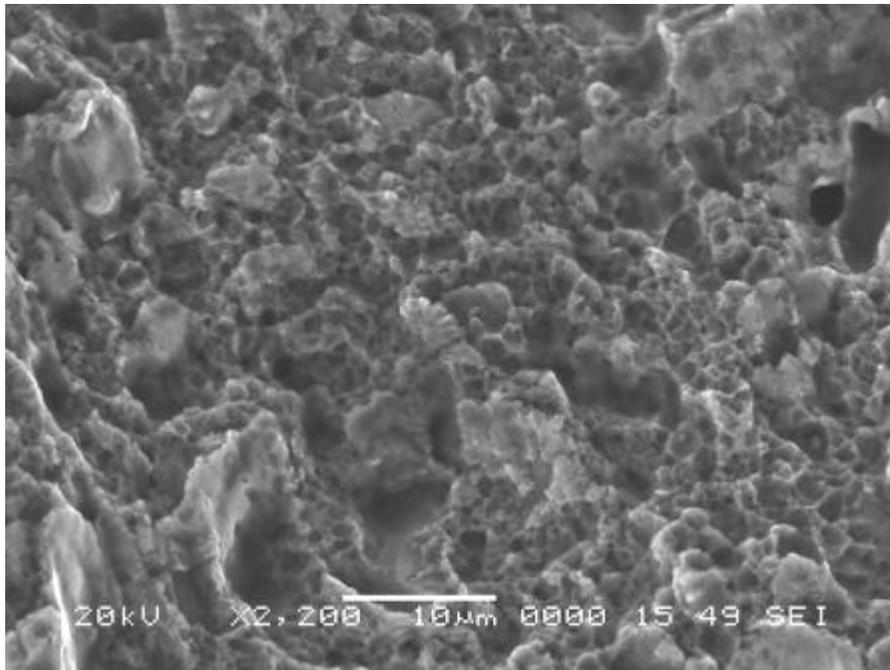
Tooth 30 is shown in figures 59–63. Multiple origins were found on the drive side, shown in figures 60–61.

Figure 61. Tooth 30 pit origin, gear fracture half.
