**Failure Analysis of OH-58 Kiowa Warrior
Drive Gear Shafts**

ARL-TR-3827

June 2006

U.S. Army Research Laboratory
Weapons and Materials Research Directorate
Aberdeen Proving Ground, MD 21005-5069

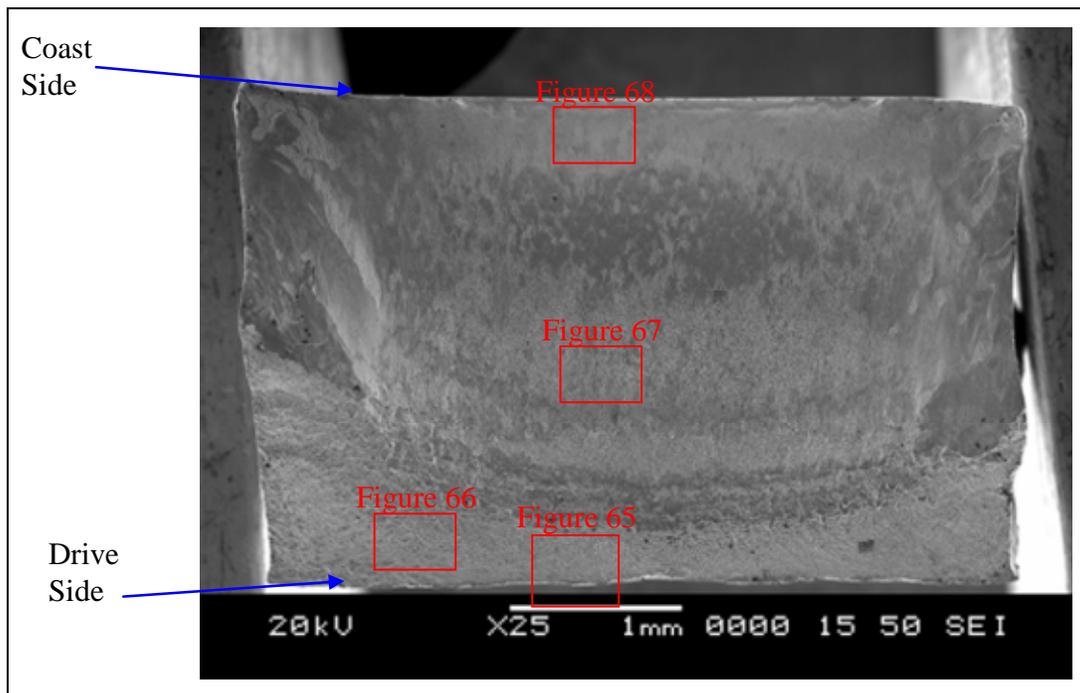
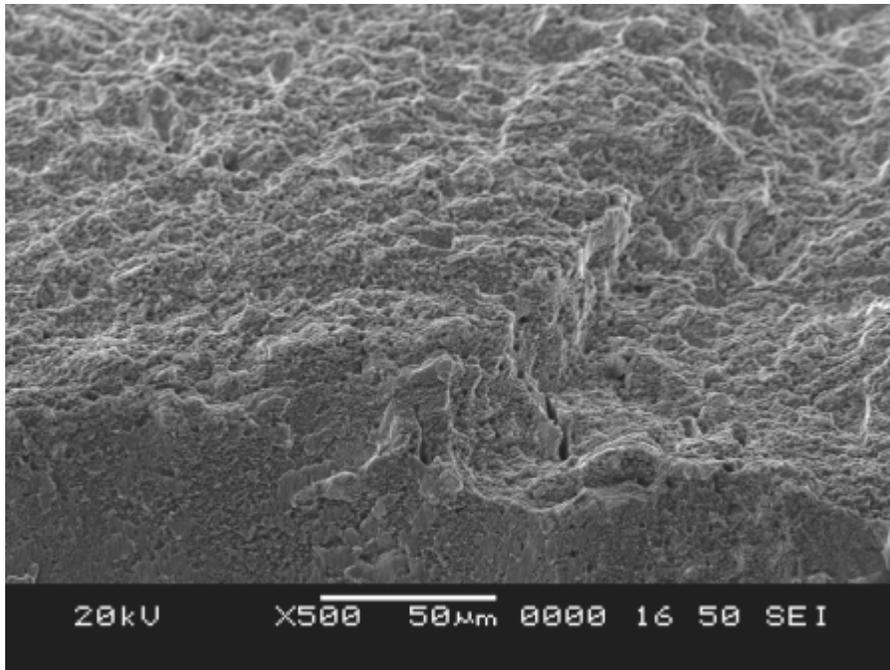
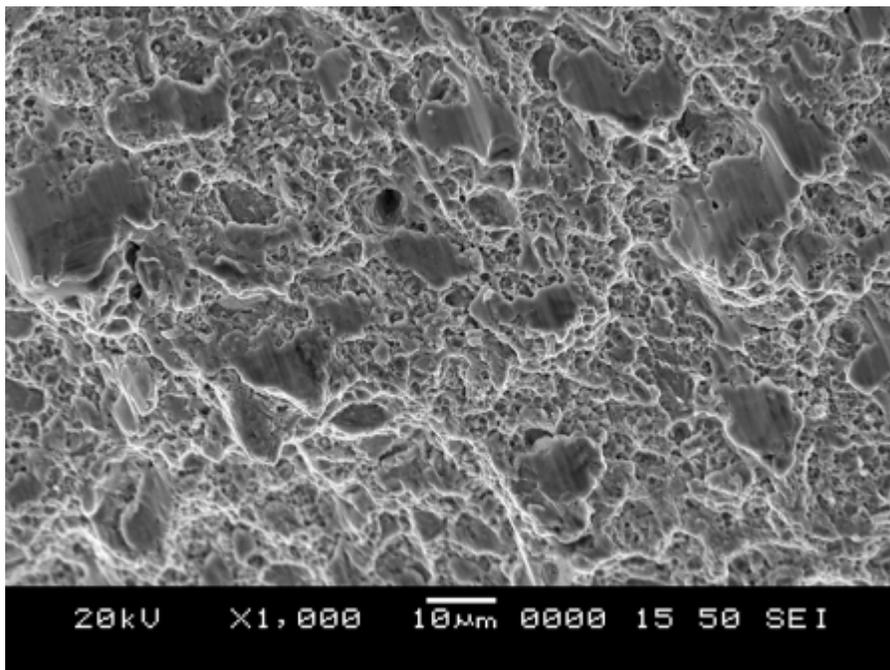
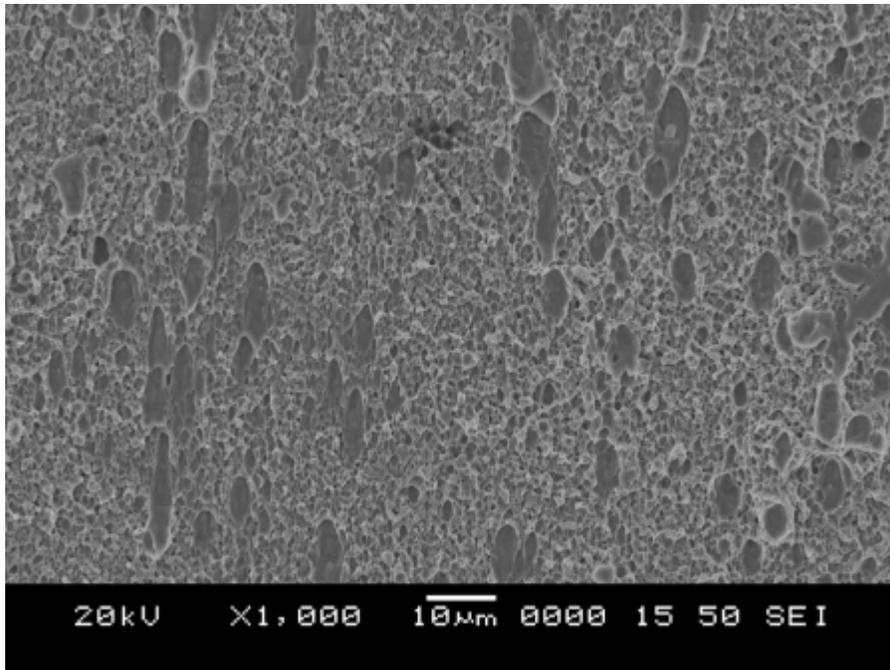
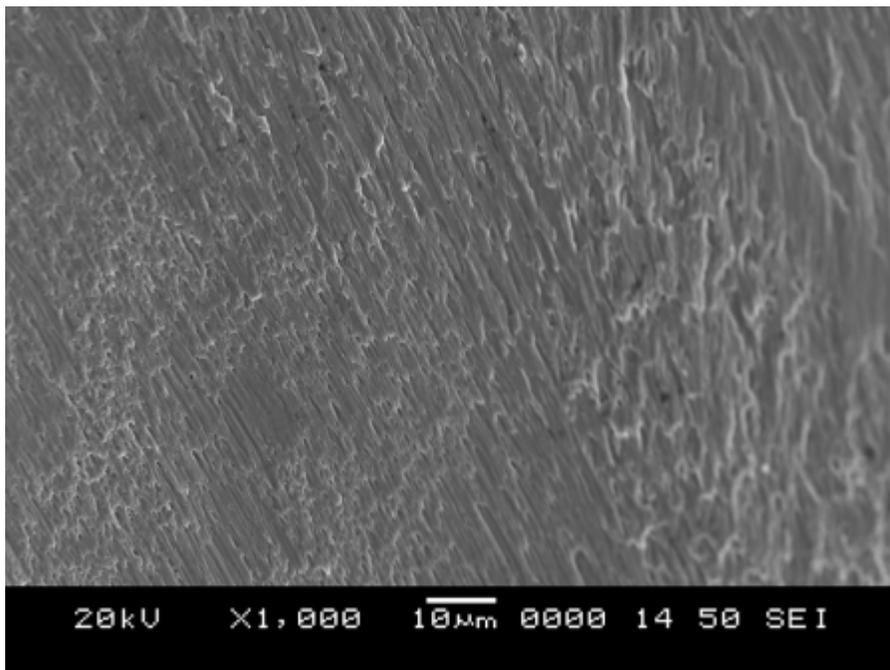
The fracture surface generated by the low cycle fatigue failure of tooth 31 is presented in figure 64. The drive side origin is shown in figure 65. The fracture morphology includes a small amount of mixed mode fracture (figure 66), but is dominated by cyclic overload in the middle of the tooth (figure 67) and near the coast side (figure 68).

Figure 67. Tooth 31 fracture surface, showing cyclic overload fracture.

Figure 68. Tooth 31 fracture surface, ductile overload.

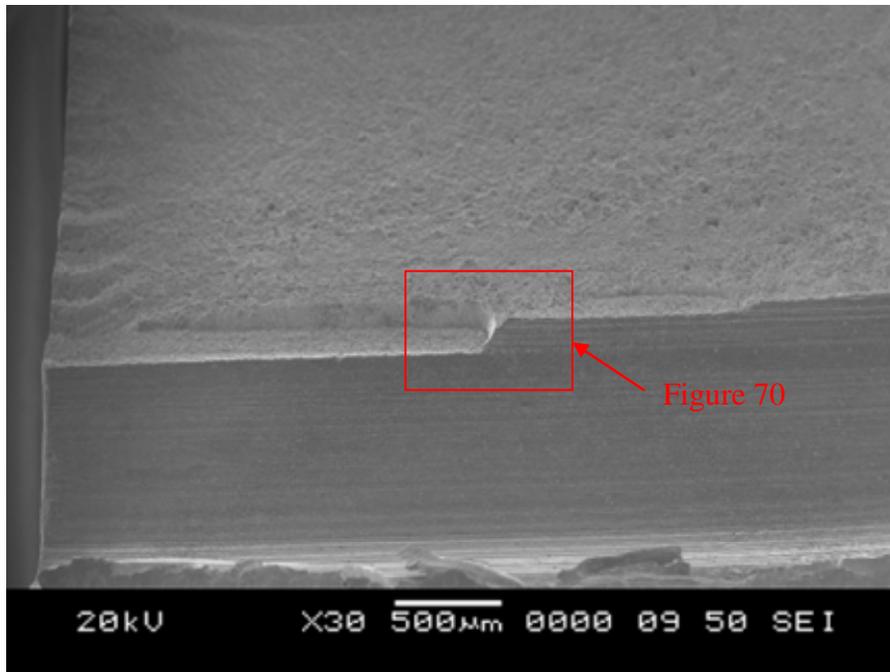
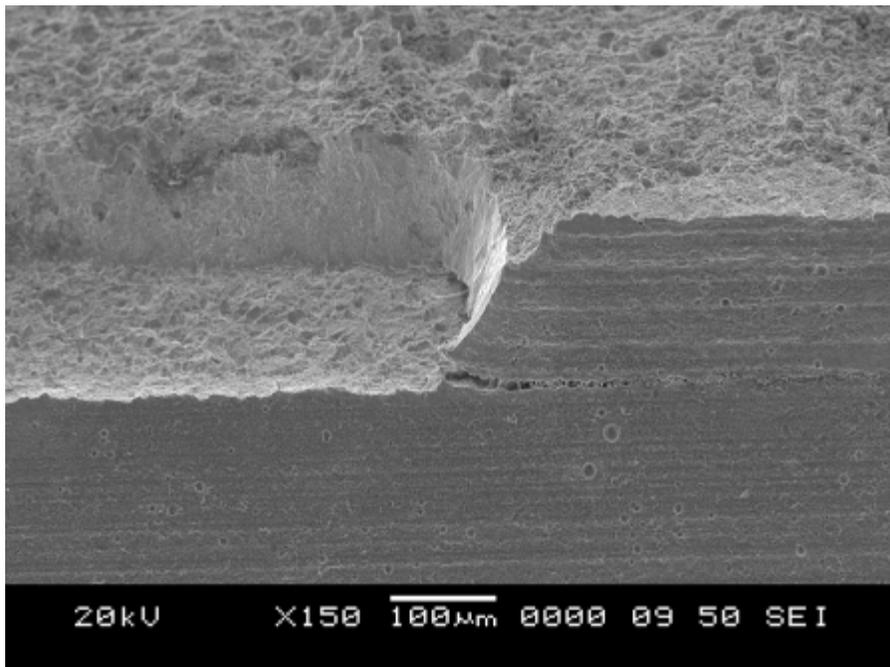
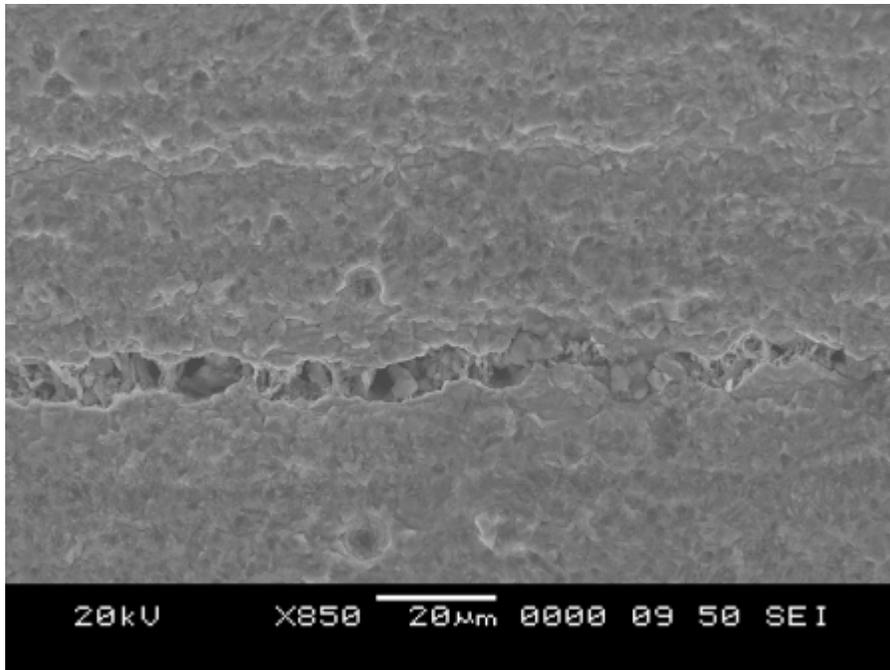
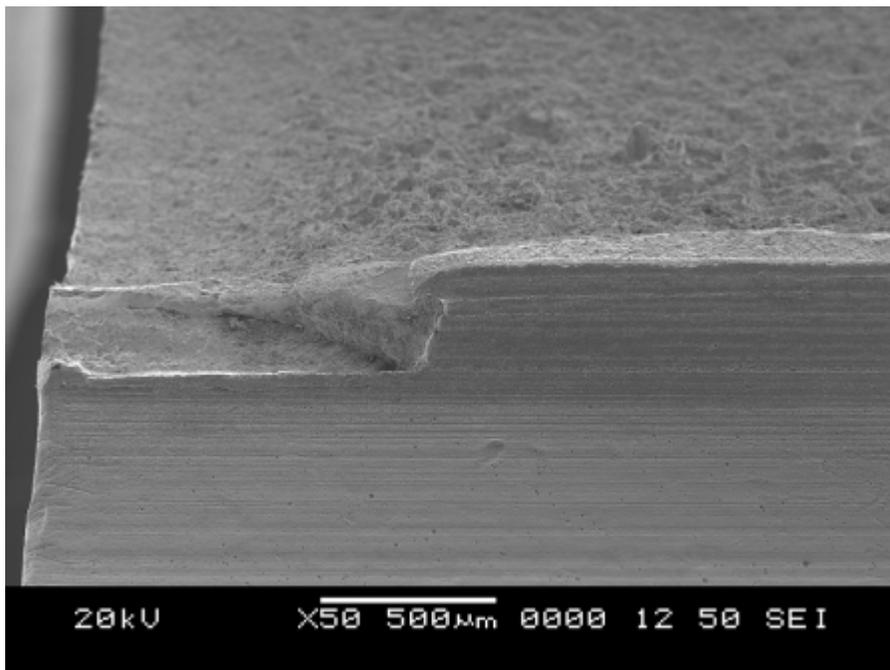
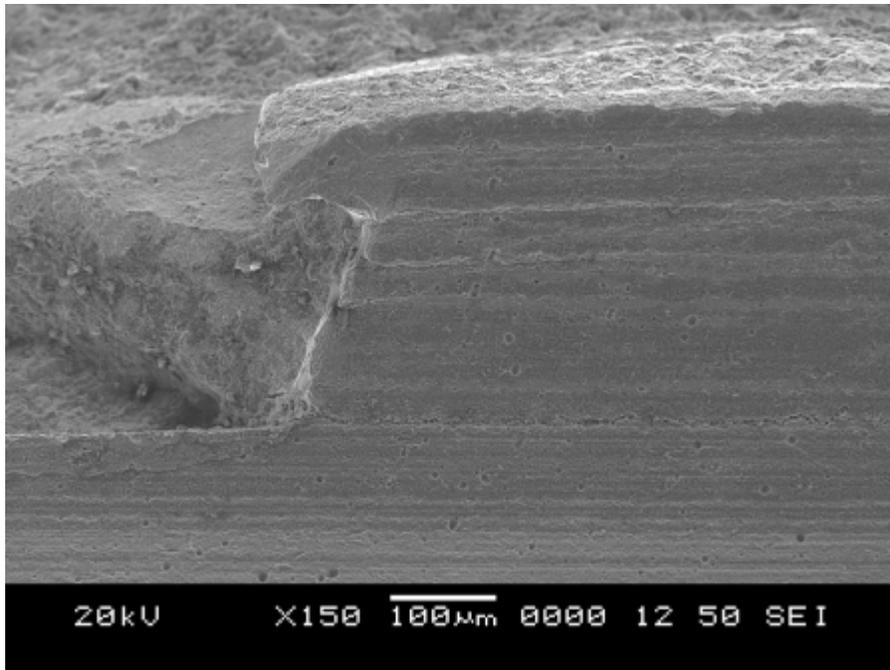
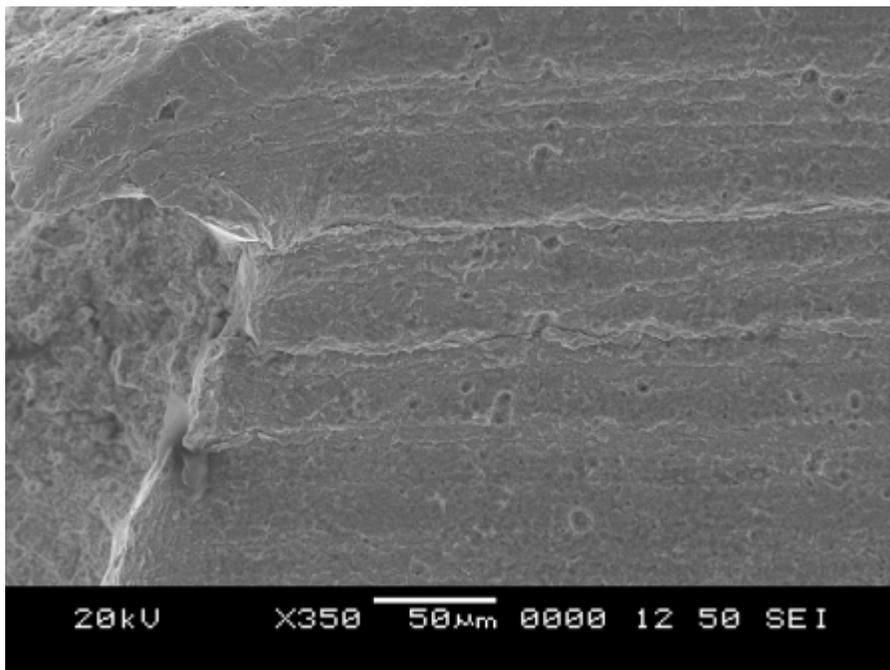
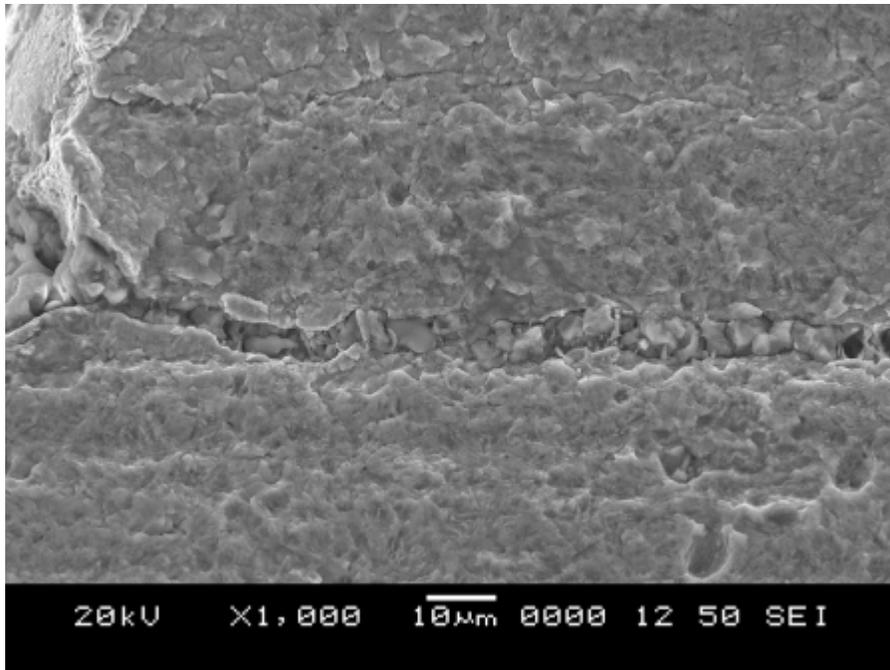
Cracking originating from coast side tool marks is shown in figures 69–75.

Figure 70. Coast side tool marks, tooth 28 root, gear half. (Note the undercut parallel to tool marks.)

Figure 71. Tooth 28 root, gear half, coast side cracking along tool marks.

Figure 74. Tooth 29 root, gear half, coast side tool marks, cracking along tool marks.

Figure 75. Tooth 29 root, gear half, coast side, cracking along tool marks.

- Identify and eliminate the source of the pitting.
 - Eliminate or reduce the magnitude of the tool marks present in the tooth root fillet.
-

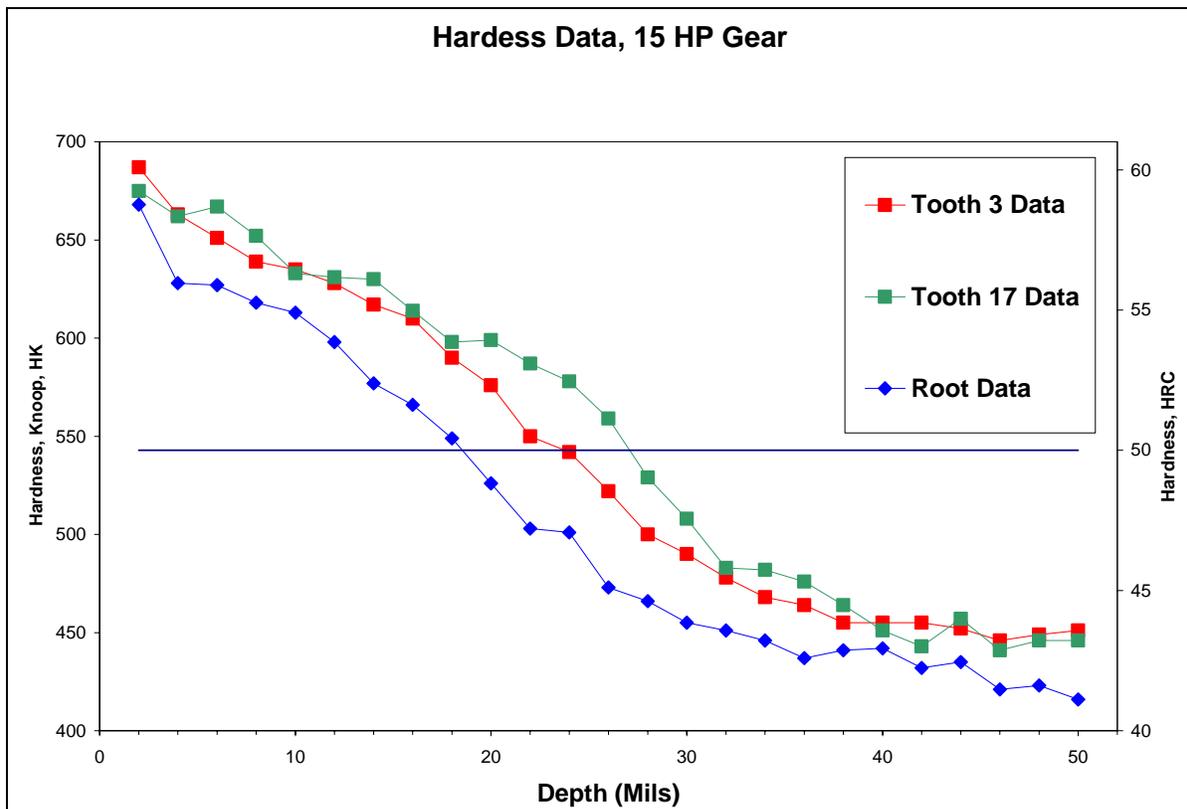
Hardness measurements were provided by Redstone Technical Test Center. They were made at the tooth root and at the face (near the pitch line) using an Instron Model Tukon 2100 microhardness tester. Effective case depth (EFD) (defined as the depth at which hardness drops to 50 Hardness Rockwell C-scale [HRC]) was found to be approximately 0.026 in at the pitch line and 0.018 in at the root. Hardness data for the profile and root are given in tables 1–3 and shown in figure 76.

Core hardness was measured to be HRC 39.5 using a Wilson Rockwell indenter (Model C524-T). Required minimum core hardness was HRC 30.

The EFD was determined to be 0.018 in at the root and 0.026 in at the pitch diameter. The EFD was defined as the depth at which a value of 50 HRC is obtained.

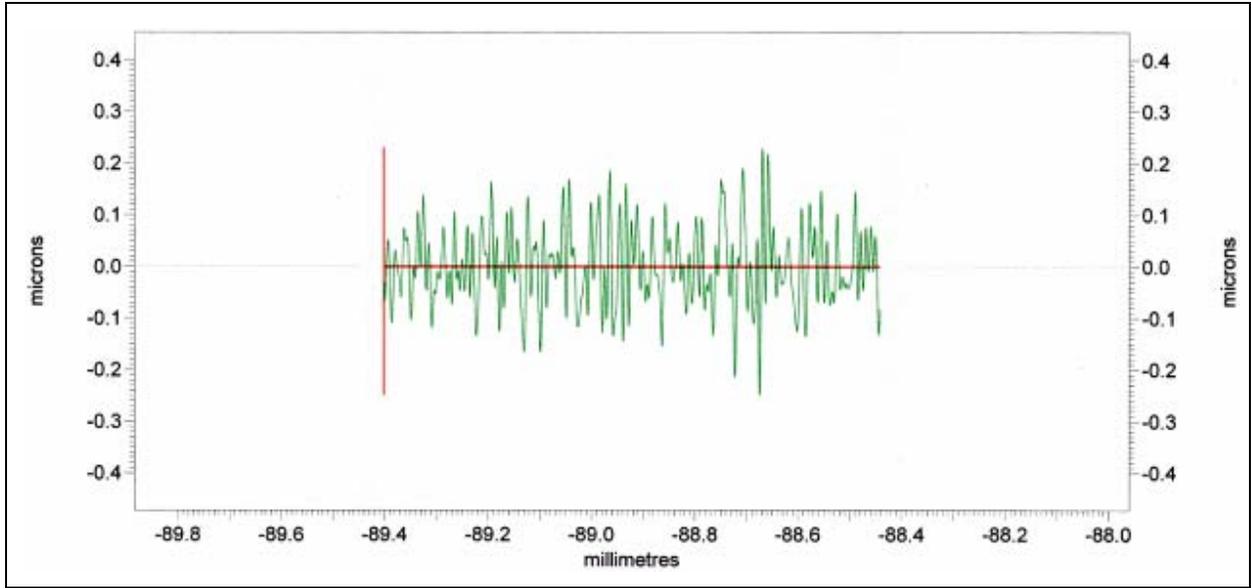
A Taylor-Hobson Form TalySurf Series 2 was utilized to perform laser surface profilometry in a non-worn area of a typical gear tooth. The root mean square (RMS) surface roughness was measured to be 2.85 $\mu\text{m-in}$ (see figure 80). This is well below the specified value (32 $\mu\text{m-in}$). It must be noted that this measurement was on the surface of a tooth that may have been polished by the mechanical action of the meshing gear teeth during service, although no appreciable wear was observed in the area where the measurement was taken. Additionally, evidence of shot peening was observed (see figure 81). Measurements in the root of the teeth were unobtainable.

The surface finish was estimated to be 2.85 $\mu\text{m-in}$, RMS. This is within the drawing specification (32 $\mu\text{m-in}$ maximum). However, tool marks were observed near the roots of gear teeth.

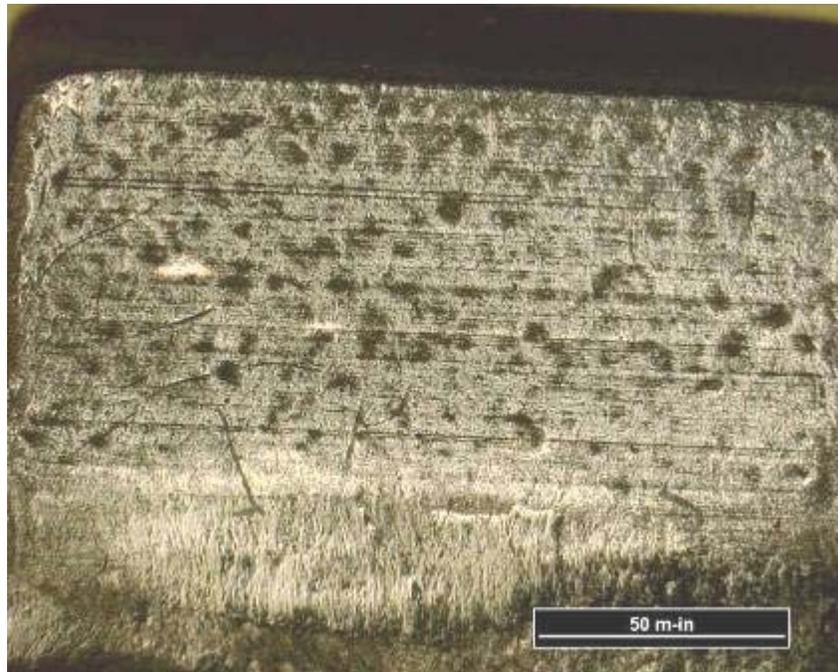
Figure 81. Optical photograph of shot peened surface finish.
