SSME 0523

TEST 902-772

FAILURE INVESTIGATION

FINAL REPORT

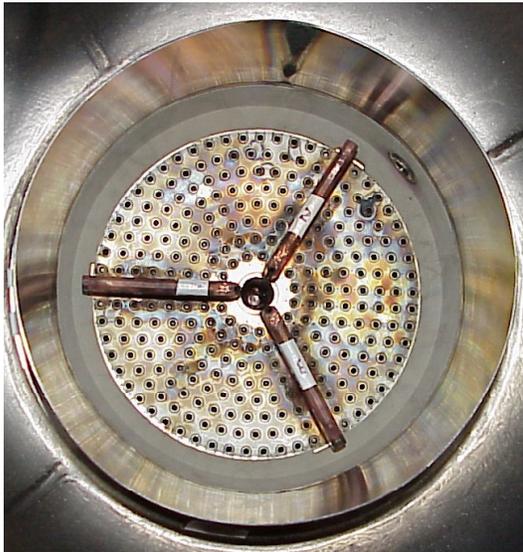
The Fuel Preburner (FPB) liner extension had erosion in the vicinity of element H15. The preburner faceplate had thermal discoloration and some minor erosion. This was a high time unit (fleetleader) so the faceplate already had some discoloration from prior testing.

Figure 7.3.1-1 View of Fuel Preburner Faceplate with Thermal Discoloration and Minor Erosion

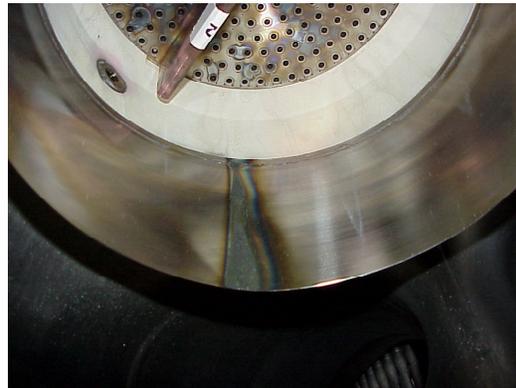
Figure 7.3.1-2 View of FPB Liner Extension Erosion

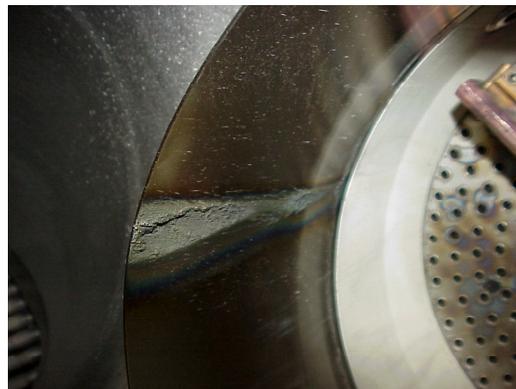
Figure 7.3.1-3 Close-up View of FPB Liner Extension Erosion

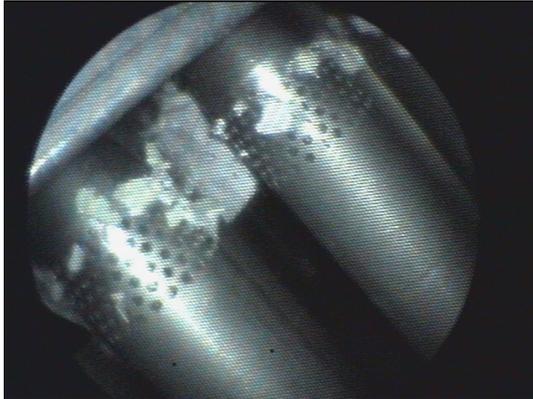
Inspections with the borescope showed white fibrous particles protruding through the holes on the FPB element sleeves. Inspection through the coolant holes on the preburner faceplate revealed contamination also. Inspection of the FPB fuel manifold showed numerous pieces of contamination lodged against and into the fuel manifold and against injector elements. The preburner injector LOX posts (LOX system) showed no anomalies.

Figure 7.3.1-4 Borescope View of Contamination Protruding into Fuel Sleeve Holes

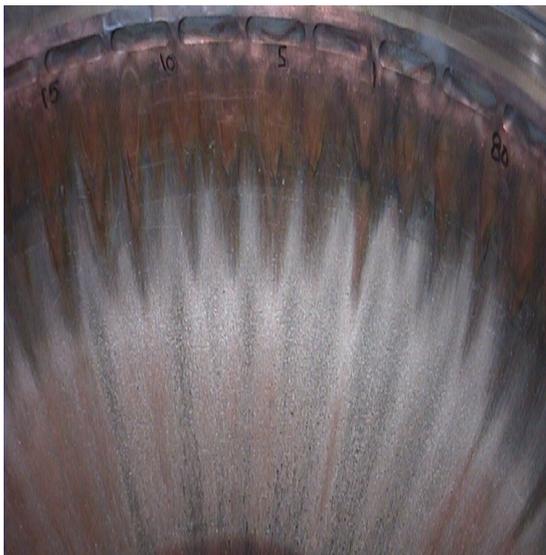
The Main Combustion Chamber (MCC) hot gas wall forward end had flame spray, slag, and numerous dings and dents, 360 degrees around. The metallic spray has not been analyzed at this point but is assumed to be HPFTP/AT materials. The level of damage is such that it could be removed via polishing and the unit could be returned to service if necessary. The MCC was back flowed to remove any contamination lodged in the coolant channels. No anomalies were noted.

Figure 7.3.1-7 View of Flame Spray on the Forward End of MCC

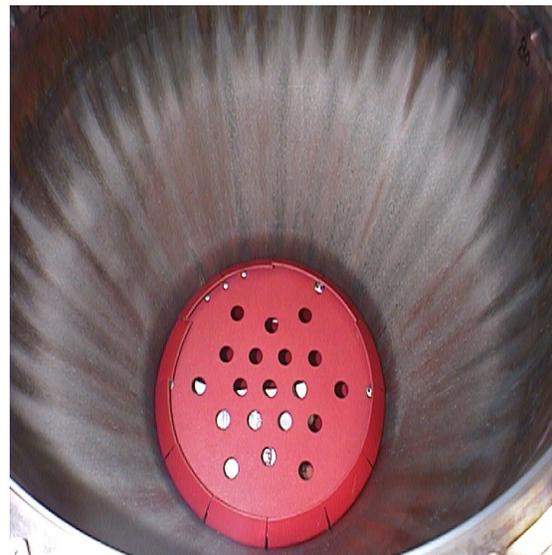
Figure 7.3.1-8 View MCC Forward End Looking Towards Throat

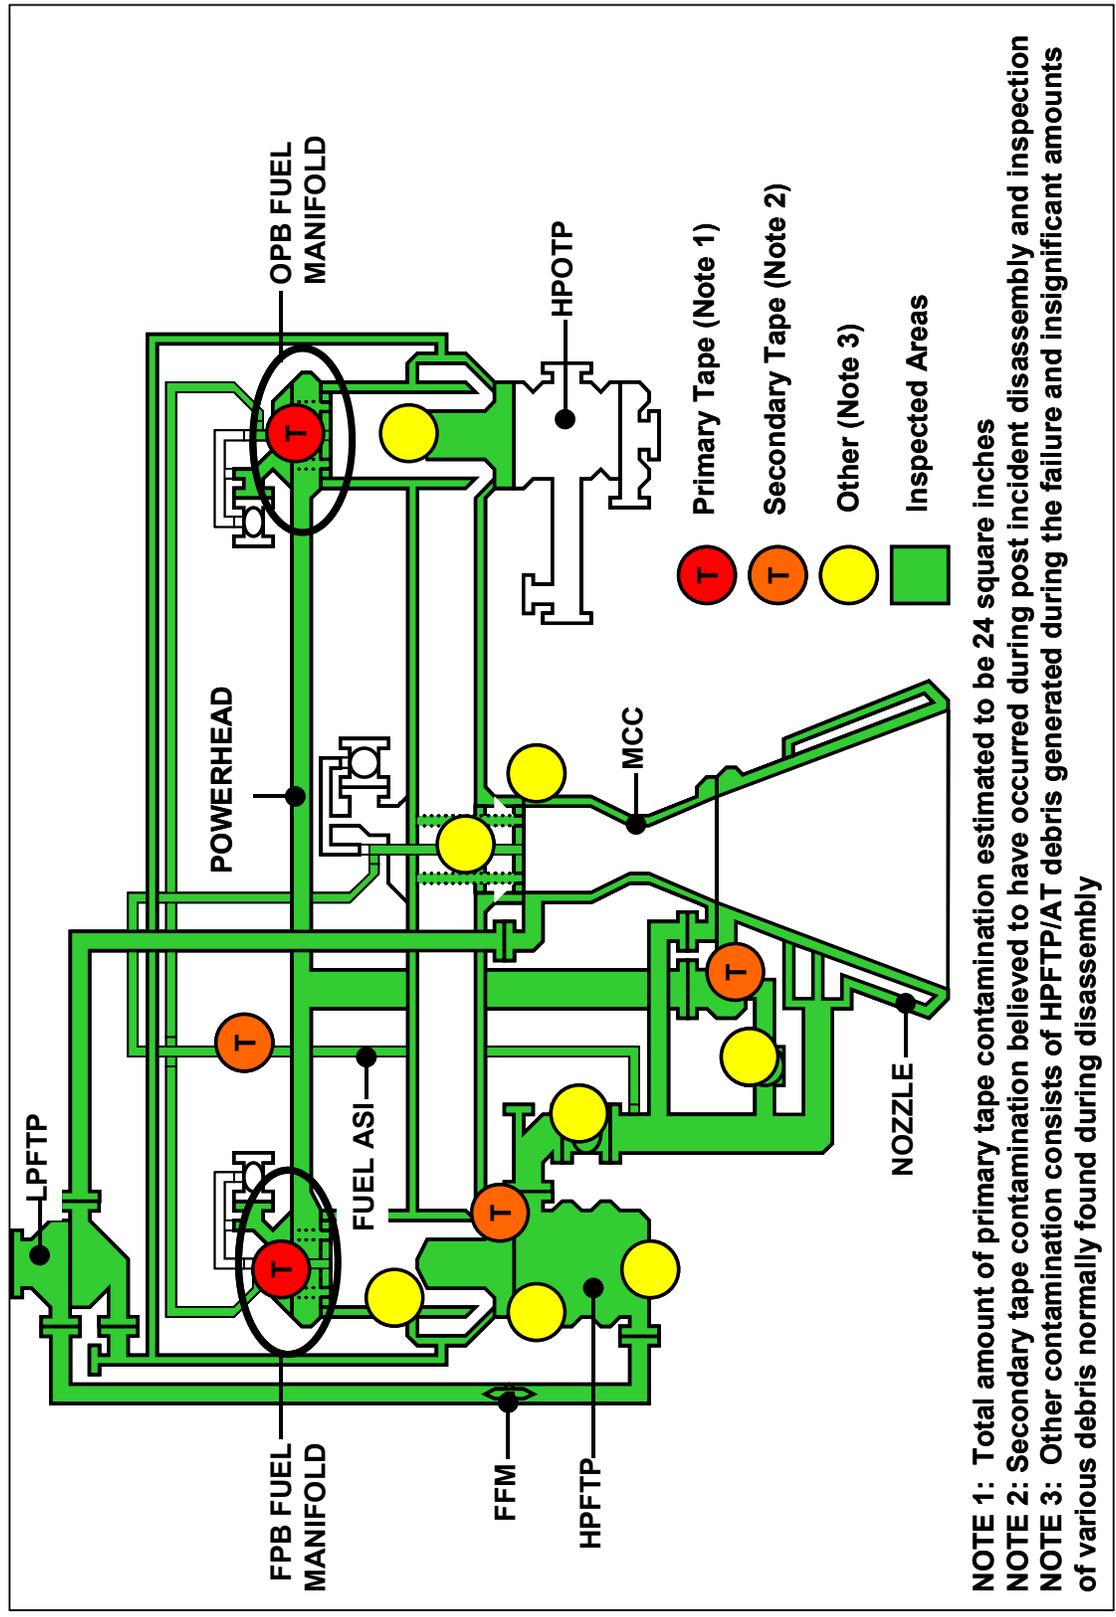
In addition to the contamination later determined to be Permacel P-670 tape (LOX tape, see Section 7.5.2) found in the FPB and OPB fuel cavities, very small amounts of similar contamination were found at joint locations F17 (mixer bowl), G6 (HPFTP/AT flange), and downstream of F5.1 (Augmented Spark Igniter (ASI) fuel supply system). These contaminants were determined to have been introduced into these areas during post-incident handling of the hardware.

Figure 7.3.1-9 Post-test Inspection Highlights and Locations of Contamination

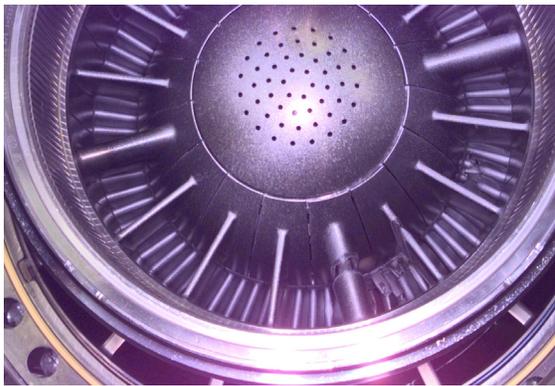
The Turbine Inlet Housing (TIH) exhibited erosion on the outer diameter flowpath wall between fat strut #15 and thin strut #14. The TIH erosion was in the same circumferential location as the streak seen on the FPB liner extension. The TIH and inlet dome were splattered with aluminum from particles generated during rubbing of pump-end seals during the vibration events. The first stage vanes were eroded at two circumferential locations between TIH struts #14 and 15 as well as between TIH struts #12 and 13. First vane segment #23 (between TIH struts #14 and 15) had evidence of heavy erosion and was missing the airfoils and ID platform.

Figure 7.3.2 – 1 Inlet Dome, Eroded TIH Struts #14 and 15 and Damaged 1st Stage Vanes

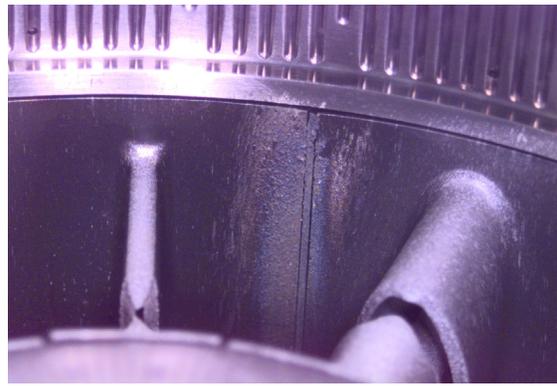
Figure 7.3.2 – 2 Erosion on Outer Flowpath Wall of TIH Between Struts #14 and 15

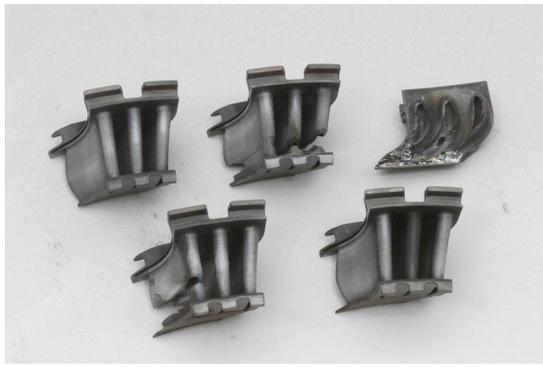
Figure 7.3.2-3 First Vane Segments #21 Through 25 Leading Edges

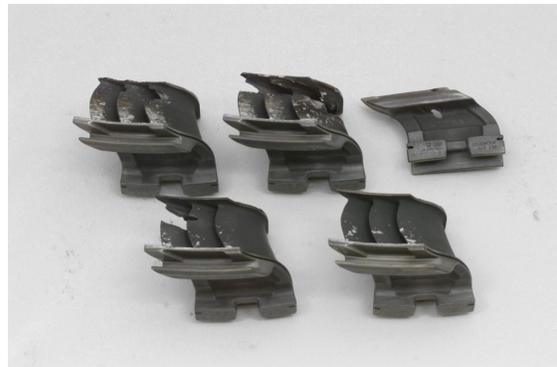
Figure 7.3.2-4 First Vane Segments #21 Through 25 Trailing Edges

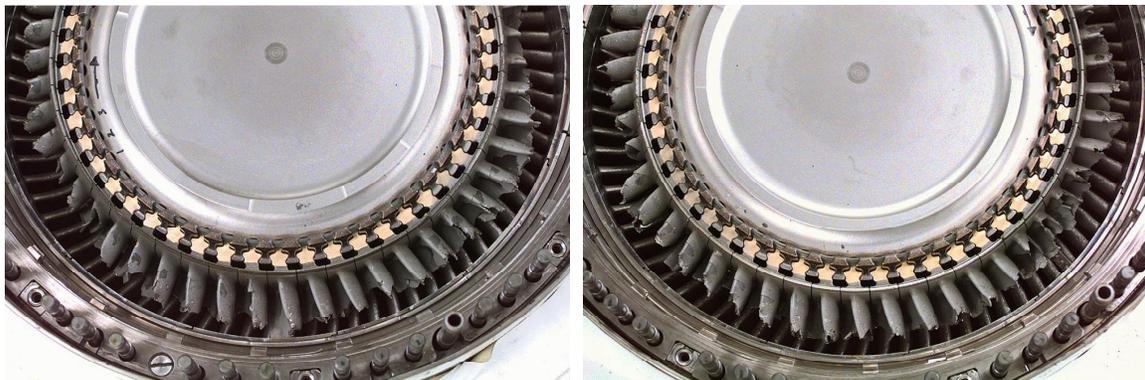
The turbine hardware downstream of the first stage vanes (first blades, second vanes, second blades, turn-around duct, and turbine exit diffuser) was all damaged by impact and is discussed in more detail in Appendix F.

Figure 7.3.2-5 First Stage Blades

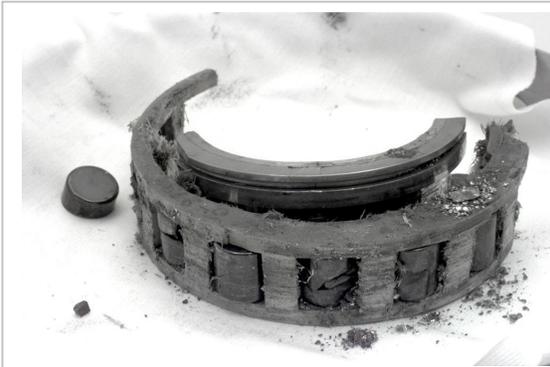
Distress to both bearings was noted. The ball bearing exhibited evidence of load path crossover on the inner race. The roller bearing failed under excessive loads during shutdown. Analysis regarding the failure mechanism and quantification of loads is being conducted under a SSME Project Office action. Further discussion of the condition of bearing components is located in Appendix F.

Figure 7.3.2-6 Roller Bearing Inner Race, Cage, and Rollers

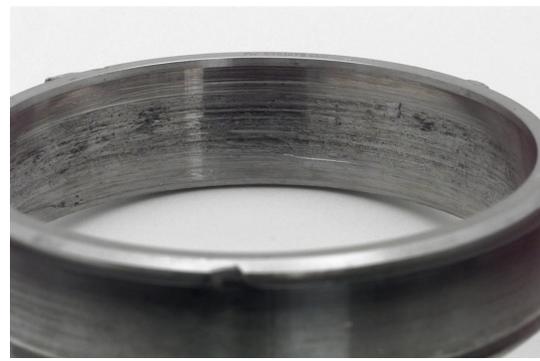
Figure 7.3.2-7 Roller Bearing Outer Race

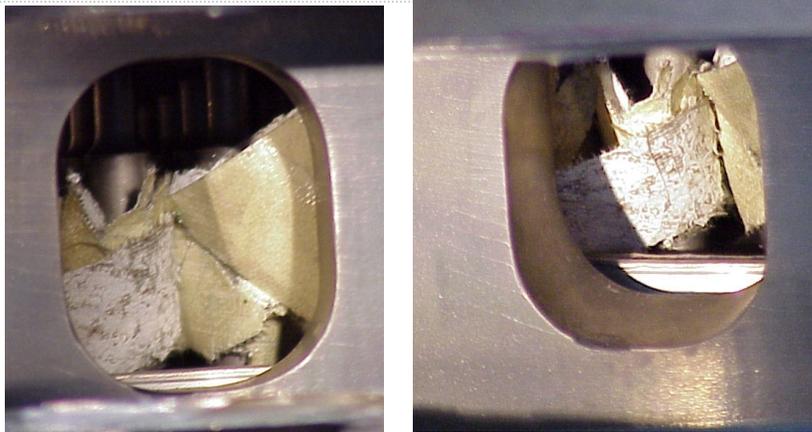
A large amount of tape was removed from the Fuel Preburner (FPB) and a smaller amount from the Oxidizer Preburner (OPB). FTIR analysis identified this material as Permacel P-670 tape, commonly referred to as LOX tape. 3.4686 grams of tape was removed from the FPB and 0.2765 grams from the OPB. Assuming a 90% recovery, the total tape in the preburners was extrapolated to 4.1612 grams. This weight of tape correlates to approximately 24.2 square inches of the Permacel P-670.

Figure 7.5.2-1 Contamination Seen in FPB Fuel Manifold Windows 4 and 5

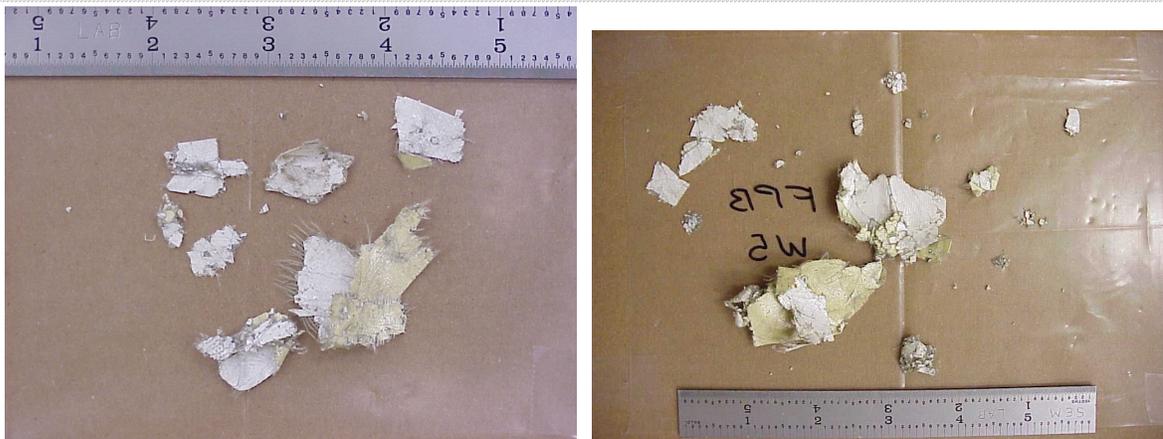
Figure 7.5.2-2. Typical Debris Removed from the Fuel Preburner

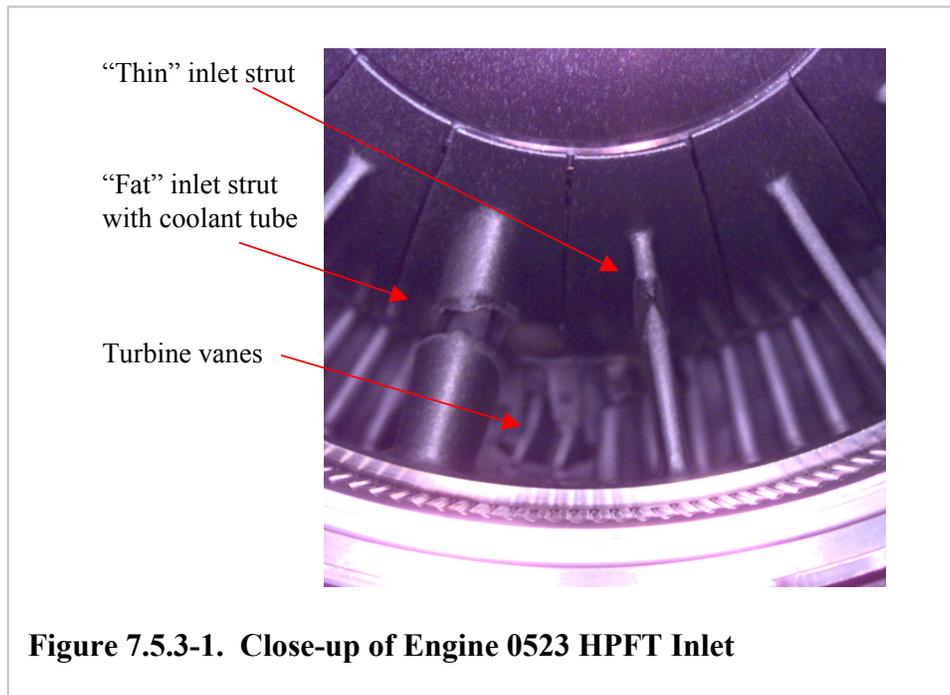
Figure 7.5.3-1 shows a close-up view of the HPFT inlet. Shown is a narrow sector where the most damage was found. First, a "thin" inlet strut is melted through. Next, a "fat" inlet strut is melted away but the enclosed coolant tube is intact. And finally, the vanes downstream of the inlet are melted. Damage not shown in this picture includes a burning/melting of the preburner liner extension along one distinct streak. This streak was found directly above the area marked "Turbine vanes" in Figure 7.5.3-1. Also, there was another small region of melted turbine vanes to the right of the area shown in the picture.

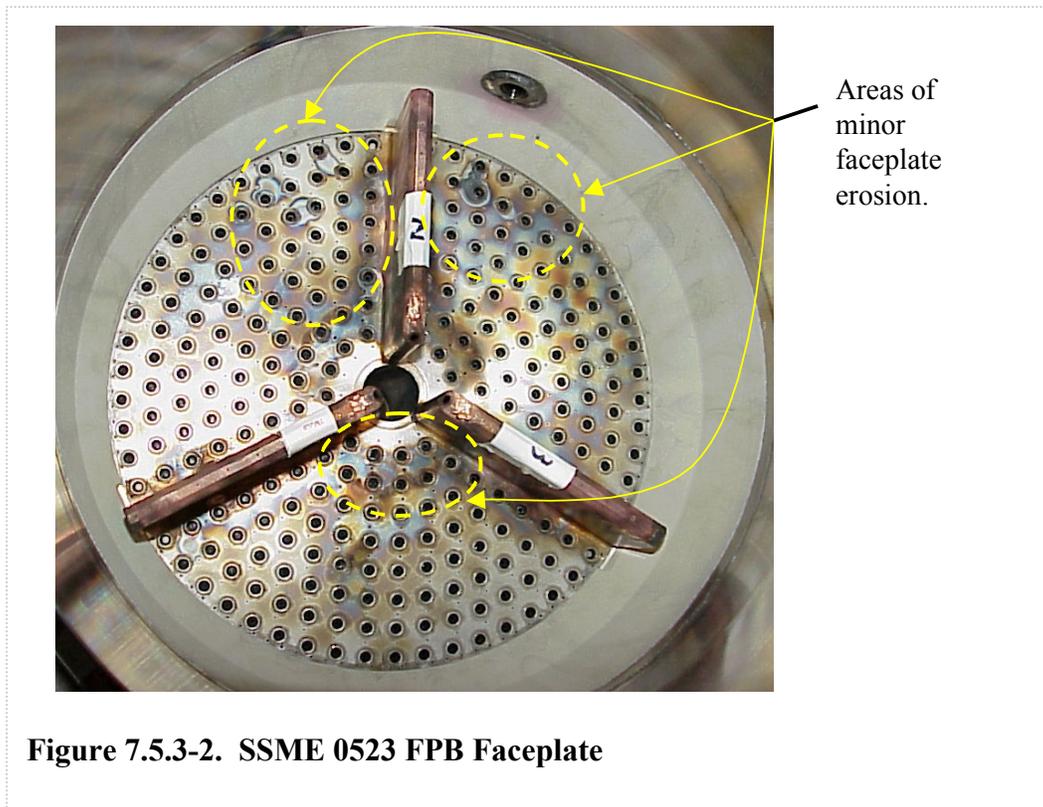
In Figure 7.5.3-2 the FPB injector faceplate is shown. Circled are a few of the areas of faceplate erosion. Much of this erosion is no more than discoloration or minor blanching but there was some material eroded away within the upper right-hand circle. The upper left-hand circle is roughly the region that was situated directly over the damage shown in Figure 7.5.3-1.

Figure 7.5.3-2. SSME 0523 FPB Faceplate

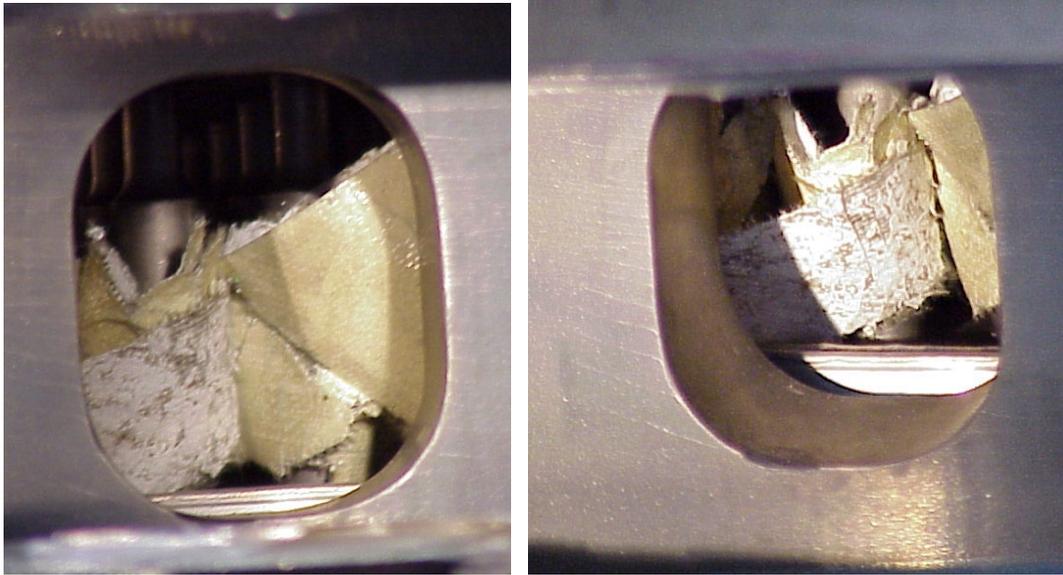
On June 16, 2000, Stennis Space Center conducted test 902-772. SSME 0523 was to be tested for a scheduled duration of 200 seconds. At engine start the tape contamination was forced downstream in the fuel system, eventually coming to rest as debris in both the Fuel Preburner (FPB) injector and Oxidizer Preburner (OPB) injector. The amount of debris in the FPB was sufficient to block multiple fuel inlet holes of several FPB injector elements in localized areas.

Figure 8.0-2 Tape Contamination Observed Through FPB Fuel Manifold Windows Upon Disassembly

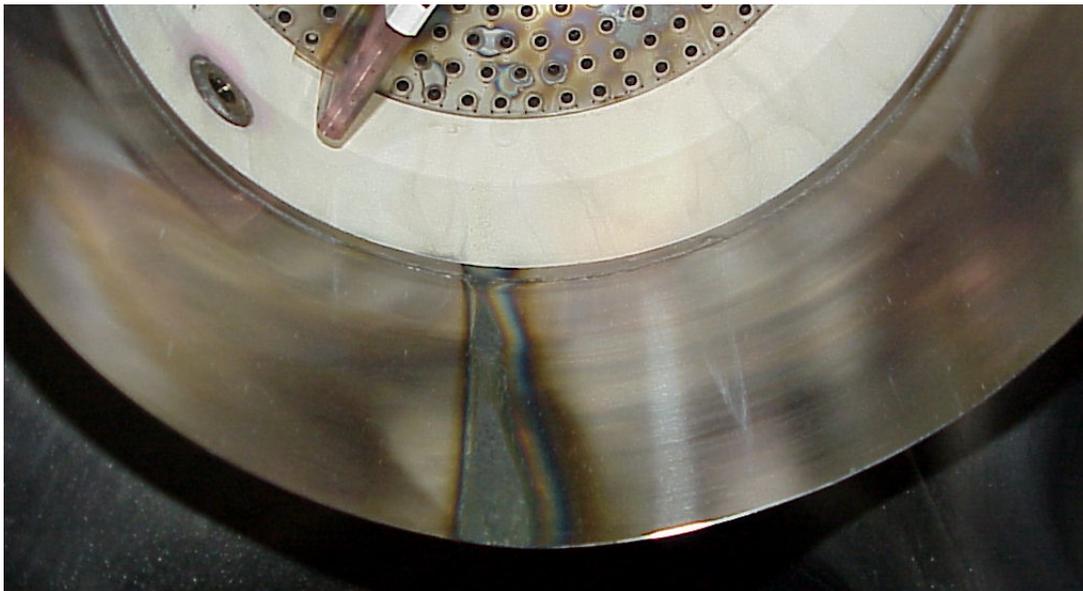
This blockage caused a localized high mixture ratio area in the preburner without affecting overall engine system performance. Data analysis indicates a localized temperature increase occurred in the vicinity of HPFT DS T Channel A measurement and the HPFT DS T measurement at joint KG2dT beginning at approximately 2.7 seconds.

Figure 8.0-3 Fuel Preburner Liner Streak

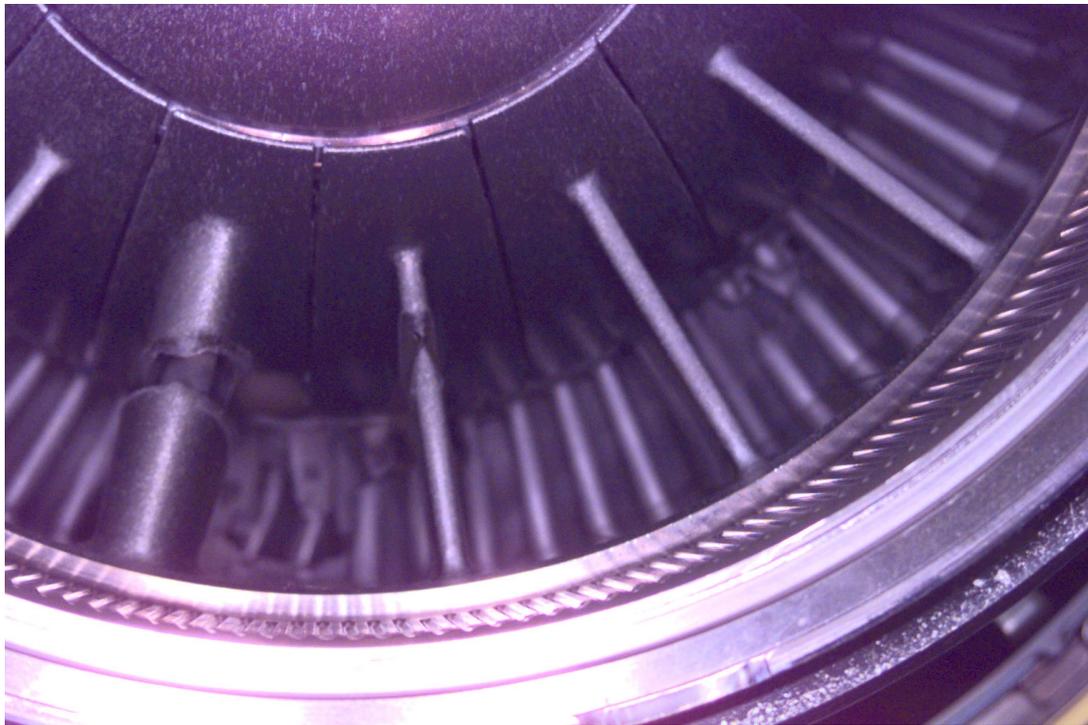
The localized temperature increase caused melting of the turbine inlet housing struts and first stage vanes in the HPFTP/AT. At 4.97 seconds, all three airfoils on first stage vane segment number 23 were melted through the chord, causing local structural failure of that segment of vanes. The inner platform of vane segment number 23 fell into the hot gas flow stream impacting the first stage blades. This caused the first stage blades to fail creating significant HPFTP/AT rotor imbalance. Data analysis indicates synchronous vibrational level increases of approximately 8 grms on the pump end and 20 grms on the turbine end.

Figure 8.0-4 HPFTP/AT 8109R1 Turbine Inlet Damage
