**REPORT ON THE
INITIAL NBIS INSPECTION
OF
CHARTIERS CREEK BRIDGE**

BMS No. 02 7421 0000 9061

BRIDGE NAME: Chartiers Creek Bridge

INSPECTION DATE: June 23, 2000

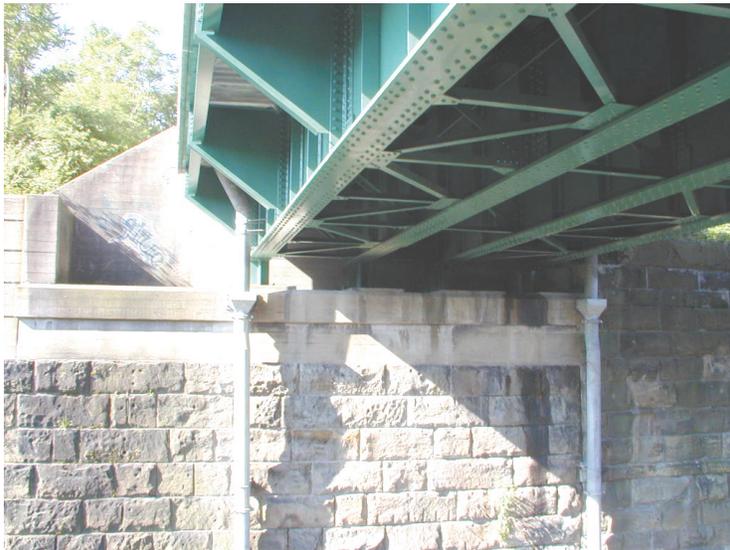
Photo No.4 South Abutment (near) - Elevation

The north and south abutments are in good condition, with a few minor problems noted. Both abutments have newly constructed reinforced concrete backwalls, bridge seats, and wingwalls with no visual deficiencies noted (see photo no.'s 4 & 5). The stem tops consist of new reinforced concrete construction, also with no visual deficiencies noted, and are attached to the existing stone masonry bases. Some locations of the stone masonry show minor cracking and loosening of mortar.

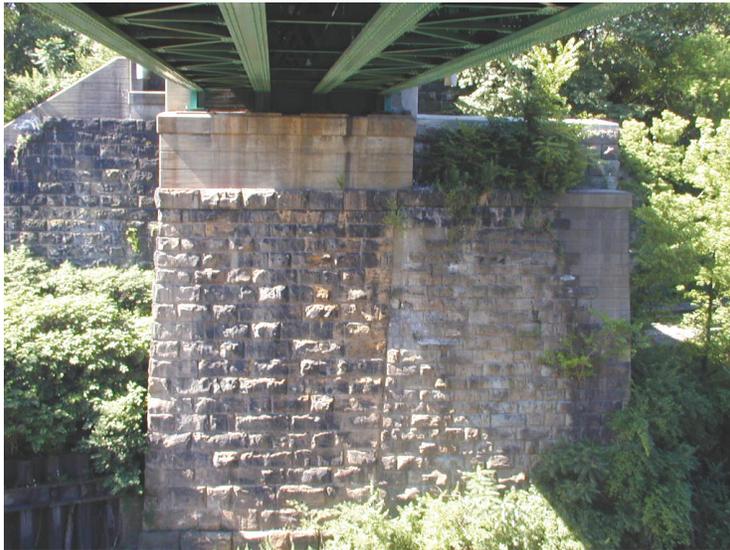
Photo No.6 Pier 1 - North Face (Looking South)

Piers 1 & 2 are in good condition with minor cracking and loosening of mortar on the existing stone masonry portion of the stems. The bridge seats, caps, and stem tops are newly constructed reinforced concrete with no visual deficiencies noted (see photo no.'s 6 & 7).

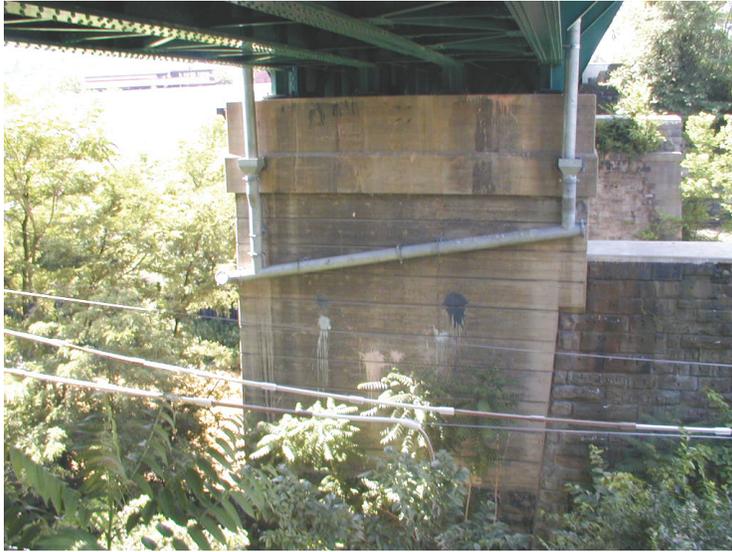
Photo No.7 Pier 2 - North Face (Looking South), note electrical lines

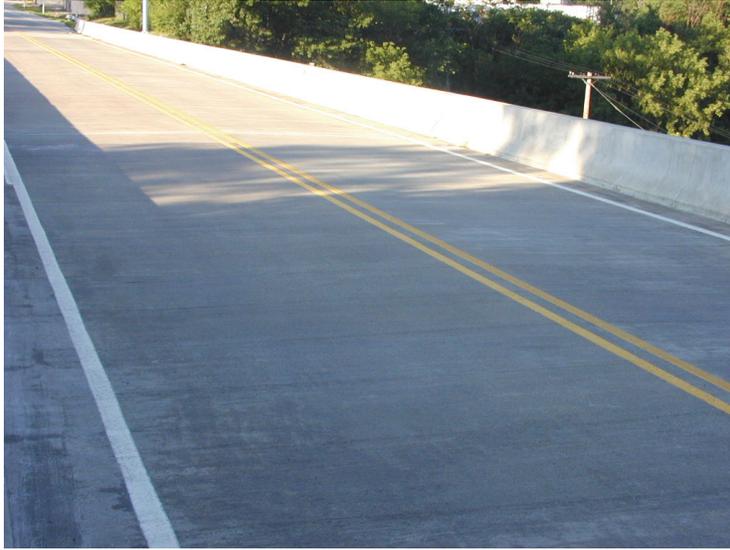
Photo No. 11 General Deck View

No deficiencies noted – new construction (see photo no. 11). All PennDOT Type 1 scuppers are in excellent condition. A few scuppers exhibit minor debris accumulation but are fully functional (see photo no. 15). Random hairline (< 0.01”) shrinkage cracks along the length of the concrete parapets are present (see photo no. 16). Deck expansion joints consist of strip seals in good condition with minor debris accumulation (see photo no. 17).

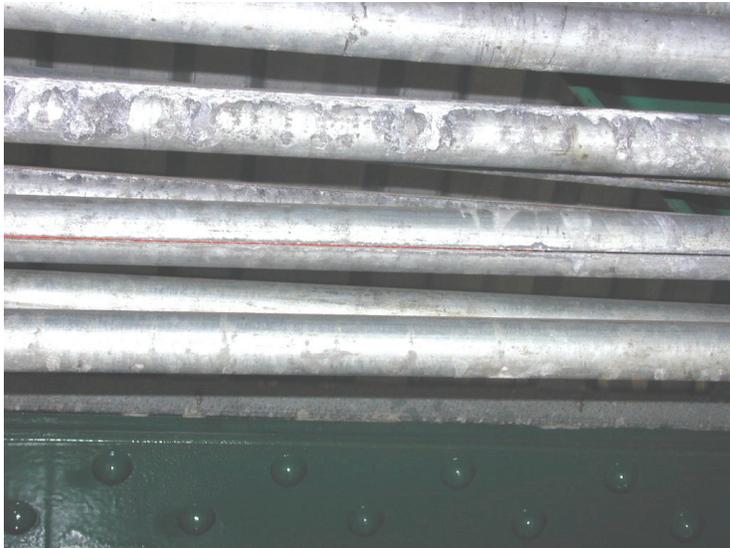
Michael Baker Jr., Inc. performed this initial inspection, which follows NBIS procedures, on June 23, 2000, via a UB-40 underbridge inspection crane. In general, the structure was in good condition with a few minor problems. Several conduits at the south abutment and in span 1 have severely buckled segments, and broken couplers and/or adapters (see photo no.'s 12 & 13). In addition, a conduit in span 3 is split and leaking water (see photo no. 14). These problems are due to the junction boxes being allowed to fill with rainwater during construction.

Photo No. 12 Conduit, Span 1 – note longitudinal crack/split

Item	Estimated Quantity	Unit Cost	Total Cost
Drain junction boxes, and conduits filled with water. Repair bent conduits, and broken couplers/adapters.	N/A	Lump Sum	\$5,000.00
Paint locations requiring final paint coat between girders 3 & 4 in span 2.	20 SF	Lump Sum	\$1,000.00

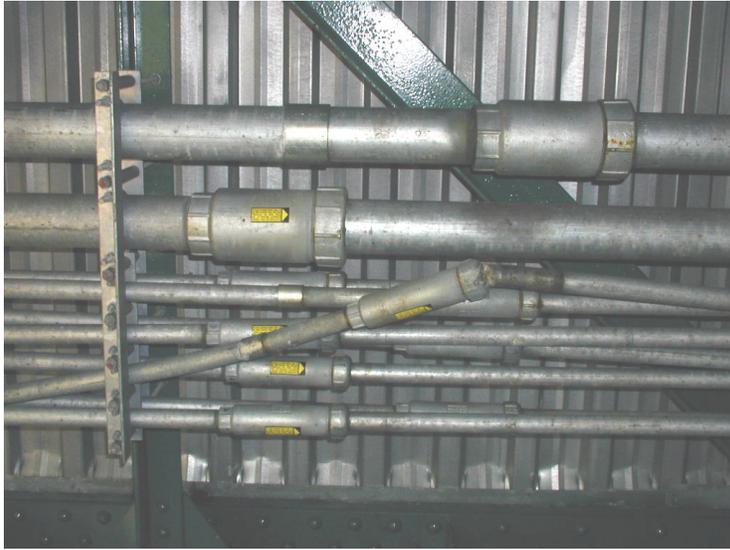
Photo No. 13 Conduit and Couplers, Span 1 – note bend in conduit, and coupler separation

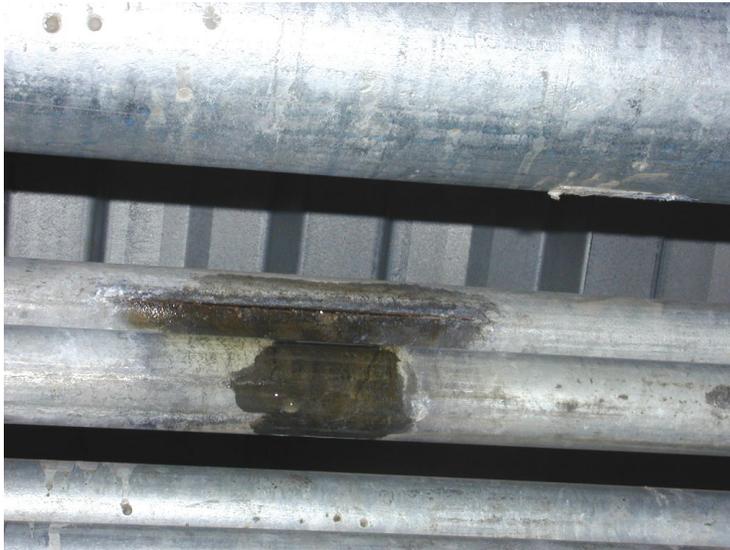
Photo No.14 Conduit , Span 3 – note conduit is split and leaking water

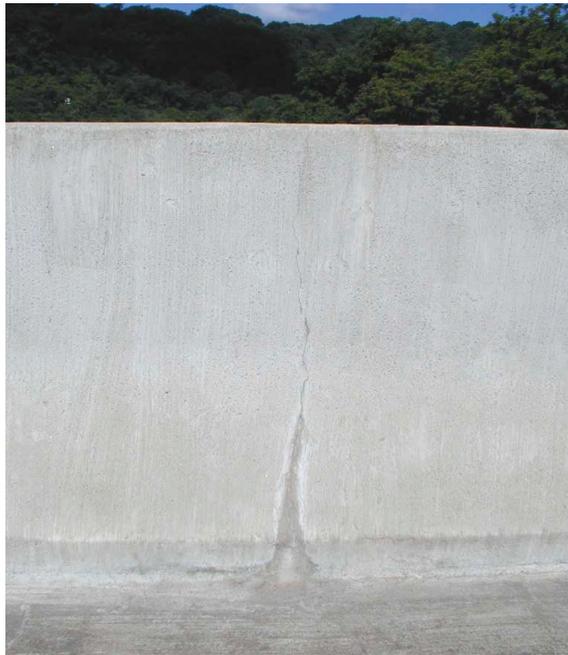
Photo No.16 Typical parapet crack

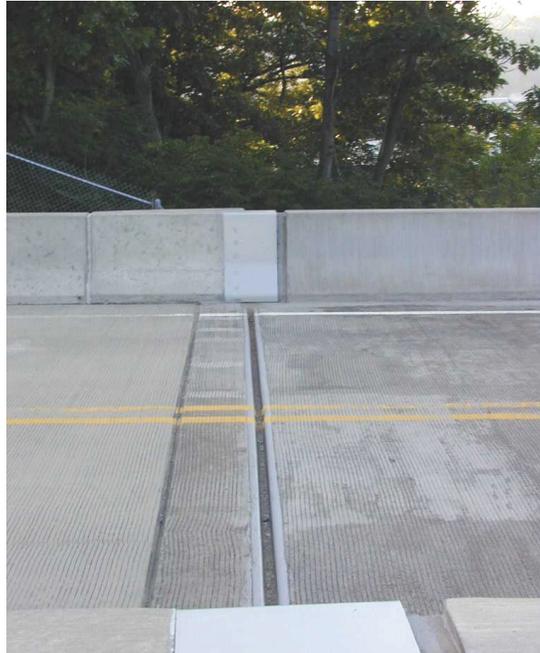
Photo No. 17 Strip Seal at North Abutment (typ.) – note minor debris accumulation

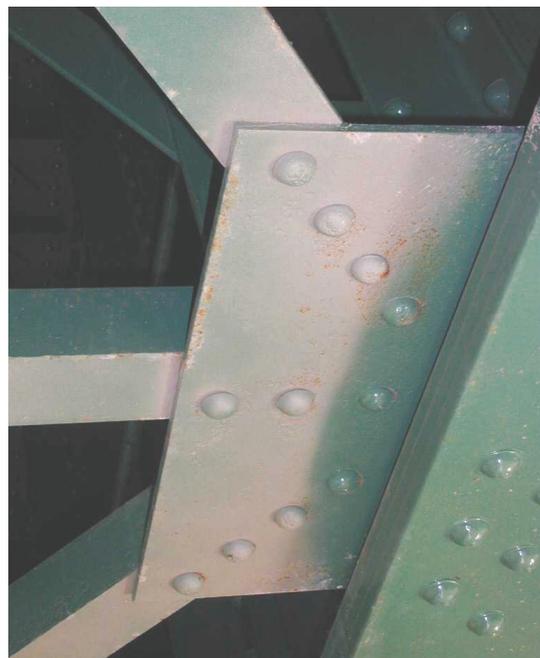
conduit in span 1. Approximately 50% of lateral bracing connections between girders 3 & 4, in span 2, were not painted with final paint coat (see photo no. 18). Laminated elastomeric bearing pads are functioning properly with no problems noted.

Photo No. 18 Lateral bracing connection between beam #3 and #4, in span 2 – note no final paint coat, and rust freckles
