by LCdr. Jay Elliott

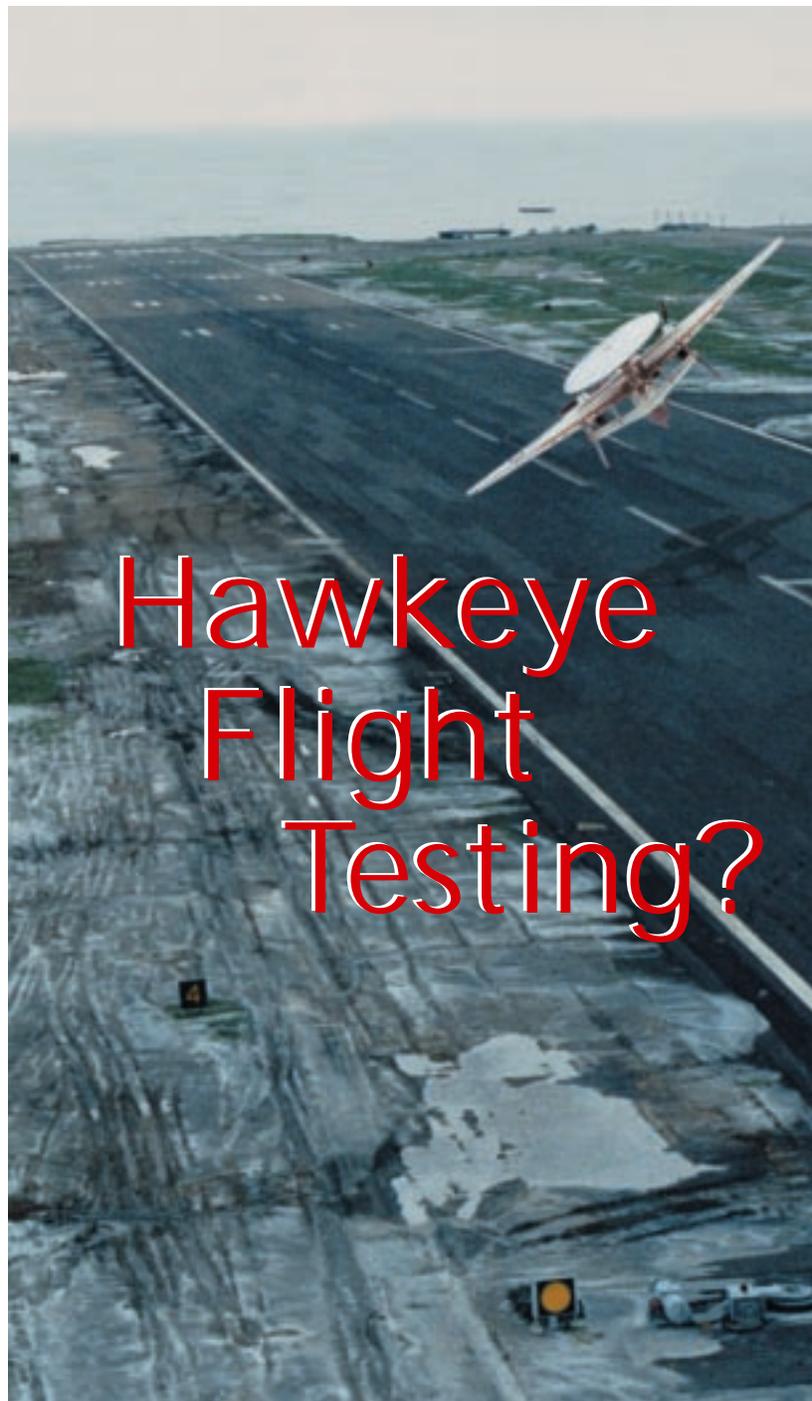
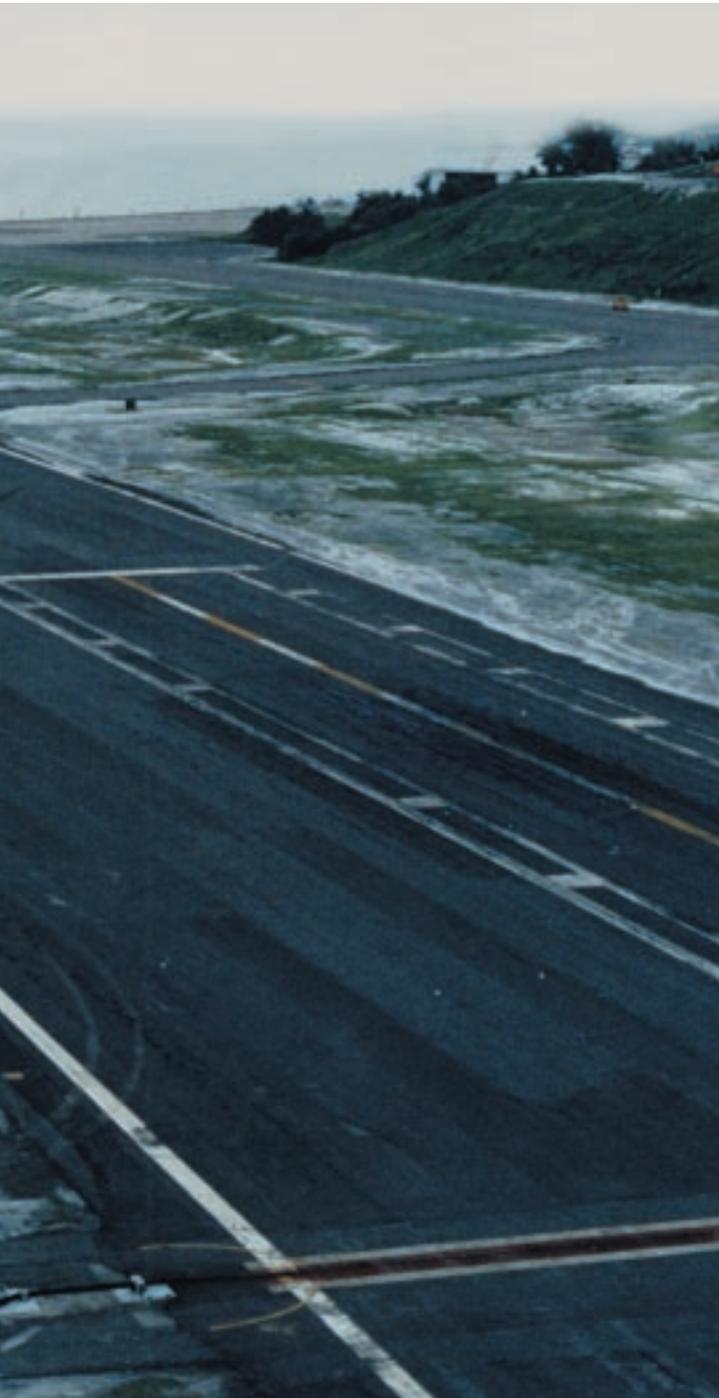
Post-flight inspection revealed that the follow-up push rod in the port aileron had failed. This failure caused the loss of feedback for aileron position, which put the aileron in a full-trailing-edge-up position. The original, port-aileron, drag-brace change had been required because, due to improper maintenance procedures, it had been bent during aileron rigging.

An EI response on the failed push rod said it normally has loads of about 2.5 pounds, and its failure load is approximately 1,550 pounds, a safety factor of 620. The most likely conclusion was that the push rod had been damaged at the same time as the drag brace. Maintenance personnel did not detect it from visual inspection and it didn't show up on subsequent throw-checks and engine turns before the flight.

If your aircraft is under control, don't change configuration unless absolutely necessary to make the landing. Had we changed flap settings, the aileron droop may have made the aircraft so hard to handle that it might have become uncontrollable.

Declare an emergency. This action will clear the space around you and reduce your cockpit workload by minimizing external factors while you handle your aircraft. 🦅
