Totally Tubular, Man

Strength of an Idea

By Ltjg. Dan Leary, USCG

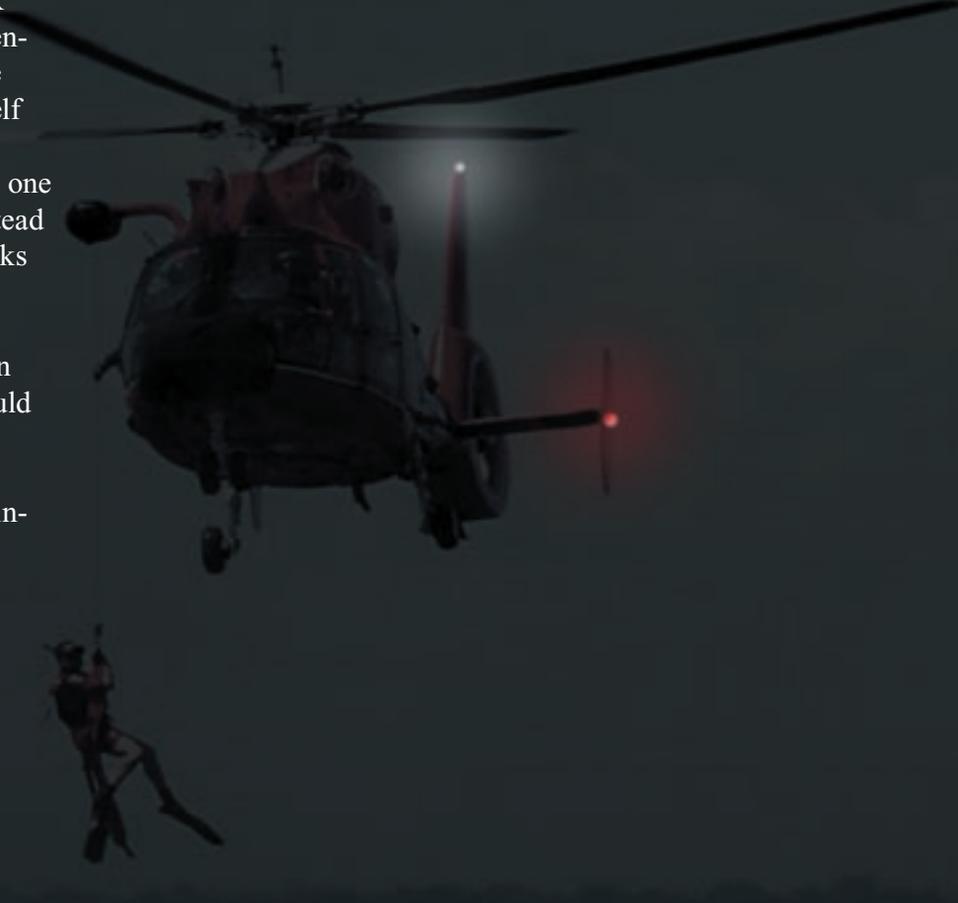
The 30-minute flight to the air station was uneventful. We debriefed the flight with the aircrew and headed for the hangar. At that moment, I looked up and saw our tail-rotor-driveshaft cover was missing. This six-foot-long cover is indeed tubular. We called the boat station, and, fortunately, they recovered our missing cover.

Post-flight inspection revealed it had failed in flight. The three fasteners showed signs of wear. Was it material failure? I'd like to think so. The helicopter just had come out of a seven-day-maintenance inspection. Did we miss the discrepancy on preflight? Three people, myself included, had preflighted the aircraft without noticing if the driveshaft cover was loose. No one had done a physical, hands-on check. We instead opted for the strength of an idea (e.g., if it looks secured, it must be).

At that moment, I looked up and saw our tail-rotor-driveshaft cover missing.

It's not mentioned in NATOPS, but I now physically check all covers on preflight. When the MLB said something tubular fell, we should have had our sister ship, or the MLB, check us with a spotlight to verify if anything was missing or out of place. We were only two min-
