Shoal Water and Sh Spell Doom

*By Lt. Paul Berthelotte,
SWO School Command*

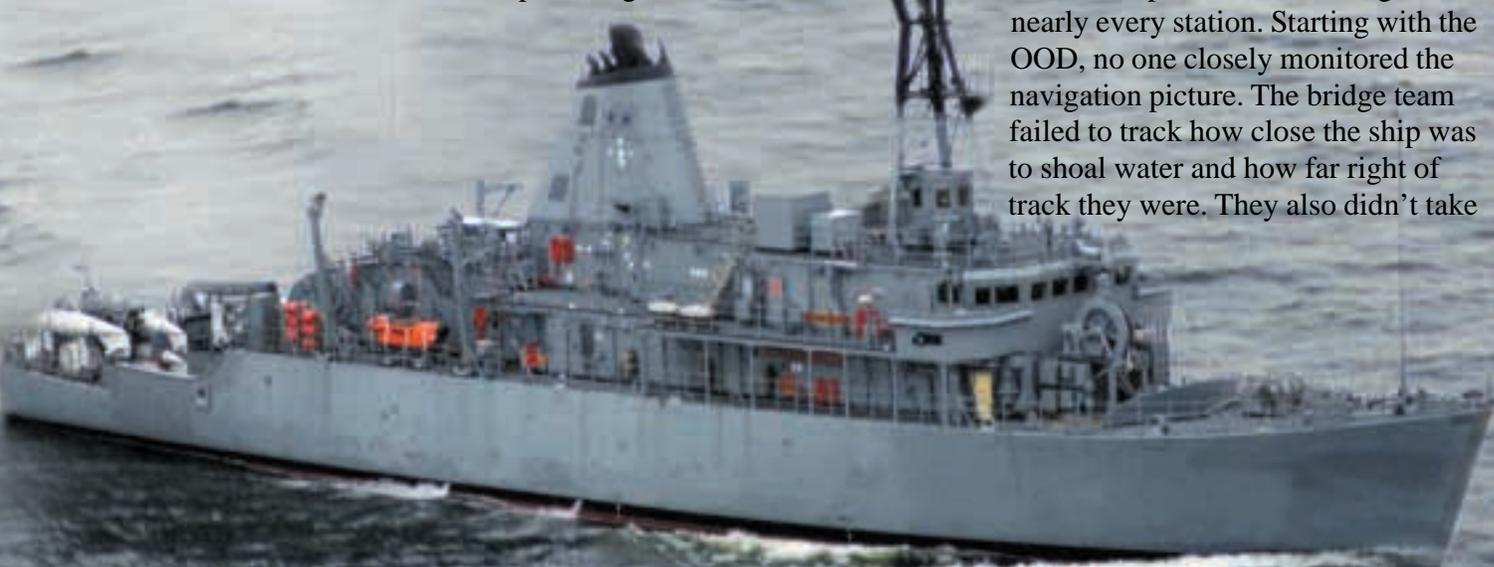
Sailors aboard an MCM like this one learned why you shouldn't operate a ship close to land or let unqualified people stand watch.

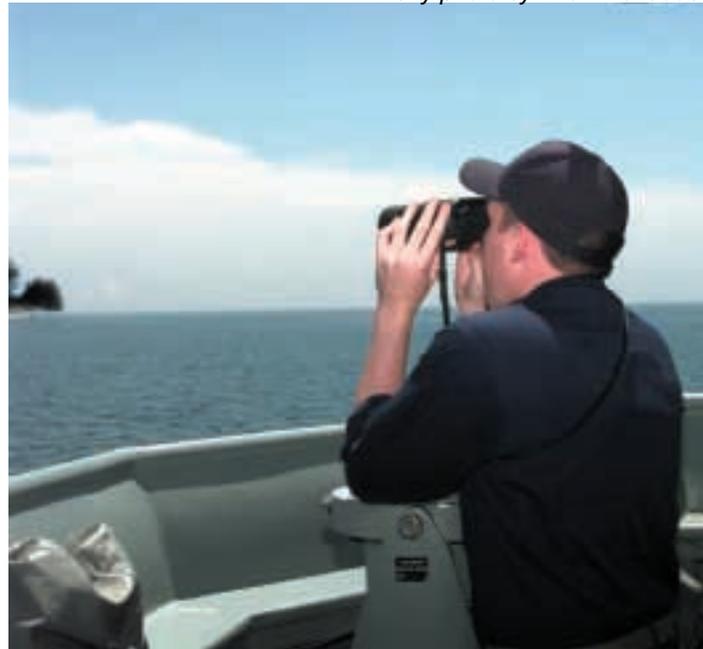
A bridge lookout aboard the MCM in this mishap made at least four reports to the bridge that the ship was coming dangerously close to the island off the starboard bow.

Eight minutes before the ship ran aground, the conning officer computed the CPA to Futagami Island off the starboard bow at 95 yards in 5 minutes. The bridge lookout made at least four reports to the bridge that the ship was coming dangerously close to the island off the starboard bow.
