# A 32-Million-Dollar Canopy Adjuster

By AE1 John Roberts, USNR

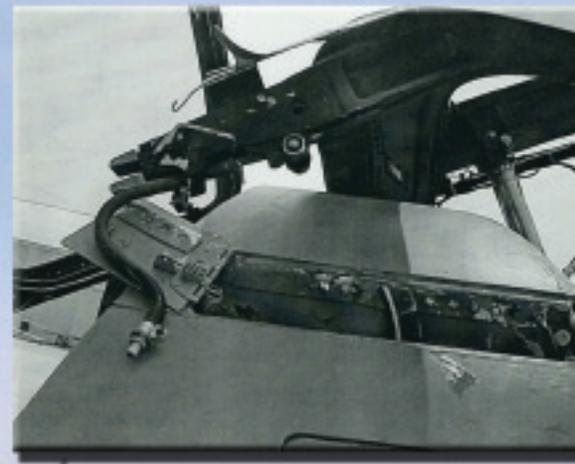
Your eyes are not crooked; the EA-6B's canopy is bent out of shape. An open canopy and jet exhaust don't mix.

I found out the canopy had not separated from the aircraft, and no one had been hurt or killed. However, my actions and the lack of action by other maintainers caused six Sailors to take a fit-for-duty exam. The incident caused \$15,000 damage to the EA-6B, extra work for another squadron, and several days of gut-wrenching anxiety for me.
