**FEDERAL AVIATION ADMINISTRATION  
AIRWORTHINESS DIRECTIVES  
SMALL AIRCRAFT, ROTORCRAFT, GLIDERS,  
BALLOONS, & AIRSHIPS**

**BIWEEKLY 2005-21**

**2005-20-11 Rolls-Royce Corporation (formerly Allison Engine Company, Allison Gas Turbine Division, and Detroit Diesel Allison):** Amendment 39-14305. Docket No. FAA-2005-22534; Directorate Identifier 2005-NE-27-AD.

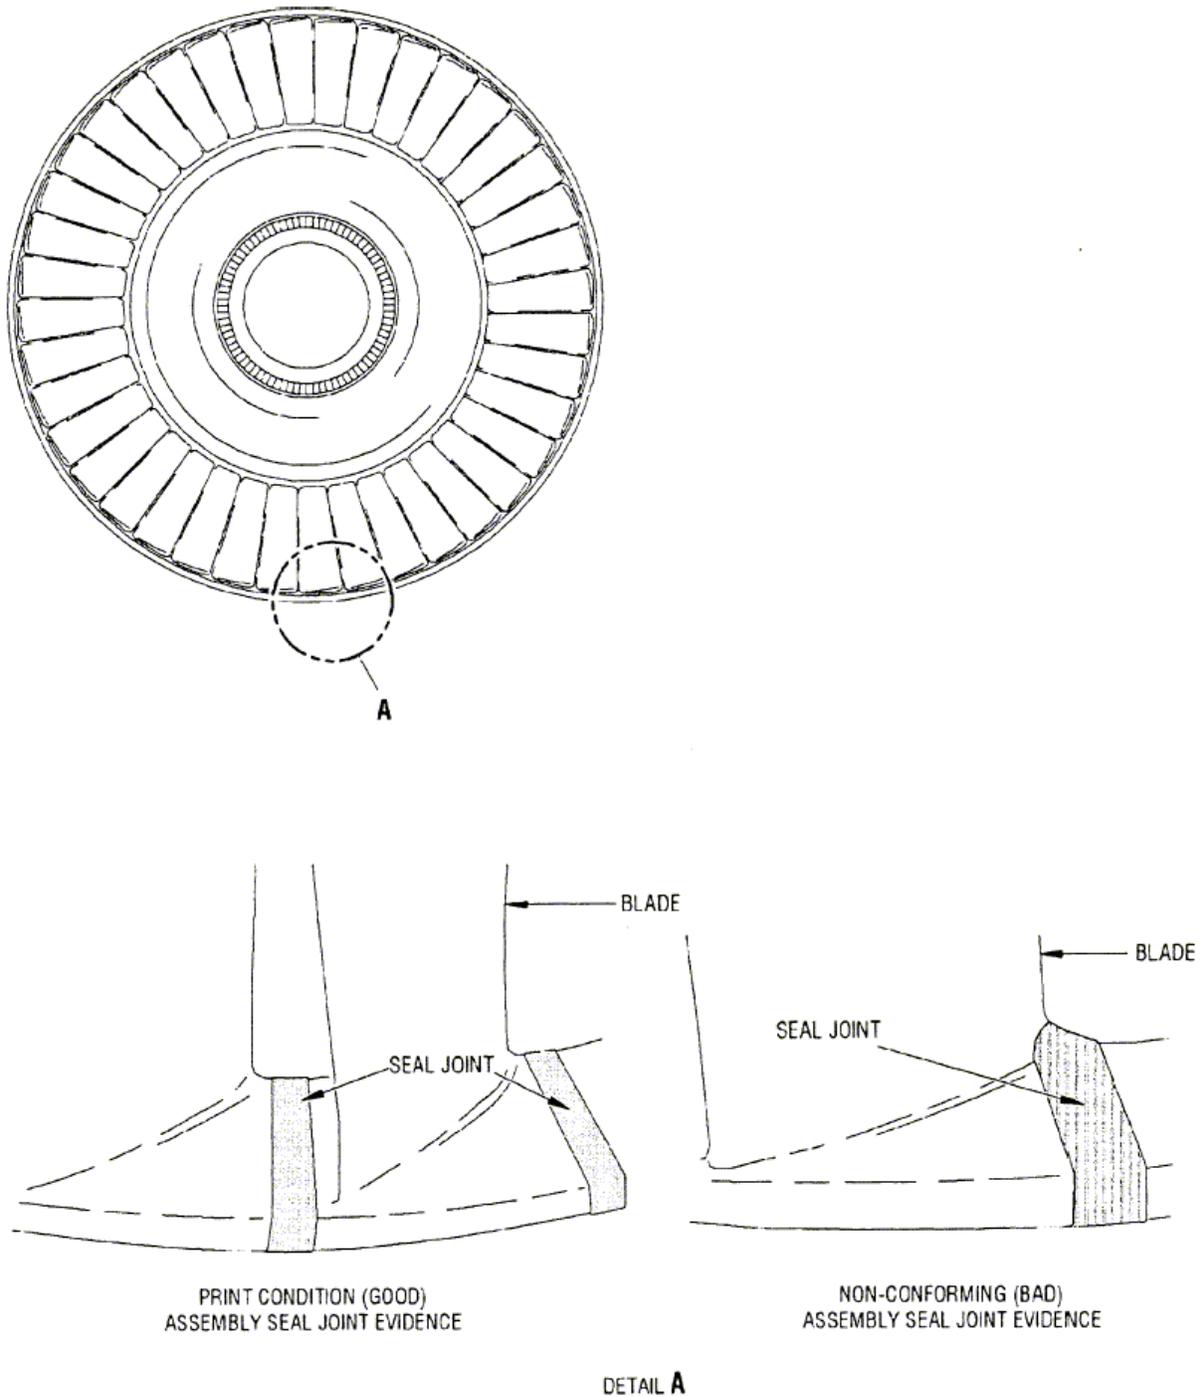
Figure 1.

(d) This AD results from reports of three failed third-stage turbine wheels and from the manufacturer's analysis of those failures. We are issuing this AD to prevent loss of power and uncommanded engine shutdown due to failure of the third-stage turbine wheel.

(h) Remove the third-stage turbine wheel and perform a onetime visual inspection of the seal joint in each passage between airfoils at the hub and shroud. Seal joint evidence must not be present within blade fillet radii. See Figure 1 of this AD for reference.

(i) Remove from service any turbine wheel that has seal joint evidence present within blade fillet radii.
