United States Department of Agriculture
Forest Service

Research
Paper
FPL-RP-674

Durability of Hardboard Lap Siding

Performance in Laboratory Testing and in Long-Term Exterior Exposure

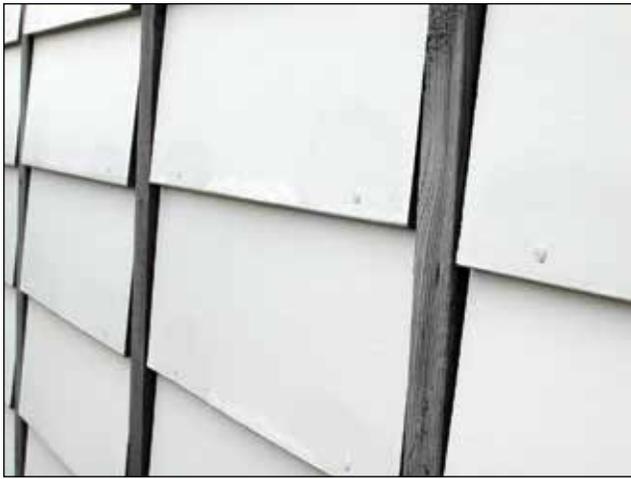
Figure 2. Two adjacent specimens in a column, each showing edge welting. This photo was taken after roughly 7 years of exposure. Welting is predominantly at mid-length of specimen (between the nails). Note lack of perceptible swelling (or welting) at the nails. The points at which on-fence thickness was measured were slightly outboard of (toward specimens ends from) the nails.

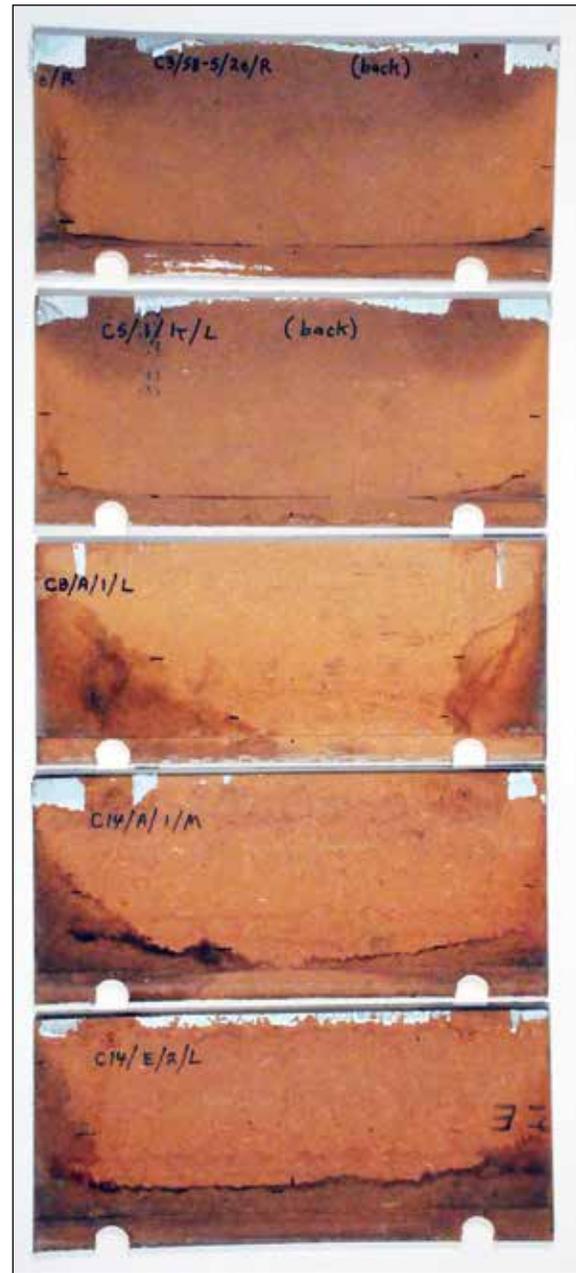
Figure 3. Rear surfaces of five specimens with staining at the drip edge at mid-specimen length. All five specimens also have staining above the lap area extending inward from the board ends, which is more extensive. The distance by which staining extends upward from the drip edge at mid-specimens length is modest in specimens C3/58-5/2e/R, C5/1/1/L, and C14/A/1/M. Intensity of staining at the drip edge is modest (faint) in specimens C3/58-5/2e/R and C5/1/1/L, but is perceptible. In all these specimens, staining at the drip edge is continuous between at least one end of the specimen and specimen mid-length.

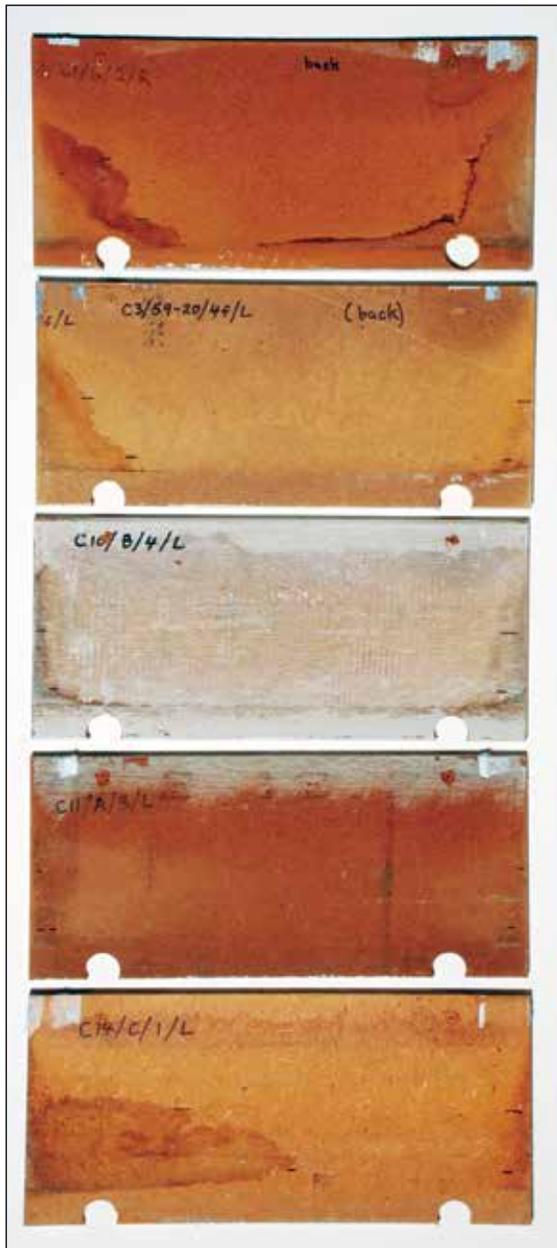
Figure 4. Rear surfaces of five specimens with staining wholly or mostly restricted to areas above the lap. In specimen C11/A/3/L, the extent of staining is modest, and the intensity so modest as to be barely perceptible. With the exception of specimen C14/C/1/L, these specimens had more extensive staining than average for their respective board classes.

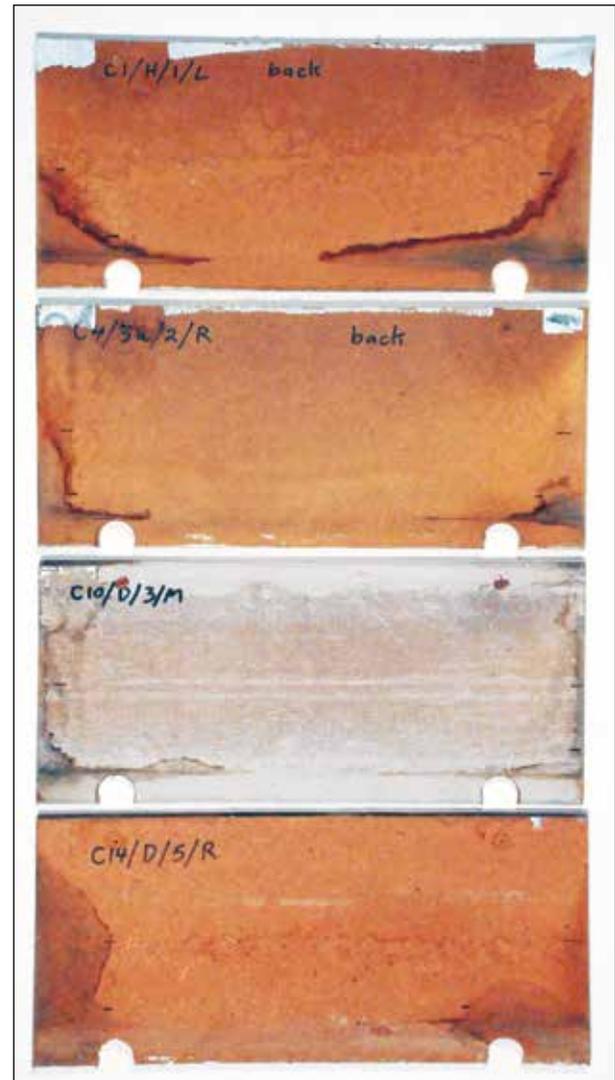
Staining in the lap area that was restricted to board ends was also sometimes observed (Fig. 5). The second evaluation phase involved documentation of sideways extent of back-surface stains from board ends, in the lap area; measurements of stain extent were made at the drip edge.

Figure 5. Rear surfaces of four specimens with staining above the lap area, extending to varying degrees into the lap area, and as far down as the drip edge on at least one specimen end, but not extending to specimen mid-length at the drip edge.

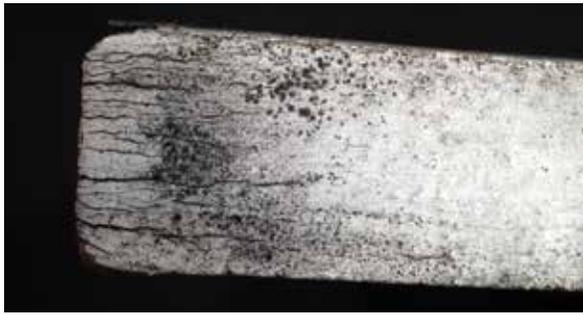
Localized drip-edge paint failures commonly occurred early during the exposure period at the ends of specimens where the drip edge intersected with the specimen end cuts. As indicated previously, the specimen end cuts were not painted and localized edge swelling occurred at end cuts. Where

the end cut intersected the drip edge, the localized swelling resulted in rupture of the paint film (at the ends of the drip edge). The rate at which drip-edge paint cracks extended from the specimen ends progressed slowly. At the final inspection, at roughly 75% of specimen ends, extension of drip edge cracks from swollen ends did not exceed 15 mm. In specimens that developed prominent drip-edge paint cracking, the cracks typically developed in patches along the drip edge, often at some distance from the board ends. Until cracking progressed to advanced stages, the patches did not connect with cracks at the specimen ends. A summary of the extent to which drip-edge paint cracks extended from the swollen ends of boards at the final inspection is shown in Table 7. The linear extents were typically modest and thus most convenient to measure on a millimeter scale. In boards of classes 8 and 12, drip-edge cracking was typically continuous along the entire length of the drip edge at the final inspection. In all other classes of board, patches of drip-edge cracks, which were typically most prevalent near specimen mid-length, rarely or never connected with board ends at the final inspection.

Figure 7a. Magnified image of the end of the drip edge of a specimen of Class 1 board. Drip-edge paint cracking is prevalent near the end of the specimen, but does not extend more than 16 mm from the specimen end. Patches of mildew are present only near the inboard terminations of drip-edge cracks. This specimen was from a bottom course location, (where water exposure was greatest), and in the left-most column of specimens (at the southwest corner of the building). This specimen showed more drip-edge mildew than any other specimen. In this photograph the outer specimen face is at the top of the specimen.

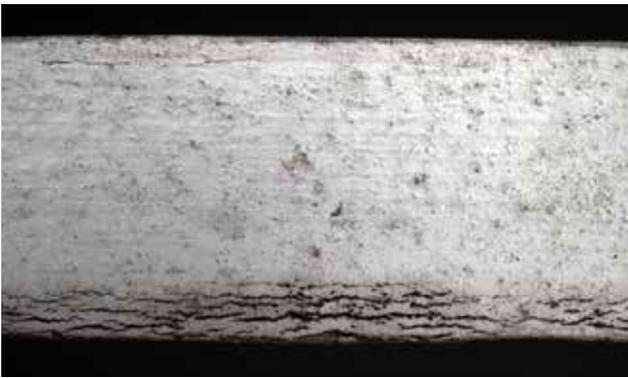
Figure 7b. Magnified image of the drip edge of a specimen of class 4 board approximately at specimen mid-length. A patch of drip-edge cracks is present near the outer edge of the drip edge, and a small amount of mildew is present in the patch of drip-edge cracks. The specimen was from a bottom course location. In this photograph, the outer specimen face is at the bottom of the specimen.

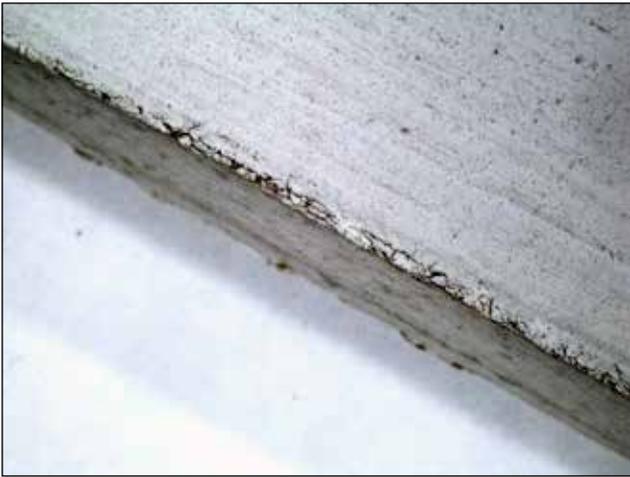
Figure 12. Magnified image showing initiation of cracking at the interface of the drip edge and the outer specimen face in a specimen of class 2 board. With the exception of these observed cracks, some cracking near the unpainted end cuts, and some surface dirt, the specimen was in pristine condition after 155 months of exposure. This specimen did not have a shaped drip edge, inasmuch as it was a specimen of noncommercial board.

indicated substantial variation in film thickness on drip edges (much more so than on specimen faces), with much of the variation being localized, and associated with unevenness of the substrate surface. Projecting fibers or fiber fragments were commonly present on drip-edge surfaces, which protruded partially (and occasionally completely) through the paint film.
