Condition Assessment of a Historic Trout Rearing Station in Upper Michigan

Research Note
FPL-RN-0334

June
2015

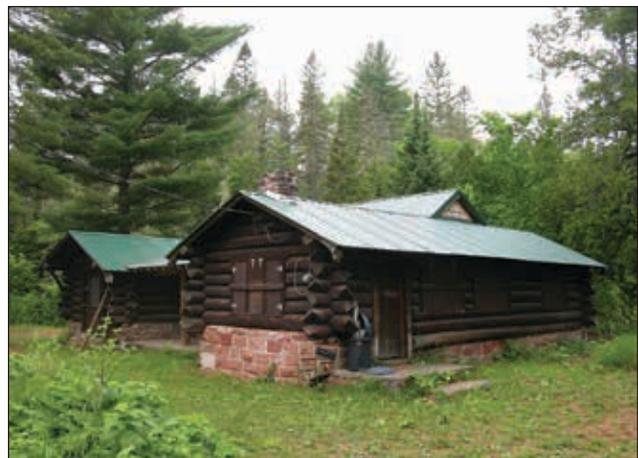
Figure 1—Otter River cabin, 2013.

We strongly recommend that the cabin be dismantled, salvaging the historic materials (hardware and any timber that is sound) and that a smaller structure be built on the site using the salvaged materials where appropriate.

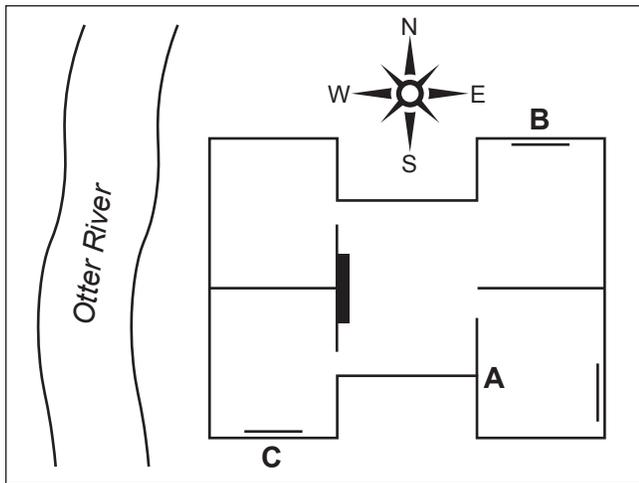
Figure 2—Orientation of the cabin relative to the Otter River. Note the location of walls A, B, and C.

Wall A is directly underneath a valley in the cabin's roof. Prior inspections revealed significant water damage. The roof was repaired subsequent to the 1998 inspection. The logs that comprise this wall section have been water damaged because of flooding from the river and water entering through the roof. All of the logs in this section are deteriorated, some severely. The logs in Wall B of the cabin showed no signs of deterioration. Several of the logs in Wall C were deteriorated.

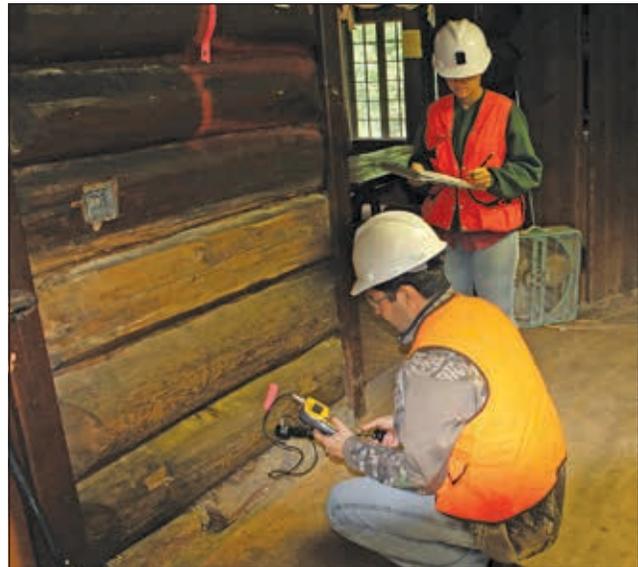
Figure 3—Testing of wall timbers using a stress-wave timing device.

We used a simple, inexpensive stress-wave timer in our inspection (Fig. 3). Sensors were placed on opposite sides of a timber. The timber was then struck, generating a stress wave. The time it took for the wave to travel between the sensors was measured by the timer and recorded. Transmission times for wood from several species are known and were used as a baseline. Transmission times significantly longer than baseline values indicated the presence of deteriorated wood.

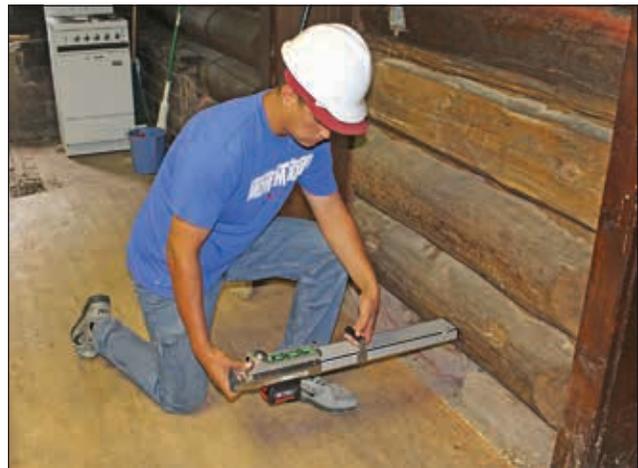
Figure 4—Micro-drilling resistance of wall timber in Otter River cabin.

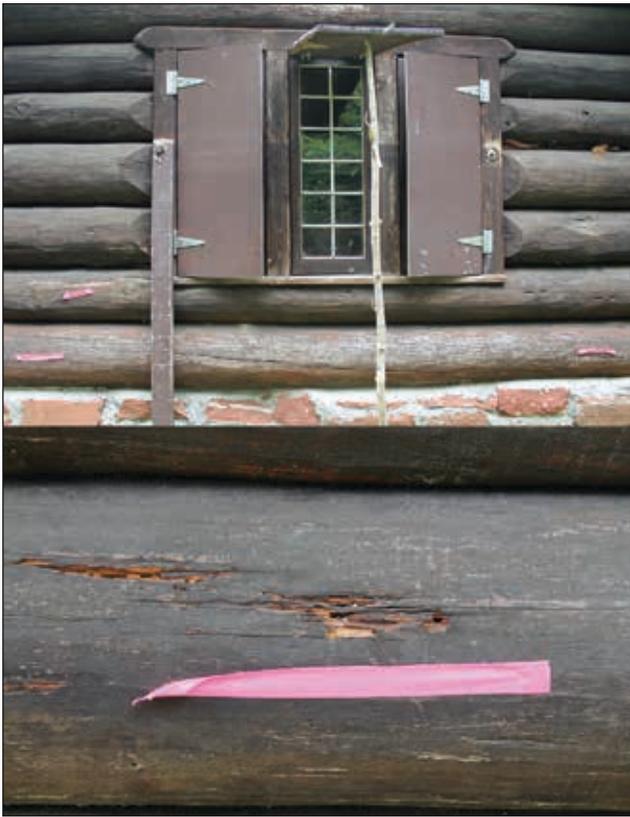
Figure 5—Visual evidence of deterioration of wall timbers.

direct contact with the sandstone foundation showed signs of significant deterioration. The log shown in Figure 5 is an excellent example of the type of deterioration we observed. It contained significant splits and cracks, and upon probing with a pocket knife was found to be soft, both indicators of advanced deterioration.

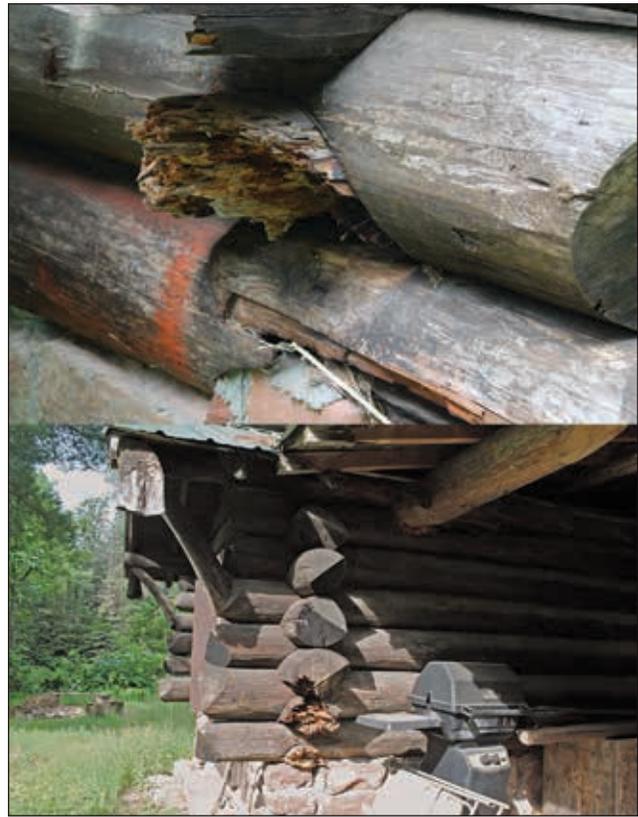
Figure 6—Visual evidence of severe deterioration of wall timbers.

Many of the logs showed signs of severe deterioration, as shown in Figure 6, with the ends of several having been entirely destroyed. Several showed signs of mechanical failure.

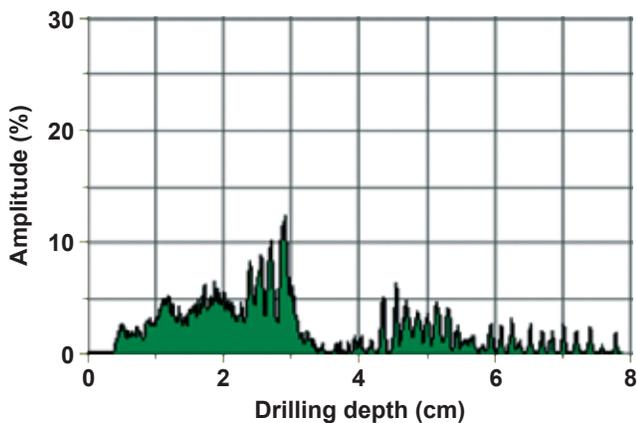
Tests results from logs that compromised Wall Section A confirmed that many were deteriorated. Most had an outer shell of solid material, whereas their core was severely

**Figure 7—Typical results obtained from a micro-drilling resistance test of a deteriorated timber from the Otter River cabin.**

deteriorated. Similarly, micro-drilling testing of several timbers in Wall Section C confirmed that they were significantly compromised (Fig. 7).
