# Hawaiian Volcanoes During 1951

GEOLOGICAL SURVEY BULLETIN 996-D

## HAWAIIAN VOLCANOES DURING 1951

By GORDON A. MACDONALD and CHESTER K. WENTWORTH

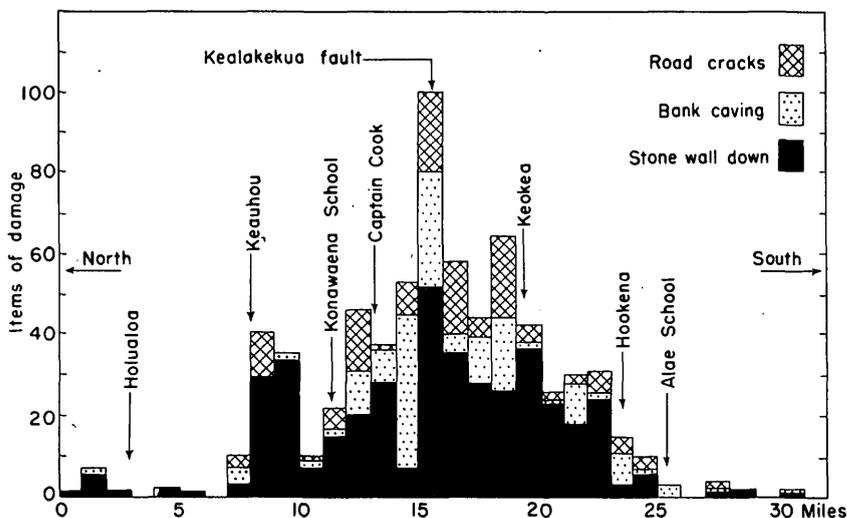
The distribution of abundance of rock slides in road cuts is shown in figure 43, in which it is represented by the portion of the columns labeled "bank caving." Like the other damage shown in the graph,

FIGURE 43.—Diagram showing the frequency distribution of three of the principal types of earthquake damage along the main highway. The arrows indicate the position on the highway of some villages and other features. Note the centering of damage near the Kealakekua fault.

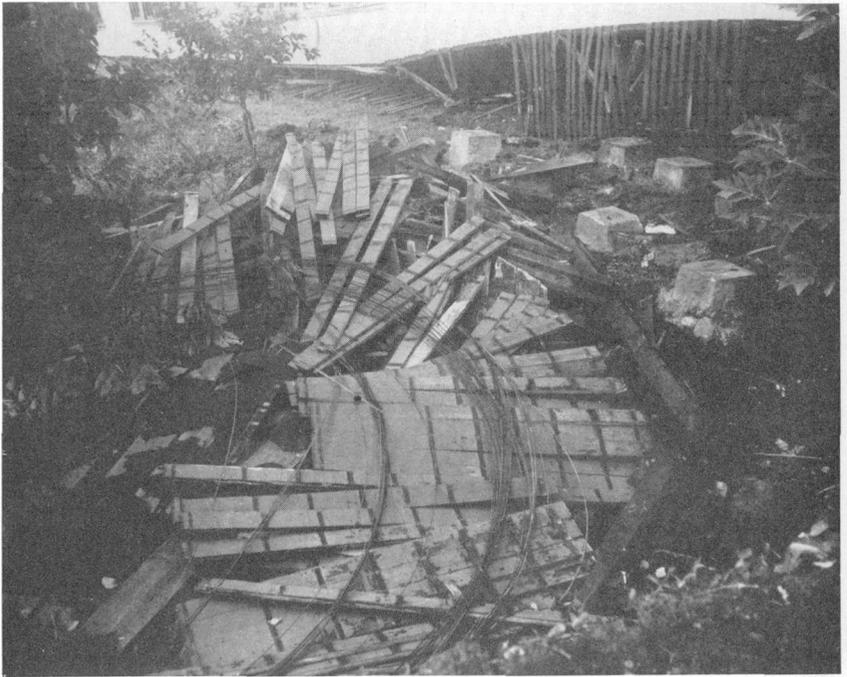
the length of the building were entirely adequate, but there was comparatively little bracing parallel to the width of the building, and some of this bracing was fastened, not to joists, but to floorboards. As a result, the underpinning was deficient in stiffness parallel to the ground slope. The direction of shaking during the earthquake was nearly parallel to this weakness in the structure, and the swaying caused the underpinning to fail in part and allow the building to slump downhill onto the ground (fig. 44). The building is a total loss.

FIGURE 44.—Honaunau School building from the southwest. All but the south end of this building was dropped and moved westward owing to inadequate bracing of the underpinning in an east-west trending direction transverse to the longer dimension. The wood-stave water tank collapsed and was thrown westward from its concrete-block footings.

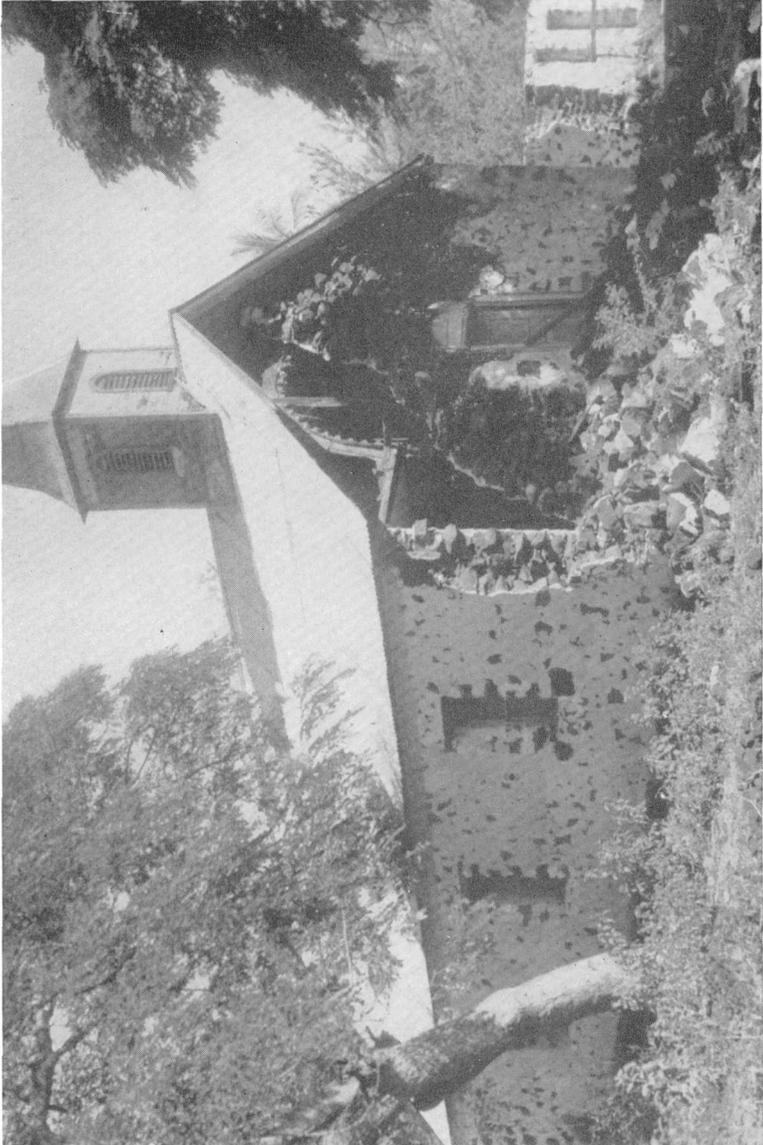
FIGURE 45.—Church at Puaa, 0.6 mile north of Hookena, viewed from the northwest. The western and eastern walls of the building were damaged. The severe damage at the northwest corner of the church building and of the old unroofed building beyond it, suggest displacement of the walls toward the northwest in the direction of the epicenter.

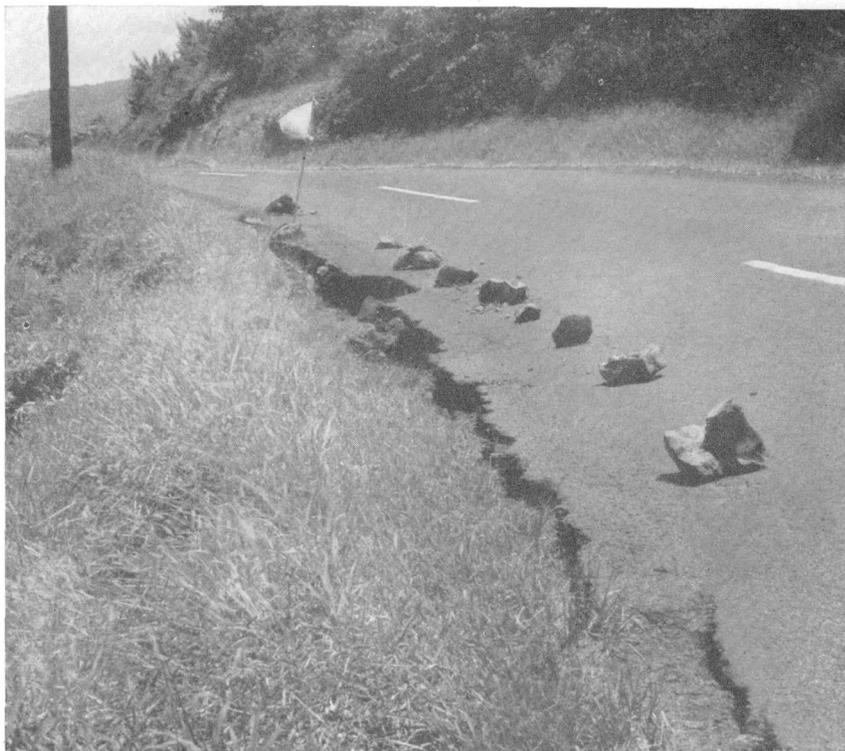
A common occurrence was the formation of a crack parallel to the edge of the pavement on its downslope side, either within the pavement a few inches from its edge, or between it and the shoulder (fig. 46). Some of these cracks were as much as 75 feet long and 8 inches wide. This apparently resulted from a downslope lurching of the shoulder that moved as a separate unit from the portion of the fill

FIGURE 46.—Crack along the edge of the highway pavement 2 miles south from Kaimalino, apparently resulting from a downslope lurching of the shoulder, which moved as a separate unit from the part of the fill beneath the pavement.

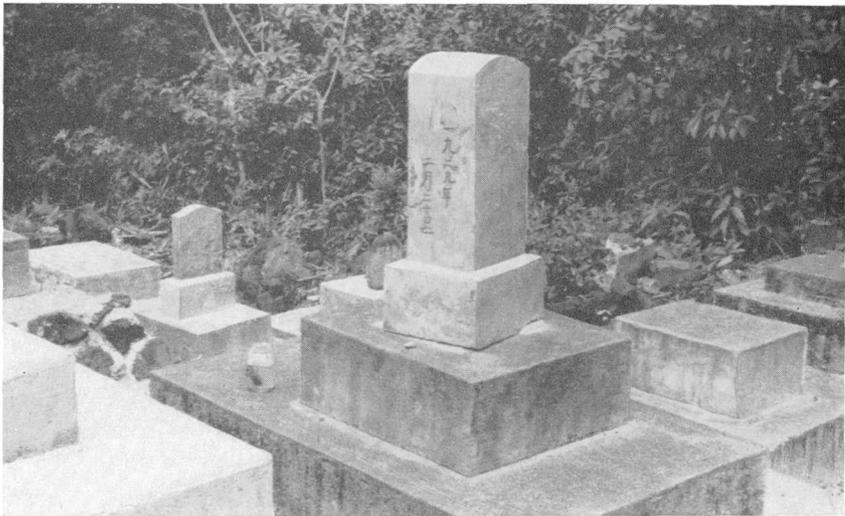
Derangement of headstones included overturning of stones (fig. 47), and shifting of stones on their bases with or without rotation. Many grave caps were broken, some by falling or disturbance of headstones, and some by lurching or slumping of the adjacent subsoil.

FIGURE 47.—Gravestone rotated counterclockwise, in the Daifukuji cemetery at Honalo. Other stones have been thrown from the vacant bases visible in the photograph and are out of sight behind the bases.
