Historic Structure Report

**BUILDING 25
ENLISTED MEN'S BARRACKS
Fort Hancock**

HISTORIC STRUCTURE REPORT

February 2002

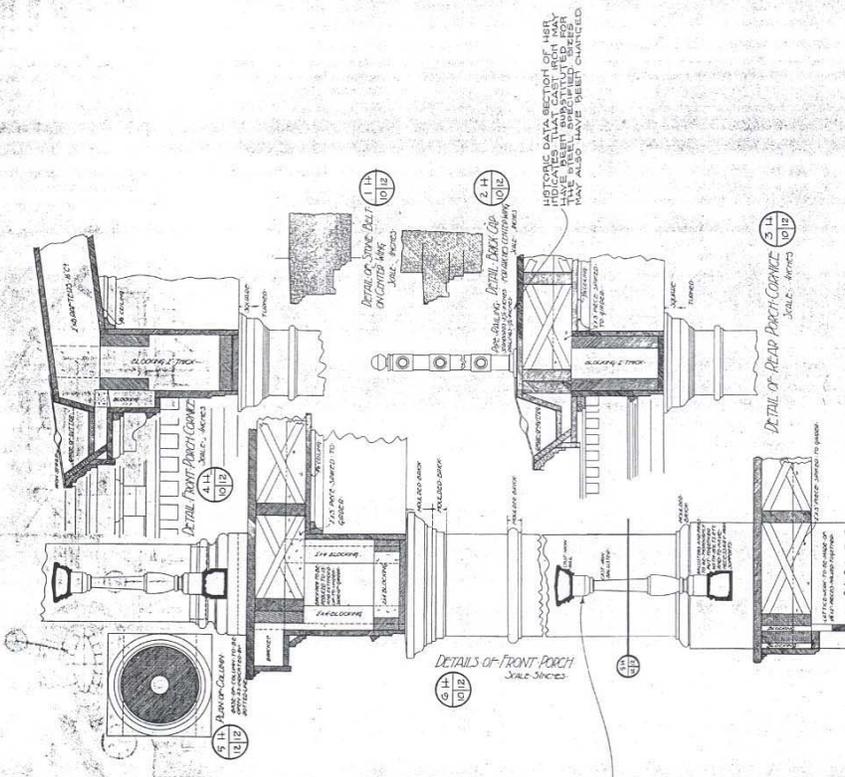
Figure 66. "Details, One Company Barracks," September 17, 1976.

NORTH PORCH NOTES APPLY, BUT CONDITION IS NOT AS SEVERE. THE WOOD MEMBERS SHOULD BE REPAIRED AND DETAILING SHOULD BE DONE IN ACCORDANCE WITH THE RESTORATION PLAN FOR THIS RESTORATION. THE WOOD MEMBERS SHOULD BE REMOVED (SALVAGED) IF POSSIBLE. THE STRUCTURAL MEMBERS SHOULD BE REPAIRED WITH ADDITIONAL FRAMING. REPAIRS SHOULD BE MADE TO THE WOOD STRUCTURE RESTORED AND THE SALVAGED WOOD MATERIALS REINSTALLED.

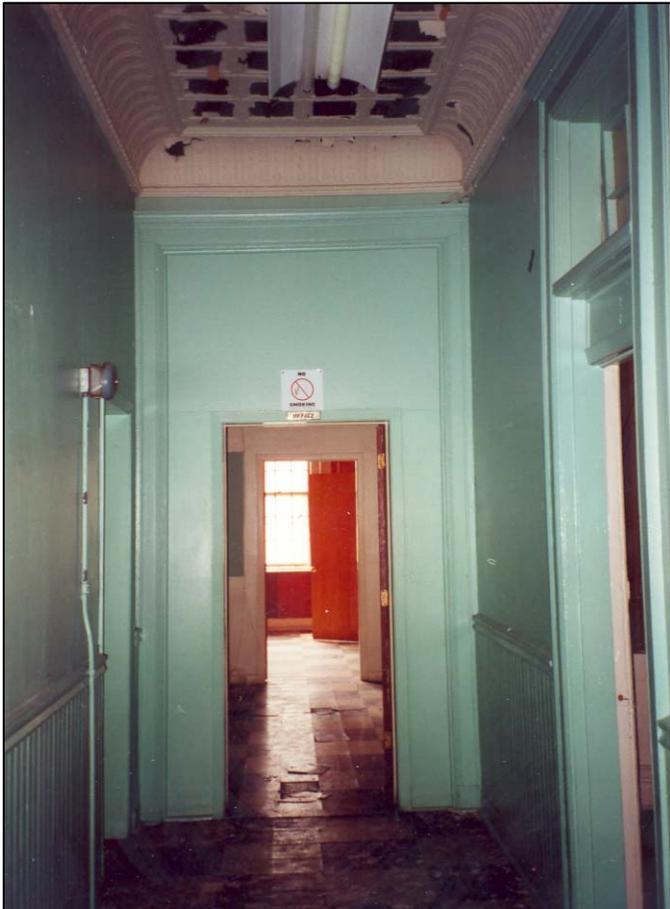
Figure 79. Doorway from side hall to mess room, showing perimeter infill for replacement door and covered transom.
