OFFICE OF SURFACE MINING
REPORT ON OCTOBER 2000
BREAKTHROUGH AT THE BIG BRANCH SLURRY IMPOUNDMENT

Martin County Coal Corporation
Big Branch Slurry Impoundment
Martin County, Kentucky

March 2002

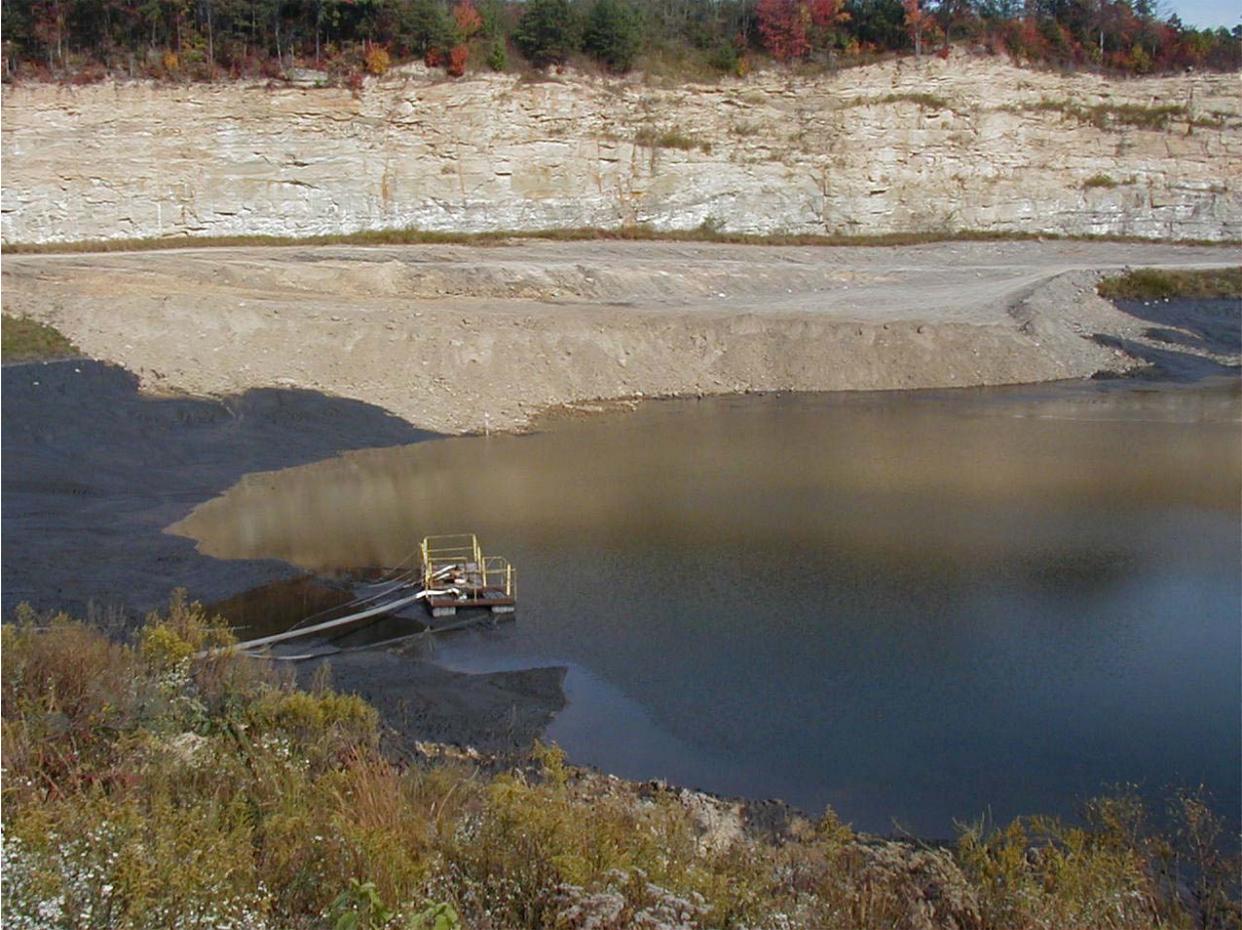
Photo 2. 2000 Breakthrough Area - October 16, 2000. Source: OSM. Pool elevation about 1,060 feet msl prior to breakthrough and 1,046 feet msl after breakthrough. Mine roof elevation 973 feet msl.

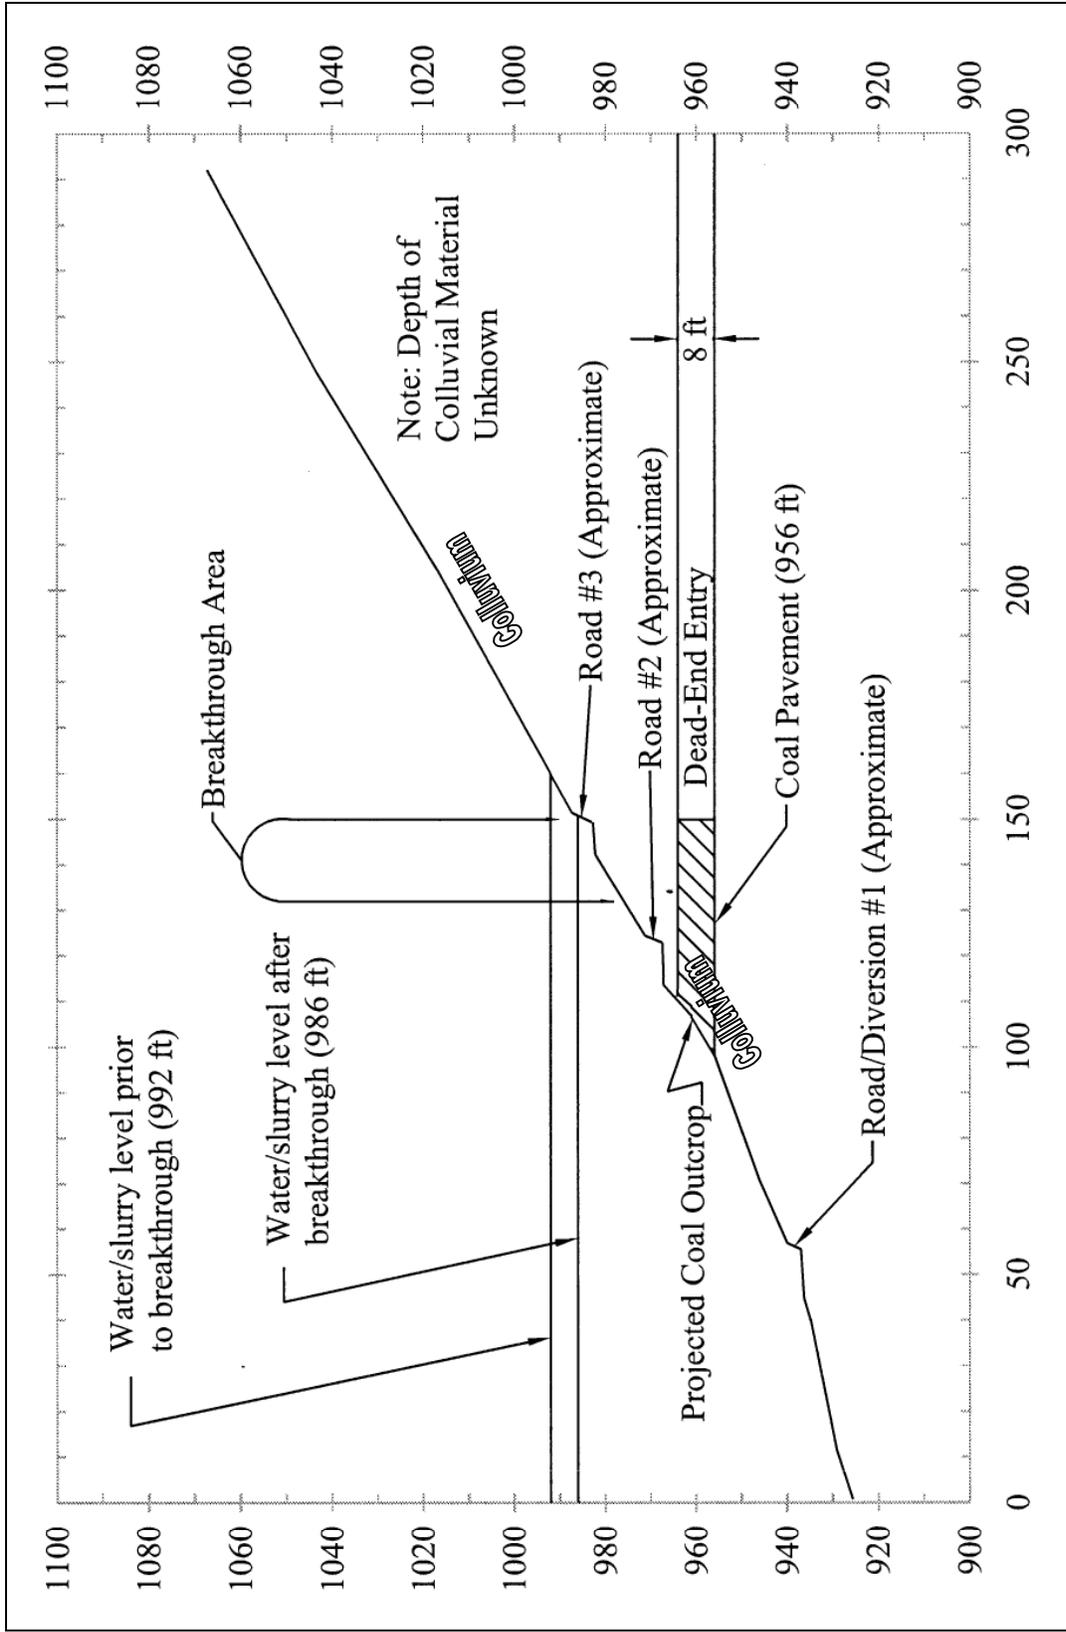
Figure 3. Cross-Section A-A' at May 1994 Breakthrough. Drawn by OSM.

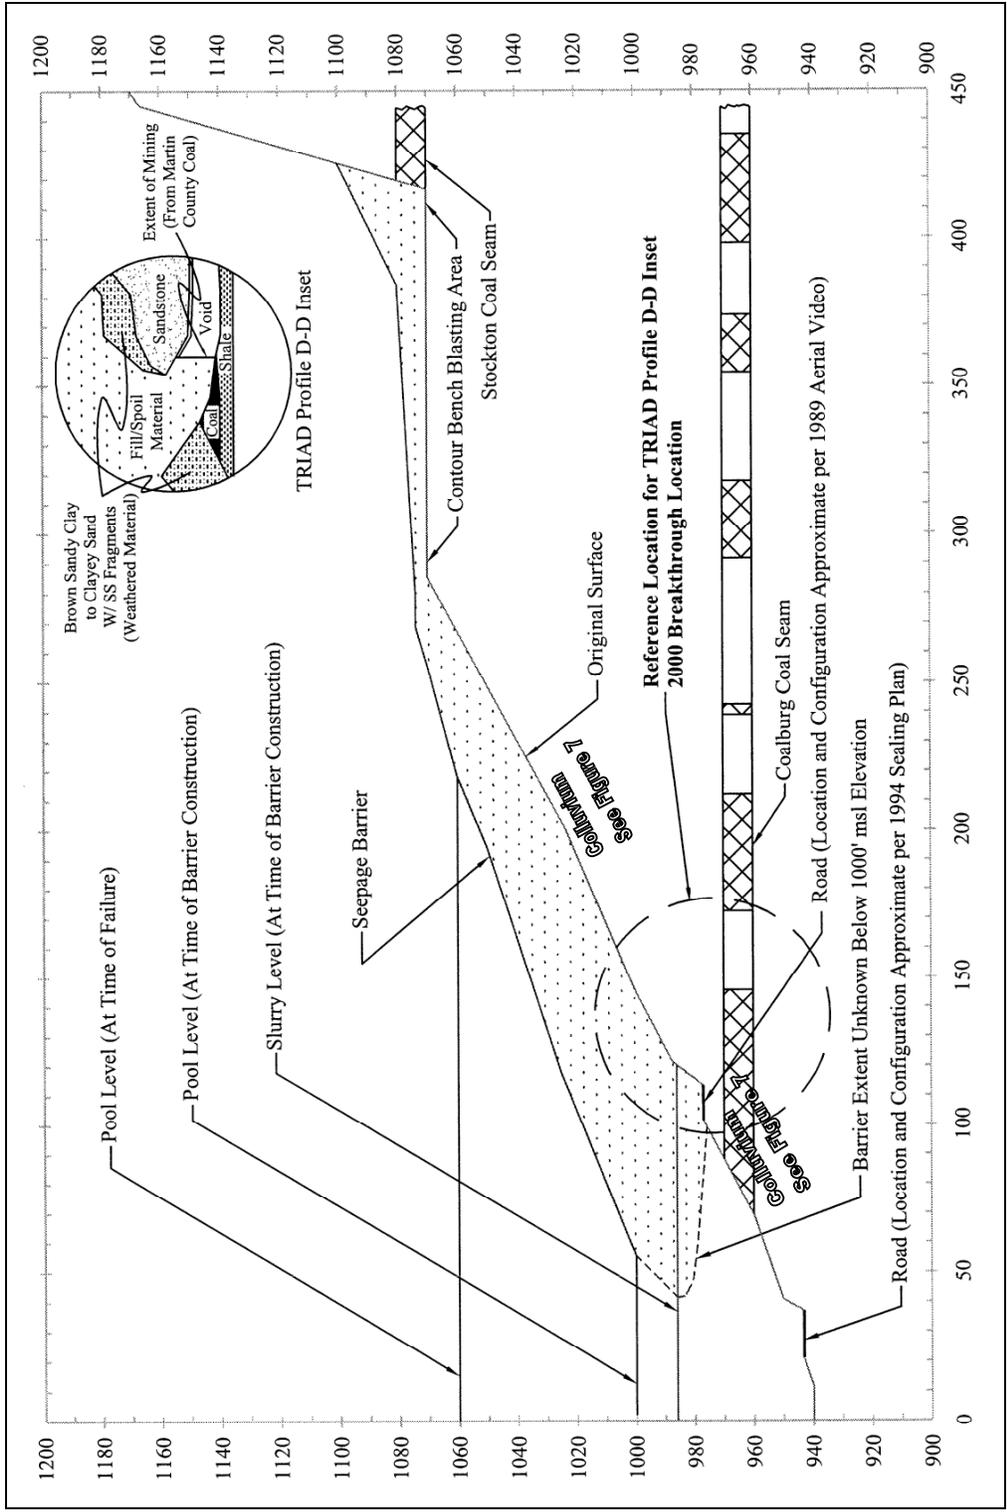
Figure 4. Cross-Section B-B' of Seepage Barrier Constructed at 2000 Breakthrough. Drawn by OSM with Triad Profile D-D inserted.

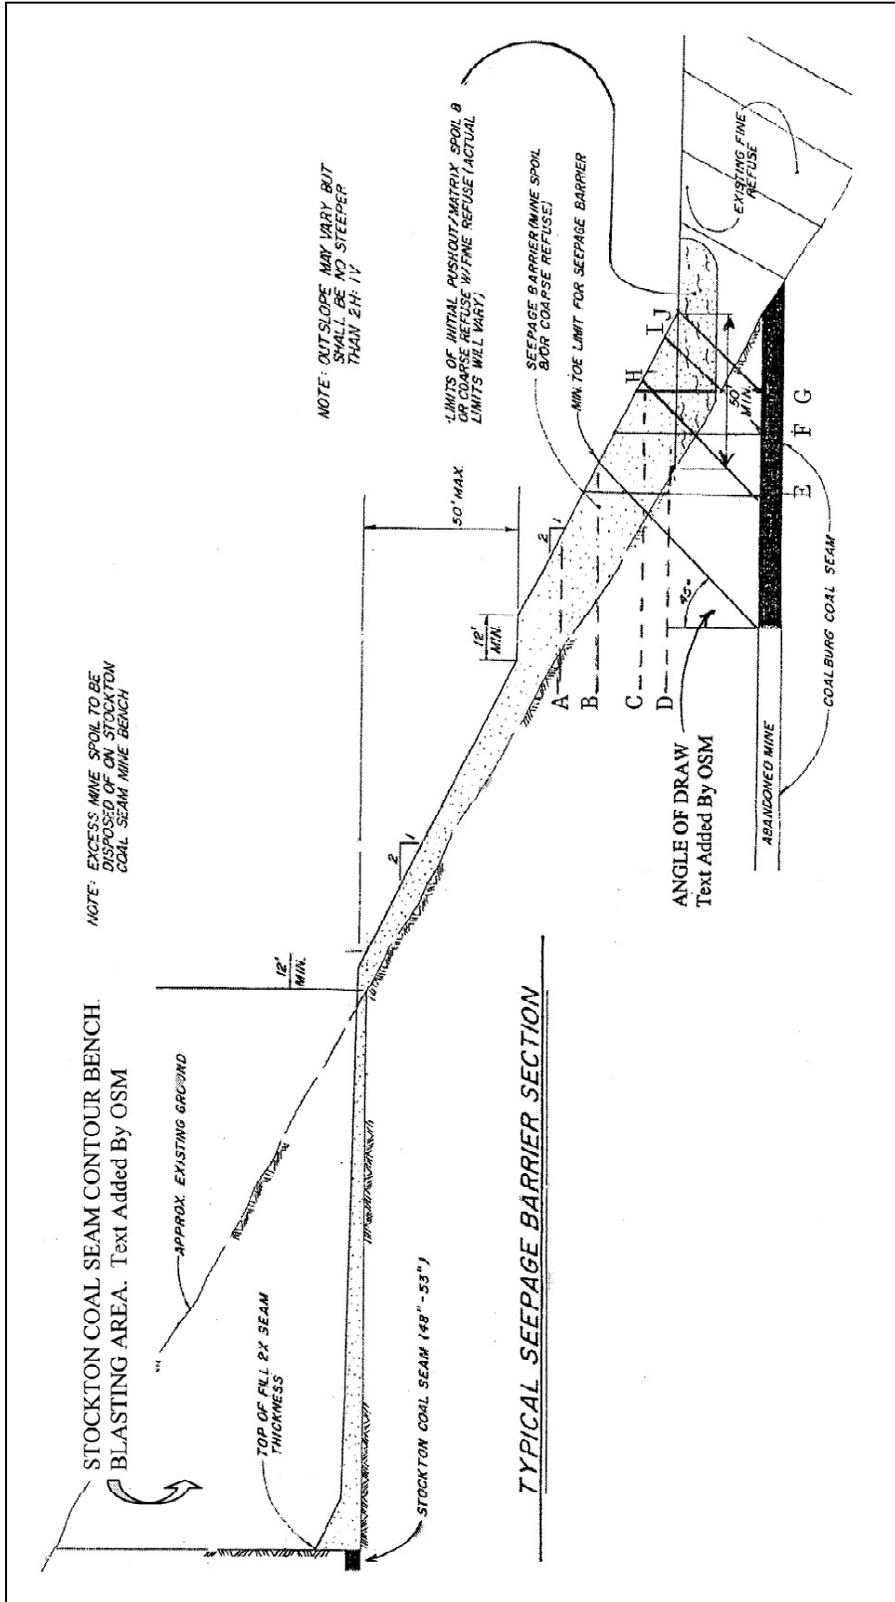
Figure 5. Cross-Section of Designed Seepage Barrier. Source: Sealing Plan, Details Sheet. Information added by OSM: 1) Mine roof caving height based on five times the mining height--line A for 12-foot mining height, line B for 10-foot mining height, line C for 7.5-foot mining height, and line D for 6-foot mining height; 2) Outcrop barrier width—vertical line E for 70-foot width, vertical line F for 50-foot width, and vertical line G for 35-foot width; 3) Lateral extent of subsidence based on a 45-degree angle of draw per MCCC —slanted line H based on a 70-foot wide outcrop barrier, slanted line I based on a 50-foot wide outcrop barrier, and slanted line J based on a 35-foot wide outcrop barrier.

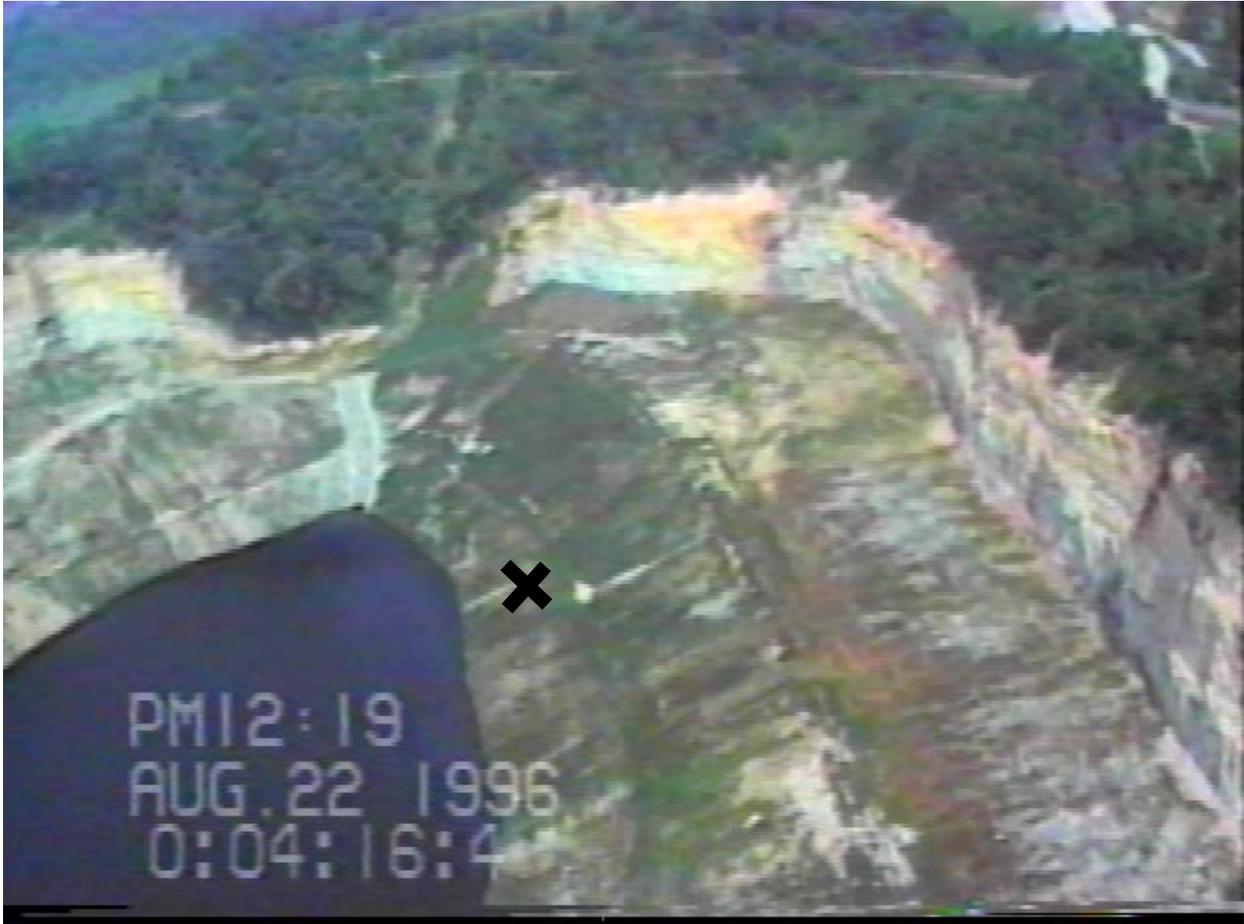
Photo 6. Seepage Barrier by 2000 Breakthrough (After Construction) - August 22, 1996. Source: DSMRE aerial video. The X marks the approximate location of the 2000 breakthrough. Pool elevation 1,018 feet msl. Mine roof elevation 973 feet msl. Contour bench elevation 1,075 feet msl.

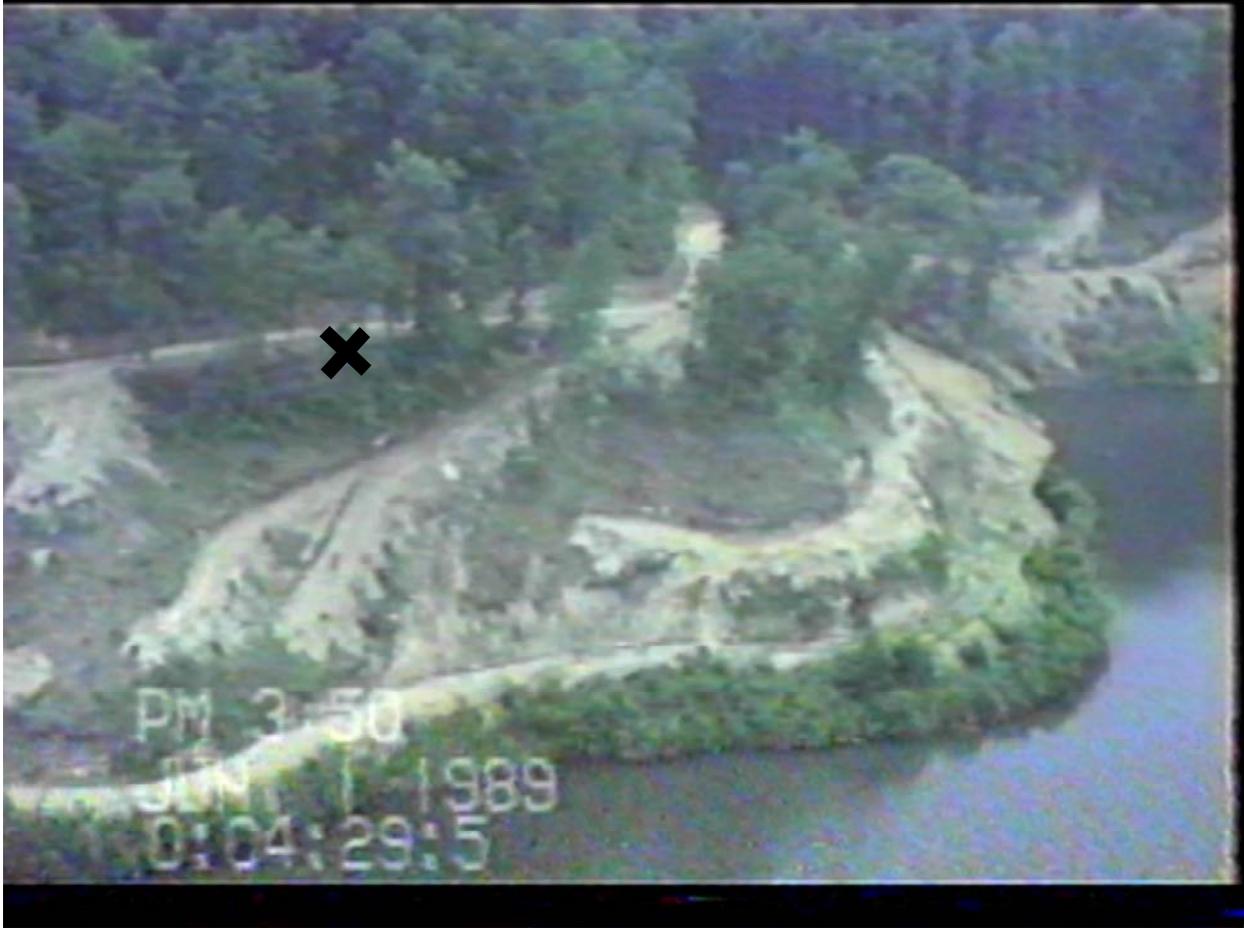
Photo 7. Surface Conditions at 1994 Breakthrough - June 1, 1989. Source: DSMRE aerial video. The X marks the approximate location of the 1994 breakthrough. Pool elevation 958 feet msl. Mine roof elevation 964 feet msl.

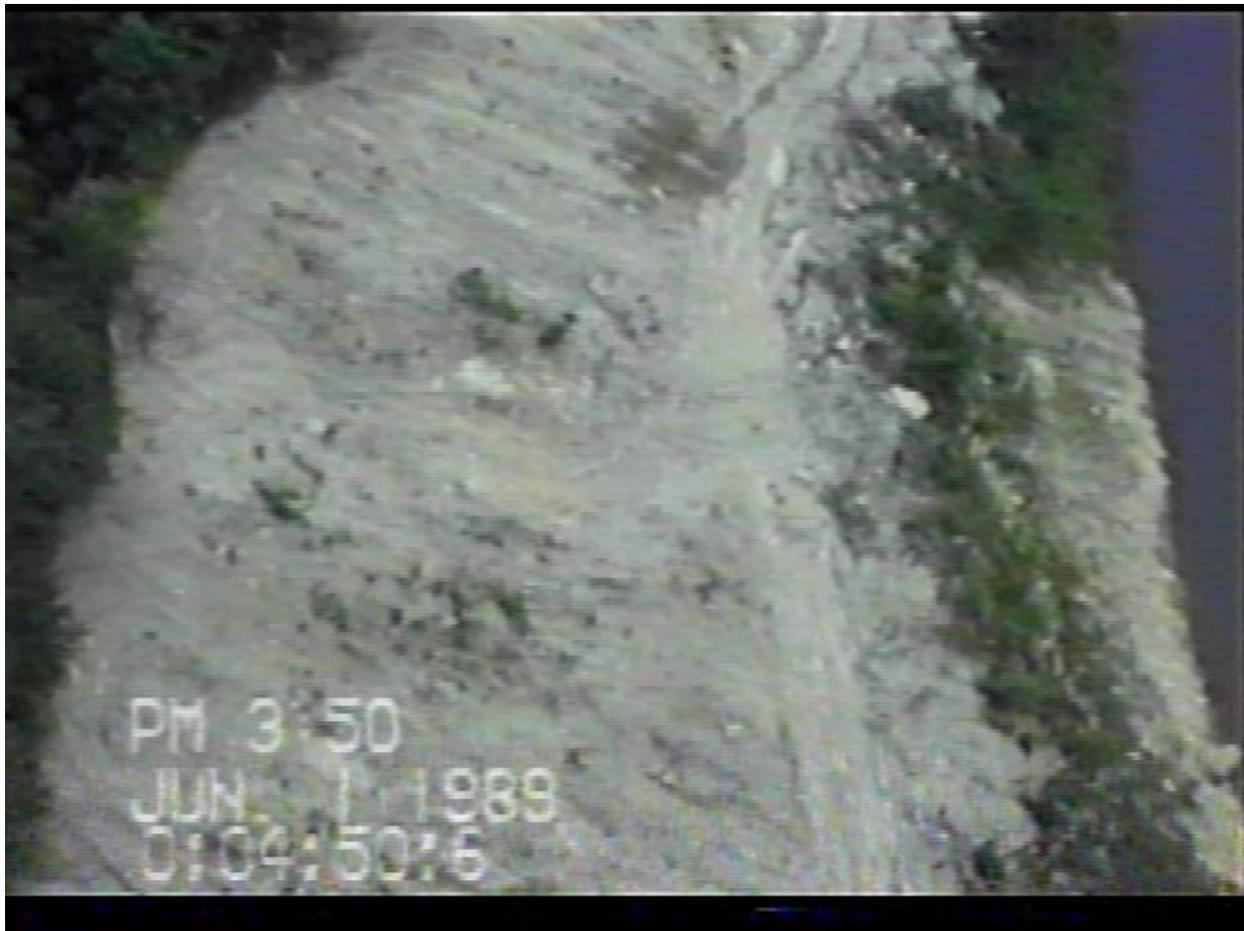
Photo 8. Surface Conditions at 2000 Breakthrough – June 1, 1989. Source: DSMRE aerial video. Pool elevation 958 feet msl. Mine roof elevation 973 feet msl.

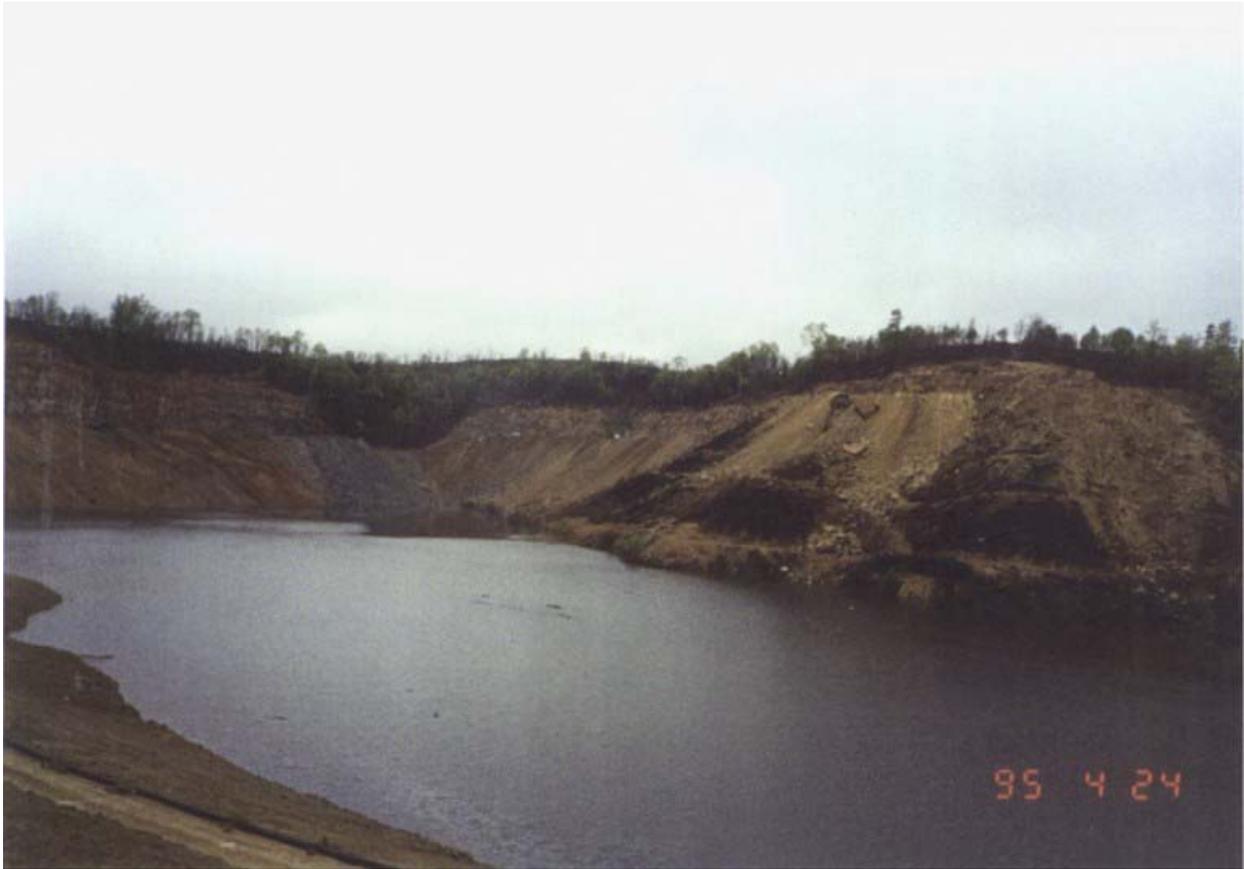
Photo 12. Seepage Barrier by 2000 Breakthrough (During Construction) - April 24, 1995. Source: GAI. The 2000 breakthrough area is located at the left-center of the photo. Pool elevation 1,000 feet msl. Mine roof elevation 973 feet msl.

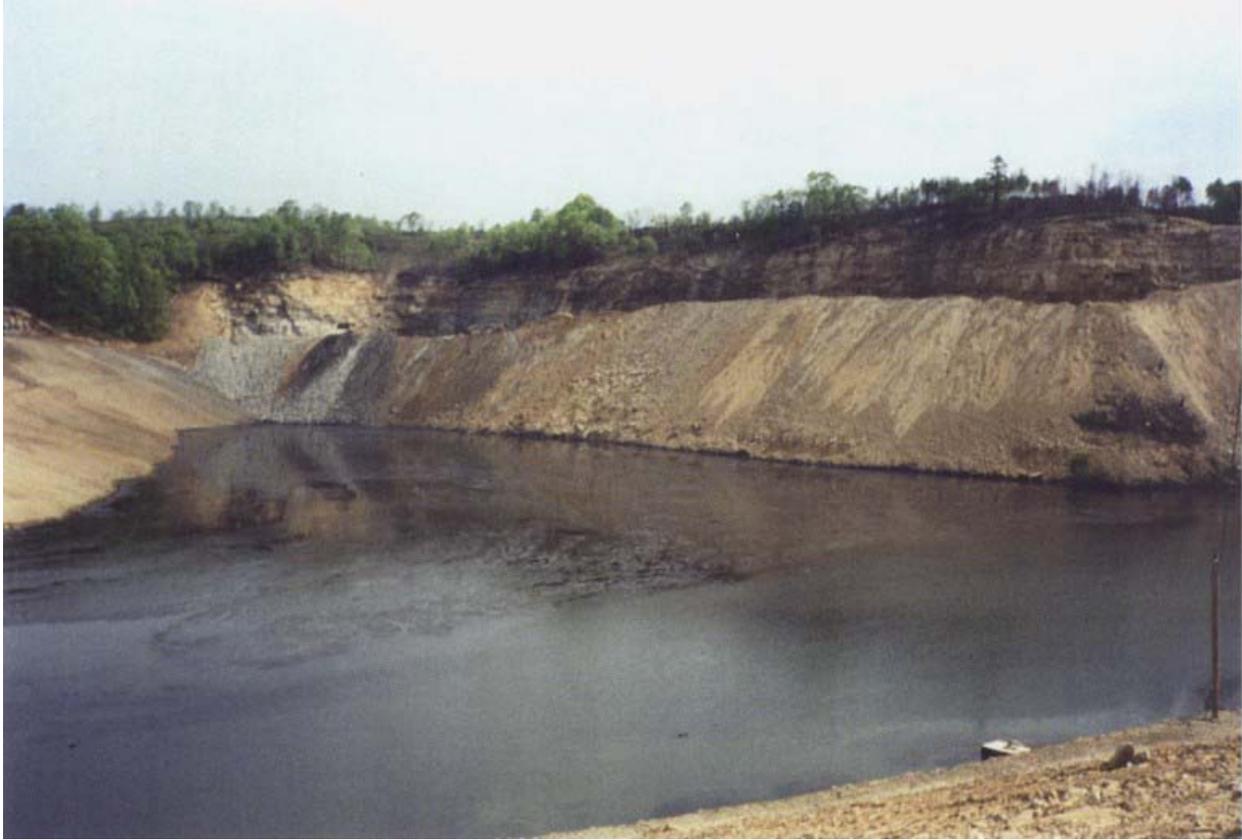
Photo 13. Seepage Barrier by 2000 Breakthrough (During Construction) - June 8, 1995. Source: GAI. The 2000 breakthrough area is located at the left-center of the photo. Pool elevation 1,001 feet msl. Mine roof elevation 973 feet msl.

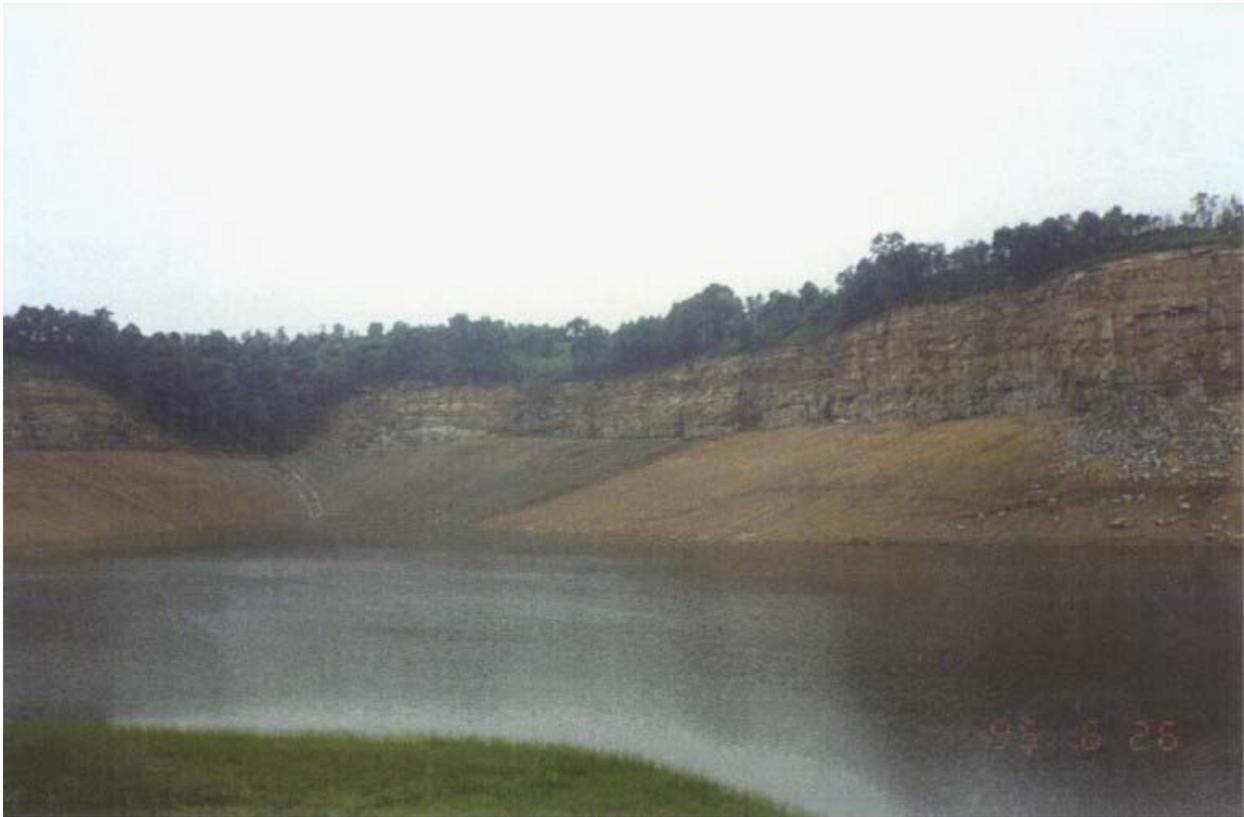
Photo 14. Seepage Barrier by 2000 Breakthrough (After Construction) - June 26, 1995.
Source: GAI. The 2000 breakthrough area is located at the left-center of the photo.
Pool elevation 1,006 feet msl. Mine roof elevation 973 feet msl. Contour bench elevation 1,075 feet msl.

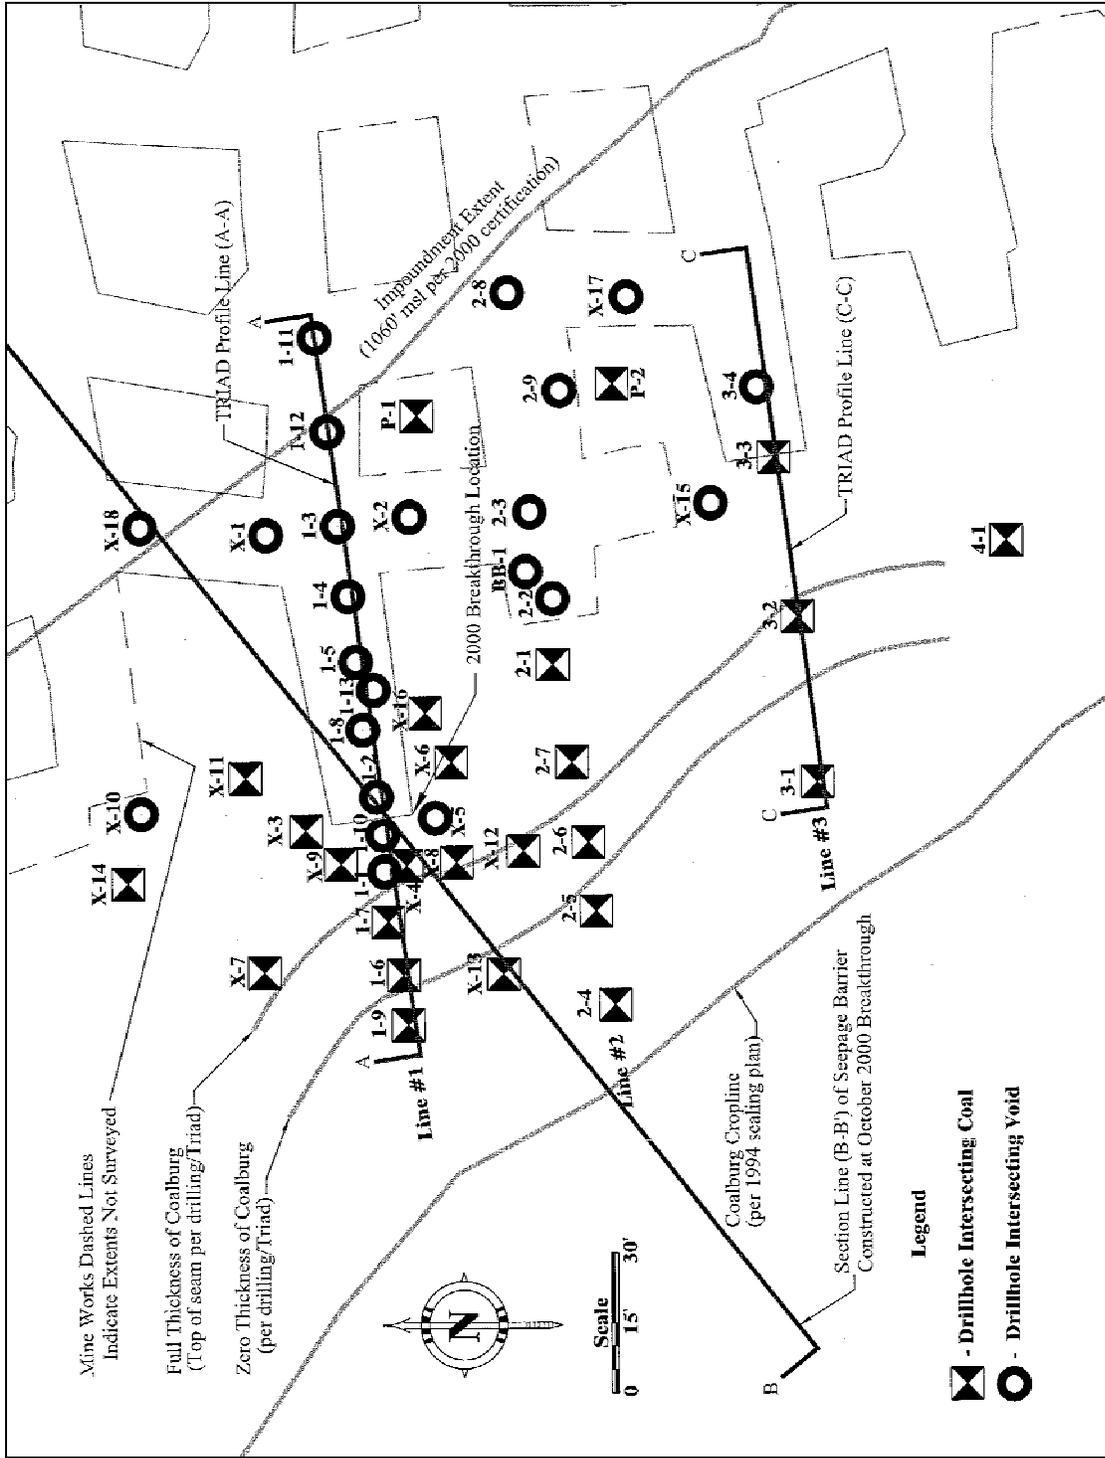
Figure 6. Drill Hole Location Map. Drawn by OSM using Triad drilling data. Note: The Triad drill logs did not indicate that voids were encountered by holes X-4 and X-8; however, these holes, along with X-5, are located in the breakthrough erosion channel.

The drilling, holes 1-1 and 1-10, identified a void beyond the mapped mine entry (mine limit) at the 2000 breakthrough. These drill holes were located along the centerline of the entry. This is in contrast to drill hole X-9, which did not identify a void near the left side of the entry. It is not known whether the “missing” coal was mined or eroded during the breakthrough. However, coal remaining at the base of the holes (1-1, X-4, X-5, X-8) suggests that the coal was eroded and not mined. Except for holes 3-4 and X-15, the Triad drilling indicates that MCCC mined the total thickness of coal.

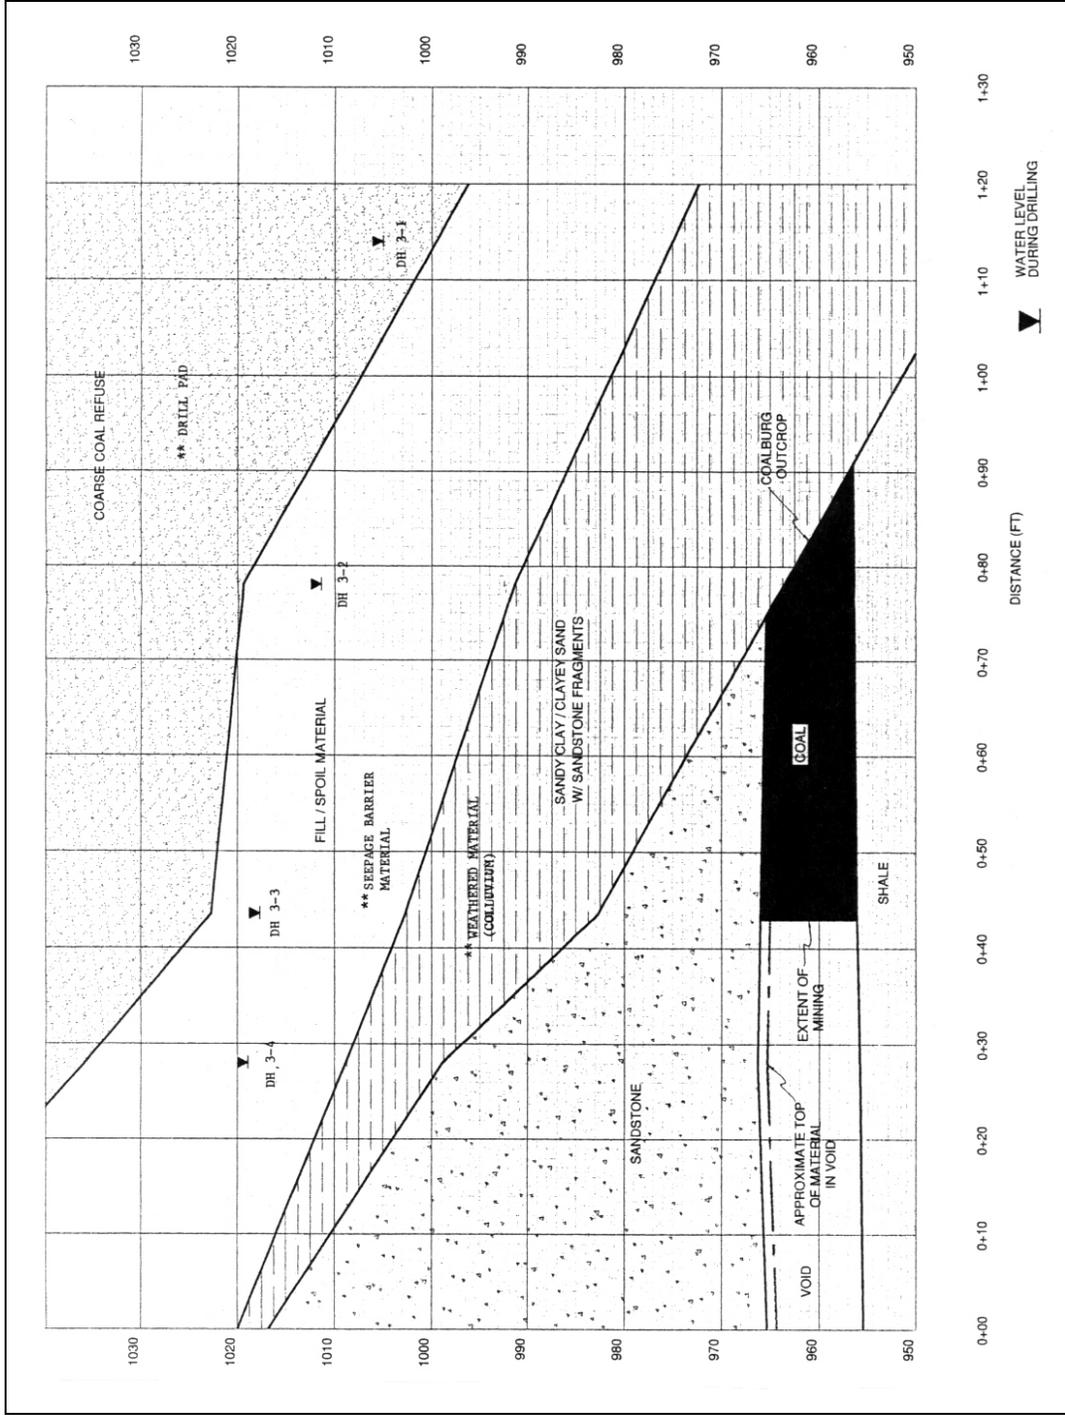
Figure 8. Triad Profile C-C. From Triad Report. Cross-Section at Line #3, Figure 6. ** Denotes Text Added by OSM.

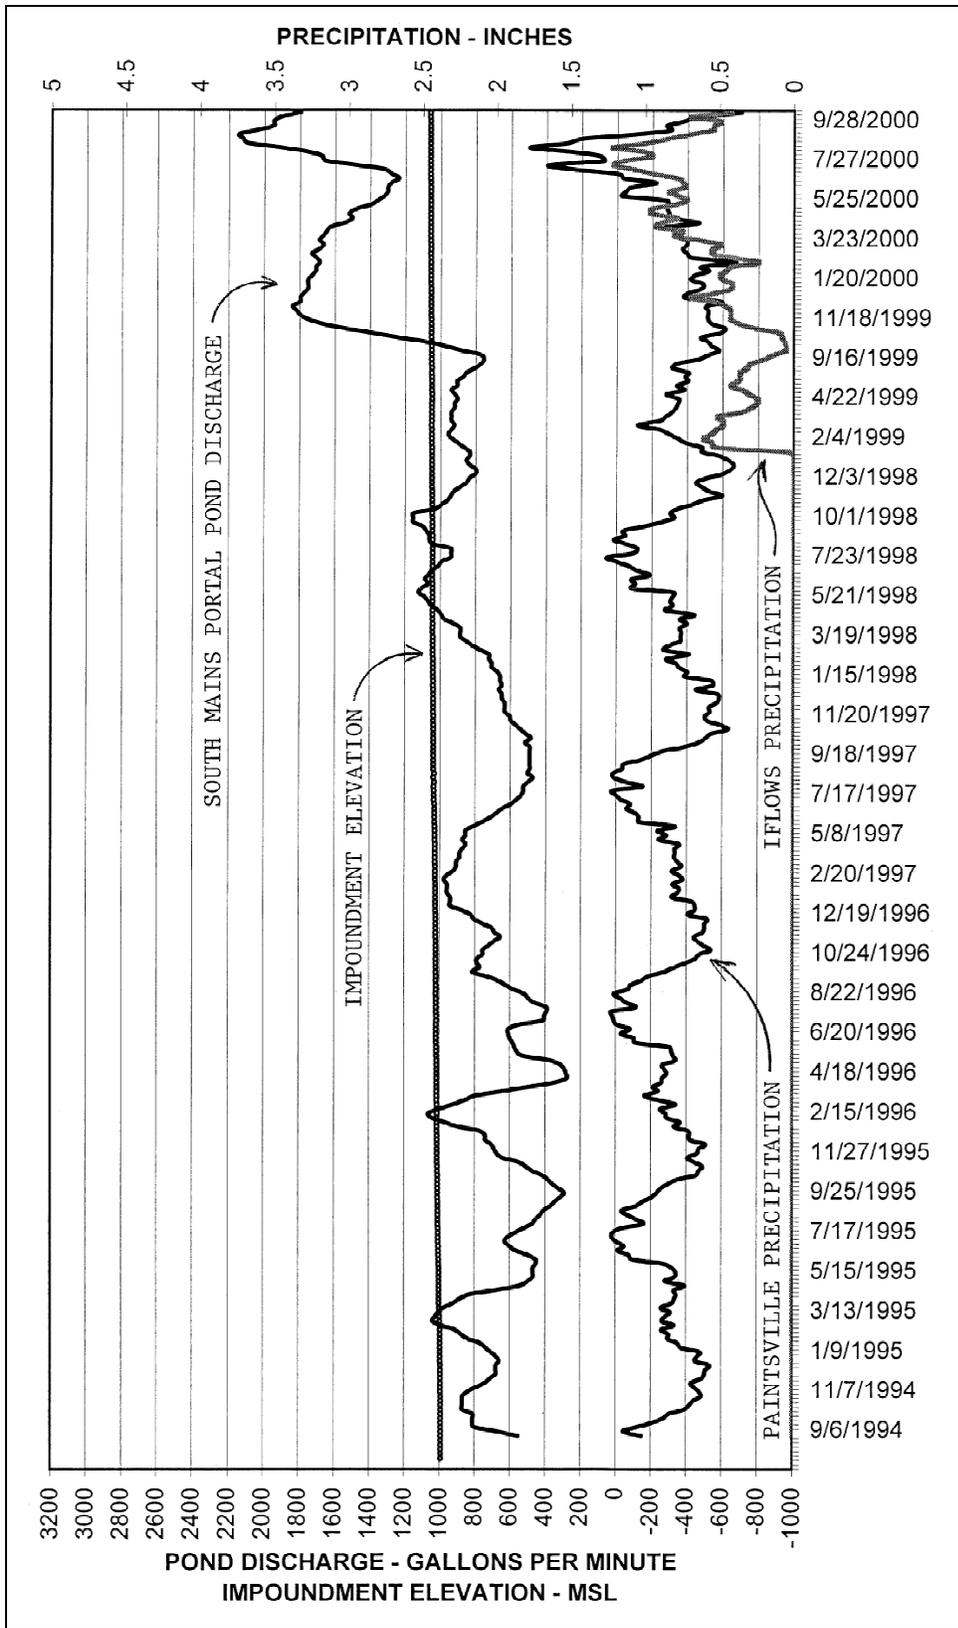
Figure 9. Impondment Elevation, South Mains Portal Pond Discharge, and Precipitation. Impondment elevation obtained from MCCC. Pond discharge calculated by OSM—for details see Appendix 10, Section 4. Precipitation obtained from National Weather Service, Paintsville, Kentucky and IFLOWS station number 3194. See Appendix 10, Figure 4 for data points. The discharge and precipitation lines are “trendlines” based on an eight point moving average.

- There was no clear, consistent trend between discharge rates and precipitation for the six ponds as contended by MCCC.
- There was not a relationship between precipitation and impoundment pool elevation.
