# The Danvers Butchery Meat Market and Cold Storage

Danvers, Massachusetts

USFA-TR-151/January 2004

# **The Danvers Butchery Meat Market and Cold Storage August 13, 2002**

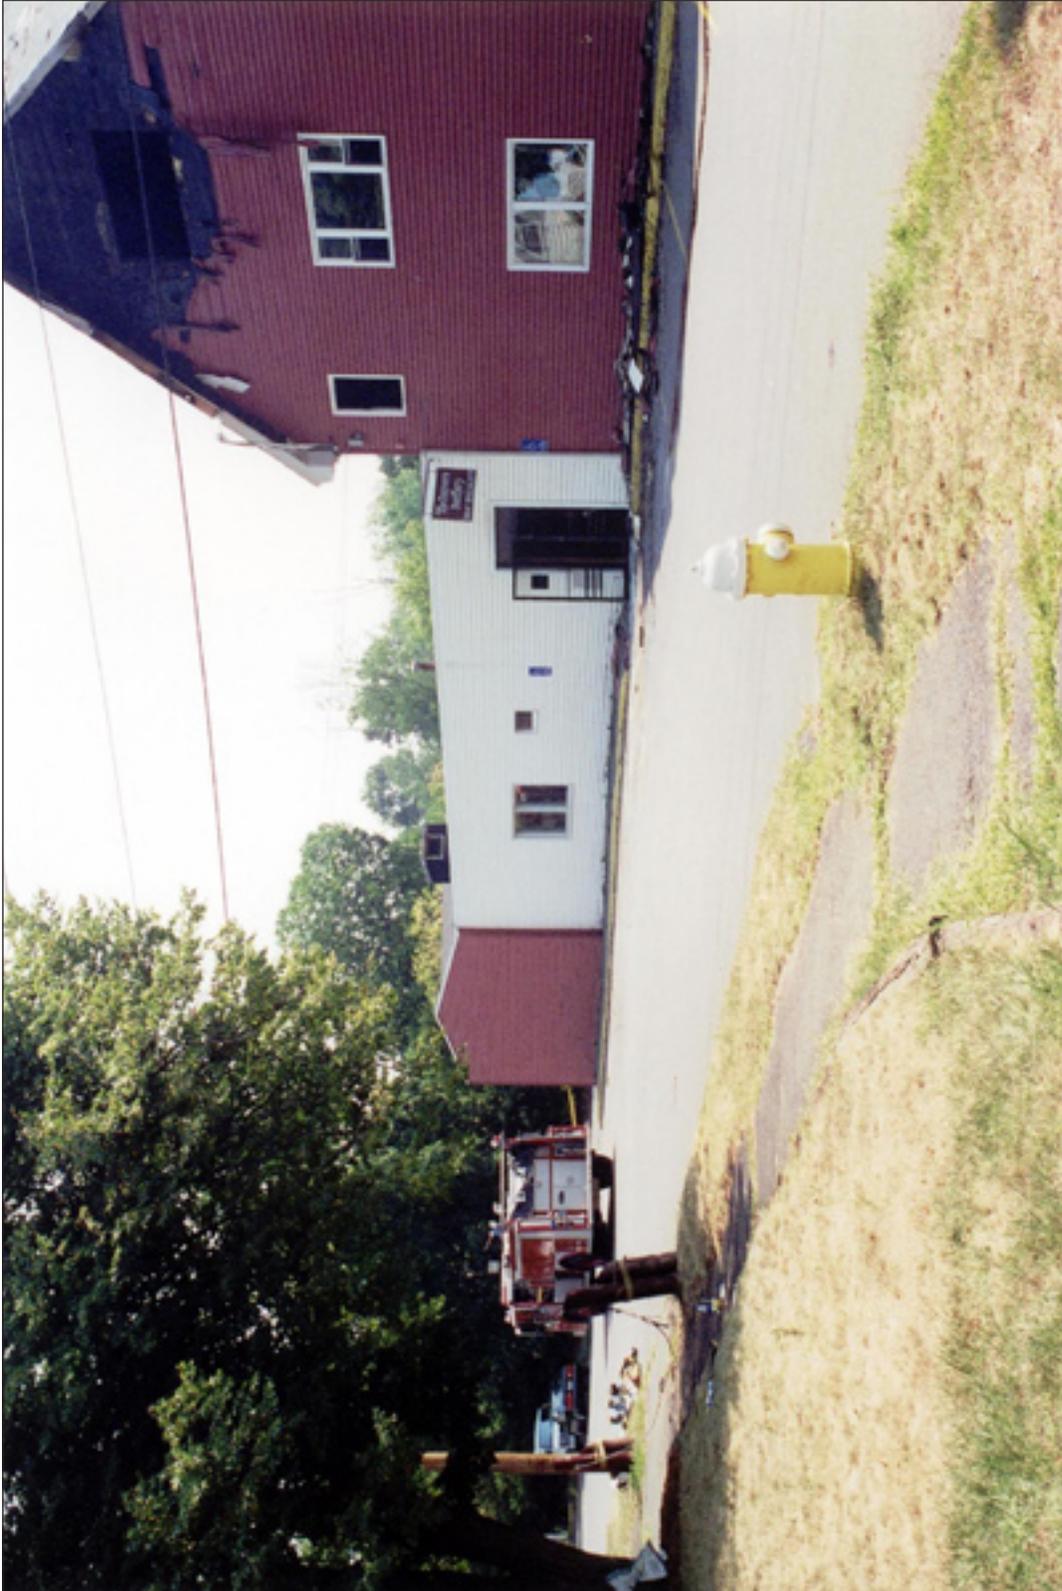
1. The eastern portion of The Danvers Butchery's Front, A side. Danvers's Engine 4, the reserve, is still on the scene. The hydrant tagged by Engine 3 is in the foreground. The interior attack was through D1, the door in the center white section. Note that the glass is still present in many windows. (Photo courtesy Danvers Fire Department)

1. The eastern portion of The Danvers Butchery's Front, A side. Danvers's Engine 4, the reserve, is still on the scene. The hydrant tagged by Engine 3 is in the foreground. The interior attack was through D1, the door in the center white section. Note that the glass is still present in many windows.

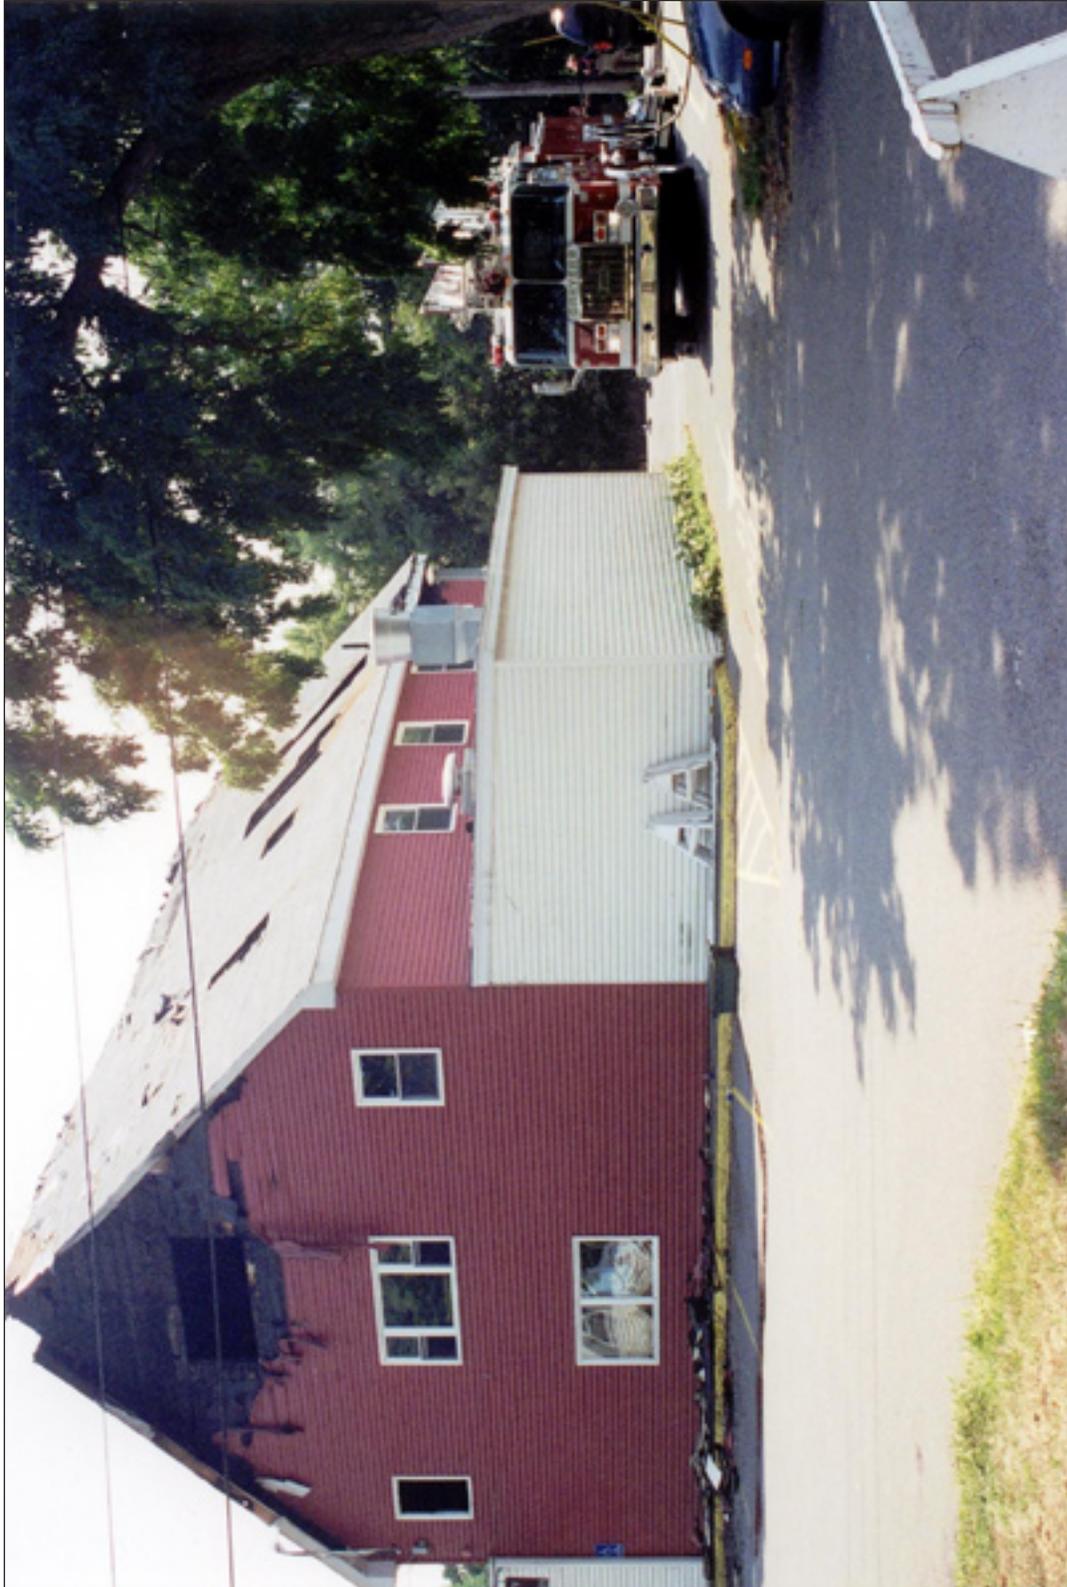
2. The western portion of the A side and the D side. Arriving firefighters observed flames from the front attic window and along the ridge. Danvers's Engine 1, a quint, is shown. (Photo courtesy Danvers Fire Department)

2. The western portion of the A side and the D side. Arriving firefighters observed flames from the front attic window and along the ridge. Danvers's Engine 1, a quint, is shown.

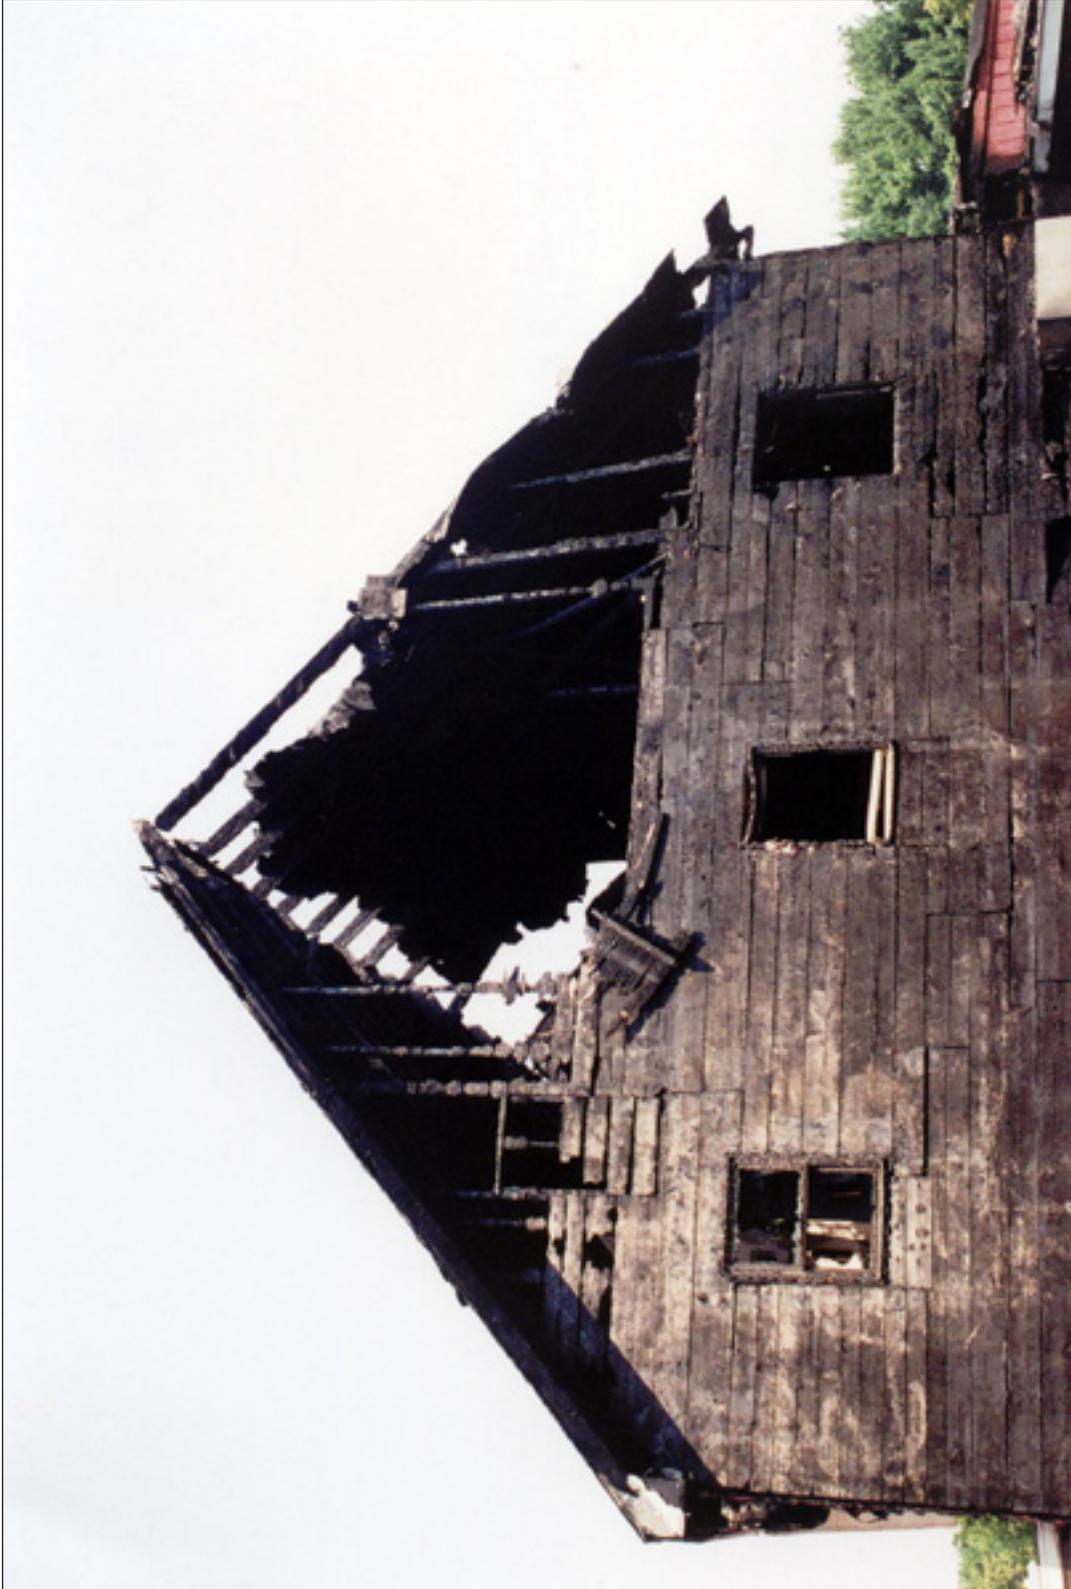
3. The upper part of the Barn's C side. The gable had burned through before firefighters arrived. The unstable roof was removed after suppression was completed. (Photo courtesy Danvers Fire Department)

3. The upper part of the Barn's C side. The gable had burned through before firefighters arrived. The unstable roof was removed after suppression was completed.

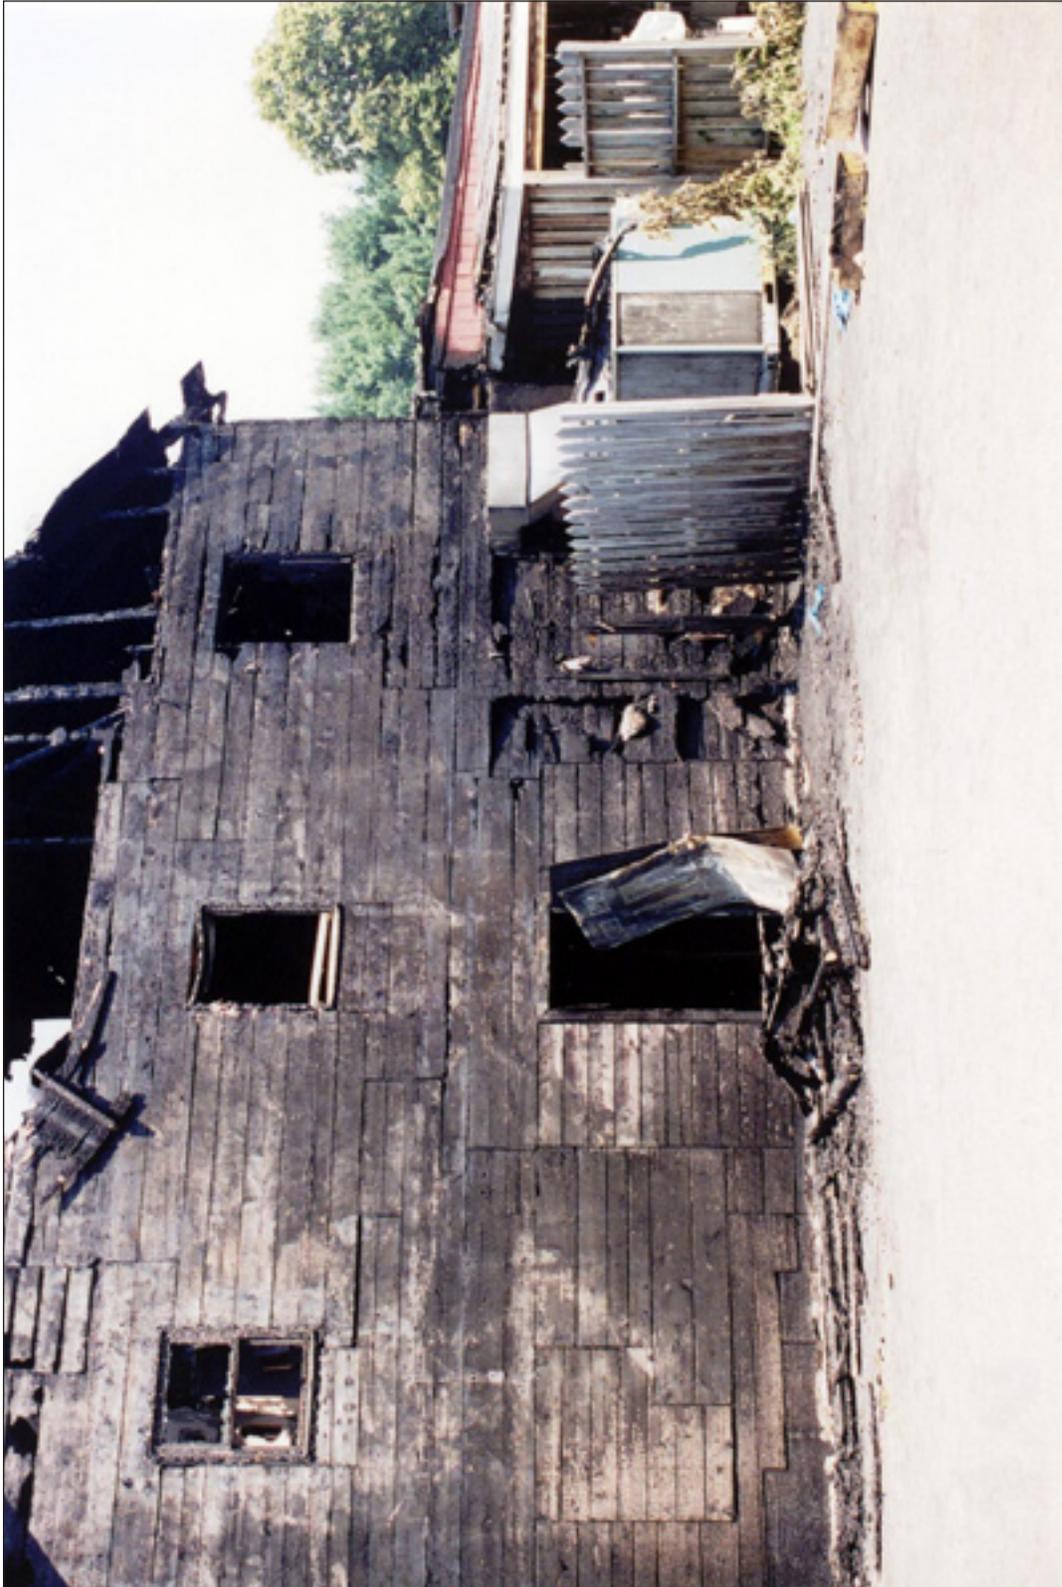
At approximately 03:00 hours, a fire started on the exterior of The Danvers Butchery. The area of origin was in a fenced enclosure next to a large air conditioning unit on the B/C corner of the Barn. (See Appendix C for details) The material first ignited is believed to have been a plastic bag filled with garbage. Sufficient combustibles were present to allow the fire to grow. Flames ignited the vinyl siding, tar paper, and sheathing. In several places flames ate through the sheathing and entered joist spaces. As flames impinged on the second floor window above, the glass failed. The fire entered the second floor and traveled through the open attic rafters once the suspended ceiling collapsed. It became visible to an awakened neighbor when the wood sheathing and vinyl siding on the C side were free burning. The property was shielded by a tree line which may have blocked earlier observations if any neighbors had, in fact, heard anything.

4. The lower portion of the Barn's C side. This surface, finished with vinyl siding, was engulfed when firefighters arrived. The area of origin is at the lower right.

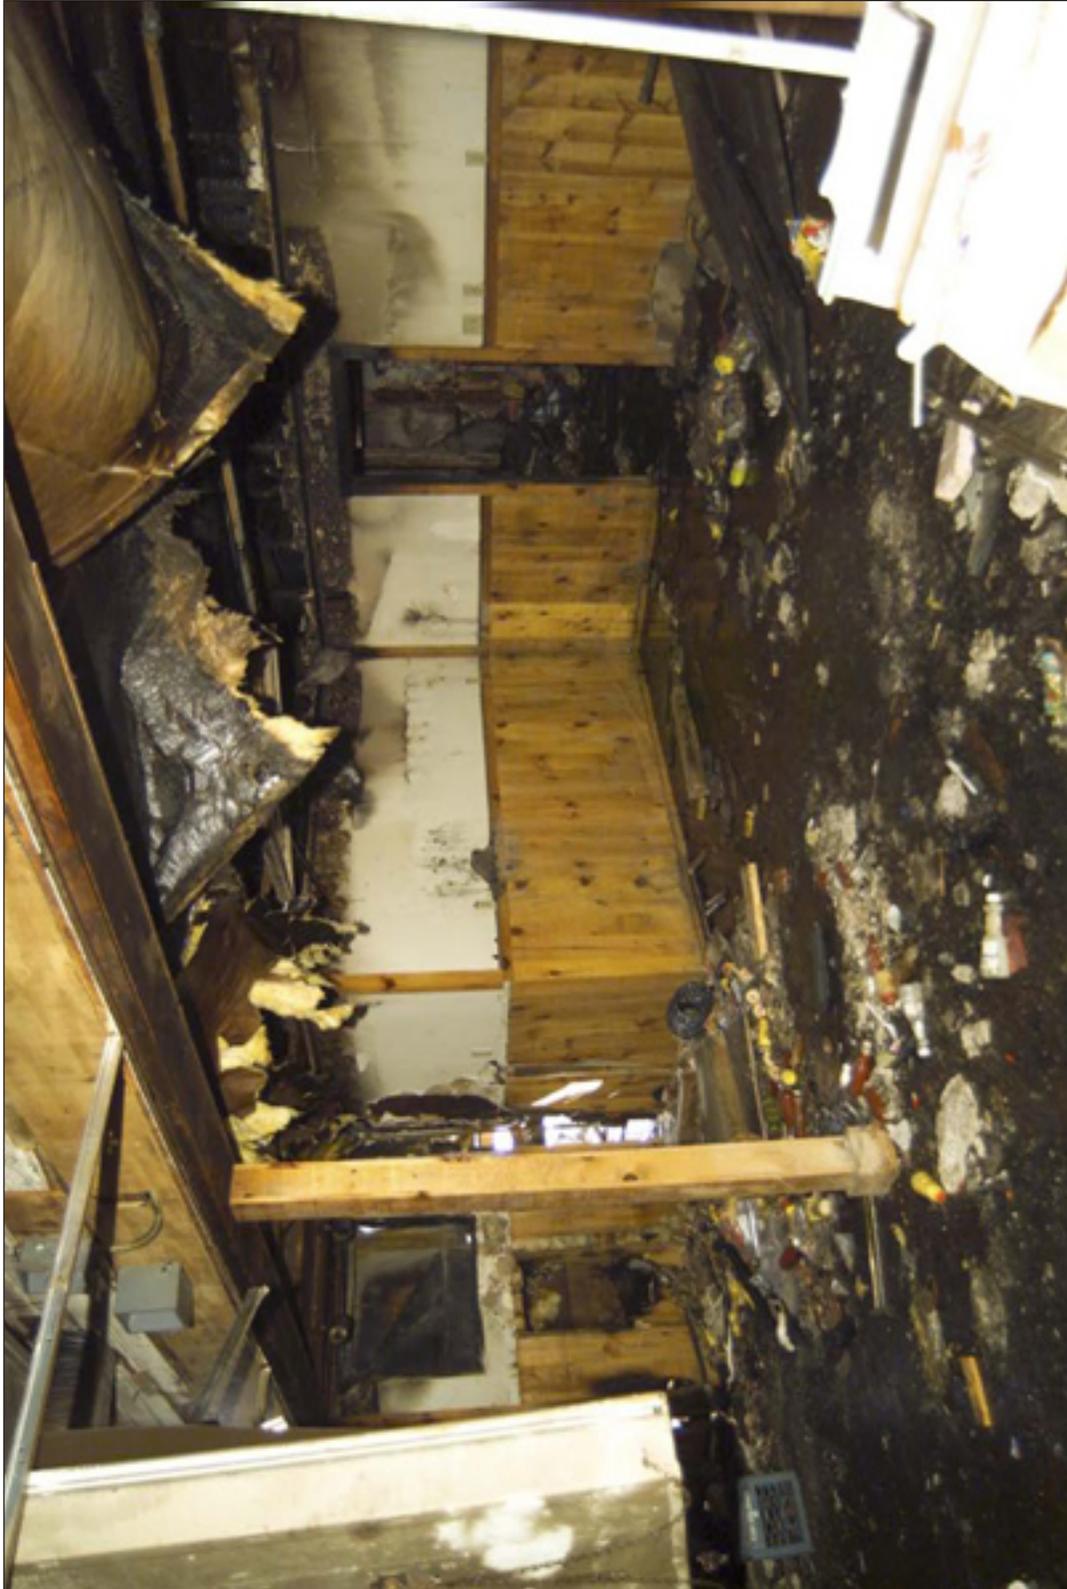
5. The rear of the Barn, 1st floor looking southwest. The protruding wall sections in the center are the outside of the electrical room. The duct from the outside HVAC unit is at the left and the entrance to the employee area is through the door right of center. The beam at the top is holding up the Barn's east wall.

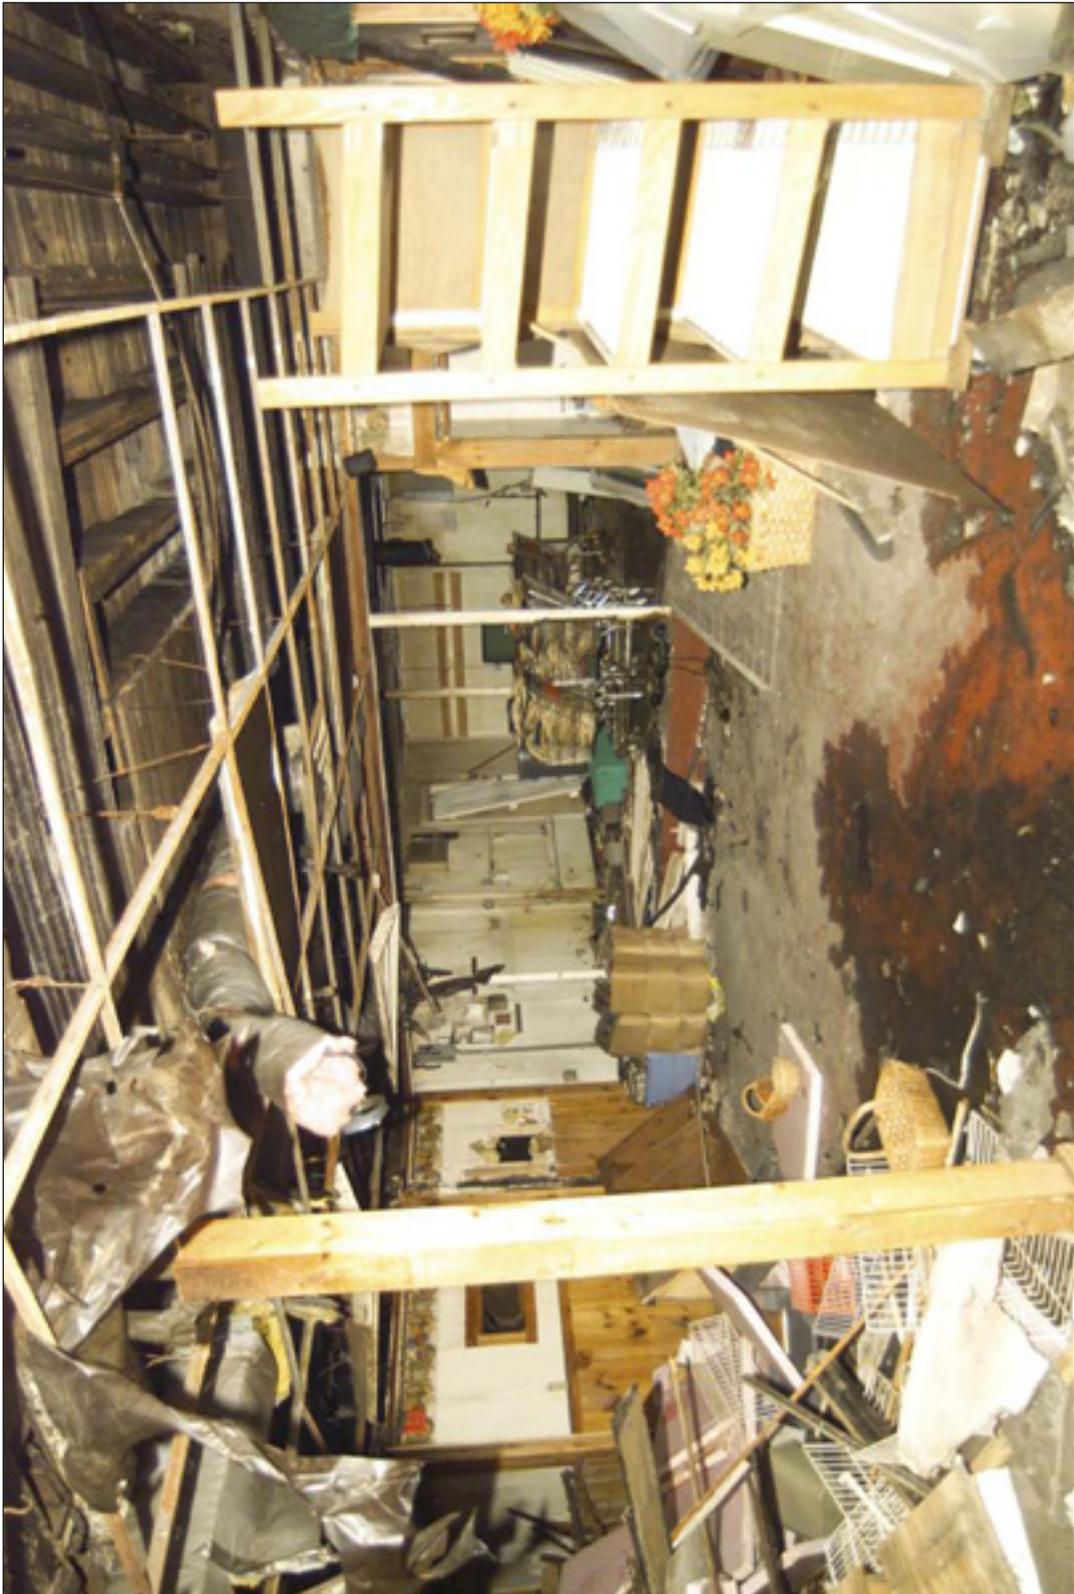
6. The north part of the Barn, 1st floor looking west into the kitchen. The fire did not penetrate the interior wall shown on the left. This photo was taken about six months after the fire, and a lot of salvage work has been done.

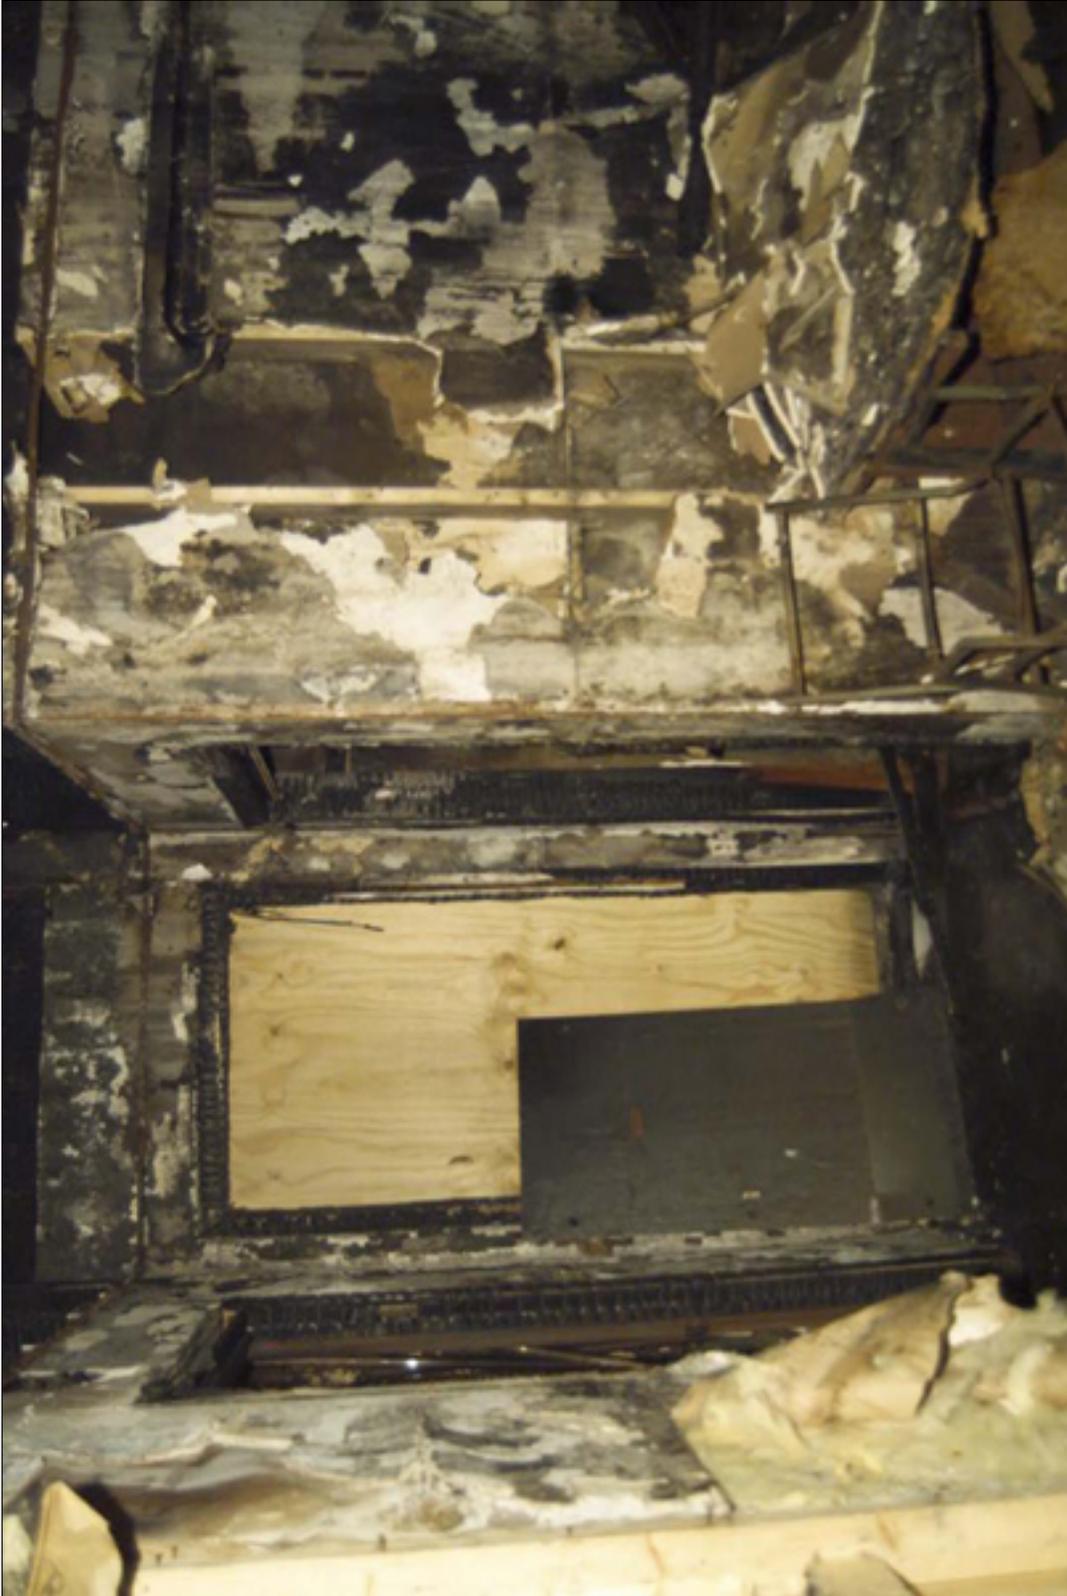
7. The employee area on the Barn's 1st floor, looking south at the D6. The electrical room is through the door on the left, and the door on the right accesses a closet under the rear stairway to the second floor.

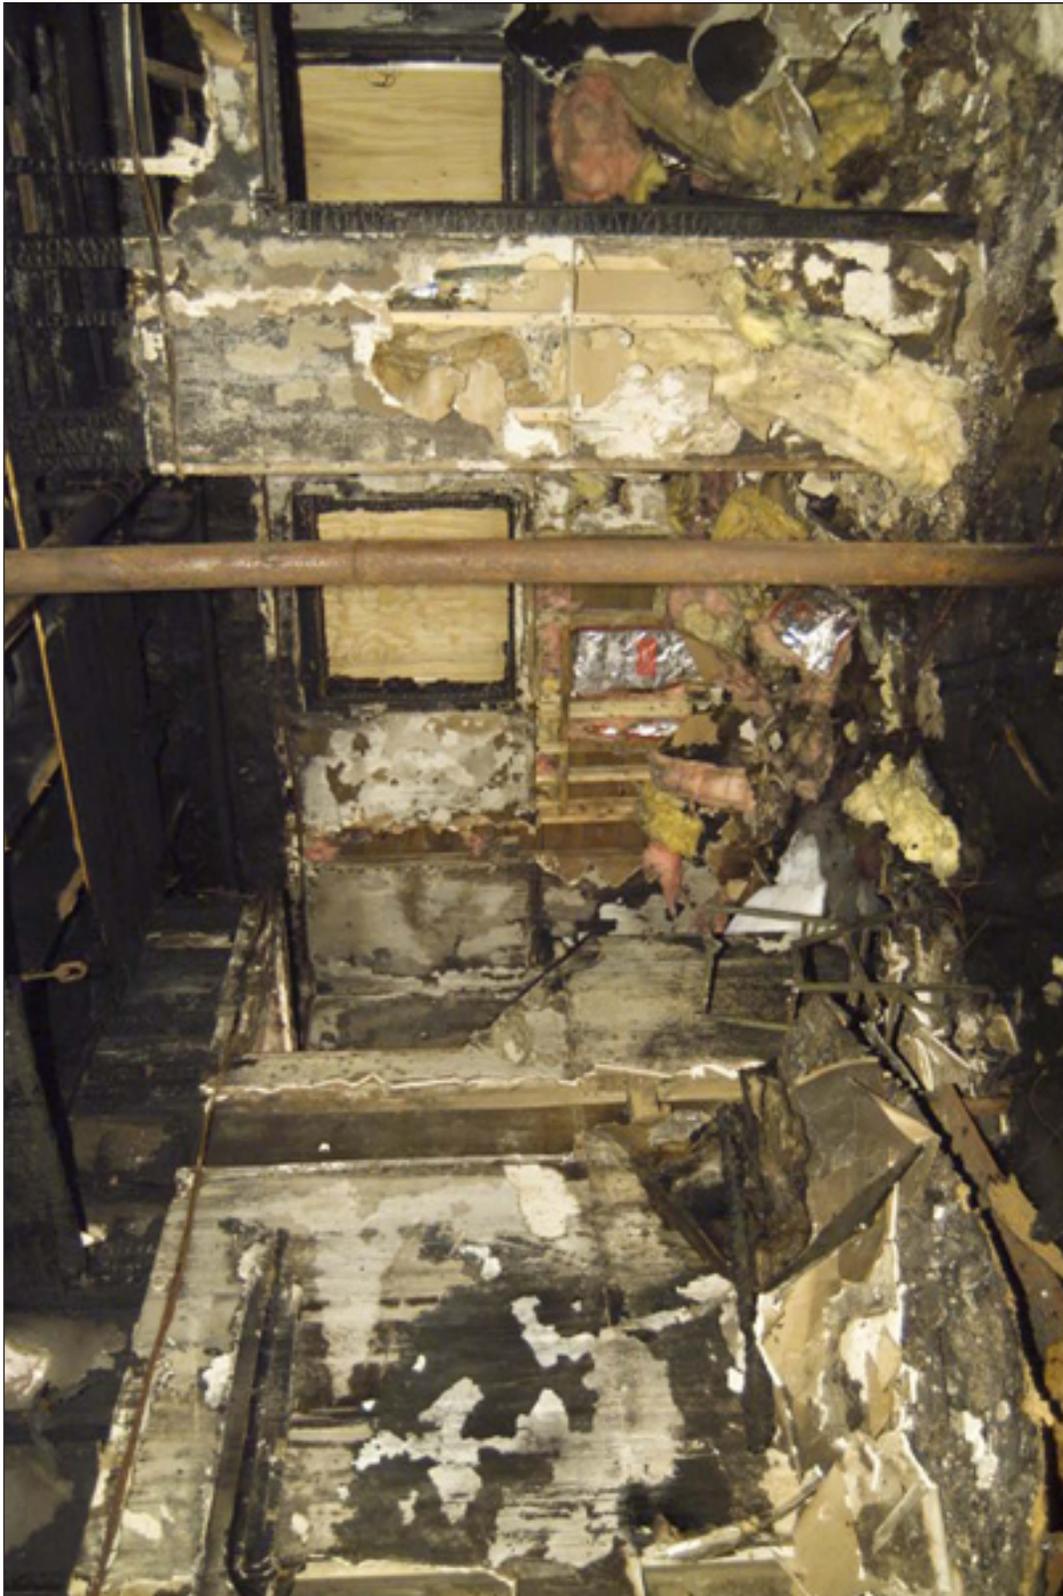
8. Another view of the employee area, looking southwest. The entrance to the staircase is at the end of the left wall where it intersects with the west wall, the C/D corner of the Barn. Fire damage in this area was caused by debris dropping down from above. The interior attack extinguished the fire in the room. (Photo is by the investigator)

8. Another view of the employee area, looking southwest. The entrance to the staircase is at the end of the left wall where it intersects with the west wall, the C/D corner of the Barn. Fire damage in this area was caused by debris dropping down from above. The interior attack extinguished the fire in the room.

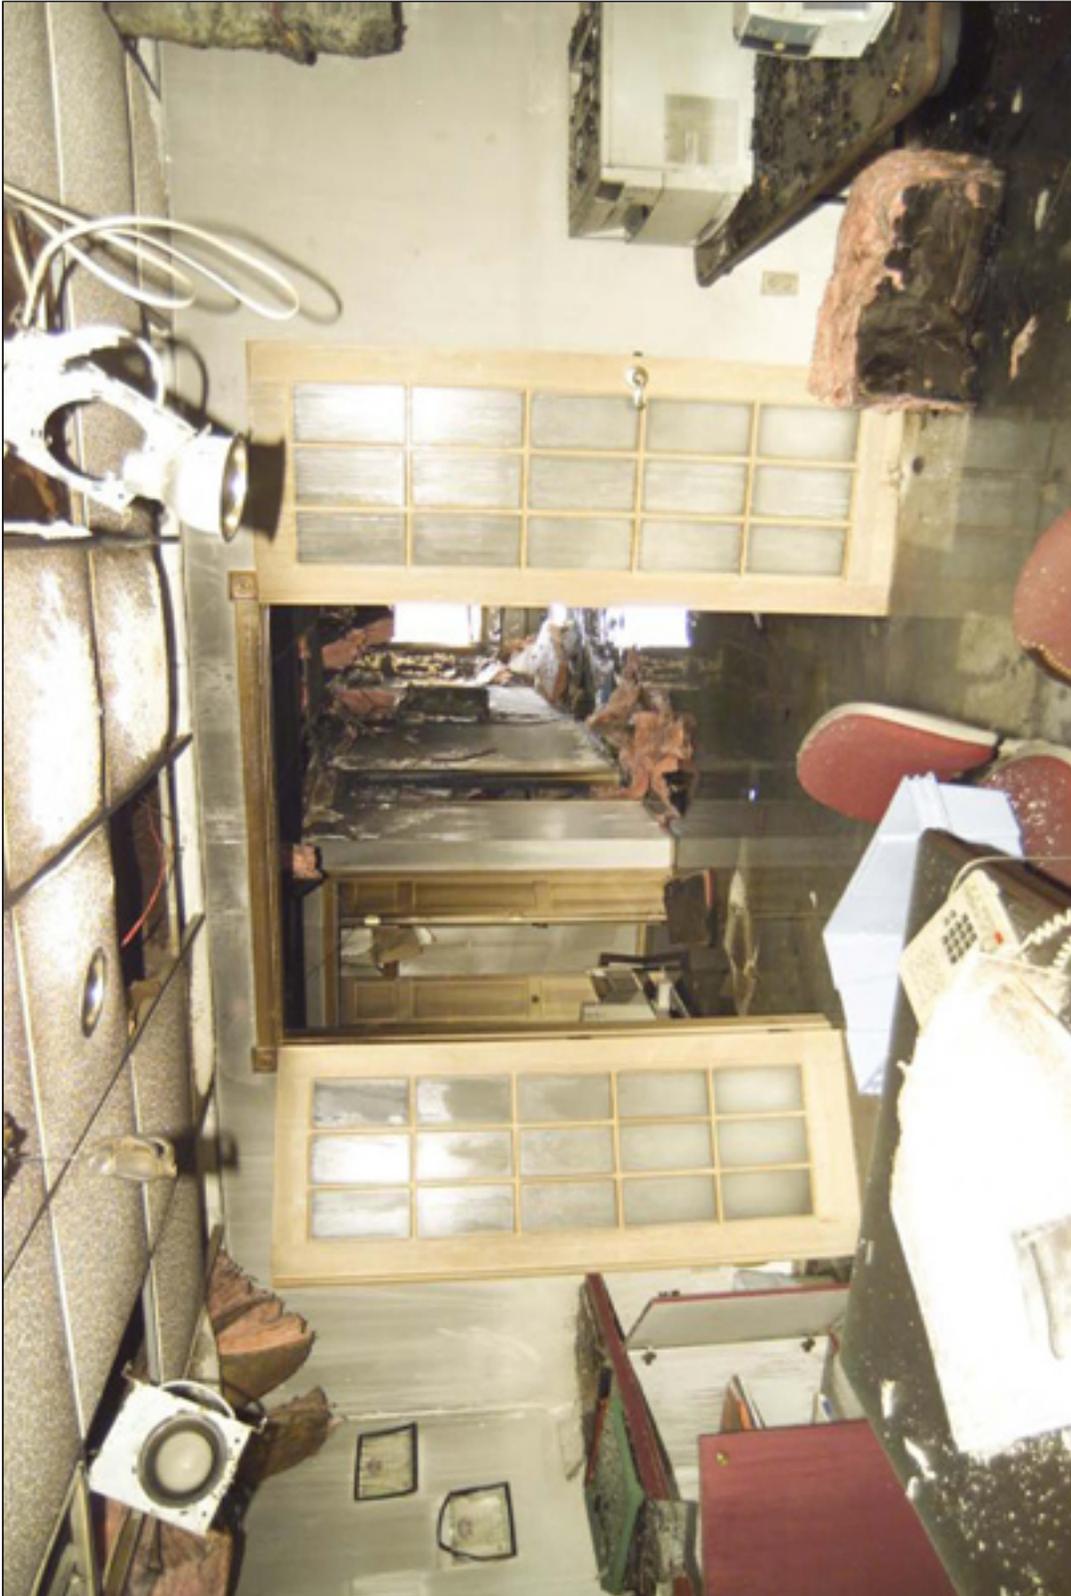
9. The Barn's second floor, looking south from the conference room. This room sustained only heat and water damage due to the presence of a wood floor in the attic. Office G can be seen through the French doors. It was devastated. (Photo is by the investigator)

9. The Barn's second floor, looking south from the conference room. This room sustained only heat and water damage due to the presence of a wood floor in the attic. Office G can be seen through the French doors. It was devastated.

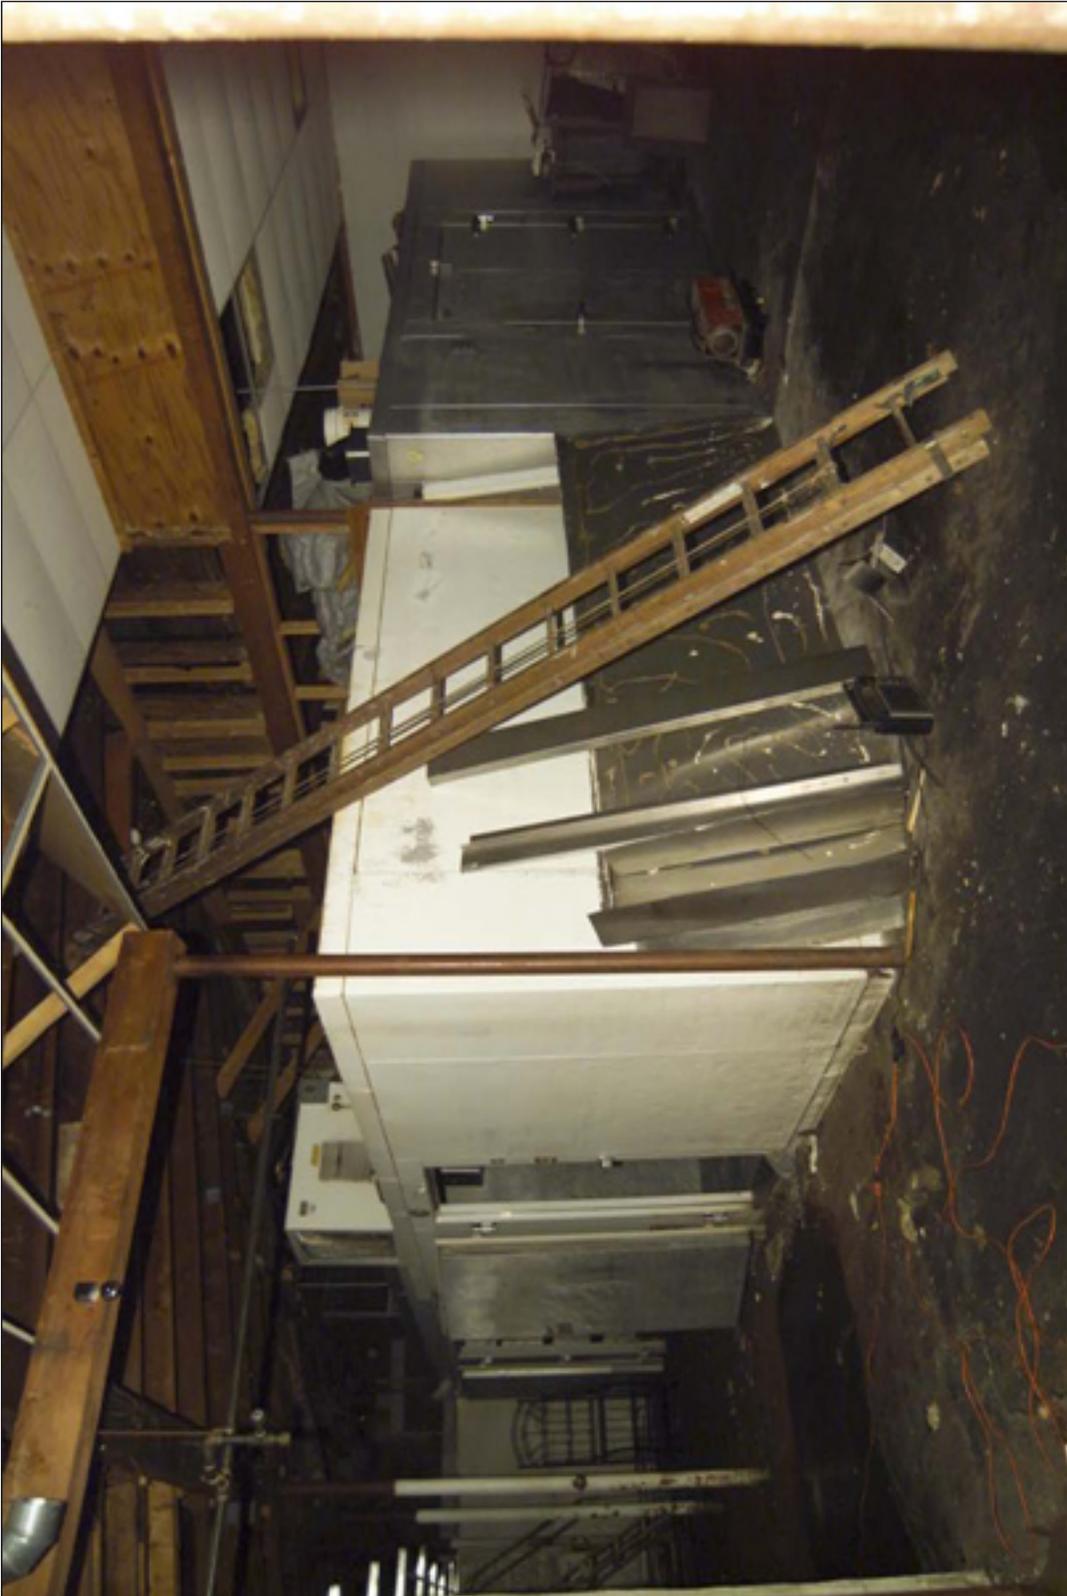
10. These are the walk-in coolers at the east end of the complex. The smoke damage was minimal, and \$40,000 worth of inventory was saved. (Photo is by the investigator)

10. These are the walk-in coolers at the east end of the complex. The smoke damage was minimal, and \$40,000 worth of inventory was saved.
