**Assessment of Paint Layers by FE-SEM and
EDS Examination**

ARL-TR-3232

June 2004

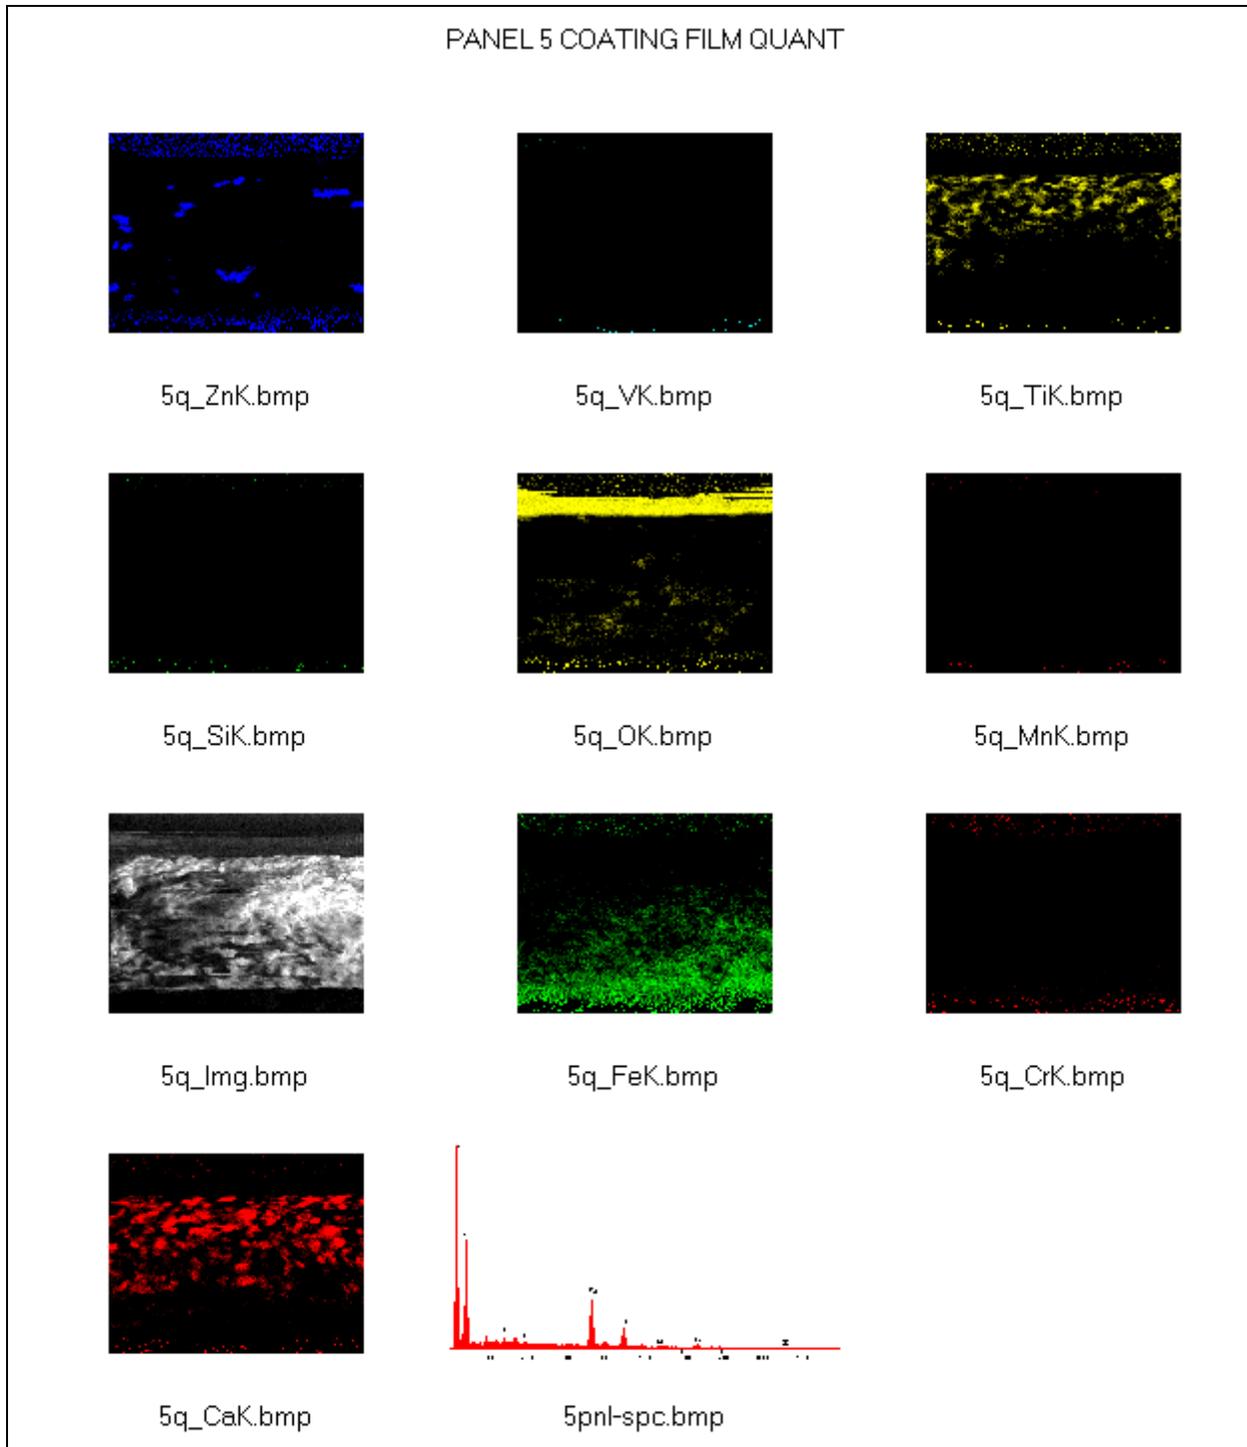
EDS detector. Figure 21 shows the results of a Quant elemental mapping of the free film oriented along the x-axis. The beam was 20 KeV with a 10- μ A emission current. The mapping was done with a 400-ms dwell time and a 128×100 pixel frame. The Zn K map reveals the presence of a number of large clusters. The apparent V K response is really a Ti K β response installed by the auto ID function. The bright solid band in the O K response is not readily explained, especially in the absence of any visible charging on the image map. The Fe K

Figure 21. Free film from panel 5. Contrast enhanced for visibility.

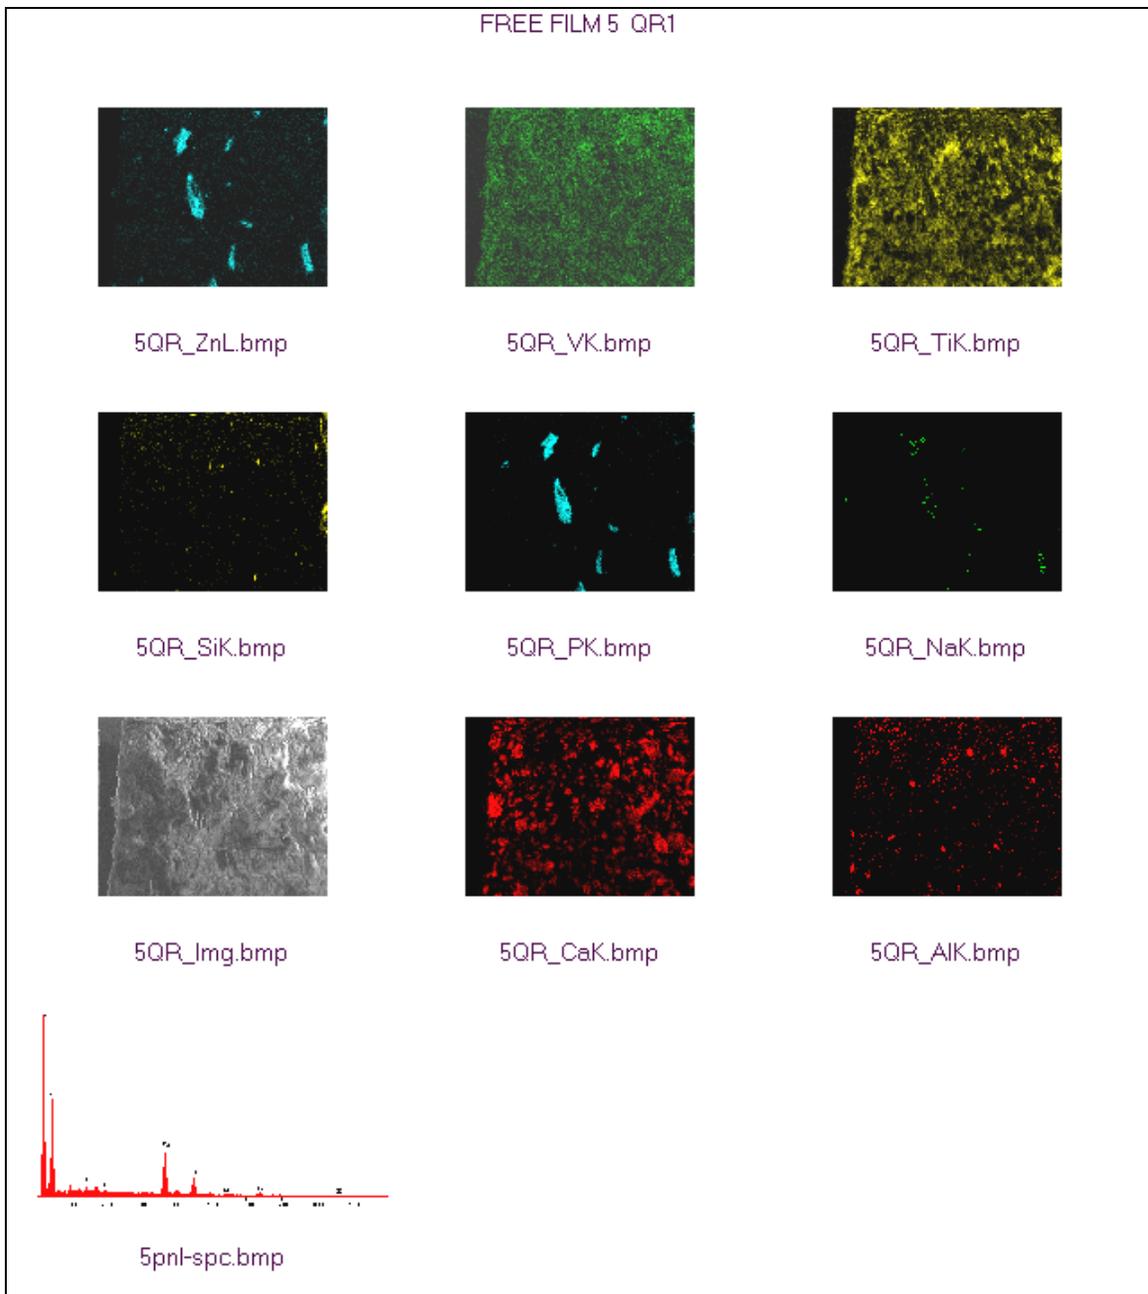
Both the Ca K and the Ti K maps are consistent with those in figure 21. The distributions seen in the Zn L, P K, and Na K maps are noteworthy, as they appear to be confined to the right-hand two-thirds of the film thickness. The size of these clusters and the Ca K clusters are significantly different from the Ti K distribution.

Figure 24. Panel 5 coating free film oriented along the y-axis.

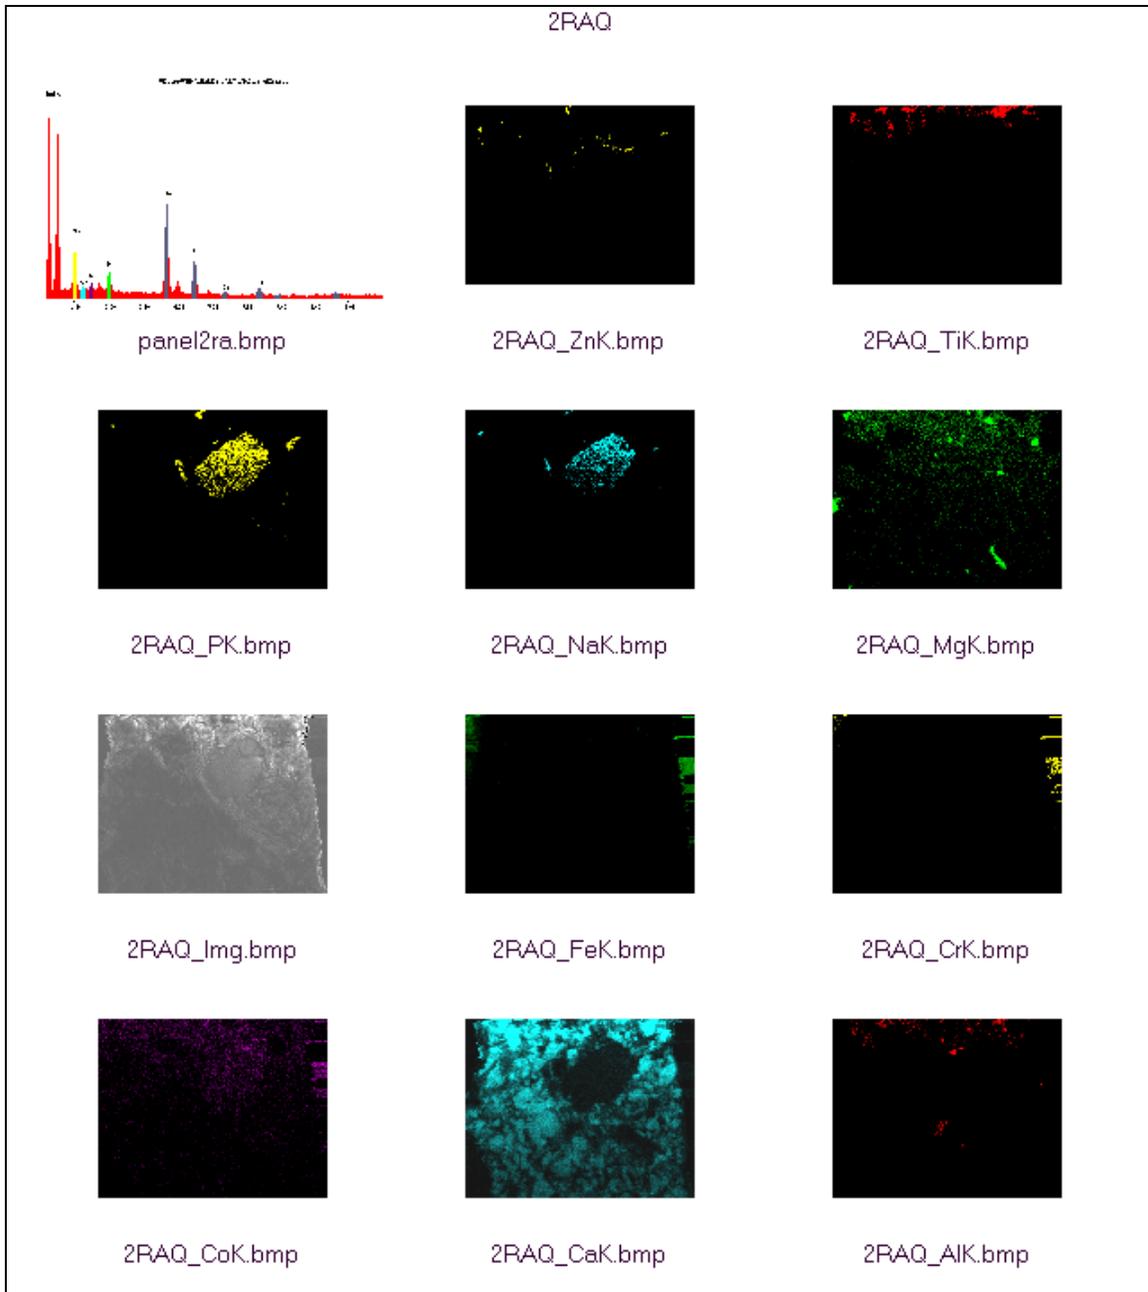
figures 26 and 27. As in the panel 5 free film, the Na, P and Zn maps exhibit large particles in the film.

The differences between figures 26 and 27 arise from the differences in the film geometry at the two sites. The surface plane labeled RAQ faces the EDS detector directly, while the surface plane labeled RBQ slopes off to the right. Note the difference of the Cr K maps between the two sites. The sample was apparently rotated to the apparent 90° position and tilted to expose the left hand image face of the coating. The mappings are mislabeled and reversed. The S-4700 does

Figure 26. Quant mapping results from panel 2 free film, y-axis alignment.

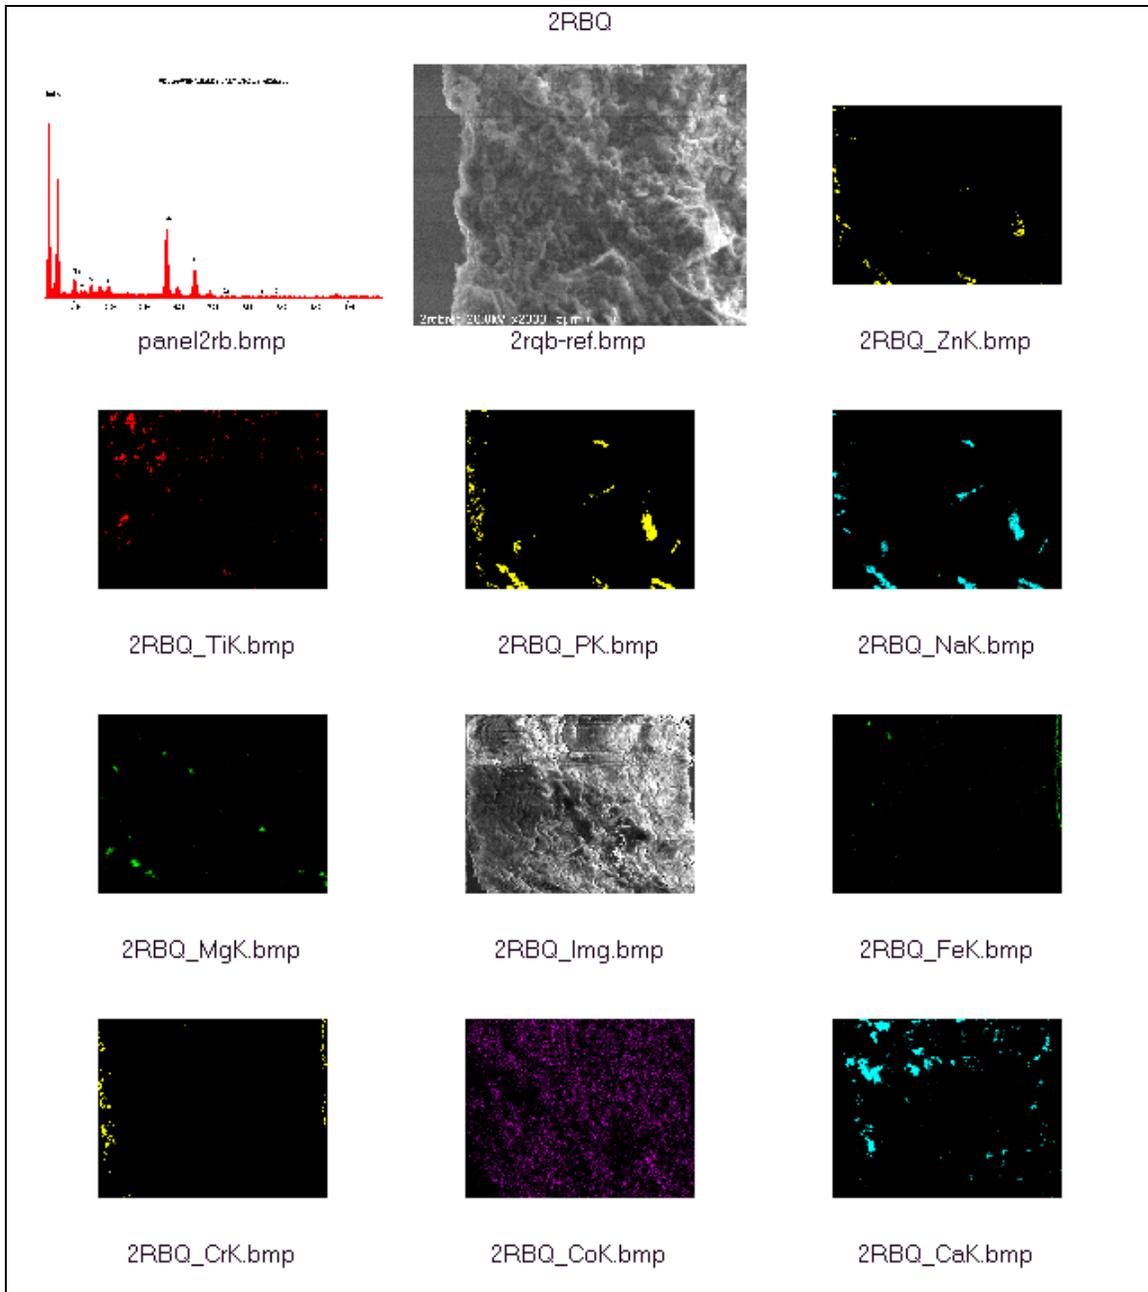
Figure 27. Second Quant mapping of panel 2 free film, y-axis alignment.

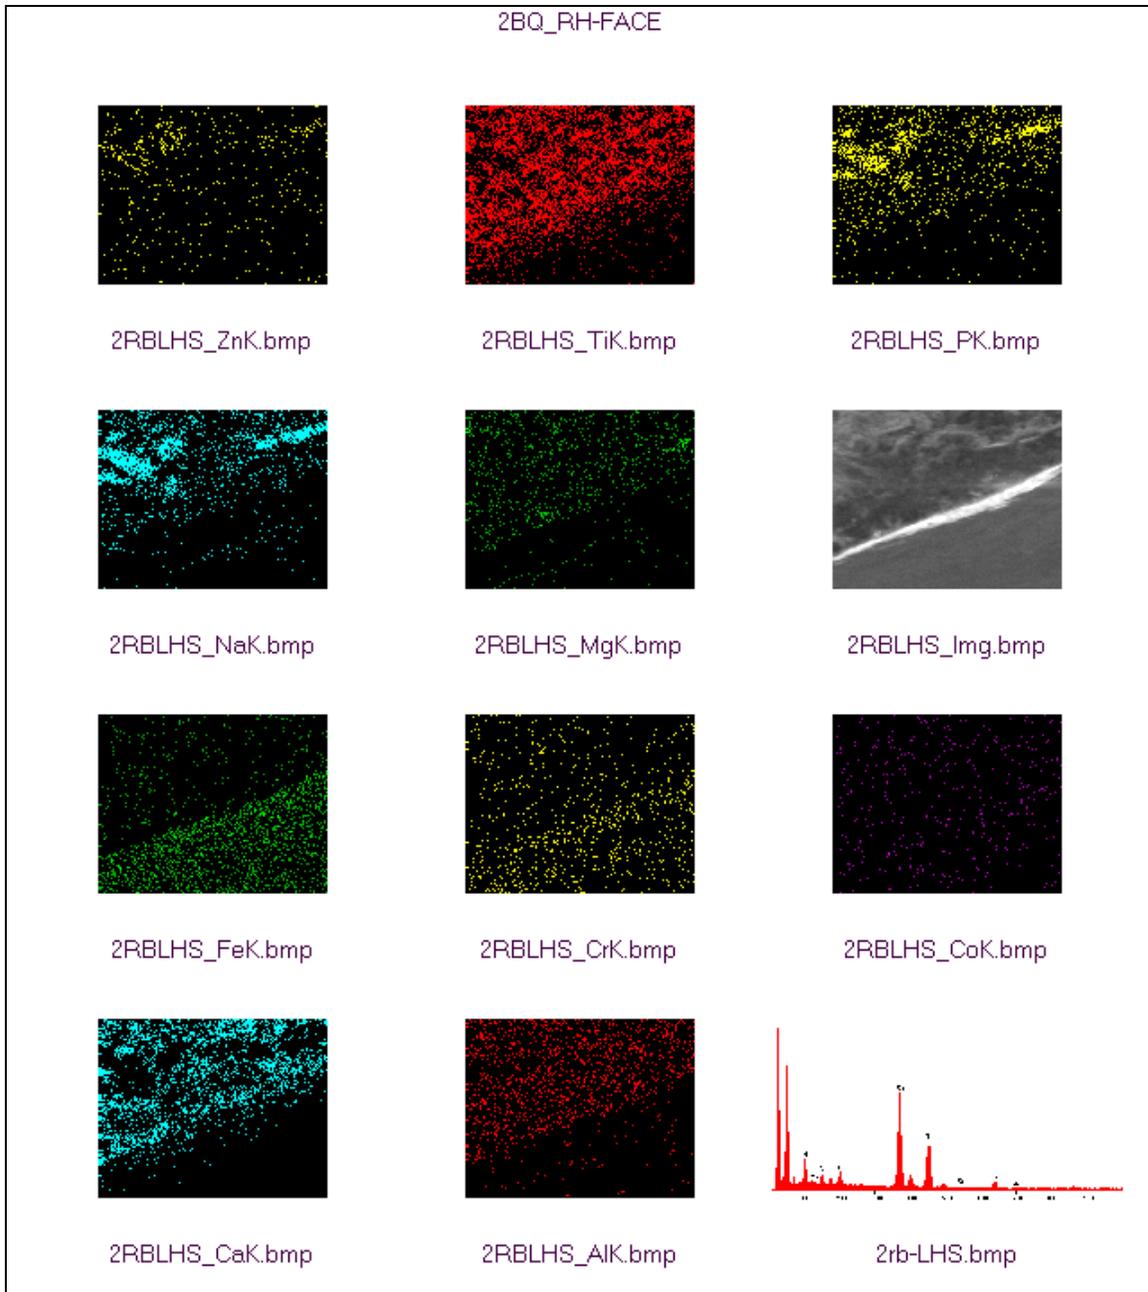
The Cr K maps in figures 29 and 30 appear to be similar for each edge. This may be a result of stacking the panels coated face to chromated face. These Live maps don't have sufficient information to identify a panel interface surface (figure 31).

Figure 29. Live elemental map of right-hand face of panel 2 free film, mapped at 20-KeV, 2-KX, and 100-ms dwell time.

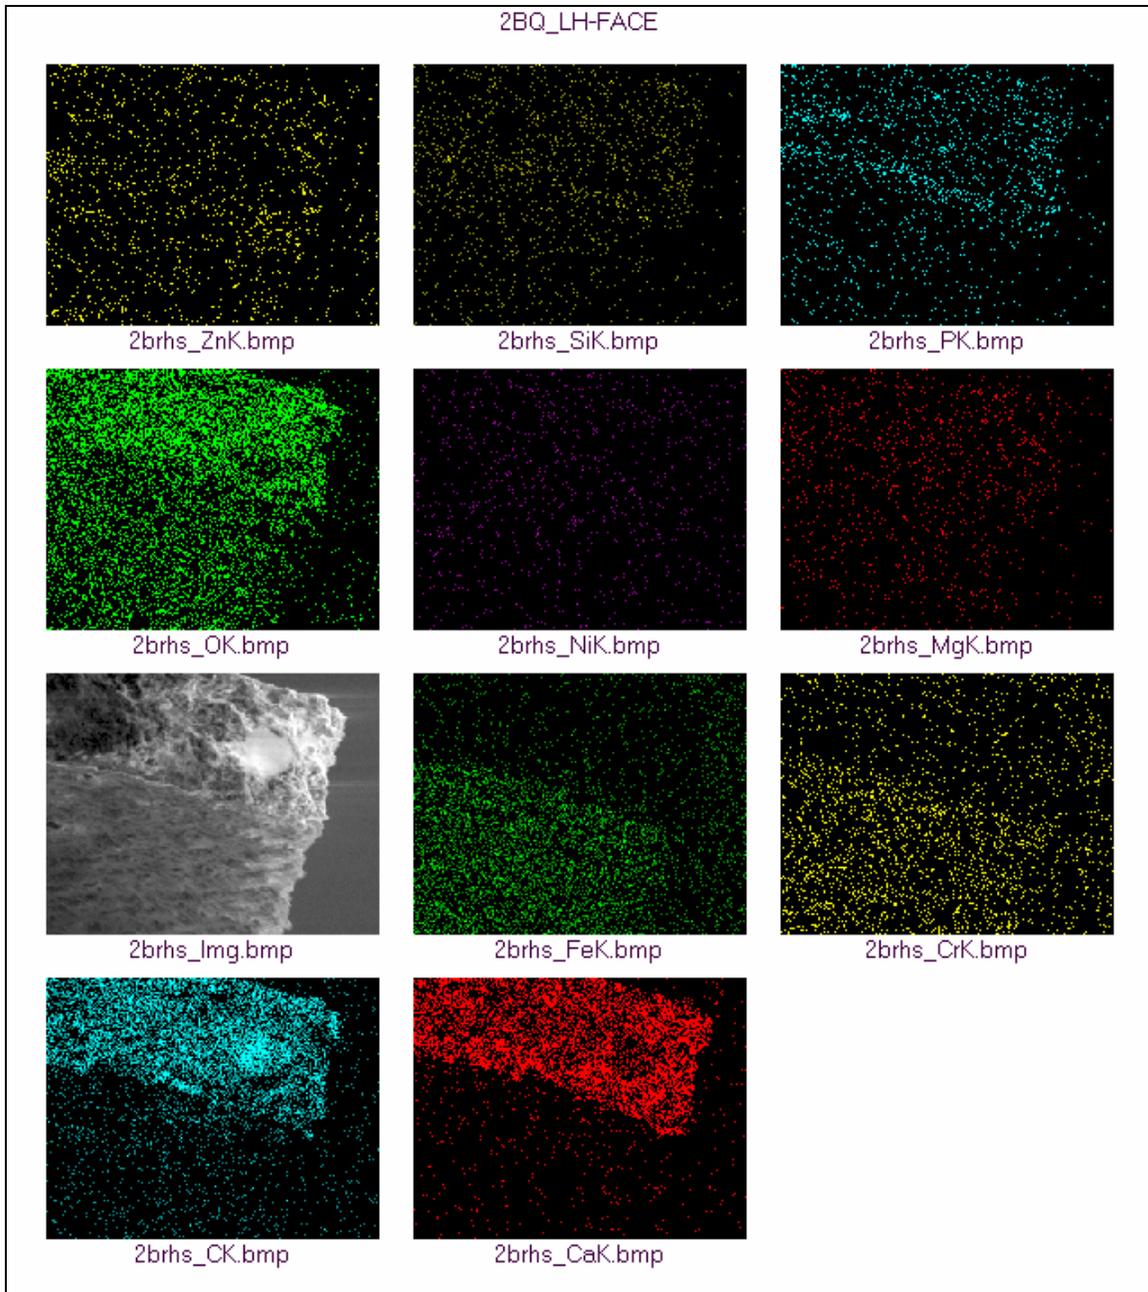
Figure 30. Live elemental map of panel 2 free film, left-hand face at 20-KeV, 900x, and 125-ms dwell time.

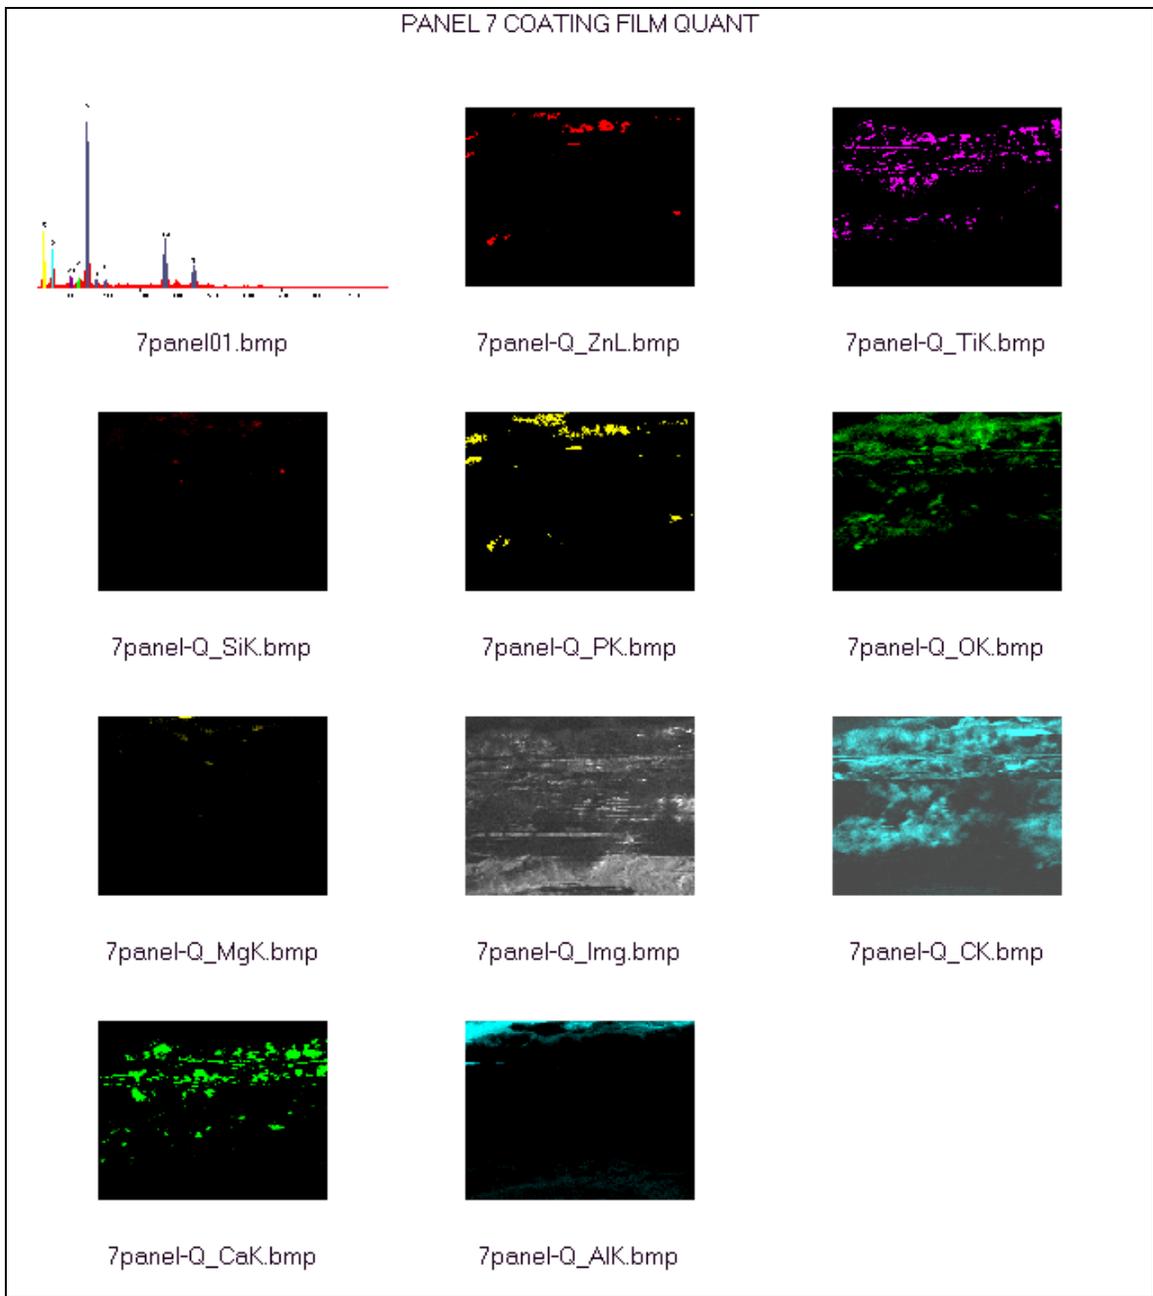
In figure 33, note the Al K map and then the distributions seen in the Zn L and P K maps. For panel 7, the Zn P inclusions are closely associated with the panel coating interface area, indicating the primer chemical and physical distributions. This primer was applied to all the panels at the same time. No distinct chromium layer or peak visible.

Figure 33. Elemental map of panel 7 coating cross section.
