Prepared in cooperation with the
Dolores Water Conservancy District

Bathymetry of Groundhog Reservoir, Dolores County, Colorado, 2011

By
Michael S. Kohn
2012

Suggested Citation: Kohn, M.S., 2012, Bathymetry of Groundhog Reservoir, Dolores County, Colorado, 2011: U.S. Geological Survey Scientific Investigations Map 3202, scale 1:8,000 (<http://pubs.usgs.gov/sim/2002/>).

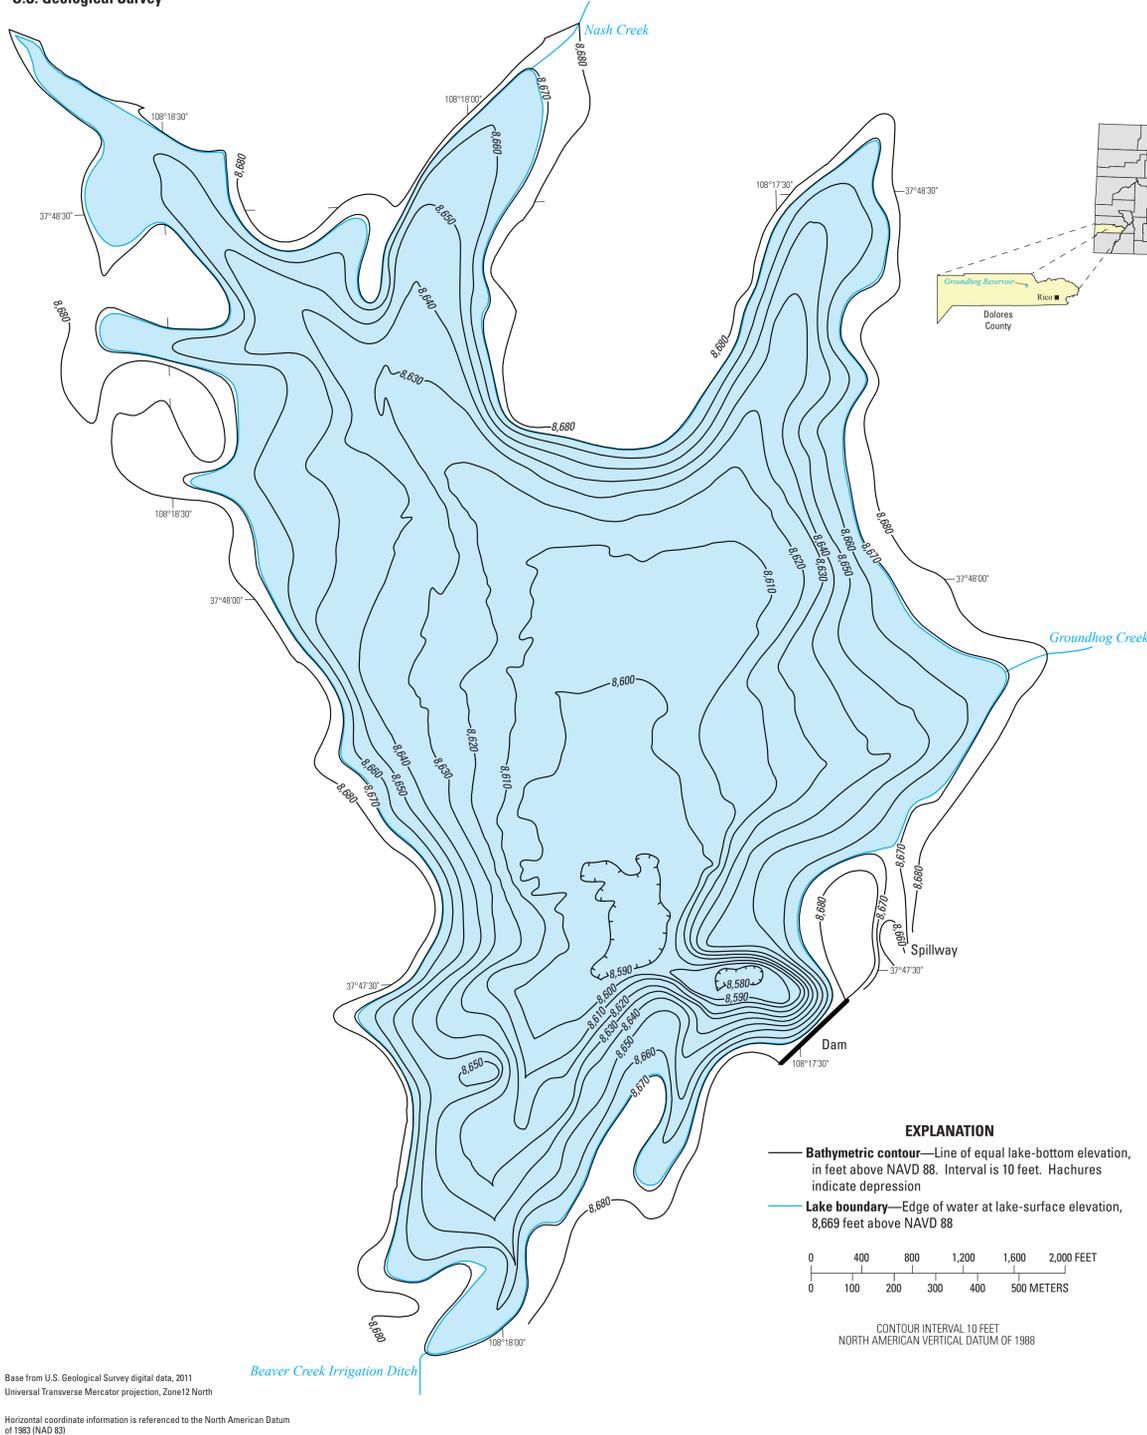
Figure 1. Bathymetric contours of Groundhog Reservoir, Dolores County, Colorado, 2011 (not for navigational use).

The bathymetry dataset was imported into Environmental Systems Research Institute (ESRI) ArcMap 9.3.1 (Environmental Systems Research Institute, Inc., 2010) so the elevation contours and reservoir area and volume could be determined from the lake bottom to approximately 2–3 ft above the top of dam. Once the 6.56-ft grid was created using HYPACK 2011, it was merged with the RTK GPS dataset in ArcMap by generating a triangulated irregular network (TIN) from both datasets. The TIN was then converted to a 6.56-ft horizontal grid, and using the contour tool in ArcMap, contours at intervals of 10 ft were produced. The areas and volumes at various elevations were computed using the surface volume tool in ArcMap (figs. 1–3, and table 1).

In figure 1, some of the upper contours are not continuous; this is mainly due to the spillway and irrigation canal not allowing for the continuation of the contours as the spillway and canal inverts are below the elevation of the top of the dam. However, in the northwest end of the reservoir and east of the Nash Creek inlet, sufficient data were not collected to resolve the contours causing the breaks. Where breaks in contours occurred, it was assumed the areas and volumes above that point were computed as if a vertical wall existed at that point. That assumption provided better results than using a high resolution digital elevation model. When comparing the 10-meter digital elevation model (DEM) (Gesch and others, 2002) at the reservoir with the data collected, it appeared that the DEM did not provide sufficient accuracy to improve the dataset collected for this report. Therefore, no DEM was used to supplement the dataset and the results of this report were generated only from field data.

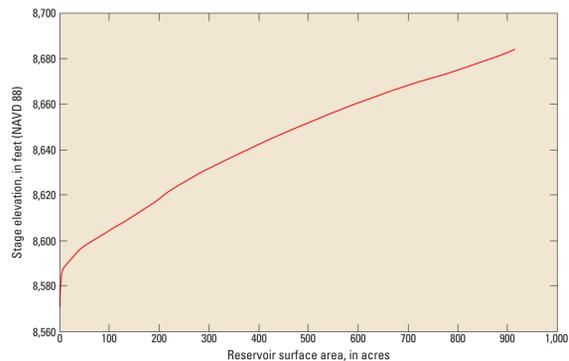
Figure 2. Stage-surface area curve of Groundhog Reservoir, Dolores County, Colorado, 2011.

From the RTK GPS data, the top of the dam was approximately 8,681 ft above NAVD 88, the spillway invert was 8,671 ft above NAVD 88, and full-pool elevation was 8,669 ft above NAVD 88. At the spillway elevation, the surface area of the lake is 738 acres (ac) and the volume is 25,800 ac-ft. The minimum elevation of the reservoir is located 100 ft below the spillway elevation. As shown in figure 3, the volume increases very rapidly with depth initially, but at elevations greater than 8,640 ft above NAVD 88, the stage-volume curve is approximately linear.

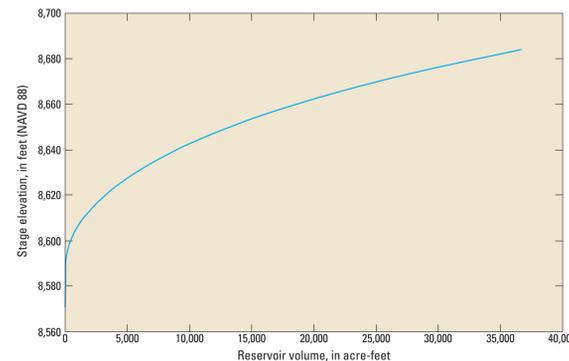
Figure 3. Stage-volume curve of Groundhog Reservoir, Dolores County, Colorado, 2011.
