# Low Wind Speed Turbine Developments in Convoloid Gearing

Final Technical Report  
June 2005 – October 2008

*Genesis Partners, LP  
Montgomeryville, Pennsylvania*

**Subcontract Report**  
NREL/SR-500-45103  
August 2010

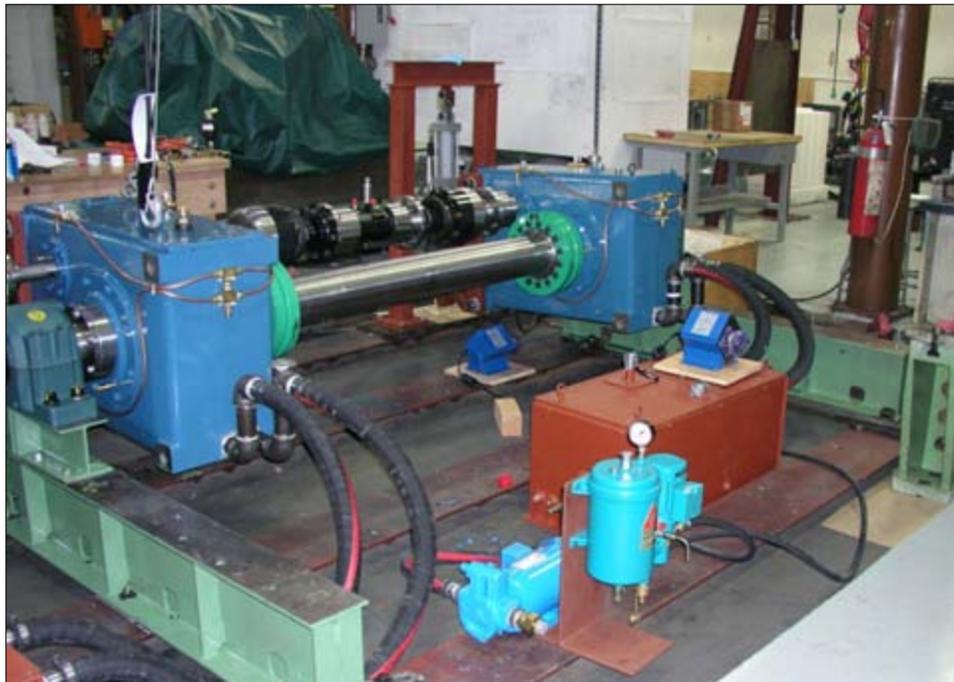
**Figure 2.2. Micon 108 test fixture, involute gearbox on the left and Convoloid gearbox on the right**

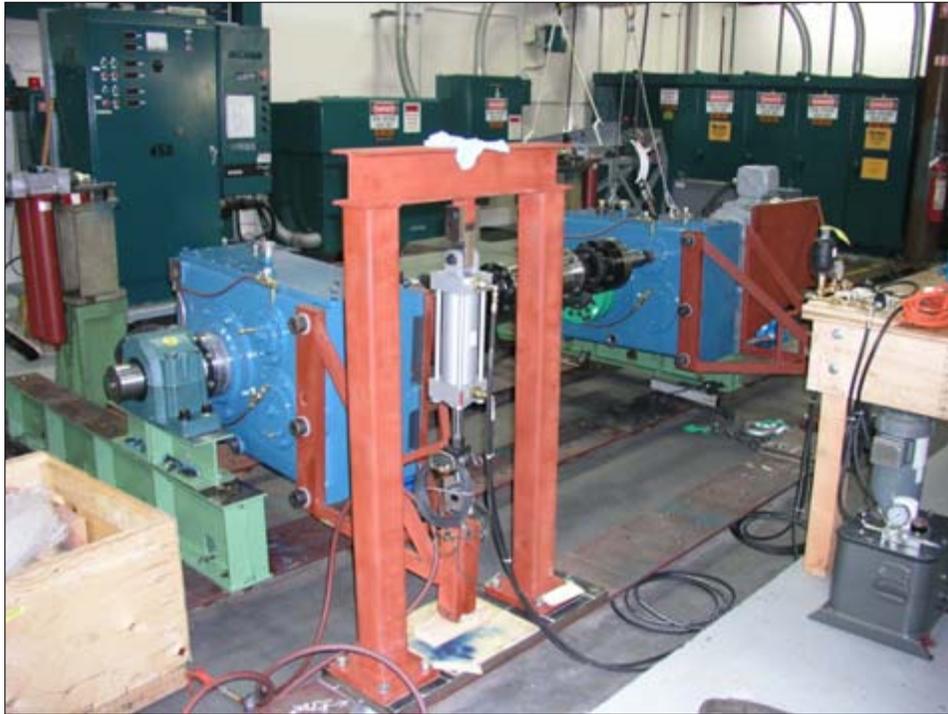
**Figure 2.3. Micon 108 test fixture, Convold gearbox with torque application hydraulic cylinder**

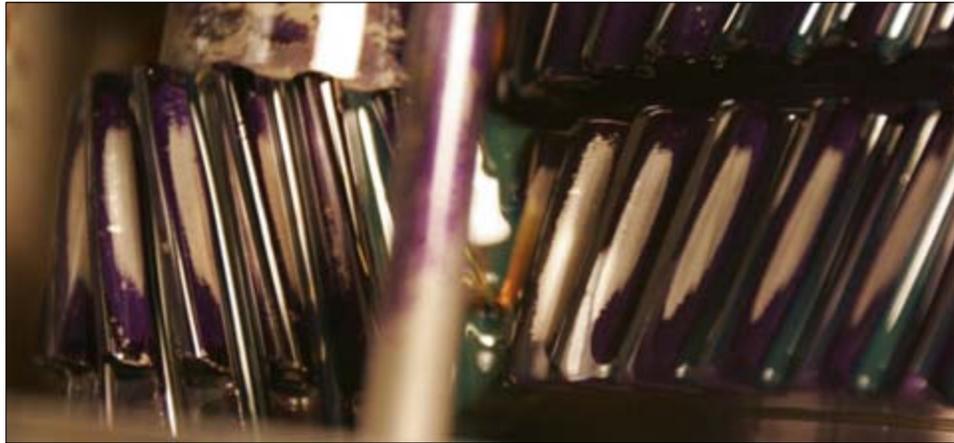
**Figure 2.5. Example of contact pattern for lightly loaded involute gearing in the 3-Hole Test**

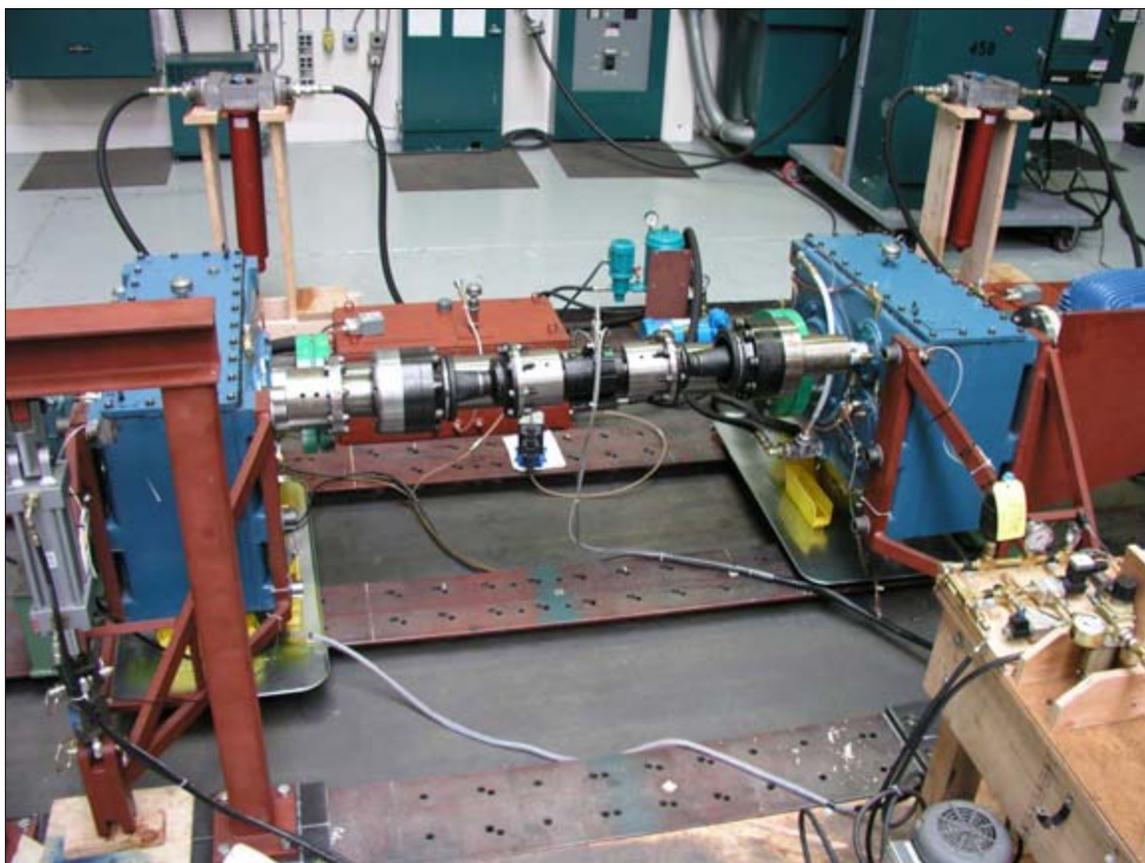
**Figure 4.2. The Micon 108 test equipment: The involute gearbox is on the right, the Convolooid gearbox is on the left; also visible on the left is the hydraulic cylinder (used to introduce loading to the system)**

To minimize as much high speed shaft misalignment as possible (and therefore reduce any potential speed variation), at no load the Convolooid gearbox was positioned with the pinion shafts unaligned. The amount of initial misalignment was calculated based upon the expected torsional deflection of the solid low speed shaft. Minor adjustments on the fixture resulted in the shafts being nearly aligned once the test load was applied.

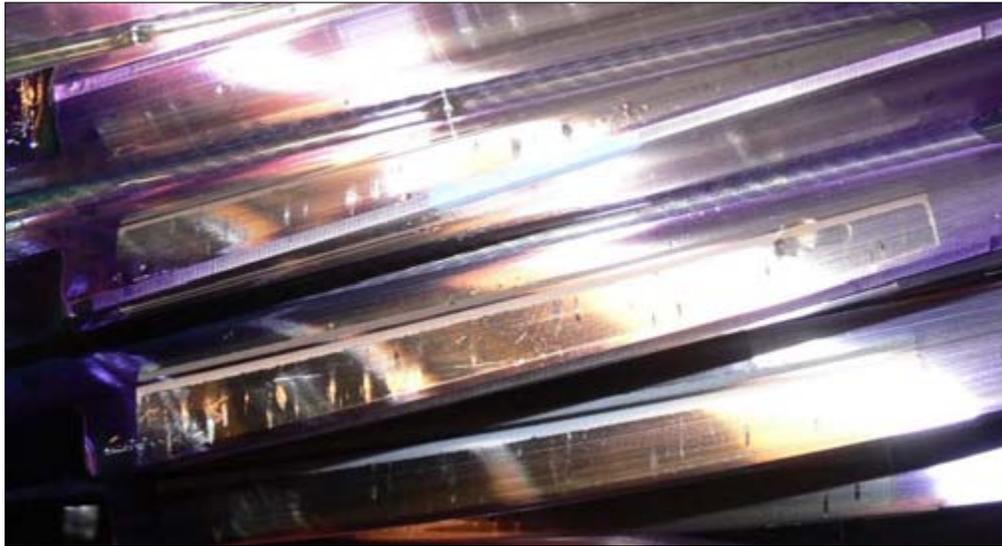
**Figure 4.6. Convuloid high speed pinion at conclusion of 200 x 200 testing; note that although there is extensive micropitting on both sides of the transition zone, it is not rapidly progressing (235.8 hours at 200% of the rated load)**

this line of wear broadened under the 200% load until after approximately 100 hours of operation. Further wear abated and did not seem to spread after this point. The initial micropitting along the edges, root, and tip did not continue to grow as the test progressed (*see* Figure 4.6).

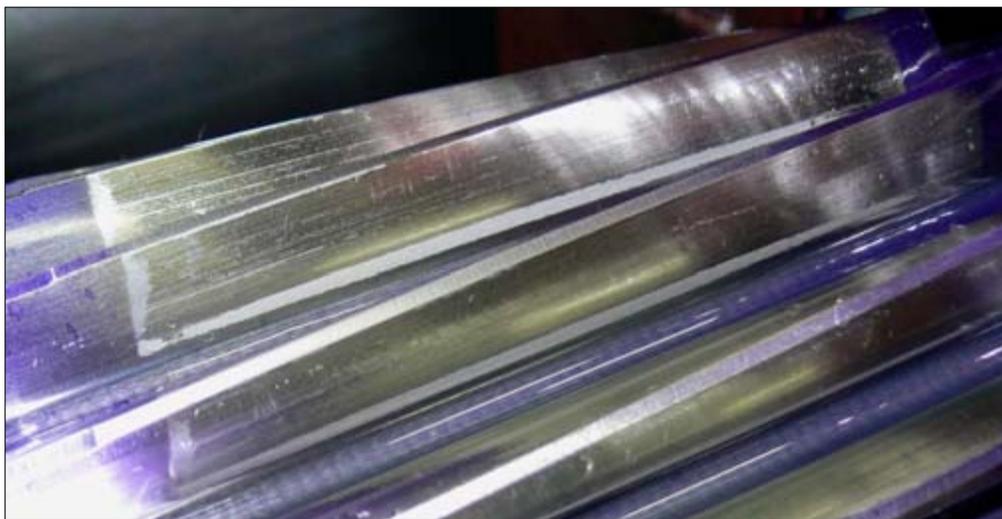
**Figure 4.7. Involute HS pinion at the conclusion of 200 x 200 testing; note the extensive micropitting in the dedendum and at the edges, some micropitting is visible along the tip, this wear is progressing (235.8 hours at 200% load)**

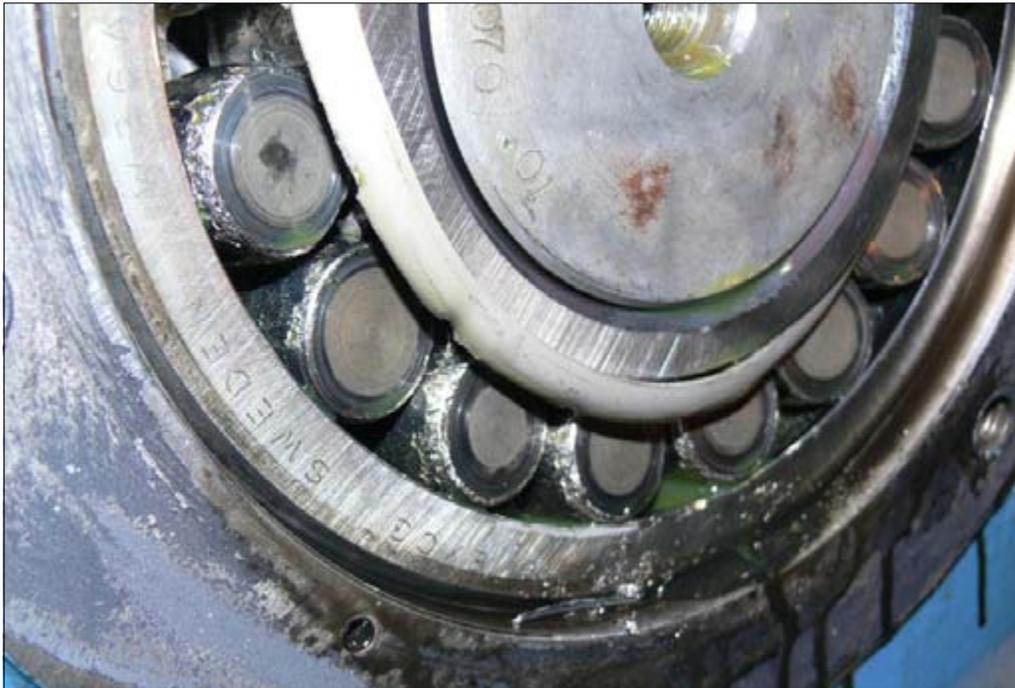
Figure 4.11. Failed spherical roller bearing in Convoloid gearbox after 763 total test hours; note pitted edges of the rollers and deformation of the cage; metallic particles are present at the bottom of the housing bore

On March 1, 2006, noise levels and unexplained fluctuations in an intermediate shaft bearing temperature in the Convoloid gearbox prompted the test monitor to shut down the test. Significant damage was present on the rollers and cage (Figure 4.11). Pieces of the cage and roller material passed through gear meshes and other bearings (Figure 4.12). Significant quantities of metal were recovered in the gearbox sump, oil reservoir, and primary filter. A day prior to the bearing failure, a magnet inspection of both gearbox sumps revealed no metal particles. After the failure, extensive quantities were found inside the gearbox housing.

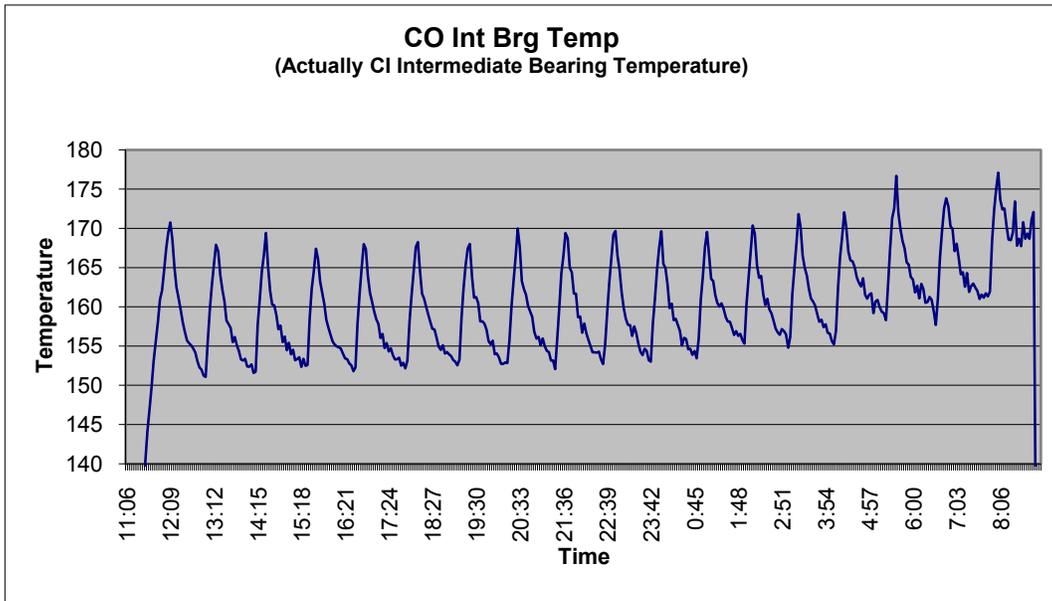
**Figure 4.13. Bearing temperature chart for the failed Convoloid intermediate bearing; note the rise in temperature after 2:18 a.m.; the jagged “saw-tooth” shape is due to cycling of the heat exchanger fan**

Analysis of temperature and vibration data taken during the final day of operation, show a distinct increase in vibration levels about 8 hours before shutdown (Figure 4.13, Figure 4.14). An observation by the operator that was written in the test log at the time of the increased vibration indicates that there was “a change in the sound” of the Convoloid gearbox. However, testing continued until a more dramatic failure occurred.

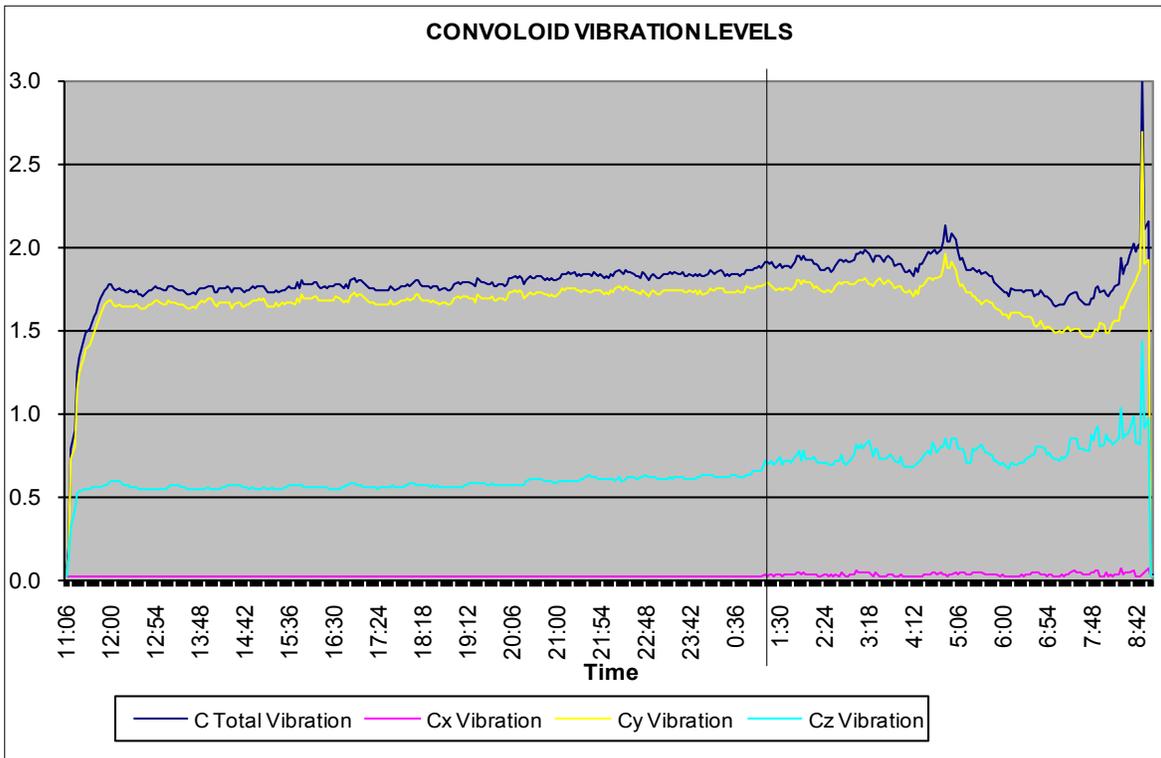
Figure 4.14. Vibration levels for the Convoloid gearbox for the last day of operation; note the increase in vibration at approximately 1:00 a.m.

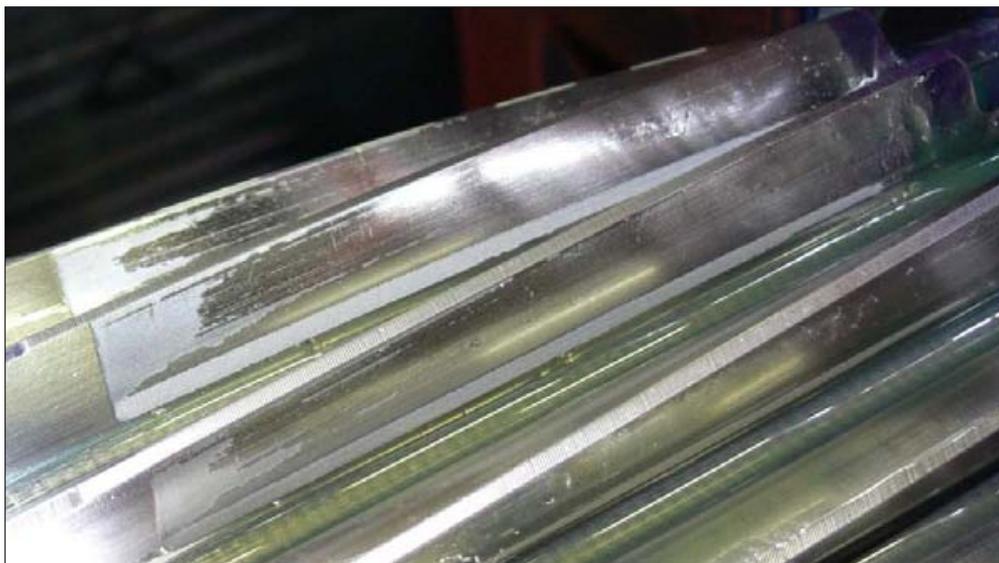
Figure 4.15. Involute HS pinion at the end of test; wear due to micropitting is extensive along one side (235 hours at 200% load; 528 hours at 240% load)

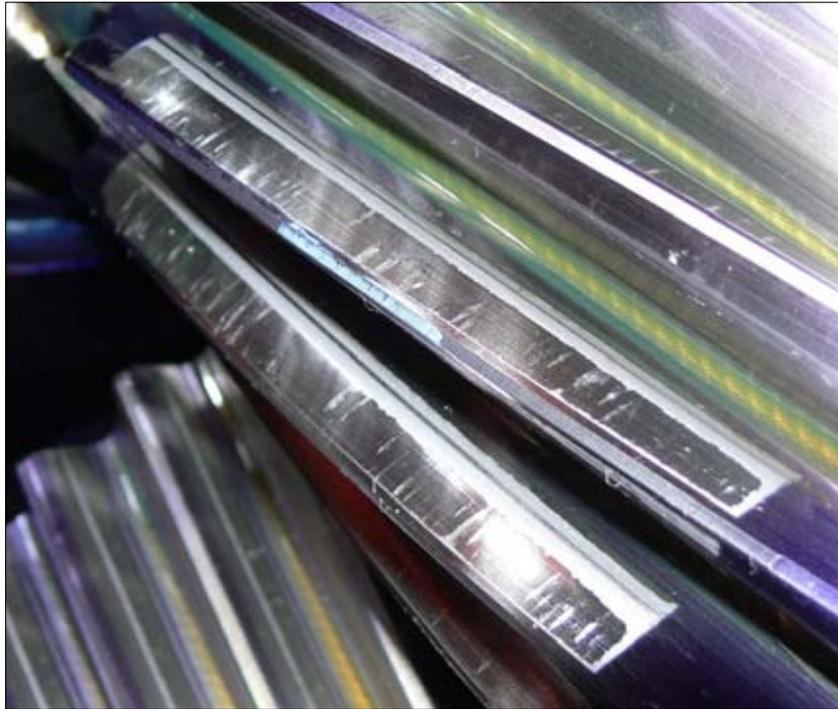
**Figure 4.16. Convolid HS pinion at the end of test; wear due to micropitting is expanded slightly during the test, but no progression occurred on the edges (235 hours at 200% load; 528 hours at 240% load)**

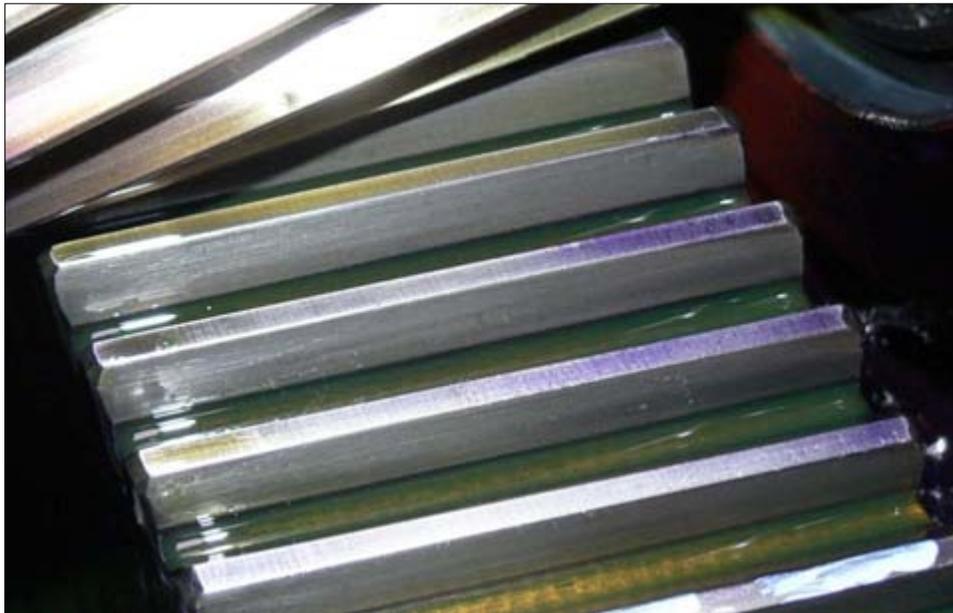
**Figure 4.17. Involute HS gear at the end of test; no wear is readily visible (235 hours at 200% load; 528 hours at 240% load)**

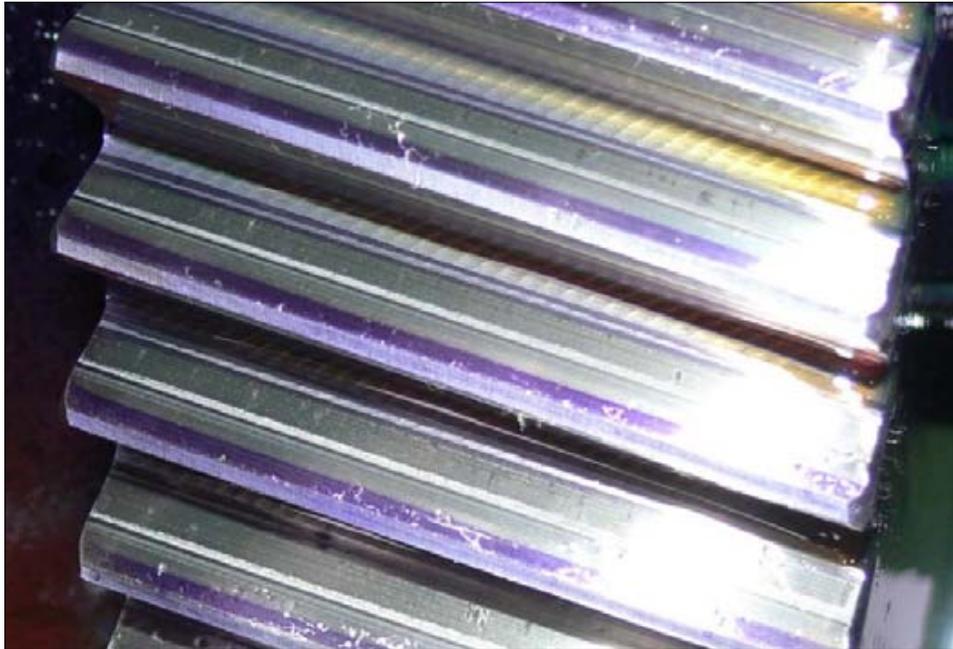
**Figure 4.18. Convolid HS gear at the end of test; some wear due to micropitting is visible on the dedendum side of the transition zone; a large section of the addendum still shows marking dye—indicating too much tip relief in the profile (235 hours at 200% load; 528 hours at 240% load)**

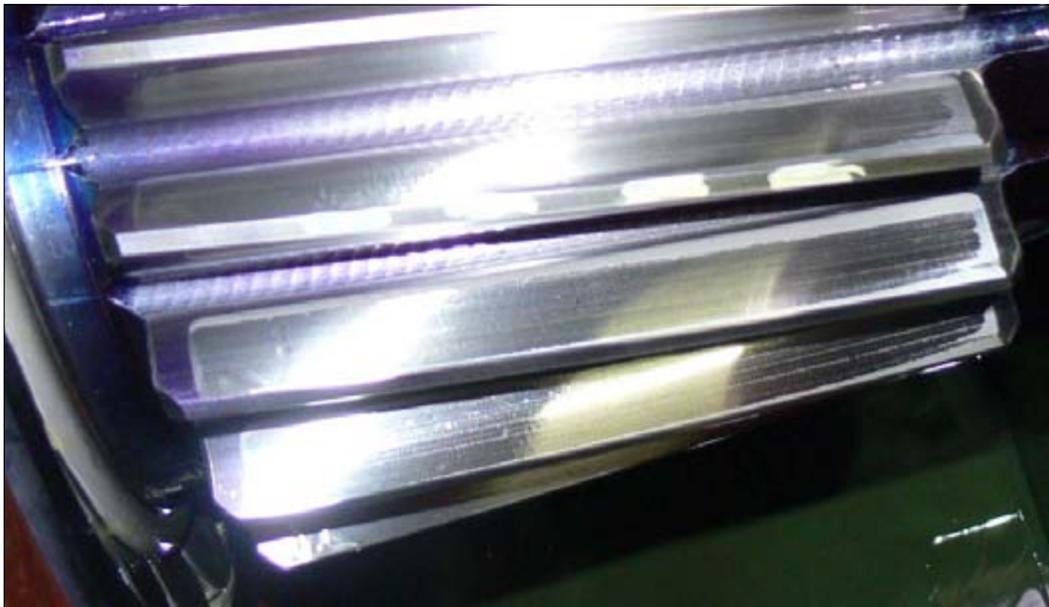
**Figure 4.19. Involute LS pinion at the end of test; similar to the HS pinion, micropitting wear is concentrated along one side and in the dedendum (235 hours at 200% load; 528 hours at 240% load)**

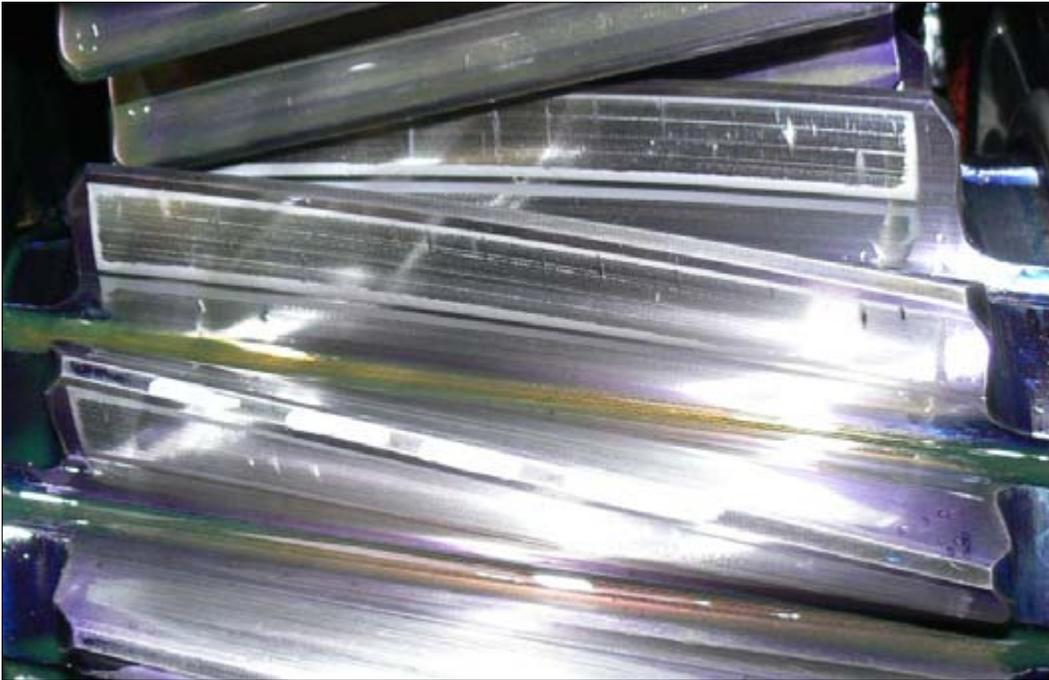
**Figure 4.20. Convolid LS pinion at the end of test; wear due to micropitting brackets the operating surface, except for in the dedendum due to proper tip relief on the mating gear (235 hours at 200% load; 528 hours at 240% load)**

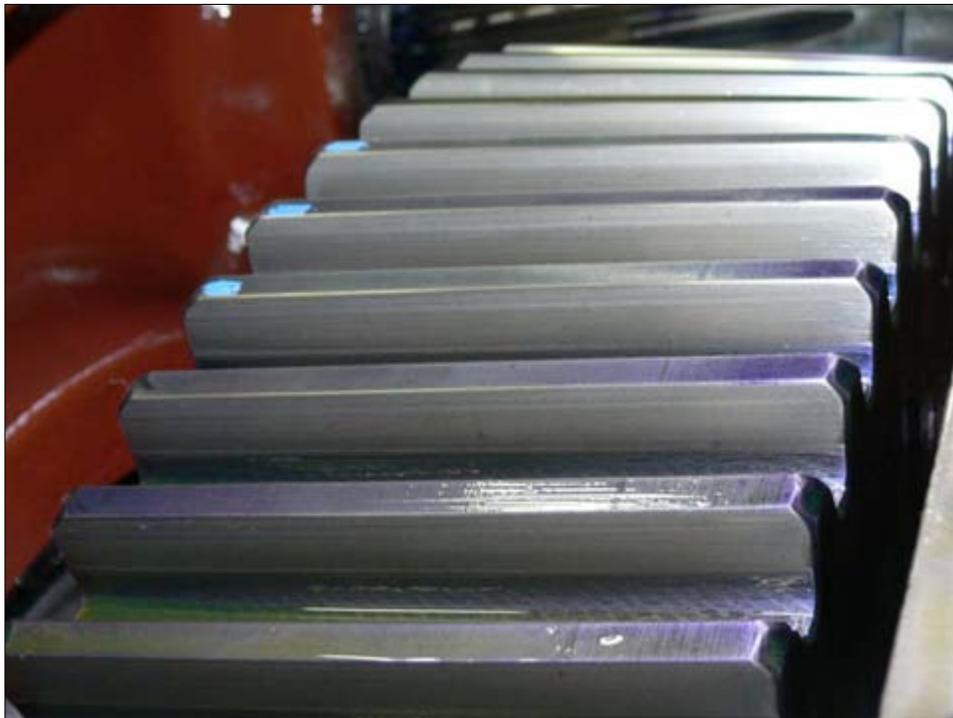
**Figure 4.21. Involute LS gear at the end of test; no wear is visible (235 hours at 200% load; 528 hours at 240% load)**

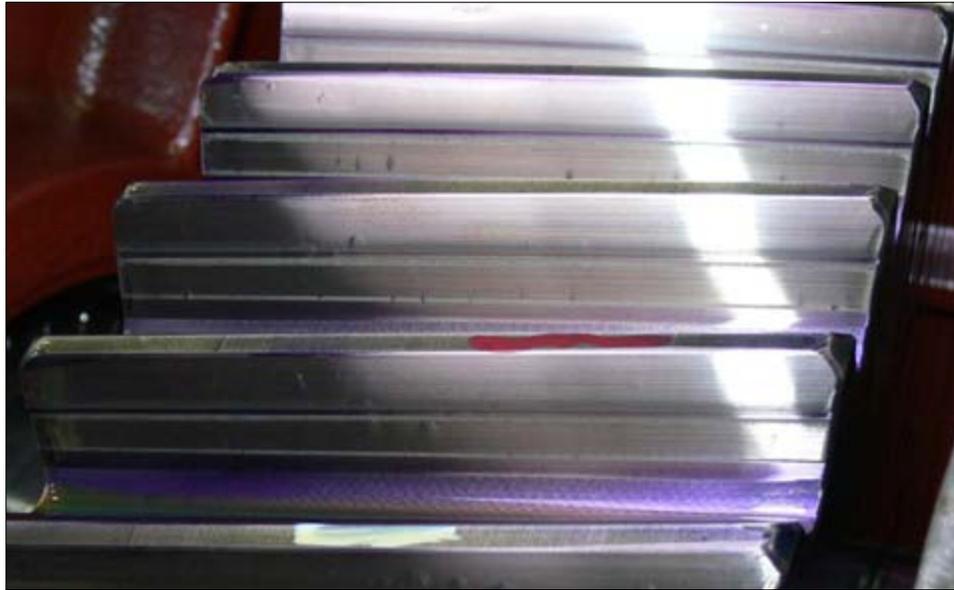
**Figure 4.22. Convolid LS gear at the end of test; slight wear due to micropitting is visible in the dedendum (235 hours at 200% load; 528 hours at 240% load)**

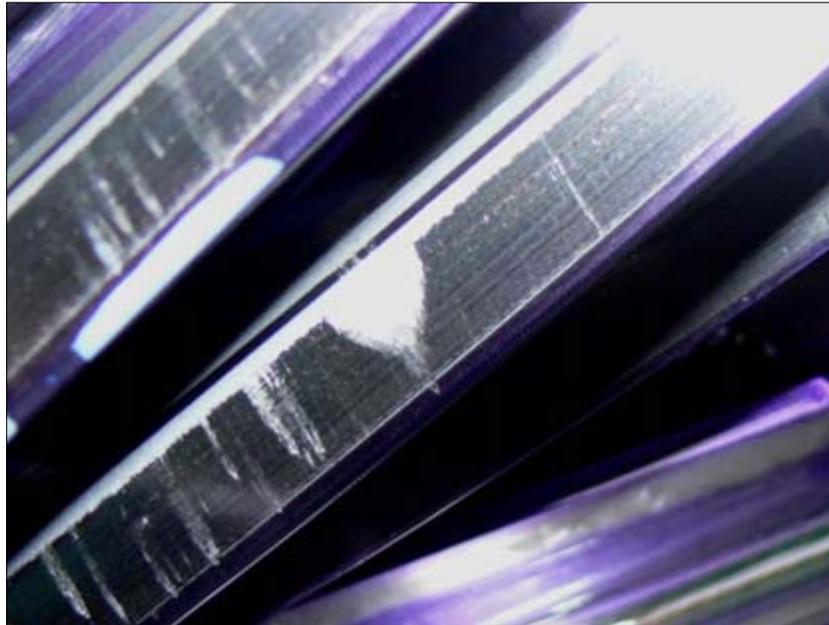
**Figure 4.23. Close-up of oil-debris damage on the Convold HS pinion; this mark began to fade at the next inspection (91.2 hours at 200% load)**

The presence of “smears” on the active surface of the gear teeth (easily visible in Figure 4.23) indicates that some small particles went through the mesh. No damage could be felt due to these marks, and old marks tended to fade as the test progressed. Oil flowed through the heat exchangers after the moving through filters, therefore it is thought that particles flushed from the exchangers could have caused the marks. These particles would have been soft aluminum, which would explain the lack of damage to the tooth surface. Any particles also would have caused variations in the orifice valves feeding the bearings.

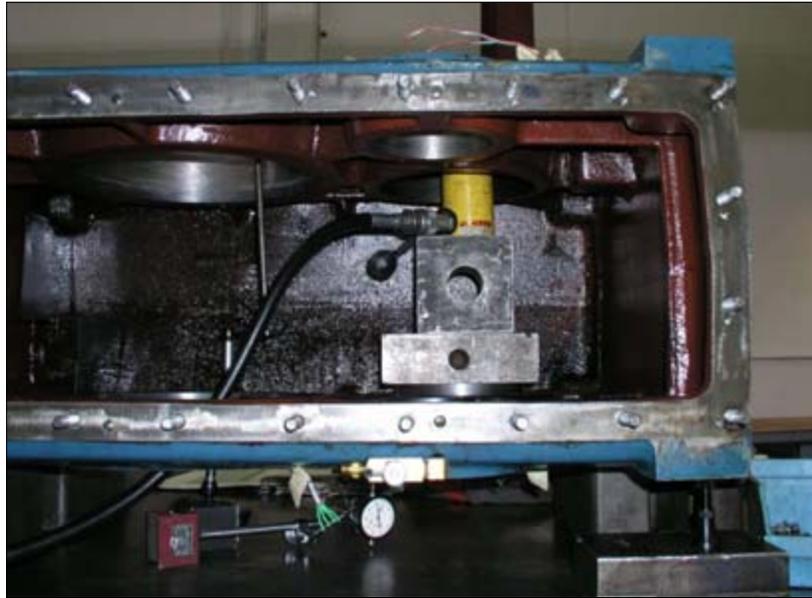
Mr. Richard L. Meredith (DC Energy) set up one of the test gearbox housings with a hydraulic ram inside to measure deflection based upon an applied load (Figure 4.24). A dial indicator was used for measurement. After the equipment was installed, the housing cover was assembled to the gearbox as was done with the test (i.e., with a bolted connection and all four taper pins installed). Application of hydraulic pressure created a force that is trying to separate, or spread the housing. At the nominal rated load (108 kW) the deflection due to the resultant gear thrust forces (~3,525 lb thrust load) was approximately 0.0055 in. As the load was increased to the new design load, deflection increased to approximately 0.017 in.

**Figure 4.24. Housing stiffness test configuration**

These values greatly exceeded expected values and negated any bearing selection that can employ opposed roller bearings for the intermediate shaft. Instead, a double-row bearing design was developed. For this type of configuration, a double-row tapered roller bearing is employed on one end of a shaft and a cylindrical roller bearing is used at the other end. The tapered roller bearing resists all gearing thrust forces, allowing the cylindrical roller bearing to carry only radial load. A similar arrangement is intended for the high speed bearings. Investigation into limitations of the low speed cylindrical bearings found that the existing bearings are sufficient to properly support expected loads.

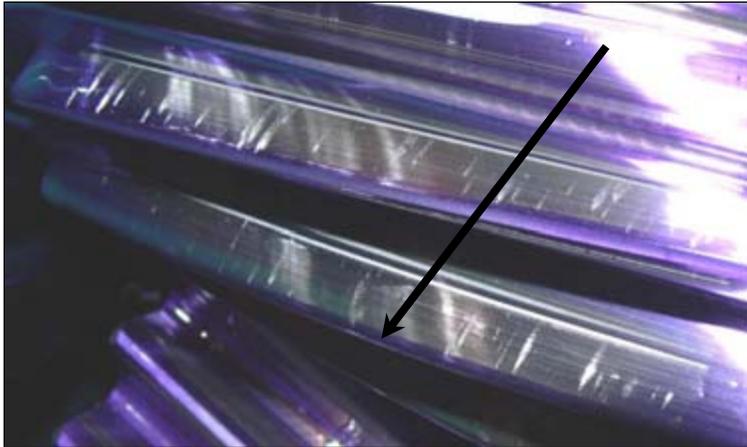
Inspection of the Convoloid high speed pinion allows for a good discussion on tip relief. Figure 4.25 shows the pinion after 154 hours operation at 77% of rated load. A little bluing is visible at the tooth tips (probably due to the chamfer) and on each end (due to crowning), but contact appears smooth at the tip with no signs of wear. When the load was increased to 200%, slight wear appears at the tip (Figure 4.26). A further increase to 240% reveals distinct tip wear (Figure 4.27). It therefore appears that the applied tip relief could be appropriate for the light load, but it is not enough for a heavier loading.

**Figure 4.25. Convoloid HS pinion (77% load, 154 hours)**

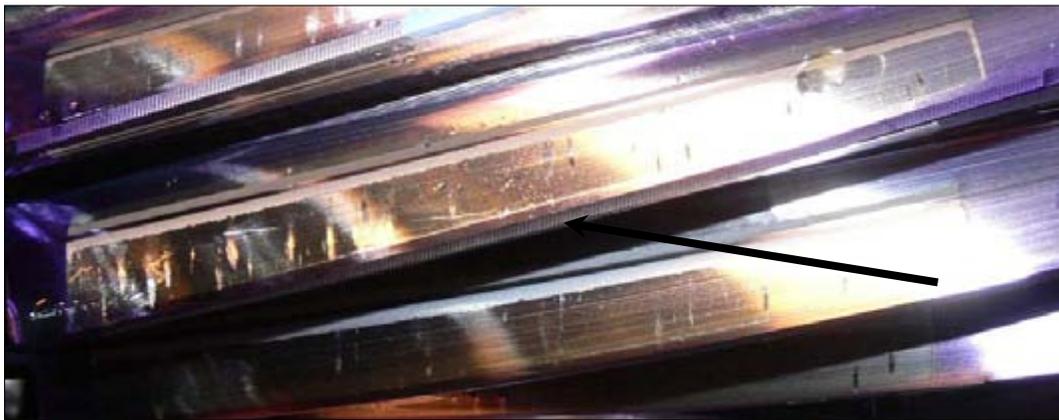
**Figure 4.26. Convoloid HS pinion (200% load, 235 hours)**

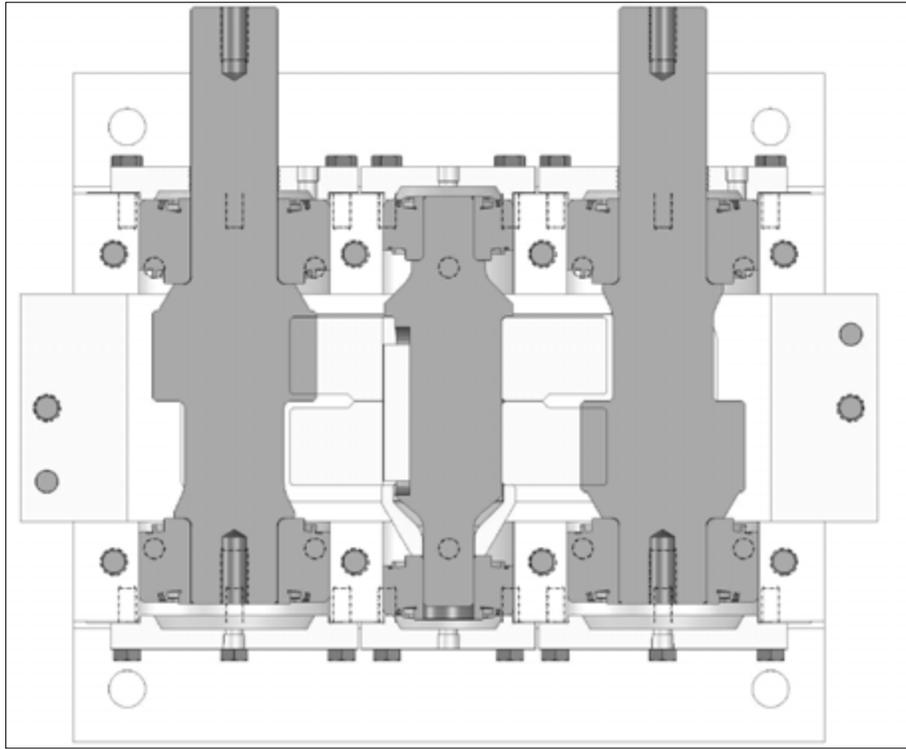
**Figure 6.2. Section view of revised gearbox design**

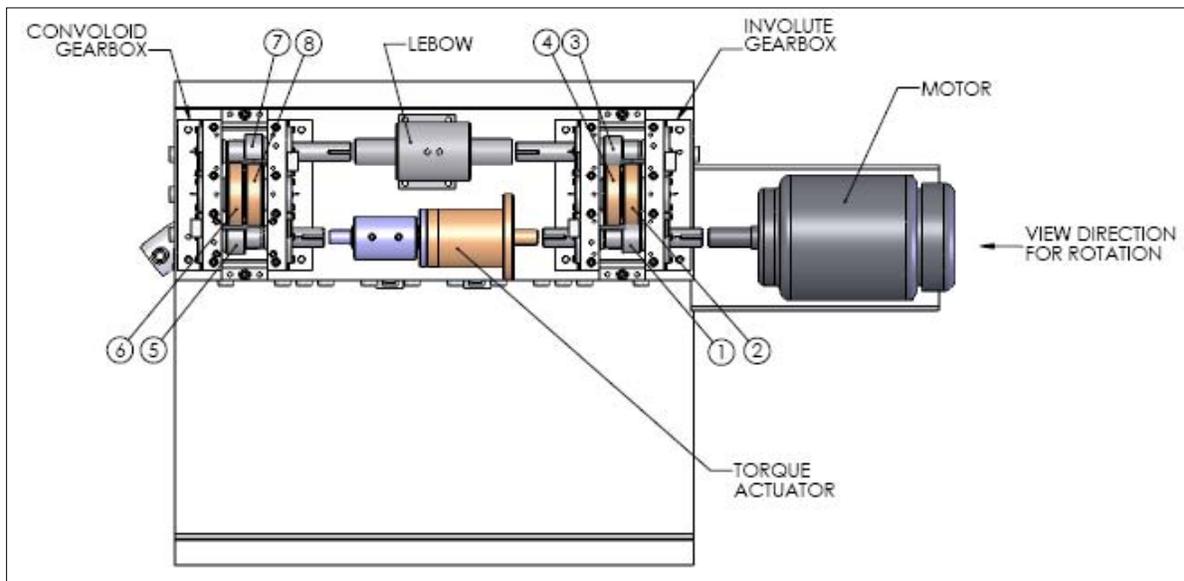
**Figure 6.4. Top view of the 3-Hole Test fixture configuration**

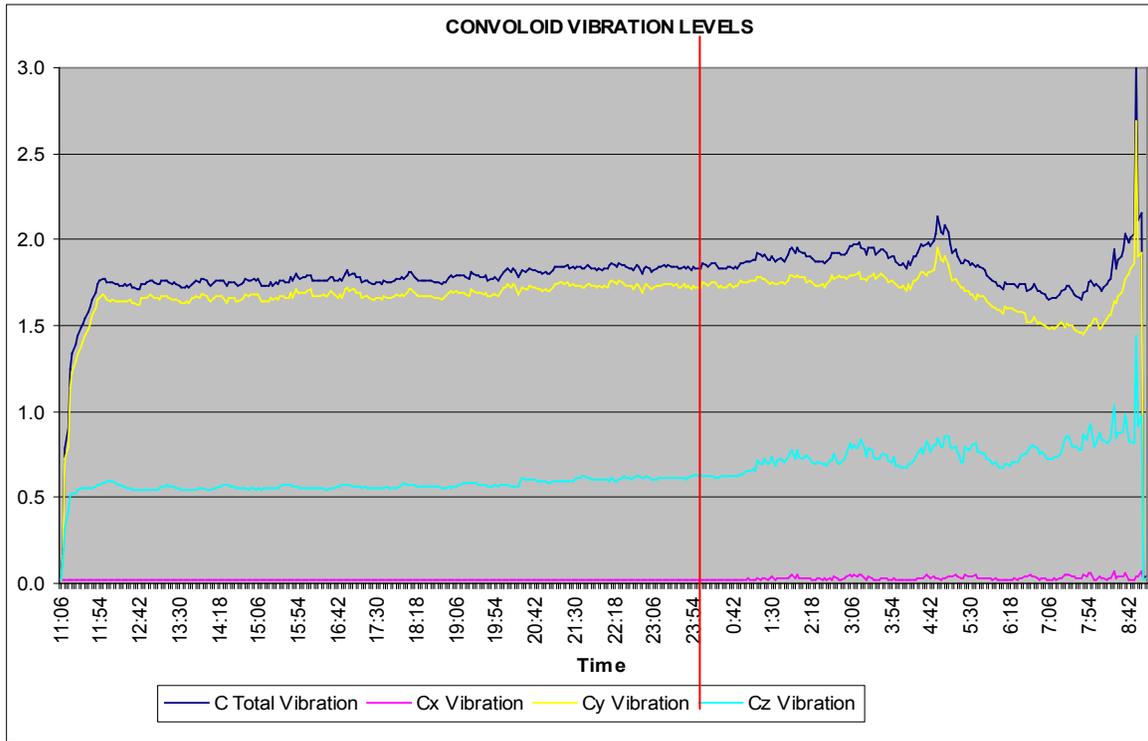
**Figure 6.5. Micon 108 vibration levels at time of bearing failure**

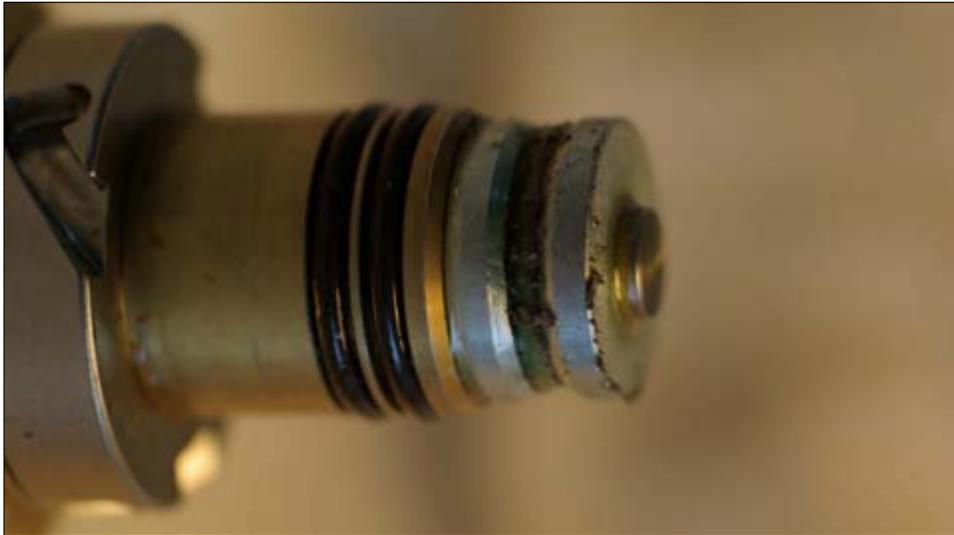
**Figure 6.6. One of the chip detectors after a surface fatigue failure**

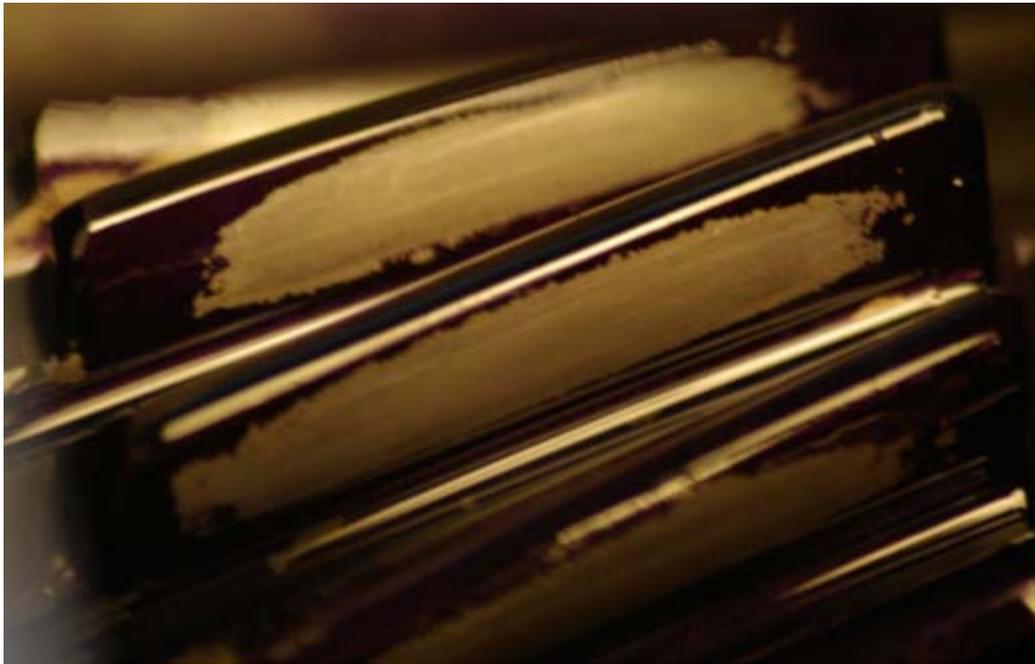
Manufacturing of the gearbox housings, the involute gearing, and the Convoloid gear blanks was accomplished with no problems. Twist correction protocols are inherent in most gear tooth grinding machine software, and depend on basic involute data to effect the necessary machine/wheel movements to mitigate twist. Convoloid forms, being non-involute, do not respond as well to these twist correction inputs as do involute tooth forms. Verification of the tooth contact was used to apply slight machine profile corrections resulting in good no-load contact. Upon installation of the gear in the test gearbox, and painting it with machining dye, the light-load contact patterns were confirmed (Figure 6.7, Figure 6.8).

**Figure 6.7. Representative involute no-load contact**

In the ideal case, a no-load contact shows marking centered on the tooth flank, and the edges of the marking gradually “feather away” leaving no hard edges. For the Convoloid gearing, there should be an empty area in the center of the flank around the transition zone with contact above and below—again with feathered edges. The original Micon-108 test had very hard contact around the transition zone. It was in this area that micropitting appeared very early in the test and at a relatively low load.

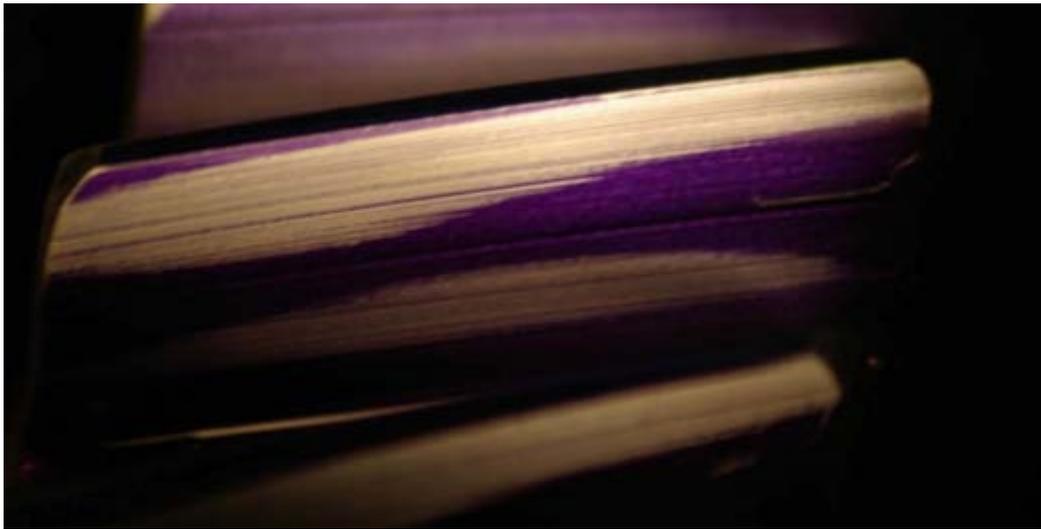
**Figure 6.8. Convoloid no-load contact**

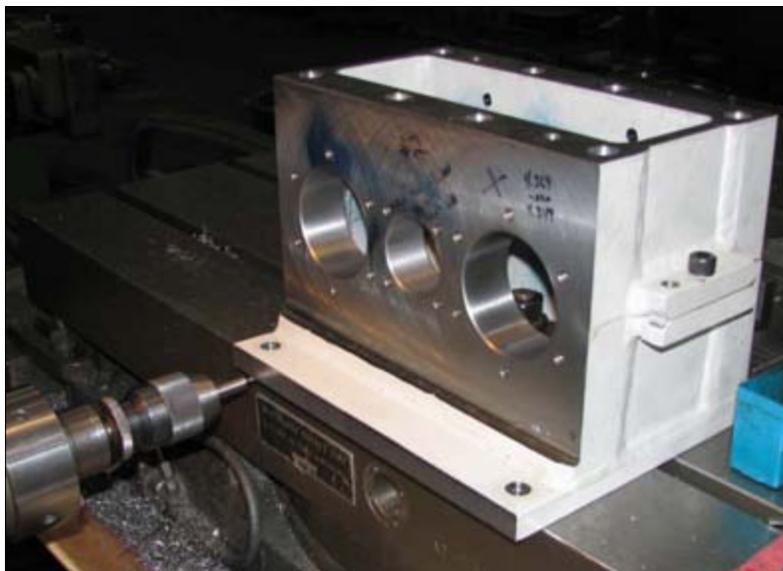
Manufacture of the gearbox housings was straightforward. The design consisted of fabricated steel upper and lower housing halves to provide exceptional bearing support. The housings (Figure 6.9) were stress relieved to prevent any unexpected distortions during testing. The two halves were pinned and bolted prior to final machining to assure bearing alignment. Housing stiffness for this test is much higher than in the previous test. In contrast to the one-piece housings for the Micon-108 test, these split housings allow easy replacement of gearbox components (Figure 6.10).

**Figure 6.9. The 3-Hole Test gearbox during final machining**

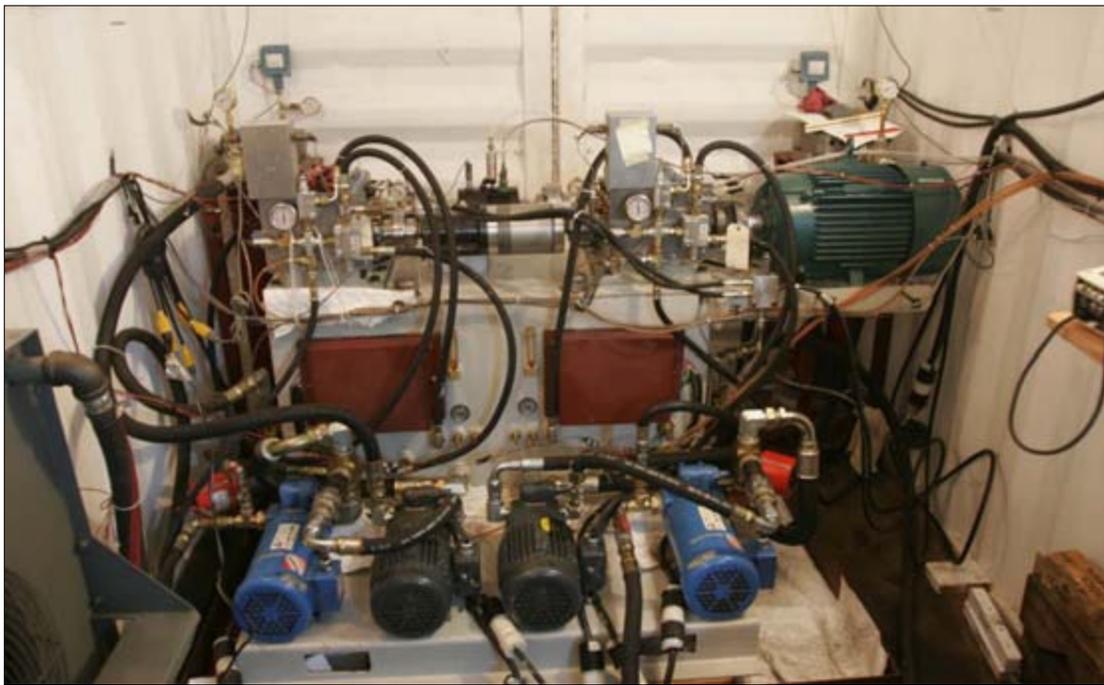
Figure 6.11. The 3-Hole Test fixture

The test fixture (Figure 6.11) consists of the two test gearboxes, the main test fixture (with drive motor, Lebow torque transducer, rotary torque actuator, and lubricating pumps), electrical control assembly, and the computer control.

The test fixture base was designed to hold all the oil for the test in separate baffled reservoirs. It was necessary to have a separate lubrication system for each gearbox to prevent cross-contamination between the gearboxes. Two separate pumps were fitted for each system—one for circulating oil taken from the reservoir through the heat exchanger and heater; and, one for supplying filtered oil to the oil manifold for distribution to each bearing and to both sides of both gear meshes. A detailed discussion of the test fixture configuration and shakedown is included in Appendix A.

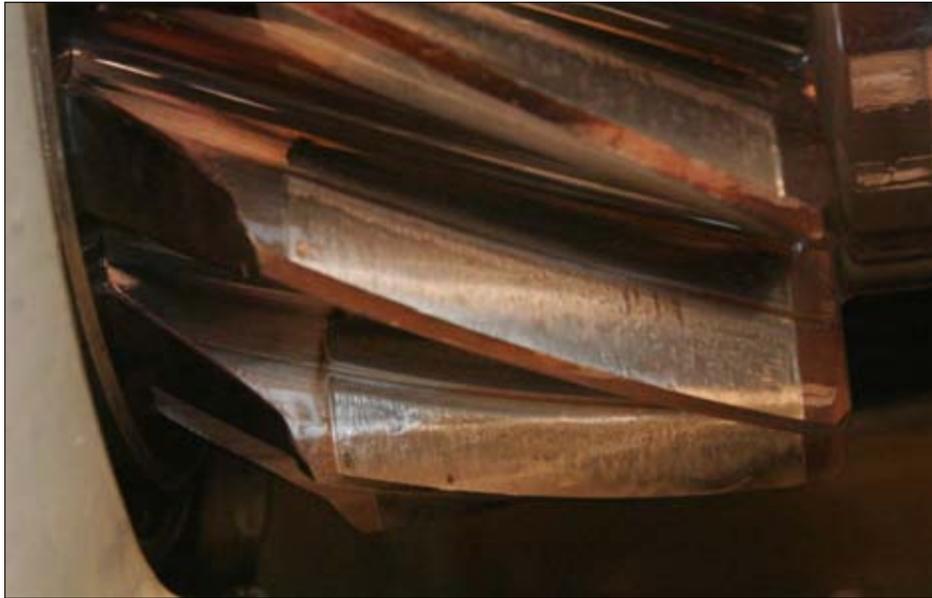
**Figure 7.1. Severe scuffing failure due to loss of lubricant**

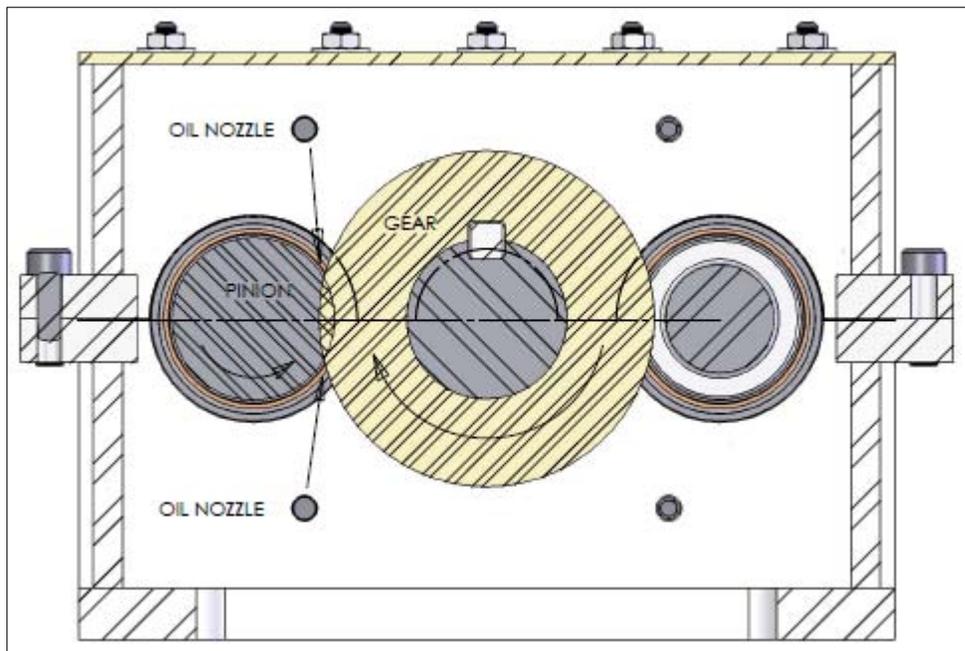
**Figure 7.2. Cutaway of the 3-hole gearbox showing the gear mesh lubricating method**

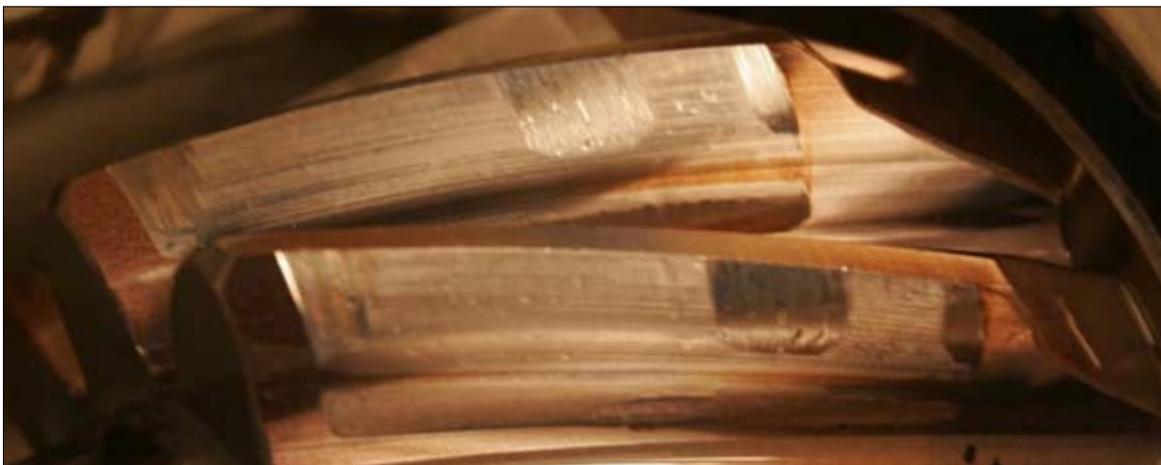
**Figure 7.3. Close-up of Convolid gear tooth with no micropitting and partial scuffing damage due to loss of lubrication**
