# Low Wind Speed Turbine Developments in Convoloid Gearing

Final Technical Report  
June 2005 – October 2008

*Genesis Partners, LP  
Montgomeryville, Pennsylvania*

**Subcontract Report**  
NREL/SR-500-45103  
August 2010

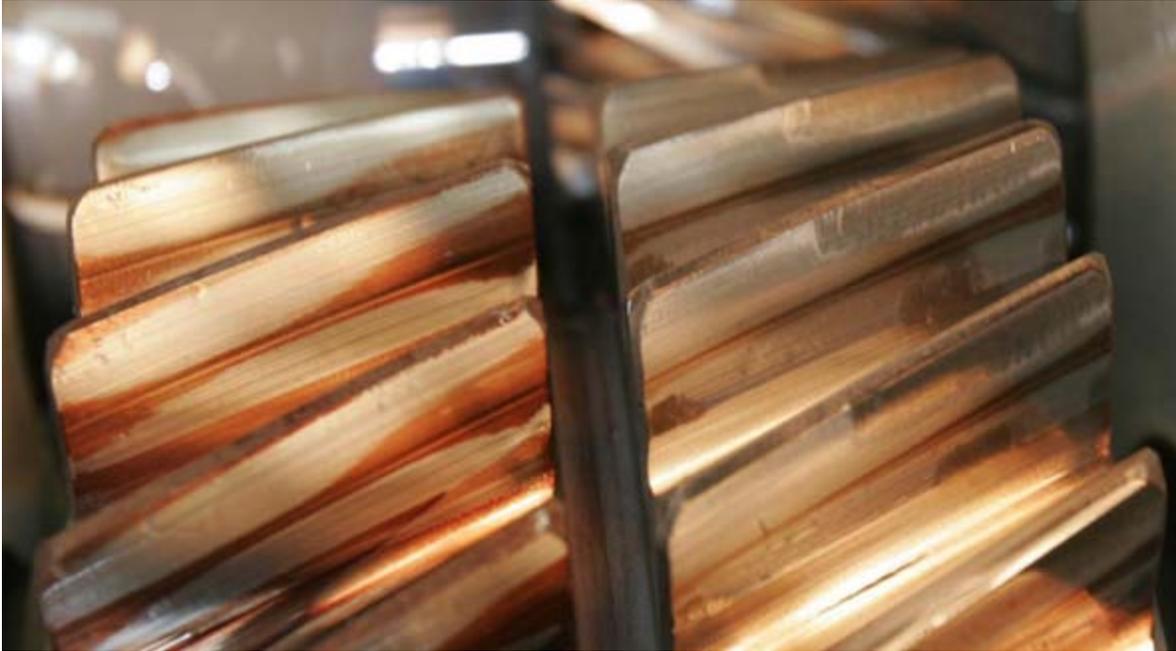
**Figure 7.4, Convoloid gearing showing some scuffing and discolored marking dye; the left gear was not loaded**

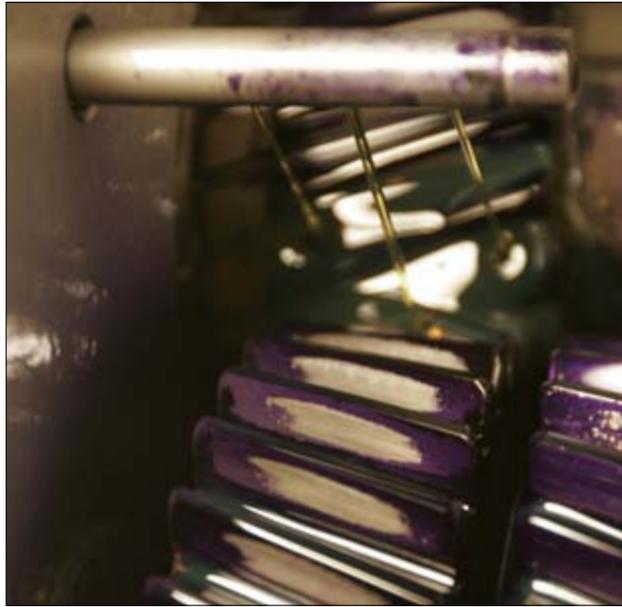
**Figure 7.5. No-load contact pattern—involute gear; lube nozzle**

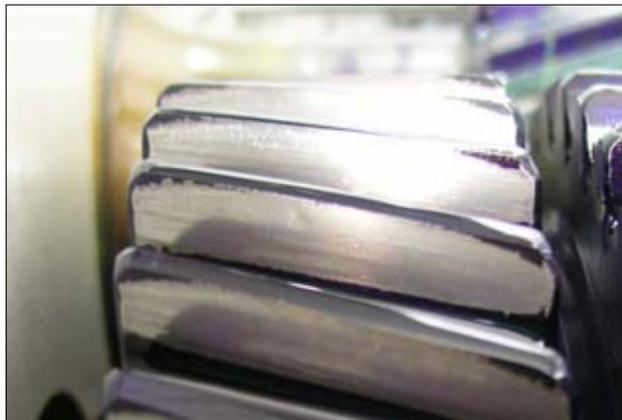
As with previous testing, the no-load and full-load contact between all gearing were documented to verify proper gear mesh (Figure 7.5, Figure 7.6). The slight presence of marking dye at the corners and in the root and tip indicate that there is no hard contact in the tooth mesh that would lead to premature wear.

**Figure 7.6. Example of the full load (7,000 lb-in) contact—involute gears**

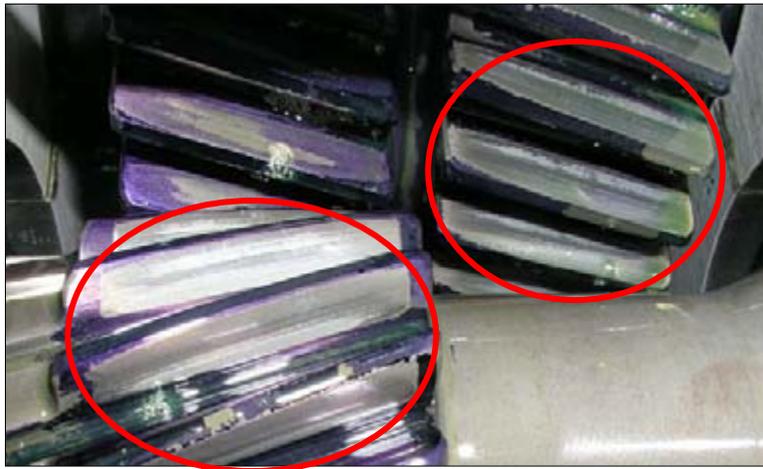
**Figure 7.7. Involute gearing showing early micropitting; both parts (circled) drive their respective mates**

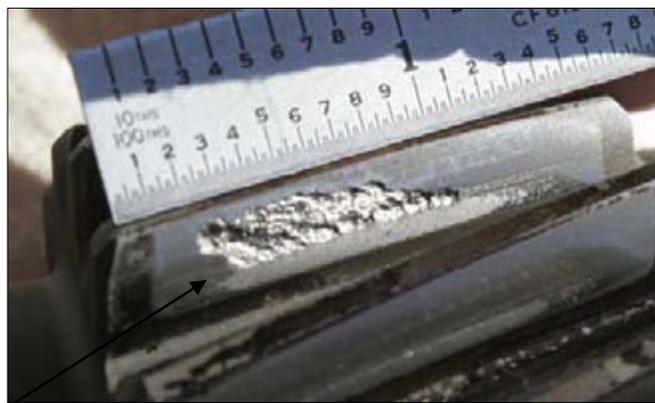
Only a summary of the surface fatigue failures appears here, a detailed discussion appears in Appendix A. After 86 hours of operation (Test 3) a significant amount of vibration was noted, prompting shutdown of the test fixture. Upon inspection, pinion 1 in gearbox 2 was found to have significant macropitting (see Figure 7.8 through Figure 7.10). The origin of the pitting appears to fall at the pitch line of the tooth flank, which is consistent with the area of highest calculated stresses for involute gearing. This pinion was operated as a reducer—the pinion drives the gear. Note that there is frosting, or micropitting, in the dedendum (near the tooth root) of the tooth flank. In some cases, this phenomenon has been thought to precipitate a macropitting failure, at the pitch line where the macropitting originated no micropitting is present. The macropitting therefore can be considered a classic fatigue failure of the type expected in this test. It is important to note that only 10 hours of operation occurred between inspections. There was no hint of damage prior to the high vibration level (manually monitored at that time) that prompted cessation of the test.

**Figure 7.8. Massive macropitting on pinion tooth flank (Test 3, gearbox 2, pinion 1)**

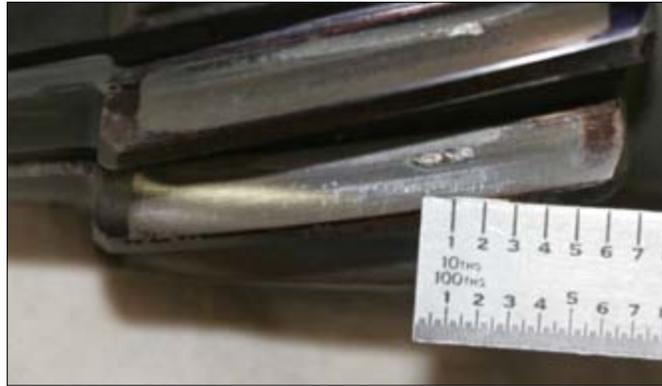
**Figure 7.9. Additional pitting**

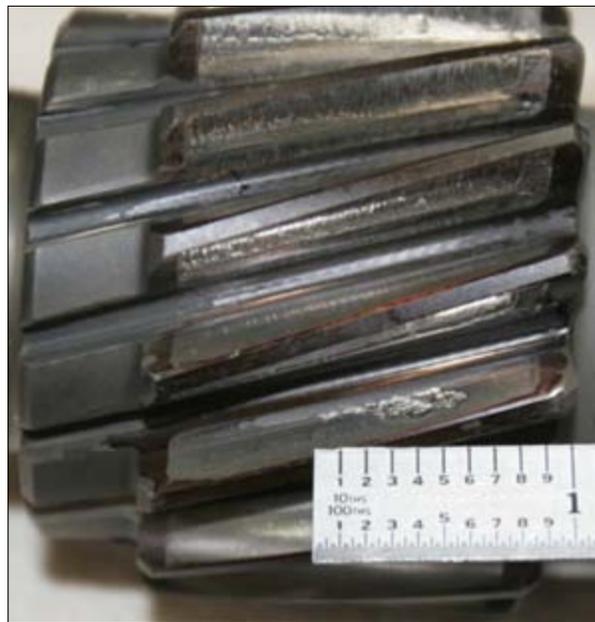
**Figure 7.10. Further pitting and opposite flank scuffing damage from Test 2**

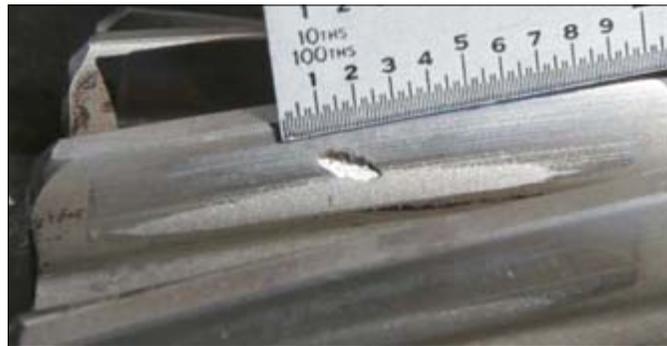
Test 4 was terminated after 18 hours due to another surface fatigue failure. Figure 7.11 and Figure 7.12 show the failure—again, a pinion operated as a speed reducer, this time in gearbox 1. Here the surface damage was found during a routine inspection. The amount of damage is indicative of the definition of failure. The total test time for this pinion was 104 hours, or 13.7 million cycles.

**Figure 7.11. Failed involute pinion from Test 4**

During testing, it appears that there is a difference due to the type of action. Both of the failed pinions were loaded as speed reducers (for example, the pinion drives the gear) and there was extensive micropitting in the dedendum of the tooth flanks. The other pinion, which was located in the same gearbox, operated for the same number of load cycles as the failed pinion in Test 4, and was loaded as a speed increaser (Figure 7.13), shows much less wear on the active flank.

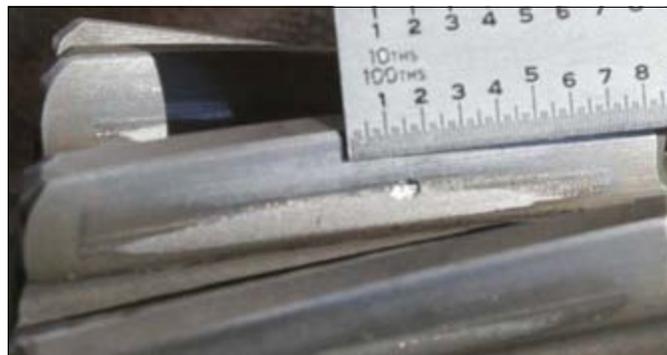
**Figure 7.12. Pinion loaded as a speed reducer**

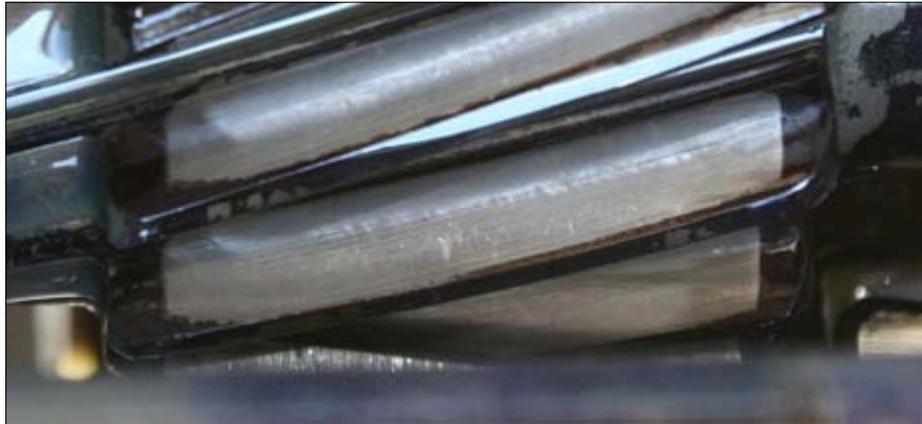
**Figure 7.13. The other pinion in the same gearbox loaded as a speed increaser and showing minimal wear**

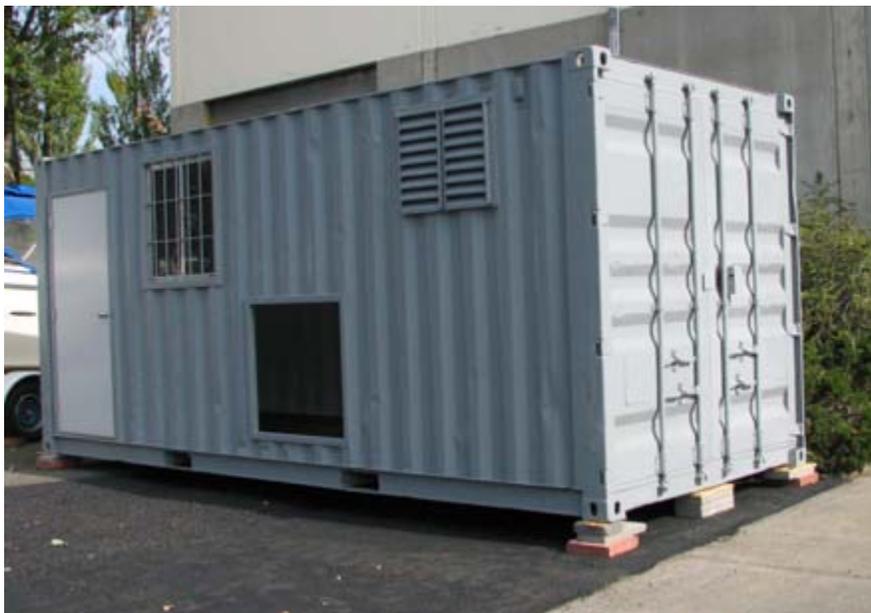
To free up manufacturing space, it was necessary to move testing outside of the original facility. Instead of locating the test in a fixed place, all equipment was fit into a 20-ft long shipping container (Figure A.1). Recently refurbished and customized with a man-door, window, heat exchanger openings (center

bottom), and air-intake vents, this enclosure allowed the entire testing fixture to be set into place through the large end doors. All power and controls are enclosed and all that is necessary for testing is to connect power (460 v, 3-phase), air, and telephone/DSL.

**Figure A.1. Test fixture enclosure**

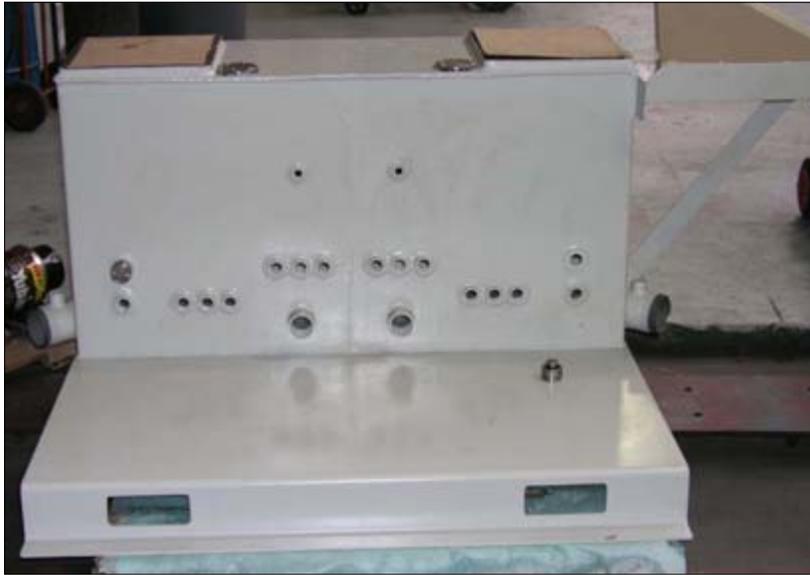
Manufacture of the test fixture was straightforward. The test fixture (Figure A.2) was covered with epoxy-based paint inside. If testing must occur with synthetic oil, multiple fittings designed into the fixture allow ready access for instrumentation and oil flow. Not shown in the figure are the internal baffles or the lubricant deflection funnels used to direct oil falling out of the test gearboxes past the chip detectors.

During assembly of the gearboxes to the test fixture, it was found that the mounting surface of the fixture had deformed when the top was welded to the tank. The resulting gaps were sufficient that oil would leak from between the gearbox and the surface. Additionally, potential harmful stresses could be applied to the gearbox housings (and subsequently to the bearings) if the mounting bolts are tightened beyond recommended torque values. Therefore, components were removed from the fixture and the mounting surface was milled. Subsequent assembly showed a much improved fit. All electrical relays and primary controls were contained in one enclosure (Figure A.2; Figure A.3).

**Figure A.2. The 3-Hole Test fixture after paint and initial top milling**

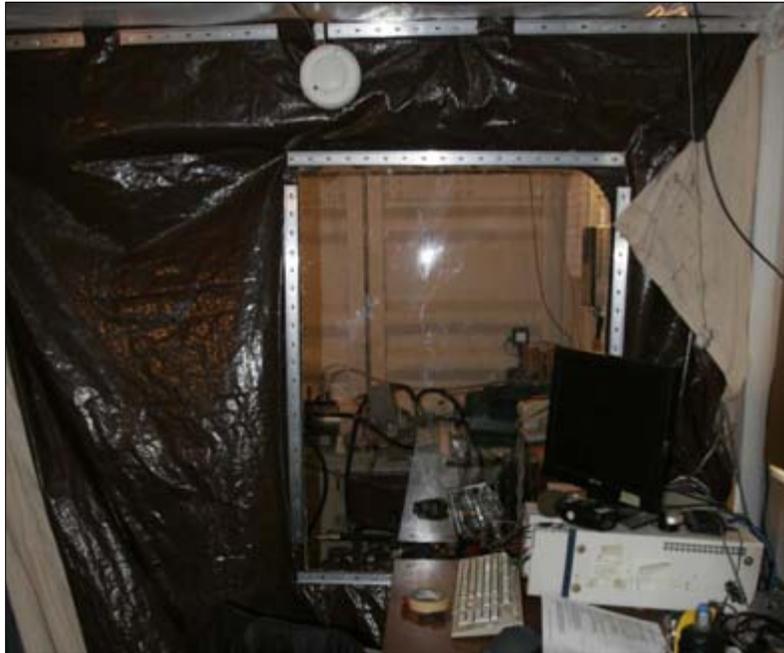
The computer control-system equipment was the same as used with the Micon 108 test, with a few additional control points—specifically, torque control and fire alarms sensors (*see* Figure A.5). After initial operation, temperatures were excessive around the computer equipment, requiring the installation of an air conditioner unit and separation of the test rig from the computers. The insulated barrier includes a polycarbonate window for visual monitoring of the test.

**Figure A.5. View inside the test container showing the computer monitoring system and polycarbonate view window**

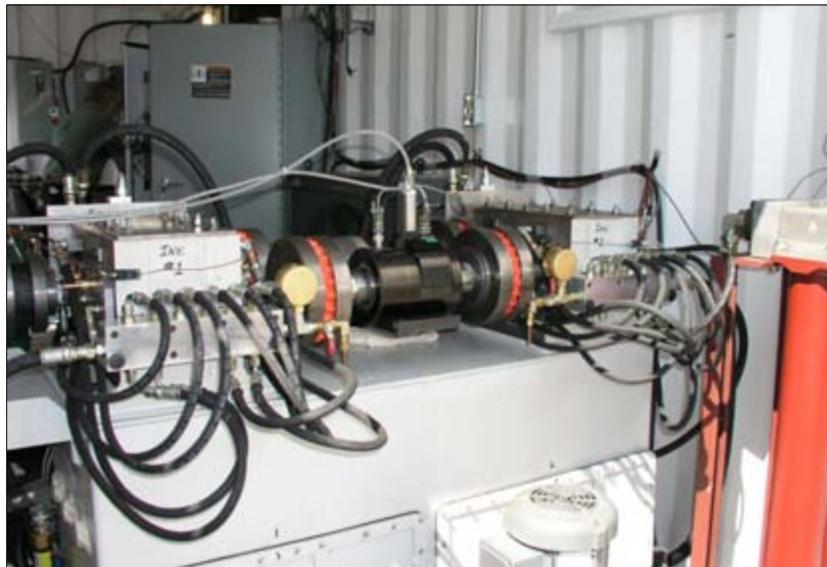
After all the components were in place (Figure A.6), preliminary operation at modest speeds resulted in excessive vibrations that could be felt in the floor of the test container. The cause originally pointed to a bent shaft in the torque actuator. After repairs, however, significant vibrations still were evident. A number of couplings then were found to have severe run-out. Subsequent repairs—including adding machined alignment sleeves over the couplings—did not correct the vibration.

**Figure A.6. Initial assembly of 3-Hole Test fixture**

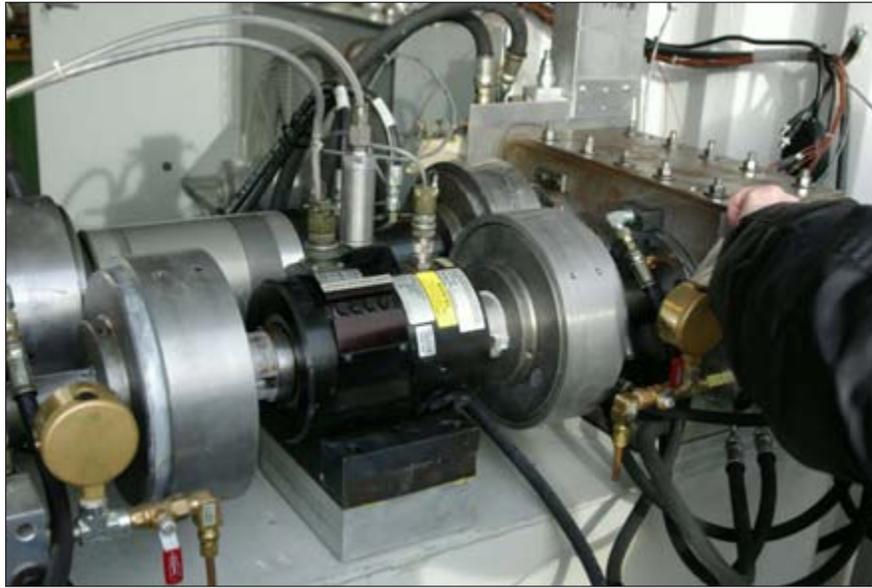
Further investigation revealed that the chosen couplings were not able to self-center due to the weight being carried between the two gearboxes (Lebow torque transducer on one shaft pair and the torque actuator between the other). Additionally, because both couplings on a given shaft (e.g., on either side of the Lebow) were flexible, a dynamically indeterminate load arrangement occurred causing the components in the middle to vibrate. (See Figure A.7.)

**Figure A.7. The 3-Hole Test fixture showing couplings with alignment covers**

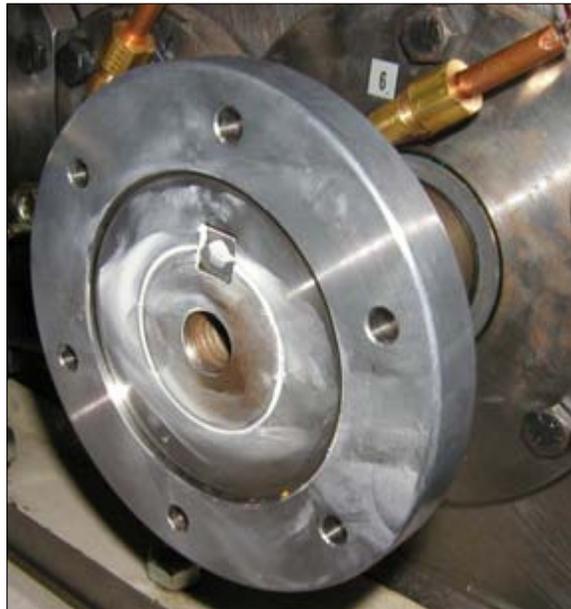
The vibration issue finally was solved by using different couplings with a rigid-flexible arrangement. This type of coupling reduces a degree of freedom, thereby better locating the coupled equipment (Figure A8, Figure A.9). Installation involves bolting the two halves together. With the bolt clearances, however, out-of-balance vibrations again were felt. Careful installation using a dial indicator to center the bolted connections resulted in very smooth operation.

**Figure A.8. Fixed half of new coupling**

Installation of rigid-flexible type couplings in place of the previous coupling design resulted in greatly improved operation. No vibration from the actuator side was evident and light vibration was felt in the torque transducer side. Efforts to balance the system, however, were not fruitful. Investigation revealed that the internal bore was not perpendicular and was not centered in one of the coupling hubs, causing the transducer assembly to oscillate. To allow vibration monitoring (necessary for unattended operation) this coupling part required correction. Although the vibration precluded unattended operation, shakedown of the fixture continued. A certain amount of torque was desired to test the system instrumentation, therefore it was thought that a reasonable amount hydraulic pressure could be applied to the torque actuator (approximated to be 25% of the operational torque). After a period, some electronic verification was possible and it was determined that the actual load was nearer 45%.

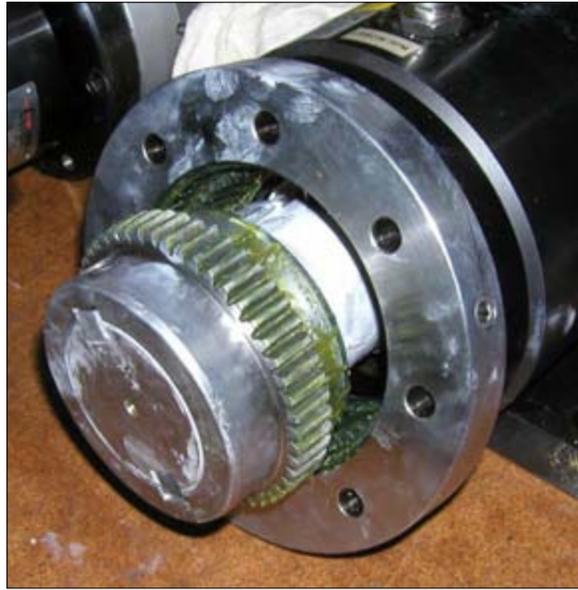
**Figure A.9. Flexible half of new coupling**

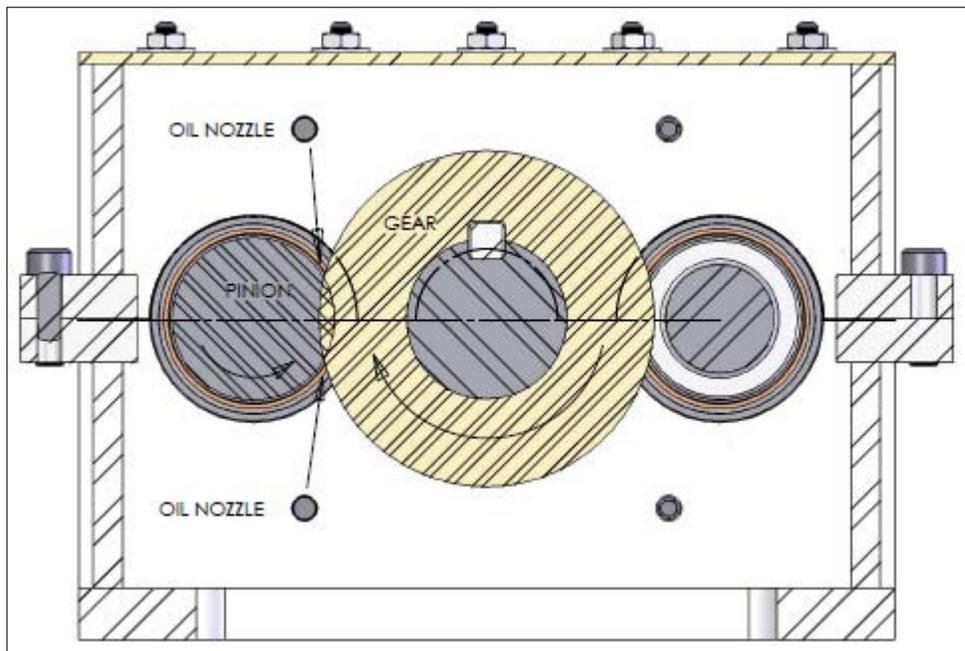
**Figure A.10. Cutaway of the 3-hole gearbox showing the gear mesh lubricating method**

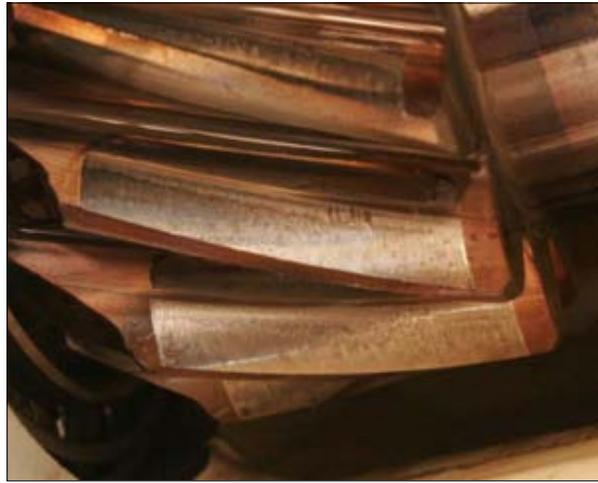
When the cap was being removed, the adjusting set-screw stuck to the cap and, inadvertently, it also was being removed. At some point, the pressure fell enough that no oil was being fed to the gear meshes. The fact that the set screw was being removed was not realized until it fell out of the pump housing—which caused 160°F oil to flow out of the machine. The machinery was shut down immediately and the pump was repaired. Inspection of the gear meshes, however, revealed extensive scuffing (welding and tearing of the loaded tooth flank) (Figure A.11; Figure A.12).

**Figure A.11. Severe scuffing on the Convoloid pinions due to loss of lubricant**

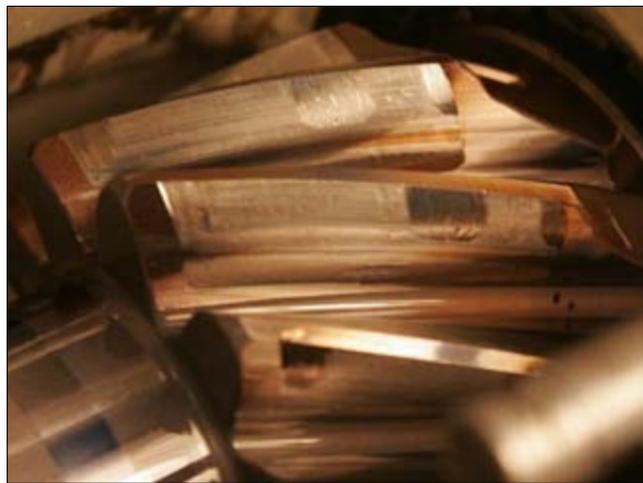
**Figure A.12. Severe scuffing on the Convoloid pinions due to loss of lubricant**

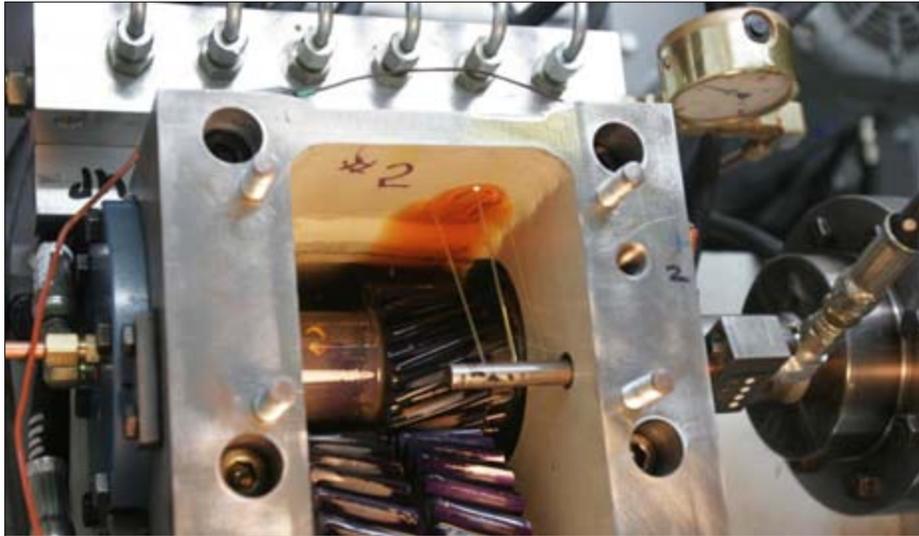
**Figure A.13. The 3-Hole Test gear mesh oil nozzles with proper oil pressure (rotated to show flow)**

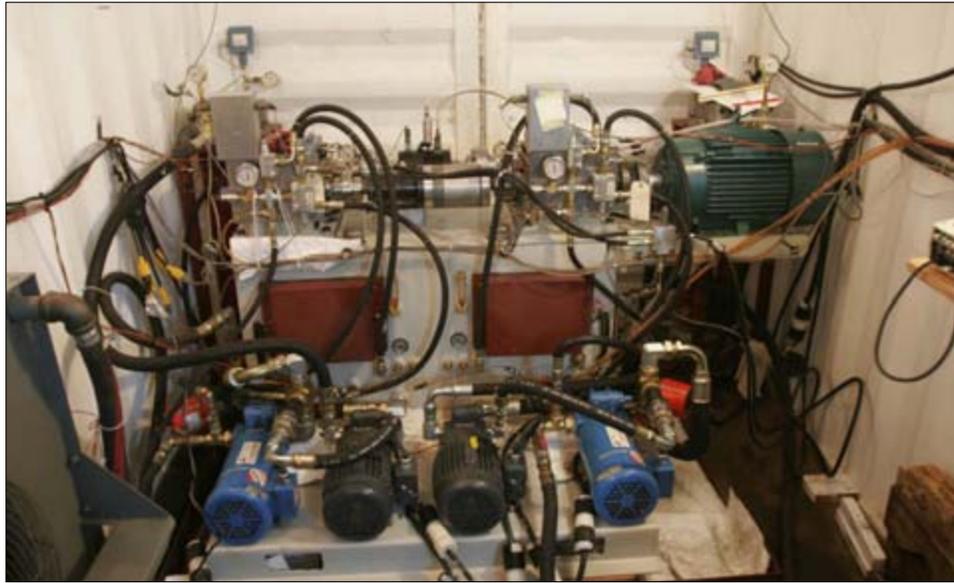
**Figure A.14. Operational configuration of the 3-Hole Test fixture**

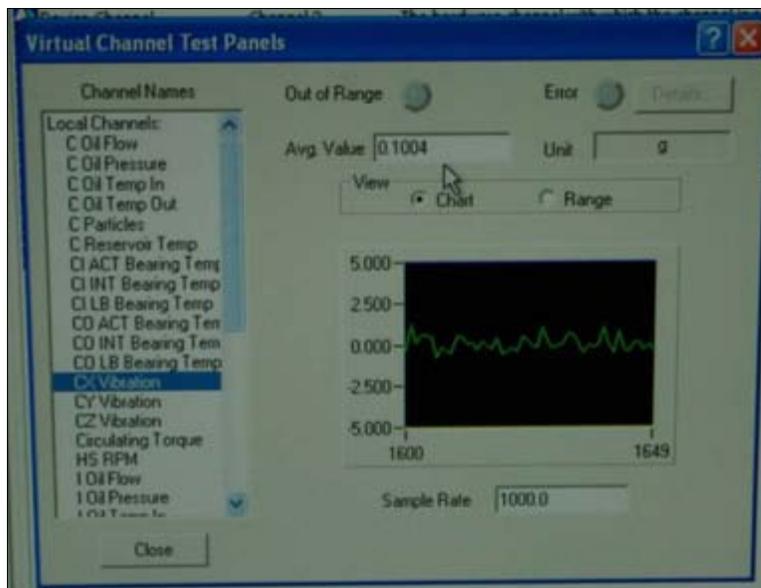
**Figure A.15. Sample of the monitoring software page (vibration shown)**

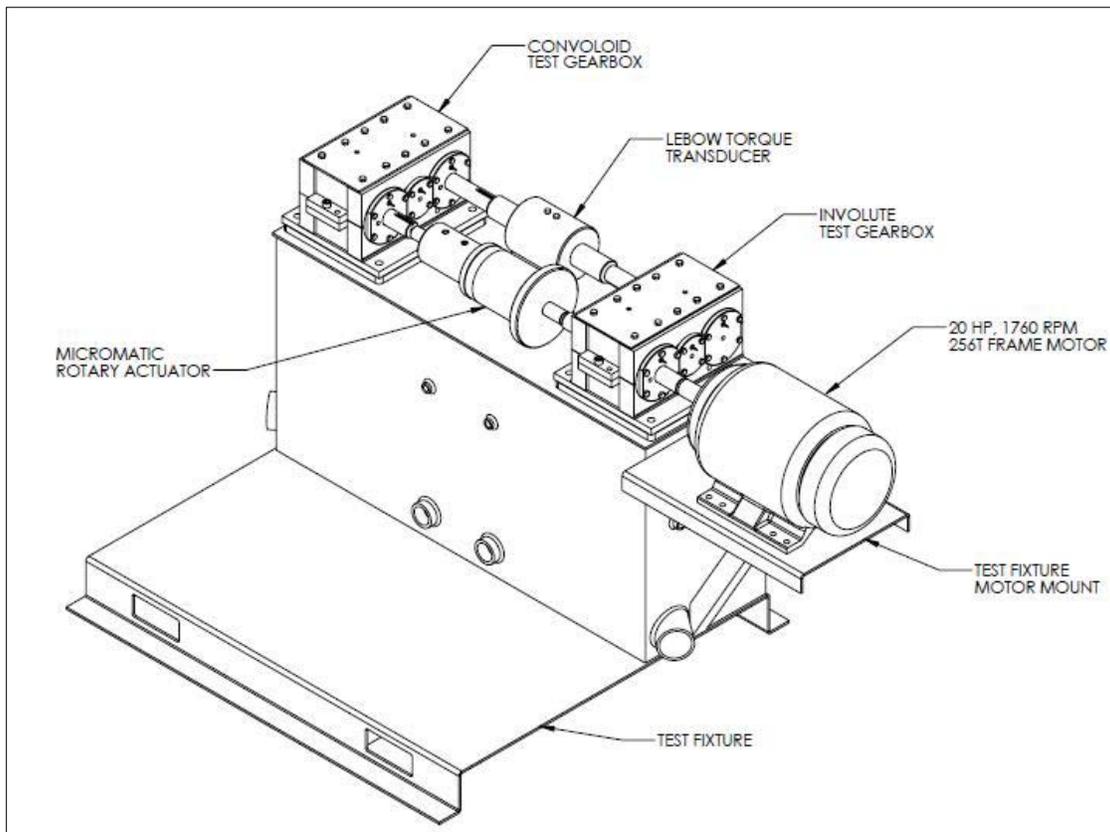
**Figure A.17. Basic layout of the 3-Hole Test**

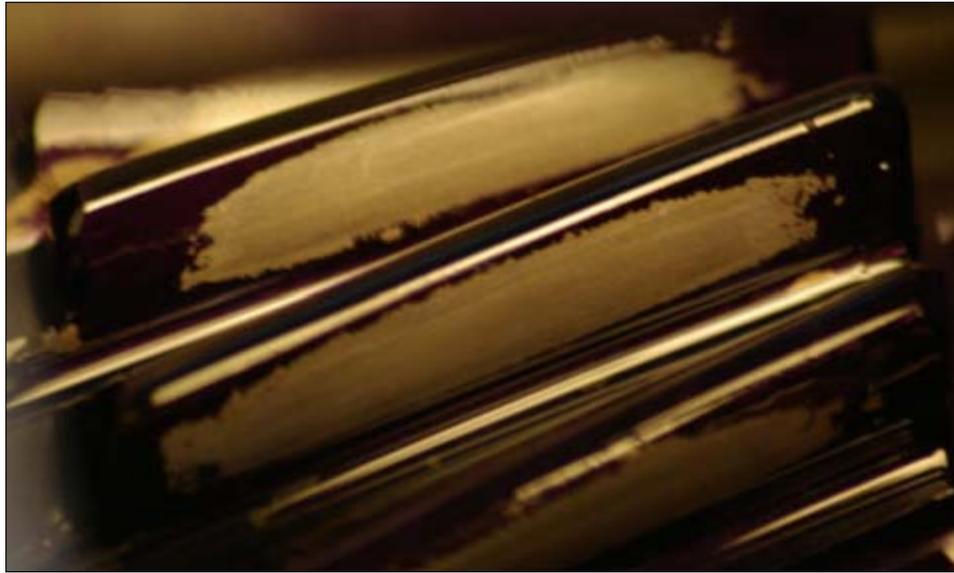
**Figure A.18. Representative involute no-load contact**

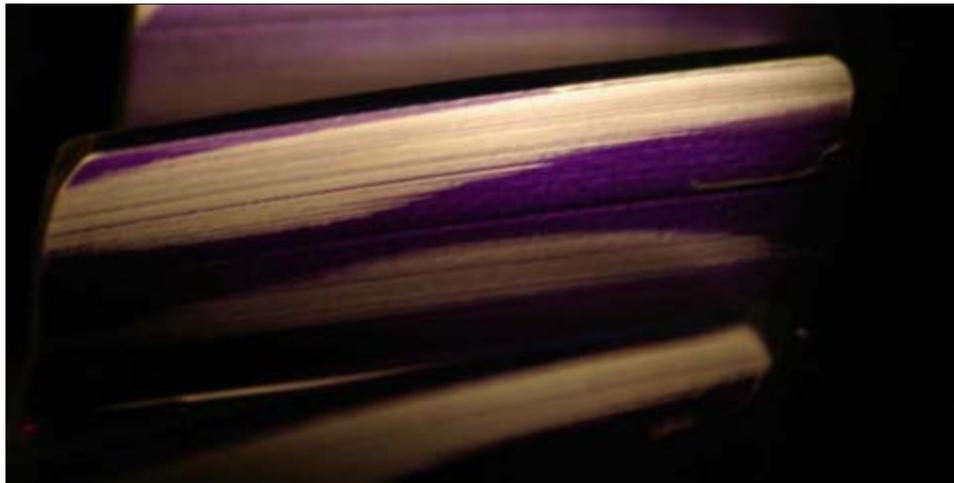
**Figure A.19. Convolid no-load contact**

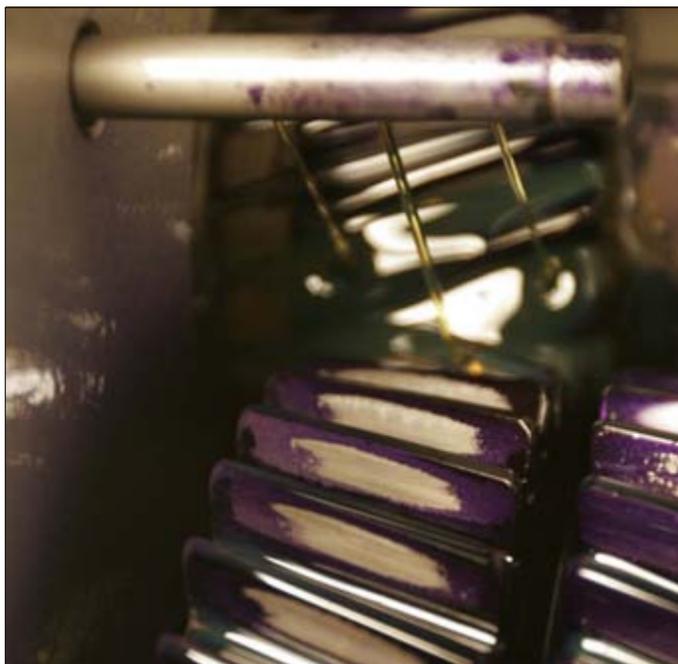
**Figure A.20. No-load contact pattern—involute gear; lube nozzle**

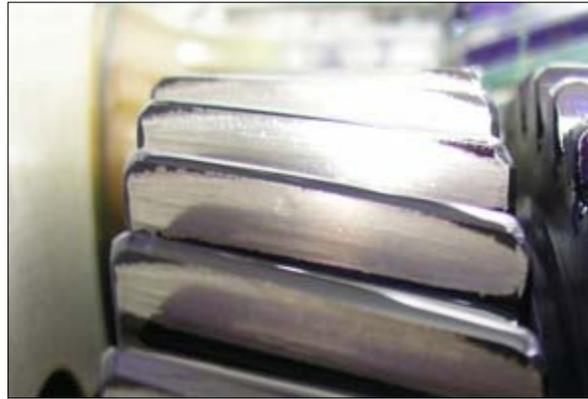
**Figure A.21. Example of the full load (7,000 lb-in) contact—involute gears**

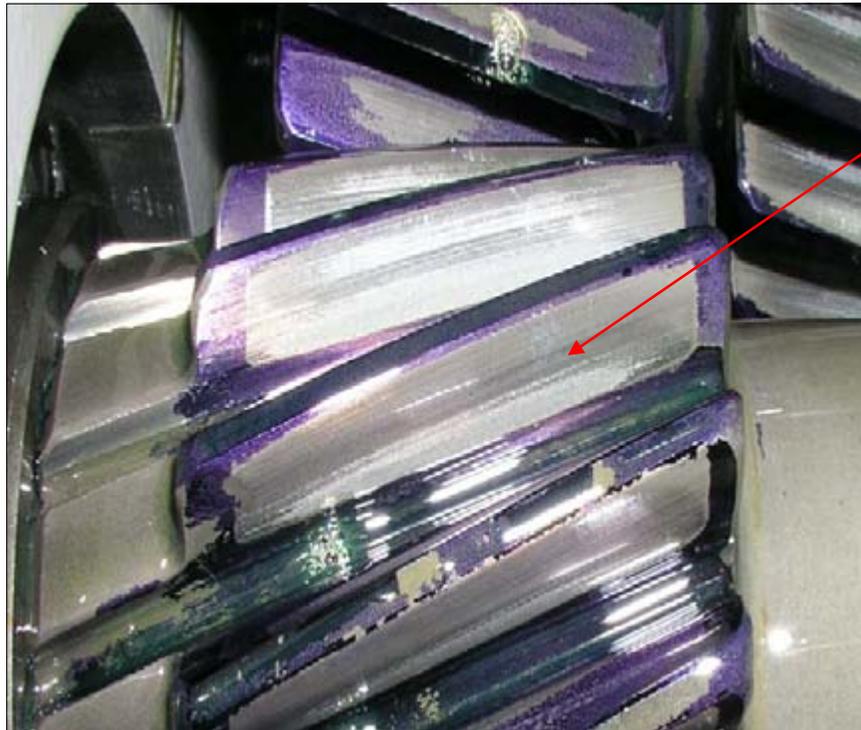
**Figure A.22. Involute pinion 1—reducer operation (pinion driving gear)—showing extensive micropitting on both the addendum and dedendum**

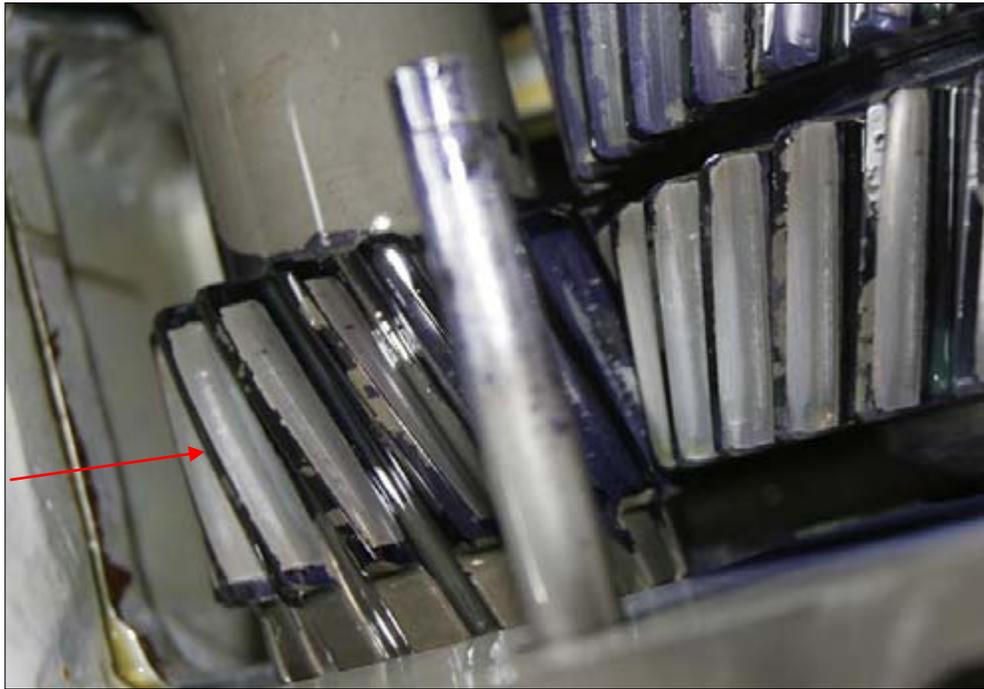
**Figure A.23. Involute pinion 2—increaser operation (gear drives pinion)—shows a smaller amount of micropitting on the pinion (arrow) as well as on the mating gear**

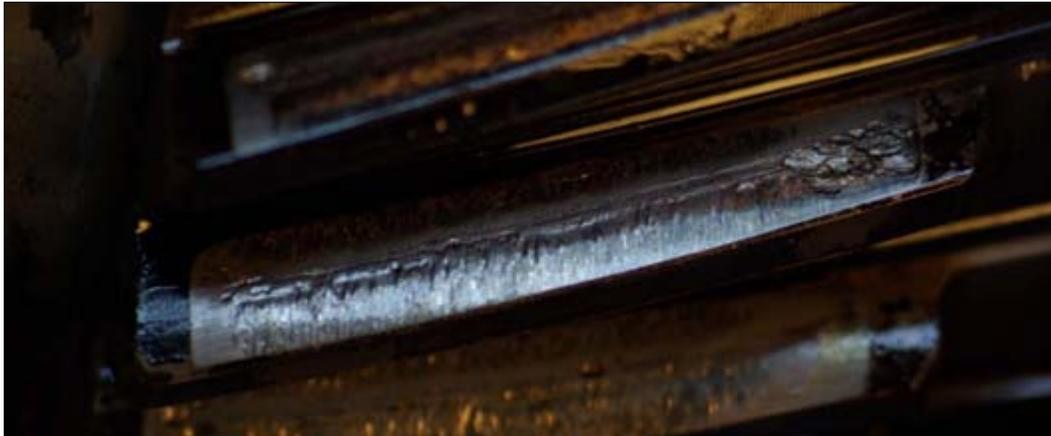
**Figure A.24. Involute (1) reducer pinion surface wear (Test 2)**

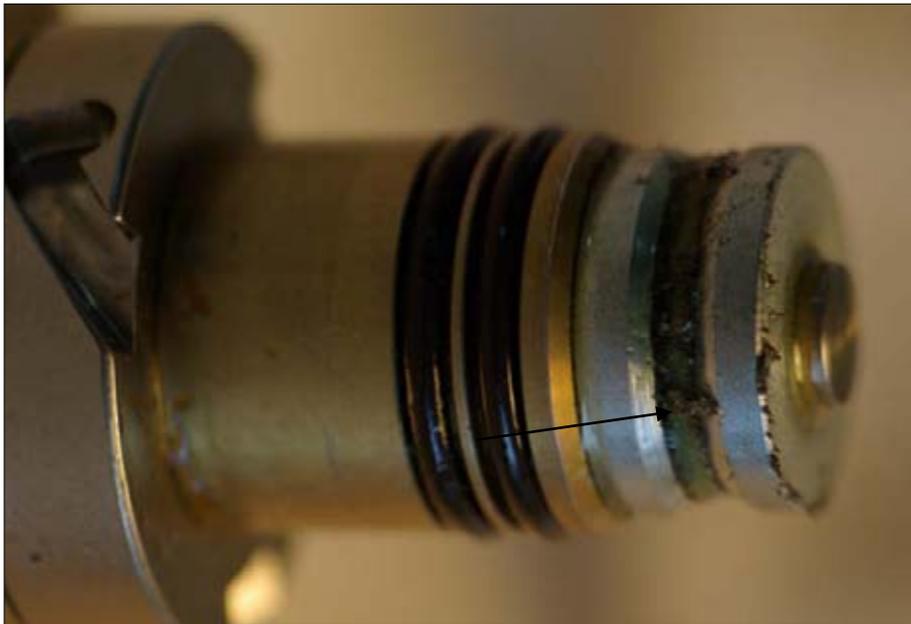
**Figure A.25. Gearbox 1 chip detector after gearing failure; note material crossing the gap**

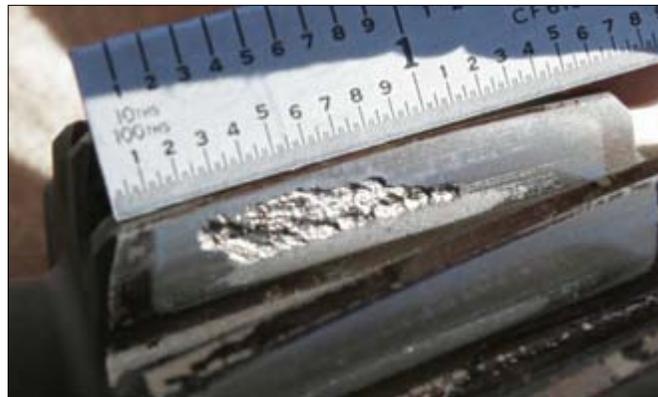
After 86 hours of operation (Test 3) a significant amount of vibration was noted, prompting shutdown of the test fixture. Upon inspection, pinion 1 in gearbox 2 was found to have significant macropitting (see Figure A.26 through Figure A.28). The origin of the pitting appears to fall at the pitch line of the tooth flank, which is consistent with the area of highest calculated stresses for involute gearing. This pinion was operated as a reducer where the pinion drives the gear. Note that there is frosting (micropitting) in the dedendum (near the tooth root) of the tooth flank. Although, in some cases this phenomenon has been thought to precipitate a macropitting failure, at the pitch line where the macropitting originated no micropitting is present. Therefore, the macropitting can be considered a classic fatigue failure of the type expected in this test. It is important to note that only 10 hours of operation occurred between inspections. There was no hint of damage prior to the high vibration level (manually monitored at that time) that prompted cessation of the test.

**Figure A.26. Massive macropitting on pinion tooth**

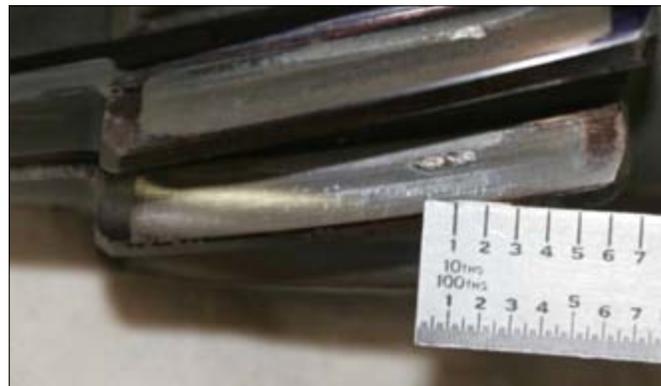
**Figure A.27. Additional pitting flank (Test 3, gearbox 2, pinion 1)**

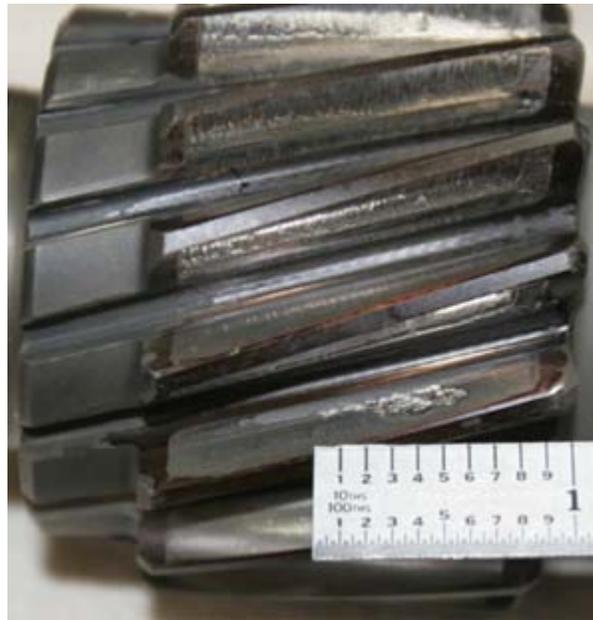
**Figure A.28. Further pitting and opposite flank scuffing damage from Test 2**

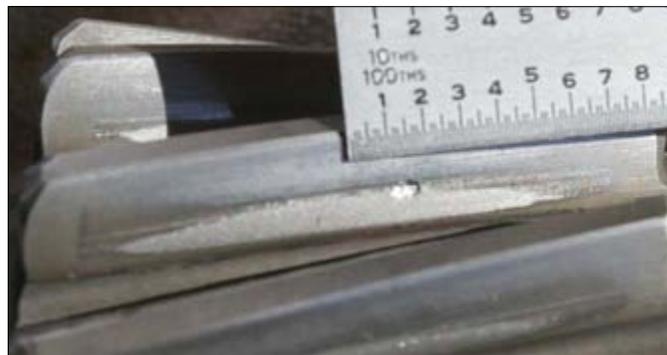
**Figure A.29. Failed involute pinion from Test 4**

Test 4 was terminated after 18 hours, due to another surface fatigue failure. Figure A.29 and Figure A.30 show the failure—again, a pinion operated as a speed reducer, this time in gearbox 1. Here the surface

damage was found during a routine inspection. The amount of damage is indicative of the definition of failure. The total test time for this pinion was 104 hours, or 13.7 million cycles.

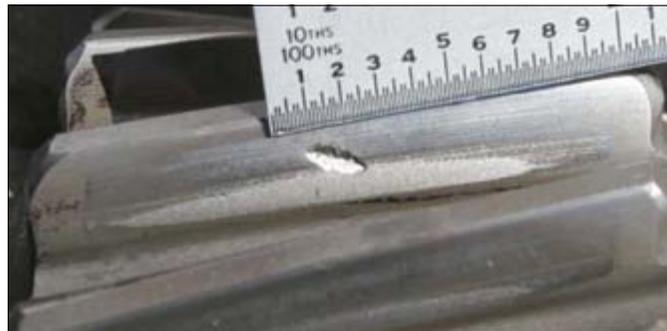
**Figure A.30. Pinion loaded as a speed reducer**

It is important to note the extensive micropitting on the tooth flanks. For these parts, it occurs almost exclusively in the dedendum of the gear tooth (below the pitch diameter). There has been much discussion in the gear industry concerning whether the type of action (speed increaser versus speed reducer) affects the appearance of micropitting, or whether it is entirely a result of load, lubrication, and surface finish. During testing, it appears that there is a difference due to the type of action. Both of the failed pinions are loaded as speed reducers (the pinion drives the gear), and there was extensive micropitting in the dedendum of the tooth flanks. The other pinion in the same gearbox with the same number of load cycles as the failed pinion in Test 4, yet loaded as a speed increaser (Figure A.31) shows much less wear on the active flank.

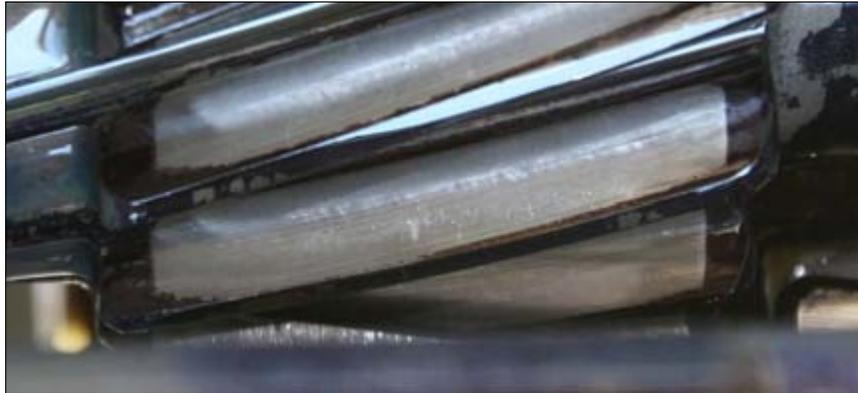
**Figure A.31. The other pinion in the same gearbox loaded as a speed increaser showing minimal wear**

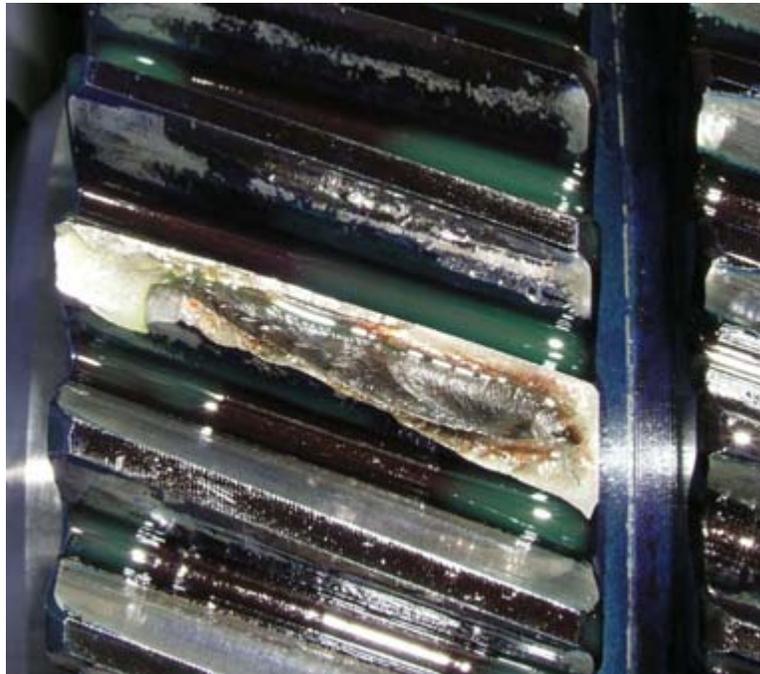
**Figures A.32. Broken involute gear tooth from Test 5; failure was due to case/core separation**

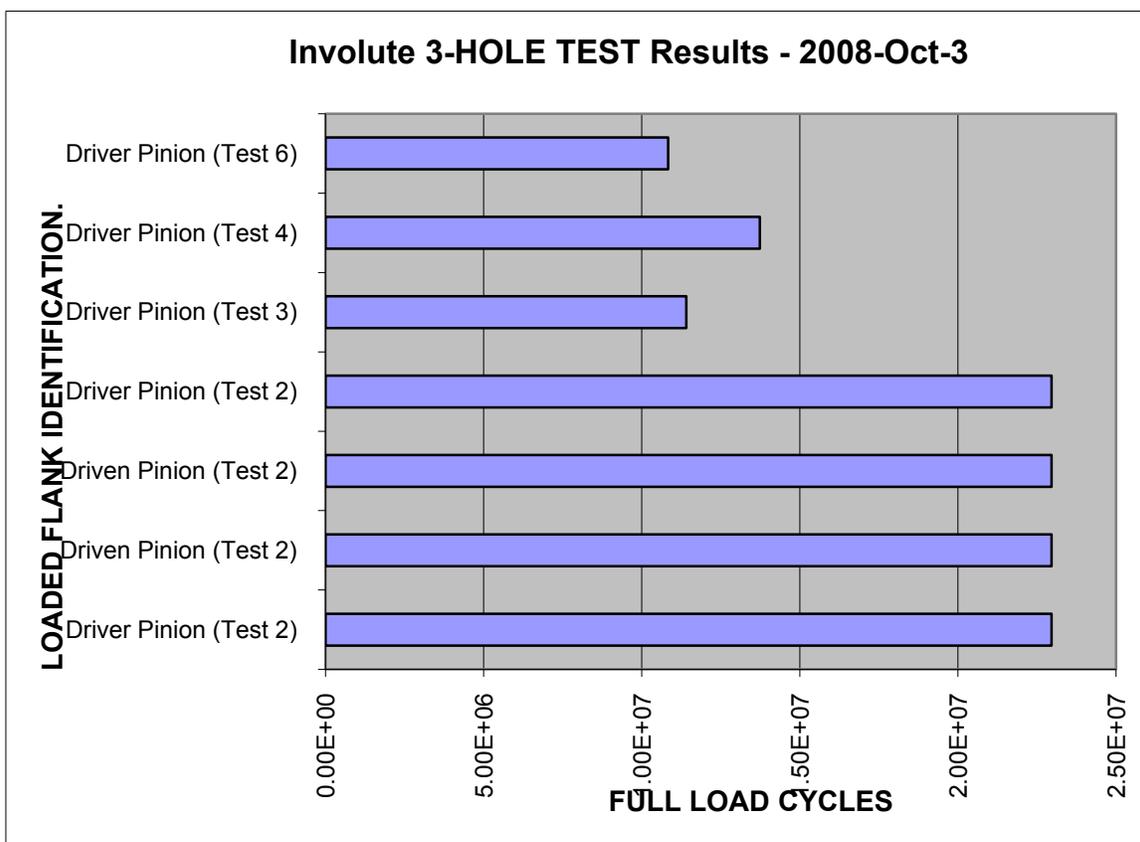
**Figure A.33. Summary of involute gear failures in the 3-Hole Test**

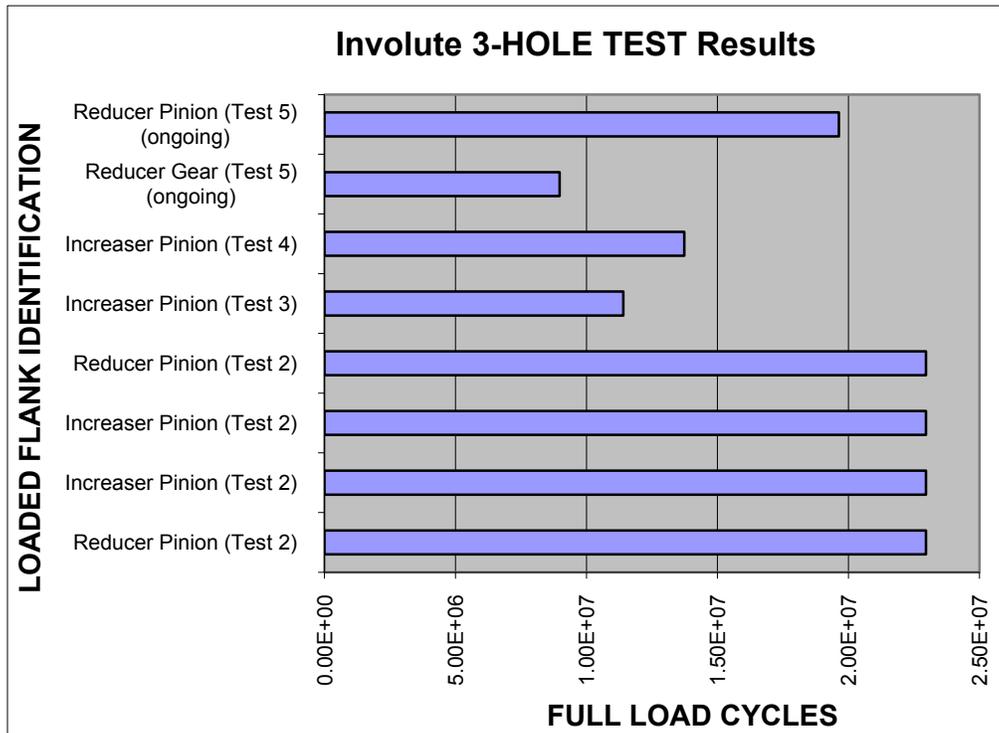
Figure A.34. Involute 3-hole test results

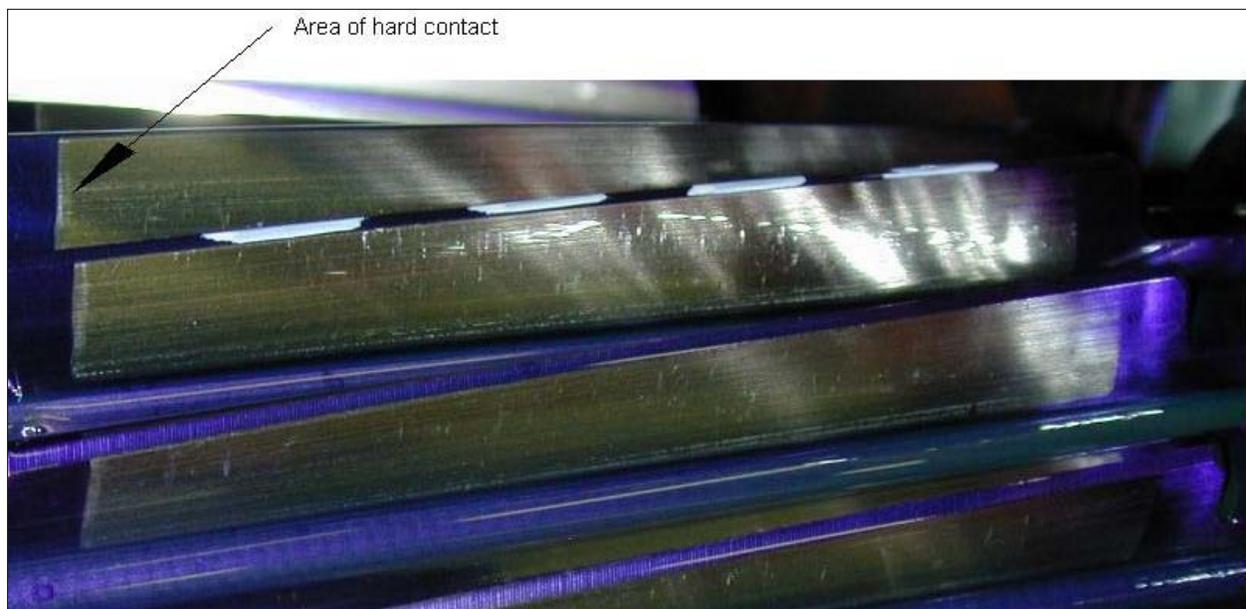
**Figure O.1. Involute high speed pinion—initial 200% loading; nearly full contact as the bluing has been nearly uniformly removed; hard contact is visible on the left side of the contact patch; paint marks on the tooth tip are used for identification to verify the same tooth was view in subsequent inspections**
