# Low Wind Speed Turbine Developments in Convoloid Gearing

Final Technical Report  
June 2005 – October 2008

*Genesis Partners, LP  
Montgomeryville, Pennsylvania*

**Subcontract Report**  
NREL/SR-500-45103  
August 2010

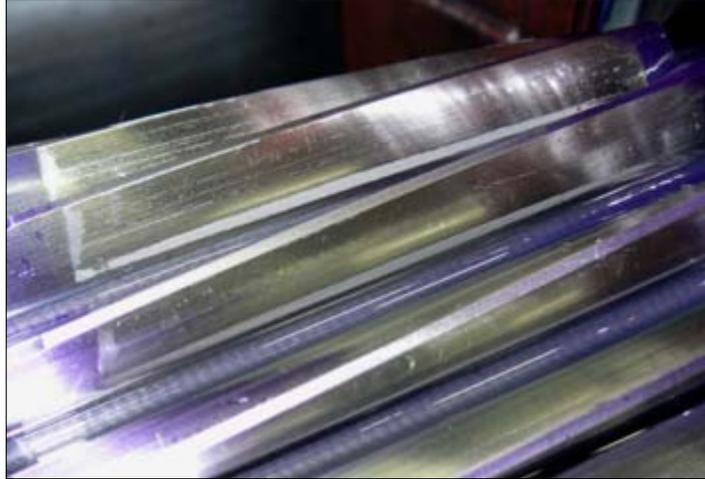
**Figure O.2. Involute high speed pinion—235 hours at 200% load; micropitting (dull gray area) in dedendum and at the edge of contact**

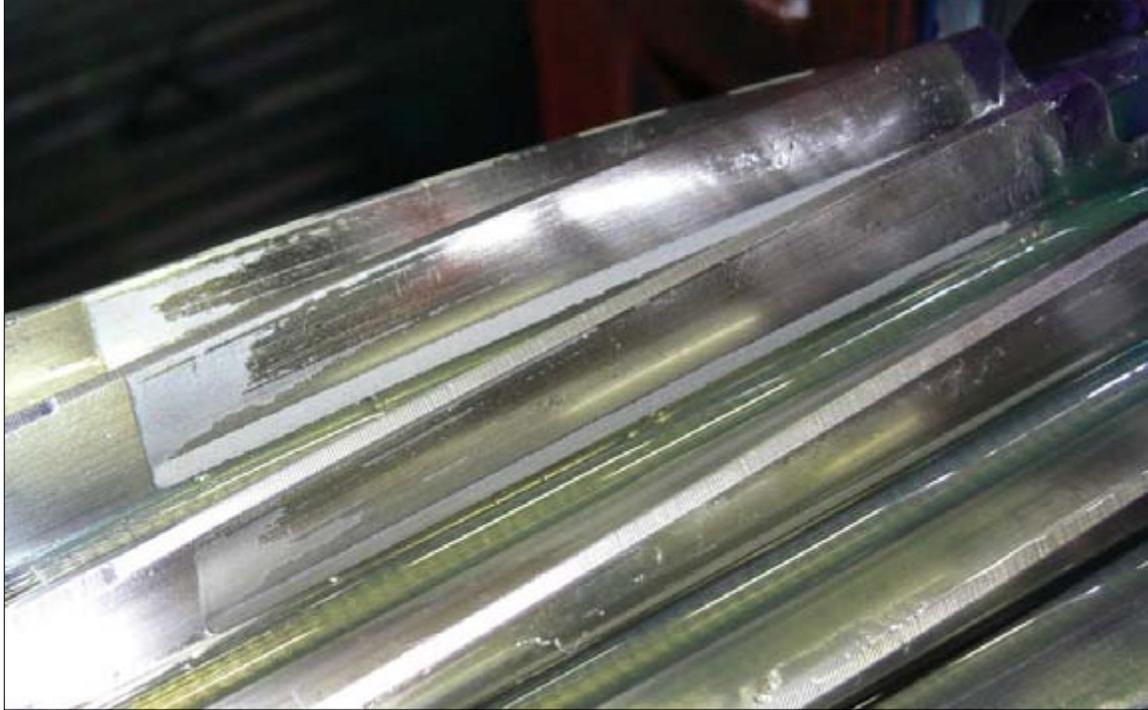
**Figure O.4. Involute high speed pinion showing extensive micropitting; 763 hours total test time ( $89 \times 10^6$  cycles). (235 hours at 200% load and 1,767 rpm motor speed, then the load was increased to 240% and speed increased to 2,050 rpm)**

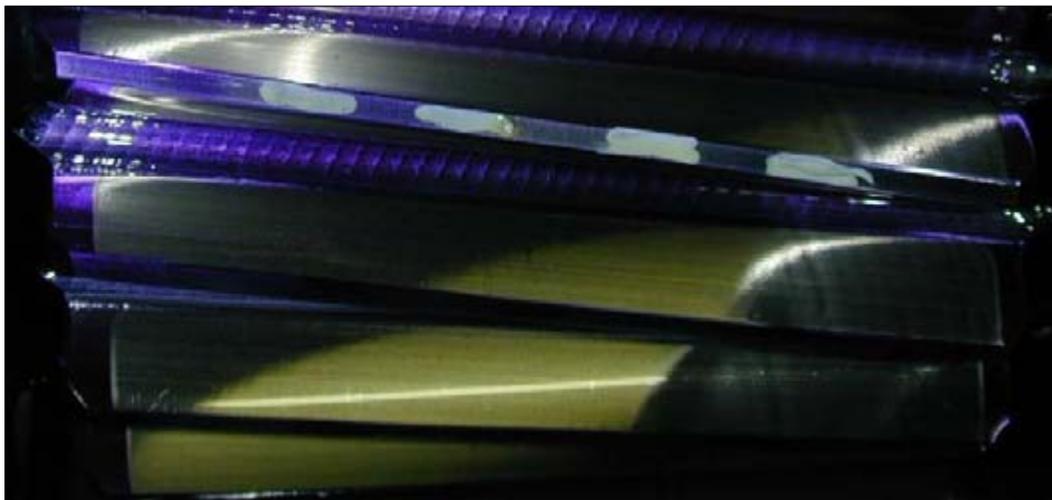
Figure O.7. Involute low speed pinion at 200% shakedown; the contact patch reveals a consistent contact pattern across the contact flank; note paint marks on teeth tips for inspection purposes

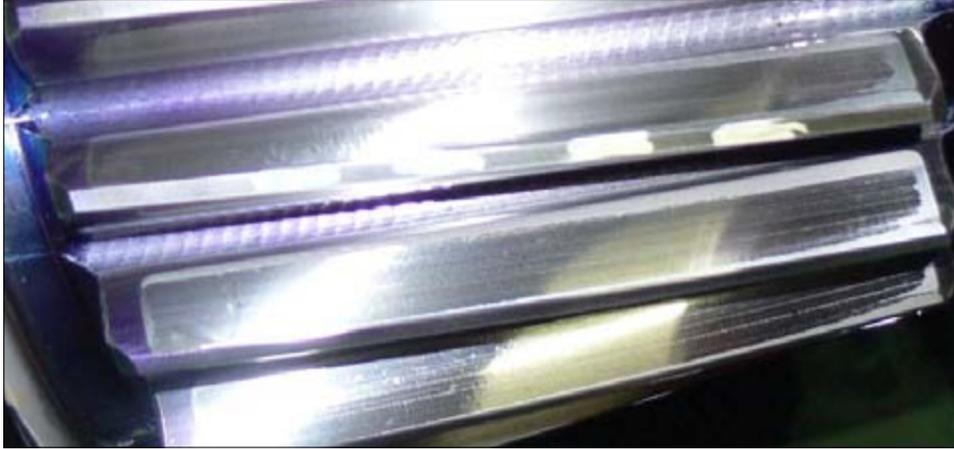
**Figure O.9. Involute low speed pinion after 763 total test hours; extensive micropitting is visible in the dedendum and at the right side**

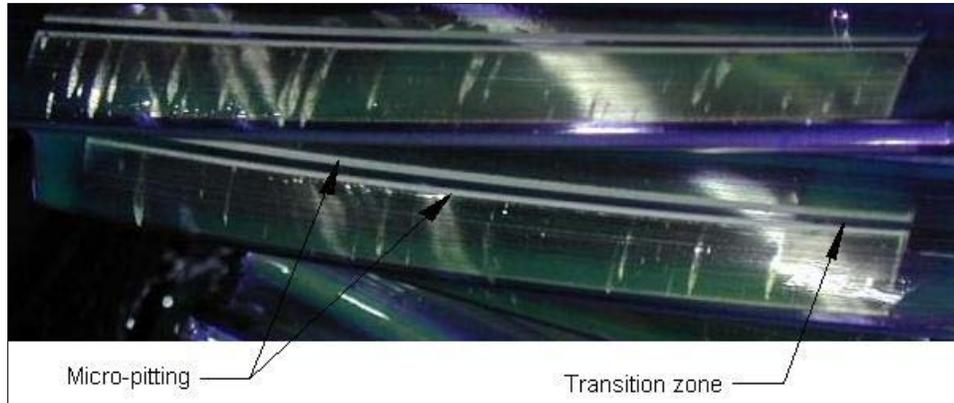
**Figure O.13. Convoloid high speed pinion after shakedown of 1 hour operation at 200% rated load; micropitting on either side of the transition zone appeared during approximately 160 hours of testing at 77% rated load; radial marks are due to aluminum particles from the heat exchanger that passed through the gear mesh; no impression could be felt nor was there any damage to the tooth flank**

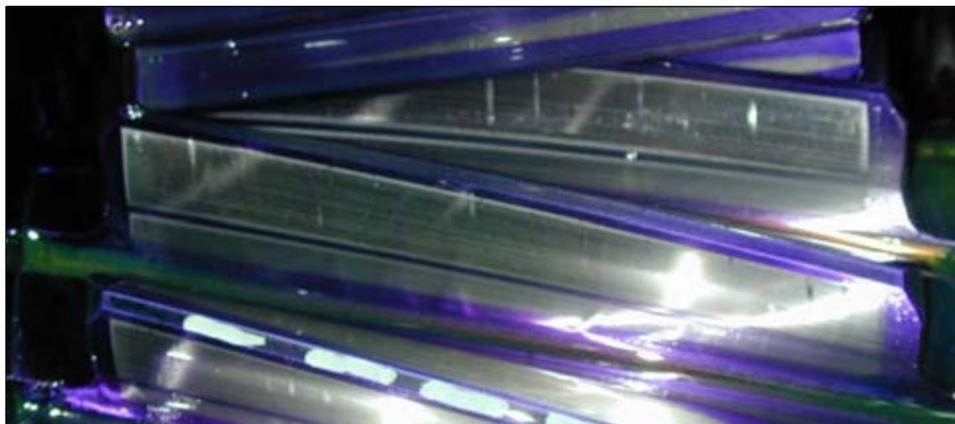
**Figure O.20. Convoloid low speed pinion after shakedown of 1 hour operation at 200% rated load; micropitting at the either side of the transition zone appeared during approximately 160 hours of testing at 77% rated load**

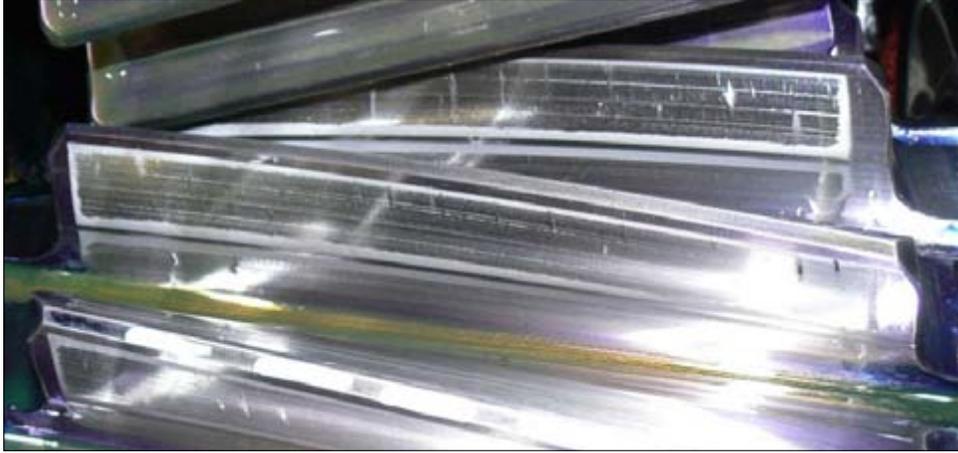
**Figure O.21. Convoloid low speed pinion after 763 total test hours**

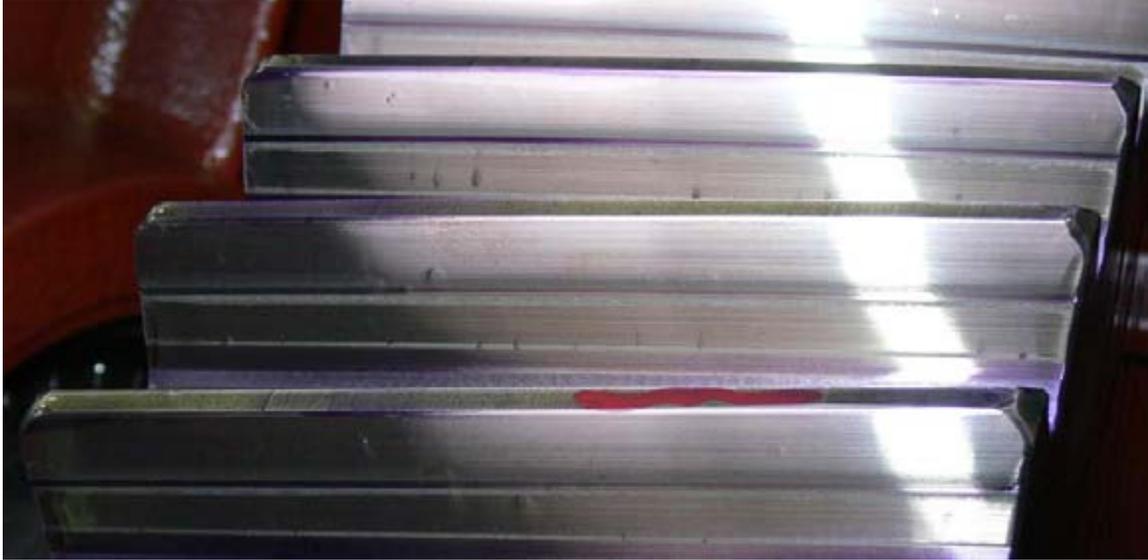
**Figure O.23. Convoloid low speed gear after 763 total test hours; light micropitting is visible at the edges of the dedendum side of the transition zone; no micropitting is evident at the tip, nor is there much bluing**

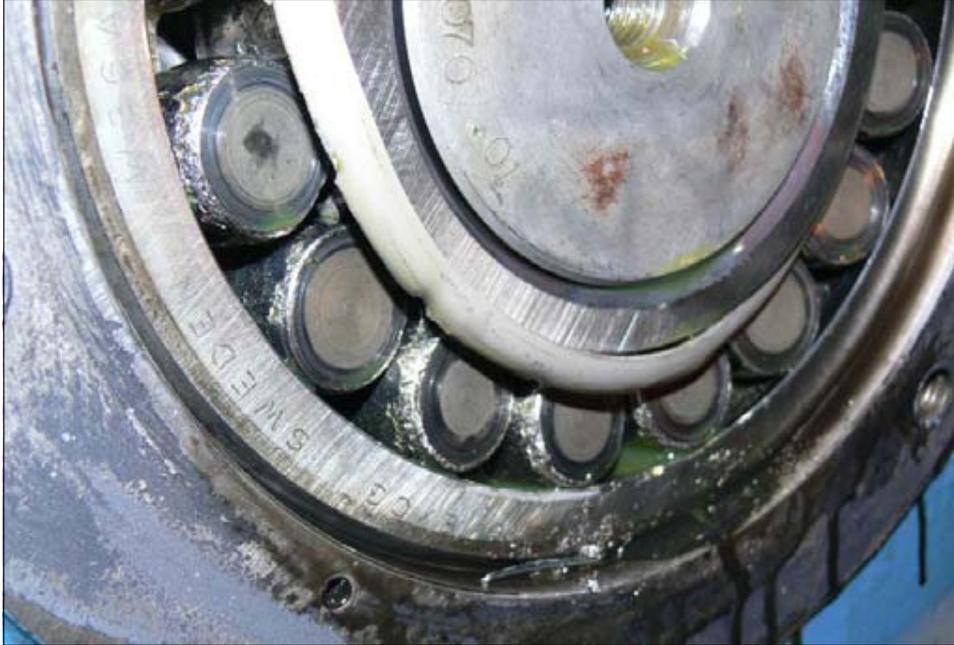
**Figure O.24. Failed spherical roller bearing in Convoloid gearbox after 763 total test hours; note pitted edges of the rollers and deformation of the cage; metallic particles are present at the bottom of the housing bore**

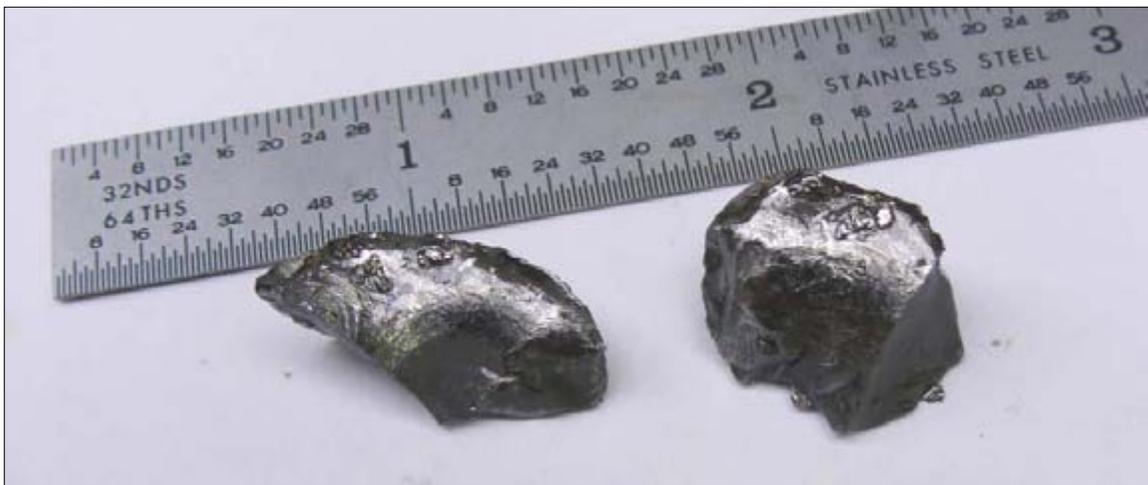
**Figure O.25. Pieces of the failed bearing**

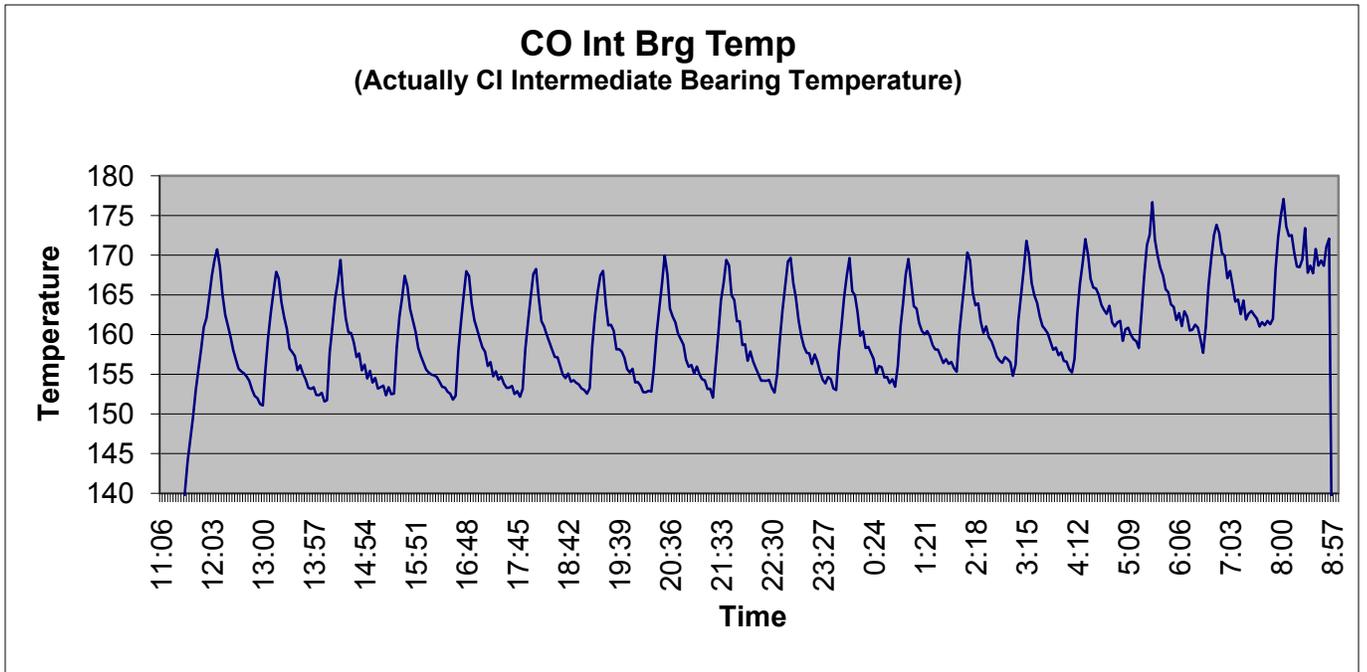
**Figure O.26. Bearing temperature chart for the failed Convoloid intermediate bearing; note the rise in temperature after 2:18 a.m.; the jagged “saw-tooth” shape is due to cycling of the heat exchanger fan**

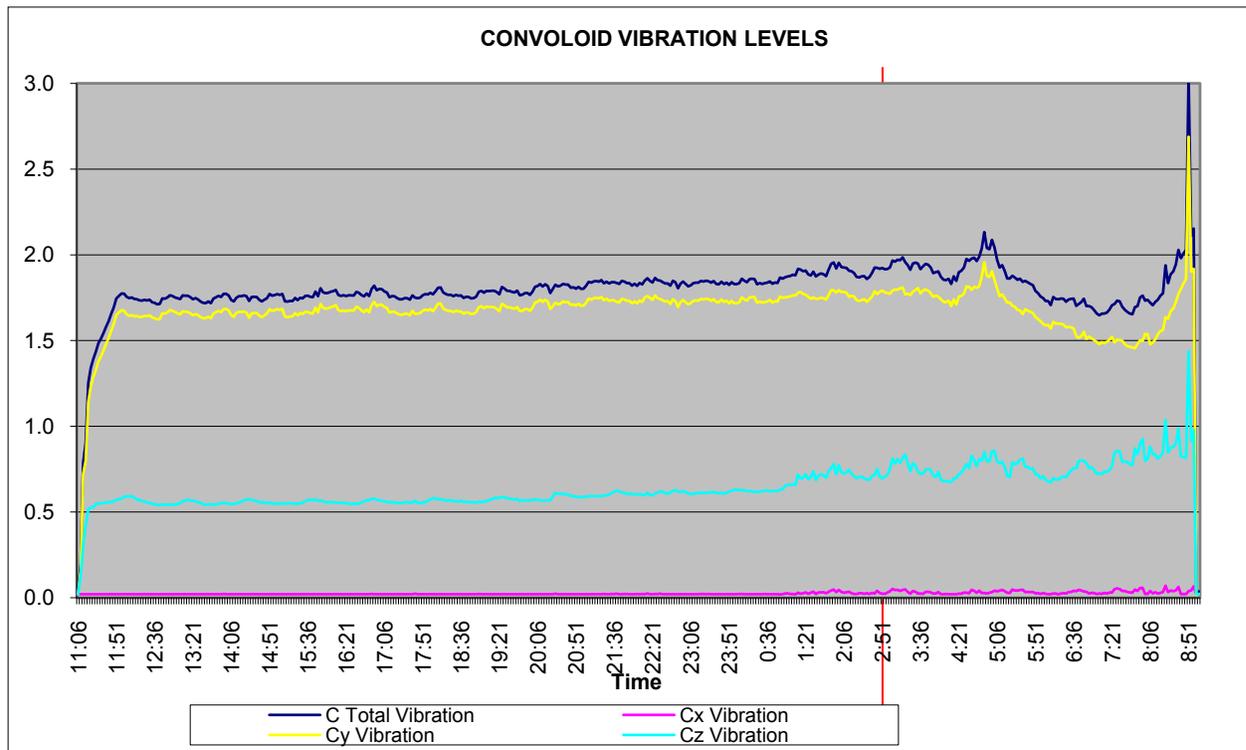
**Figure O.27. Vibration levels for the Convoloid gearbox for the last day of operation; note the increase in vibration at approximately 1:00 a.m.**

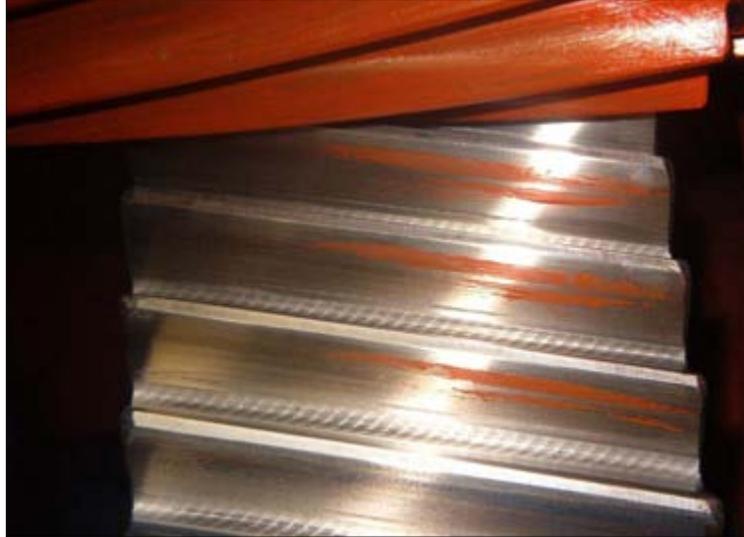
**Figure P.2. Convoloid High speed gear mesh no-load contact patch prior to lead modification; gearing has been assembled into the test housing**

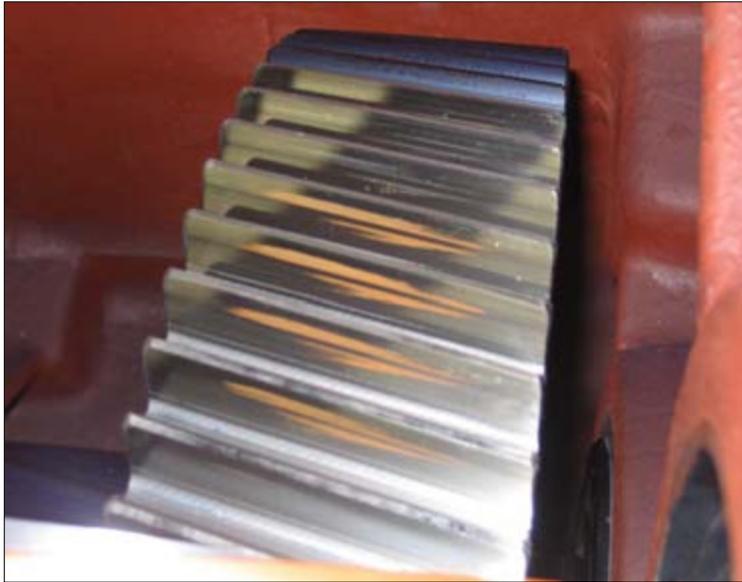
**Figure P.3. Convoloid high speed gear mesh no-load contact patch after lead modification**

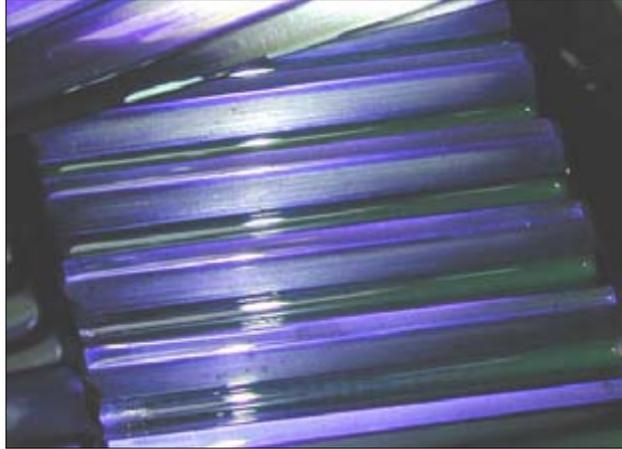
**Figure P.4. HS Involute, 77% shakedown contact**

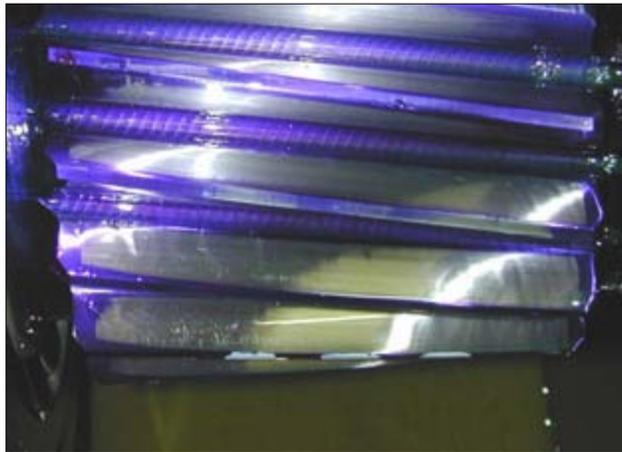
**Figure P.5. LS Involute, 77% shakedown contact**

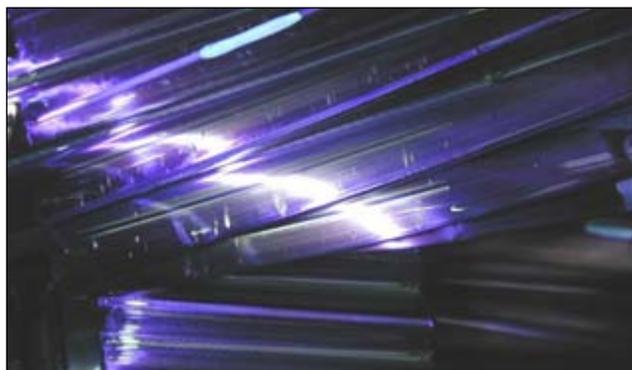
**Figure P.6. HS Convoloid, 77% shakedown contact**

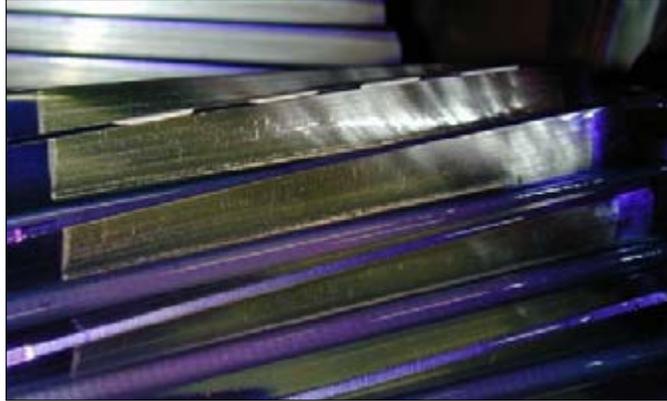
**Figure P.10. Involute HS pinion with micropitting in the dedendum and edge distress (true 200% load after 21.9 hours)**

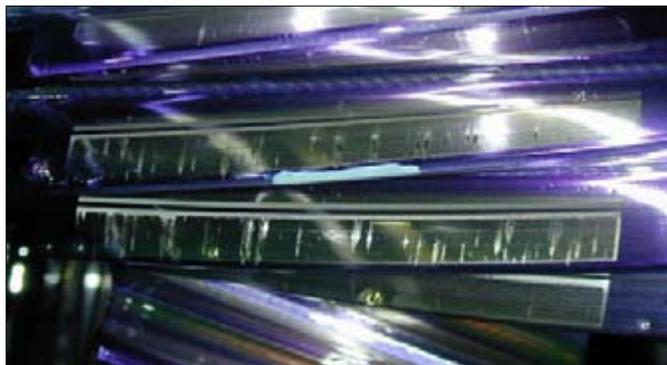
**Figure P.12. Convoloid HS pinion with full face contact, showing transition zone micropitting and edge distress (21.9 hours at 200% load)**

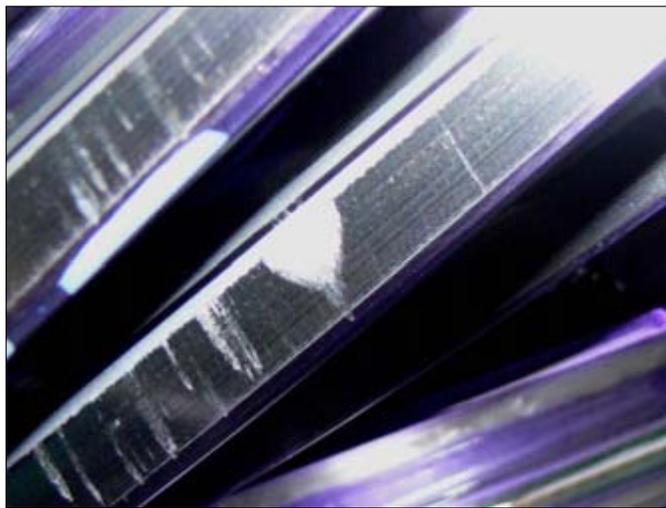
**Figure P.17. Close-up of oil-debris damage on the Convolid HS pinion; this mark began to fade at the next inspection (91.2 hours at 200% load)**

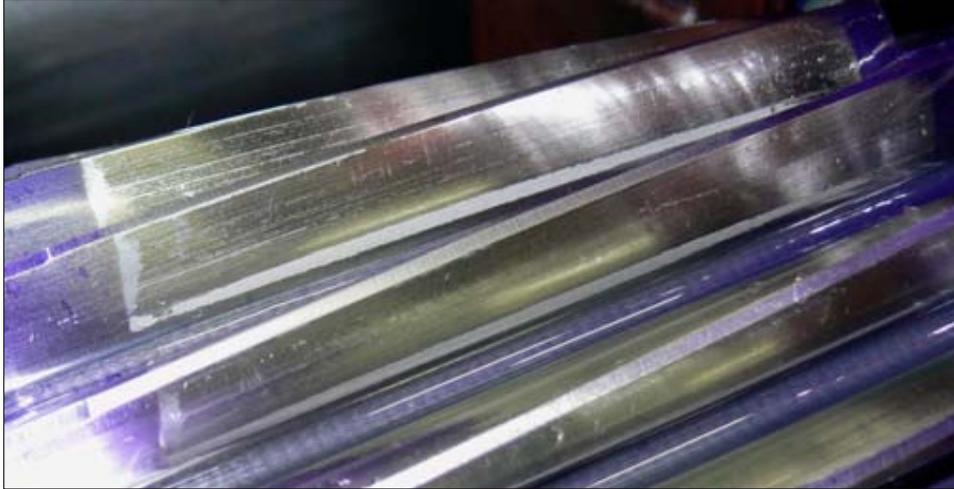
**Figure P.19. Involute HS pinion at the conclusion of the 200% testing; note the extensive micropitting in the dedendum and at the edges; some micropitting is visible along the tip; this wear is progressing (235.8 hours at 200% load)**

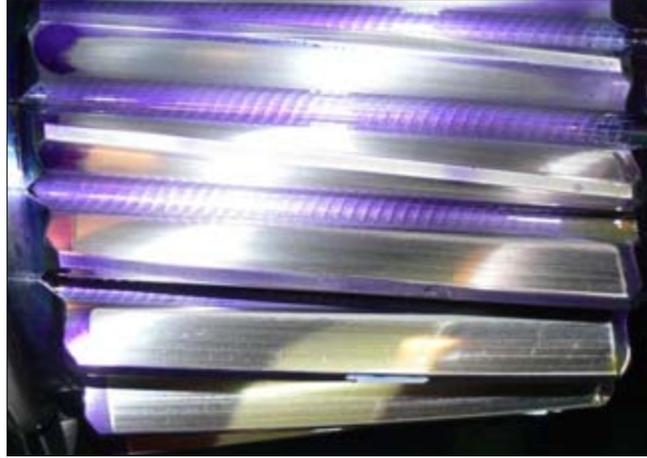
**Figure P.22. Involute LS pinion at the conclusion of the 200% test showing micropitting wear around edges and at grinding peaks (235 hours at 200% load)**

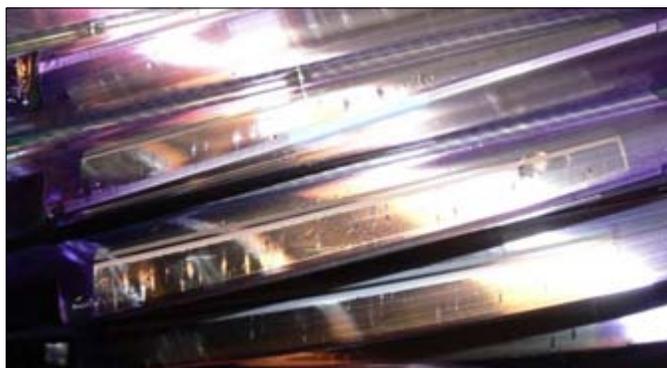
**Figure P.24. Convoloid HS pinion at conclusion of the 200% test. Note that although there is extensive micropitting on both sides of the transition zone, it is not rapidly progressing (235.8 hours at 200% of the rated load)**

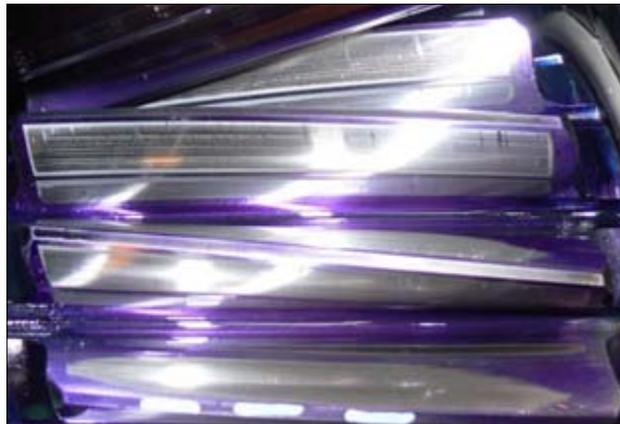
**Figure P.26. Convold LS pinion at the conclusion of the 200% test; micropitting is present at all edges except for the bottom of the dedendum (235 hours at 200% load)**

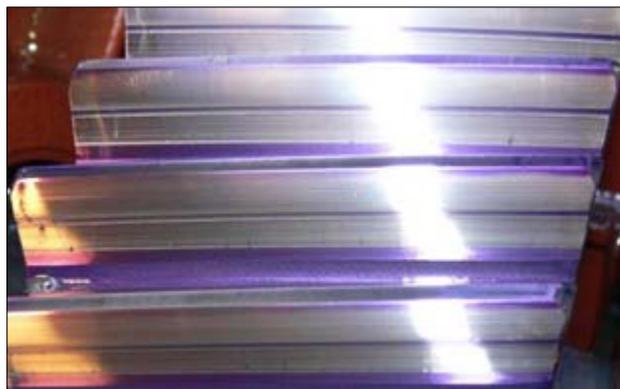
**Figure P.27. Convold LS gear at the conclusion of the 200% test; light micropitting is evident around the transition zone and at the root; good tip relief causes the wear pattern to fade away at the tip; 235 hours at 200% load**

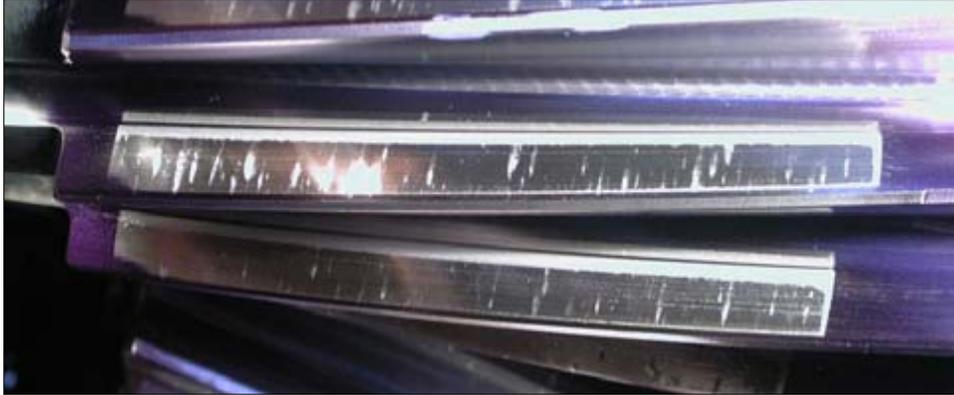
**Figure P.34. Convoloid HS pinion showing minimal progression of micropitting (235 hours at 200% load; 355 hours at 240% load) vertical streaks are from aluminum particles (from the heat exchanger)**

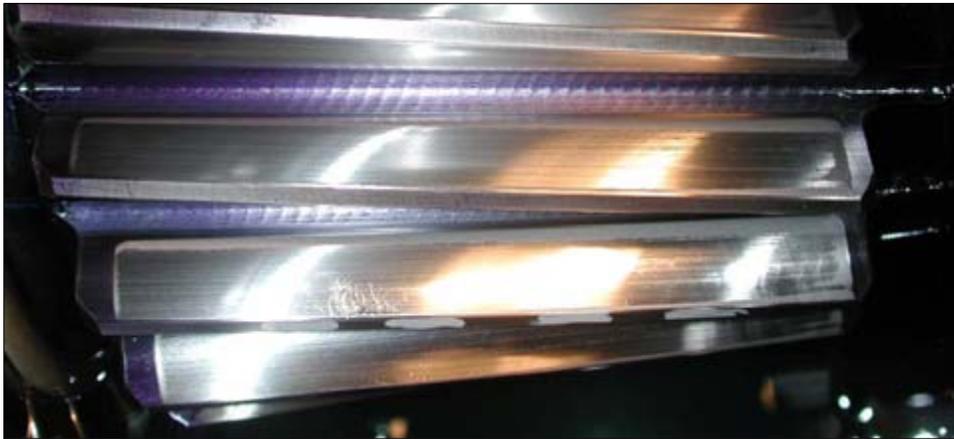
**Figure P.35. Involute LS pinion showing substantial micropitting at the right edge and in the dedendum (235 hours at 200% load; 355 hours at 240% load)**

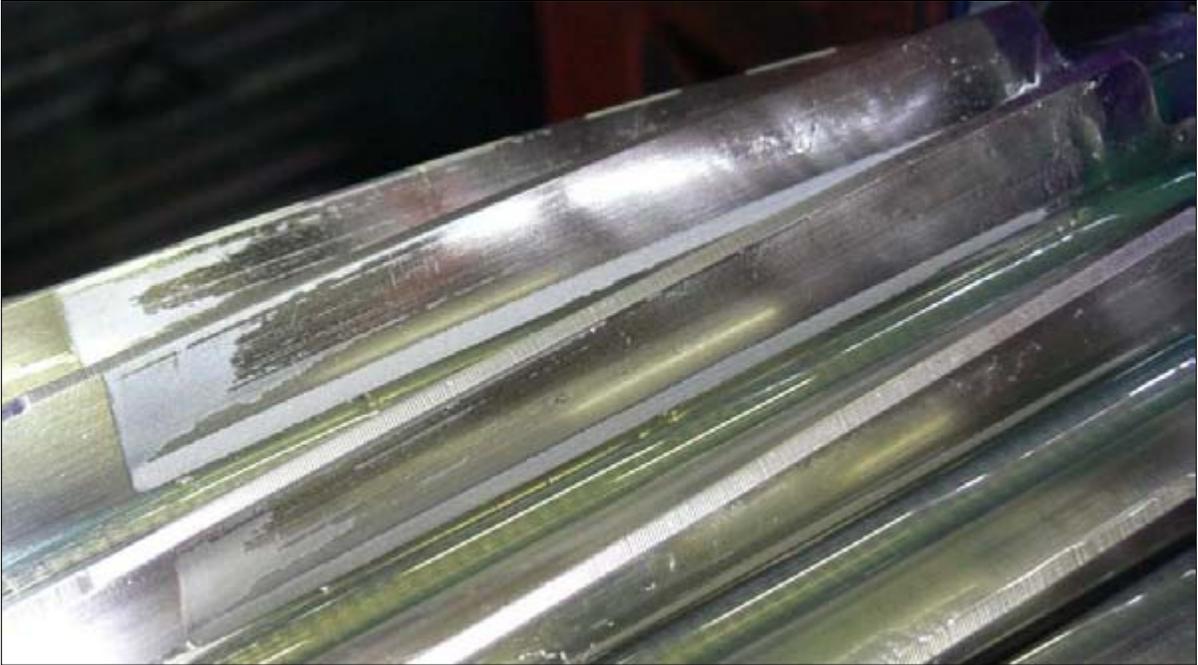
**Figure P.37. Involute HS pinion at the end of test; wear due to micropitting is extensive along one side (235 hours at 200% load; 528 hours at 240% load)**

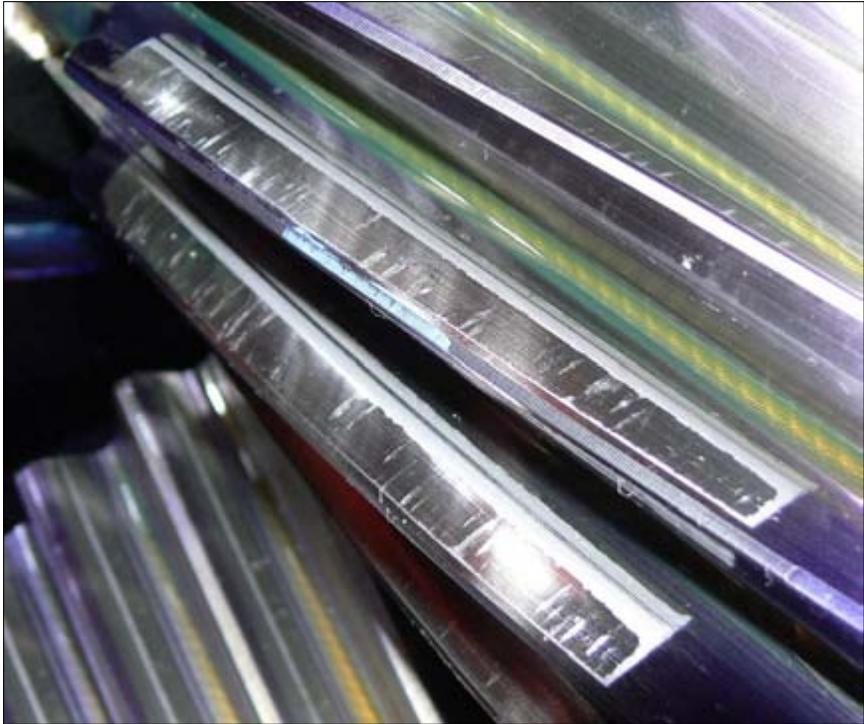
**Figure P.38. Convoloid HS pinion at the end of test; wear due to micropitting is expanded slightly during the test, but no progression occurred on the edges (235 hours at 200% load; 528 hours at 240% load)**

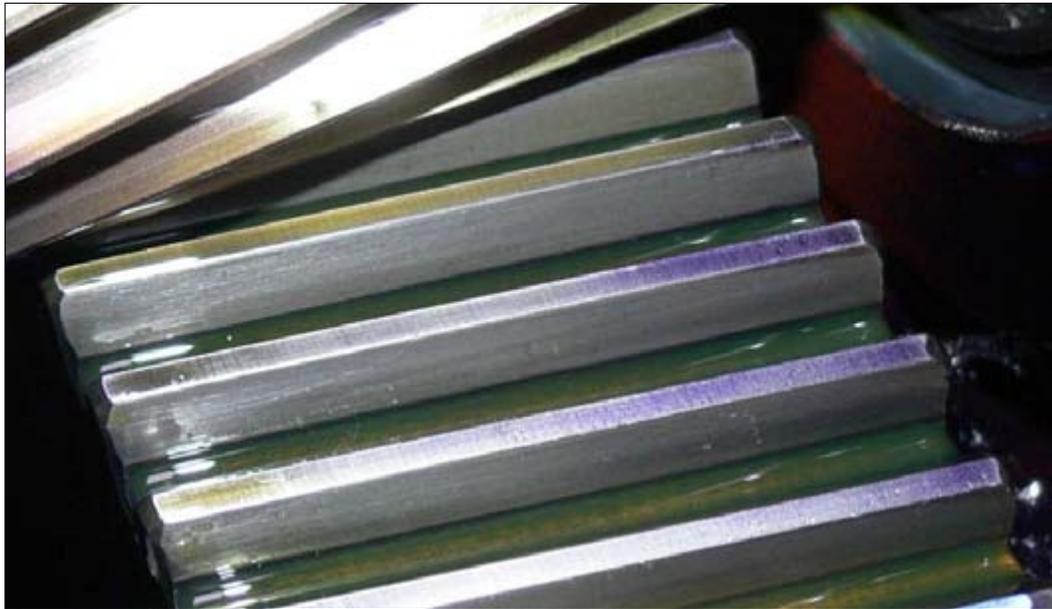
**Figure P.39. Involute HS gear at the end of test; no wear is apparent (235 hours at 200% load; 528 hours at 240% load)**

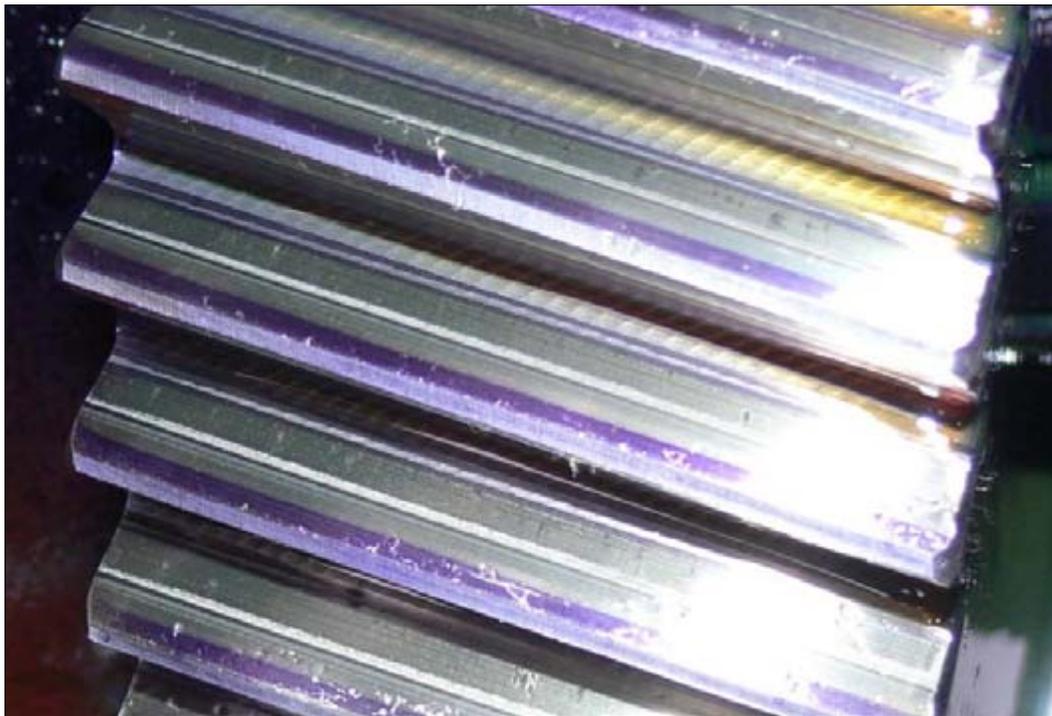
**Figure P.40. Convoloid HS gear at the end of test; some wear due to micropitting is visible on the dedendum side of the transition zone; a large section of the addendum still shows marking dye indicating too much tip relief in the profile (235 hours at 200% load; 528 hours at 240% load)**

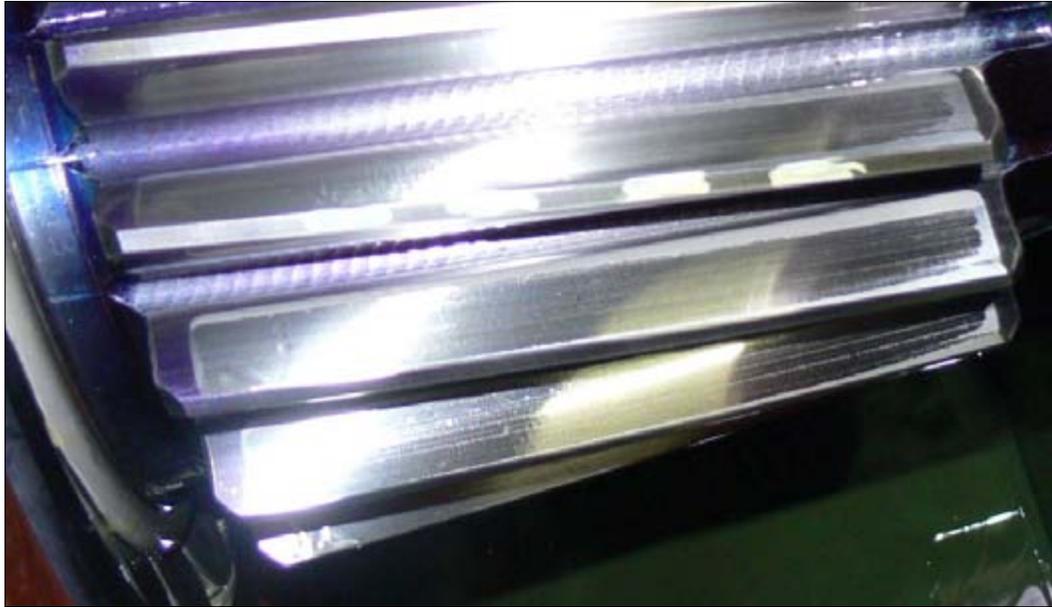
**Figure P.41. Involute LS pinion at the end of test; similar to the HS pinion, micropitting wear is concentrated along one side and in the dedendum (235 hours at 200% load; 528 hours at 240% load)**

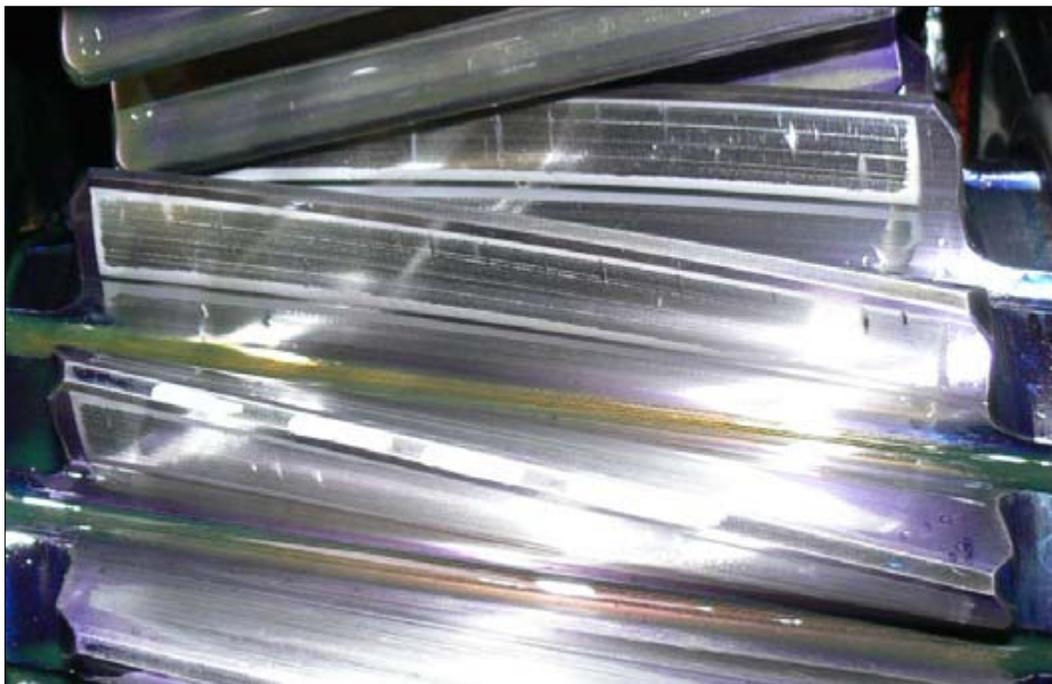
**Figure P.42. Convoloid LS pinion at the end of test; wear due to micropitting brackets the operating surface except for in the dedendum due to proper tip relief on the mating gear (235 hours at 200% load; 528 hours at 240% load)**

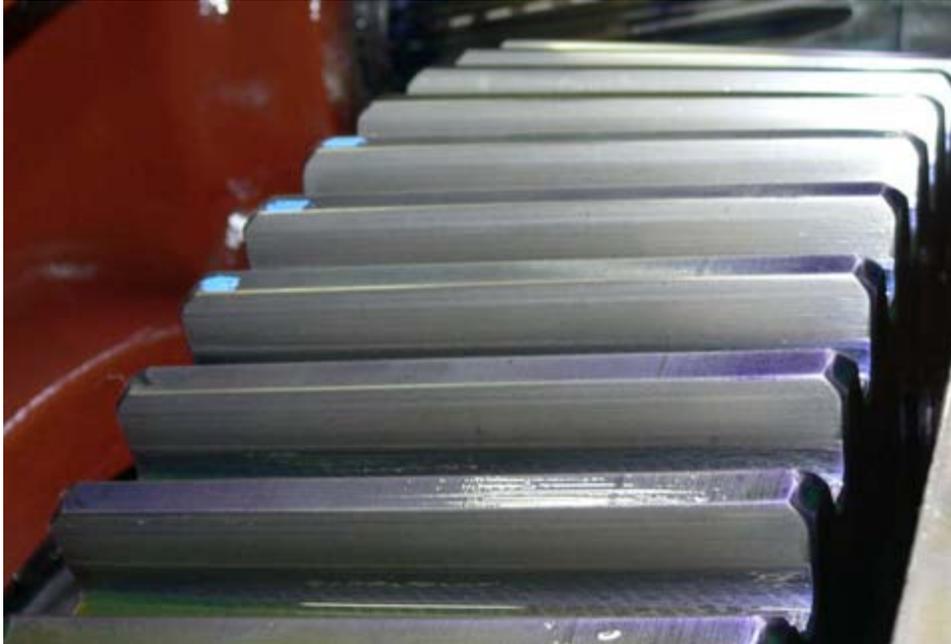
**Figure P.43. Involute LS gear at the end of test; no wear is visible (235 hours at 200% load; 528 hours at 240% load)**

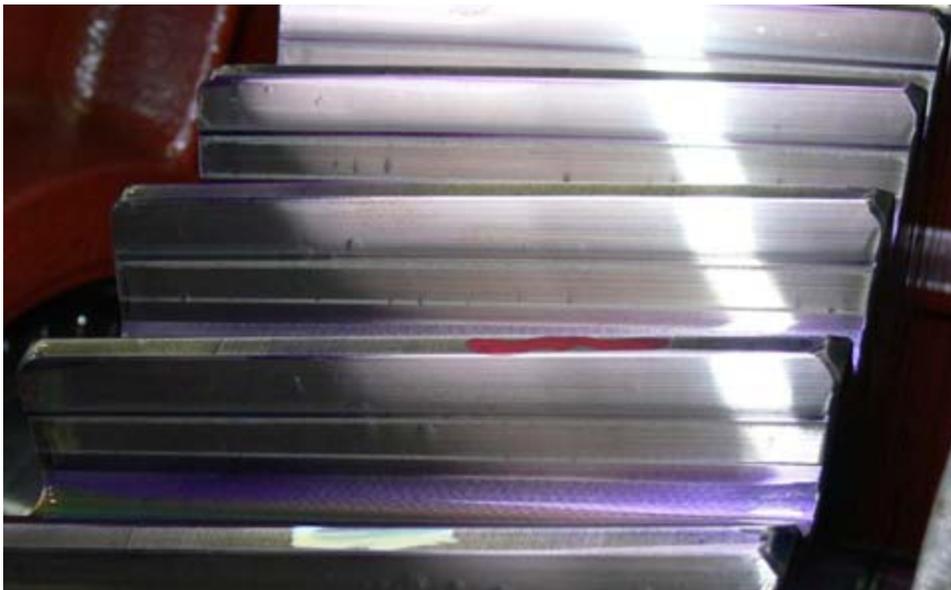
**Figure P.44. Convoloid LS gear at the end of test; slight wear due to micropitting is visible in the dedendum (235 hours at 200% load; 528 hours at 240% load)**

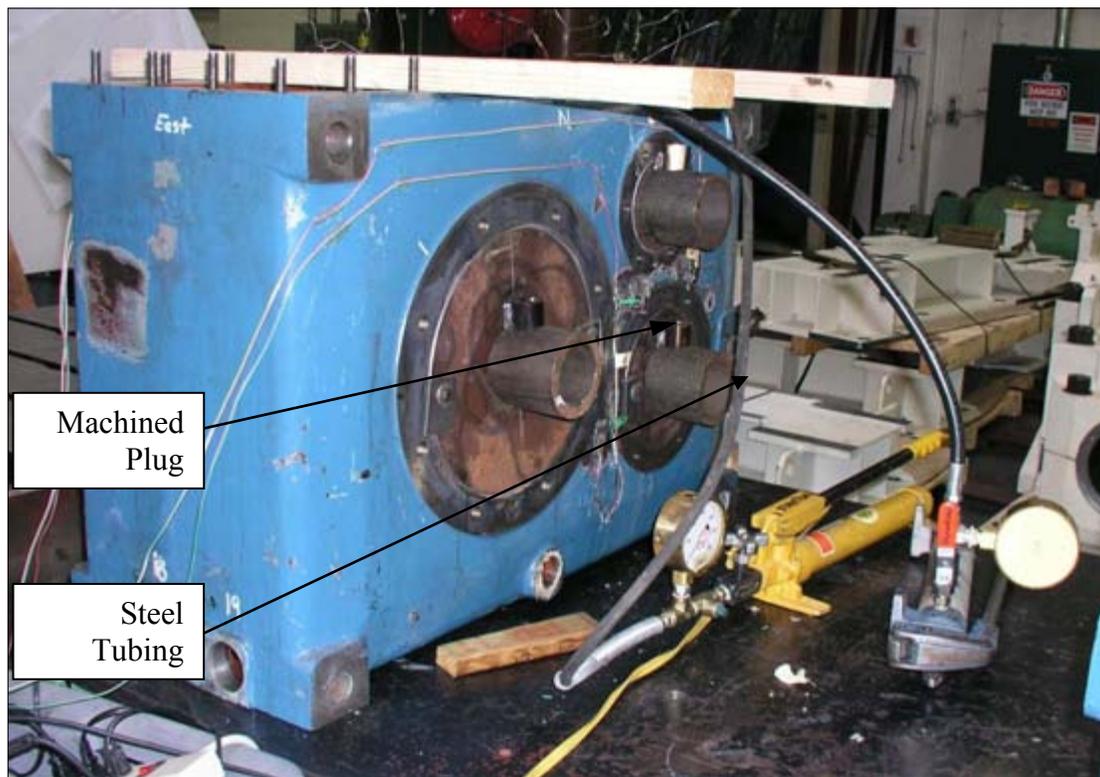
**Figure U.1. Static load test equipment set-up**

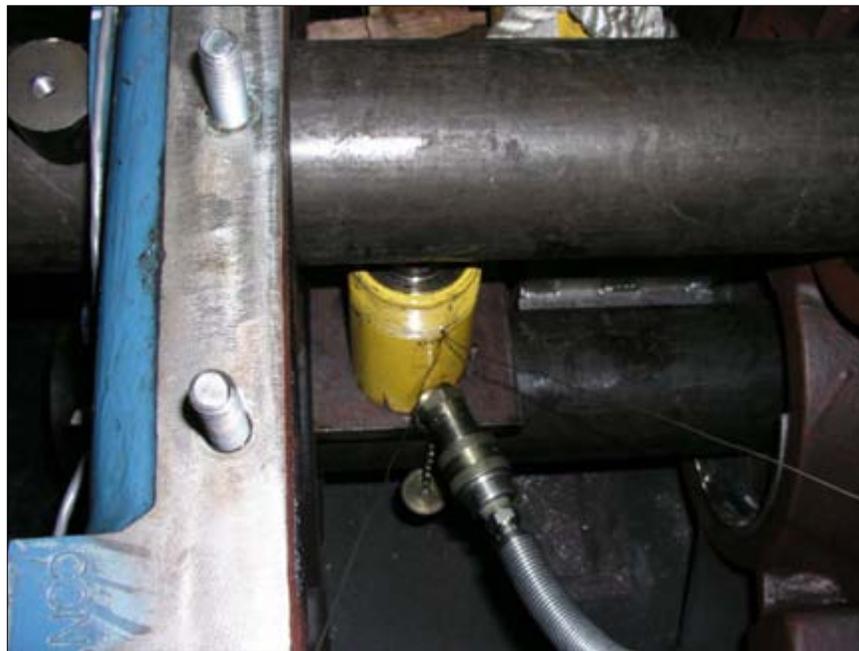
**Figure U.2. Close-up of a hydraulic cylinder in position to apply a separating load**

The amount of loading applied is related to the forces produced by the torques of the operational test. At the end of the test, a torque equal to 240% of the rated load was applied. This equates to an approximate separating force of 5,200 lb between the HS and INT bores, and a force of 16,800 lb between the INT and LS bores. The range of forces to be applied by the hydraulic cylinders began with no loading (to establish the strain gage offset) and increased (in 500-psi increments) to 3,000 psi (~9,400 lb) on the HS cylinder and 2,500 psi (~18,050 lb) on the LS cylinder. The amount of pressure on the LS cylinder was limited to prevent an excessive amount of load on the housing.
