NASA/TM-2009-215747  
NESC-RP-05-126/04-093-E

# Deep Impact Delta II Launch Vehicle Cracked Thick Film Coating on Electronic Packages Technical Consultation Report

<b>NASA Engineering and Safety Center Technical Consultation Report</b>	Document #: <b>RP-05-126</b>	Version: <b>1.0</b>
Title: <b>Deep Impact Delta II Launch Vehicle Cracked Thick Film Coating on Electronic Packages Technical Consultation Report</b>		Page #: 1 of 41

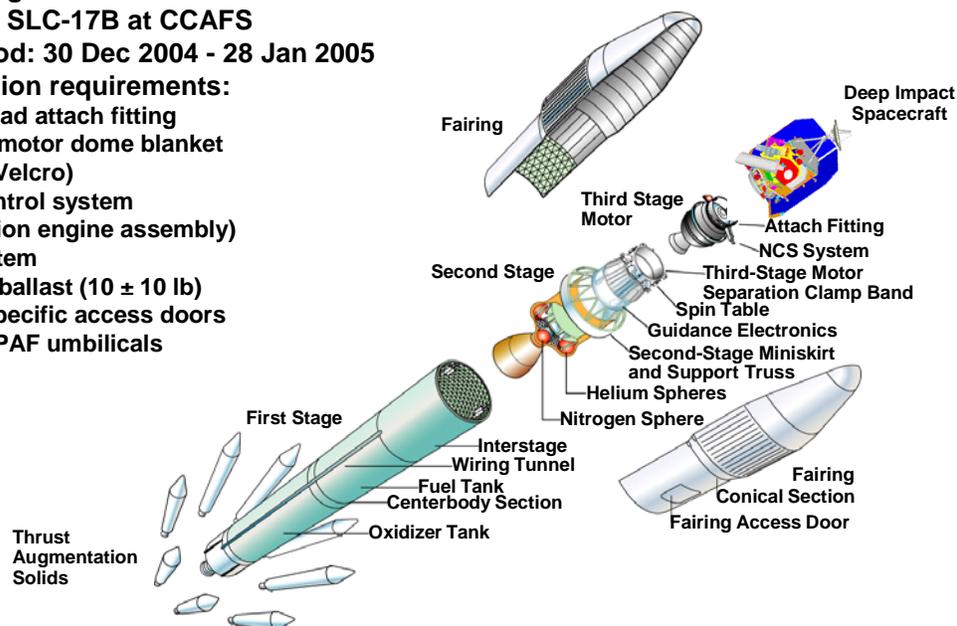
- Vehicle configuration: 7925-9.5
- Launch site: SLC-17B at CCAFS
- Launch period: 30 Dec 2004 - 28 Jan 2005
- Unique mission requirements:
  - 3712C payload attach fitting
  - Third stage motor dome blanket (with metal Velcro)
  - Nutation control system (37 lbf reaction engine assembly)
  - De-spin system
  - Third-stage ballast (10 ± 10 lb)
  - 2 mission-specific access doors
  - Two 37-pin PAF umbilicals

Figure 6.1-1. Deep Impact Launch Configuration

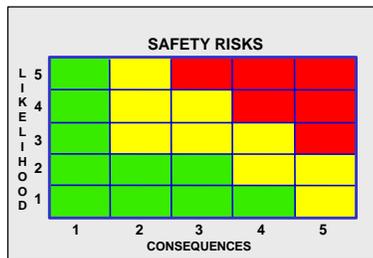
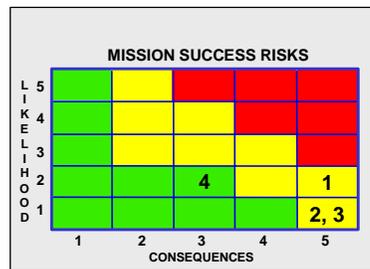
**Figure 6.3-1. KSC S&MA Deep Impact Residual Risk Assessment Summary**

The overall risk assessment performed by KSC S&MA is shown in Figure 6.3-1. The TFA crack issue was assessed as a medium residual risk item.

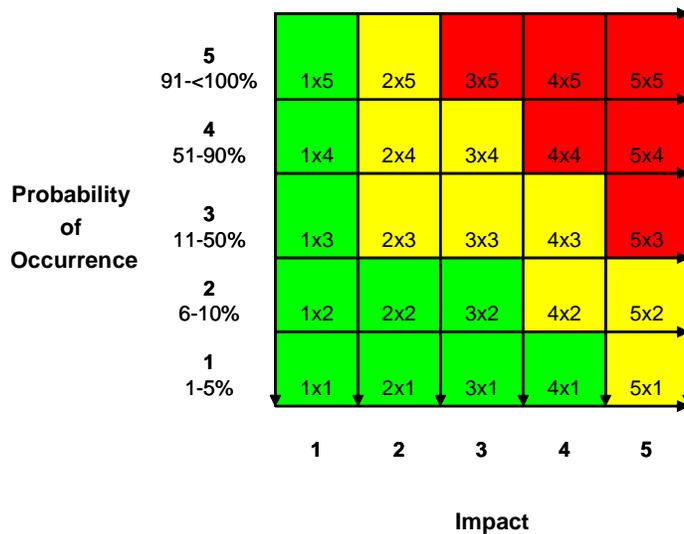
**Figure 6.3-3. LSP Risk Definition Matrix**

The LSP and the launch vehicle manufacturer used a risk assessment matrix as shown in Figures 6.3-2 and 6.3-3. An assessment of probability of an issue causing failure within 100 flights was made based on the judgment of program engineering.

SMA does not use the percentages shown

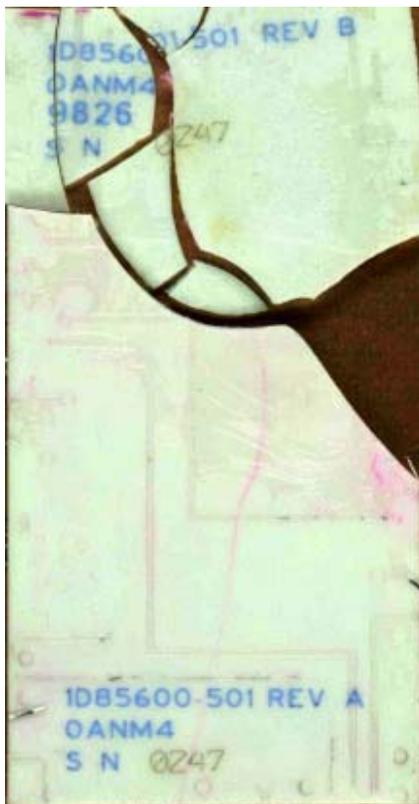
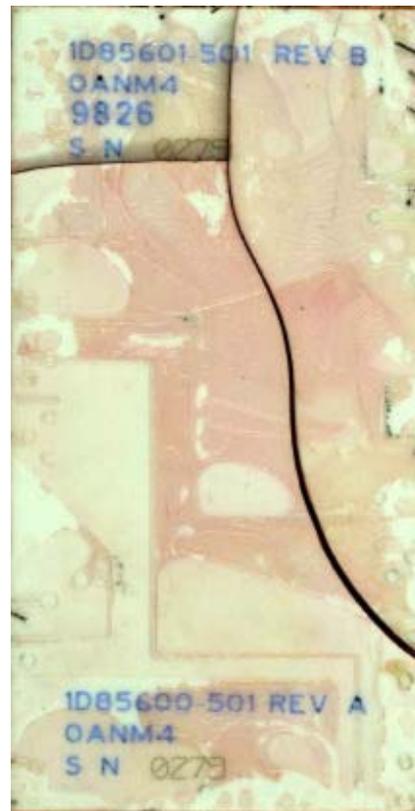
**Figure 7.1-1. Photographs show TFA Cracking**

*Note: Cracks exhibit brittle "glass-like" fractures. (Reference: NASA Presentation: "Cracked Thick Film Assemblies, Delta II, Stage 2 Servo Amplifier CCA EBR-02043, contributions by Thomas Bulk et al)*

The technical information, sent by the LSP to the team for review, includes pictures of two shattered TFAs (Figure 7.1-1) taken after removing the TFAs from their circuit cards. The pictures show completely disconnected shards of alumina. It seems impossible that traces crossing these fracture lines could have remained intact during all the stresses applied to them while these alumina substrates were still mounted to the circuit card. There should have been no problem detecting these cracks.

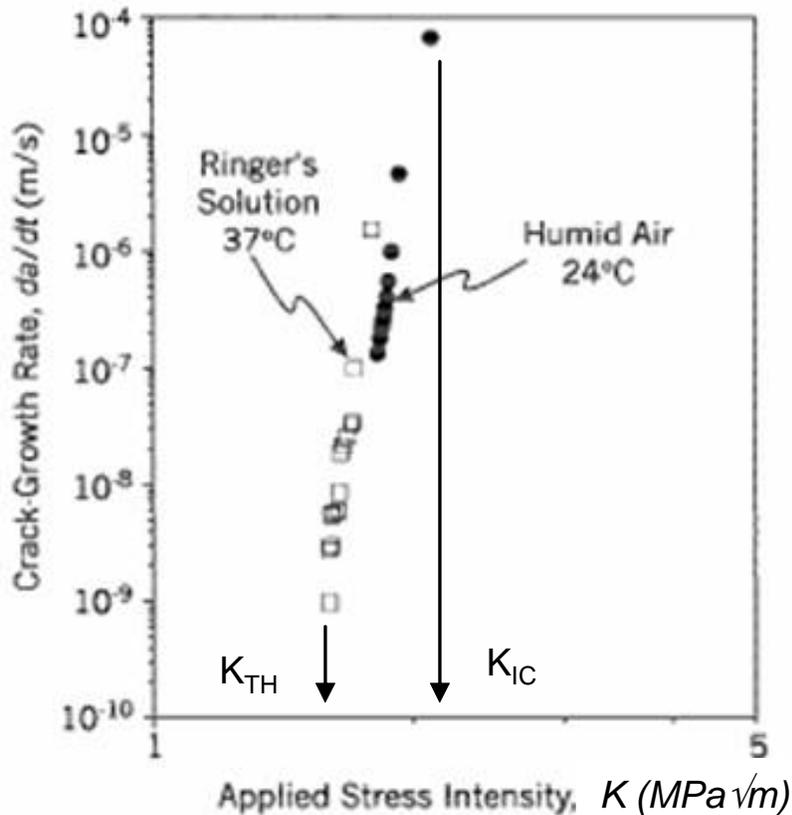
Figure 7.1-2. Crack Velocity Curve for Sapphire in both Moist Air and Ringer's Solution

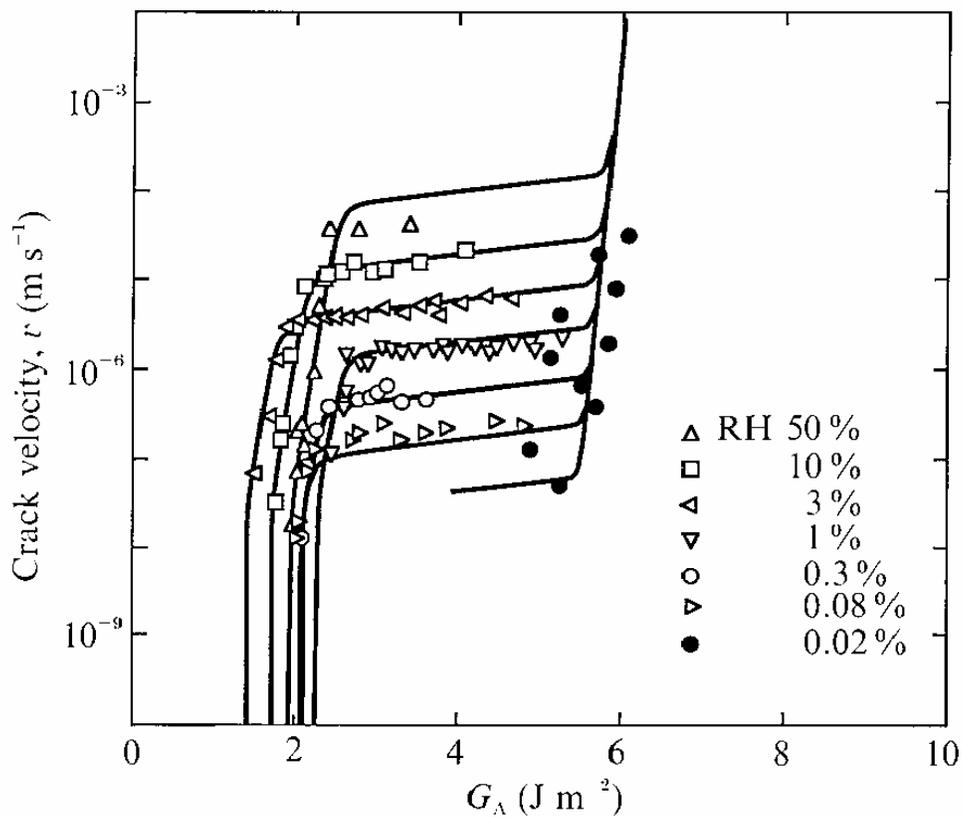
Figure 7.1-3. Crack Velocity Curves for Sapphire Exposed to Air showing Increased Crack Growth Velocity with Increased RH

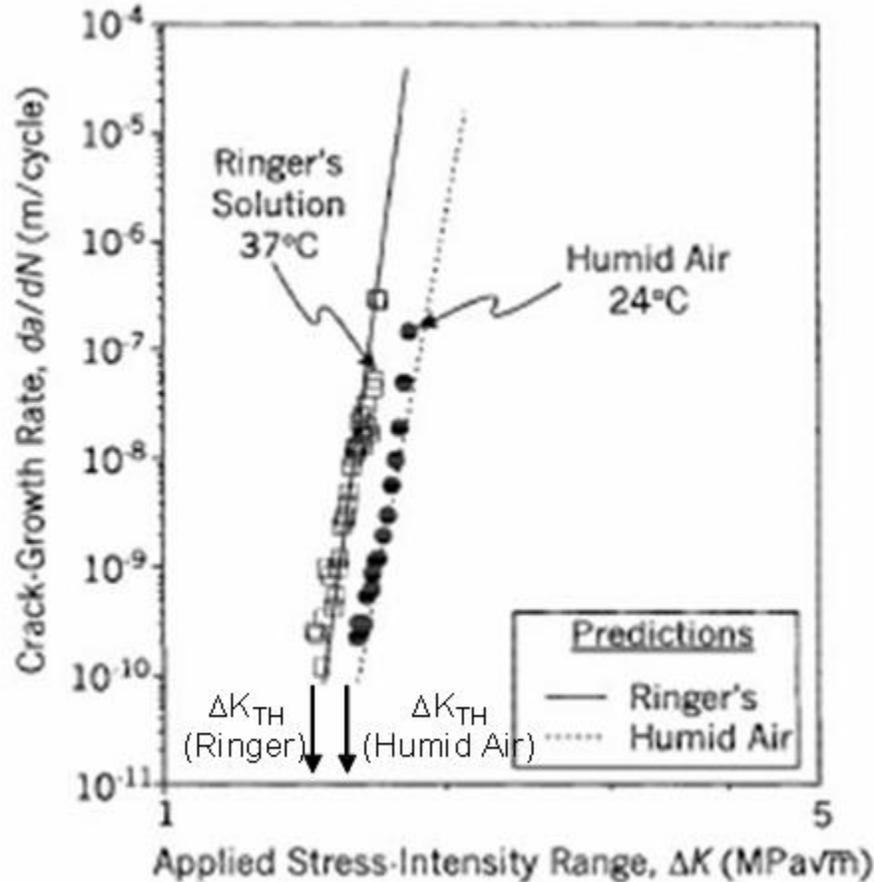
**Figure 7.1-4. Comparison of the Environmental Fatigue Crack Growth Characteristics of Sapphire in Moist Air and Ringer's Solution (NaCl, Na lactate, KCl, CaCl)**

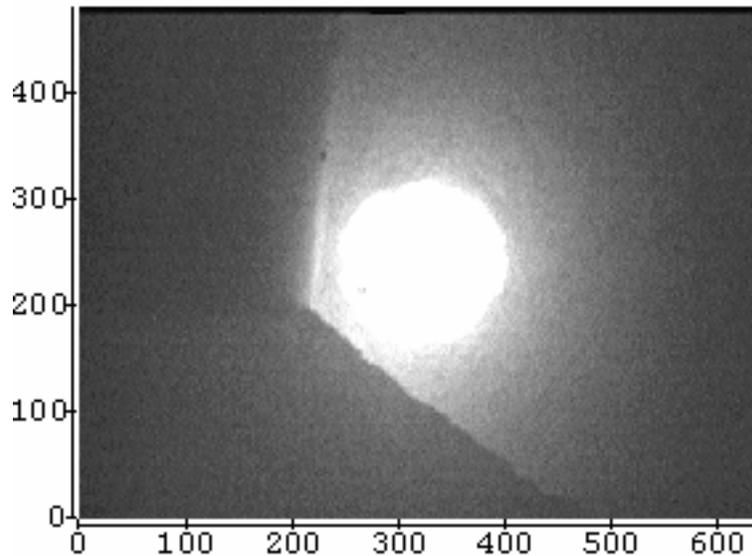
**Figure 7.1-5. Pair of Cracks at ~50X of a Slab of Alumina (V-shaped Cracks)**

Figure 7.1-6 is the same image, but mildly enhanced to better show the crack. This image is the ratio of Figure 7.1-5 to an image of precisely the same spot when used to illuminate a featureless region of the ceramic. These two figures illustrate how powerful this non-destructive inspection method is.

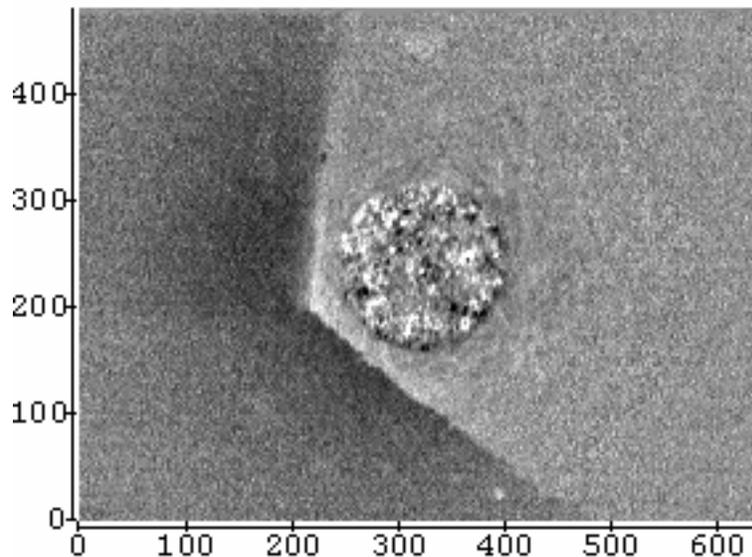
**Figure 7.1-6. Ratio of Figure 7.1-5: Closer View of Crack Image**

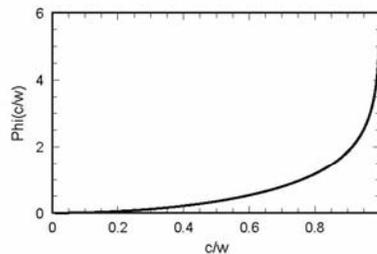
The factor  $\Phi(c/w) = - \ln [\cos(\pi c/2w)]$  is shown in the figure. (Note that  $\Phi > 0$ , since the cos-term is always less than unity and, thus, the logarithm is always negative.)

Figure 1:  $\Phi(c/w)$  versus  $(c/w)$

The usual case for a wire is that the length  $\ell$  is many times the width  $w$ , and so the relative increase is very small indeed. Consider a wire that is one foot long and has a square cross section with  $w = 0.05$  inches (close to #18); then,  $(4w)/(\pi \ell) = 0.0053$ . An increase in the resistance by 1% requires  $\Phi = 1.88$ , or  $c/w = 0.903$ . That is, the cut must extend to 90.3% of the width in order to increase the resistance of this choice of wire by 1%.
