# Effectiveness of Catch Basins Equipped with Hoods in Retaining Gross Solids and Hydrocarbons in Highway Runoff, Southeast Expressway, Boston, Massachusetts, 2008-09

Scientific Investigations Report 2010-5182

By Kirk P. Smith

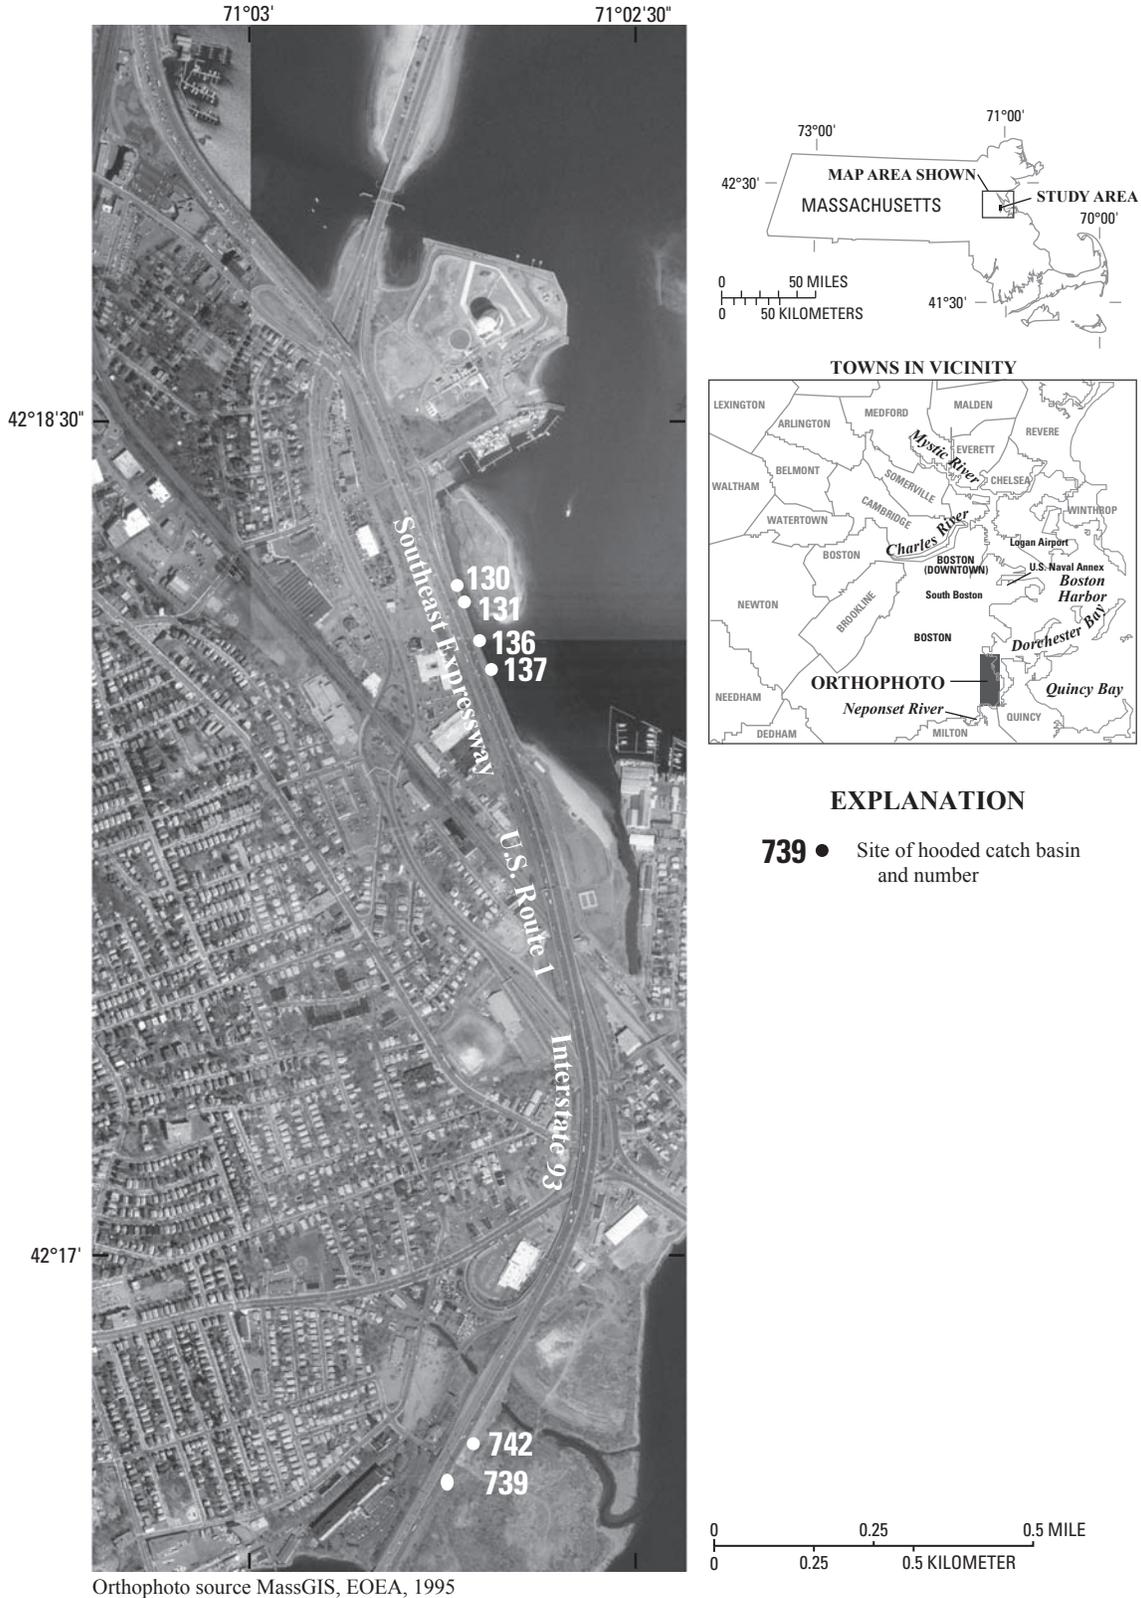
Figure 1. Study area with hooded catch basins, Southeast Expressway in Boston, Massachusetts.

The study area is composed of two northbound sections of the Southeast Expressway near the Neponset River and Tenean Beach in Boston, Massachusetts (fig. 1). Within the study area, deep-sump catch basins provide primary treatment for highway runoff. Highway runoff collected by the catch basins either is discharged to the embayment near Tenean Beach or infiltrates in the ground at the toe of the highway embankment. The two segments of highway that contain the hooded catch basins monitored in this study are about a mile apart.

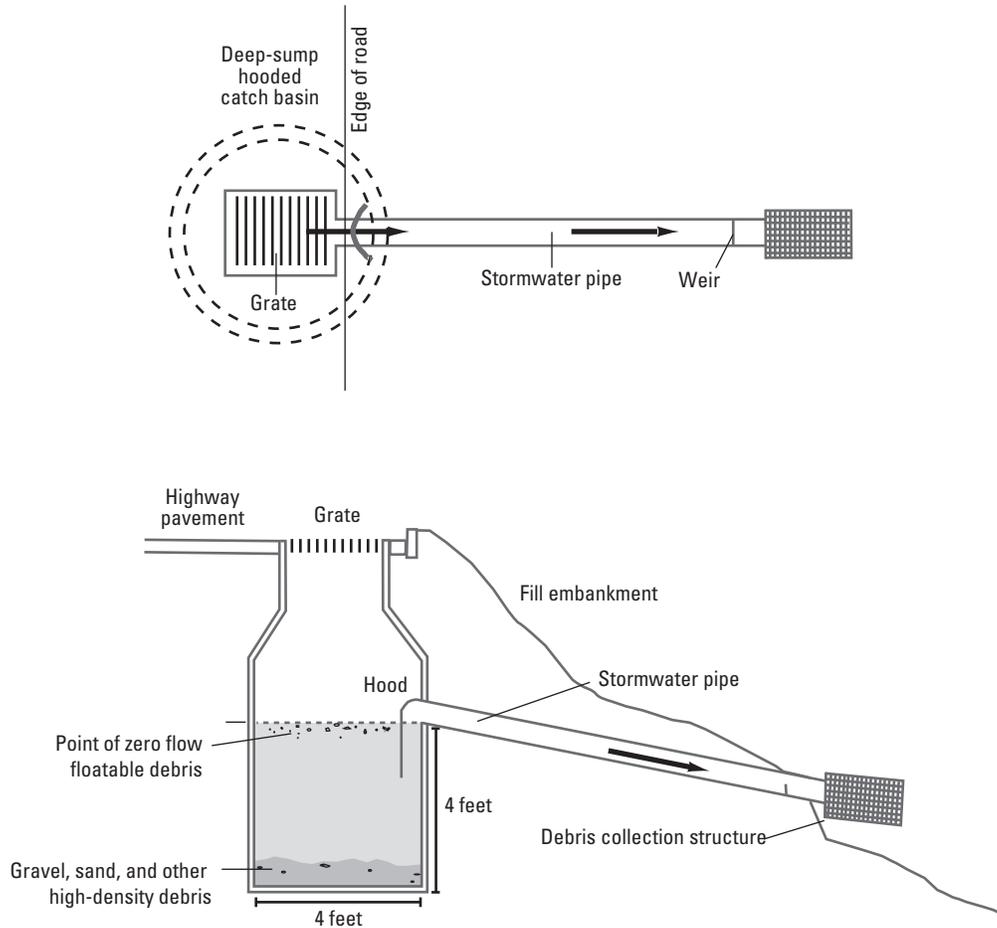
**Figure 2.** Schematic diagram of a deep-sump off-line hooded catch basin and location of the weir and debris collection structure.

Catch basins are circular concrete containers below the highway with steel grates at the pavement surface (fig. 2). The catch basins monitored along the Southeast Expressway have sumps (that is, storage area below the outlet pipe) that are 4 ft deep and are termed deep-sump catch basins. The catch basins do not contain curb inlets, and the grates cover the entire inlet. The initial catch-basin grates (fig. 3) contained 2 rows of 10 open parallel slits (1.2 in. by 9.4 in.); however, the highway was resurfaced about halfway through the study period (August), and the grates were replaced. The new grates (fig. 4) contain 36, 2.4 in. by 2.4 in. square openings. Prior to this study, each catch basin was equipped with a hinged cast-iron hood which fit over the catch-basin sump outlet. The hood loosely encapsulates the outlet opening and extends about 0.5 ft below the bottom of the outlet. As part of this study, cast-iron hoods were removed from four catch basins, and hoods of more recent designs were installed according to the manufacturers' specifications.

basins (fig. 2) located on the right-most northbound lane on the Southeast Expressway at sites 131, 136, and 739. The monitoring site at catch basin 739 was configured to measure and record rainfall, as well as the water level in the outlet of the catch basin. This monitoring site also was configured to collect water samples at the outlet of the catch basin for the analysis of concentrations of OG and TPH. Programmable water-level sensors also were installed in the catch basin outlet at sites 131 and 136. The Eliminator hoods (fig. 5B) and the single Snout hood (fig. 5C) were installed after the catch basins were cleaned. Cast-iron hoods were left in place at the remaining two catch basins. Debris collection structures were installed at each of the six monitoring sites after the catch basins were cleaned (fig. 2). These cylindrical devices (fig. 6) were constructed from 0.25-in. galvanized mesh screen. The

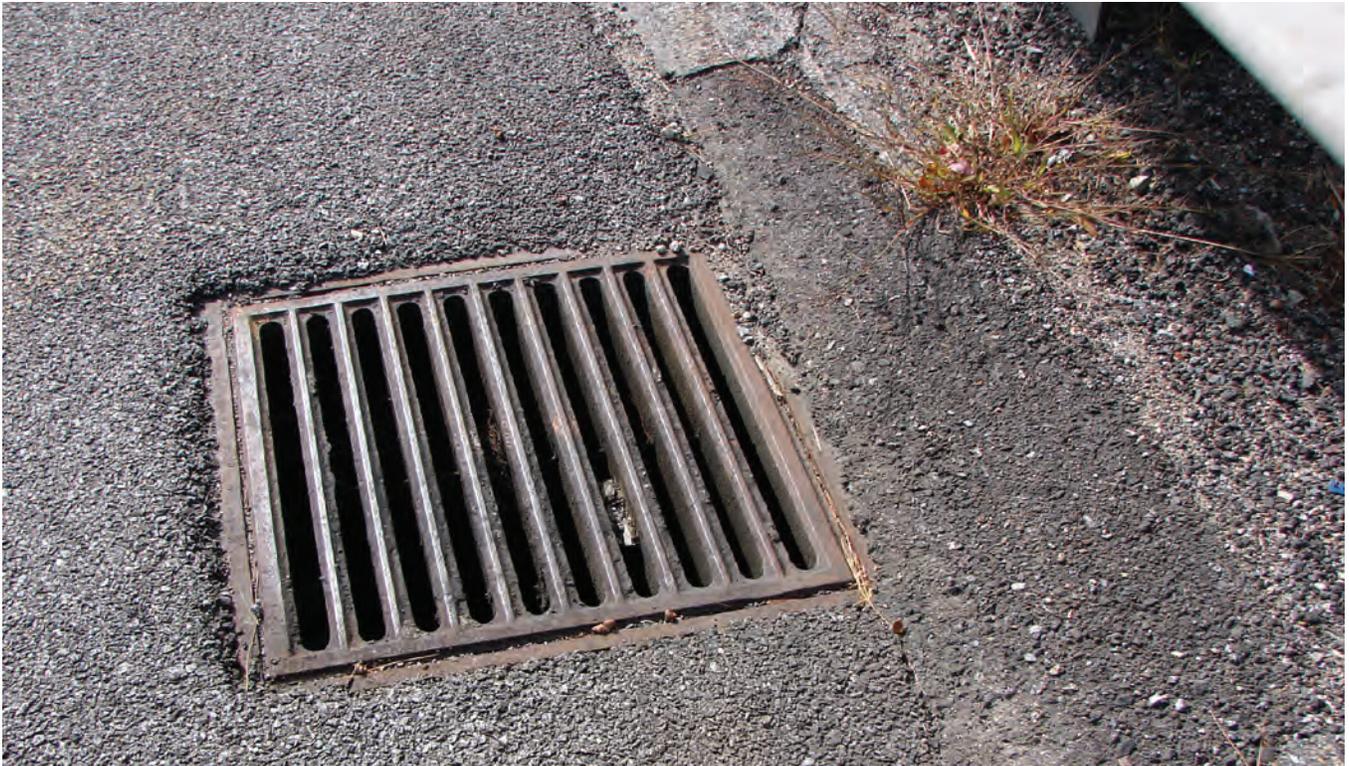
**Figure 3.** Grate installed on a catch basin along the Southeast Expressway in Boston, Massachusetts, at start of the study.

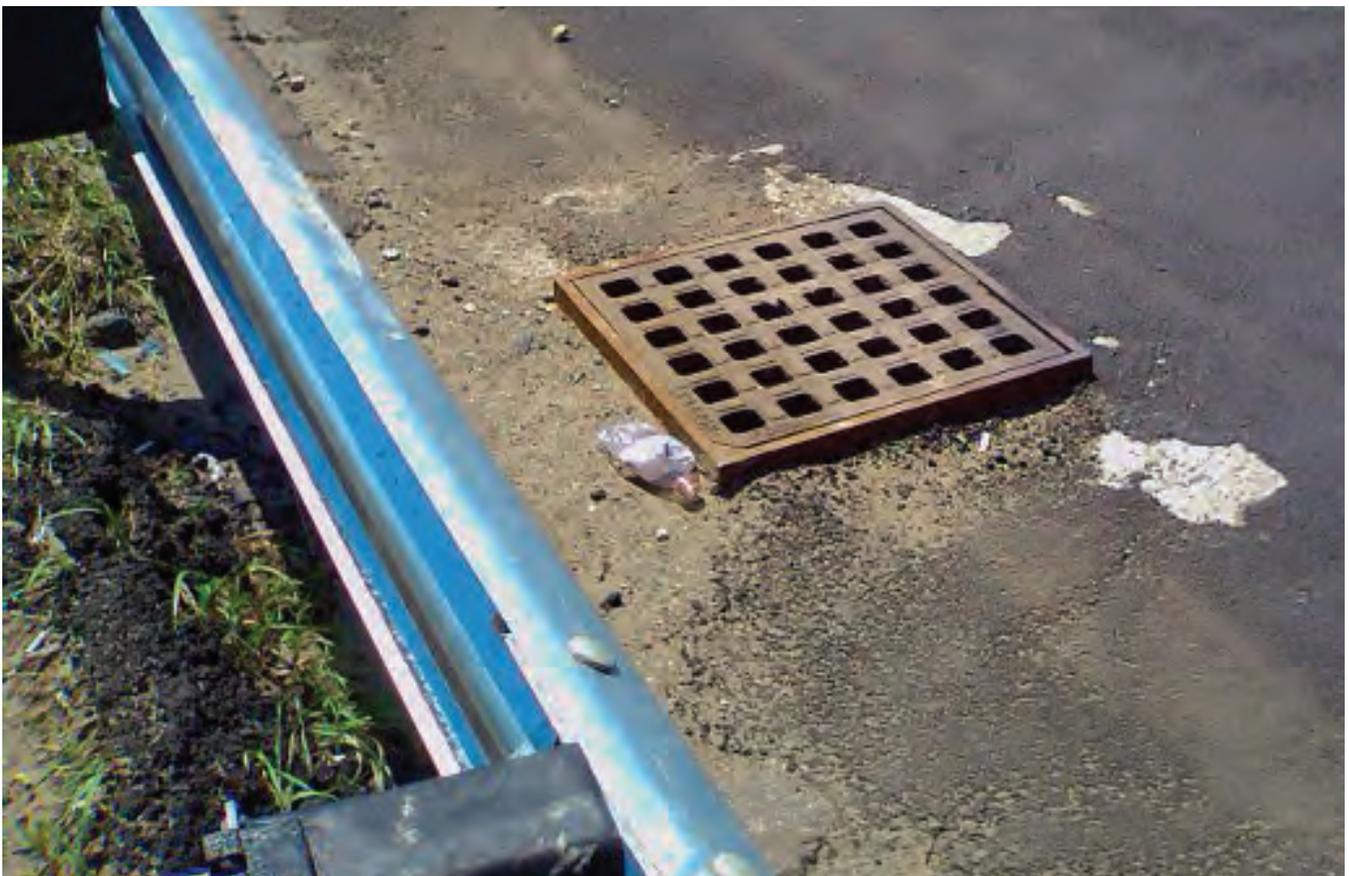
**Figure 4.** Grate installed on a catch basin along the Southeast Expressway in Boston, Massachusetts, during resurfacing of the highway.

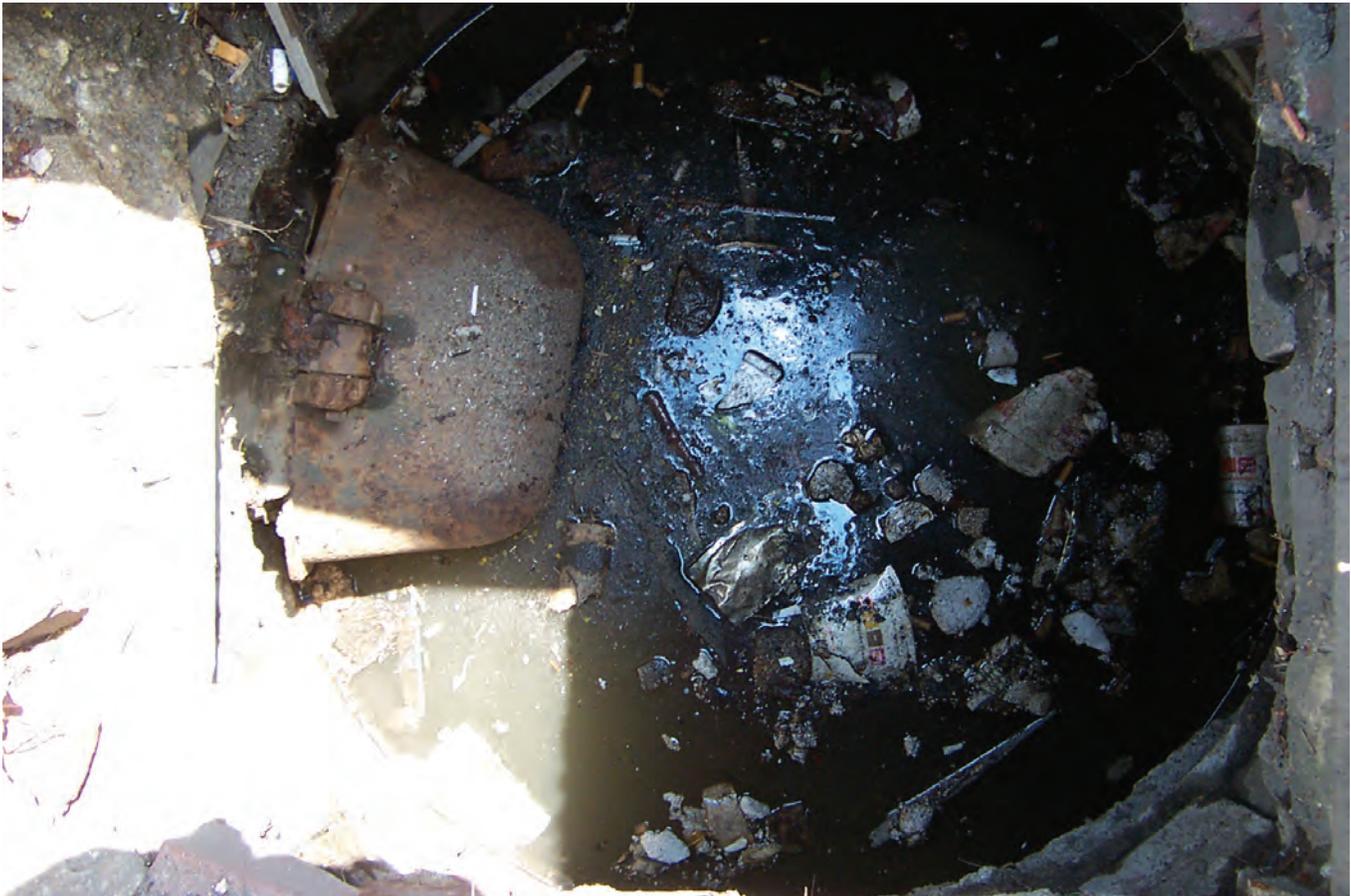
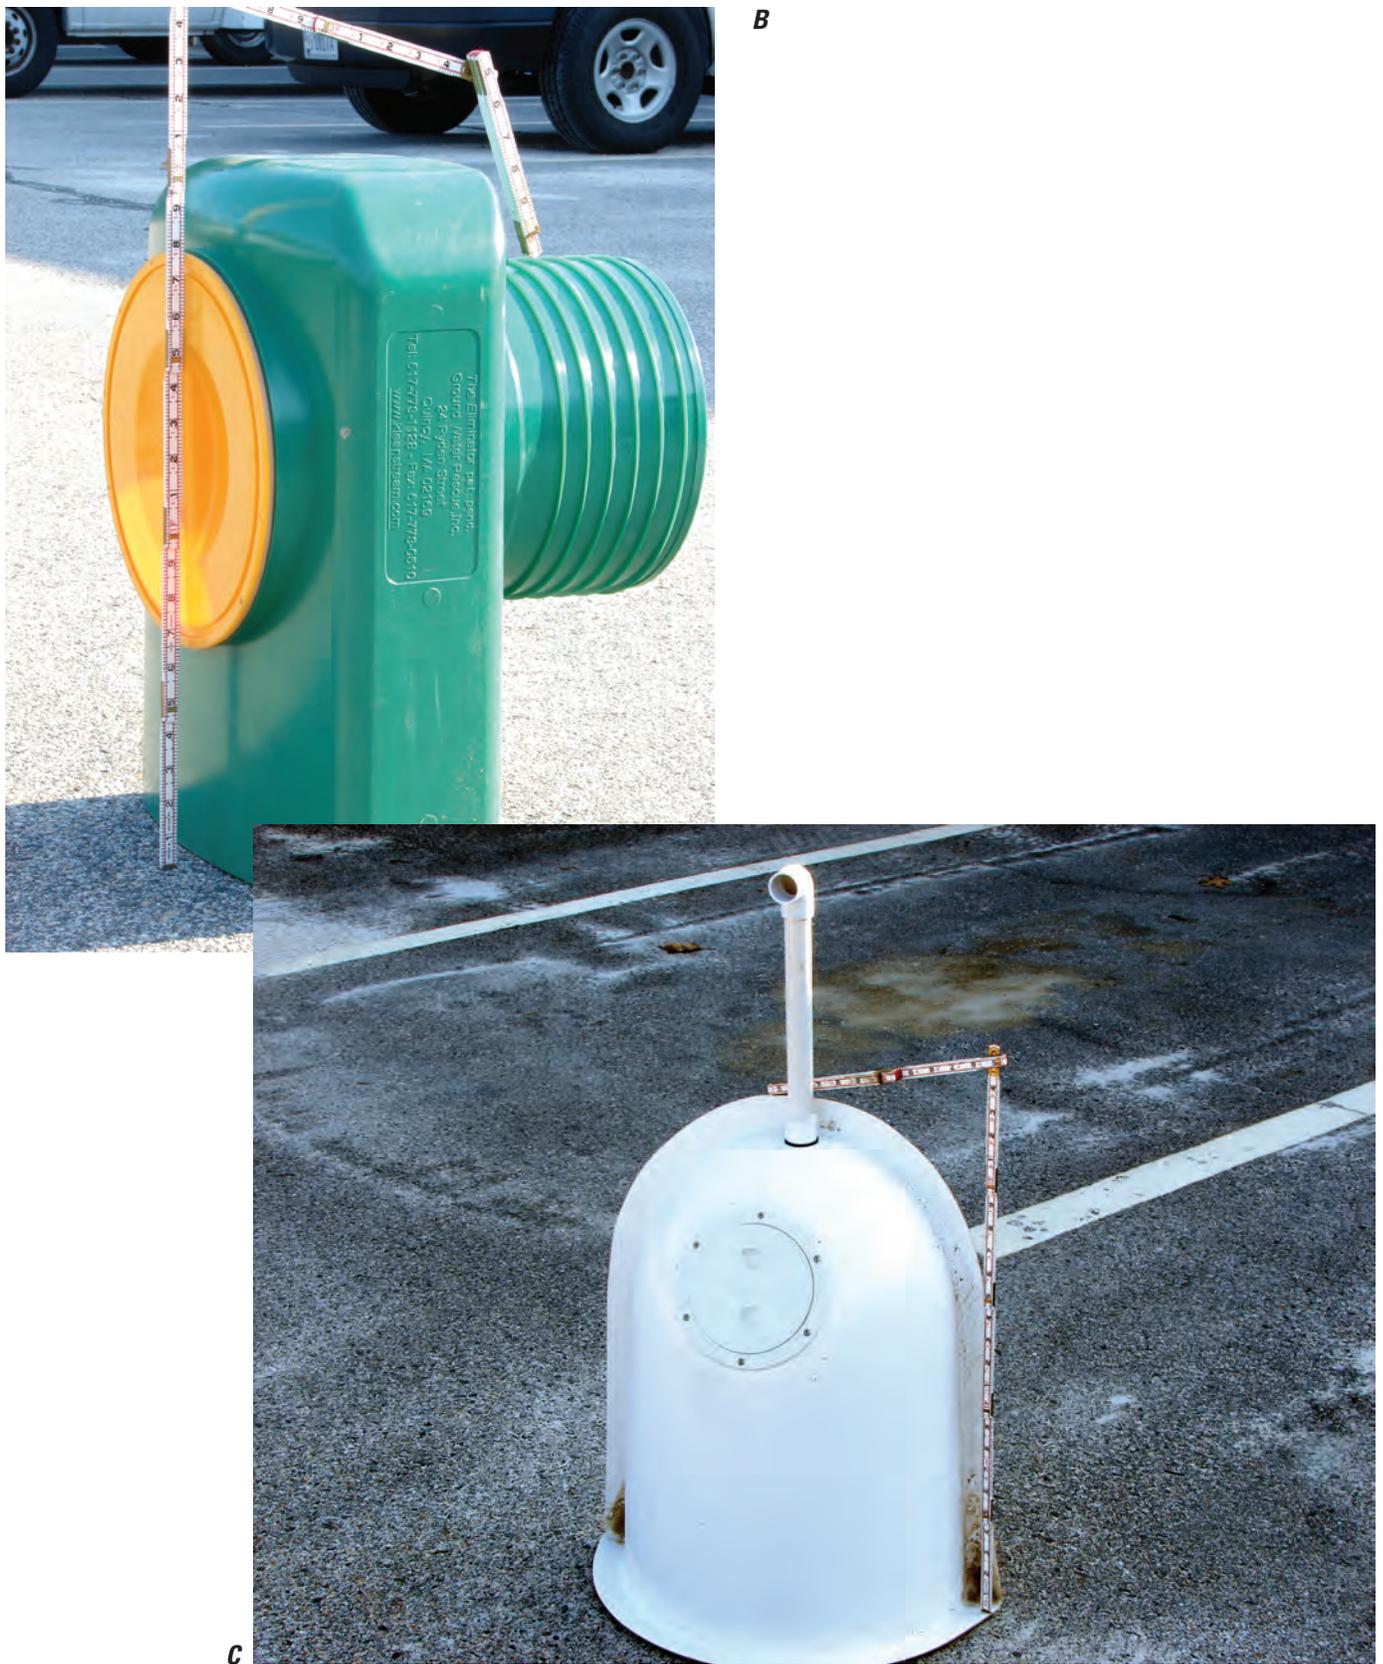
A

**Figure 5.** A, standard cast-iron hood typically used along the Southeast Expressway, B, an Eliminator hood, and C, a Snout hood, which were tested along the Southeast Expressway in Boston, Massachusetts, 2008.

On the basis of the previously defined criteria, six deep-sump, off-line catch basins were selected for monitoring gross highway solids (table 1). The cast-iron hoods (fig. 5A) were left installed in two catch basins (sites 131 and 742). Three molded plastic hoods, known as Eliminator hoods (fig. 5B), were installed at monitoring sites 136, 137, and 739, and a single fiberglass anti-siphoning hood, known as a Snout (fig. 5C), was installed at monitoring site 130. The design of the Snout hood requires the device to be mounted flush with the catch-basin wall. Unfortunately, the interior walls of many of the catch basins were deteriorated, and sub-drain pipes

the loose fit of the cast-iron hood, the Eliminator hood fit tightly in the outlet pipe of the catch basin, and as a result, this device could retain floating oil and grease in the catch-basin sump under static conditions. However, the concentrations of OG and TPH in samples of highway runoff were not substantially different from those concentrations measured in samples of highway runoff collected from catch basins containing cast-iron hoods, which have no ability to retain floatable oils and grease. Furthermore, the similarity between the concentrations of the respective constituents in the vertical profile sample collected from the sump at the conclusion of storm sampling and the concentrations measured in samples of highway runoff indicates that the load for each constituent discharged from the catch basin dwarfs what was remaining in the sump of the catch basin. For example, the load of OG and TPH measured at the outlet of catch basin 739 for just the five storms sampled in this study was more than 80 times greater than the load remaining in the sump of the catch basin in April 2009, about 5 months after the catch basin was cleaned. These data indicate that OG and TPH become emulsified in the sump of each catch basin during storms and circumvent the hoods. However, during static conditions, the Eliminator hood, and presumably the Snout hood as well, potentially could retain more than 6 ft<sup>3</sup> of floatable oils (assuming a catch basin 4 ft in diameter and a hood depth of about 0.5 ft below the catch-basin outlet) that result from breached fuel tanks or other lubricant reservoirs as the sump water is displaced by a floating layer of product less than or equivalent to the depth of the hood below the catch-basin outlet. If the depth of the floating product exceeds the bottom of the hood, the product will begin to discharge from the catch basin.

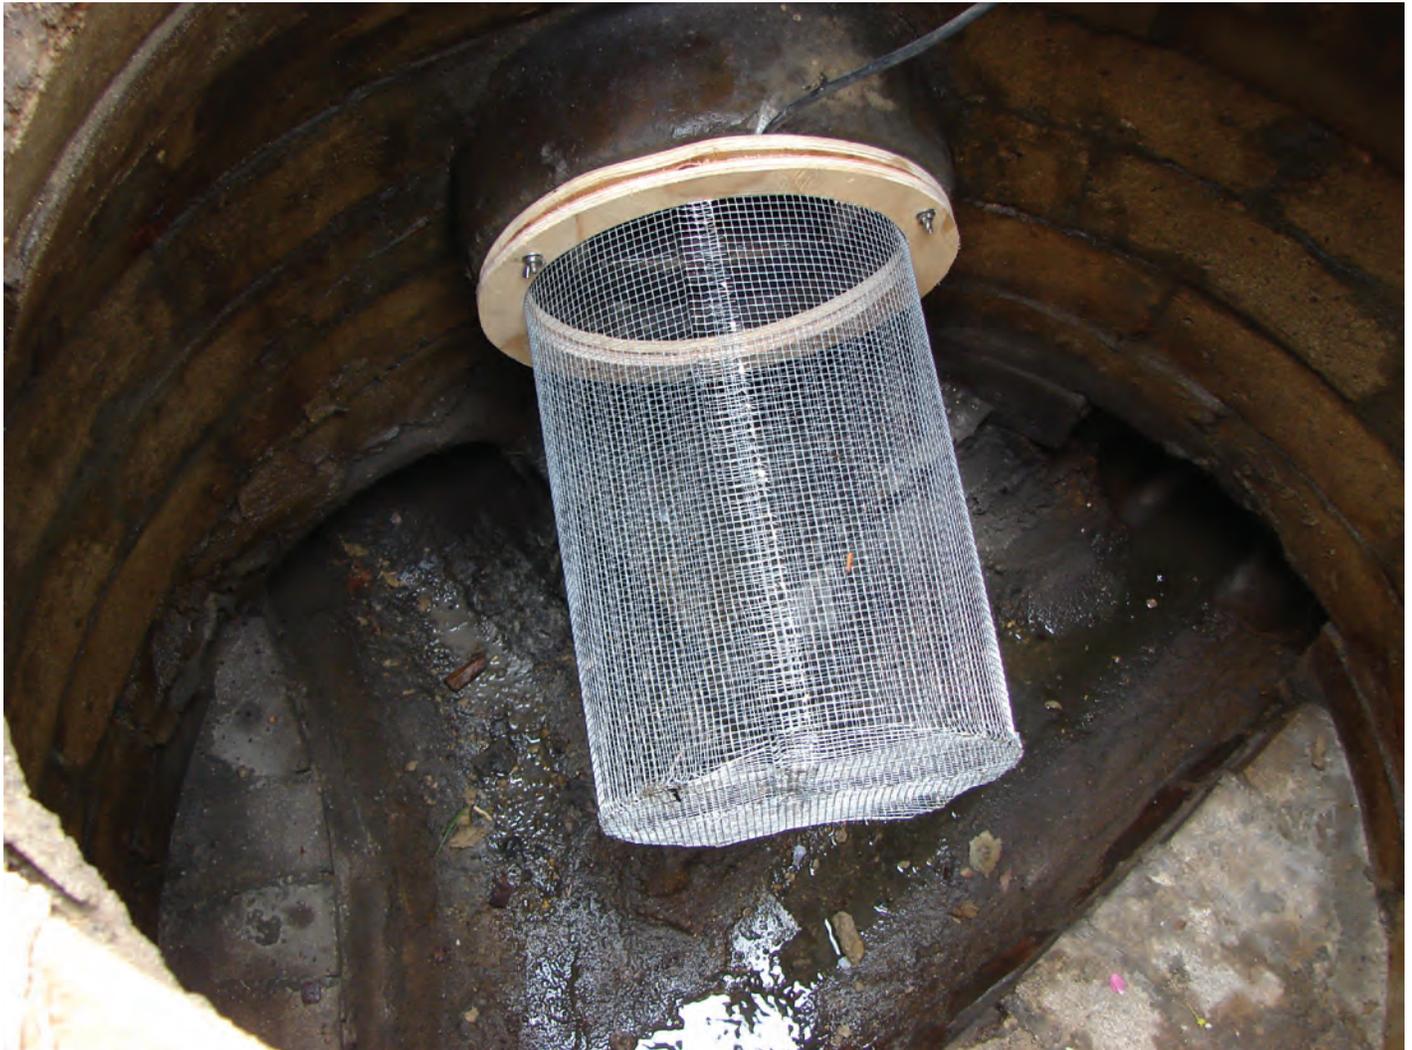
**Figure 6.** A typical debris collection structure attached to the catch-basin outlet pipe along the Southeast Expressway in Boston, Massachusetts, 2008.

screen was sandwiched between two plywood rings at the open end of the device. These rings were secured to the end of each pipe with bolts and wing nuts.

Gross solids were retrieved about every week from each collection structure (fig. 6) at the end of a storm or series of storms. Solids removed from each device were placed in bags and transported to the USGS Massachusetts Water Science Center. Seed materials were removed from the mass of solids and tabulated. The mass of captured material from each catch-basin outlet was determined by drying the contents (less any seed material) at 105 degrees Celsius (°C) to a constant weight in a laboratory oven over a period of several days (table 3). The contents of each sample of dried solids were identified by visual inspection. Identifiable materials were placed in general categories, such as cigarette butts, plastics (wrappers, Styrofoam, and other plastics), and natural vegetation matter. The net weight for each category of each sample was measured and recorded to the nearest 0.01 milligram (table 4). Once all samples were processed, the individual samples of

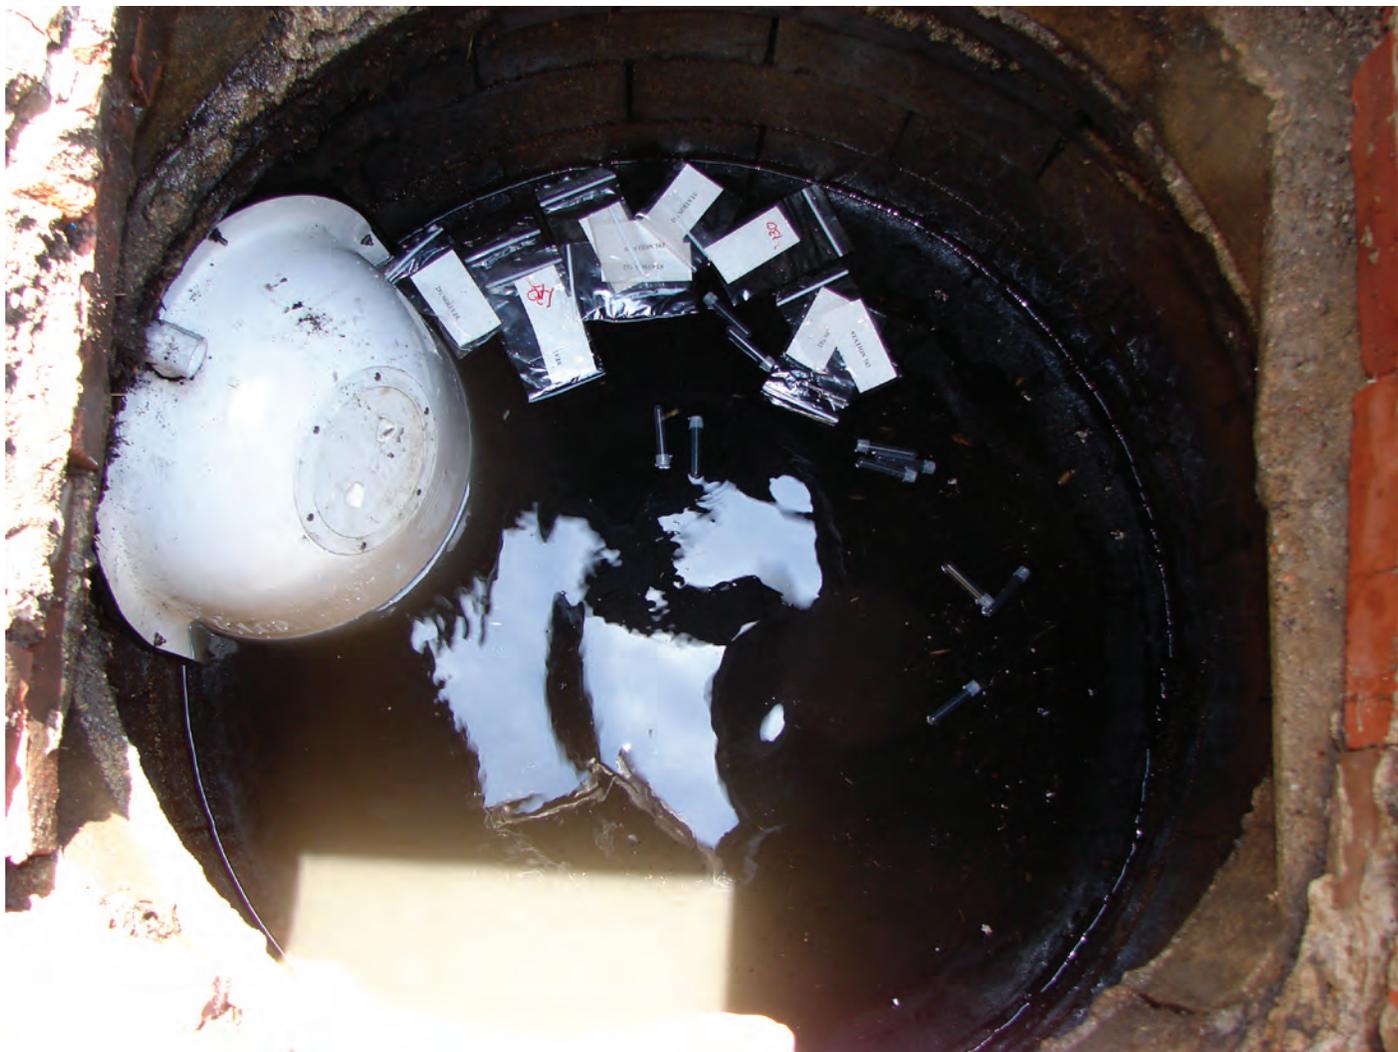
**Figure 7.** Seed materials added to the sump of catch basin 130 along the Southeast Expressway in Boston, Massachusetts, 2008.

Following the installation of the new hoods and the occurrence of one or more storms, two types of floatable seed material were added to each of the catch basins (fig. 7) once the water in each catch basin resumed a normal static level. These materials included small sealed zip-lock bags (4 x 6 inches) with a label inside and small plastic tubes that were slightly larger in diameter than a cigarette or pen. These seed materials were quantified after each sample collection and again at the end of the field study to help determine the effectiveness of each hood in retaining standardized floatable materials.

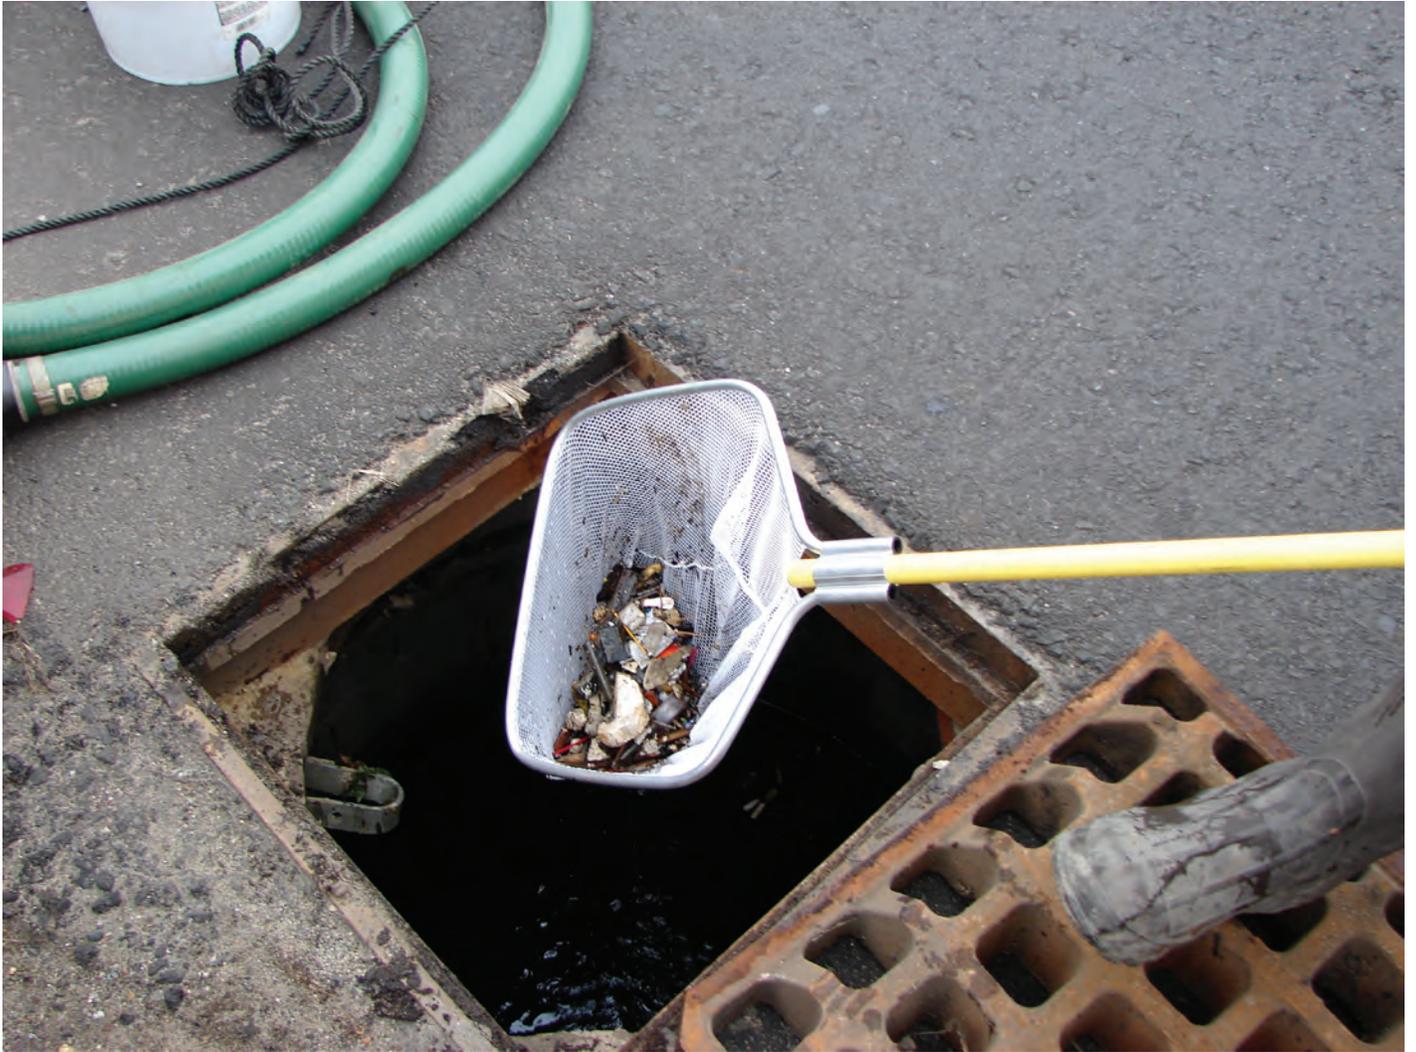
**Figure 8.** Floatable materials collected in a net from catch basin 739 on the Southeast Expressway in Boston, Massachusetts, 2008.

At the end of the solid-monitoring phase of the study, all floatable debris were removed with a net (fig. 8) from each catch basin, except for the catch basin at site 131, which did not have standing water in the sump. The remaining sump contents were removed one catch basin at a time with a vacuum truck. The sump deposits beneath the hoods were removed manually because there was insufficient room in the catch basin to angle the intake for the vacuum pipe under the hoods. The tank on the vacuum truck was cleaned prior to each

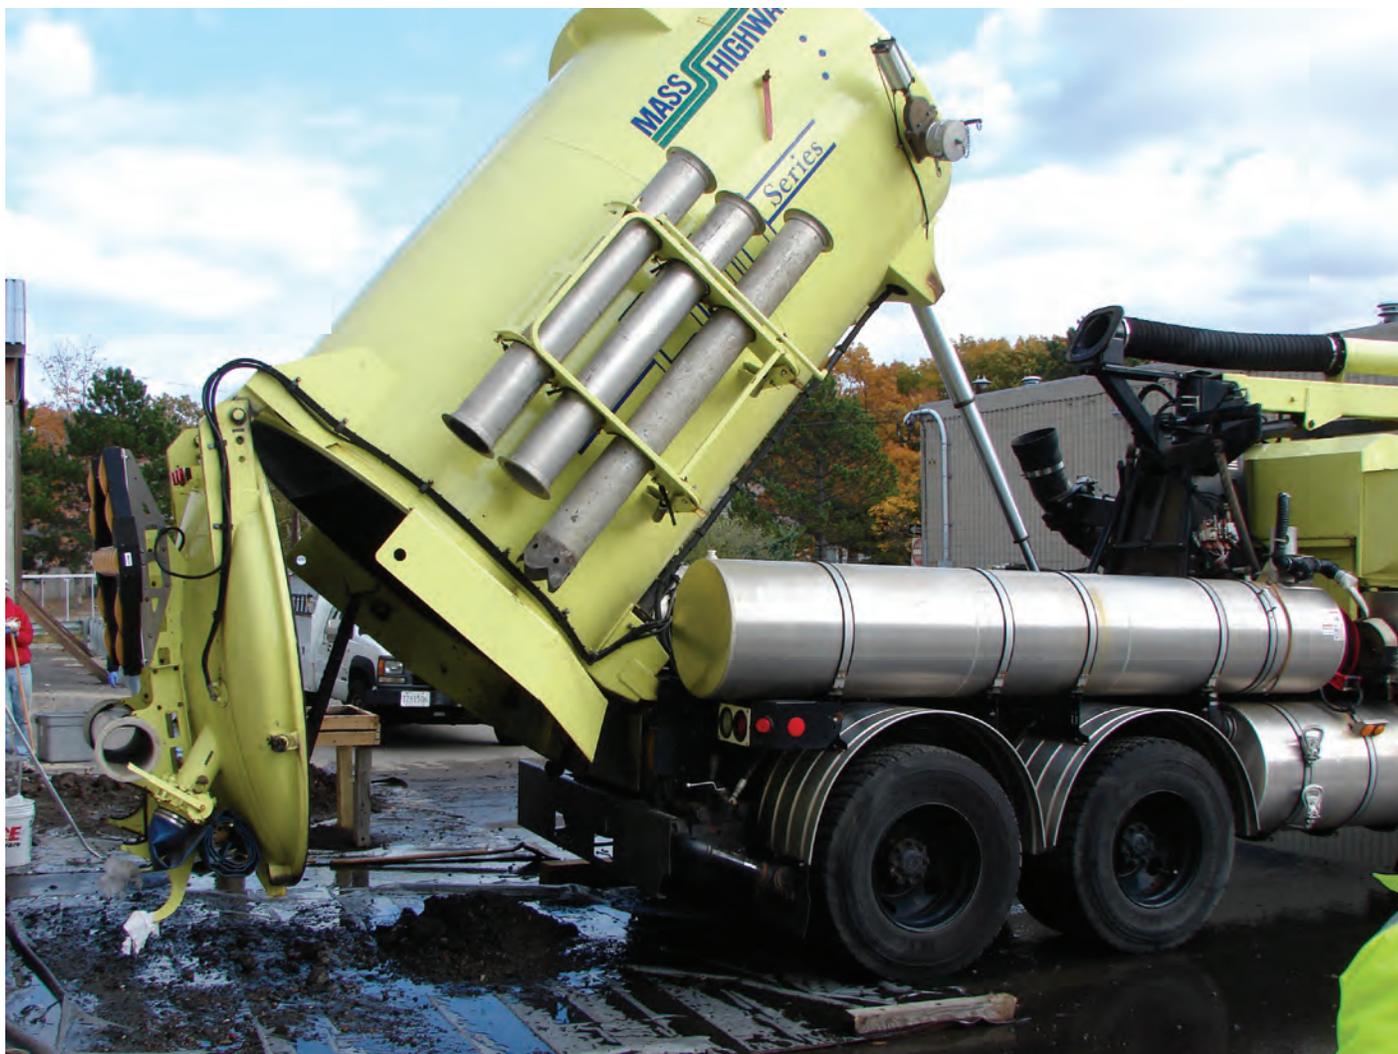
**Figure 9.** A vacuum truck emptying the entire contents of a single catch basin on a tarp prior to sample processing.

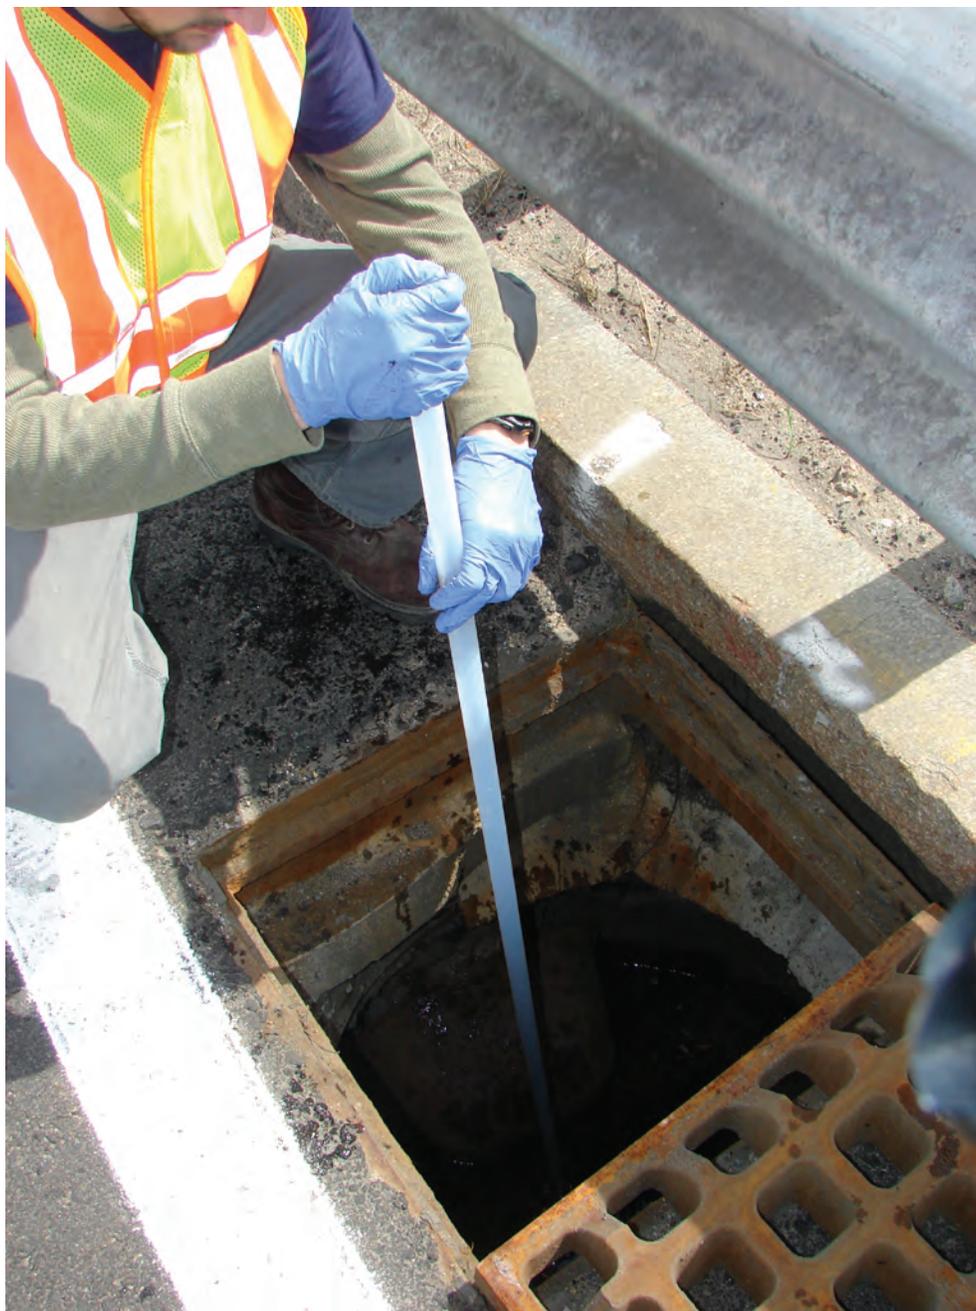
**Figure 10.** A vertical water-column sample being collected with a Teflon dip-stick sampler from catch basin 739 on the Southeast Expressway in Boston, Massachusetts, 2009.

the sump water at each catch basin. A sample of the water column also was collected from the catch basin at site 739 in April 2009 using a Teflon dip-stick sampler (fig. 10). The dip-stick sampler consisted of a 7-ft Teflon pipe with a valve containing four 0.25-in. holes set 90 degrees from each other at the bottom and a closure at the top. The sample of water was collected by slowly lowering the device from the water surface to the sump floor at which point the top of the device was sealed, the sampler was removed, and the contents were dispensed directly into a precleaned bottle. This process was continued until sufficient water was collected for analysis. Finally, five flow-weighted composite samples of highway runoff were collected from the outlet of catch basin 739 from December 2008 to April 2009.

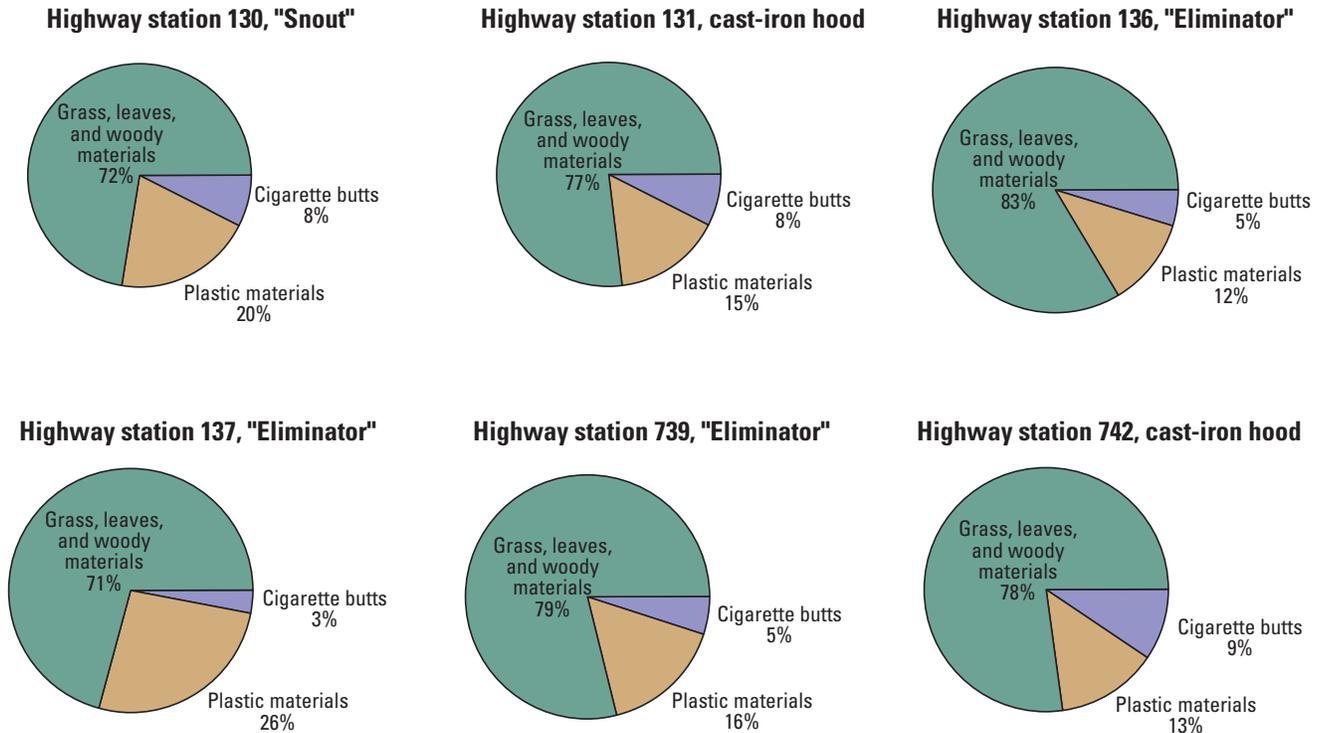
**Figure 11.** Pie chart showing the distribution of highway solids collected from the outfalls of six deep-sump off-line hooded catch basins along the Southeast Expressway in Boston, Massachusetts, May through November 2008.

The distribution of identifiable materials collected from the outlets of the six catch basins was similar (fig. 11). From 71 to 83 percent of all solids collected at the outlets of the six catch basins was natural vegetation matter. These distributions are similar to results for highway locations listed in other studies (Kim and others, 2006; ASCG, Incorporated, 2005; Kim and others, 2004). If the calculation for the effectiveness of the catch basins equipped with hoods is restricted to low-density anthropogenic materials (that is, floatable litter and automobile refuse) that are not readily biodegradable, the effectiveness for most hooded catch basins increases (table 5, anthropogenic low-density solids). Although such omissions seemingly improve the perceived effectiveness of the catch basins, natural organic matter will decompose and release nutrients and other constituents into the receiving water body, and therefore, natural organic matter should be included as objects of concern. Previous research indicates that the effectiveness for deep-sump hooded catch basins may be improved with more frequent catch-basin maintenance (USEPA, 1999a); however, this may be impractical given the small amount of gross solids measured weekly (< 100 grams) in the catch basin outlets during this study.

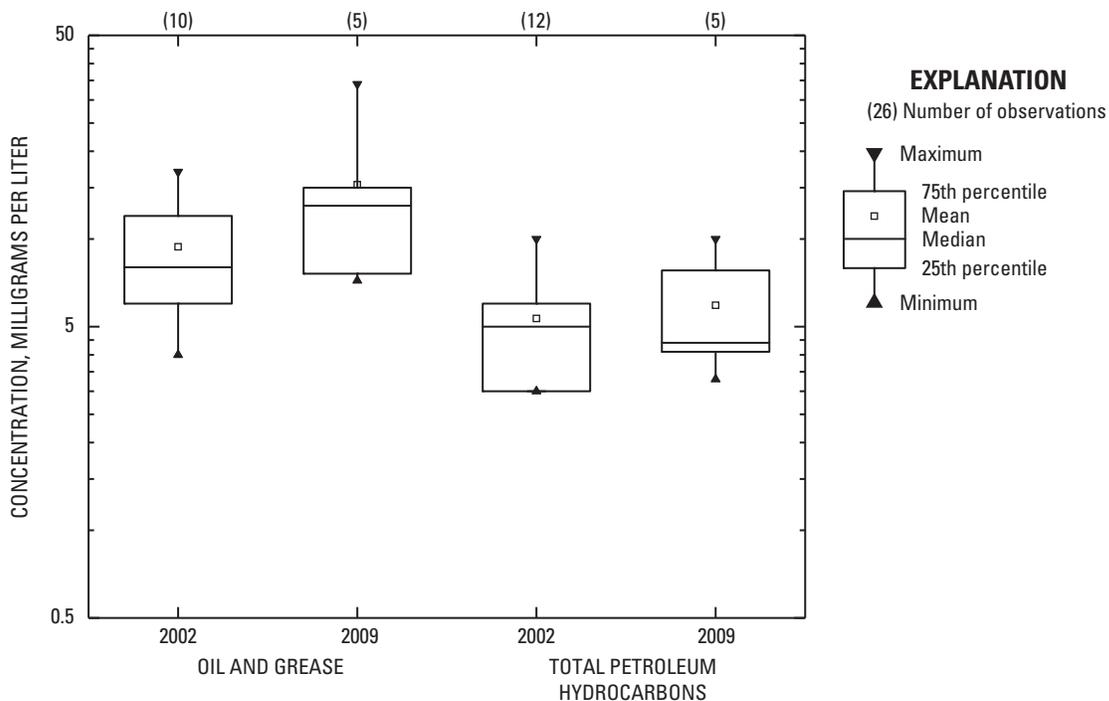
**Figure 12.** Box plot of the distribution of concentrations of oil and grease, and total petroleum hydrocarbons, measured in composite samples, collected in a prior U.S. Geological Survey study (Smith 2002), of highway runoff discharged from deep-sump off-line catch basins containing cast-iron hoods and those measured in composite samples of highway runoff discharged from a deep-sump off-line catch basin equipped with an Eliminator hood collected in this study (2009) along the same section of road on the Southeast Expressway in Boston, Massachusetts.
