**Second U.S. Nuclear
Regulatory Commission
International Steam Generator
Tube Integrity Research
Program**

Final Project Summary Report

Argonne National Laboratory

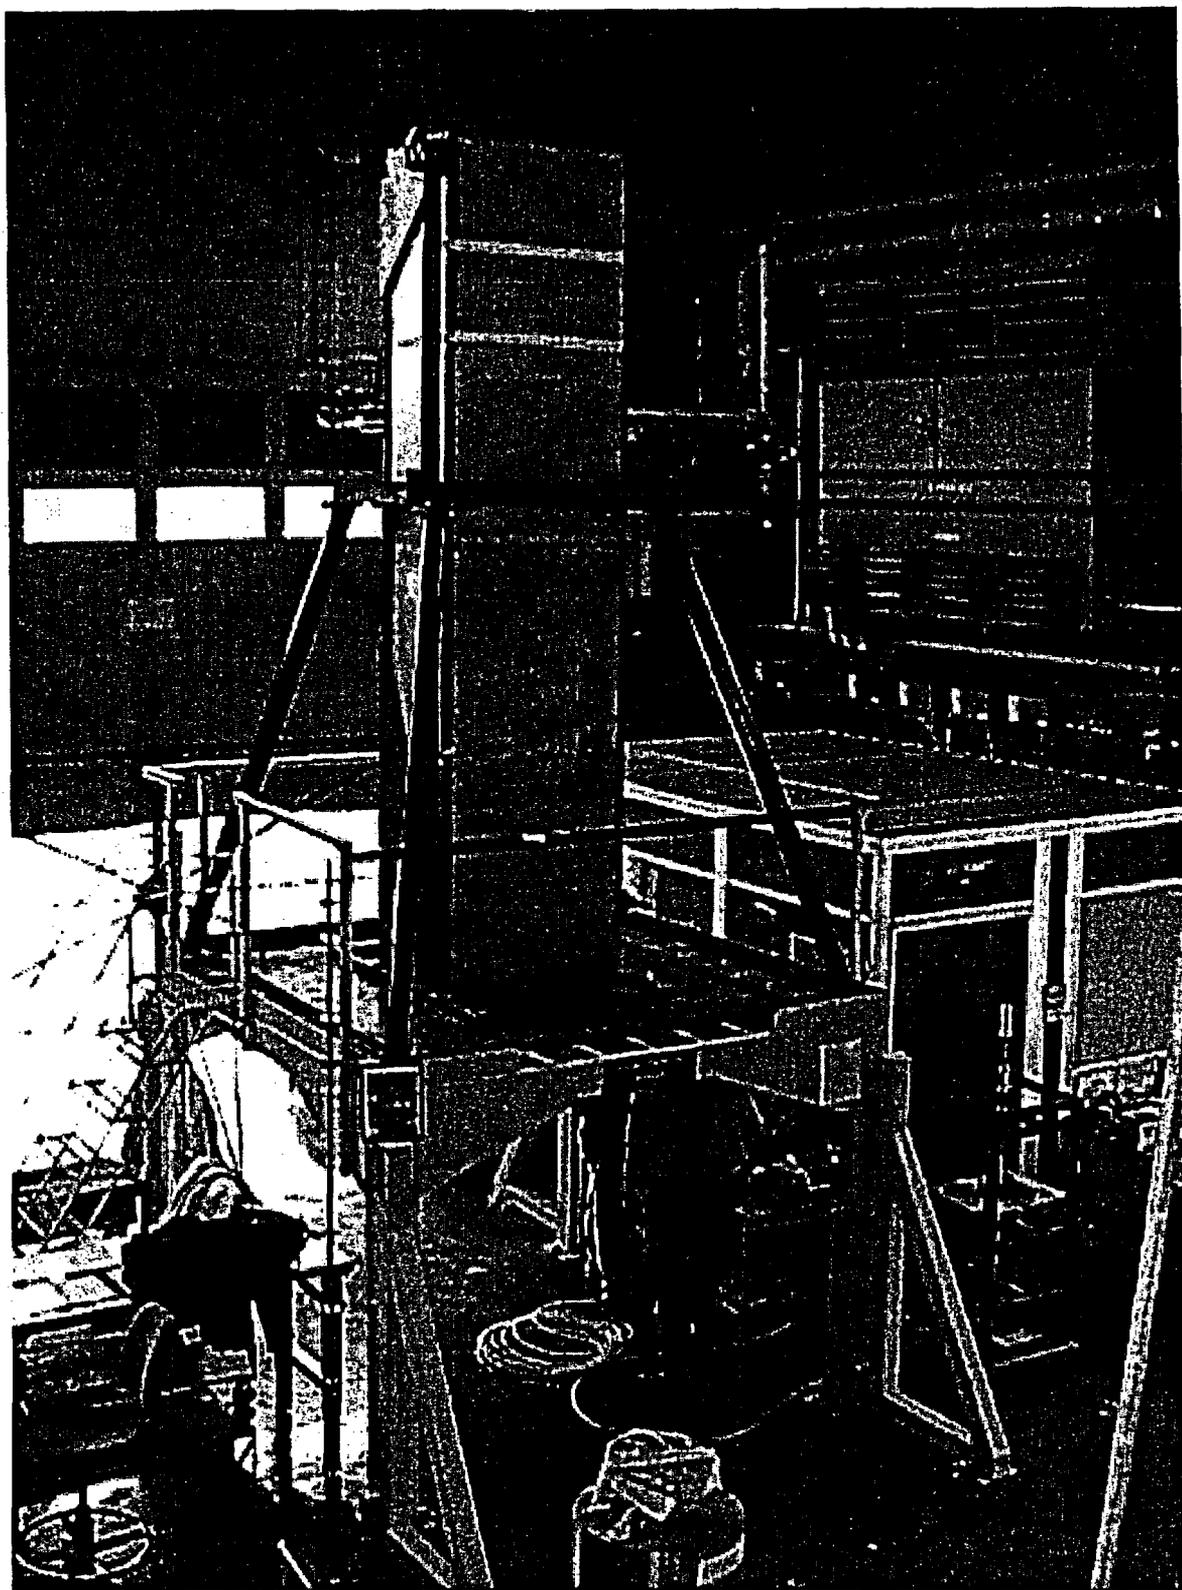
Figure 2.2. Photograph of mock-up during acquisition of eddy current data.

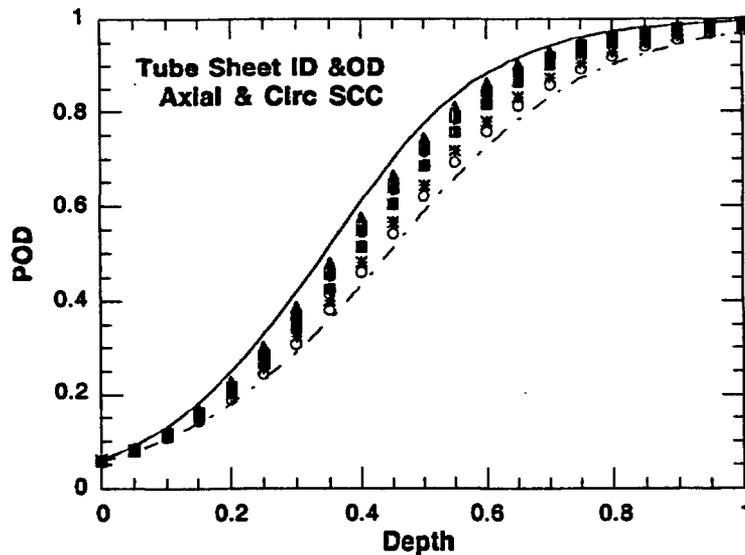
Figure 2.27. MRPC POD by team as a function of maximum depth (as fraction of wall) in the tube sheet. The solid line represents the best team, the dashed line represents the worst team, and the symbols represent the remaining teams. ID and OD are combined for the purpose of comparing teams.

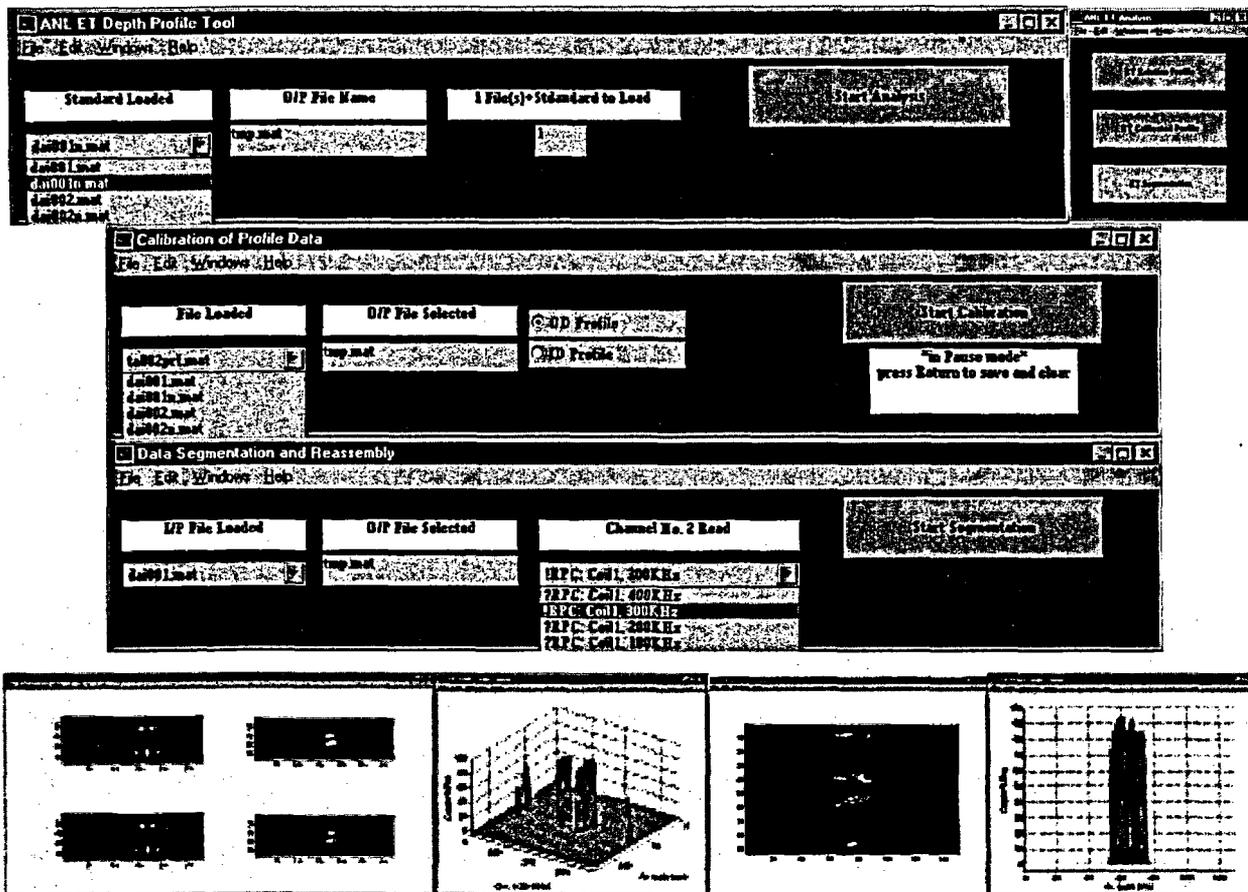
Figure 3.12. Series of MATLAB-based GUI tools (top four rows) for computer-aided analysis of EC inspection results acquired with standard commercial instruments. Also shown (bottom two rows) are several graphical display formats such as Image, terrain, and cross-sectional NDE profiles of tube test section at various stages of analysis.

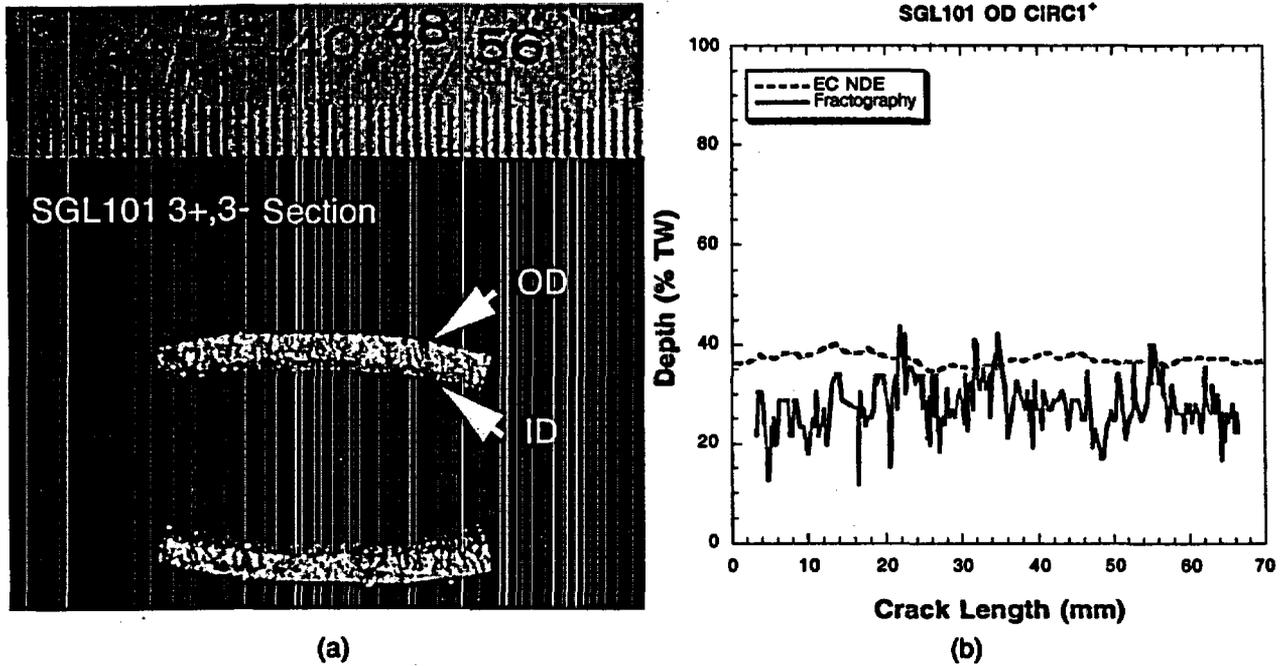
Figure 4.1. Fractography profile and NDE for circumferential IDSCC 1 in specimen SGL101.

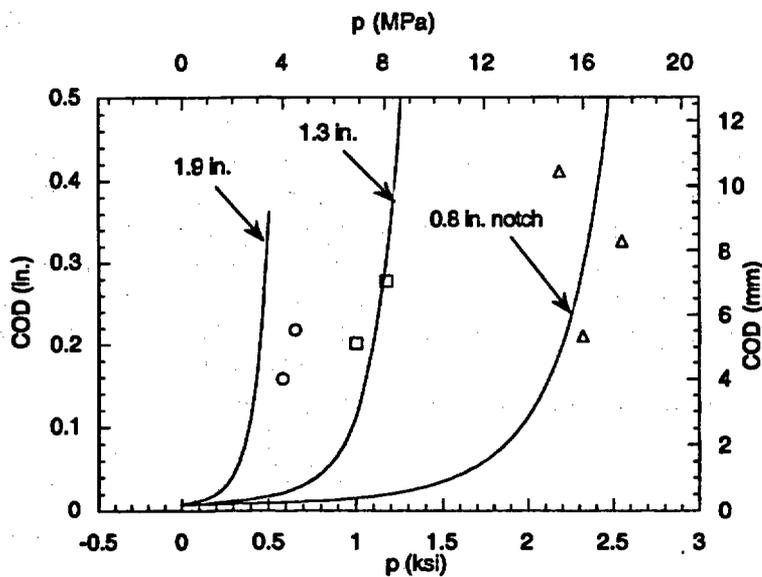
Figure 4.57. Calculated variations of crack opening displacements with pressure. Symbols denote measured COD values after the tests.

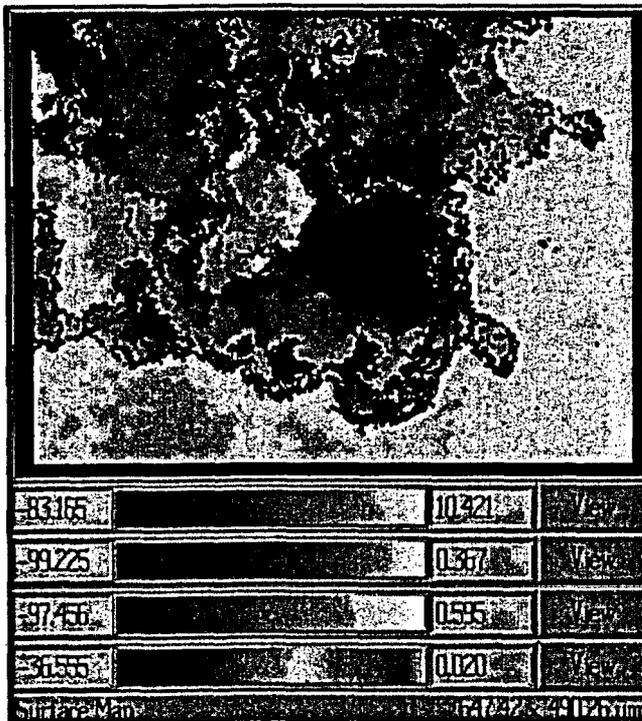
Figure 4.68.
Depth of the erosion zone shown in Fig. 4.67, as determined using interferometric techniques.

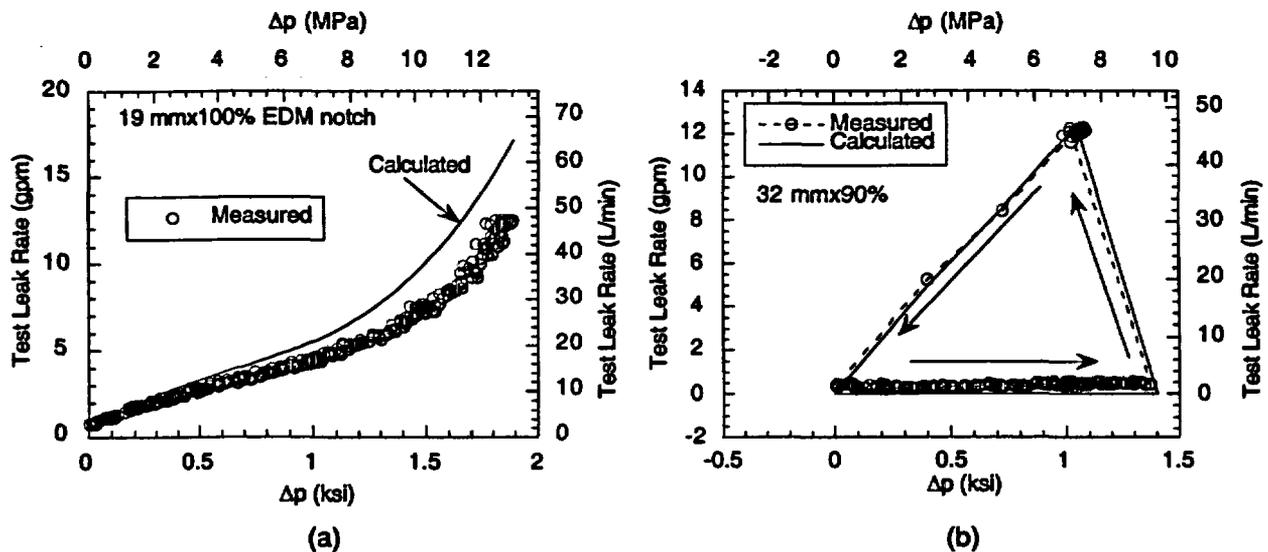
Figure 4.80. Calculated and measured pressure vs. leak rate plots for tests (a) OM169 (100% TW) and (b) OM171 (90% TW), both conducted on as-received tubes at 20°C.

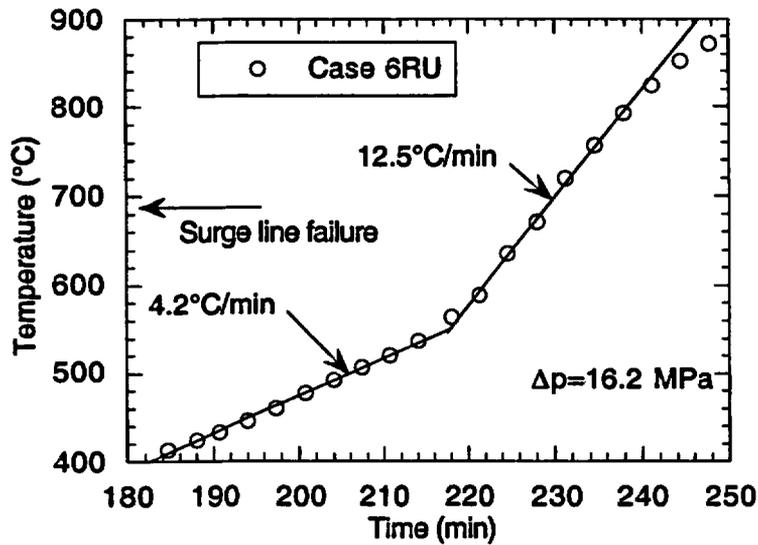
Figure 4.92. Time-temperature history used for testing Electrosleeved tubes with notches in the parent tubes at ANL.

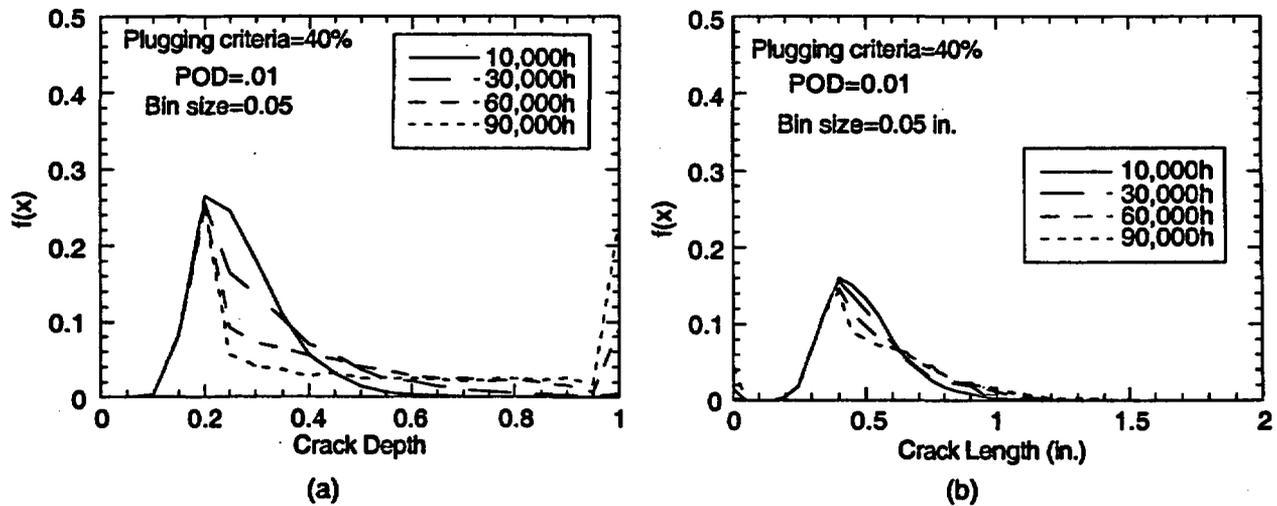
Figure 5.6. Variation of the distribution of (a) crack depth and (b) crack length with time for initial residual stress of 30 ksi and POD = 0.01.
