Fathom

The Naval Safety Center's Afloat Magazine

April-June 2003

Volume 35, Number 2

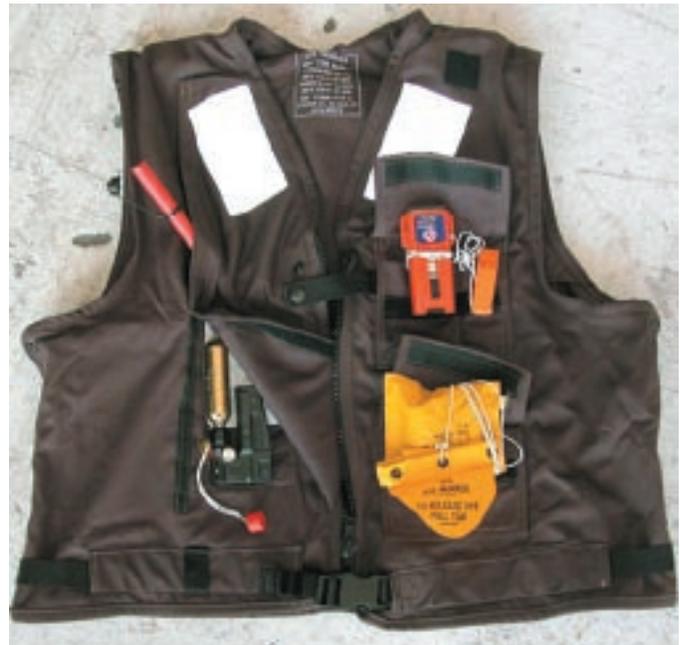
A fully outfitted Mk-1 life preserver shows the sea-dye marker pouch in the preserver's lower left pocket. The marker has been added to the float-coat's allowance equipage list (AEL).

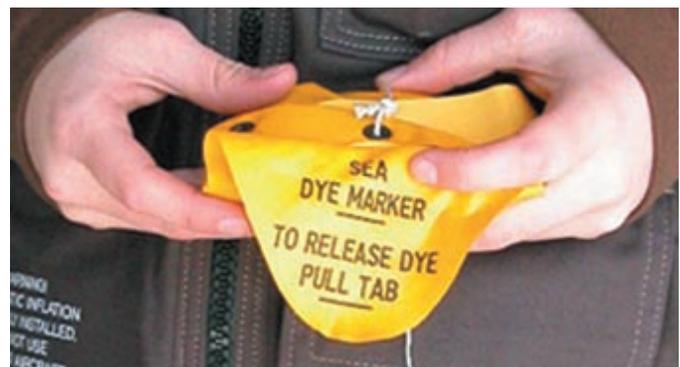
This is a closeup of the sea-dye marker pouch. Updated Mk-1 life preserver MRCs, which include the sea-dye marker, are being distributed to the fleet through spring SFRs.

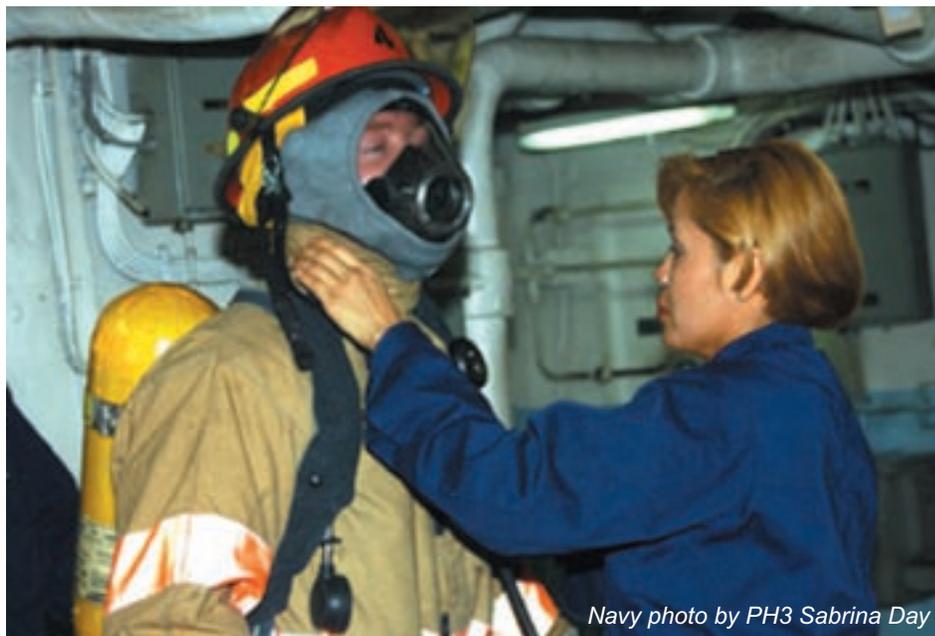
This firefighter is wearing the incorrect personal protective hood as part of his firefighter ensemble (FFE). The currently authorized firefighter hood to be worn with the FFE is beige, not gray.

The gray, GQ anti-flash hood is to be worn with blue coveralls and anti-flash gloves as part of shipboard gear donned during GQ. The new firefighter's hood can be identified by its large flared bib and gold color (similar to the color of the firefighter's suit). The newer hood is manufactured with a two-layer knit material, the outer layer being high-temperature resistant, polybenzimidazole (PBI) and kevlar, with the inner made of PBI and flame-resistant rayon. It is more durable, is longer

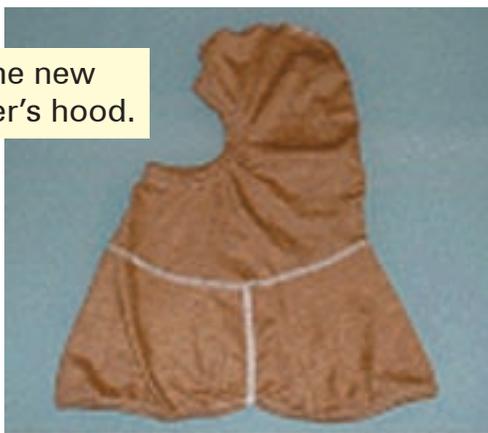
This is the new firefighter's hood.

for better neck and shoulder protection and has a larger face opening to accommodate the SCBA/OBA face-mask.

The firefighter hood is slowly replacing existing anti-flash hoods currently worn with the FFE. The new hood is certified by the National Fire Protection Association and by Underwriters' Laboratory (UL).

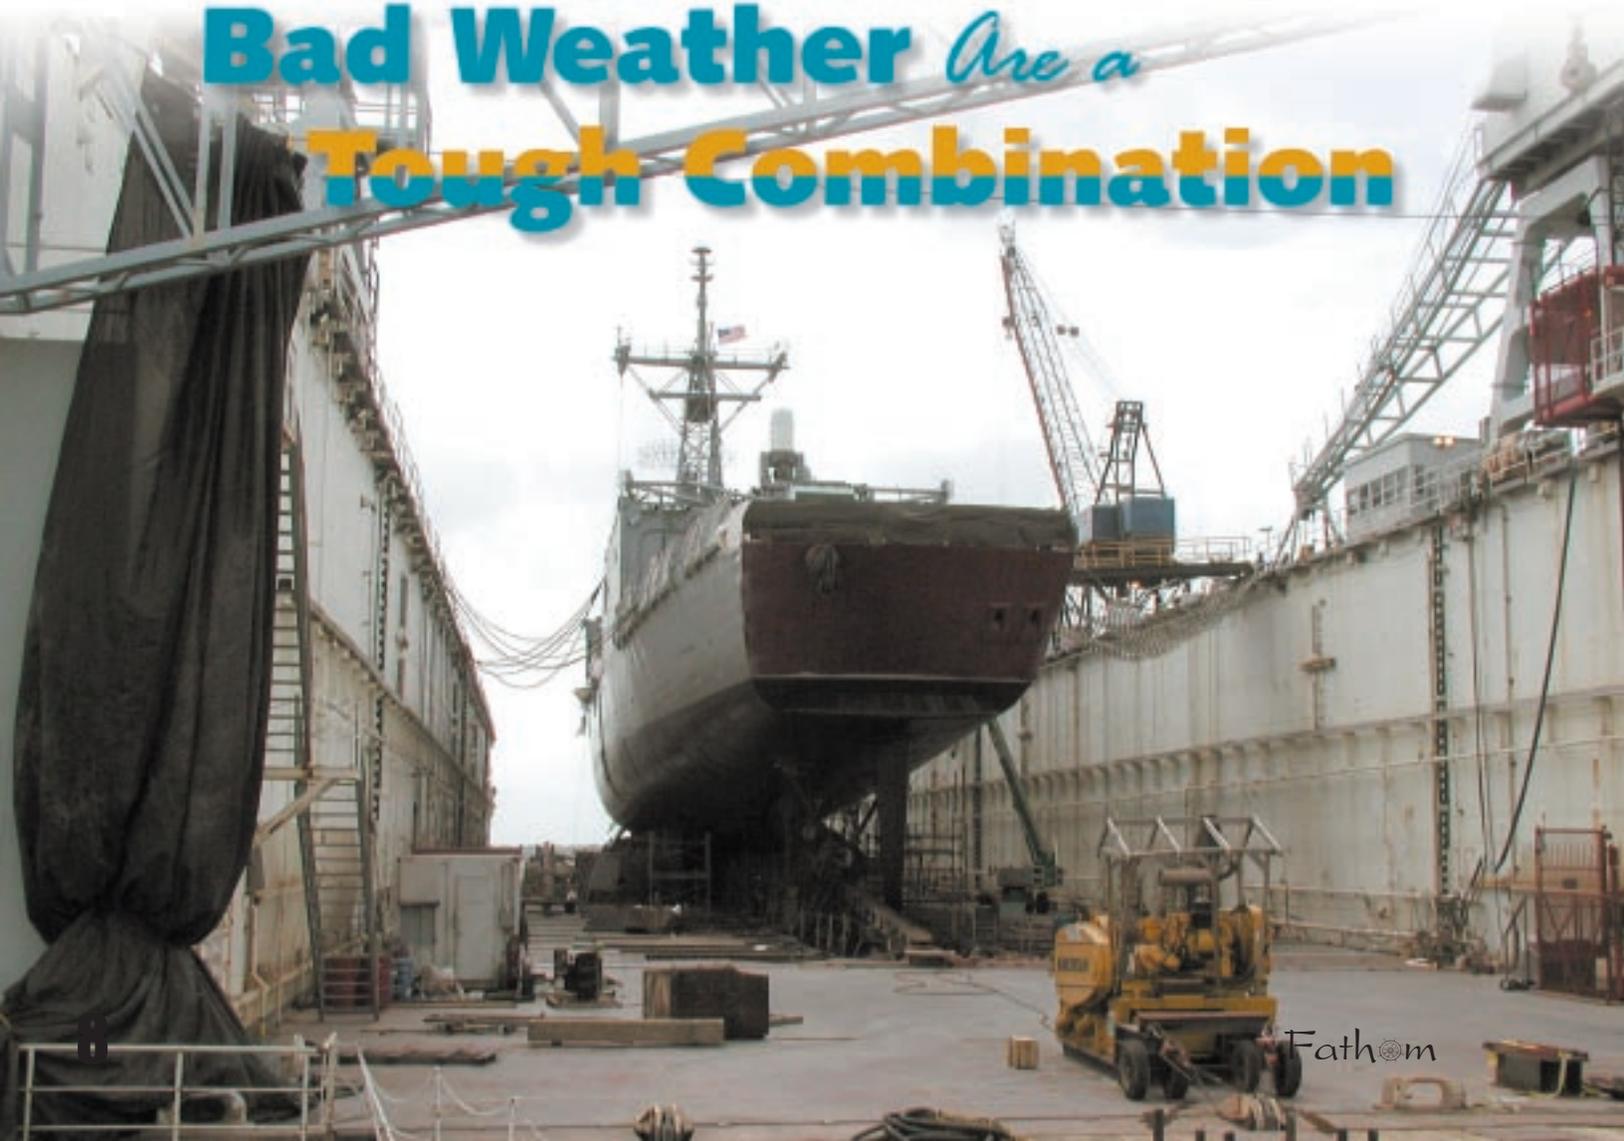
Among potential hazards requiring constant attention were hatches and doors: Many had been removed for repair or were kept open for ventilation and hose passage. This situation could have been a big problem during an afternoon downpour since each opening could have been an area where water could have entered. To fight this possibility, relatively simple but effective actions were initiated.

While planned dams can keep water out of a space, people sometimes unknowingly can create dams that lead to unwanted water buildup. For instance, after removing the ship’s lifelines, contractors replaced them with plywood, which created a funnel and a dam around the entire ship. Ship’s force cut holes in the wood to allow for runoff and to avoid trapping water on the deck.

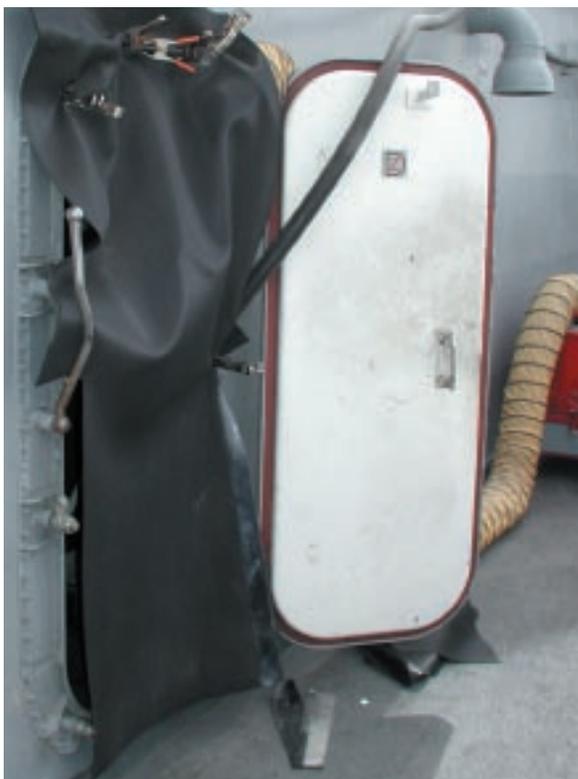
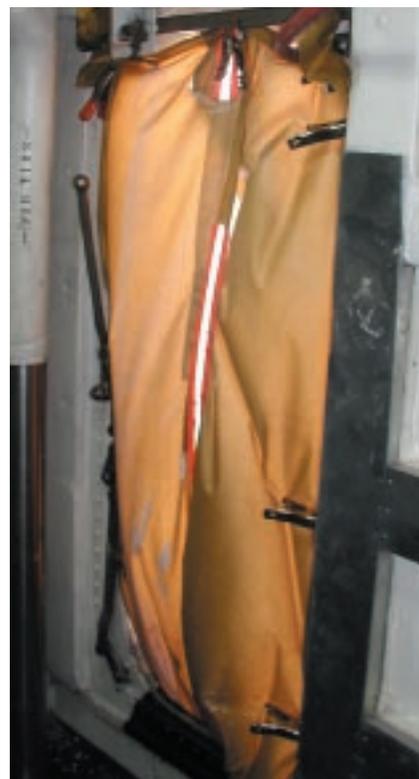
To keep rainwater and storms from entering openings where doors and hatches had been removed for maintenance, *Samuel B. Roberts’* Sailors used smoke curtains and other suitable material to cover the openings and keep the ship’s interior dry.

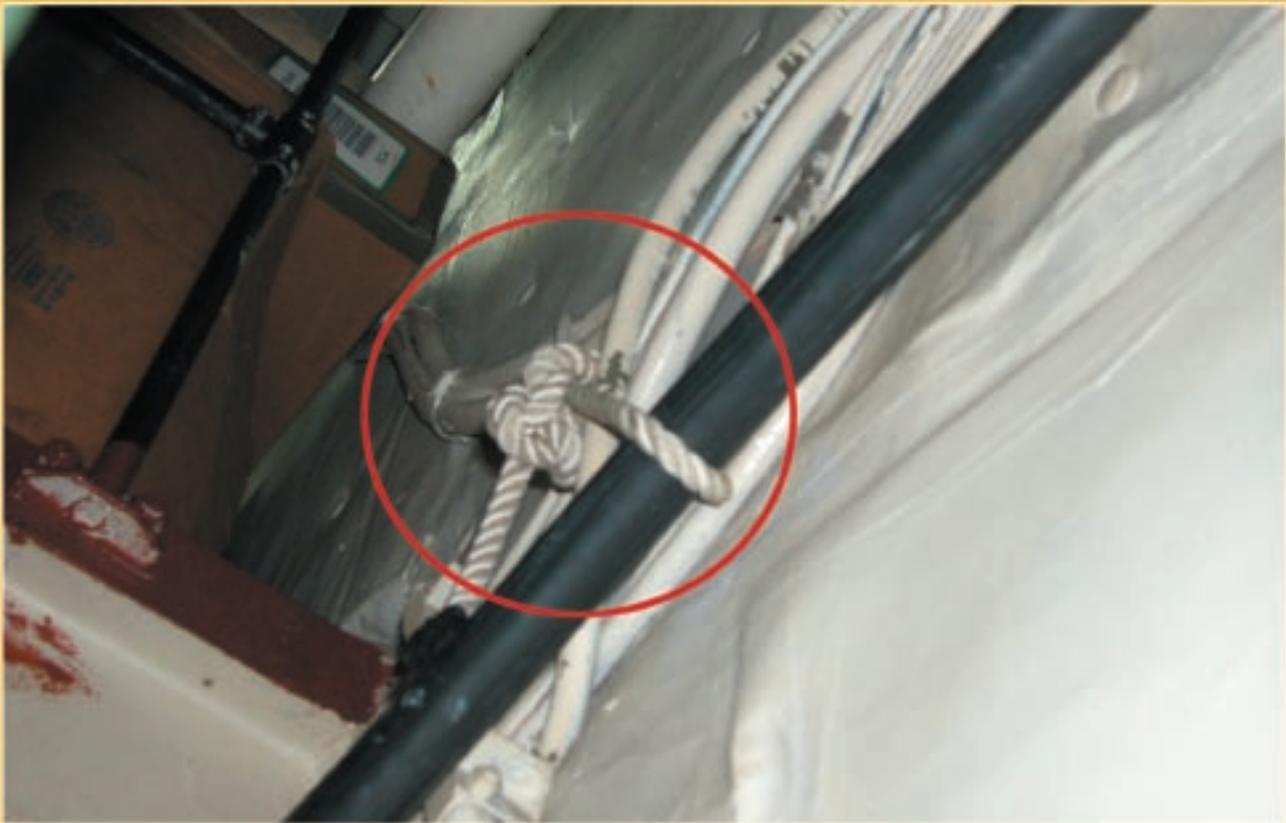
**This is *not* the way
to hang a cable.**

See NSTM 300, Paragraph 4.6.7.1 and Table 4-4; and DoD Standard 2003, Chapter 3 (Bulkhead Penetrations) and Chapter 4 (Cableways) for the proper way to run and hang cables.

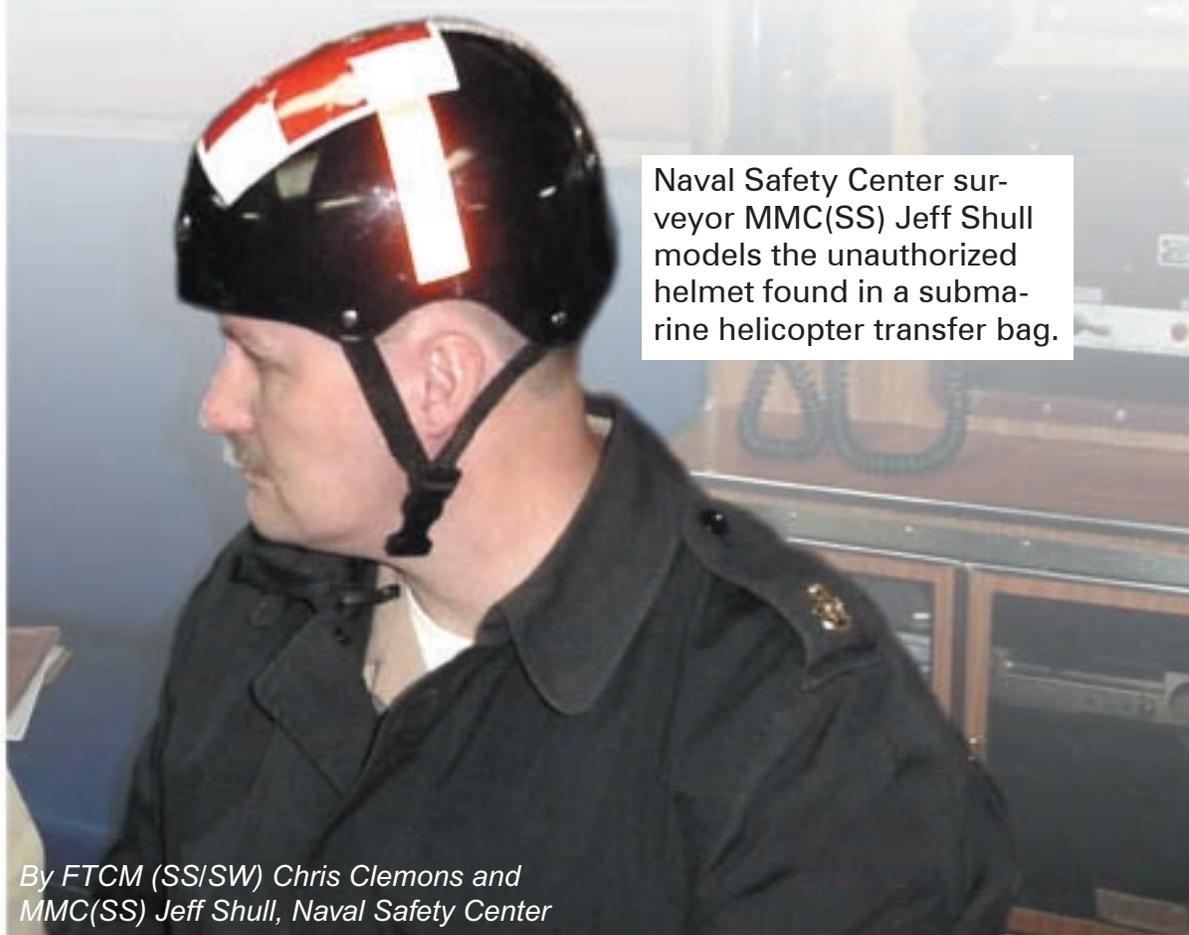
Naval Safety Center surveyor MMC(SS) Jeff Shull models the unauthorized helmet found in a submarine helicopter transfer bag.

During a recent submarine safety survey, we were inspecting a boat's helicopter transfer bag and found almost everything complied with the allowance equipage list (AEL). Then: Oops! We came across several commercial bicycle helmets. The chief-of-the-boat said the squadron had approved using the bicycle helmets in place of the cranial helmets listed on the AEL.

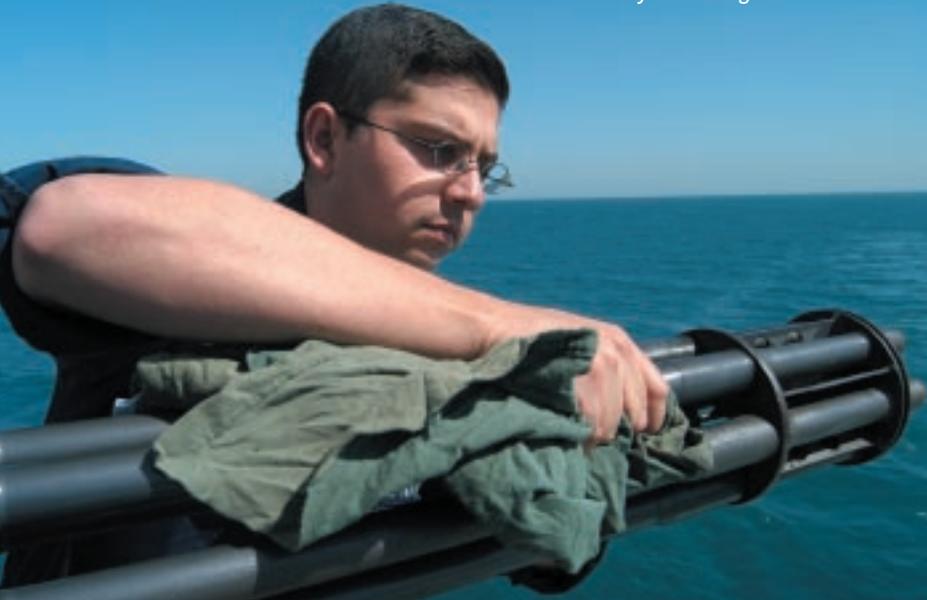
FC3 Adrian Herevia conducts preventative maintenance and corrosion inspection on a Close-In Weapons System (CIWS) gun barrel aboard USS *Kearsarge* (LHD 3) during the ship's participation in support of Operation Iraqi Freedom.

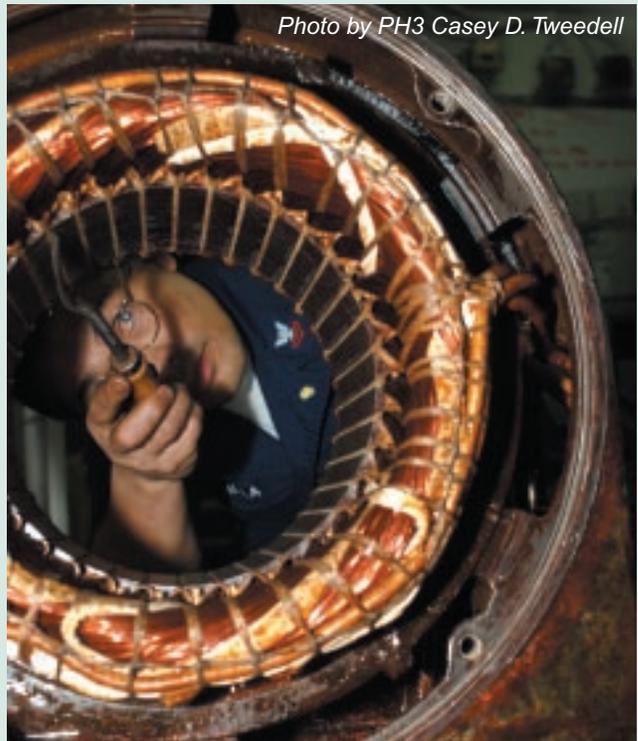
A USS *Constellation* (CV 64) electrician repairs a generator in the ship's motor-rewind shop. One problem discovered during Naval Safety Center surveys is that of electrical work-bench PMS often being overdue or ignored.

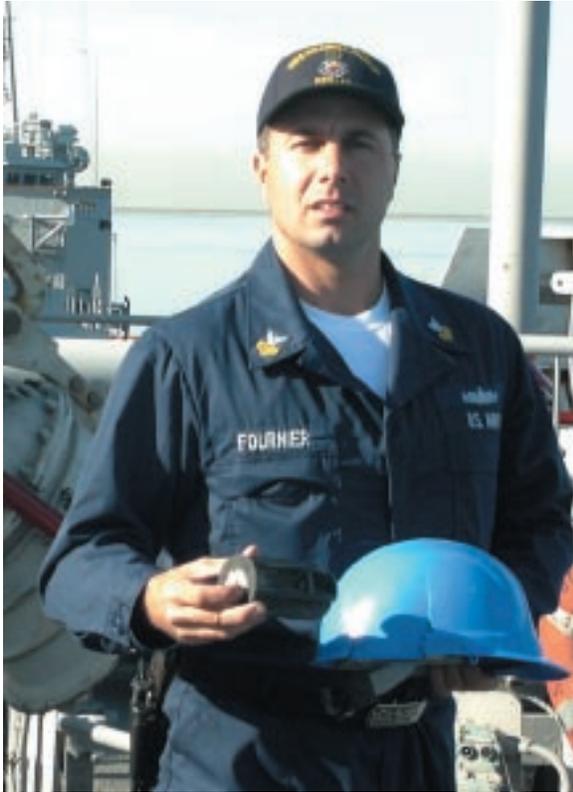
BM1(SW) Michael Fournier (above) holds the hard hat he was wearing during an underway replenishment, and the rubber shot-line projectile that hit his helmet. A close-up photo of the helmet shows the damage where the projectile struck the helmet. One can only speculate about how seriously Petty Officer Fournier might have been injured had he not been wearing his hard hat.

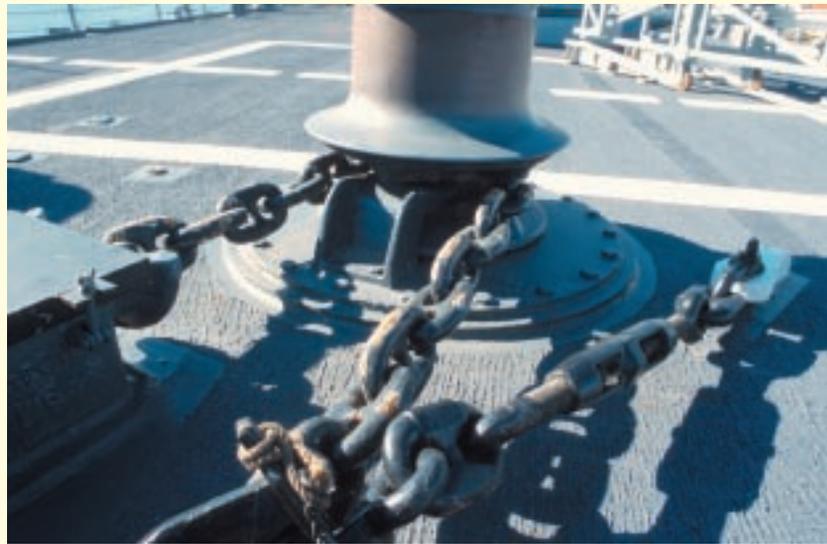
A simple way to protect these fittings from saltwater corrosion and weather is to cover them

with plastic, snug-fitting caps. These protective caps are available through the supply system. Not only do they keep out salt spray and other elements, but the caps also protect the fittings from debris.

Because the plastic caps can become FOD, however, check with your supervisor before you install them on any equipment on or near the flight deck or at any location where FOD could be an issue.

Knowing your fittings' sizes also is critical because the caps must fit snugly to keep out moisture. Contact your supply-department representative for information about these caps. ☺

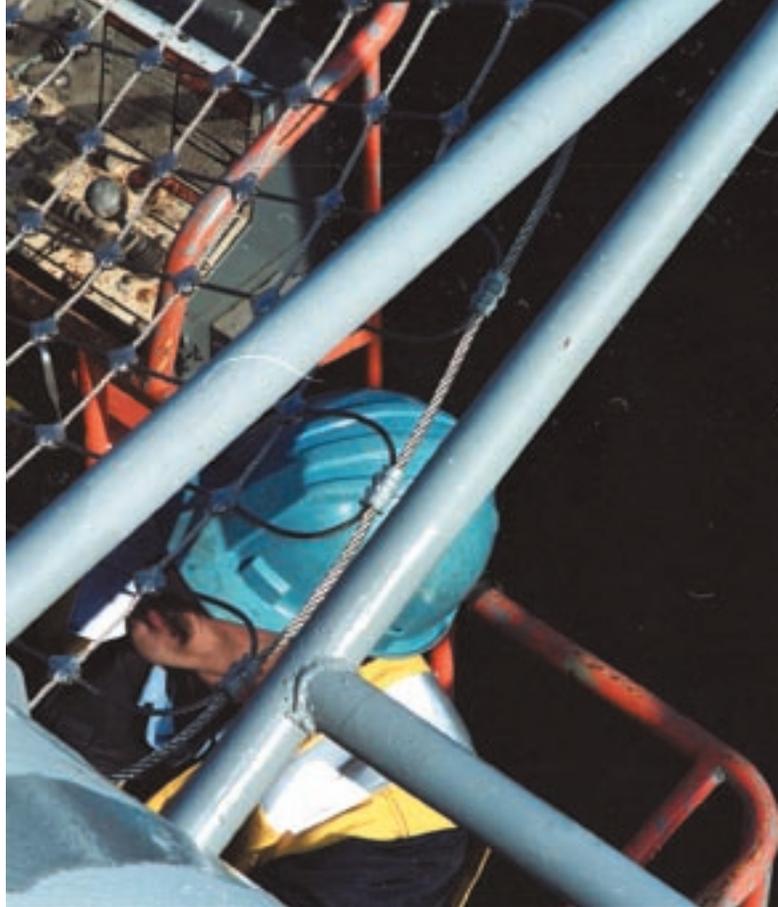
A USS *Enterprise* (CVN 65) Sailor is barely visible as he works on one of the ship's deck-edge nets. The *Enterprise* is undergoing overhaul in the Norfolk Naval Shipyard.

Each net must pass specific safety tests, including being able to support 1,000 pounds for 10 minutes. After passing that test, each net was again measured and inspected for broken strands, rips, or tears. *Enterprise's* net crew finished making the new nets in mid-December: They then had to tackle installation.

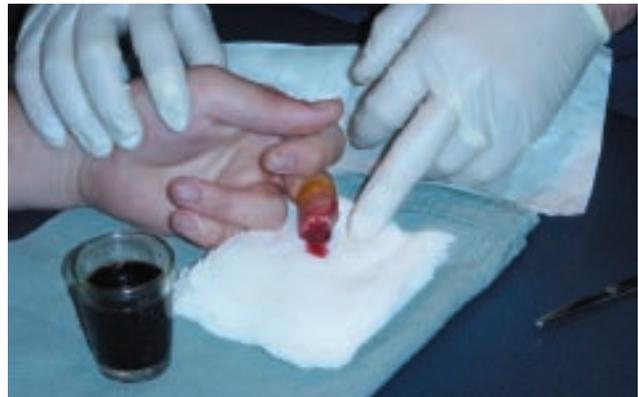
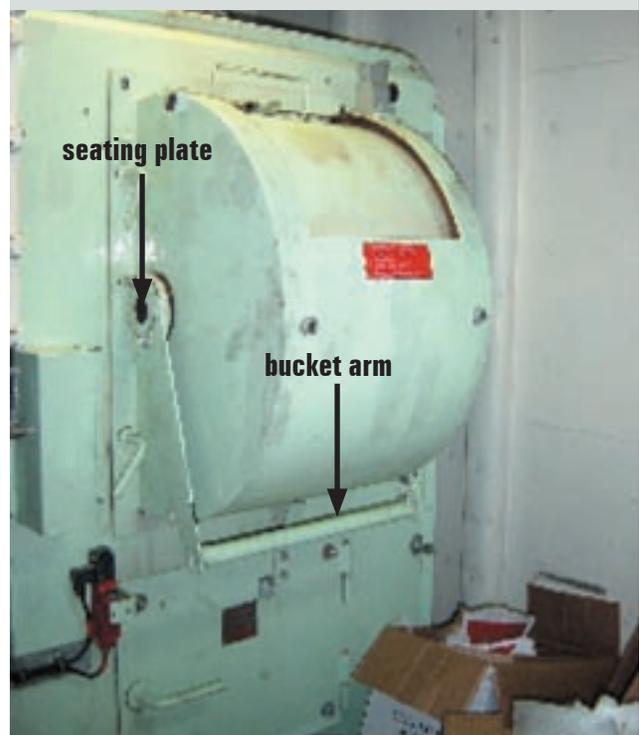
Because a Coast Guard petty officer had his hand in the wrong place, he lost the tip of a finger (above) to an incinerator like the one below. This incinerator is found aboard all 12 Coast Guard *Hamilton*-Class, high endurance cutters.

Operators have been reminded to be more vigilant—and to stay focused—while operating the incinerator. ☹
