A Place for Everything, And Everything in Its Place

By AS1 Terry Doss

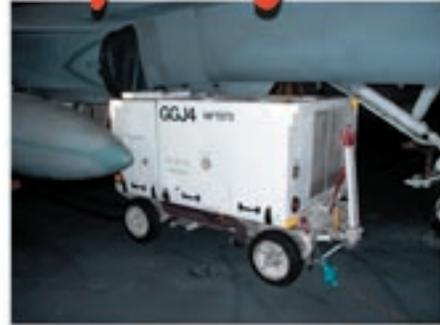
These events served as an open invitation for “Murphy” to jump in. One of the tie-down chains fell through the oil-filler access panel on top of the Jenny, touched the starter solenoid and frame, and initiated fireworks equal to those on the Fourth of July.

The Jenny arced and sparked, resulting in a Class-C fire that burned the positive and negative battery cables and melted the battery post.

A general rule of thumb to follow is, “If the support equipment doesn’t have non-skid on top of it, don’t place any gear on top.”
