# Aircraft 1, Headset 0

By LCdr. Terry Carroll, Leslie York, and Dale Glardon

# Feeding a Harrier

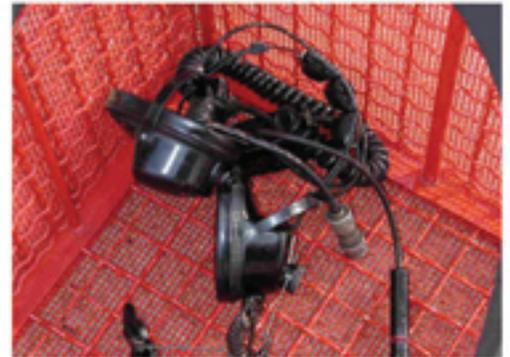
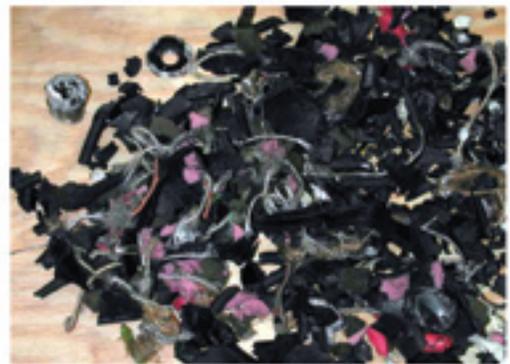
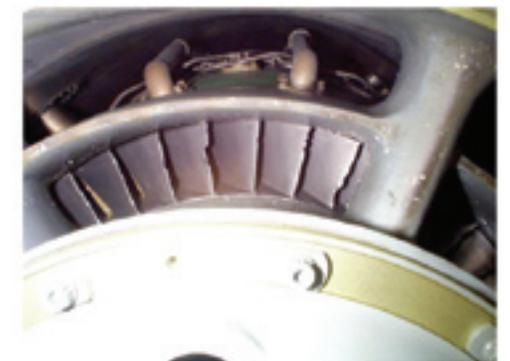
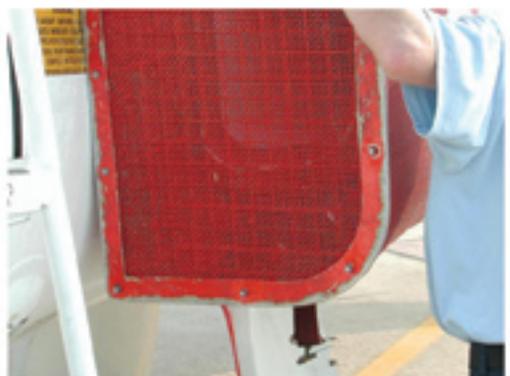
A comm headset never should be carried in an intake screen. An engine will turn any object into “trash” and will damage it’s blades. Keep intakes free of any foreign objects.

Turn procedures require a headset and a communication cord. Had the bad one been turned in as broken and a new one checked out, the maintainer would not have stood on the boarding ladder with a bad headset stuffed in the turn screen. The headset FODed the engine, and the damage cost \$265,913.69.
