INACTIVE MINE LAND REUSE

Summit County, Colorado

2003 National Site Assessment Symposium

Kevin Mackey and Joe Vranka

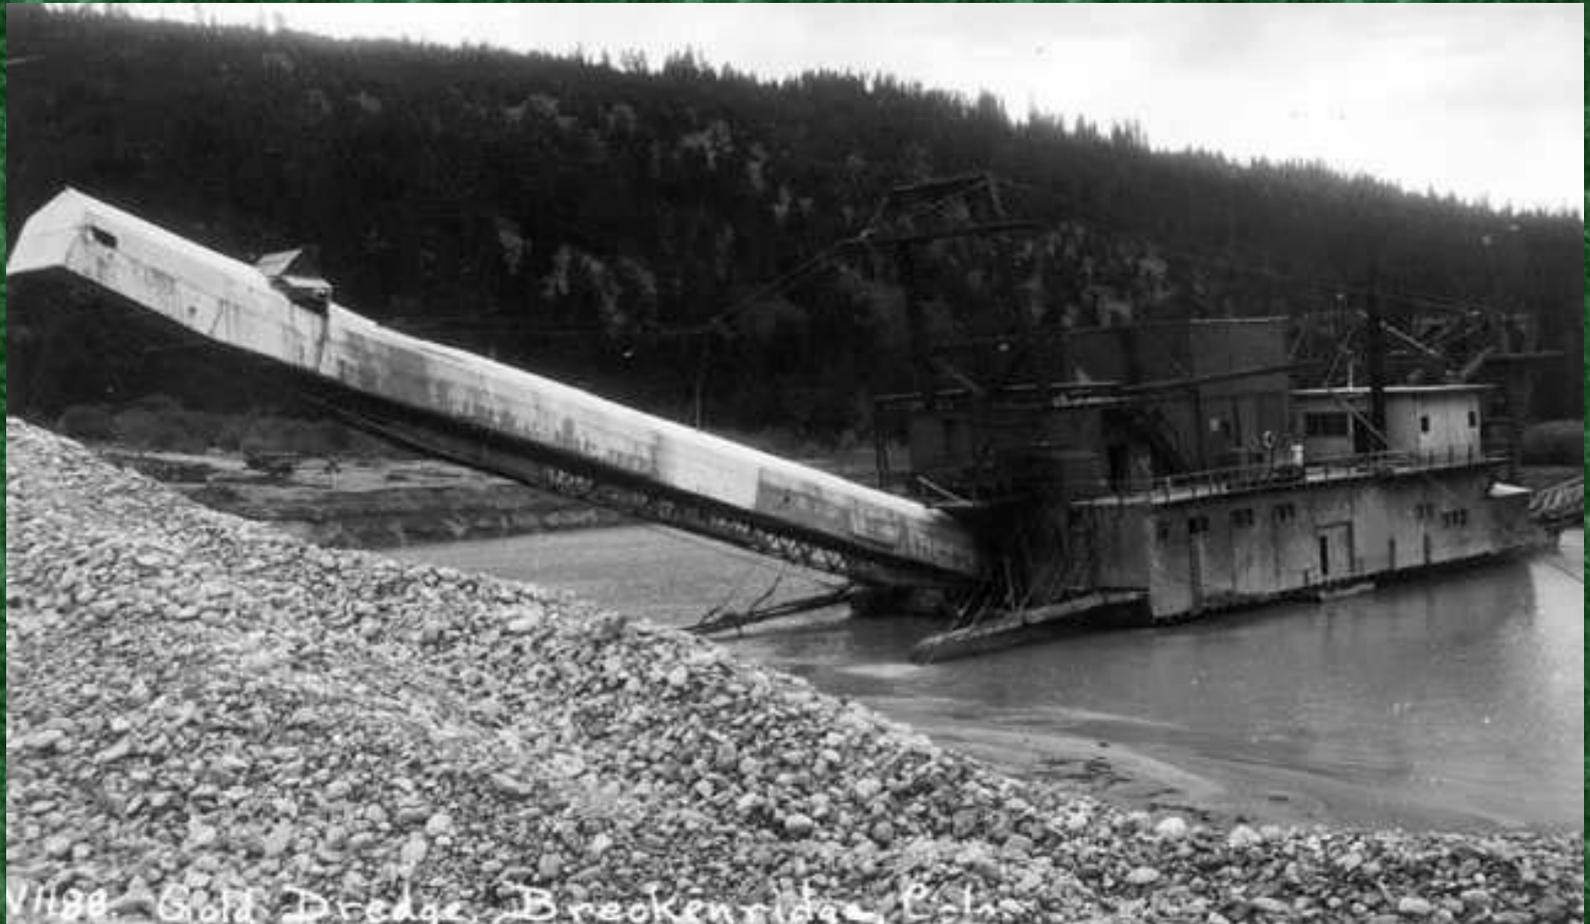
Gold Dredging

V. 189. Gold Dredge, Breckenridge, Col.

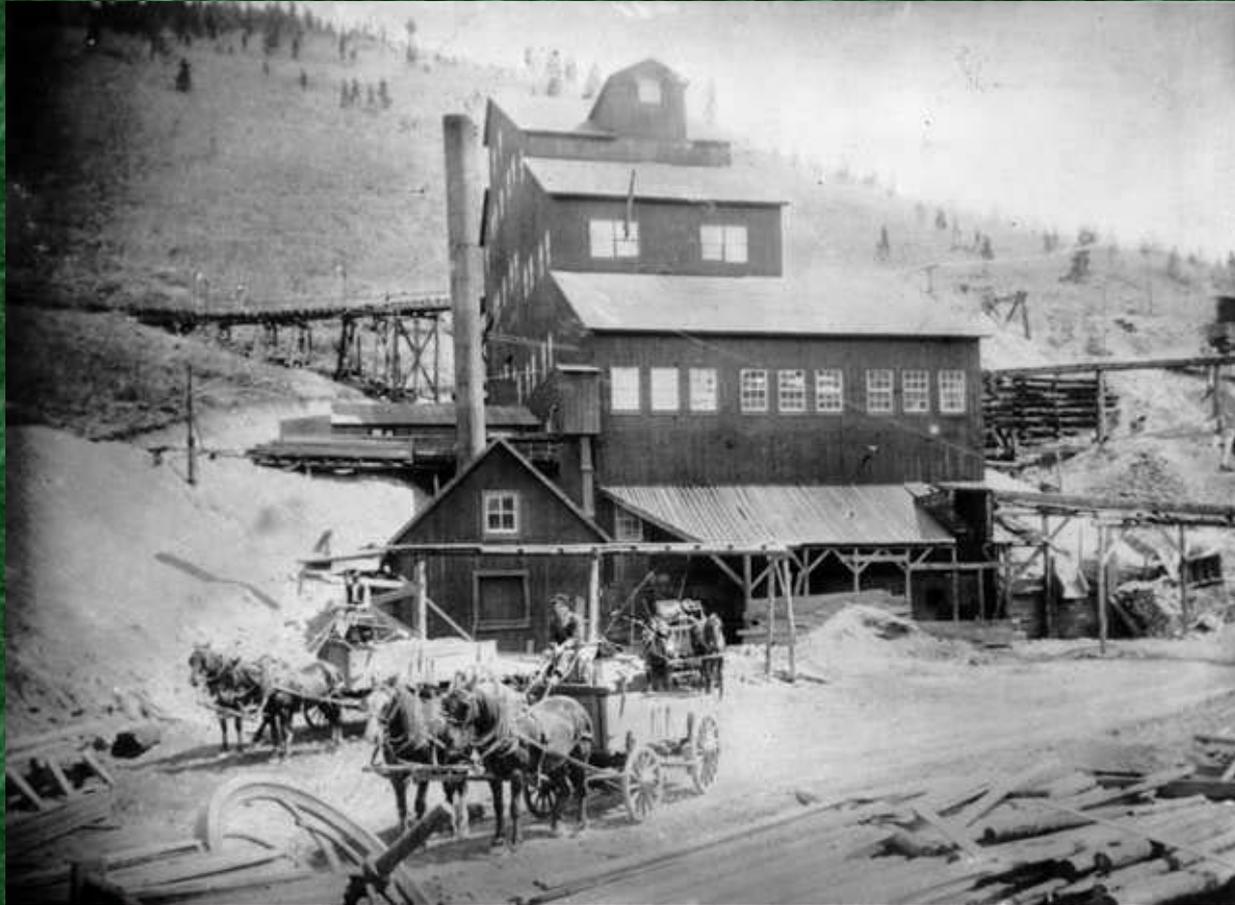
Wellington-Oro

- Lead-Zinc-silver sulfide and gold lode mining.
- Original claim in 1881.
- Operations began 1887.
- Operations ceased in 1973.

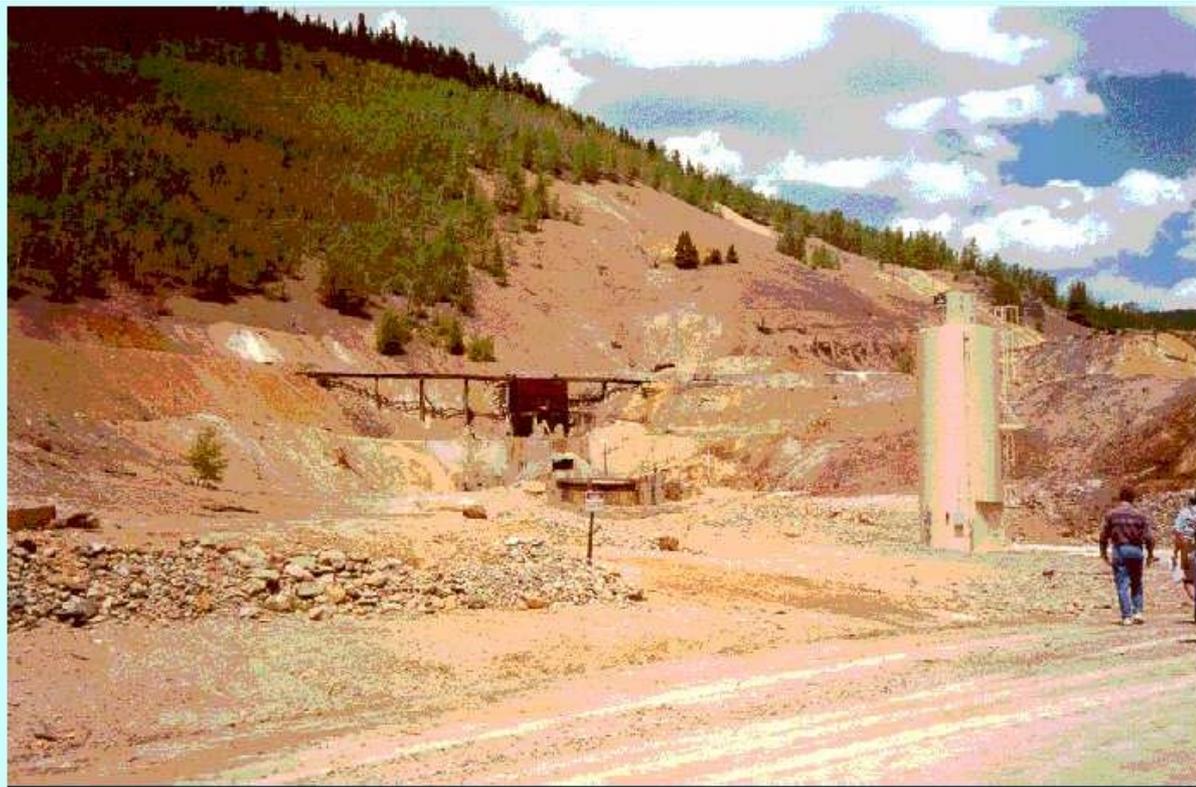
Wellington-Oro

- Waste rock and tailings containing inorganic contaminants
-
- Over twelve miles of flooded mine tunnels.

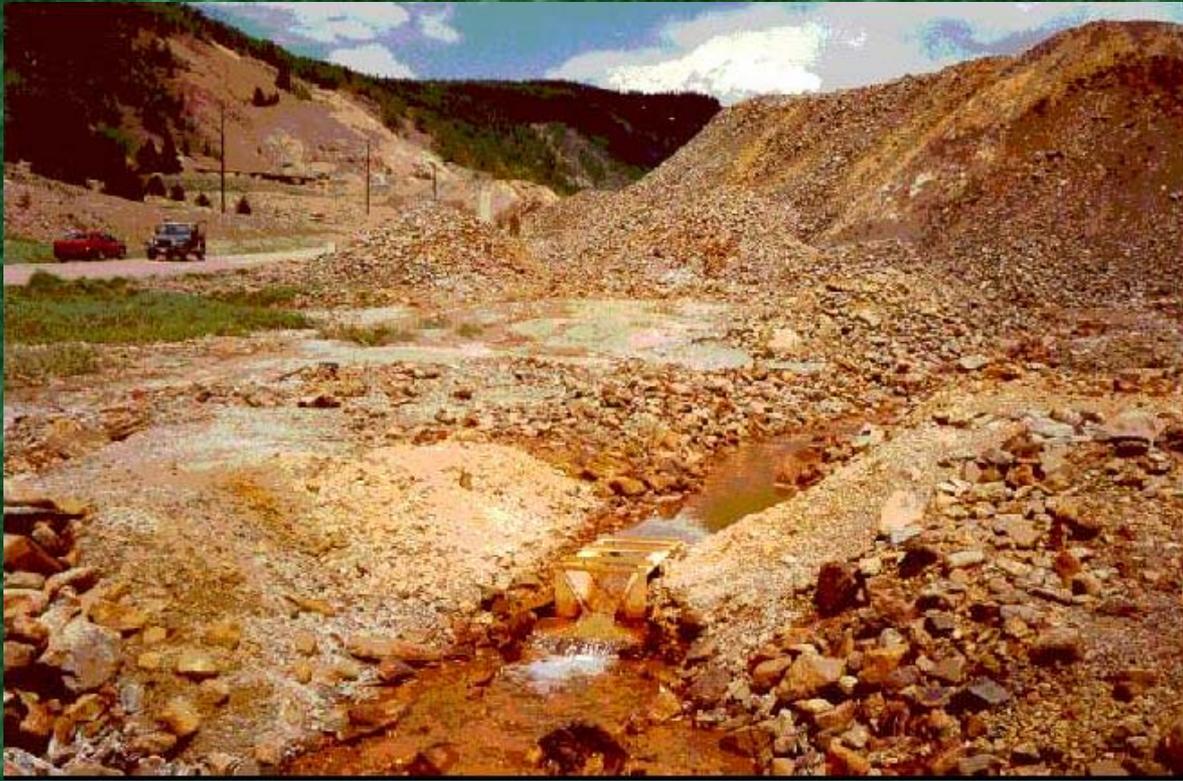
Wellington-Oro Mine Pool

- Flooded mine workings surface via faults and fractures and migrate to French Creek.
- Acutely toxic concentrations of zinc and cadmium impact French Creek.
- Contamination has decimated all aquatic life in French Creek and resulted in fish kills in Blue River.

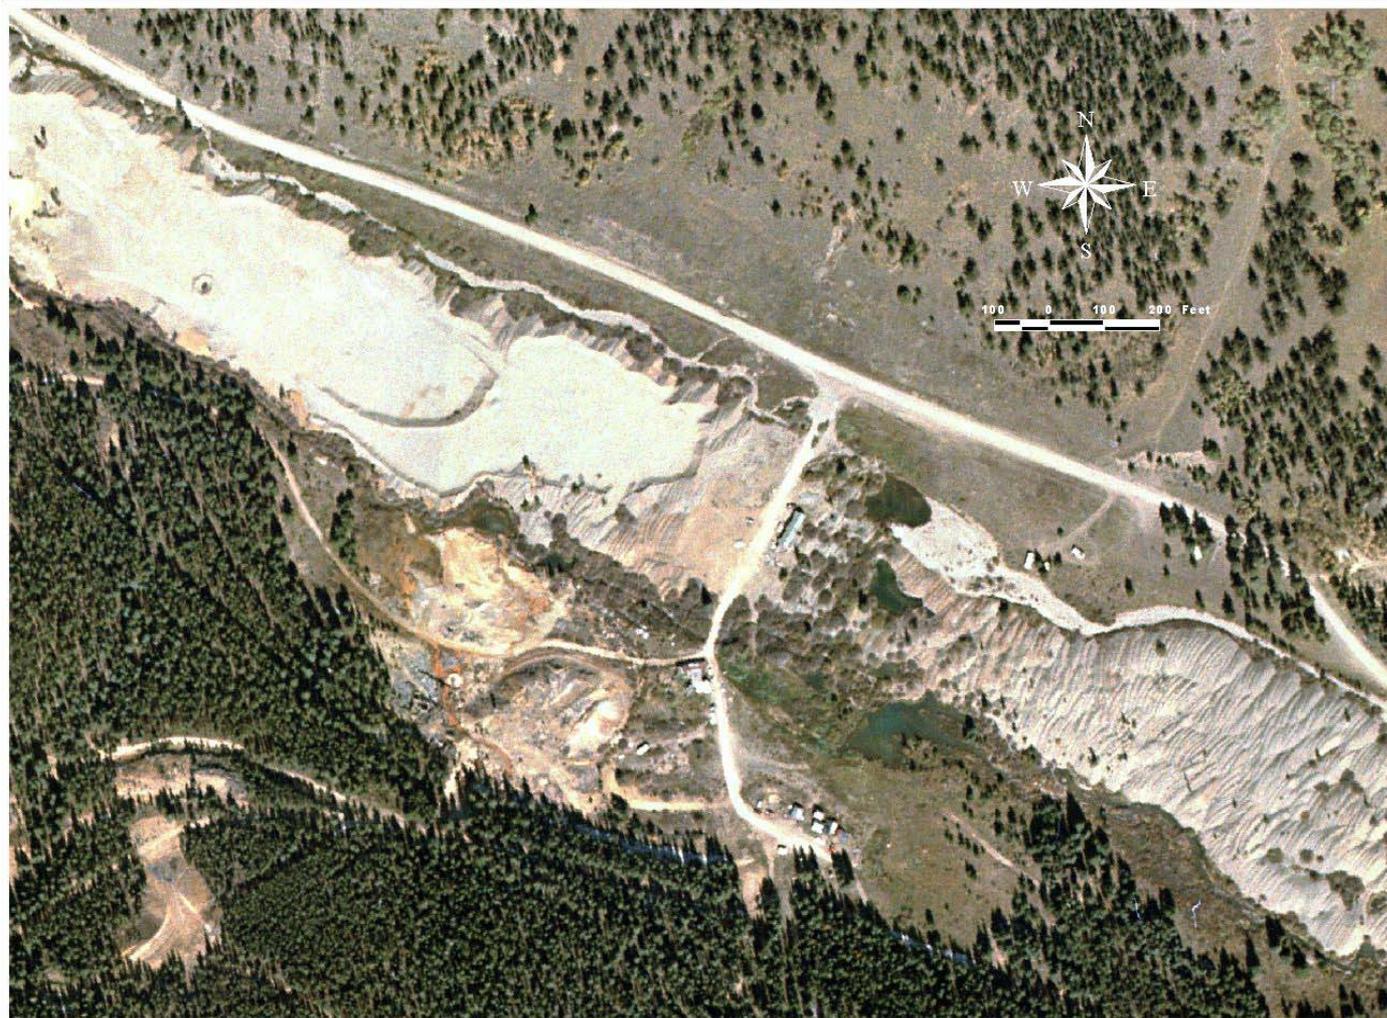
FIGURE 3

Detailed Sample Location Map

IXL/Royal Tiger
Mine and Mill Site
Summit County, Colorado

- - Soil Sample
- ⬡ - Waste Source Sample
- ▲ - Surface Water/Sediment Sample
- ▲ - Adit Sample Location

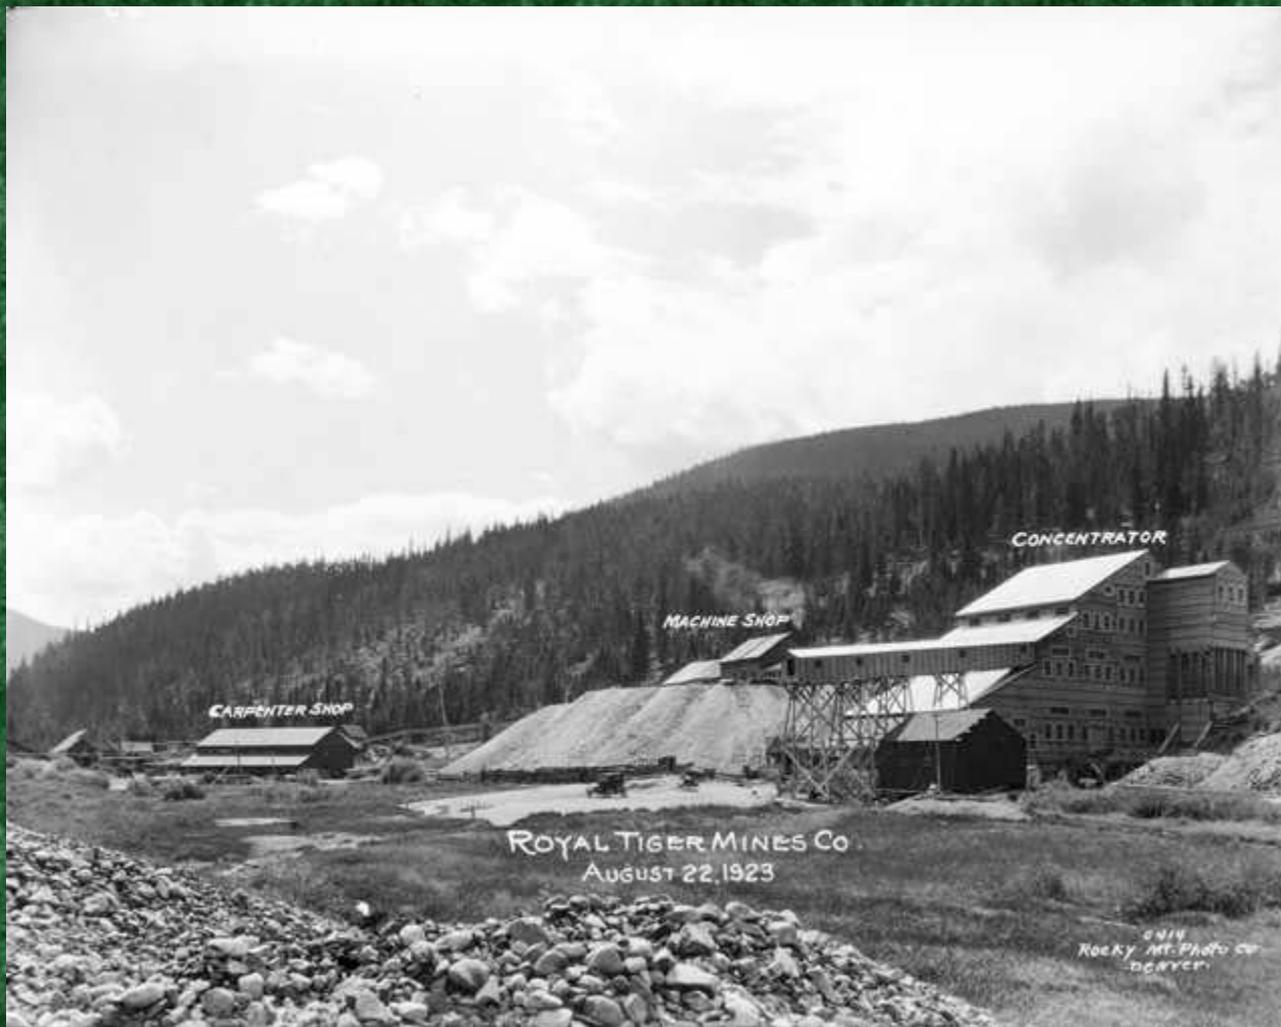
IXL/Royal Tiger Adit

- Flow – 0.4 cfs
- pH – 5.98
- Zn – 4,000 $\mu\text{g/L}$
- Cd – 18 $\mu\text{g/L}$
- Mn – 1,100 $\mu\text{g/L}$
