Aggradation and Degradation of the Palisades Gully Network, 1996 to 2005, with Emphasis on the November 2004 High-Flow Experiment, Grand Canyon National Park, Arizona

Open-File Report 2008–1264

By Joseph E. Hazel, Jr., Matt Kaplinski, Roderic A. Parnell, and Helen C. Fairley

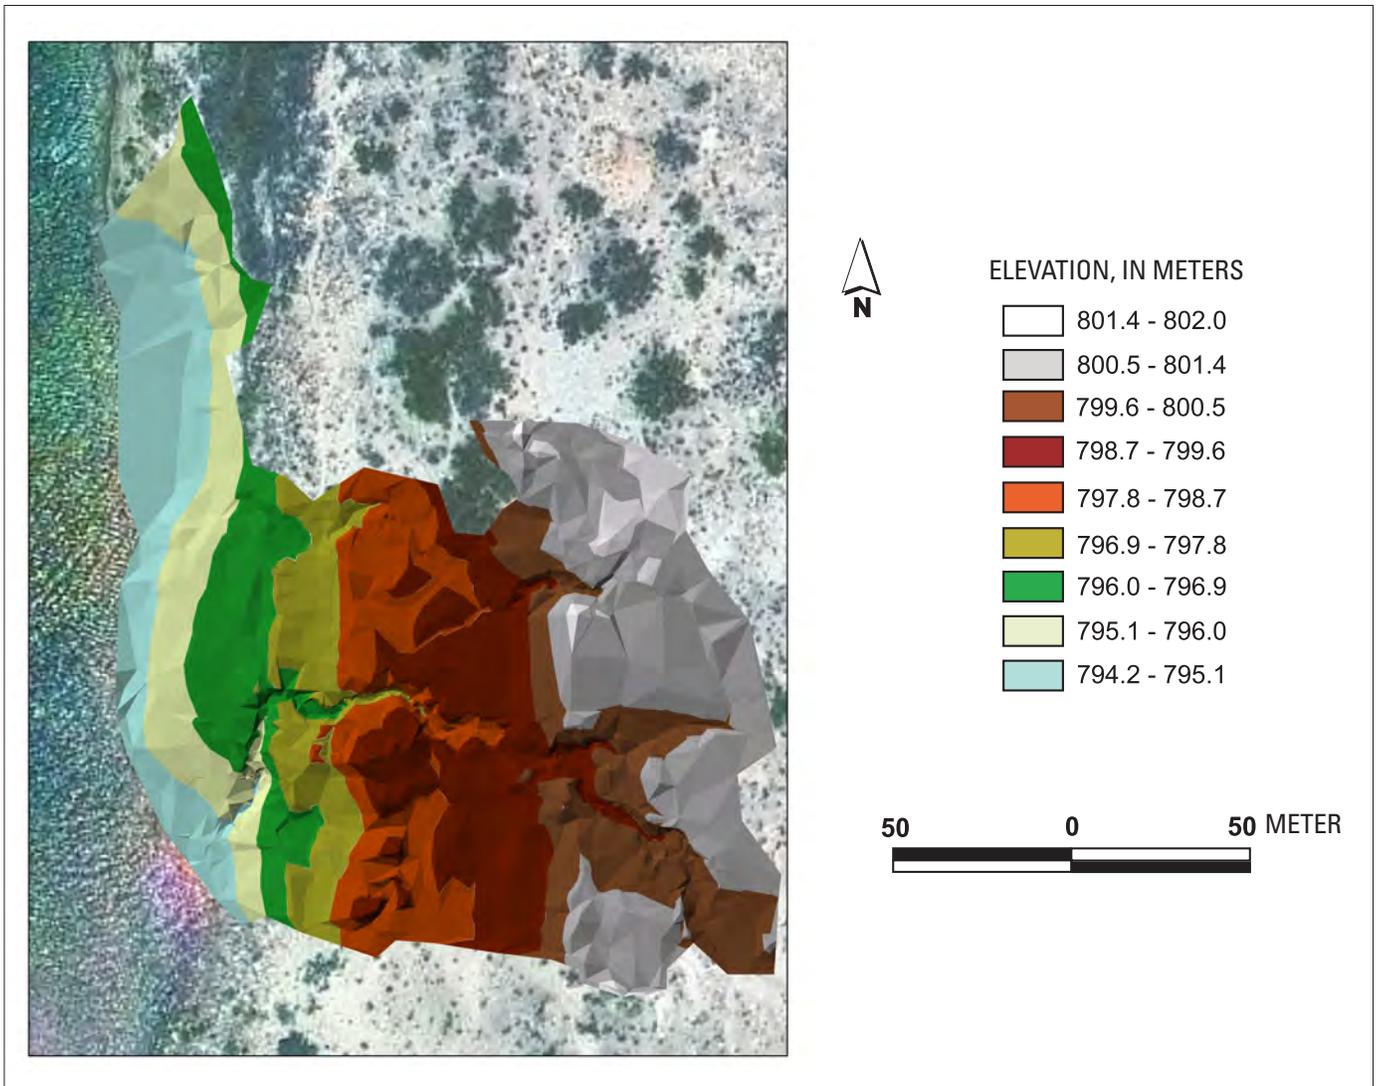
Figure 5. Palisades drainage network topography constructed from the point data collected on November 20, 2004.

Digital elevation models (DEMs) were created from surveys where survey extent allowed using surface modeling software (fig. 5). The DEMs were used to calculate volume changes and to delineate a channel centerline along equally spaced 0.2-m distances in the south gully mouth between the 566 and $1,274 \text{ m}^3/\text{s}$ stage elevations. However, it is difficult to account for channel sinuosity with this method, and elevation errors are introduced with increasing gully length and convexity. Pederson and others (2003) developed a technique, which was adopted by this study, to compare longitudinal gully profiles by normalizing points collected along the gully thalweg between two fixed endpoints. The endpoint locations are shown in figures 2 and 4. Neither centerline method nor the normalized alternative method is “noise free,” and considerable variation is introduced to the profile depending on how the check dams and thalweg were defined and surveyed by different researchers. The centerline method is less subjective than the normalized alternative, which
