# Hydraulic Characteristics of Low-Impact Development Practices in Northeastern Ohio, 2008–2010

Scientific Investigations Report 2011–5165

By Robert A. Darner and Denise H. Dumouchelle

In cooperation with the Chagrin River Watershed Partners

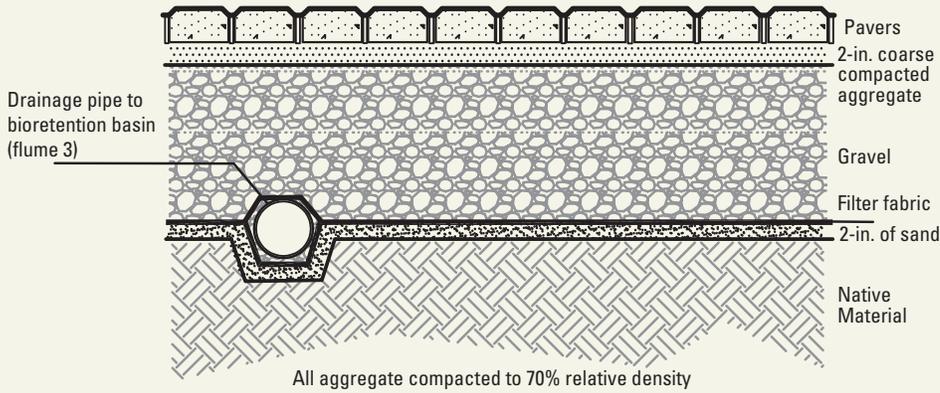
**Cover drawing.** Construction detail of paver parking lot and rain garden for Washington Street site, Geauga County, Ohio. (Modified from engineer drawings provided by Cawrse and Associates, Inc.)

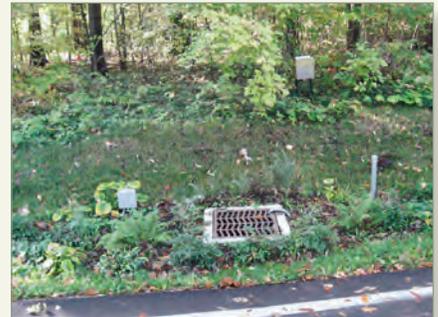
**Inset photo, top.** One of the rain gardens along Sterncrest Drive site, Cuyahoga County, Ohio, showing monitoring equipment, drainage grate, and plant growth from October 2008.

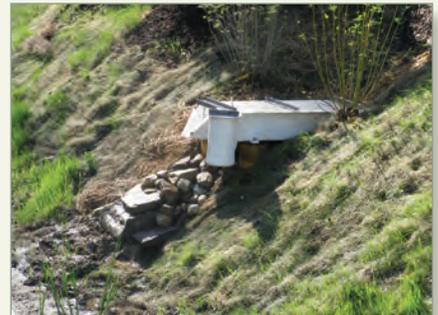
**Inset photo, center.** Flume 2 at Washington Street site, Geauga County, Ohio, measuring any overflow from the rain garden.

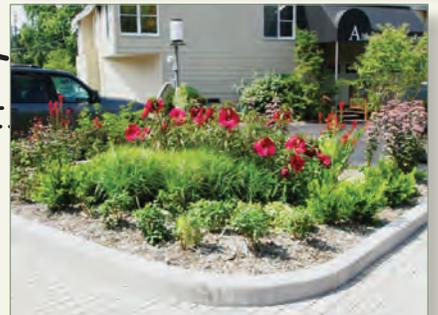
**Inset photo, bottom.** Washington Street rain garden showing weather station and plant growth, August 2008. (Photograph by Cawrse and Associates, Inc., employees.)

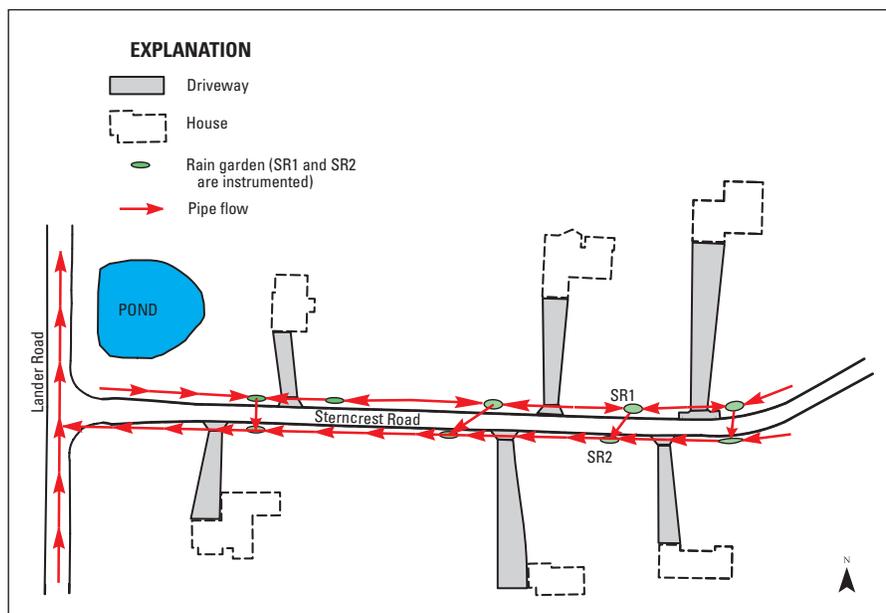
**Figure 2.** Site plan for stormwater best-management practice along Sterncrest Drive site, Cuyahoga County, Ohio.

The overflow grates on two rain gardens, one north (SR1) and one south (SR2) of Sterncrest Drive (fig. 2), were instrumented with sensors that measured specific conductance and temperature. These sensors were used to determine the occurrence and duration of overflows; however, without additional instrumentation, the volume of the overflows could not be computed. The sensors were connected to a data logger adjacent to the rain garden. The data logger queried the sensor every minute and recorded the measurement if there was a change since the last measurement. Data also were recorded every 6 hours to ensure that the data logger was operational during periods when sensor readings were unchanging.

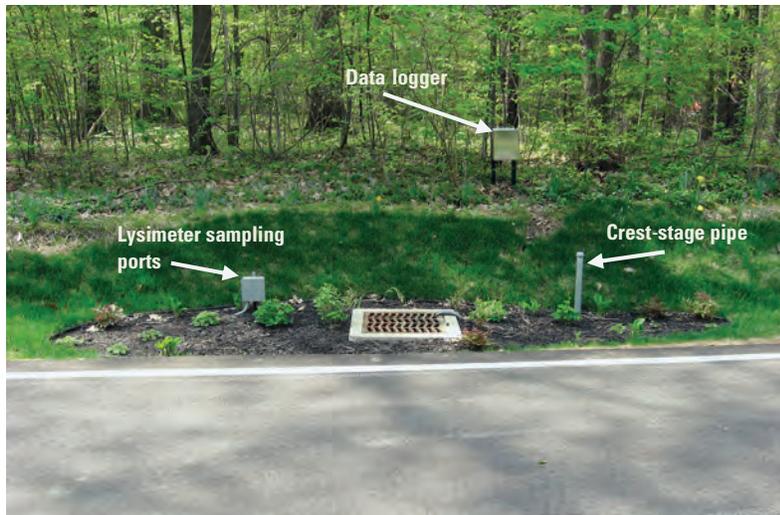
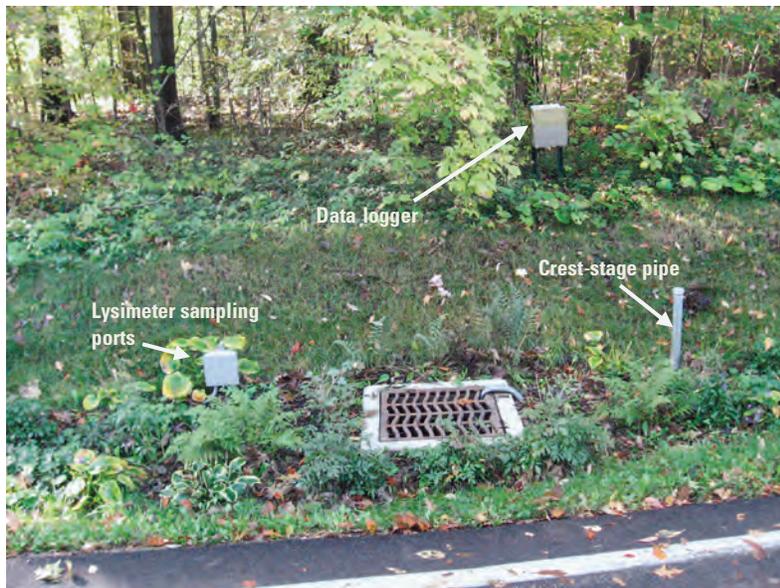
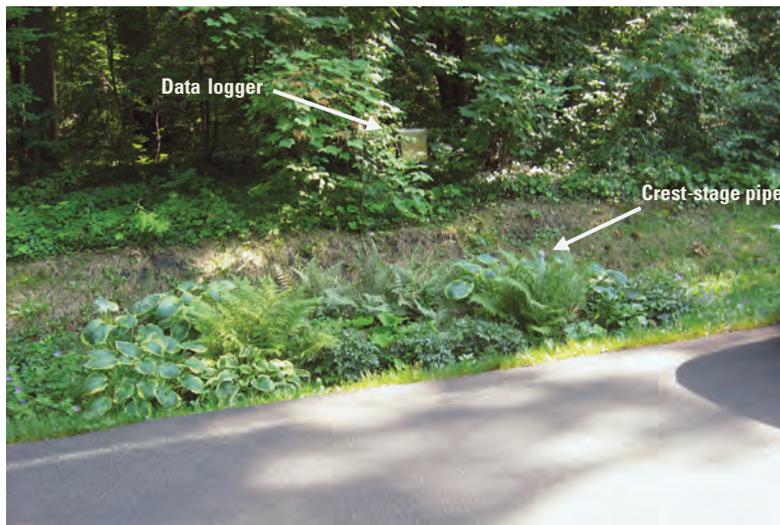
**A** May 7, 2008

**B** October 9, 2008

**C** July 14, 2010  
Lysimeter sampling port  
obscured by plant growth

**Figure 3.** Photographs of one of the rain gardens along Sterncrest Drive site, Cuyahoga County, Ohio, showing monitoring equipment, drainage grate, and plant growth from May 2008 to July 2010.

The construction details of the bioswale are shown in figure 4. One important difference between the bioswale and the rain gardens is the type of vegetation used for cover. The bioswale is only 1.5 ft wide and covered with turf grass, whereas the rain gardens are 6 ft wide, planted with perennials, and mulched with double-shredded wood mulch (figs. 2 and 3).

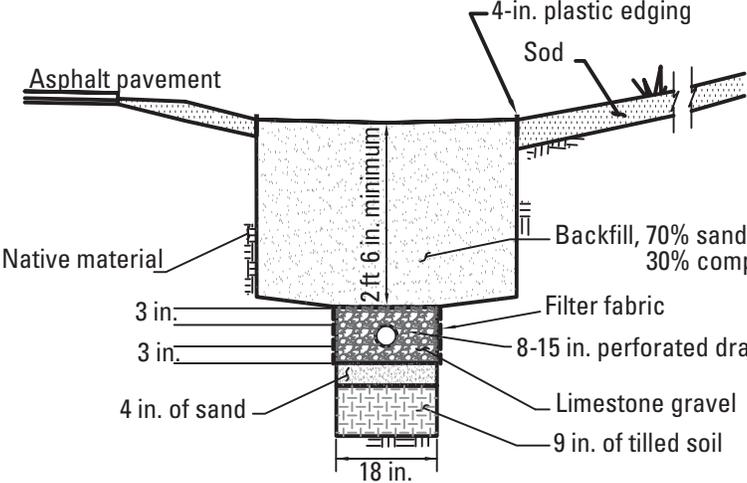
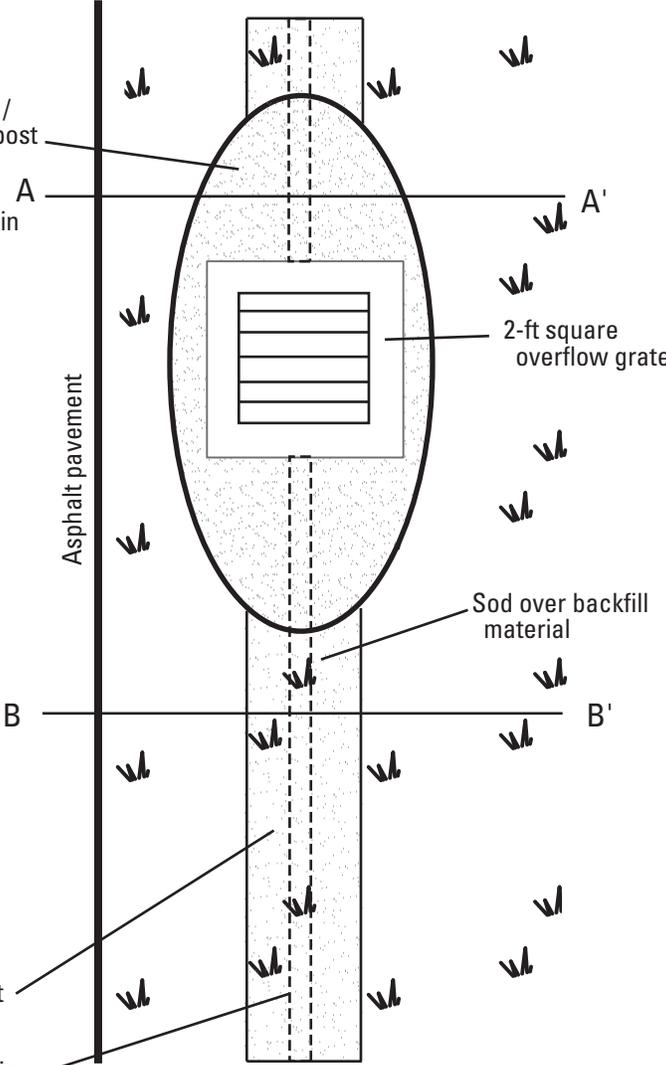
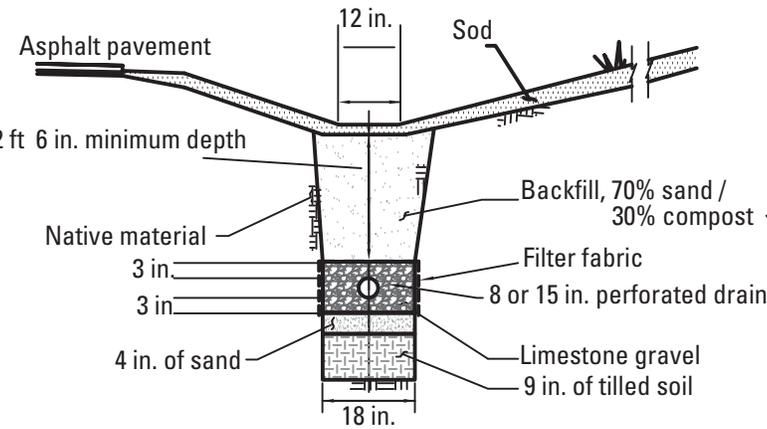
Typical rain garden detail section A-A'

Plan view of bioswale-rain garden system

Typical swale detail section B-B'

Figure 4. Construction detail for bioswale and rain gardens along Sterncrest Drive site, Cuyahoga County, Ohio (modified from engineer drawings provided by Orange Village, Ohio).

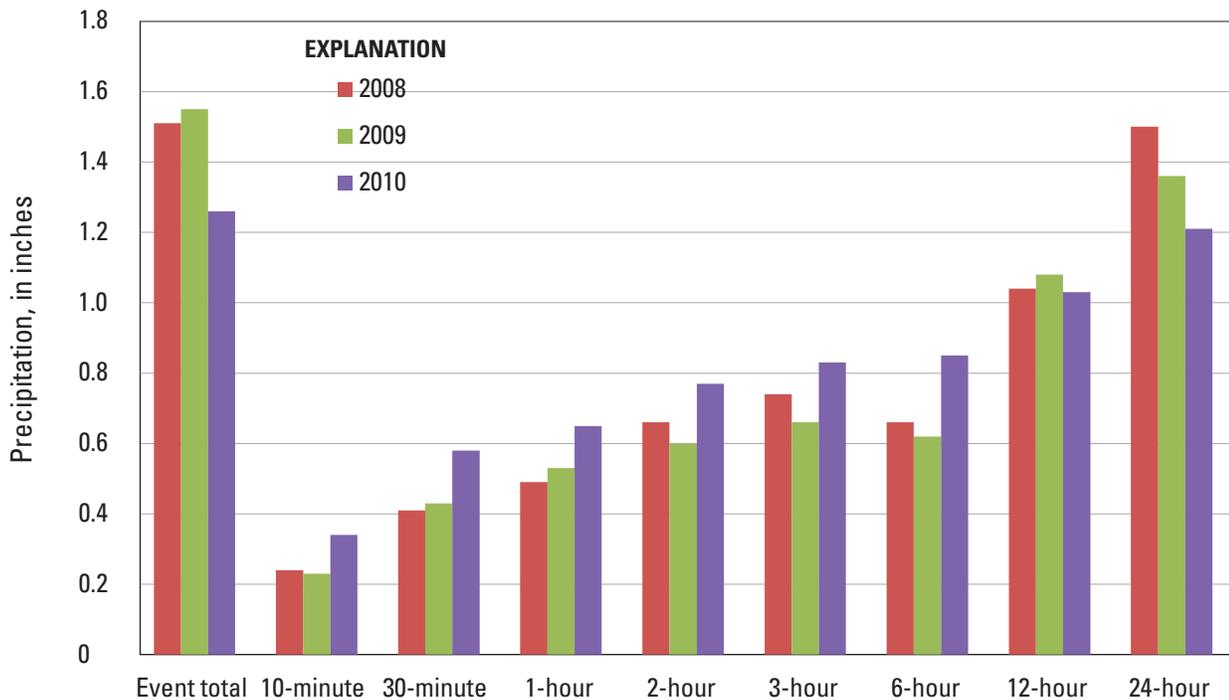
**Figure 5.** Annual average duration and depths for precipitation events that exceeded the 0.75-inch design storm at Sterncrest Drive site, Cuyahoga County, Ohio.

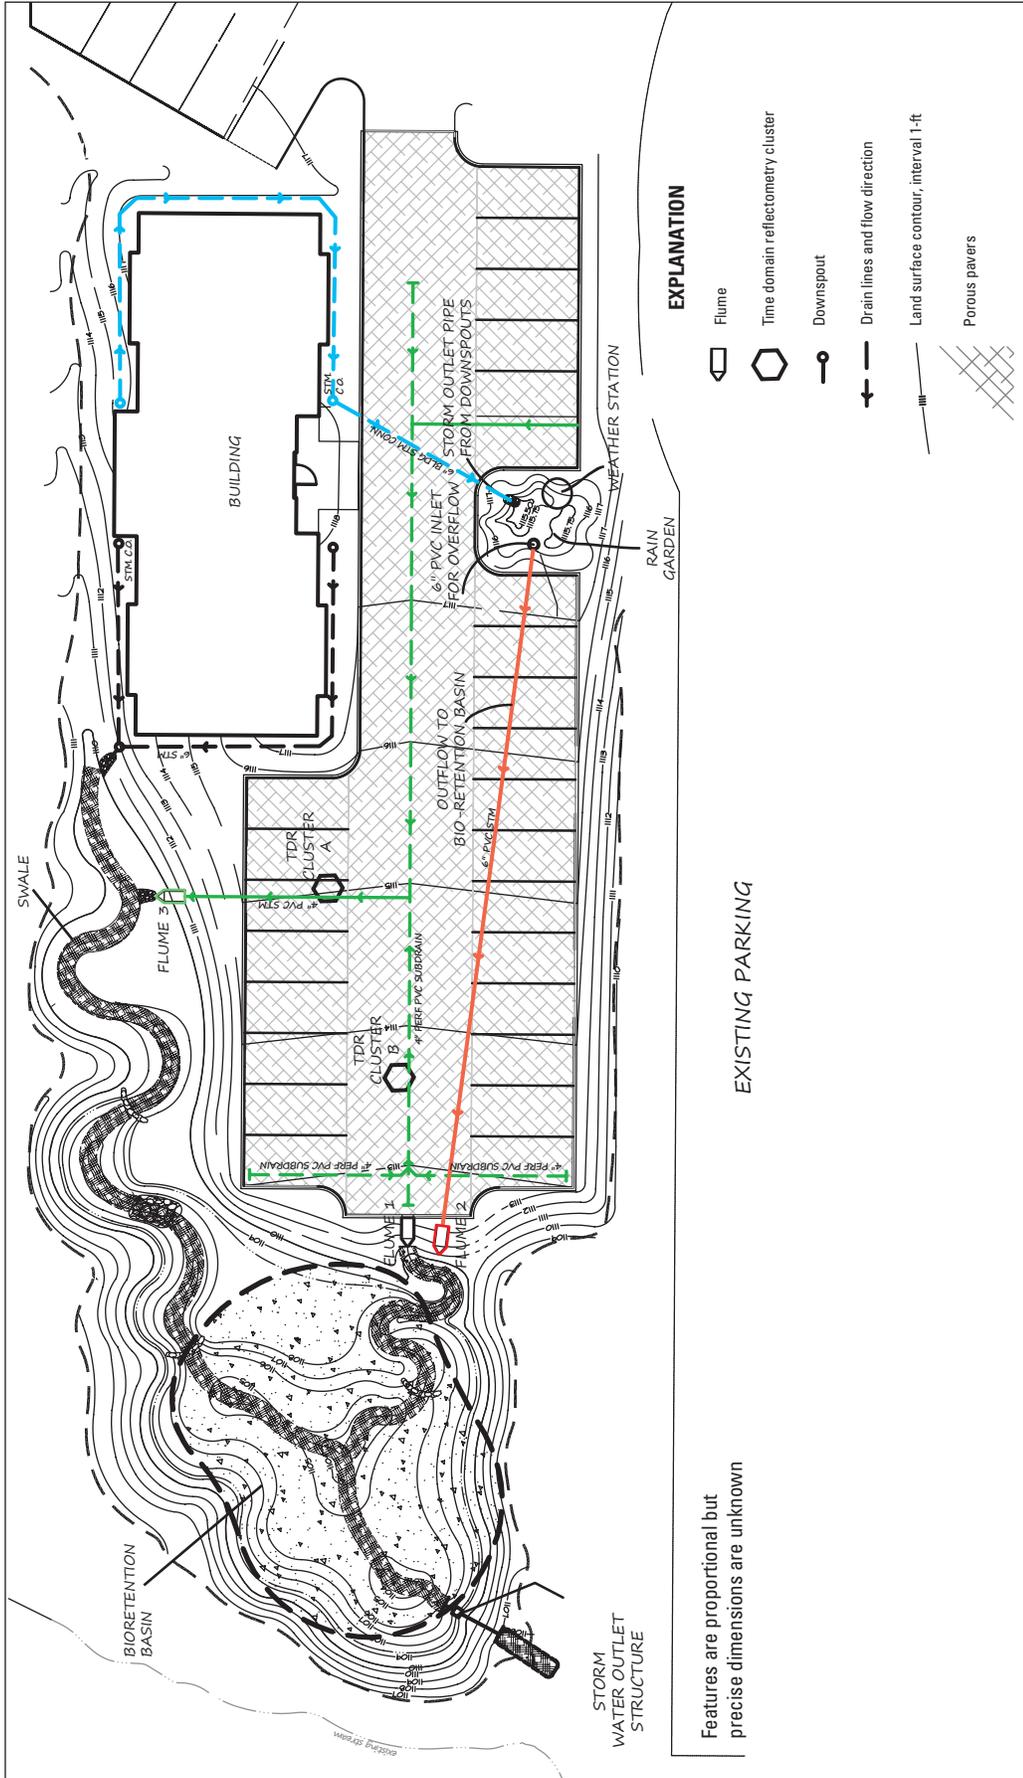
Features are proportional but precise dimensions are unknown

**Figure 6.** Site plan for stormwater best-management practices at Washington Street site, Geauga County, Ohio (modified from engineer drawings provided by Cawrse and Associates, Inc.).

Discharge from the pervious-paver subsurface drains (flume 3, fig. 6), overland flow from the parking lot (flume 1, fig. 6), and overflow from the rain garden (flume 2, fig 6 and 7) were determined by means of prefabricated H-flumes (fig. 8). Water levels in the flumes were measured in attached external stilling wells by means of pressure transducers connected to data loggers that initiated and stored the water-level readings. Water levels, specific conductance, and temperatures were measured every minute and, at a minimum, recorded every 10 minutes. When the stage exceeded 0.05 ft above no flow, any change in water level of more than 0.01 ft also was recorded. The corresponding specific conductance and water temperature were stored with each coincident water-level reading.

Location on figure 6	Sensor number	Depth below top of pavers (feet)
Cluster A	1	2.8
Cluster A	2	1.5
Cluster A	3	1.2
Cluster B	4	2.7
Cluster B	5	1.7
Cluster B	6	1.5

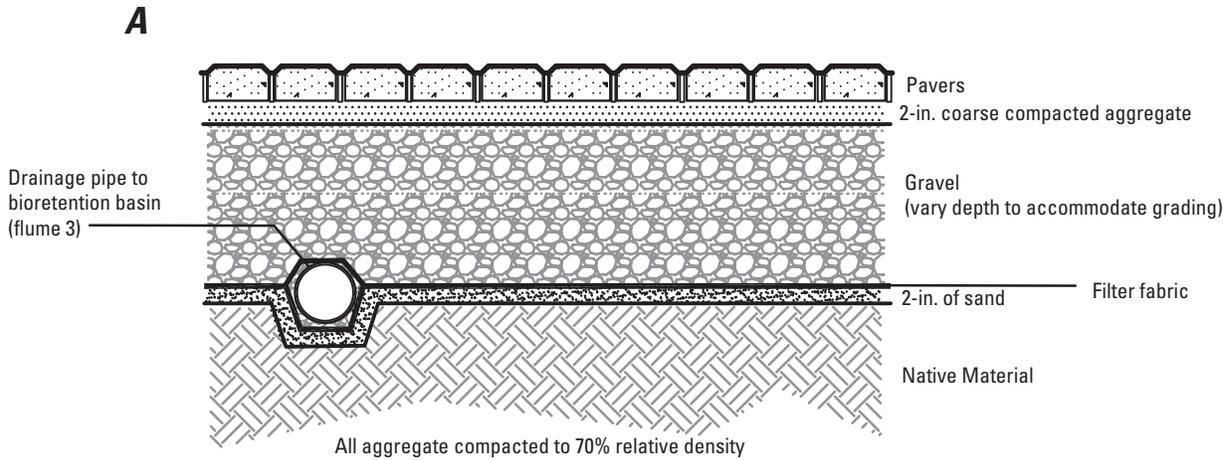
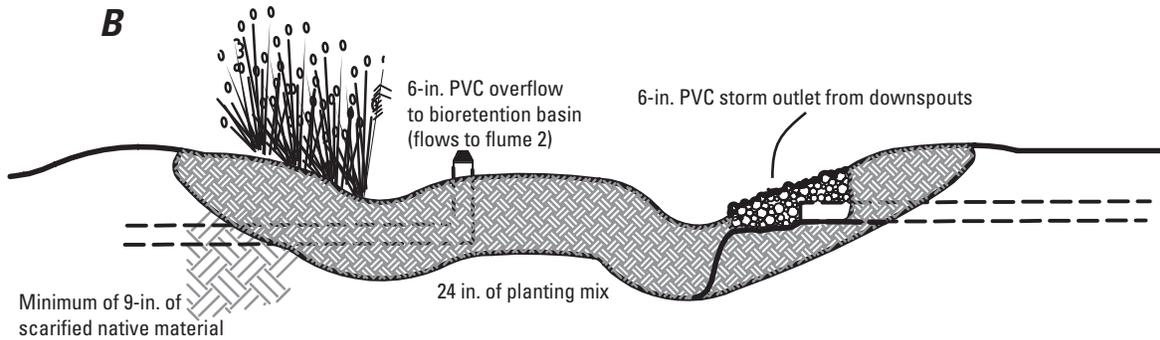
Typical Paver Detail

Typical Rain Garden Detail

**Figure 7.** Construction detail for Washington Street site, Geauga County, Ohio. *A*, Paver parking lot. *B*, rain garden. (Modified from engineer drawings provided by Cawrse and Associates, Inc.)

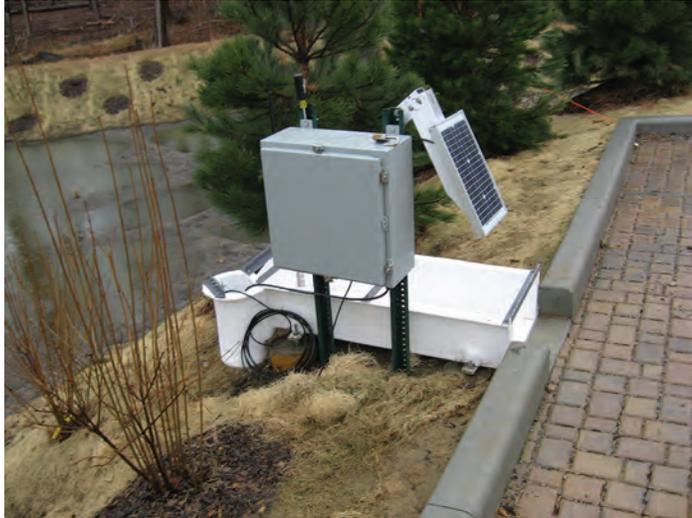
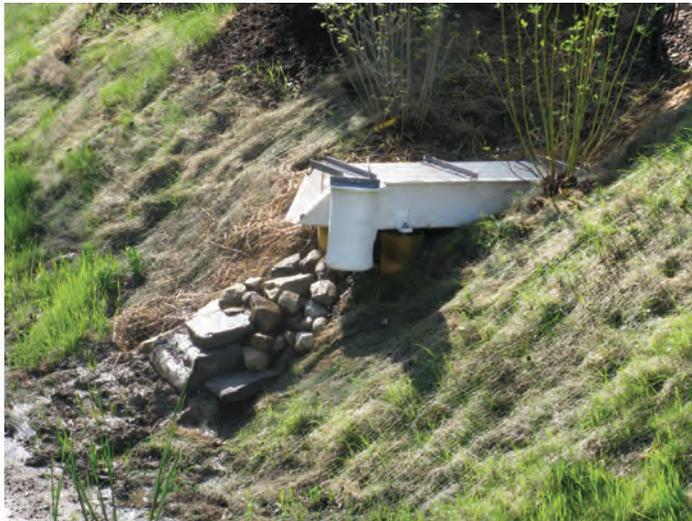
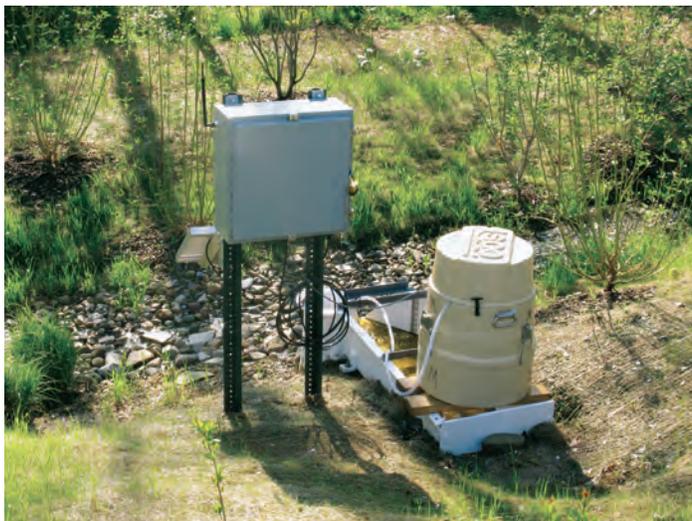
**A** Flume 1

**B** Flume 2

**C** Flume 3

**Figure 8.** Photographs of the flumes at Washington Street site, Geauga County, Ohio. Flume 1, *A*, measures surface flow over the parking lot; flume 2, *B*, measures any overflow from the rain garden, and flume 3, *C*, measures the flow from the drain line.

No runoff was recorded in flume 1, which measures surface runoff from the pervious paver parking lot, indicating all precipitation that fell on the parking lot either infiltrated through the void spaces between the pavers or evaporated. Runoff was recorded from flume 2, the rain-garden overflow, on three occasions with the largest volume being on August 10, 2009, when 19.9 ft<sup>3</sup> of water moved through the overflow

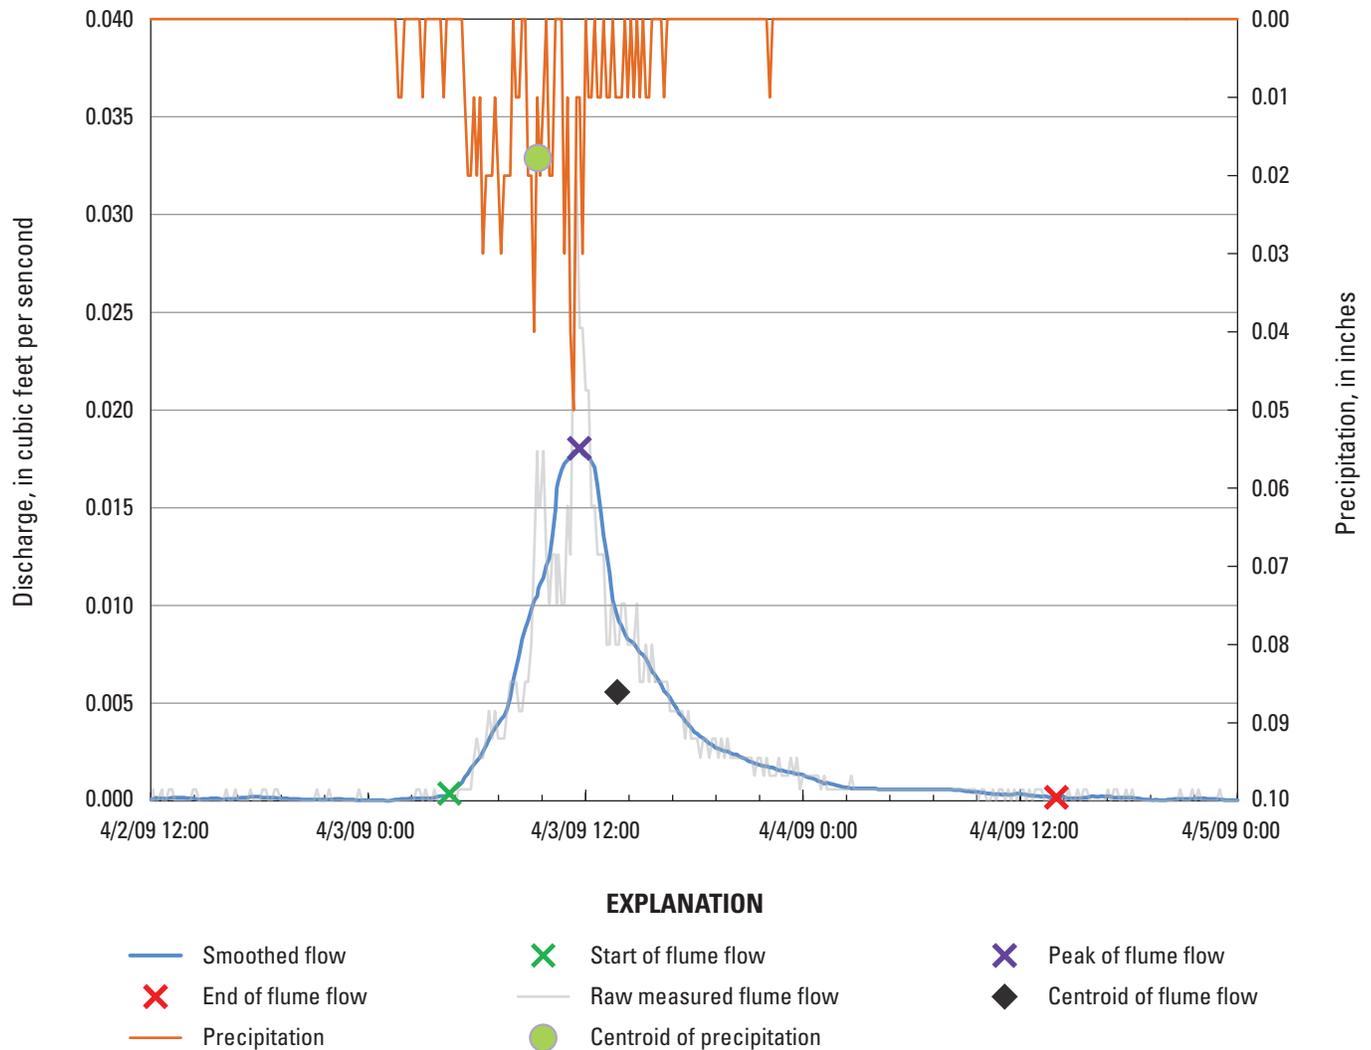
**Figure 9.** Hydrograph of typical precipitation event at the Washington Street site showing the spreadsheet selections of begin, peak, and end of flow, as well as the centroids of flow and precipitation.

Centroid lag time is the time, in minutes, between the centroid of precipitation and the centroid of the flume flow (runoff). Centroid lag time is a measure of how quickly water moves off or through the impervious surfaces and other drainage routes to the discharge points. For the event described in figure 9, the centroid of the precipitation event was on April 3, 2009, at 09:22, and the centroid of the flume flow was on April 3, 2009, at 13:45, so the centroid lag time was 263 minutes.

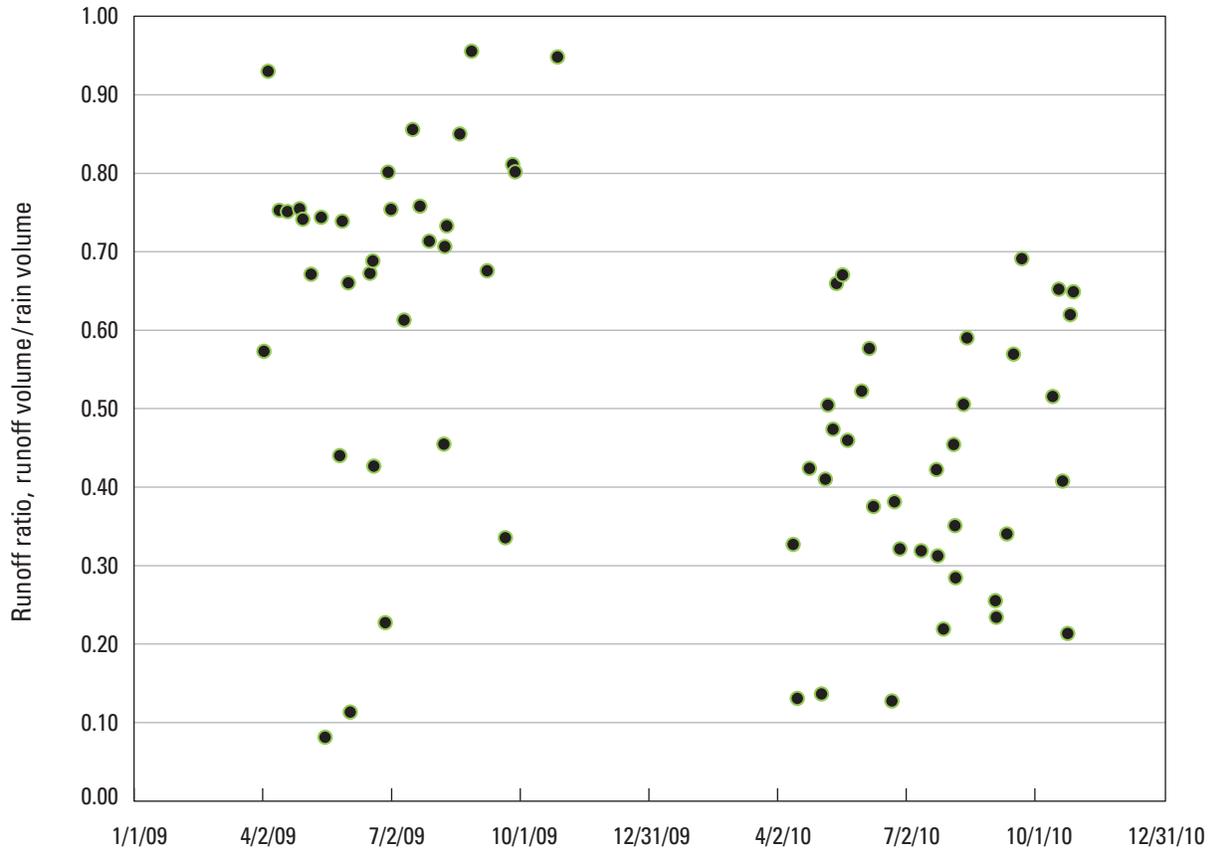
**Figure 10.** Runoff ratio for the pervious-paver/rain-garden BMP at Washington Street site, Geauga County, Ohio, April through October 2009 and 2010.

Only events with complete runoff hydrographs, precipitation, and TDR data were analyzed. A total of 34 out of 42 precipitation events in 2009 and 36 out of 46 precipitation events in 2010 produced sufficient data for analysis. The runoff ratios for 2009 and 2010 (fig. 10) suggest an improvement in the performance of the BMP over time. One explanation may be the maturation of vegetation in the rain garden promoted more rapid infiltration through a denser root mass (Selbig and Balster, 2010). In addition, transpiration in 2010 may have been greater because the plants in the rain garden were more fully established (fig. 12).

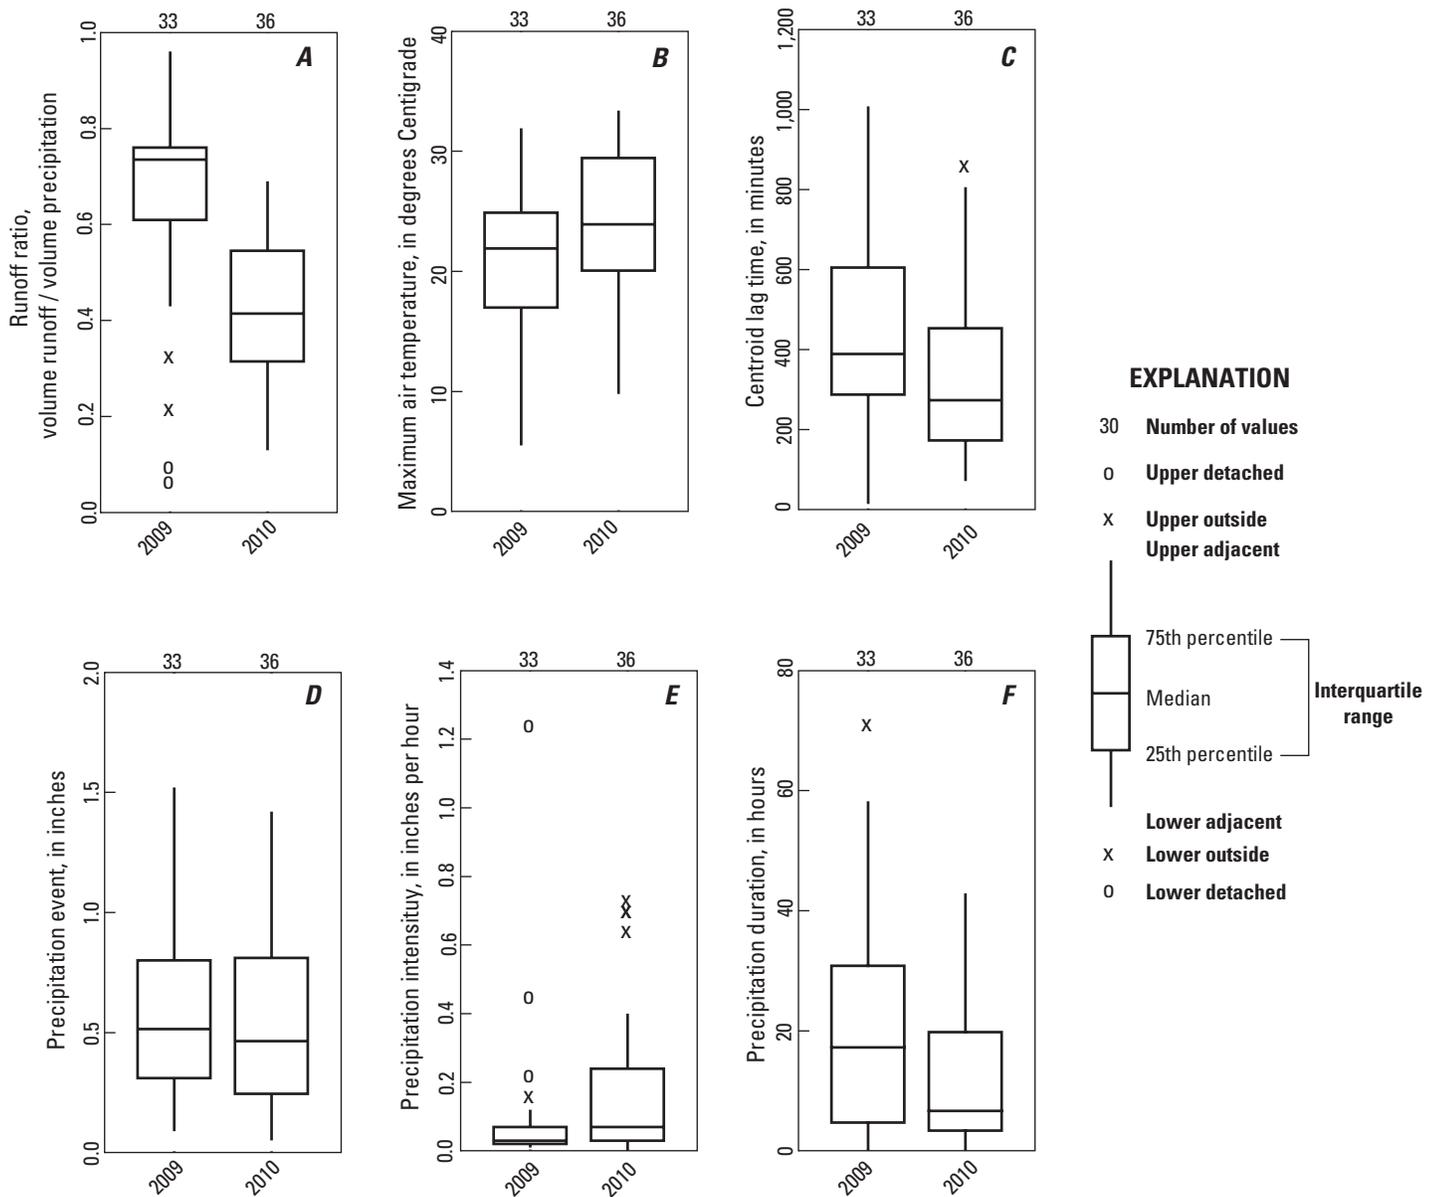
**Figure 11.** Boxplots of climatological and flow characteristics, Washington Street site, Geauga County, Ohio, 2009 and 2010. A, Runoff ratio. B, Maximum daily air temperature (degrees Celsius). C, Centroid lag. D, Precipitation event size. E, Precipitation intensity. F, Precipitation duration.

The Wilcoxon rank-sum statistic is a nonparametric test to compare two datasets, in this case different event characteristics from 2009 and 2010. Figure 11A shows that the runoff ratio decreased from 2009 to 2010 ( $p$ -value  $< 0.01$ ), indicating that more water is being removed in 2010 than in 2009 (presumably through ET or infiltration). Figure 11D and E show that although precipitation-event depths in 2009 and 2010 were not statistically different, the intensity of the events increased ( $p$ -value = 0.02). During the same time, the centroid lag decreased (fig. 11C;  $p$ -value = 0.03), indicating that the water that moved through the BMP did so faster, possibly in response to the increased intensity (fig. 11E) and shorter duration (fig. 11F) of the precipitation events. Another possibility could be the development of preferential flow paths beneath the pavers.

Some of the decrease in runoff in 2010 may be attributable to increased evaporation due to higher maximum daily air temperature (fig. 11B). The warmer weather could have heated the pavers and base material more in 2010 than in 2009, thereby increasing evaporation. Another possible explanation for the lower runoff ratios in 2010 could be the maturation and increased growth of the plants in the rain garden (fig. 12), with roots penetrating the clay rich substrate and increasing infiltration (Selbig and Balster, 2010).

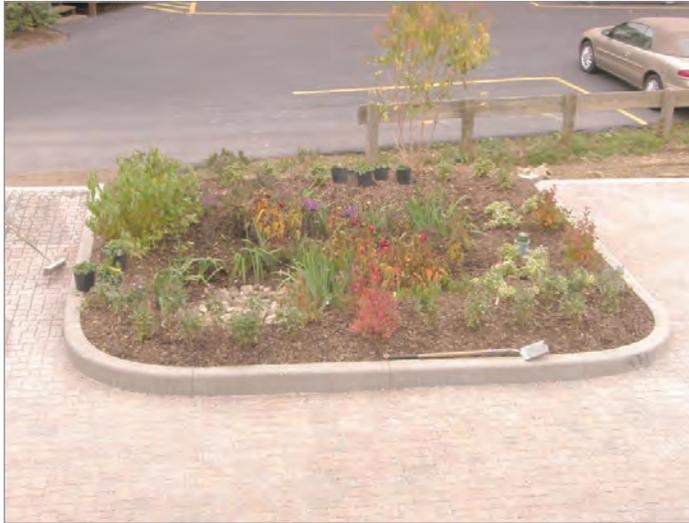
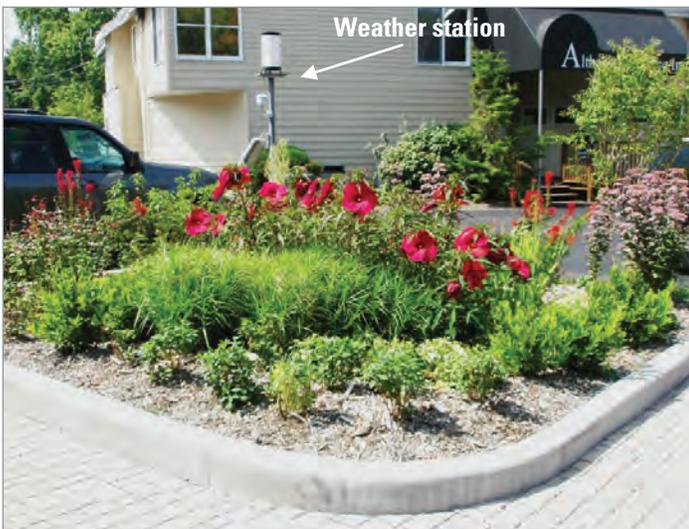
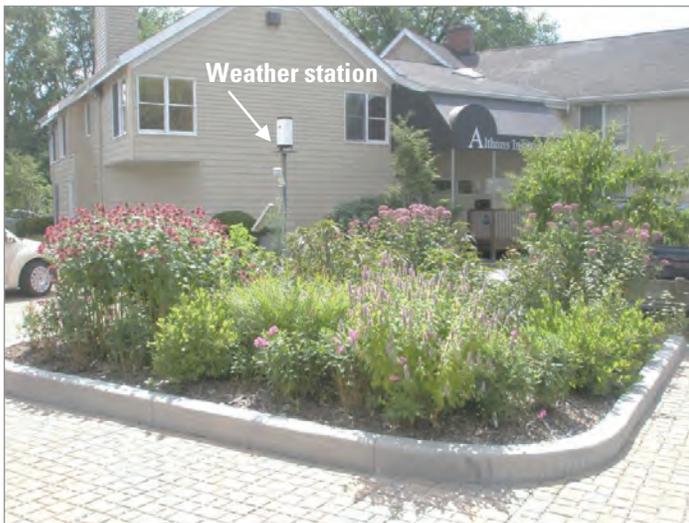
**Figure 12.** Photographs of Washington Street rain garden showing weather station and plant growth from October 2008 to August 2010. (Photographs by Cawrse and Associates, Inc., employees.)

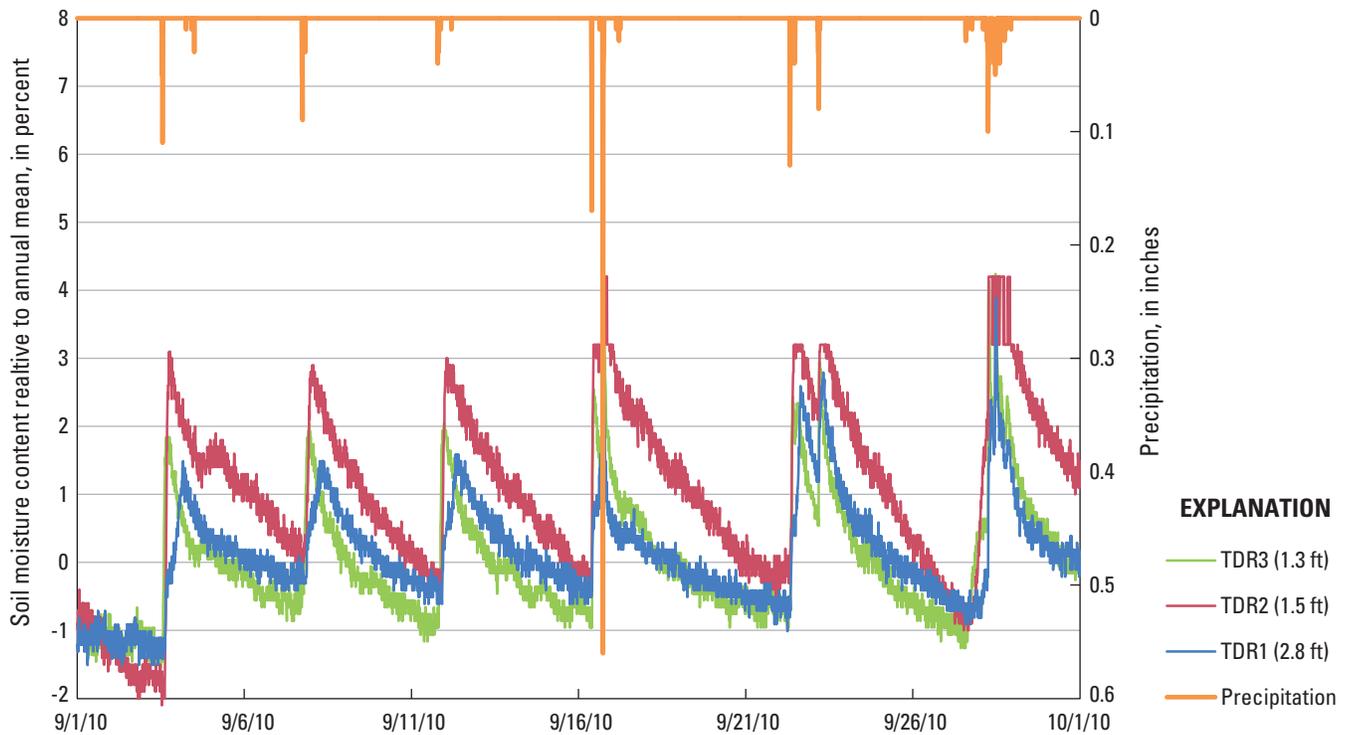
**Figure 13.** Time-domain reflectometer relative soil moisture for one month, cluster A, Washington Street site, Geauga County, Ohio. The graph shows that the BMP does not have time to return to a steady state before the next precipitation event.

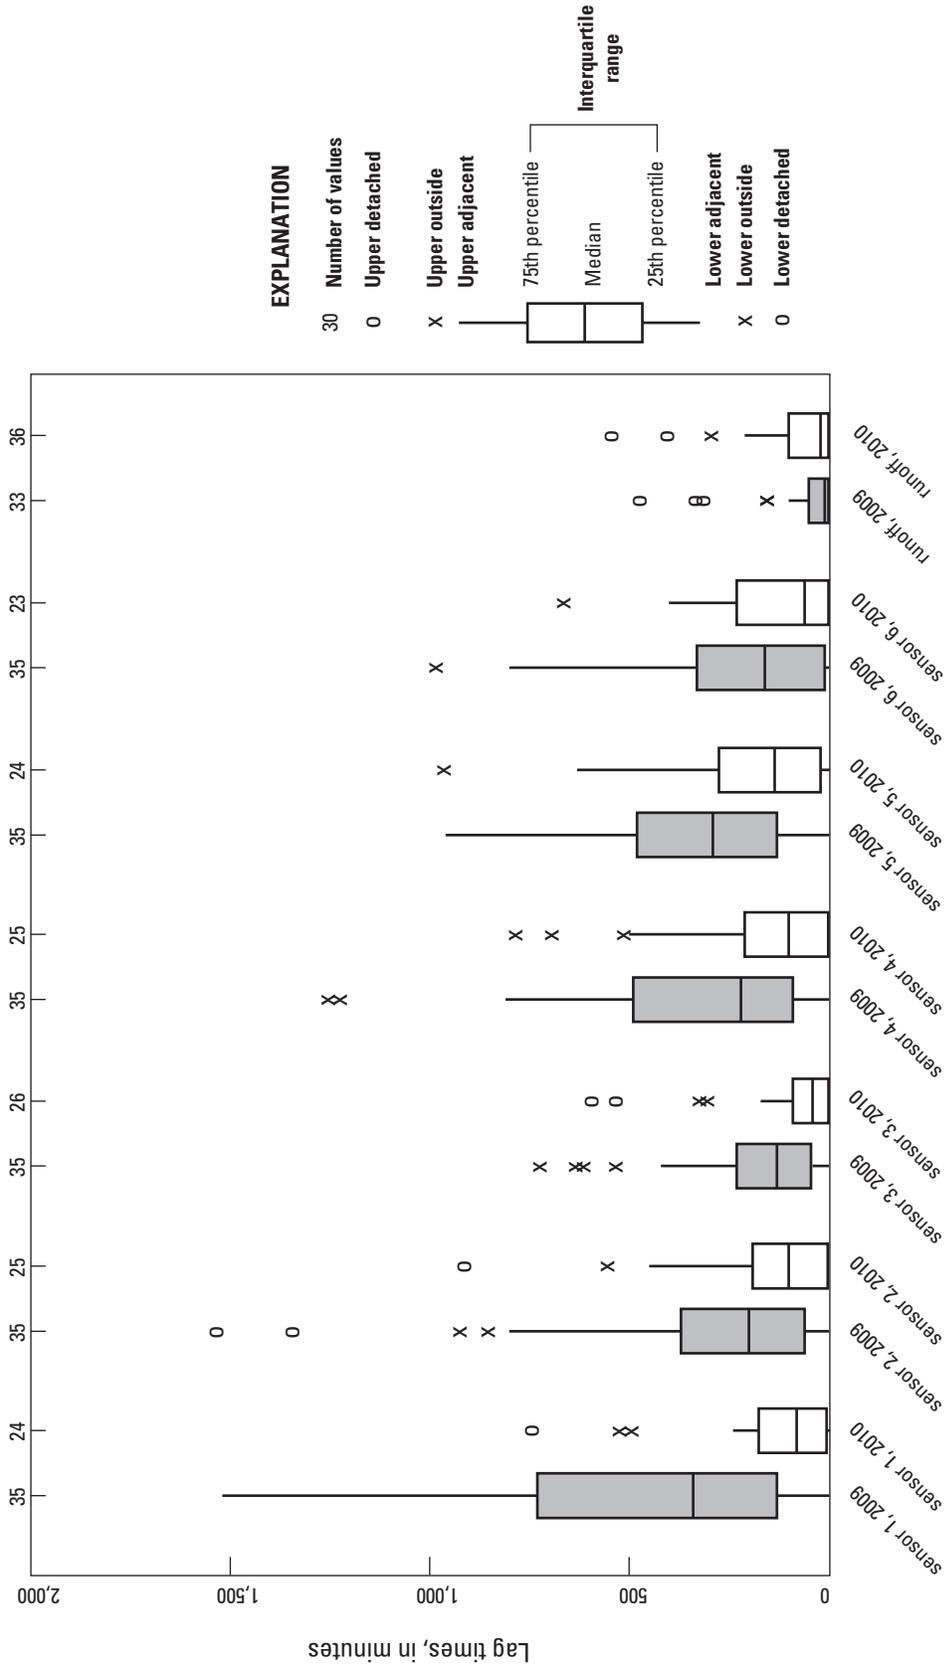
Figure 14. Boxplots of specific-conductance lag times for six soil-moisture sensors and runoff, 2009 and 2010, Washington Street site, Geauga County, Ohio.

The SC lag times for the TDRs in 2010 are noticeably shorter than the those in 2009 (fig. 14). Part of this quicker response time could be attributed to the tendency toward more intense precipitation events in 2010 as compared to 2009 (fig. 11E) and/or the possible development of preferential flow paths. Preferential flow paths can develop over time as water movement through the BMP forms channels or as desiccation or settling cause fractures. With additional data, provided that the storm intensities and durations are similar to those in 2009
