# Optical and Scanning Electron Microscopy of the Materials International Space Station Experiment (MISSE) Spacecraft Silicone Experiment

*Ching-cheh Hung and Kim K. de Groh  
Glenn Research Center, Cleveland, Ohio*

This research characterized and compared the degree of AO degradation of silicones by analyzing optical microscope images of samples exposed to LEO AO as part of the Spacecraft Silicone Experiment. The Spacecraft Silicone Experiment consisted of eight DC 93-500 silicone samples exposed to eight different AO fluence levels (ranged from 1.46 to  $8.43 \times 10^{21}$  atoms/cm<sup>2</sup>) during two different Materials International Space Station Experiment (MISSE) missions.

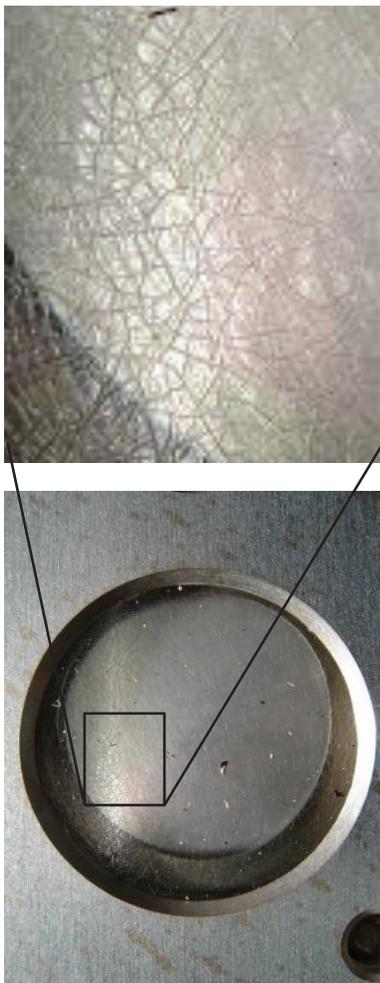
Figure 1. Post-flight photograph of MISSE 2 DC 93-500 sample 2-E5-1 showing the crazed surface.

The most obvious effect observed for silicones during AO environment exposure are changes in surface morphology. Under optical microscopy, all space exposed silicone surfaces contain “islands” separated by numerous crack lines (as shown in Fig. 1, Ref. 5) after they have been exposed to relatively low AO fluence exposures. Surface morphology changes, however, have not been used in the past to characterize silicone degradation during AO exposure. This is because of the difficulty in developing a standard method that can quickly, accurately and quantitatively be used to analyze changes in surface morphology. The problem of using numbers to characterize changes in pictures, however, is greatly alleviated due to the recent advancement of imaging analysis computer software. Consequently, using morphology changes to characterize silicone degradation due to AO exposure has become feasible. In this study, the morphology of retrieved MISSE 2 & 4 silicone samples were examined and quantified. Commercially available image analysis software was used to analyze images of the samples taken by an optical microscope. Scanning electron microscope (SEM) was also used to examine features that were beyond the capability of the optical microscope. No attempts were made to use the image analysis software to analyze the SEM images.

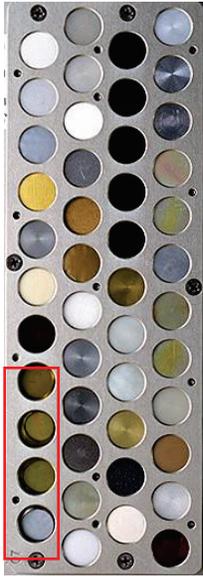
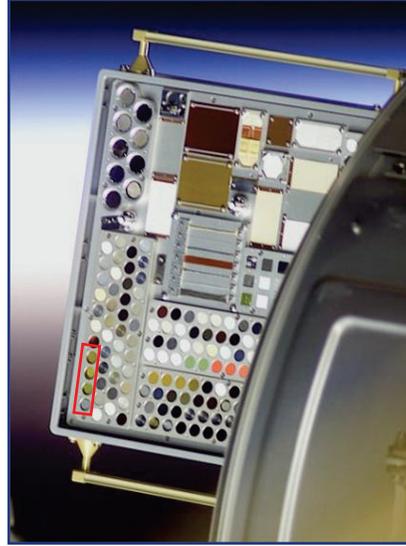
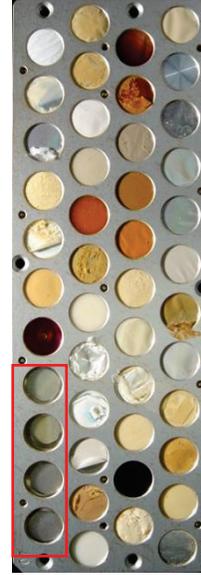
Figure 2. MISSE 2 Tray E5 with the Spacecraft Silicone Samples highlighted, a). Prior to flight, b). MISSE 2 on the ISS Quest Airlock (the Spacecraft Silicone Experiment samples are outlined), and c). After space flight.

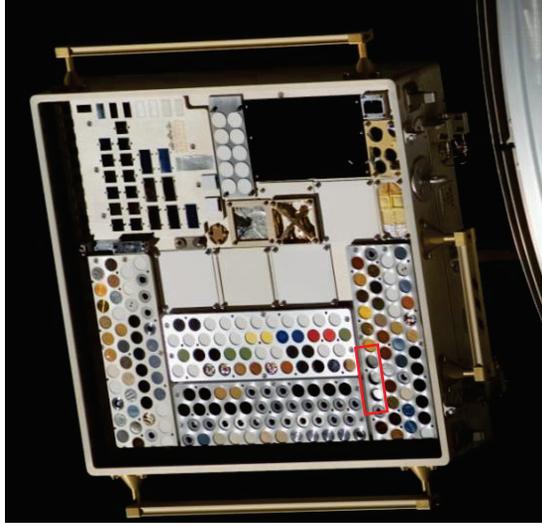
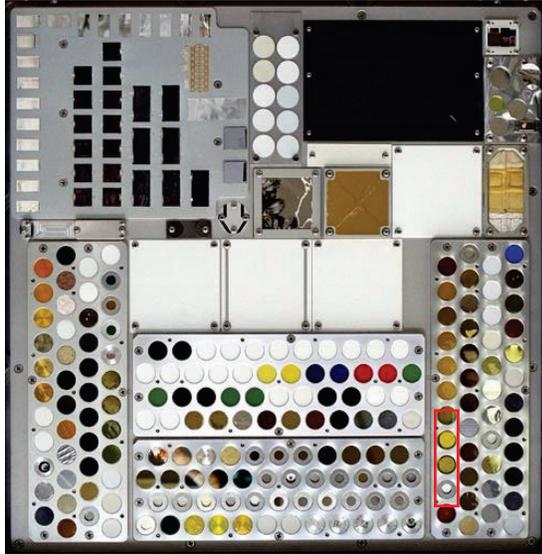
Figure 3: MISSE 4 with the Spacecraft Silicone Experiment samples highlighted, a). Prior to flight, and b). On-orbit just prior to retrieval (August 2007).

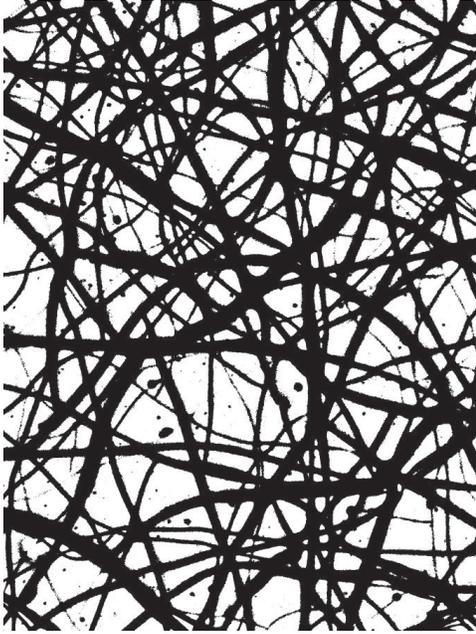
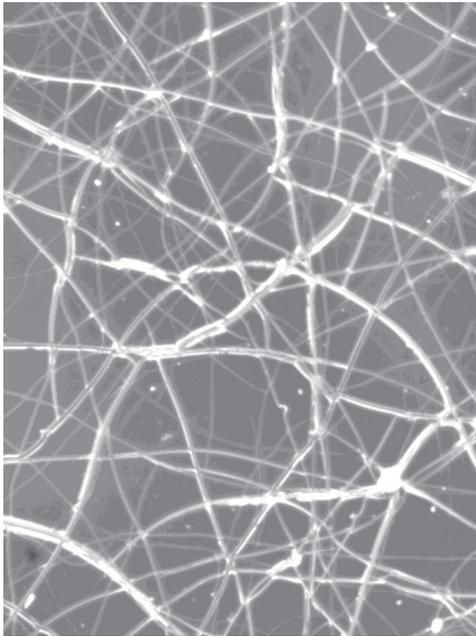
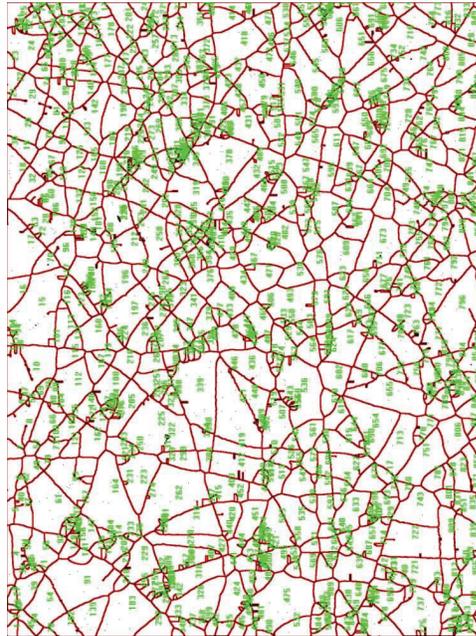
Figure 5: Optical micrograph of silicone DC93-500 exposed to 8.43 E21 fluence atomic oxygen in Low Earth orbit during MISSE 2 mission

- (a) Original picture (Upper left)
- (b) Converted version of original picture (black crack and white non-crack area) (above)
- (c) Converted version with all cracks made into thin lines (left)

The original picture (Fig. 5(a)) was at first modified by removing the shades of grey, so that the region occupied by crack lines became 100 percent white and the rest of the areas became 100 percent black. The black and white in this picture was then inverted to give Figure 5(b), which can be used by the software to calculate individual and total white (island) areas. The black thick lines (crack lines) in Figure 5(b) were then reduced to thin lines by the software to result in Figure 5(c), from which the perimeter of individual areas as well as sum of perimeters of all areas in the picture can be calculated by the software. The total length of the crack lines in the picture were then calculated as half of the sum of perimeters of all areas in the picture. Individual, total and average island areas were also calculated from Figure 5(c).

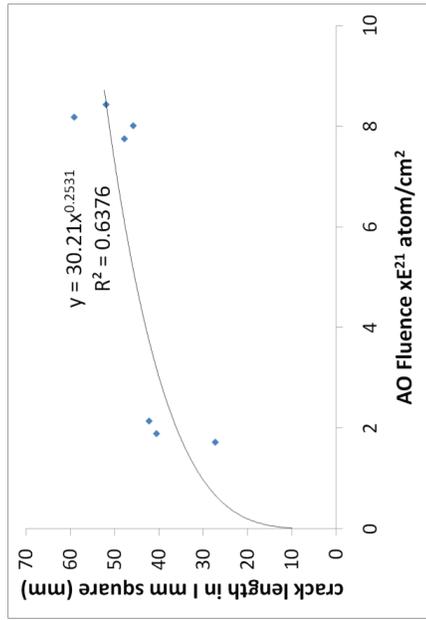
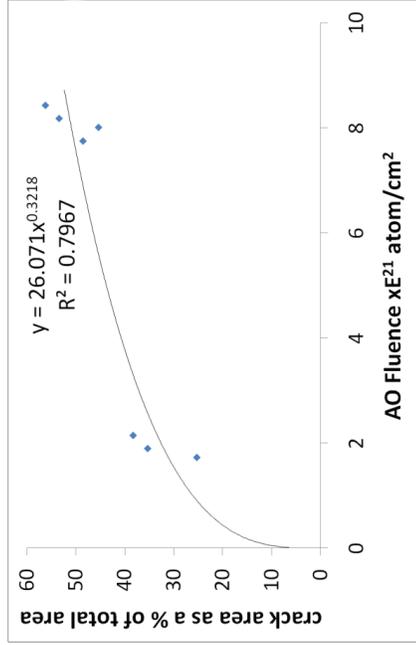
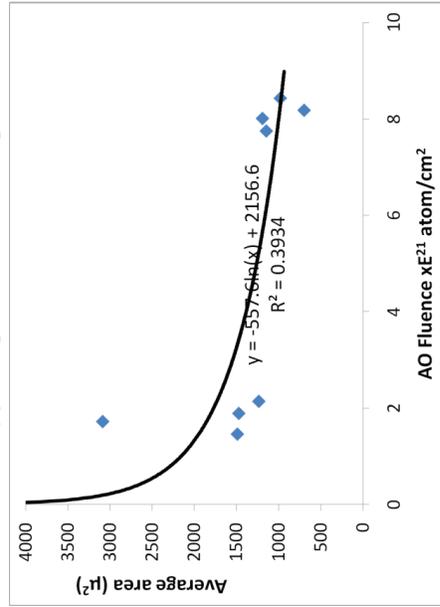
6(a) Total length of cracks in mm within 1 mm<sup>2</sup> for atomic oxygen exposed silicone samples

6(b) Crack area as a % of area for atomic oxygen exposed silicone samples

6(c) Average island area

Figure 6: Plots and the trend lines of morphological parameters as a function of the fluence

The three different characterization parameters (the average area of the islands, the fraction of sample surface area that is occupied by crack lines, and the total length of crack lines per unit area of the sample surface) for the samples that were degraded by AO exposure to seven different fluence levels are summarized in Table 2. Since average crack widths can be estimated from crack length and crack area described above, they were calculated and also shown in Table 2. Figure 6 contains plots and corresponding trend lines of these morphological parameters plotted against the AO fluence. Exponential equations were used to represent the trend lines because of the observation that changes of the morphological parameters were fast at the beginning, but slowed down continuously as the total fluence increased.

A review of Table 2 and Figure 6 revealed that, among the three morphological parameter-fluence relations, the fraction of sample surface area that is occupied by crack lines seems to have the least data scattering and most consistent trend, as shown in Figure 6(b). The other two plots had larger data scattering. These large data scattering may be an artificial effect resulting from the data processing.

Data scattering of the fraction of sample surface area that is occupied by crack lines is the least among these three. This may possibly be a result of it being the simplest data processing method, as it was calculated from images of crack areas (see picture (b) in all Figures in Appendix A), while the other two parameters were calculated from images where crack areas needed to be reduced to thin lines (picture (c) from all Figures in Appendix A). Regardless of the reason why some trends appears to be more complicated than others, the above results suggest that the best morphological parameter to characterize the degradation of silicone under AO exposure would be the crack line area as a percent of the total sample surface area because it has the least data scatter.

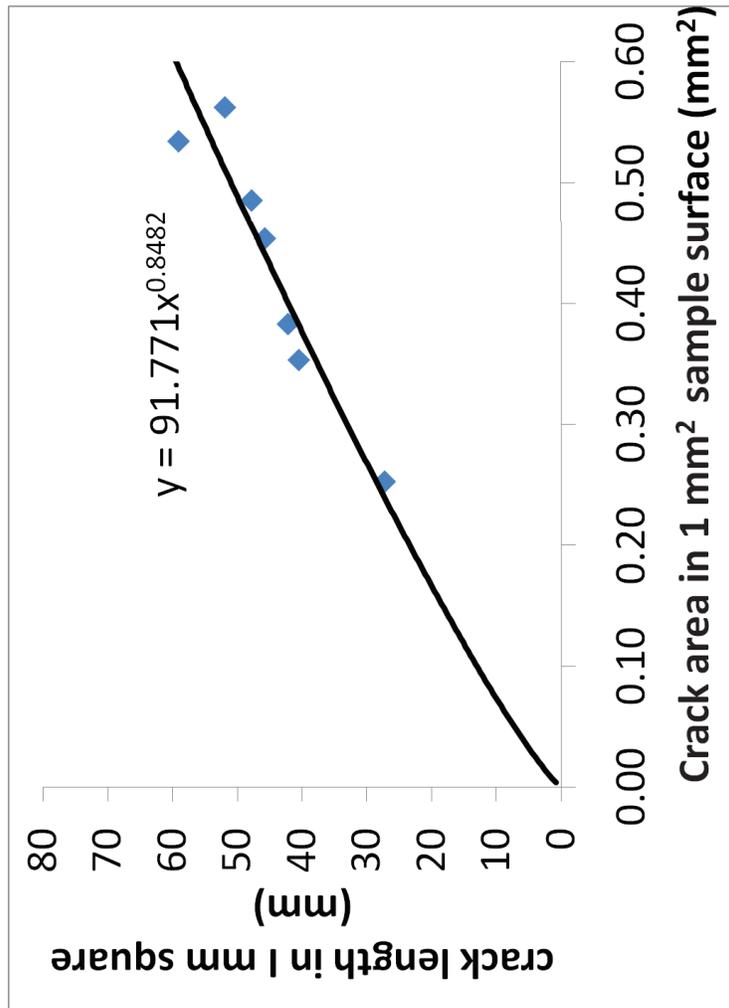
Figure 7: Crack surface area increases almost linearly with crack length, indicating the crack width does not change much during the entire time of atomic oxygen exposure

Figure 7 is a plot of crack length per area versus crack area per total area. It shows the surface area increases almost linearly with crack length, indicating that crack width does not change much. Newly formed cracks continue to have the same width as the old ones until the fluence reached a very high level. This suggests that crack propagation is mostly either by growth of new cracks or by lengthening of the old cracks until the island areas become thick, glassy, and small.

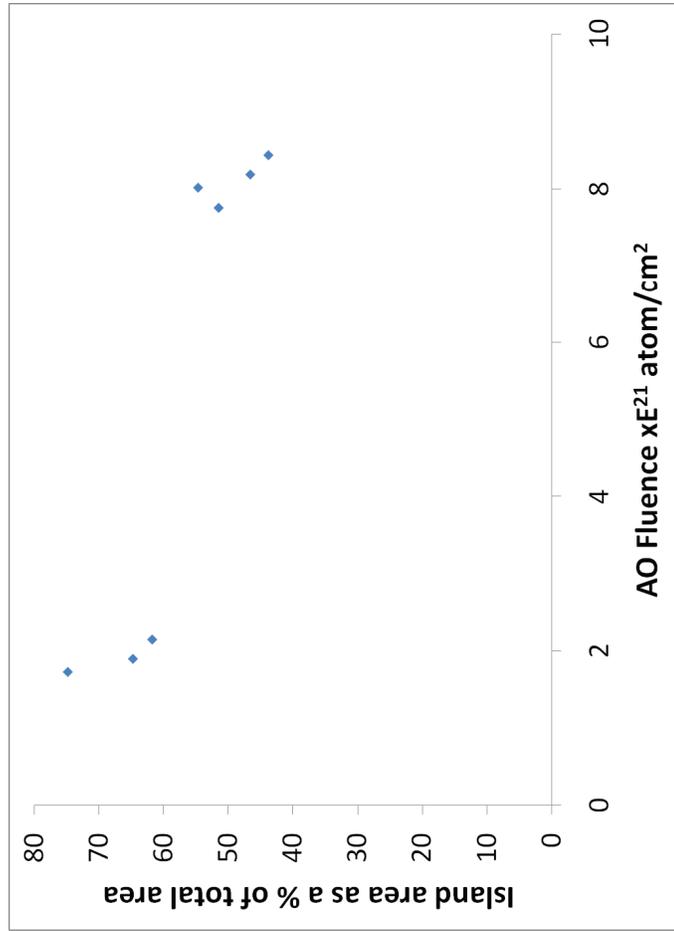
Figure 8: Island area as a % of area of atomic oxygen exposed silicone samples. This would be the theoretical specular transmittance due to crack area assuming the specular transmittance at the crack is zero

For the AO fluence level studied here ( $1.72\text{-}8.43 \times 10^{21}$  atom/cm<sup>2</sup>), adding island area as percent of total area to crack area as percent of total area would result in 100 percent. Therefore, for the plot of percent island area (A) as a function of fluence (F), the data fit (Fig. 8) an exponential equation

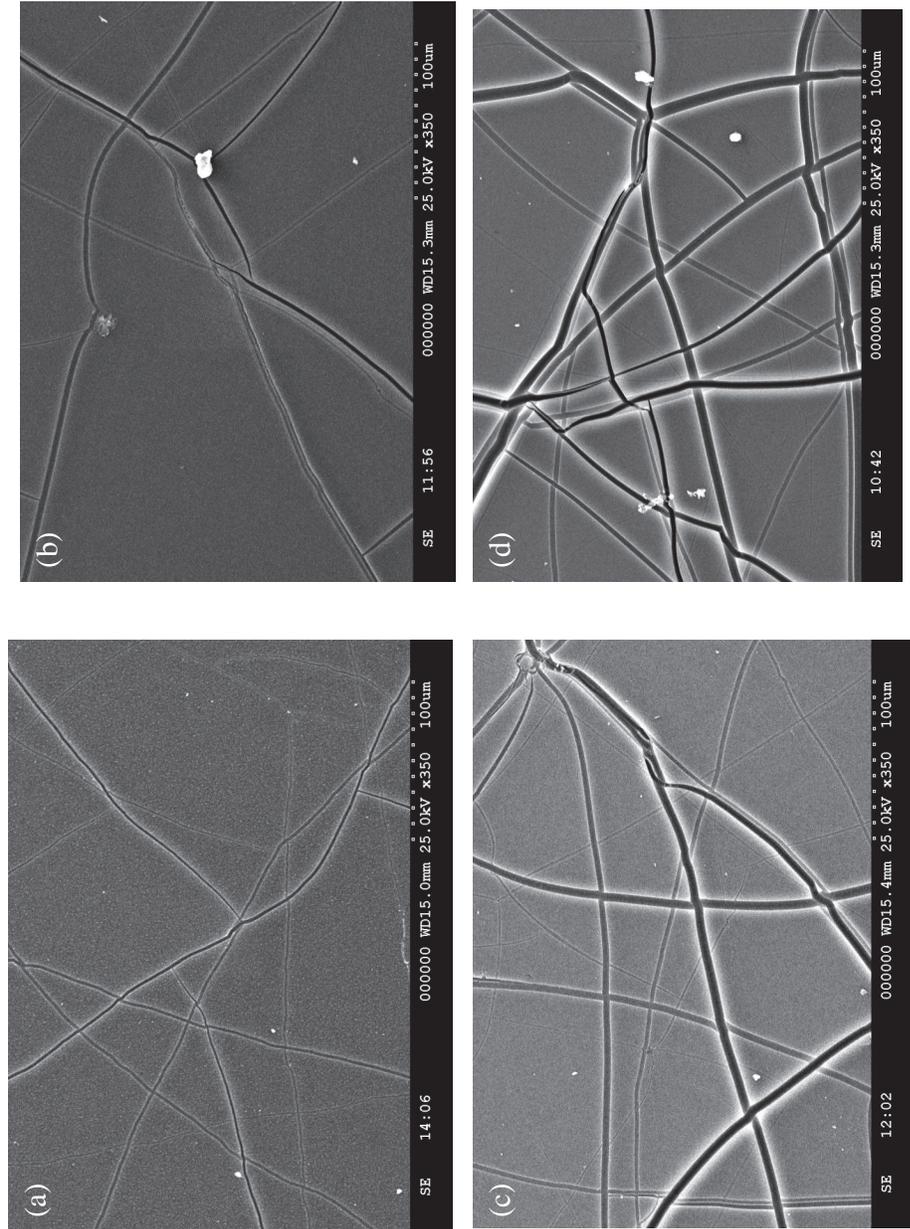
Figure 9: SEM pictures of silicone exposed to different level of AO fluences (a)  $1.72 \times 10^{21}$  atom/cm<sup>2</sup> (b)  $2.14 \times 10^{21}$  atom/cm<sup>2</sup> (c)  $7.75 \times 10^{21}$  atom/cm<sup>2</sup> (d)  $8.43 \times 10^{21}$  atom/cm<sup>2</sup>

The representative SEM images of silicone samples exposed to different AO fluences are presented in Figures 9(a) to (d). It can be seen that at lower AO exposure levels (Fig. 9(a) and (b)), the cracks are relatively simple and can be understood as the result of shrinkage of a thin layer of silicone surface due to silicone-AO reactions.

It can also be seen that new crack lines split old crack lines, and some old crack lines seem to stop cracking after some time, as many new crack lines become wider and deeper than the old crack lines. This data suggests that the oldest and first cracks, which are narrow, occur on surfaces that are under only small tensile stress. After the event of a crack, there will be a re-distribution of stress and tensile stress parallel to the crack becomes reduced. However, in directions approximately perpendicular to the initial cracks, stress builds up to accumulate to greater than that at the time of the initial cracks. This causes the newest cracks to open wider and deeper than the initial cracks. In general, the process continues to cause the newest branch cracks to be wider and deeper than older cracks. Consequently, some of the old crack lines diminish their cracking because the stress on them decreases. The more mud tiled the surface becomes, the deeper the thickness of silicone oxidation, which grows slower with fluence because the atomic oxygen has a more difficult time migrating deep to unoxidized silicone. Although the surface gradually becomes very cracked, the islands remain well adhered because their surface layer is a gradual transition from completely oxidized silica to unoxidized silicone interior. It would only be for very thin surface layer where oxidation could occur through the full thickness causing the silicone to be significantly converted to silica that the mud tiles could break apart. This may be a durability threat for silicone Fresnel lenses, inflatable structures, or silicone coatings in low Earth orbit.

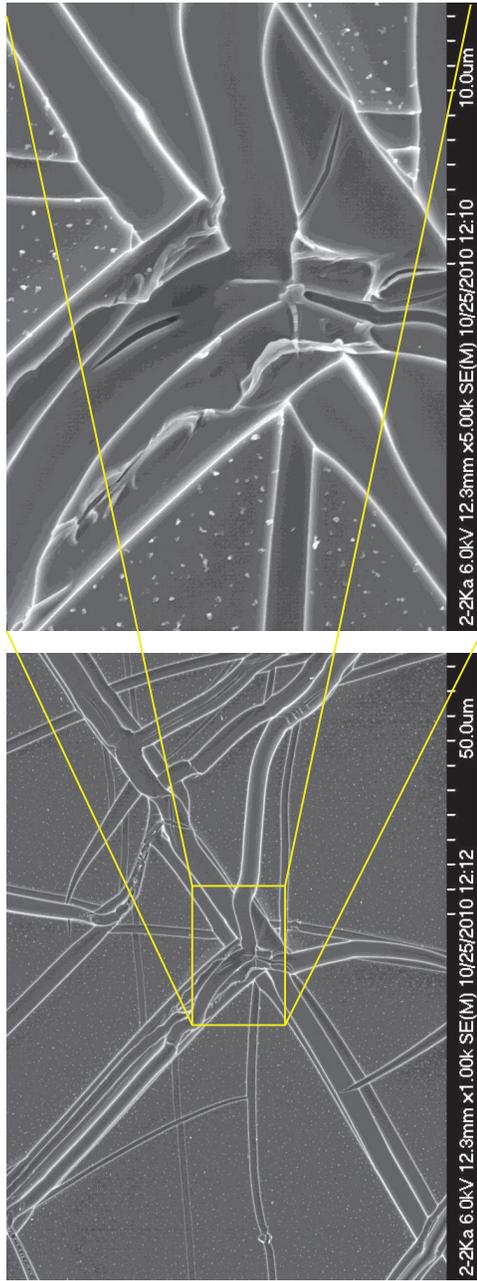
Figure 10: Pictures show part of the cracked surface stopped cracking as it became increasingly glassy and thick, but the rest of the cracked surface continues to crack into greater depth due to the cycles of forming thin oxide layer- causing high stress-cracking (Fluence =  $8.01 \times 10^{21}$  atom/cm<sup>2</sup>)

In the case of diminishing stress, after long AO exposure, the part of the surface that has not yet cracked develops a thick glassy layer, which is structurally stronger than a newly formed very thin oxide layer. Under stress, this newly formed layer will crack first to release the stress, and, further cracking of the thick glassy layer can be prevented. In the case of intensifying stress, the cycle of brittle surface formation-shrink-crack will continue until the stress is reduced, or the cracks become too deep for AO to reach. There are also observed cases where part of the cracked surface become increasingly glassy and thick, but the rest of the cracked surface continues to crack into greater depth due to the cycles of forming thin oxide layers causing high stress-cracking (Fig. 10).

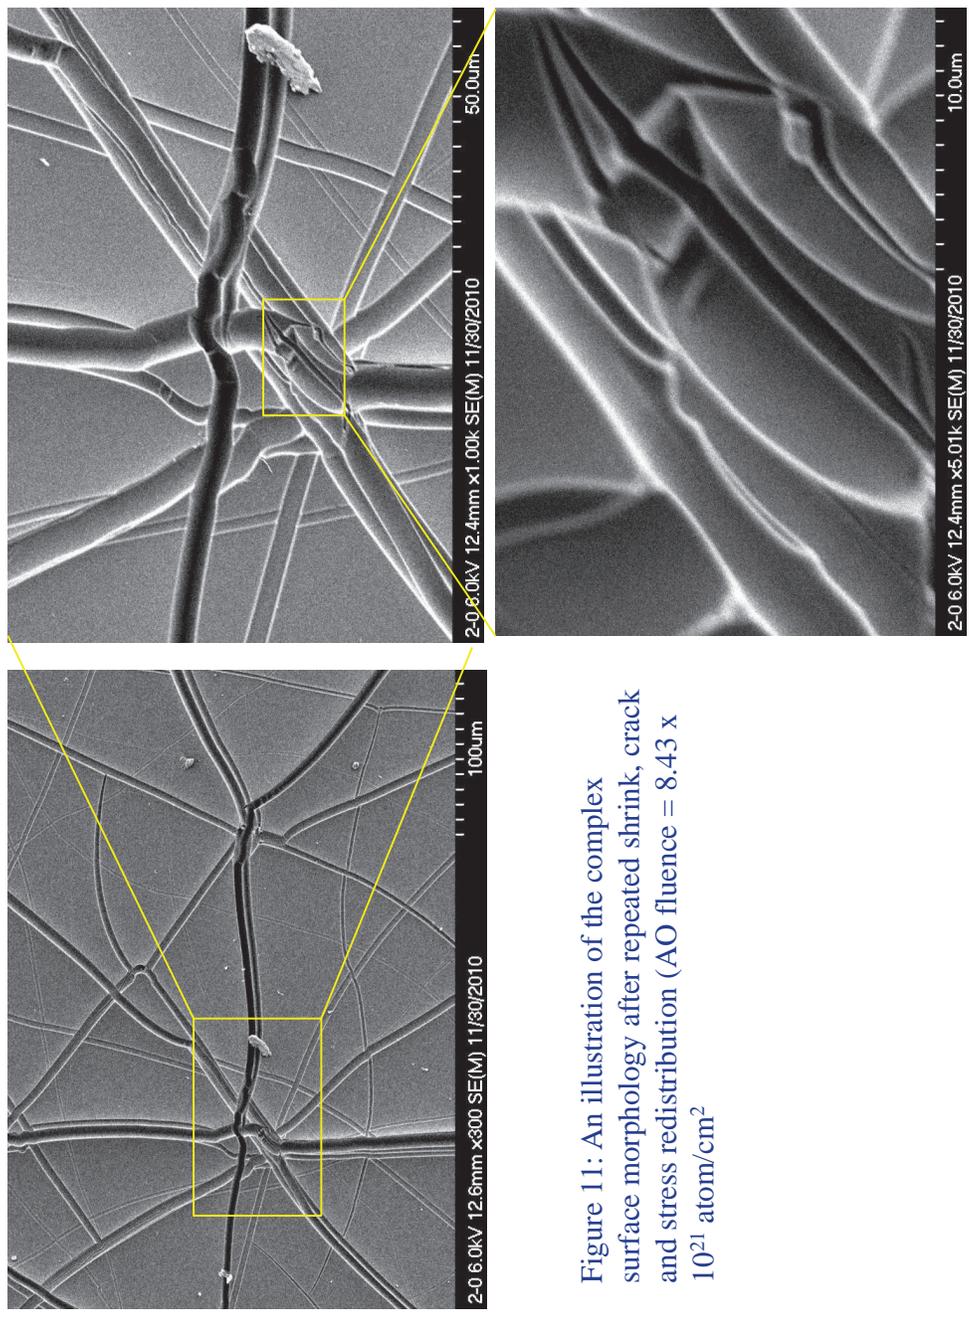
Figure 11: An illustration of the complex surface morphology after repeated shrink, crack and stress redistribution (AO fluence =  $8.43 \times 10^{21}$  atom/cm<sup>2</sup>)

Figure 11(a) to (c) are pictures of the complex crack morphology from the highest AO fluence exposed sample in this research (fluence =  $8.43 \times 10^{21}$  atom/cm<sup>2</sup>).

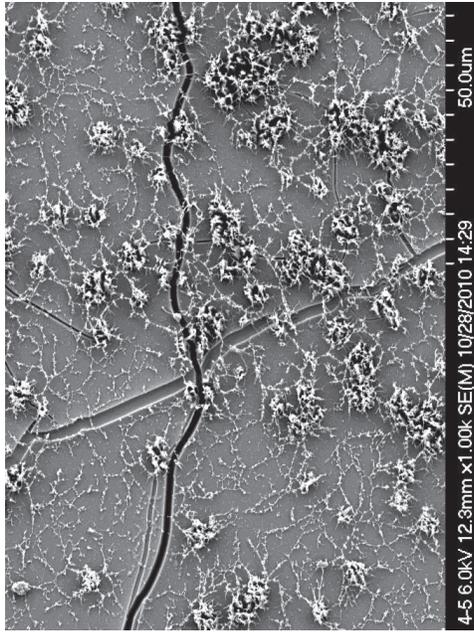
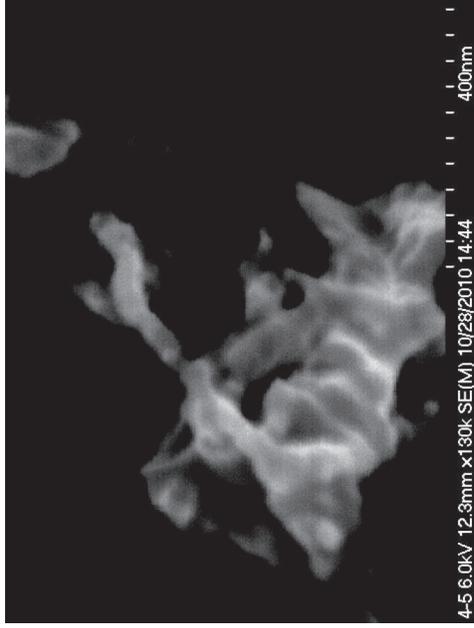
Figure 12: SEM image of residual Kapton on the MISSE flight sample with the lowest AO fluence exposure ( $1.46 \times 10^{21}$  atom/cm<sup>2</sup>). EDS show it contains more carbon and oxygen than the pristine silicone.

It was observed that the silicone sample with the lowest AO fluence (sample 4-E22-5) has a large amount of debris material on it, seen primarily as white spots and clusters (Fig. A8 in Appendix A). These are residual fragments of the Kapton H cover layer placed on top of the silicone for the purpose of adjusting AO exposure of the under-laying silicone to a lower level. Since the residue resulted in strong interference during image analysis, optical microscope data obtained from this sample was not further examined. This sample, however, was further examined by SEM which will be described later in this report.

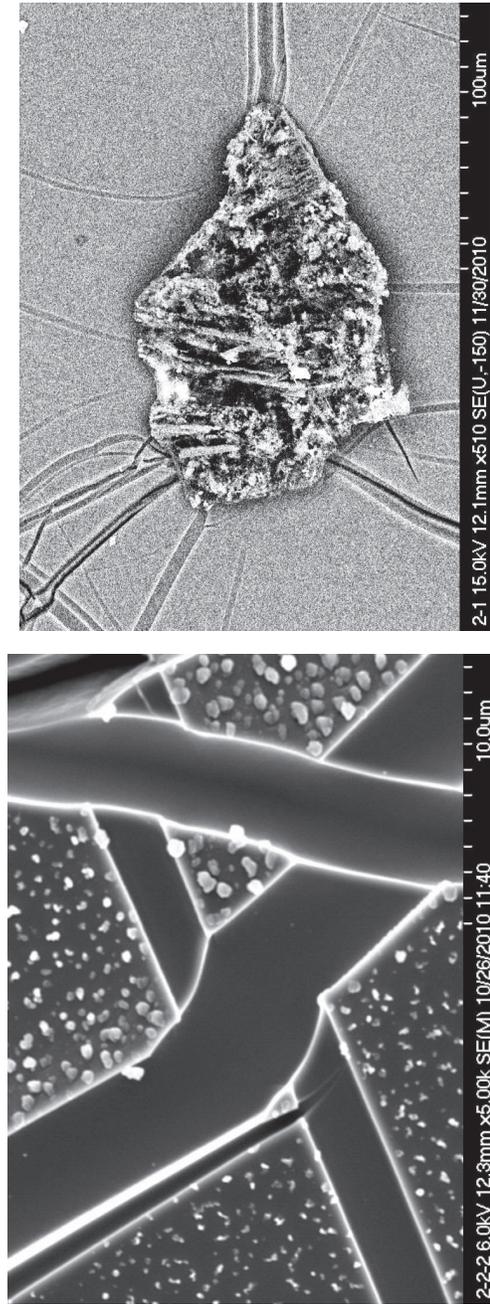
Figure 13: (a) The nano-sized particles on the sample surface are  $\text{SiO}_x$  where  $x$  is close to 2 (EDS data). It is believed to be fragments of silicone trapped by the Kapton H cover layer and then oxidized by atomic oxygen ( $8.18 \times 10^{21}$  atom/cm<sup>2</sup>). (b) External materials believed to be organic contamination (from sample exposed to AO fluence of  $8.43 \times 10^{21}$  atom/cm<sup>2</sup>). EDS show it contains C, O Na, Mg, Al, Si, S, P, Cl.

All of the samples had some debris on them also. These particles were examined using EDS, and will be described at the final part of the Scanning Electron Microscope Image Analysis Section. These particles also contribute to the interference of signals, especially during the process of signal enhancement. During this process a large number of very small “islands” were created around these particles at the same time when the very faint crack lines were enhanced and therefore preserved. The error cause by this interference will be discussed in Section “Possible error”.

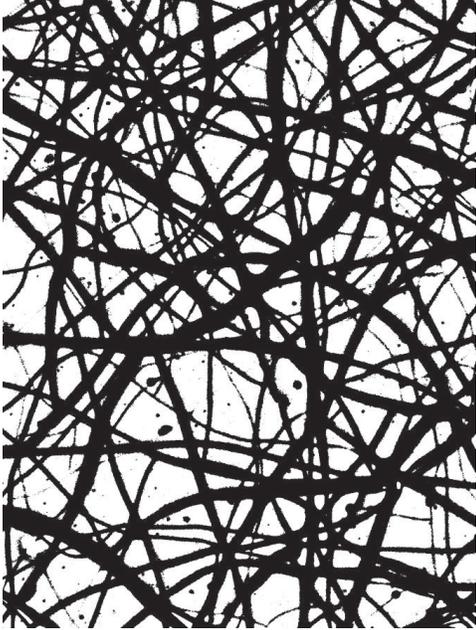
Figure A1 Optical micrograph of silicone DC93-500 exposed to 8.43 E21 fluence atomic oxygen in in Low Earth Orbit during MISSE 2 mission

- (a) Original picture (Upper left)
- (b) Converted version of original picture (black crack and white non-crack area) (above)
- (c) Converted version with all cracks made into thin lines (left)

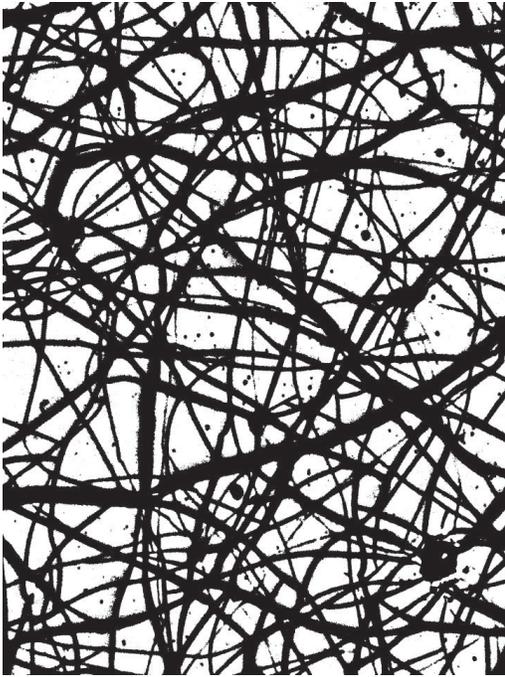
Figure A2: Optical micrograph of silicone DC93-500 exposed to 8.18 E21 fluence atomic oxygen in in Low Earth Orbit during MISSE 2 mission

- (a) Original picture (Upper left)
- (b) Converted version of original picture (black crack and white non-crack area) (above)
- (c) Converted version with all cracks made into thin lines (left)

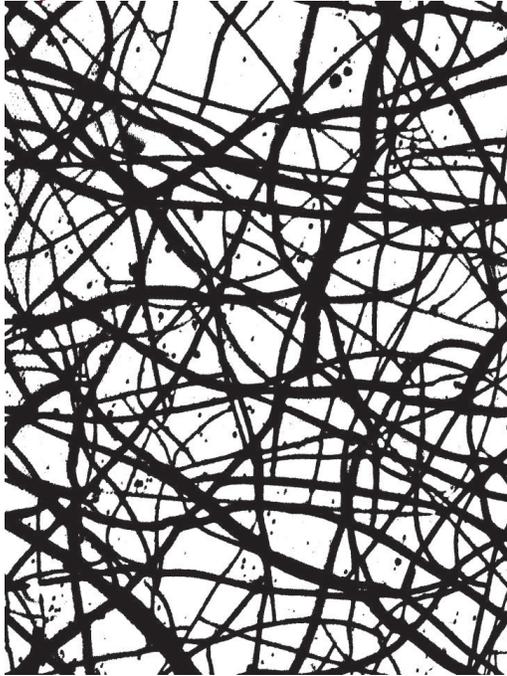
Figure A4: Optical micrograph of silicone DC93-500 exposed to 7.75 E21 fluence atomic oxygen in in Low Earth Orbit during MISSE 2 mission

- (a) Original picture (Upper left)
- (b) Converted version of original picture (black crack and white non-crack area) (above)
- (c) Converted version with all cracks made into thin lines (left)

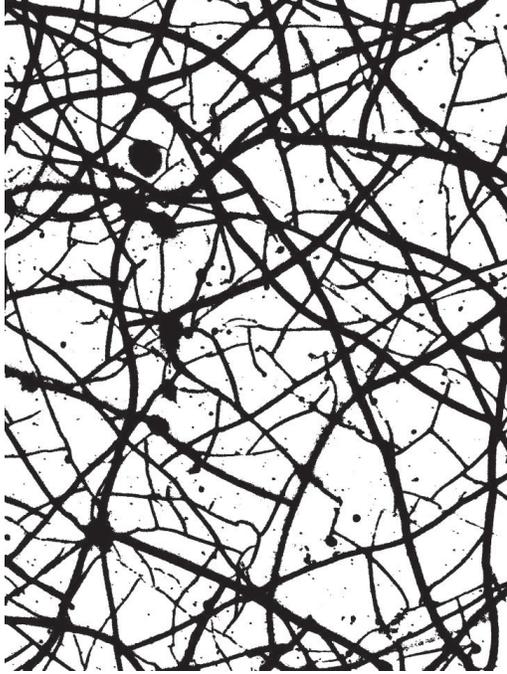
Figure A6: Optical micrograph of silicone DC93-500 exposed to 1.89 E21 fluence atomic oxygen in Low Earth Orbit during MISSE 4 mission

- (a) Original picture (Upper left)
- (b) Converted version of original picture (black crack and white non-crack area) (above)
- (c) Converted version with all cracks made into thin lines (left)

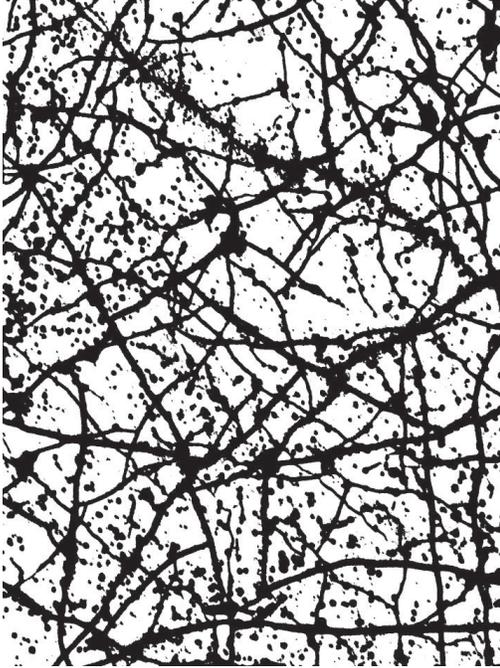
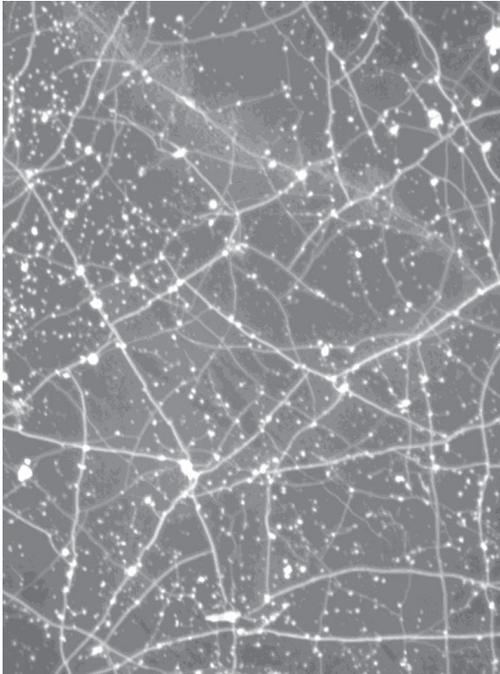
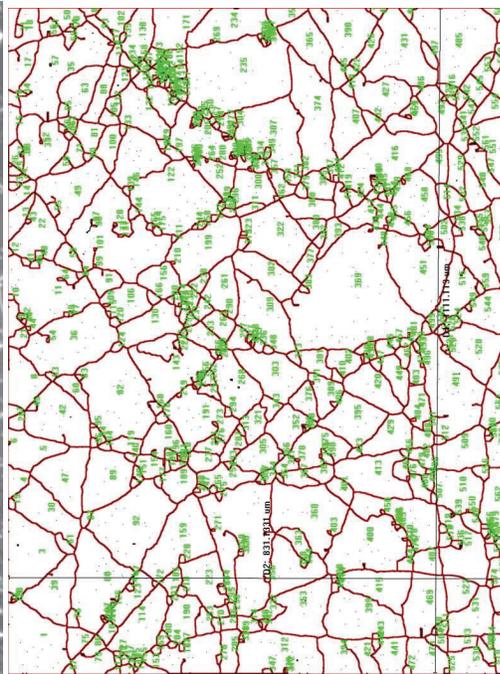
Figure A8: Optical micrograph of silicone DC93-500 exposed to 1.46 E21 fluence atomic oxygen in Low Earth Orbit during MISSE 4 mission

- (a) Original picture (Upper left)
- (b) Converted version of original picture (black crack and white non-crack area) (above)
- (c) Converted version with all cracks made into thin lines (left)
