# Resonant Vibrations Resulting from the Re-Engineering of a Constant-Speed 2-Bladed Turbine to a Variable-Speed 3-Bladed Turbine

**Conference Paper**  
NREL/CP-5000-50009  
December 2010

# Resonant vibrations resulting from the re-engineering of a constant-speed 2-bladed turbine to a variable-speed 3-bladed turbine

**The CART3 (Controls Advanced Research Turbine, 3-bladed) at the National Wind Technology Center has recently been converted from a 2-bladed constant speed machine to a 3-bladed variable speed machine designed specifically for controls research. The purpose of this conversion was to develop an advanced controls field-testing platform which has the more typical 3-bladed configuration. A result of this conversion was the emergence of several resonant vibrations, some of which initially prevented operation of the turbine until they could be explained and resolved. In this paper, the investigations into these vibrations are presented as “lessons-learned”. Additionally, a frequency-domain technique called waterfall plotting is discussed and its usefulness in this research is illustrated.**

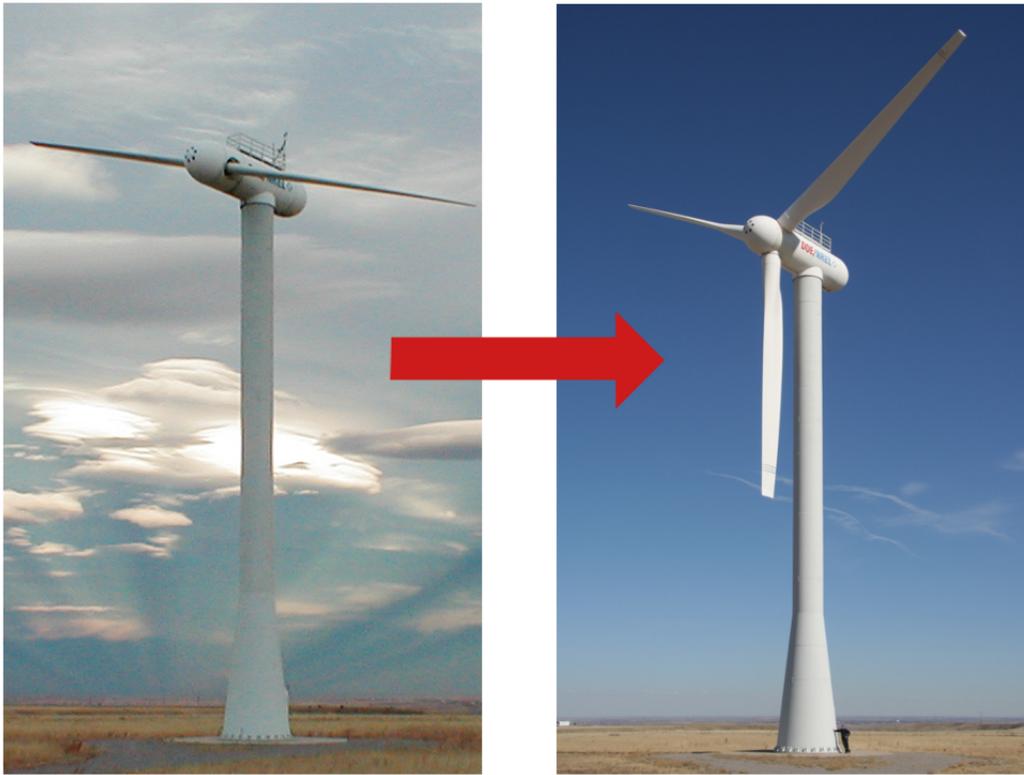
**Figure 1. Converting the CART3 from a 2-bladed constant speed turbine (PIX #18279) to a 3-bladed variable speed turbine (PIX #18278)**

In the process of developing the CART3, several modifications were made to the original turbine. First, the original 2-bladed teetering hub was replaced with a customized 3-bladed hub. The blades in the new hub are pitched using electric drives, which allow pitch rates up to 26 deg/s. Additionally, the hub and blades were instrumented with encoders and strain gauges. In Figure 1, the conversion from 2-bladed to 3-bladed is shown.

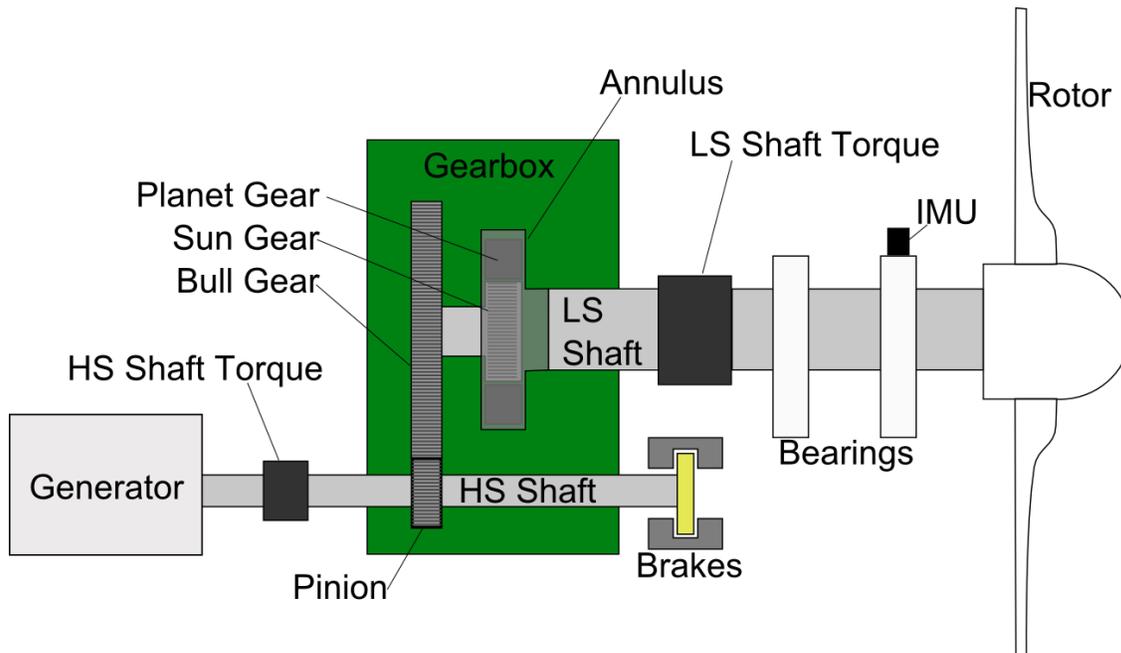
Figure 2. Schematic representation of the CART3 drivetrain. The main components of the drivetrain are illustrated along with relevant sensors (torque transducers on the HSS and LSS are shown along with the inertial measurement unit (IMU))

The drivetrain of the CART3 is shown in Figure 2. Illustrated are the main structural components, as well as, sensors used in measuring torque levels and acceleration.

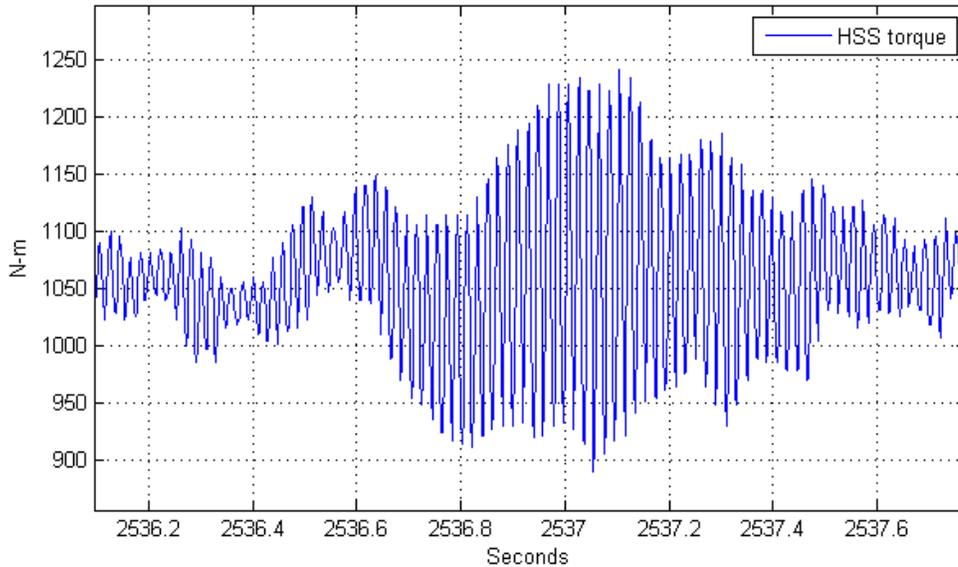
Figure 3. 52 Hz torque oscillation on the HSS of the CART3

To demonstrate the way in which waterfall plots are utilized, the investigation into the 52 Hz oscillation mentioned above is discussed. An example of this behavior is provided in Figure 3. This vibration was assumed initially to have been produced by the generator; however its occurrence when the generator was offline disproved this. Additionally the oscillation frequency did not change with rotor speed, while the amplitude did, increasing and decreasing with changes in rotor speed.

Using waterfall plots, the HSS oscillation observed in the time domain in Figure 3 was identified. After determining the nature of the oscillation, it was decided that the oscillation was acceptably small and no further action was taken. In the remaining sections, waterfall plots are used to identify and resolve the more serious vibrations encountered.

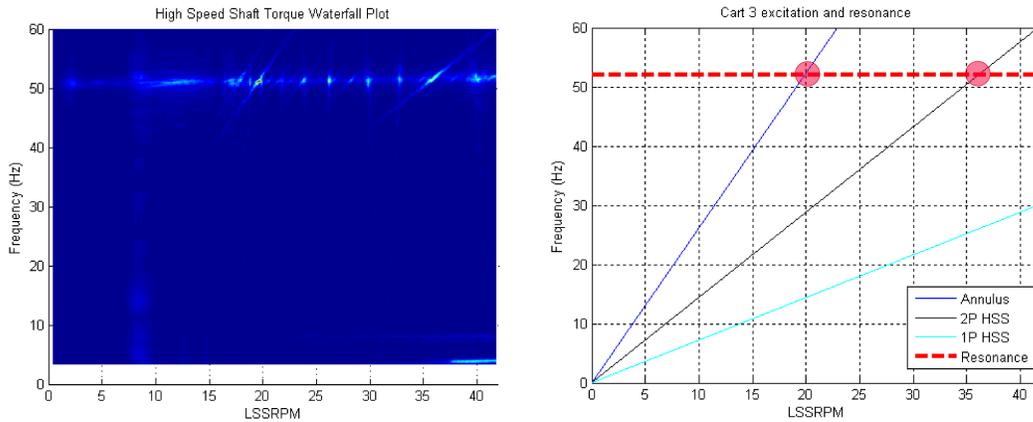
Figure 4. Comparing waterfall plot of HSS torque (left) with per-rev and gear-meshing frequencies of the CART3 (right)

To better understand this phenomena, we began producing waterfall plots of the HSS torque signal. The waterfall plot for the high-speed shaft torque is shown in Figure 4. The waterfall plot in Figure 4 provides an illustration of how the frequency content of the torque varies with rotor speed. The results are instructive; a spike is consistently observable at 52 Hz, but the amplitude “blooms” at rotor speeds where this frequency is coincident with another RPM-dependent oscillation. This strongly suggests a resonance at 52 Hz, which is excited by coincident excitation frequencies.

It is possible to identify the dominant excitation frequencies as being mechanically induced. These excitation frequencies are mapped out in the right plot in Figure 4 and are identified as gear-meshing and shaft “per-revolution” frequencies. The source of these frequencies can be seen in Figure 2. Both shafts (high-speed shaft (HSS) and low-speed shaft (LSS)) produce excitation frequencies at per-revolution intervals and are sometimes call per-rev excitations and are notated 1P for once per-revolution, 2P for twice per-revolution and so on. These are typically labeled 1P for once-per-revolution, 2P for twice-per-revolution. In addition, gear meshing frequencies occur at frequencies of number of teeth times revolution speed of gear. The annulus meshing frequency would be the number of teeth on the annulus gear multiplied by the low speed shaft 1P frequency.

The gear meshing frequencies also produce harmonics. By comparing the waterfall plot derived from the running data with the locations of the excitation frequencies, it appears that the vibration is a structural resonance, excited predominantly by RPM-dependent excitation.

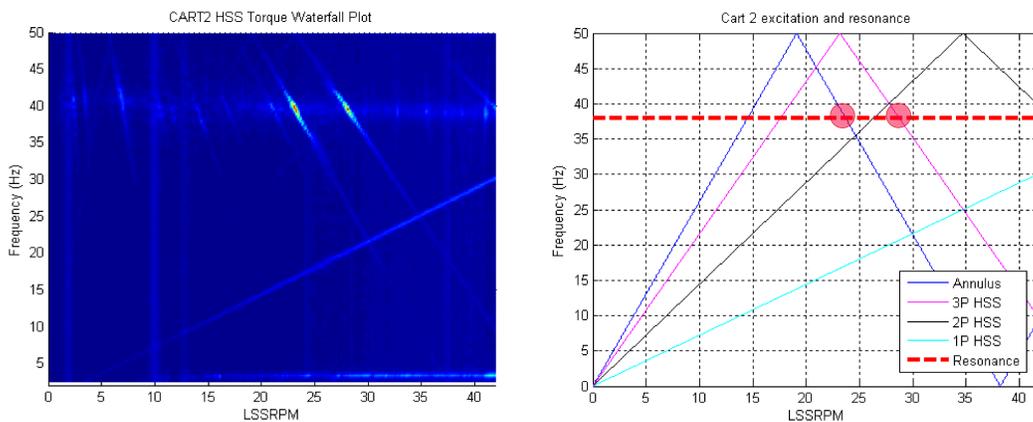
Figure 5. Comparing waterfall plot of HSS torque on the CART2 with per-rev and gear-meshing frequencies of the CART2. Note that due to nyquist reflection about 50 Hz, the resonance at 62 Hz appears at 38 Hz.

Further determination could be made through a comparison with the CART2. As mentioned earlier, the CART2 and CART3 started as identical turbines. However, the CART3 was converted to a 3-bladed turbine. In addition, on the CART2 the synchronous generator was replaced with an induction generator. Based on these changes, one would expect a resonance to exist at a higher frequency on the CART2. Rebuilding Figure 4 using CART2 data, Figure 5 indicates this is true. One thing to point out in looking at Figure 5 is that the CART2 control system samples data at 100 Hz, which places the Nyquist frequency at 50 Hz, and therefore, some of the excitation signals (and the resonance at 62 Hz) are reflected about the Nyquist frequency.

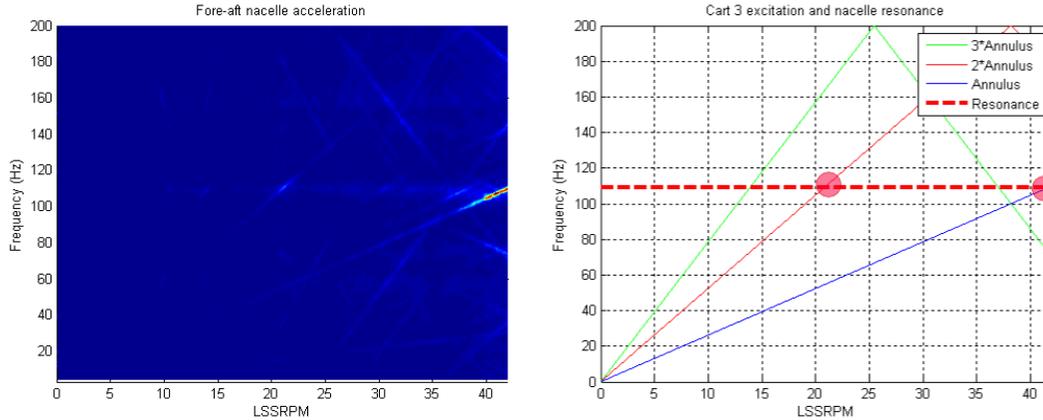
Figure 6. Comparing waterfall plot of frequency spectra of nacelle acceleration with locations of gear-meshing frequencies for CART3 (Nyquist frequency at 200Hz).

A resonant vibration in the nacelle acceleration, similar to the HSS torsional vibration described above, was also discovered, and seems to be a resonance excited by coincident excitation frequencies. However, this vibration is of a more critical nature and it is large enough to trigger the SCADA system’s over-acceleration fault mode on the CART3. Also, the coincidence of excitation and resonance occurred at rated rotor speed, which means that the turbine’s controller speed objective causes the rotor to dwell on this overlap. Acceleration is measured on the CART3 by an inertial measurement unit (IMU) mounted to the front thrust bearing of the turbine (see Figure 2). The waterfall plot for the acceleration in the fore-aft direction, measured by the IMU, is shown in Figure 6.

Considering Figure 6, there is, as was the case on the HSS, a resonance excited by per-rev frequencies. The large oscillation around the rated speed is due to the overlap with the annulus (a stage in the gearbox) meshing frequency.

This raised the question of how changes made to the CART3 could cause this, and why was it not been observed earlier on the CART2? The answer, in a similar way to previous observations on the HSS torque signal, was there was a resonance on the CART2, but at a higher frequency. This would imply that the annulus meshing frequency never coincides with the resonance.

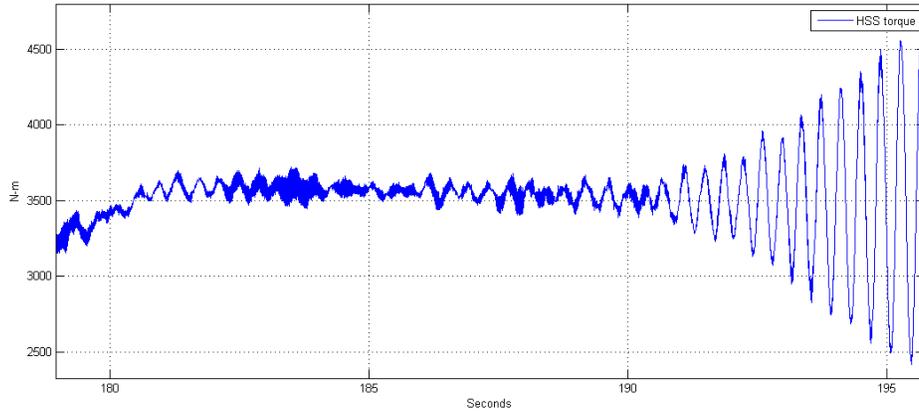
Figure 7. Collected signals from CART3 during operation at rated speed

The final problematic oscillation which emerged following the re-engineering was an unstable oscillation in the drivetrain and edgewise collective bending. This oscillation can be seen looking at HSS torque collected from the CART3 during a test run shown in Figure 7.

This oscillation, as was the case for the oscillation observed in nacelle acceleration, forced the turbine to stop upon reaching rated speed. It was measured in generator torque, HSS torque, LSS torque, and collective edgewise bending (all blades bending in the same direction in the plane of rotation.) The oscillation occurred whenever rated speed was achieved, and we collected a catalog of these occurrences to study. Based on results like those shown in Figure 7, the following initial observations were reached:

- The oscillation is torsional in nature, operating on both shafts of the drivetrain and, also in the “edgewise collective” mode.
- The oscillation at 2.7 Hz is the first torsional mode of the drivetrain. It is always present to some extent when the turbine is operating and is always coupled with edge-wise bending. However, only at rated speed does it exhibit the behavior shown in Figure 7, where each cycle is larger than the previous.

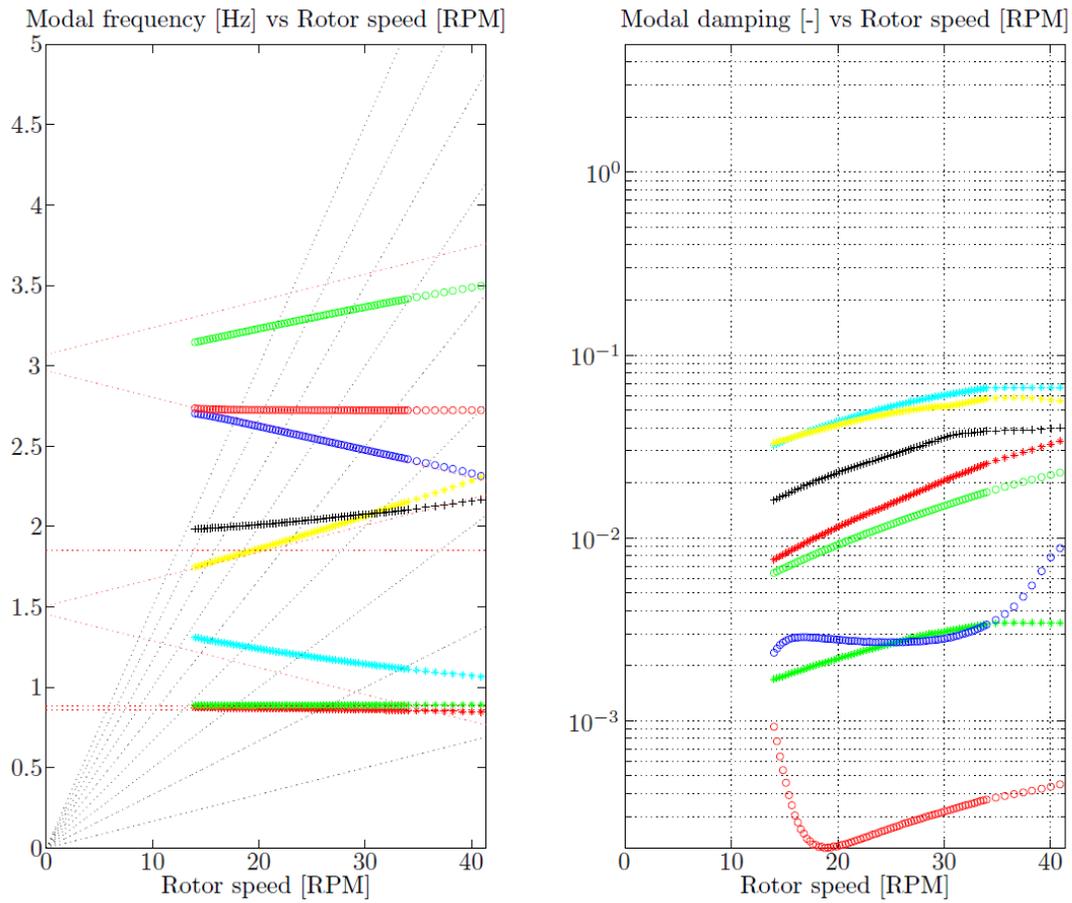
Figure 8. Eigenfrequencies and corresponding modal damping vs rotor frequency (RPM). The red dotted lines represent the predicted modes based on the modal test<sup>11</sup> and the black dashed lines represent the 'per-rev' excitations. Black crosses indicate the flapwise collective blade bending mode. Green and blue circles indicate the edgewise blade bending asymmetric modes. The 2.7 Hz drivetrain/edgewise coupled mode is indicated by red circles and has the least damping.

To test these two possibilities, a plot of the model frequencies and damping was derived using non-linear models of the CART3. FAST (Fatigue, Aerodynamics, Structures, and Turbulence) is a wind turbine modeling software supported by the NWTC, which can be used to simulate wind turbines, as well as produce linearized models of turbine systems.<sup>10</sup> A FAST model of the CART3 was developed, using known structural properties, and tuned to match the results of a modal test completed in 2009.<sup>11</sup> This non-linear model was then linearized at a range of wind-speeds to produce a set of mode frequencies and mode damping for modes in the range of 0-10 Hz. In Figure 8, the result of this simulation is shown. The predicted modal frequencies are shown with predicted modal damping, using the various colored markers. Additionally, red-dotted lines are used to indicate the results determined by modal testing of the CART3, and to show the relative agreement between model and reality. Finally, this plot was further verified through comparison with waterfall plots of multi-blade coordinate signals, such as collective flap bending and asymmetric edgewise bending.

Observing Figure 8, it can be seen that neither the collective flap mode, nor progressive or regressive edgewise bending modes, is very close to 2.7 Hz at rated speed, which makes both possibilities unlikely. Therefore, both causes were removed from consideration.

This idea was inspected first using results shown in Figure 8, where the damping of the 2.7 Hz mode (red circles) is provided in the right hand plot. These damping values were computed in “worst-case,” ignoring structural damping. The values provided in Figure 8 indicate that this mode is indeed poorly damped, although not negatively so. Additionally, the minimum level of drivetrain damping is predicted to occur well before rated rotor speed.

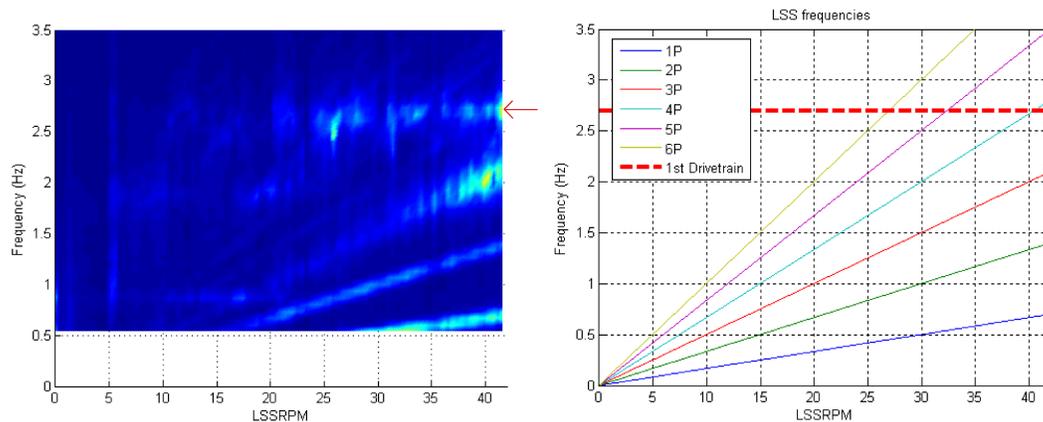
**Figure 9. Waterfall plot of the low-speed shaft (LSS) torque. A small red arrow indicates the location of the large 2.7 Hz oscillation**

A variant of the hypothesis, forwarded in the previous subsection, is that the drivetrain/edgewise coupled mode, while not negatively damped, is very lightly damped. A persistent excitation signal at 2.7 Hz could, therefore, cause the increasing oscillation at 2.7 Hz. The difficulty for this hypothesis is in identifying the excitation, as had been done in the earlier cases of HSS torque and nacelle acceleration. A waterfall plot of shaft torque is shown in Figure 9.

A candidate excitation is clearly 4P. Certainly this will cause some increase in the magnitude of the 2.7 Hz oscillation. However there are some problems with this hypothesis. First, why should 4P be of greater excitation than 6P? In other waterfall plots, 6P seems to be the larger of the two excitations, and this is logical on a 3-bladed turbine. Further, 4P does not appear to have a strong physical meaning on a 3-bladed machine outside of a harmonic of 1P.

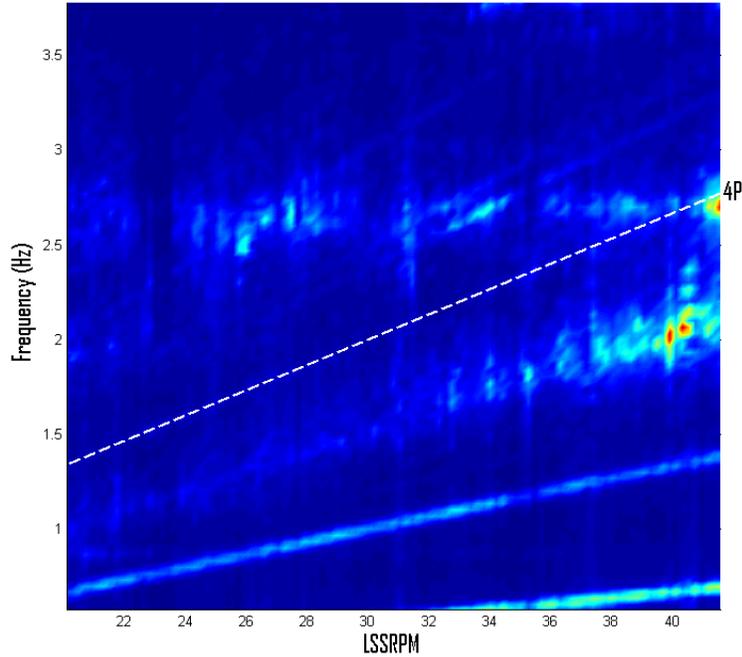
Figure 10. Zoomed in waterfall plot of low-speed shaft torque with 4P excitation shown.

The 4 per-rev excitation does not appear to be a direct match to the resonance at rated speed. Figure 10 is a close-up view of the waterfall plot for low-speed shaft torque near where the 2.7 Hz resonance intersects 4P. It can be seen that the unstable vibration does not occur where the per-rev excitation intersects the resonance. This indicates that it is not simply a low-damped resonance driven by a per-rev excitation.

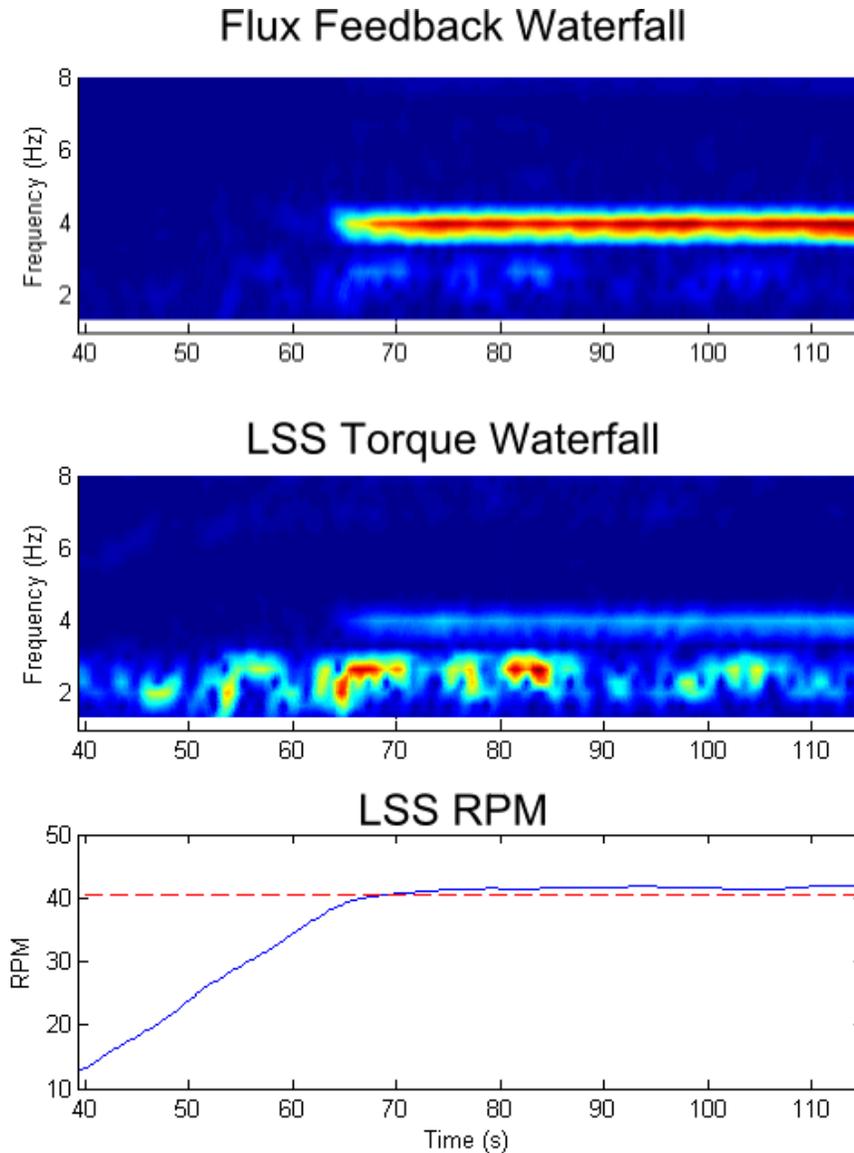
**Figure 11. Time-based waterfall plots of flux feedback and LSS torque when running in reduced torque and rated speed**

called a spectrogram.) A time-based waterfall plot of signals collected with the reduced torque controller is shown in Figure 11.

The top waterfall plot is the flux feedback, an internal drive measurement of generator flux. The middle figure is LSS torque and the lower plot is provided to show the rotor speed over time. Notice that when the speed crosses a certain threshold, a 4 Hz oscillation suddenly appears in flux. This oscillation is not a known structural mode of the wind turbine and behaves in a persistent way which is dissimilar to normal drive resonances (compared for instance with the stochastic nature of the 2.7 Hz oscillation in LSS torque.) This oscillation is observable in all cases when the drive approaches rated speed. Both full and reduced torque controllers show this phenomenon. In the case of the full torque controller however, after reaching rated speed, the oscillation in the flux suddenly switches from 4 Hz to 2.7 Hz and the mode destabilizes. This is taken as strong evidence that there is indeed a behavior change in the PE at near rated speed.

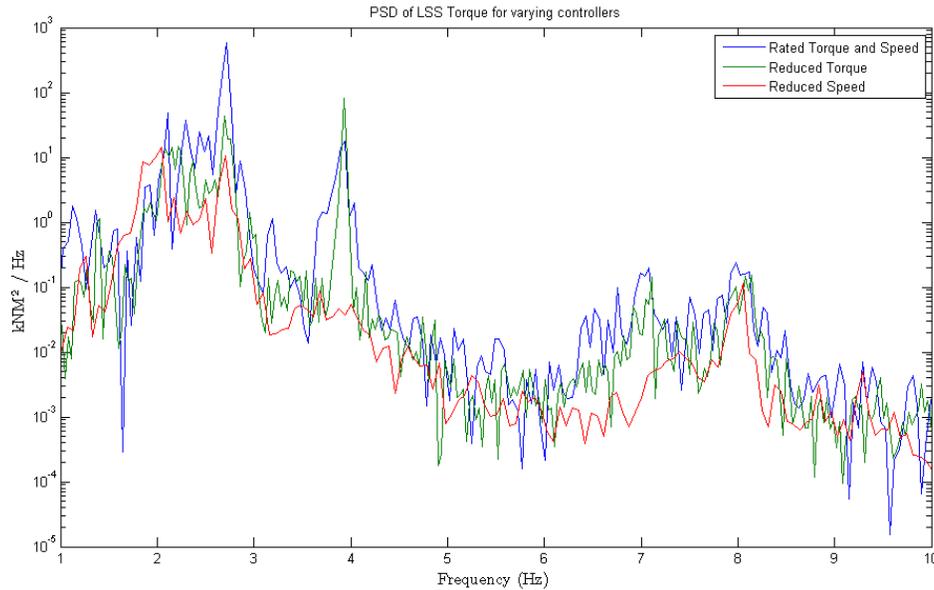
Figure 12. Comparing the PSD of LSS torque for various control options

to avoid the change in PE behavior. To test this hypothesis, the turbine rated speed was reduced to 37 RPM. This produced the desired result. The 4 Hz oscillation did not appear and the 2.7 Hz oscillation remained stably bounded. A power spectral density plot in Figure 12 compares the three control variations (full torque and speed, reduced torque and reduced speed.)

Because reducing the rated speed of the turbine is successful in eliminating the 4 Hz oscillation and the instability at 2.7 Hz, the CART3 is now able to run at least in this configuration. However, it is not known at this point whether the PE behavior observed is a fundamental limitation of the drive or can be ameliorated. This work continues.
