Wind Turbine Generator System Safety and Function Test Report for the Entegriety EW50 Wind Turbine

Technical Report
NREL/TP-5000-56587
November 2012

Safety and Function Test Report for the Entegrity EW50 Wind Turbine

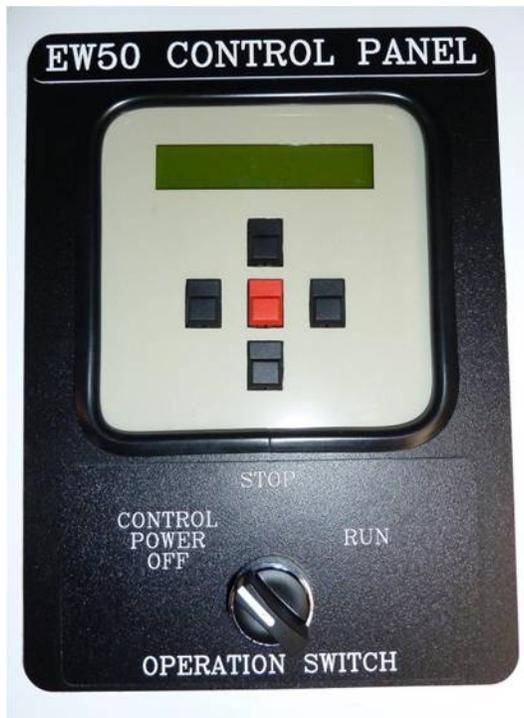
Figure 13 Control panel, showing a rotary switch (Photo by Joe Smith, NREL PIX# 22247)

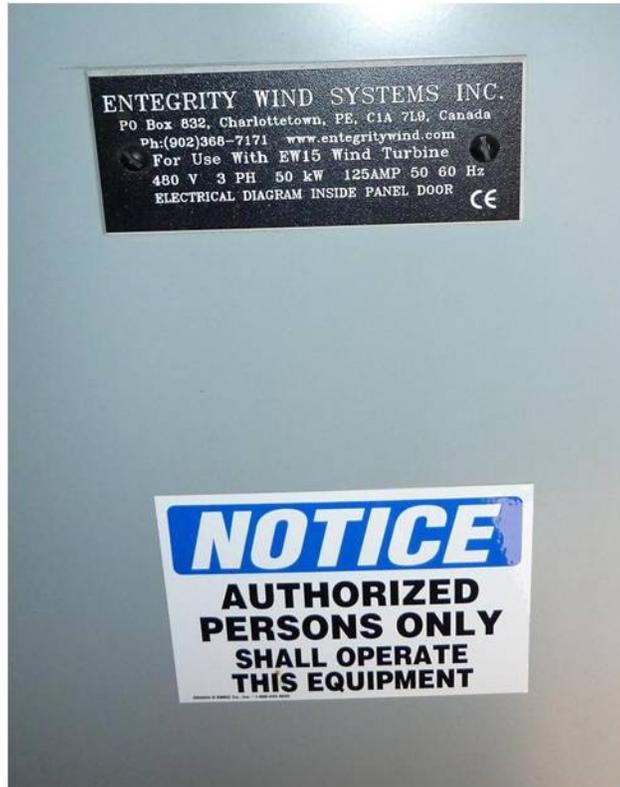
Figure 14 Signs on outer enclosure of control panel; “Notice” sticker added by NREL
(Photo by Joe Smith, NREL PIX# 22244)

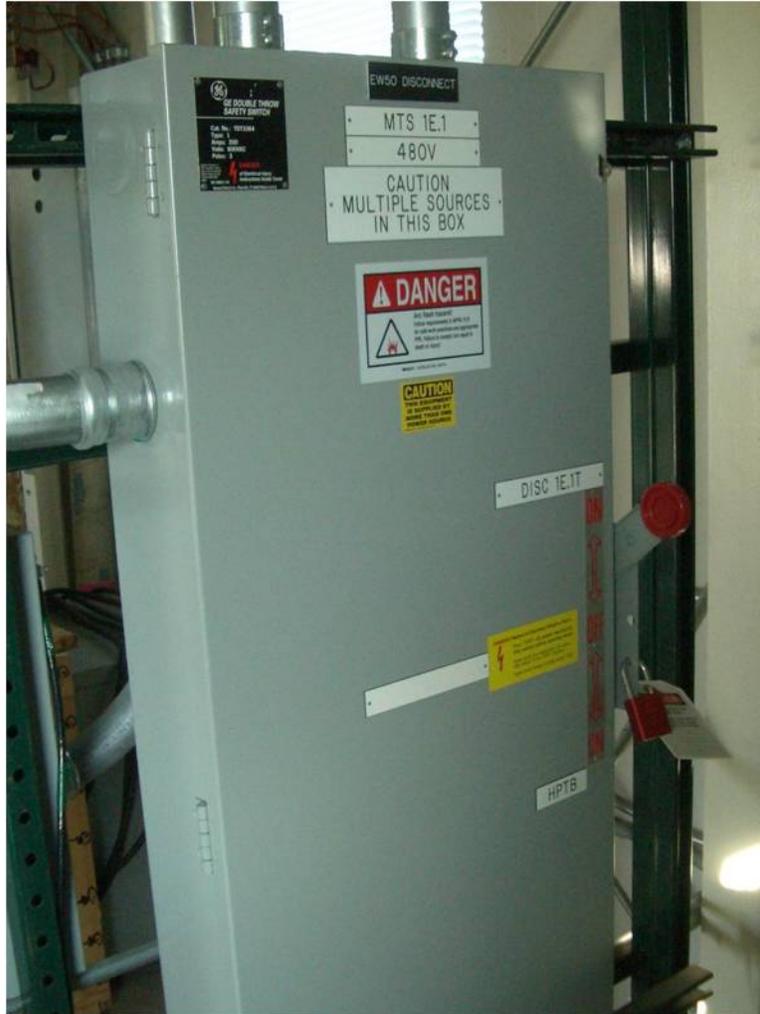
**Figure 15 EW50 lockable disconnect switch at data shed
(Photo by Joe Smith, NREL PIX# 22242)**

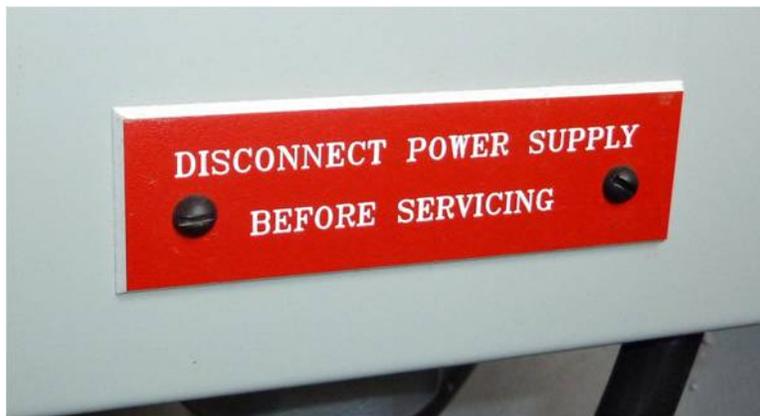
**Figure 16 Warning sign on outer cover of EW50 control panel
(Photo by Joe Smith, NREL PIX# 22245)**

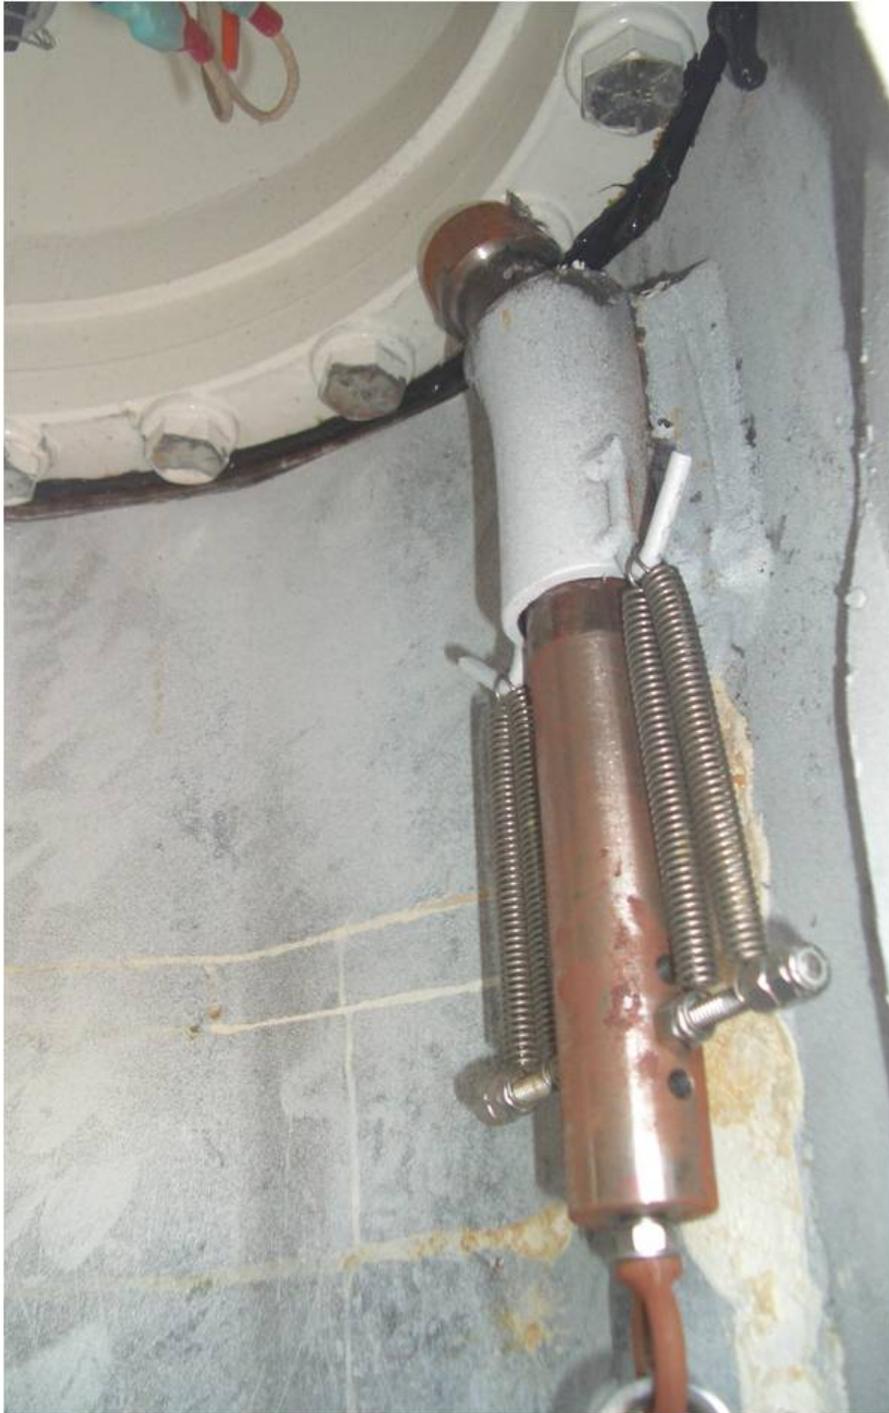
The EW50 was delivered with a yaw lock mechanism, in the form of a spring loaded pin, which inserts between bolts on the yaw ring. However the wire clamps holding the pin appear to have loosened (or never were tight enough) and the pin slowly moved into position. During this slow failure the yawing motion of the turbine bent the pin over into an inoperable position and scraped most of the bolts in the yaw ring; see Figure 17.

**Figure 17 Bent yaw lock pin and cosmetically damaged yaw ring bolts
(Photo by Joe Smith, NREL PIX# 22249)**

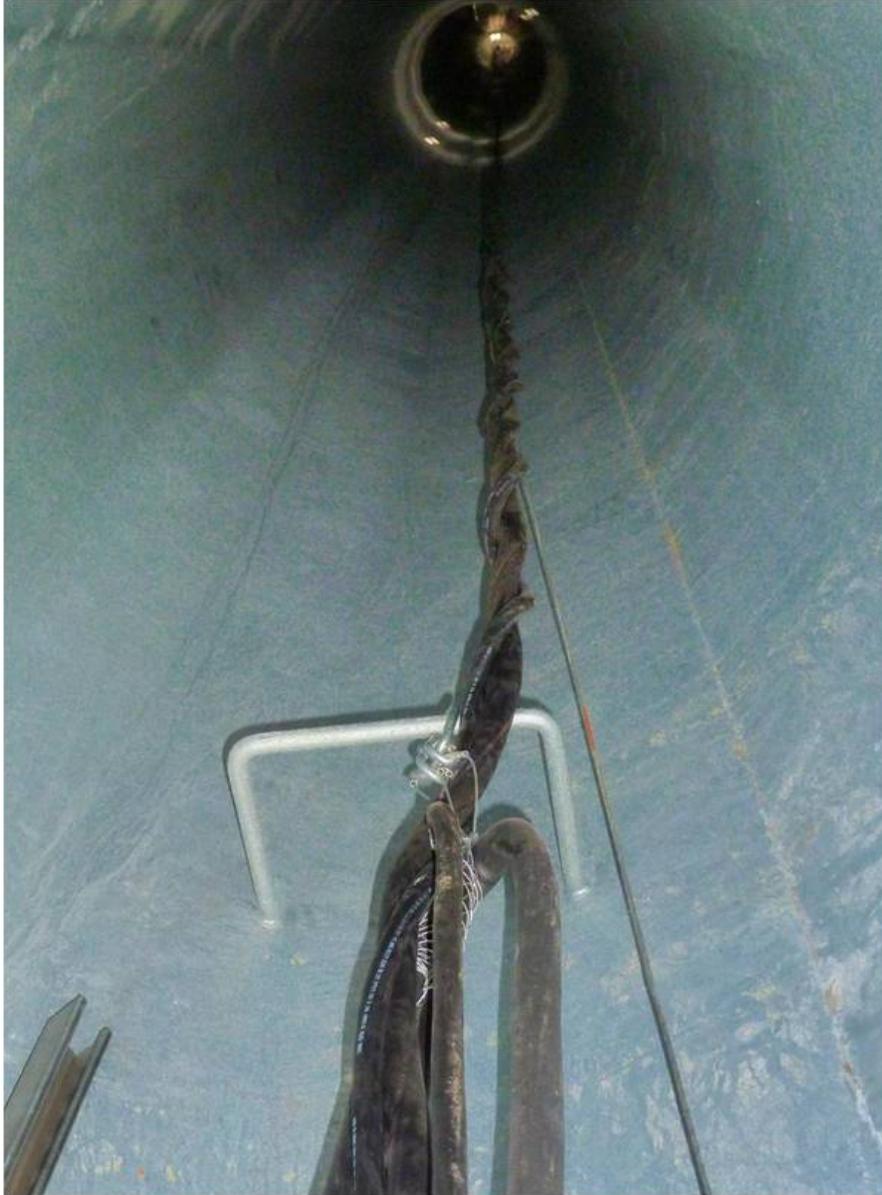
The droop cable can over twist. There are connectors intended to decouple the droop cables, in order to prevent them from over twisting. However, because of the strain relief installation, these connectors were isolated from the twisting, and they will not decouple before the cables over twist. See Figure 18, which shows that the cables above the strain relief are twisted, and the cables are untwisted below the strain relief; the decoupling connectors are below the strain relief. Once during the 18 months of operation the cable was untwisted by decoupling the connectors and untwisting the cables. Figure 18 shows the level of cable twist after approximately one year at the NWTC. The Entegriy 6-month inspection record lists checking for cable twist.

Figure 18 Strain relief prevents the cable twist from transferring to the cable decouples at the tower base (Photo by Joe Smith, NREL PIX# 22240)
