Floods of June 2012 in Northeastern Minnesota

Scientific Investigations Report 2012–5283

By Christiana R. Czuba, James D. Fallon, and Erich W. Kessler

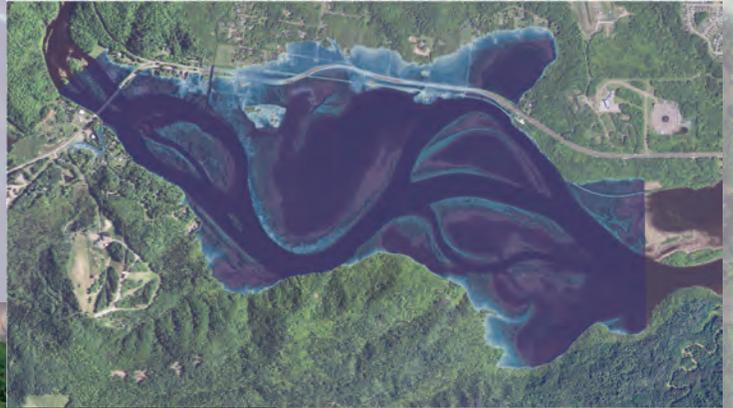
Cover. Left: View of homes flooded by the St. Louis River in the Fond du Lac neighborhood of Duluth, Minnesota, taken from a helicopter on June 21, 2012 (photograph provided by Walter Leu, Minnesota Department of Transportation).
Top right: An inundation map showing approximate flood-peak extents and depths for June 2012 for the St. Louis River at the Fond du Lac neighborhood of Duluth, Minnesota (entire map is in appendix 2 of the report). Map prepared by Christiana Czuba, U.S. Geological Survey, November 2012. Map base from 2010 National Agricultural Imagery program (U.S. Department of Agriculture, 2010).

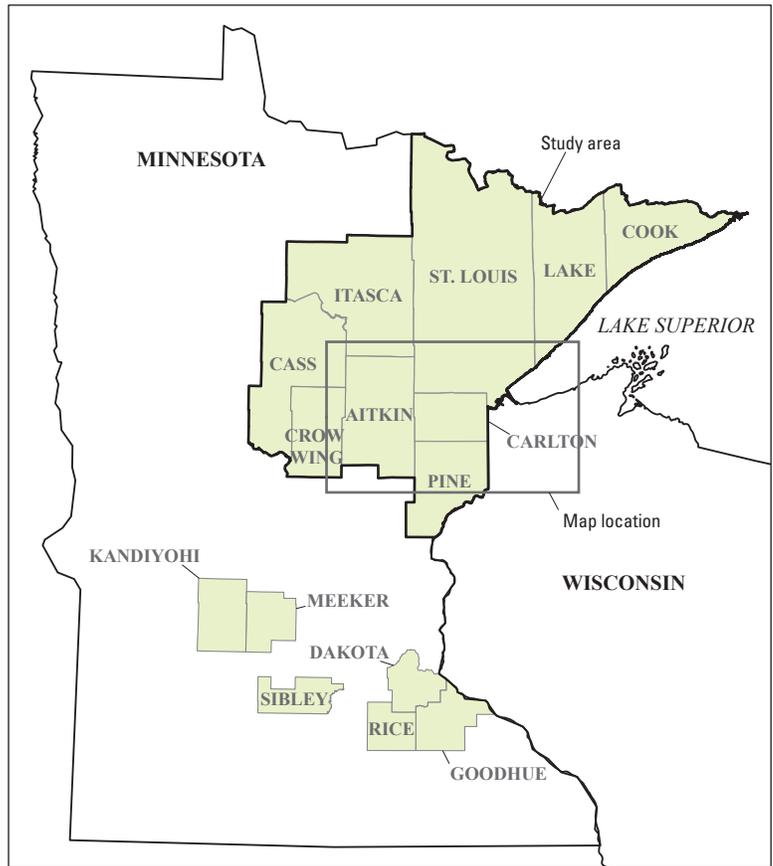
Figure 1. Locations of study communities in the counties with disaster declarations in northeastern Minnesota affected by the June 19–20, 2012, flood events.

Minnesota Department of Natural Resources State Climatology Office, 2012b); however, this report focuses only on the flooding effects in northeastern Minnesota, including the nine contiguous counties of Aitkin, Carlton, Cass, Cook, Crow Wing, Itasca, Lake, Pine, and St. Louis (fig. 1).

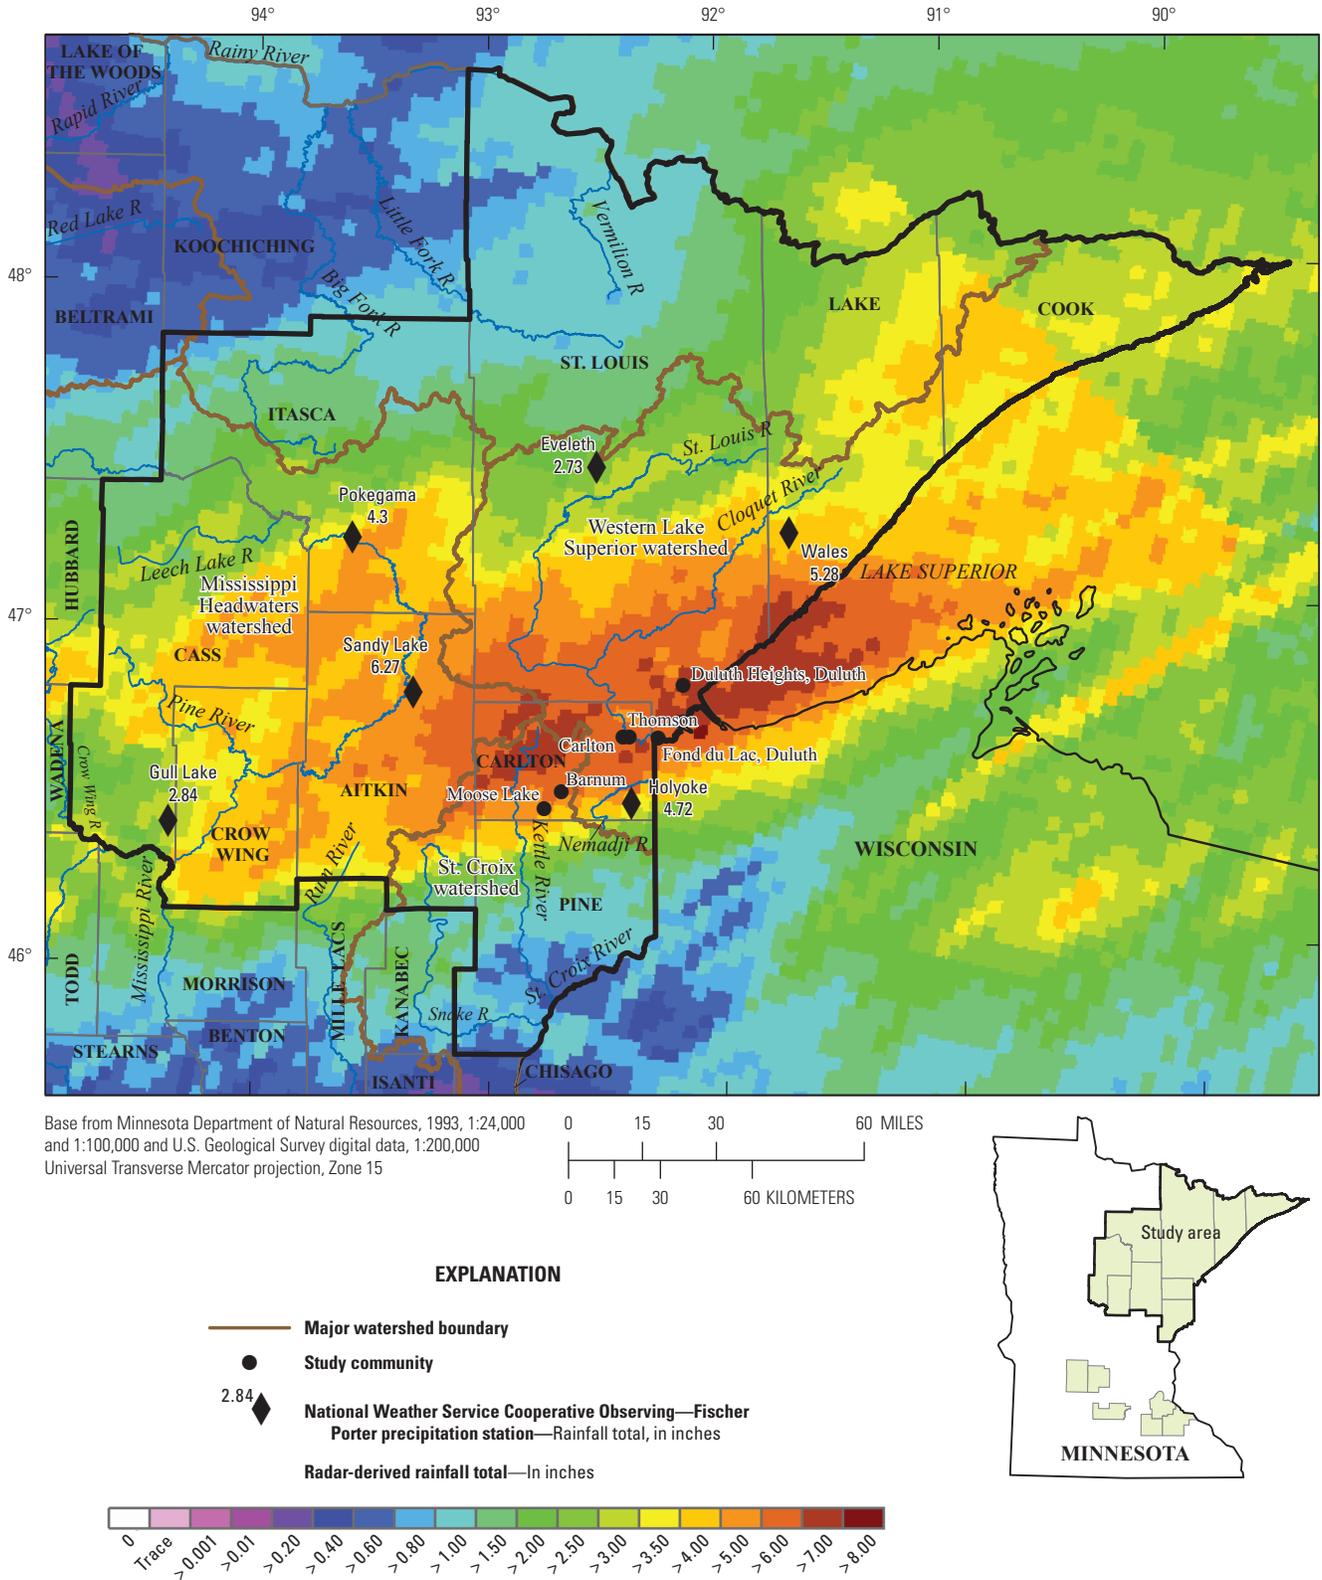
Figure 2. Distribution of 2-day rainfall totals for 7 a.m. Central Daylight Time June 19 through 7 a.m. Central Daylight Time June 21, 2012, and rainfall totals at selected National Weather Service (NWS) Cooperative Observing—Fischer Porter precipitation stations. Rainfall data provided by Steve Gohde and Diane Cooper of the National Weather Service (written commun., 2012).

A spatial gridded dataset of estimated rainfall totals prepared by the NWS (National Weather Service, written commun., 2012) shows rainfall totals of 7 in. and greater for June 19–20, 2012, in parts of Carlton County and southern St. Louis County (fig. 2). Total rainfall amounts for six NWS Cooperative Observing—Fischer Porter precipitation stations in northeastern Minnesota recorded rainfall totals ranging from 2.73 in. at Eveleth in St. Louis County to 6.27 in. at Sandy Lake in Aitkin County for the storm event on June 19–20, 2012 (fig. 2; table 1). Local direct measurements of rainfall totals may differ from the spatial gridded dataset that is developed from radar data. A seventh Cooperative Observing—Fischer Porter precipitation station is located in Floodwood (not shown) in St. Louis County but was not included in this report because the gage was overtopped during the June rainfall and data were lost.

The cumulative 15-minute rainfall data from the six NWS Cooperative Observing—Fischer Porter precipitation stations (locations shown in fig. 2) indicate the magnitude and timing of the rain that fell throughout the storm events on June 19–20, 2012 (fig. 3). Instantaneous rainfall intensities were as great as 2 to 4 inches per hour (in/h) in the evening of June 19, 2012.

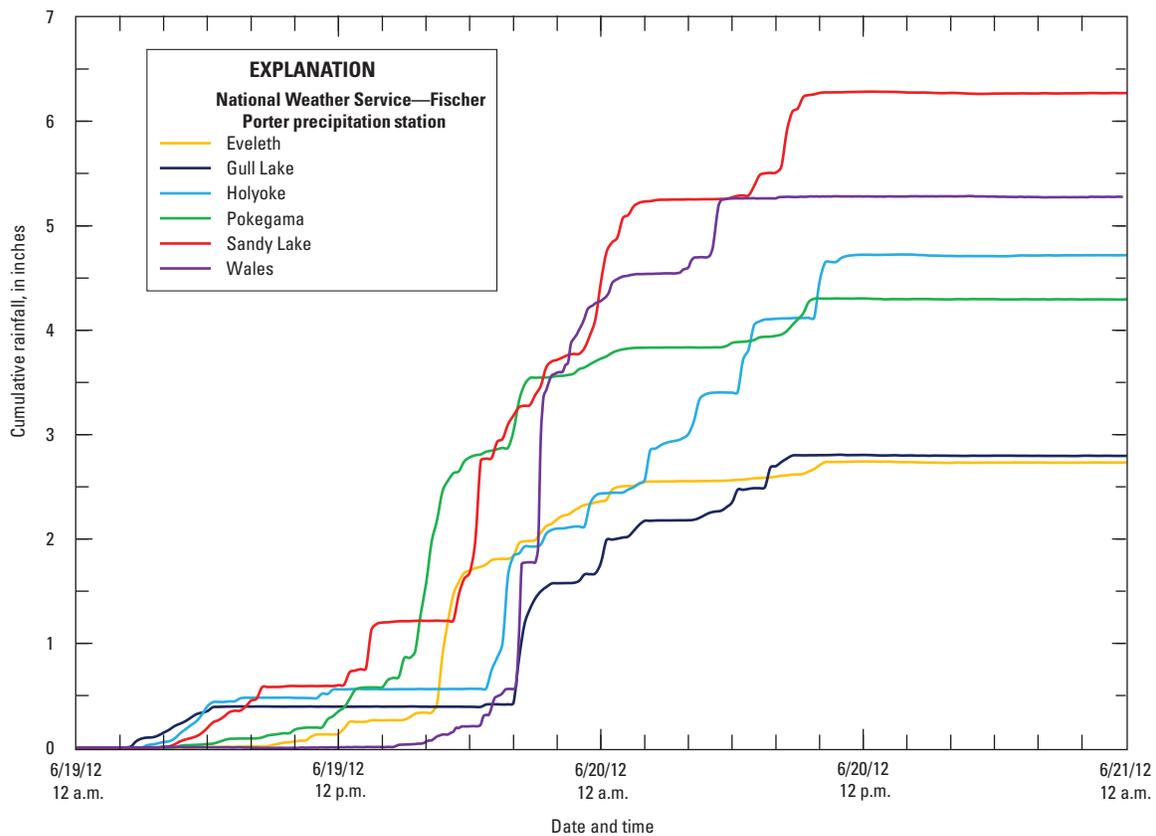
Figure 3. Cumulative daily rainfall during June 19–20, 2012, at selected National Weather Service (NWS) Cooperative Observing—Fischer Porter precipitation stations in northeastern Minnesota.

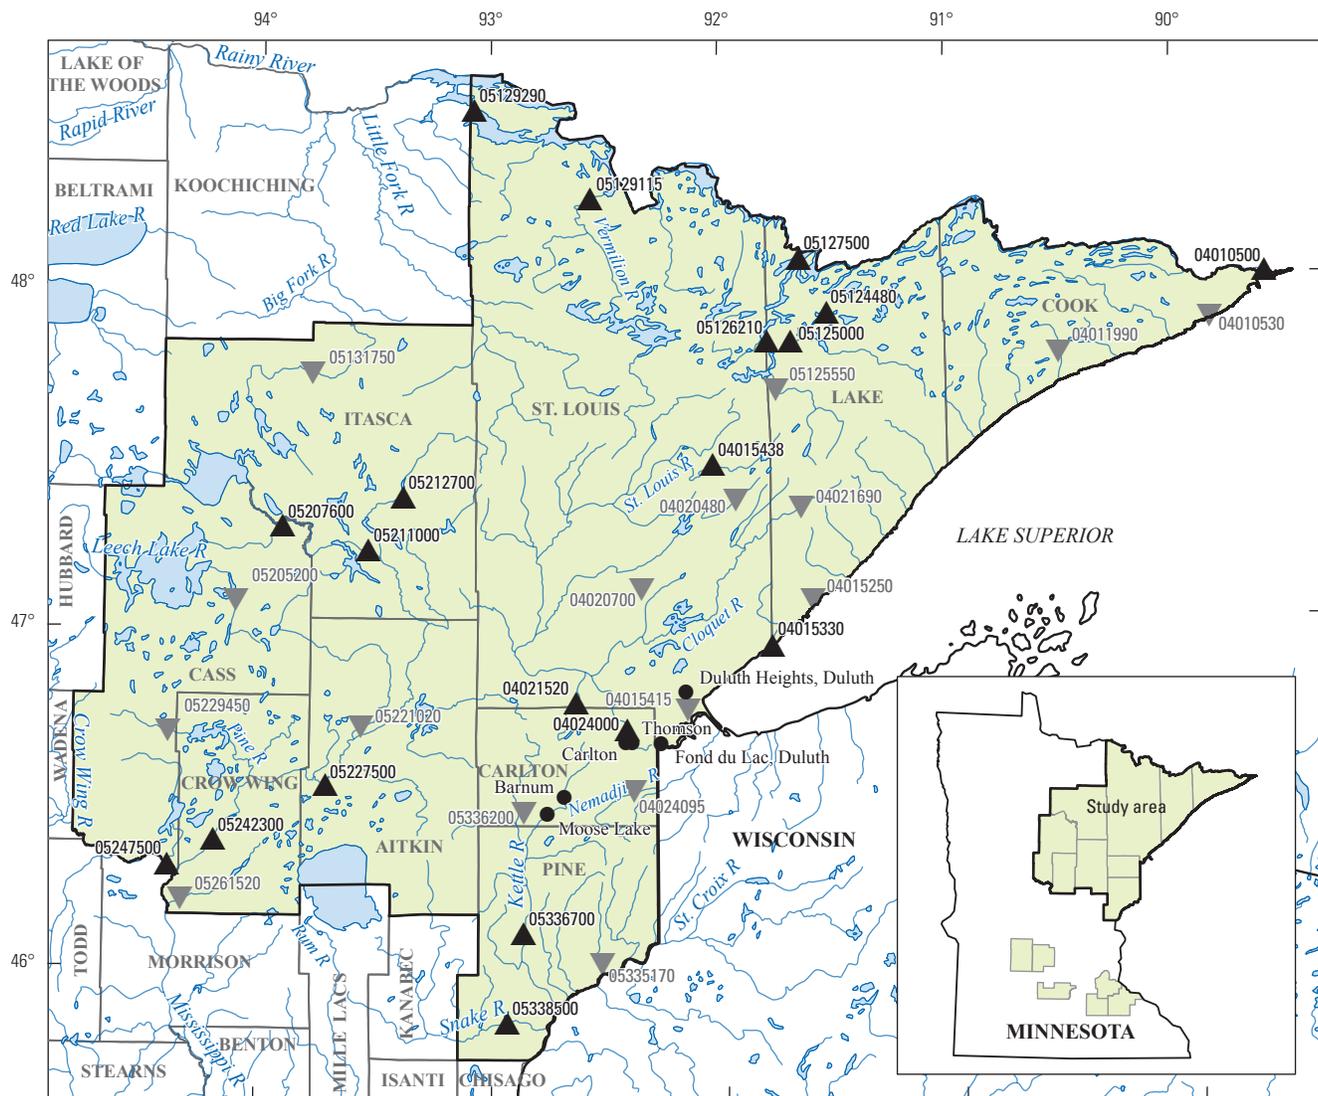
- Counties with disaster declarations
- Study community
- 05338500 Continuous-record streamgage with number
- 05335170 Crest-stage gage with number

Figure 4. Locations of selected U.S. Geological Survey streamgages in the counties with disaster declarations for the floods of June 2012 in northeastern Minnesota.

Peak streamflows documented in this study were determined at 35 USGS streamgages (19 **continuous-record streamgages** and 16 **crest-stage gages**; locations shown in fig. 4). Continuous-record streamgages record stream levels continuously and for those referred to in this report, data are recorded electronically and telemetered to USGS offices for processing in near real time. Crest-stage gages (CSGs) are partial-record, nonmechanical, nontelemetered gages intended to record only the peak (crest) stream level since the last site visit.

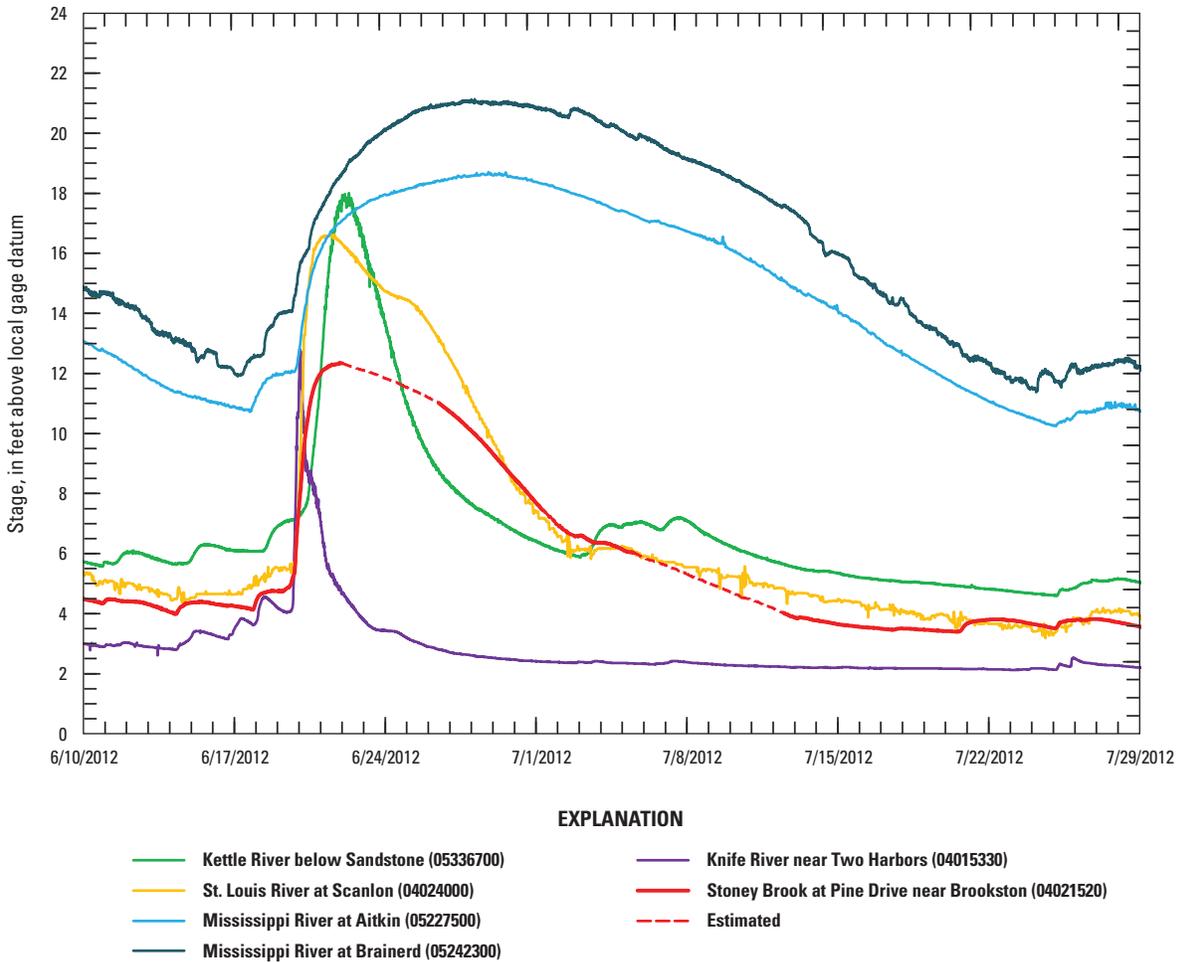
Figure 5. Provisional stage hydrographs at selected U.S. Geological Survey streamgages in northeastern Minnesota for June 10 through July 29, 2012.

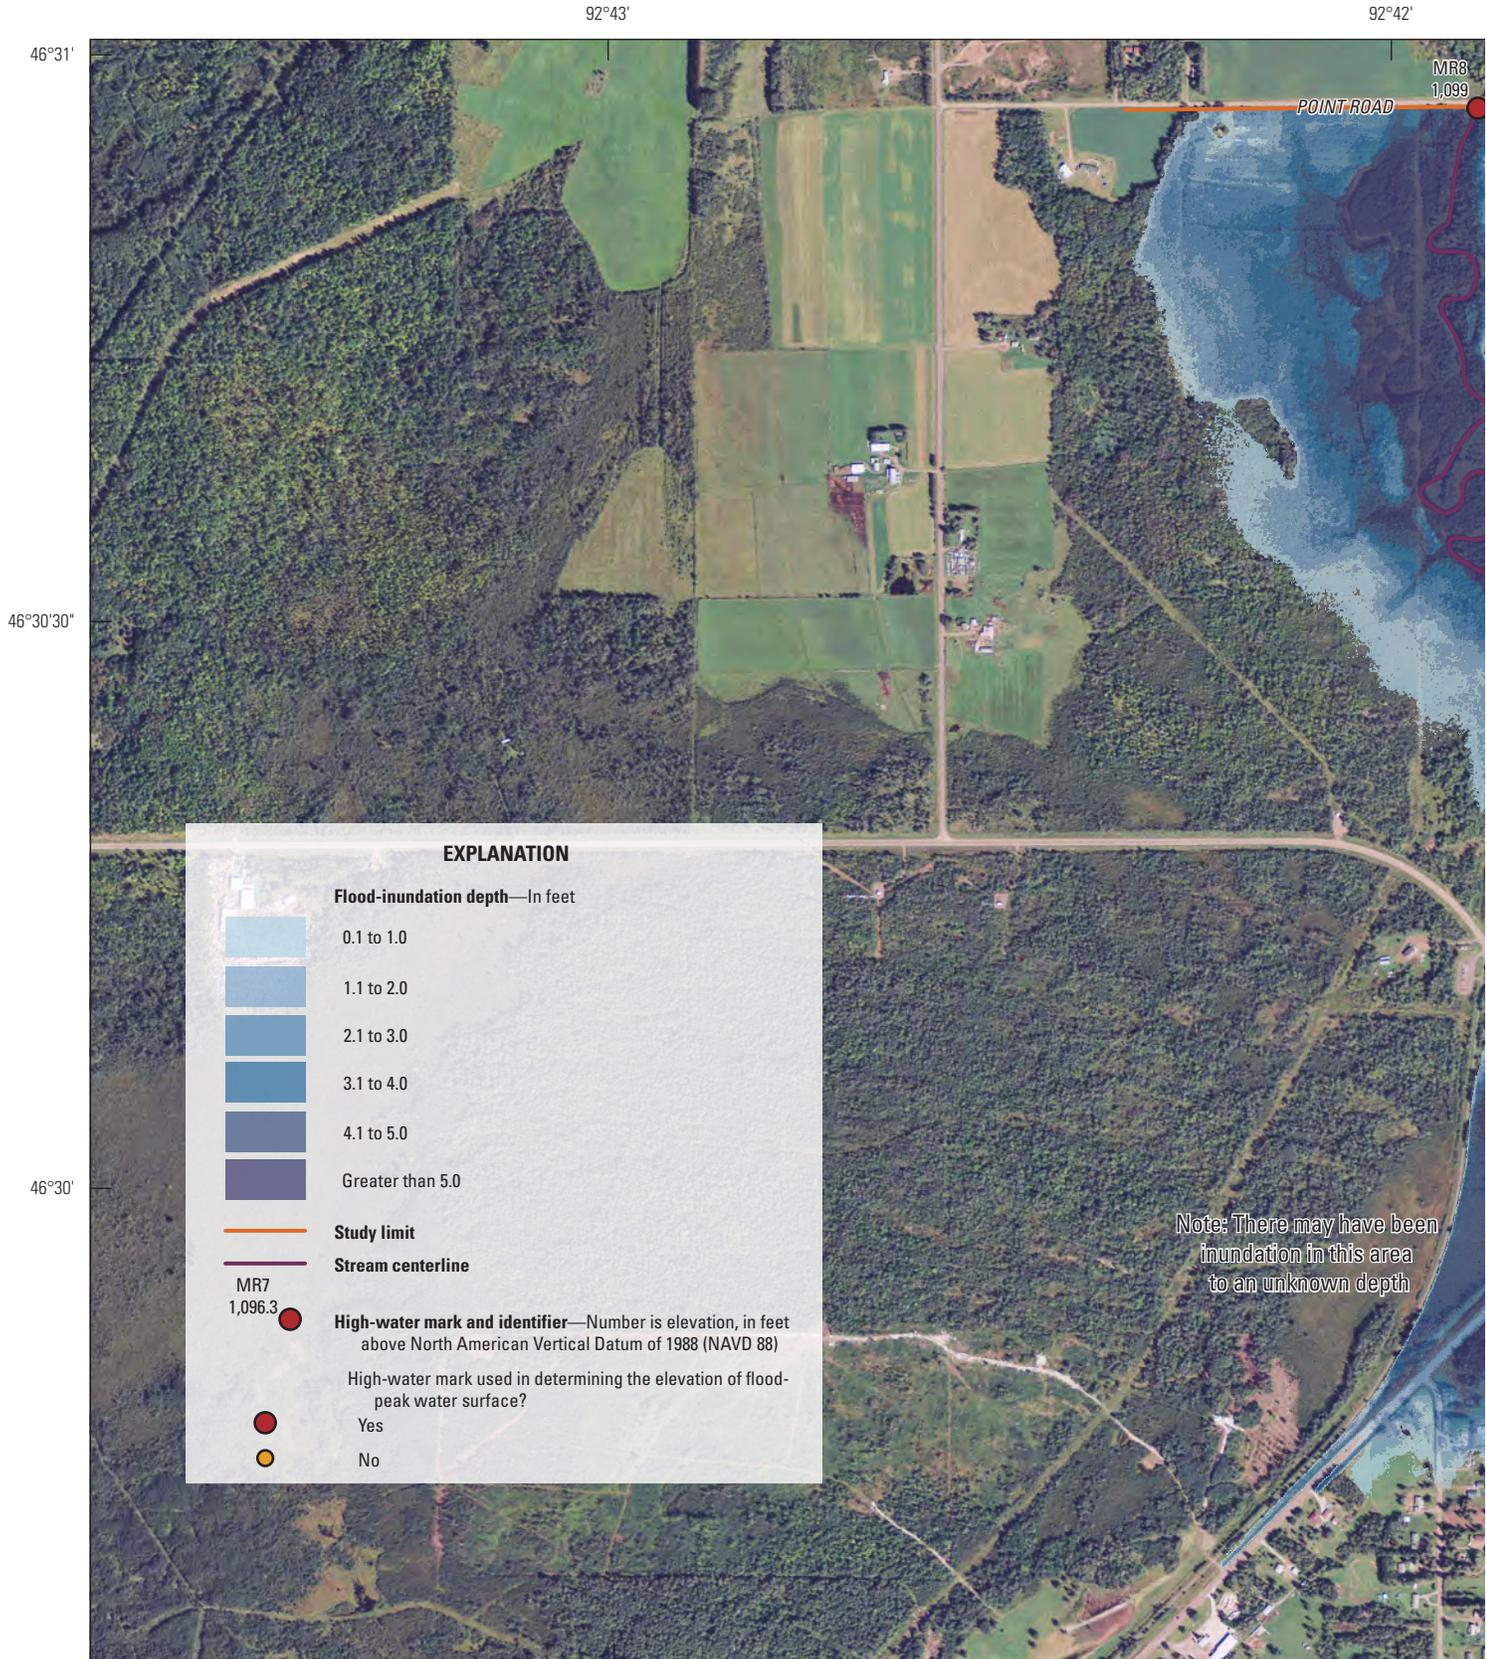
Figure 2–1. Approximate extent and depth of flood-peak inundation, flood of June 2012, for the Moose Horn River at Barnum, Minnesota.

Although few high-water marks were identified in Barnum (fig. 2–1), photographs taken by residents during the floods also provided information on what areas of town were flooded by the Moose Horn River. Southwest of town, inundation was mapped by assuming that floodwaters spilled out of the channel and backed up this drainage area that normally flows north into the Moose Horn River during low-flow conditions.

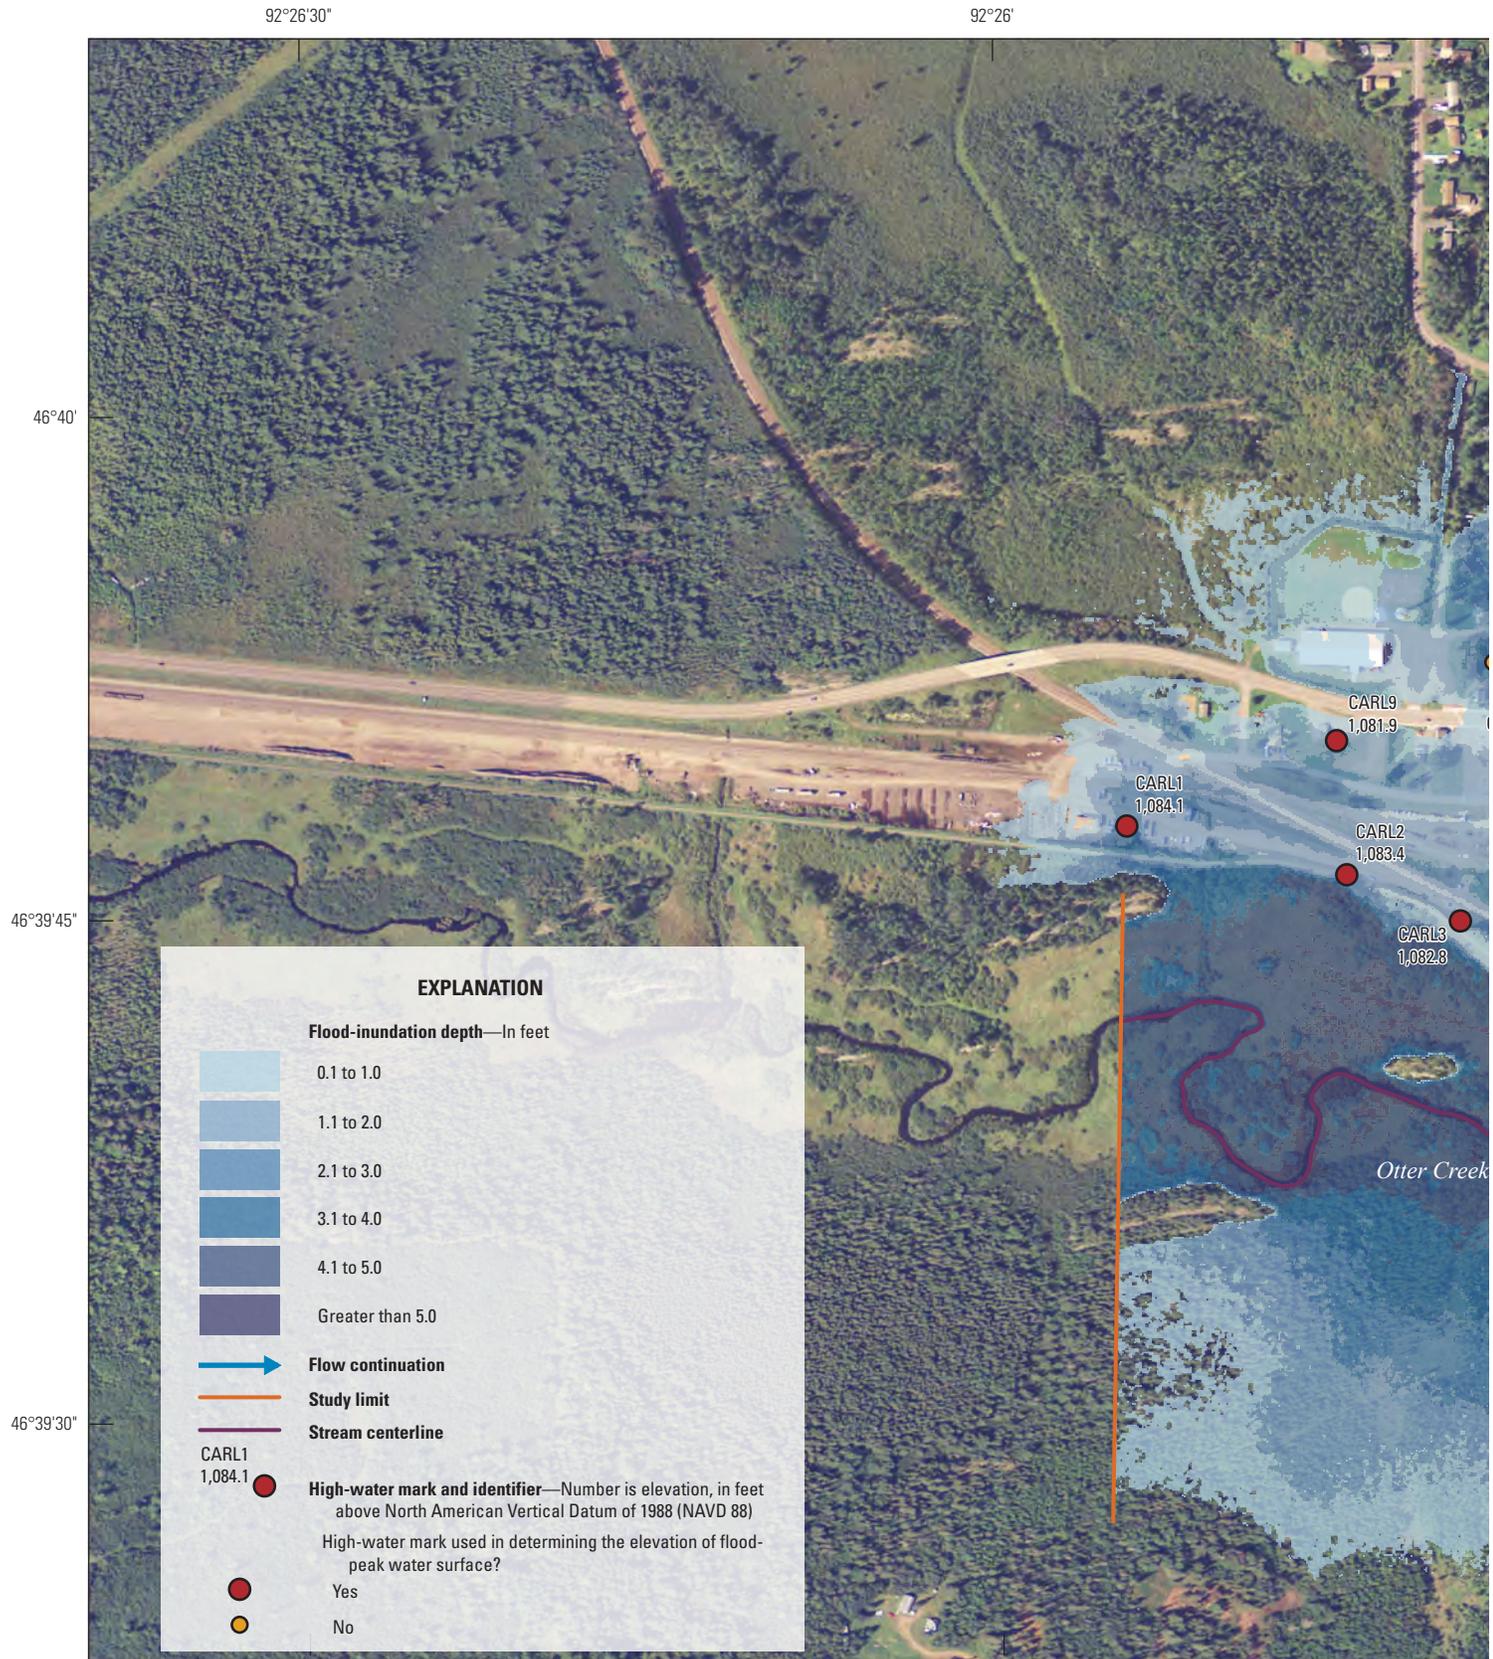
Figure 2–2. Approximate extent and depth of flood-peak inundation, flood of June 2012, for Otter Creek at Carlton, Minnesota.

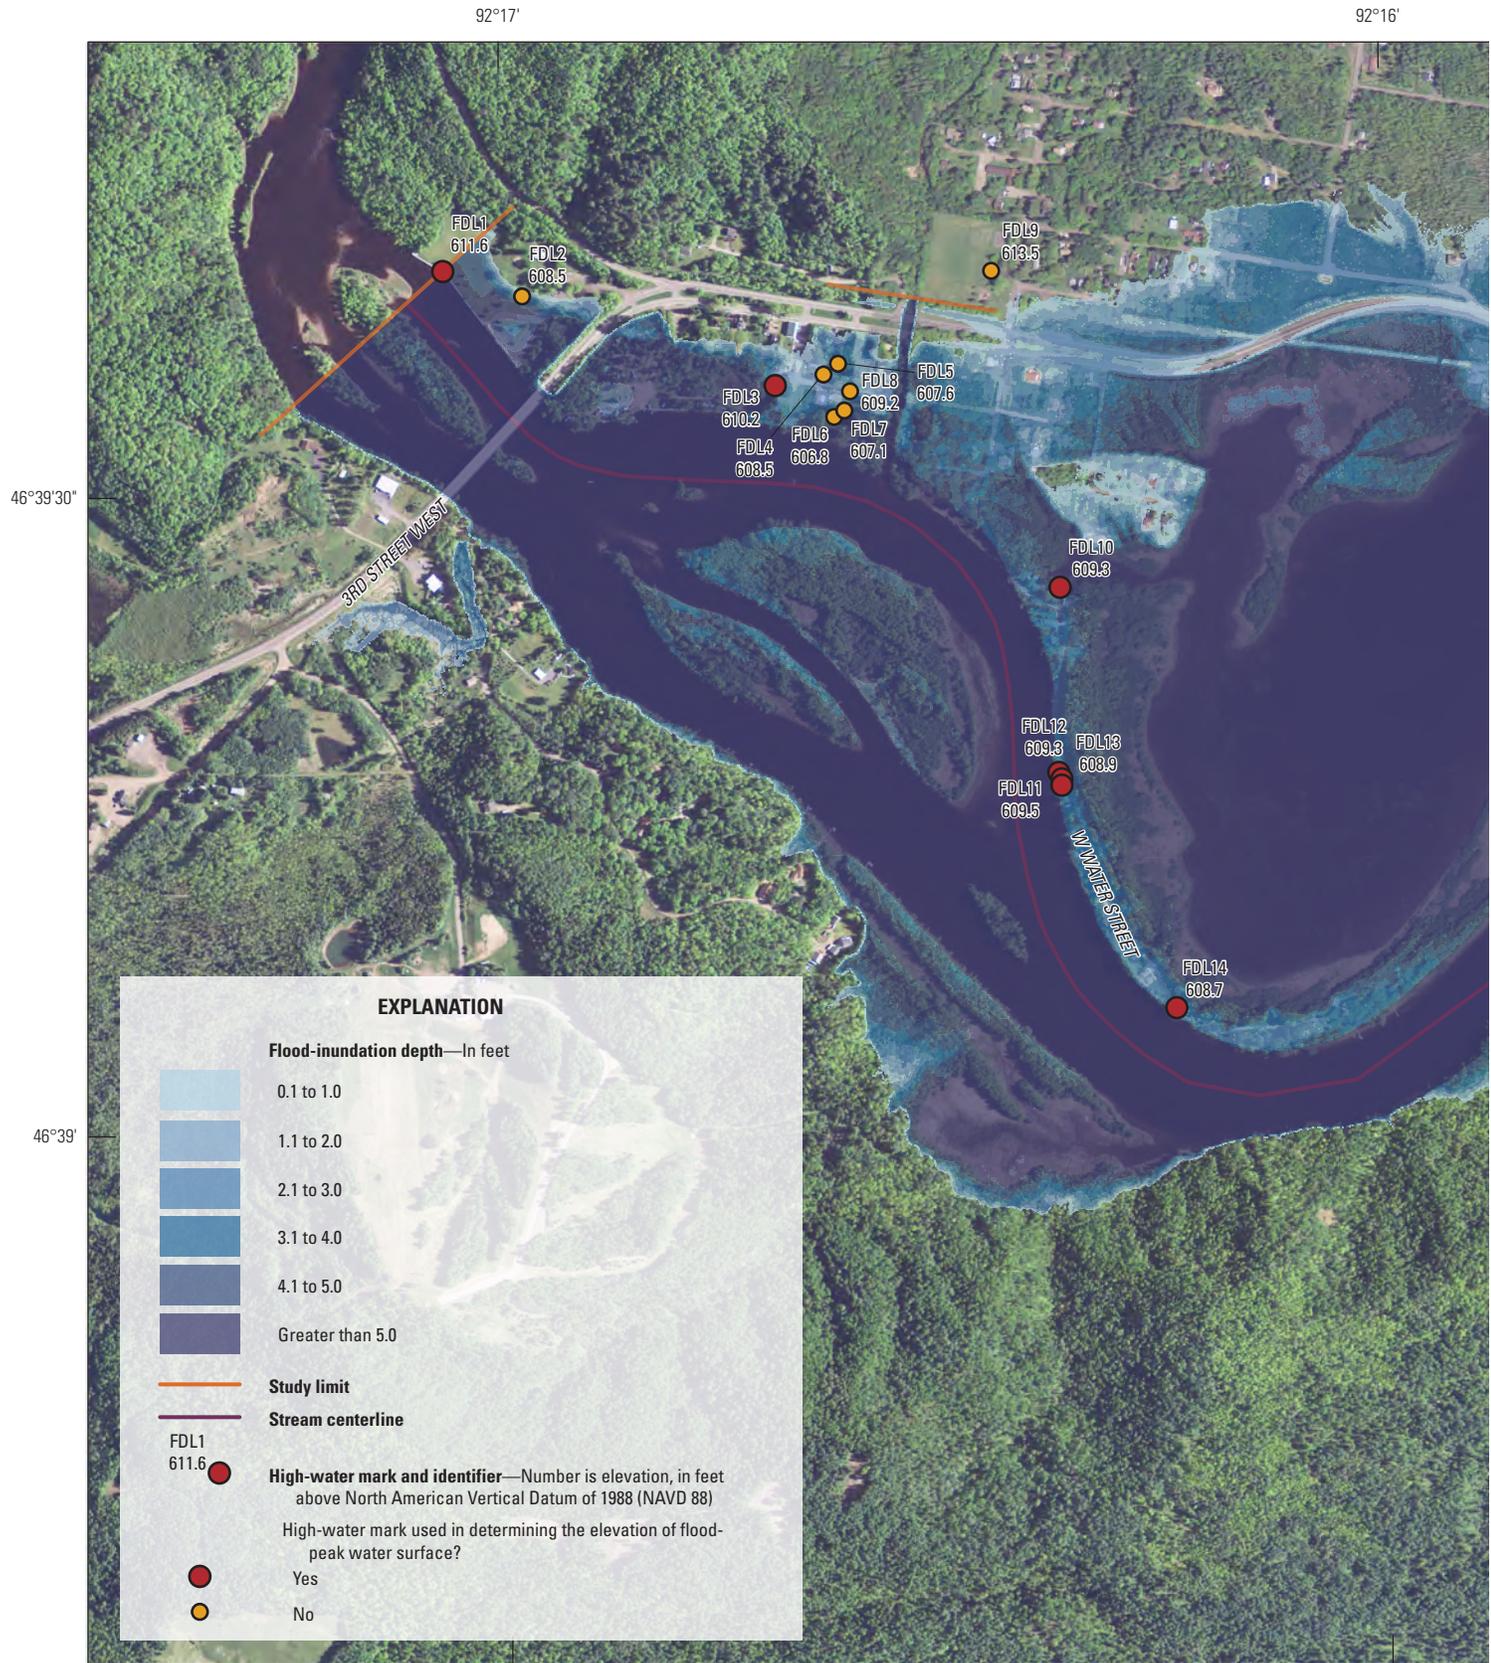
Figure 2-4. Approximate extent and depth of flood-peak inundation, flood of June 2012, for the St. Louis River at the Fond du Lac neighborhood, Duluth, Minnesota.

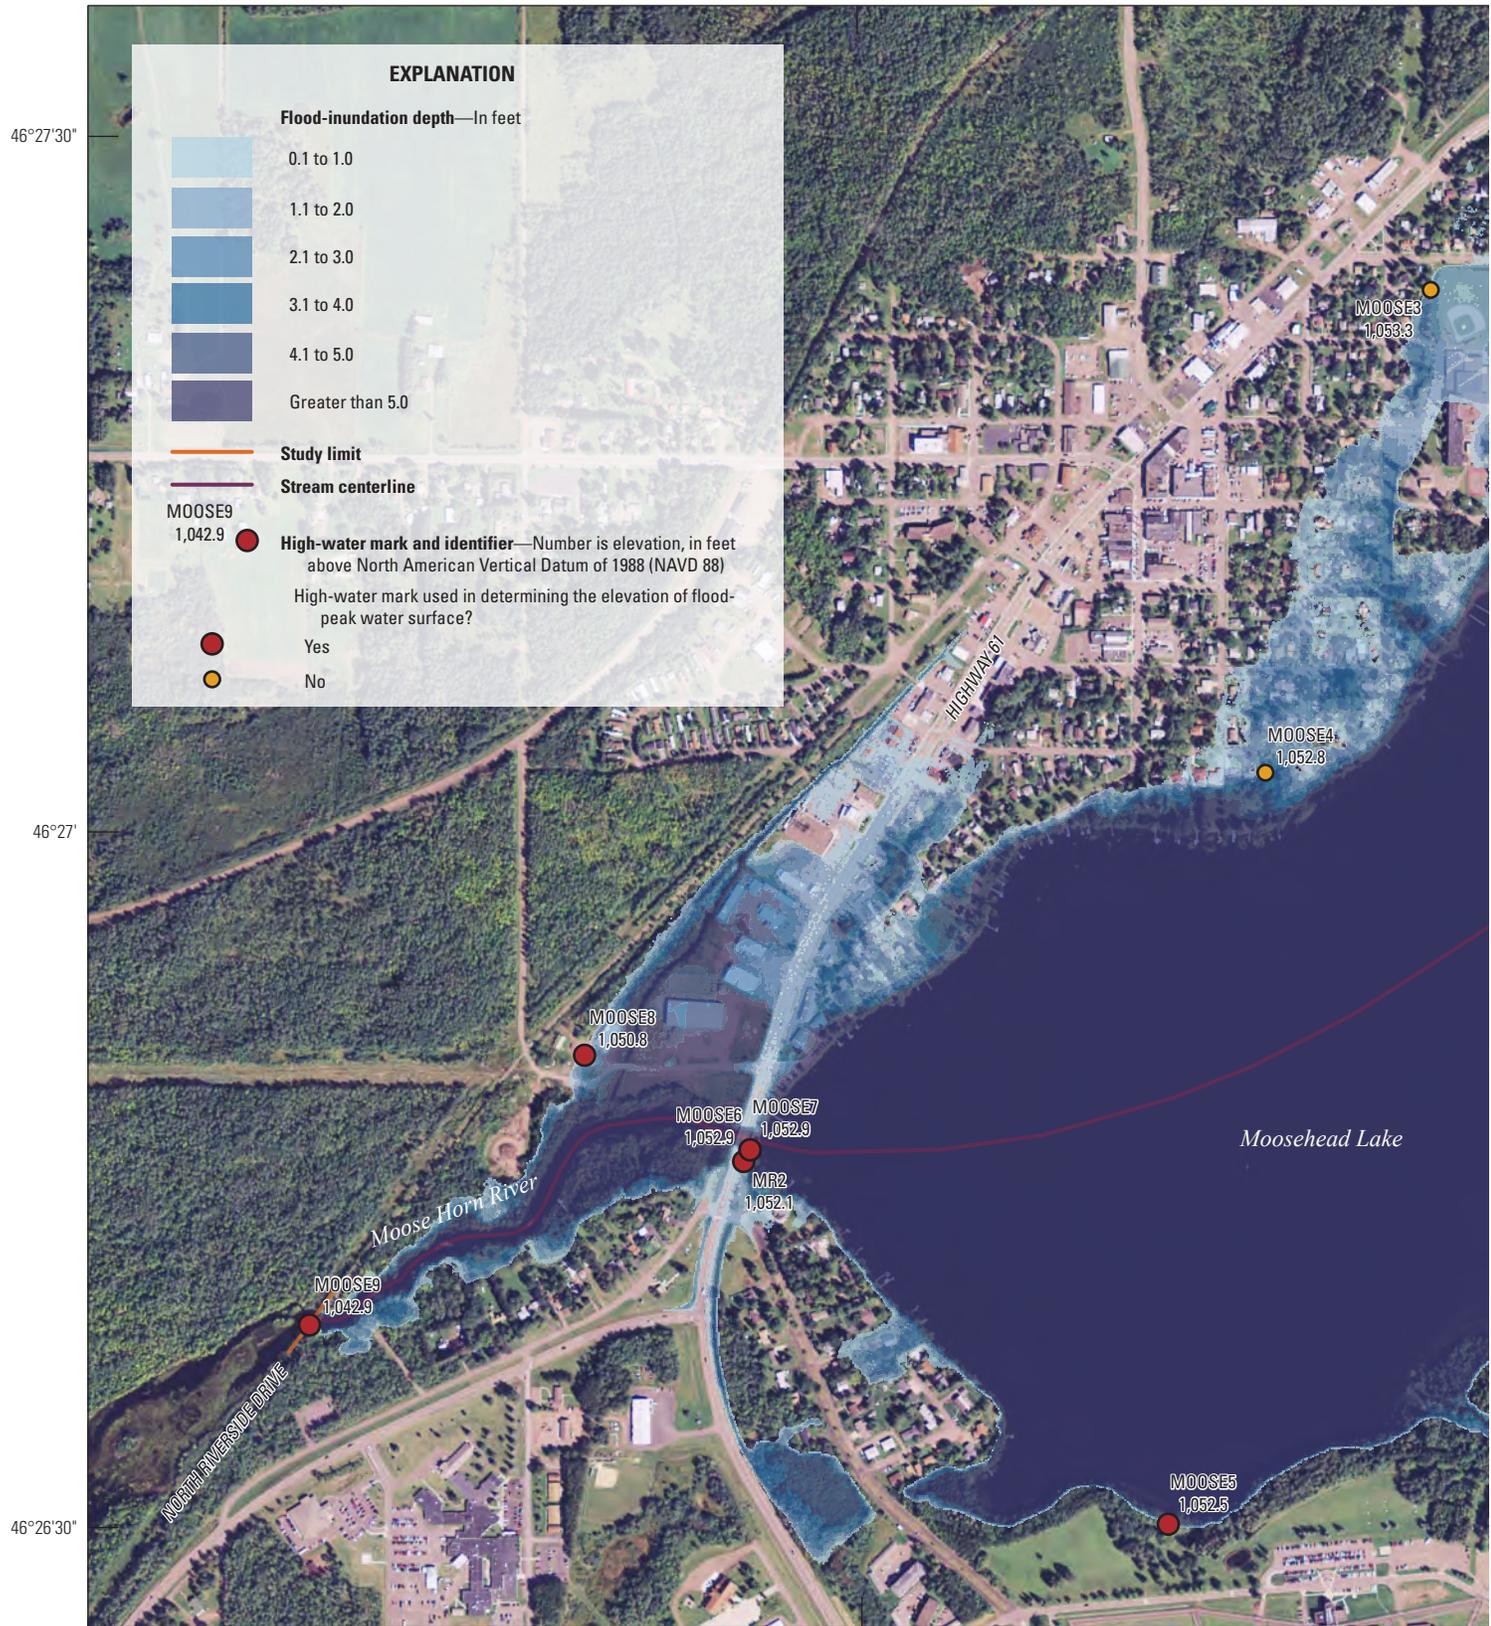
Figure 2-5. Approximate extent and depth of flood-peak inundation, flood of June 2012, for the Moose Horn River and Moosehead Lake at Moose Lake, Minnesota.

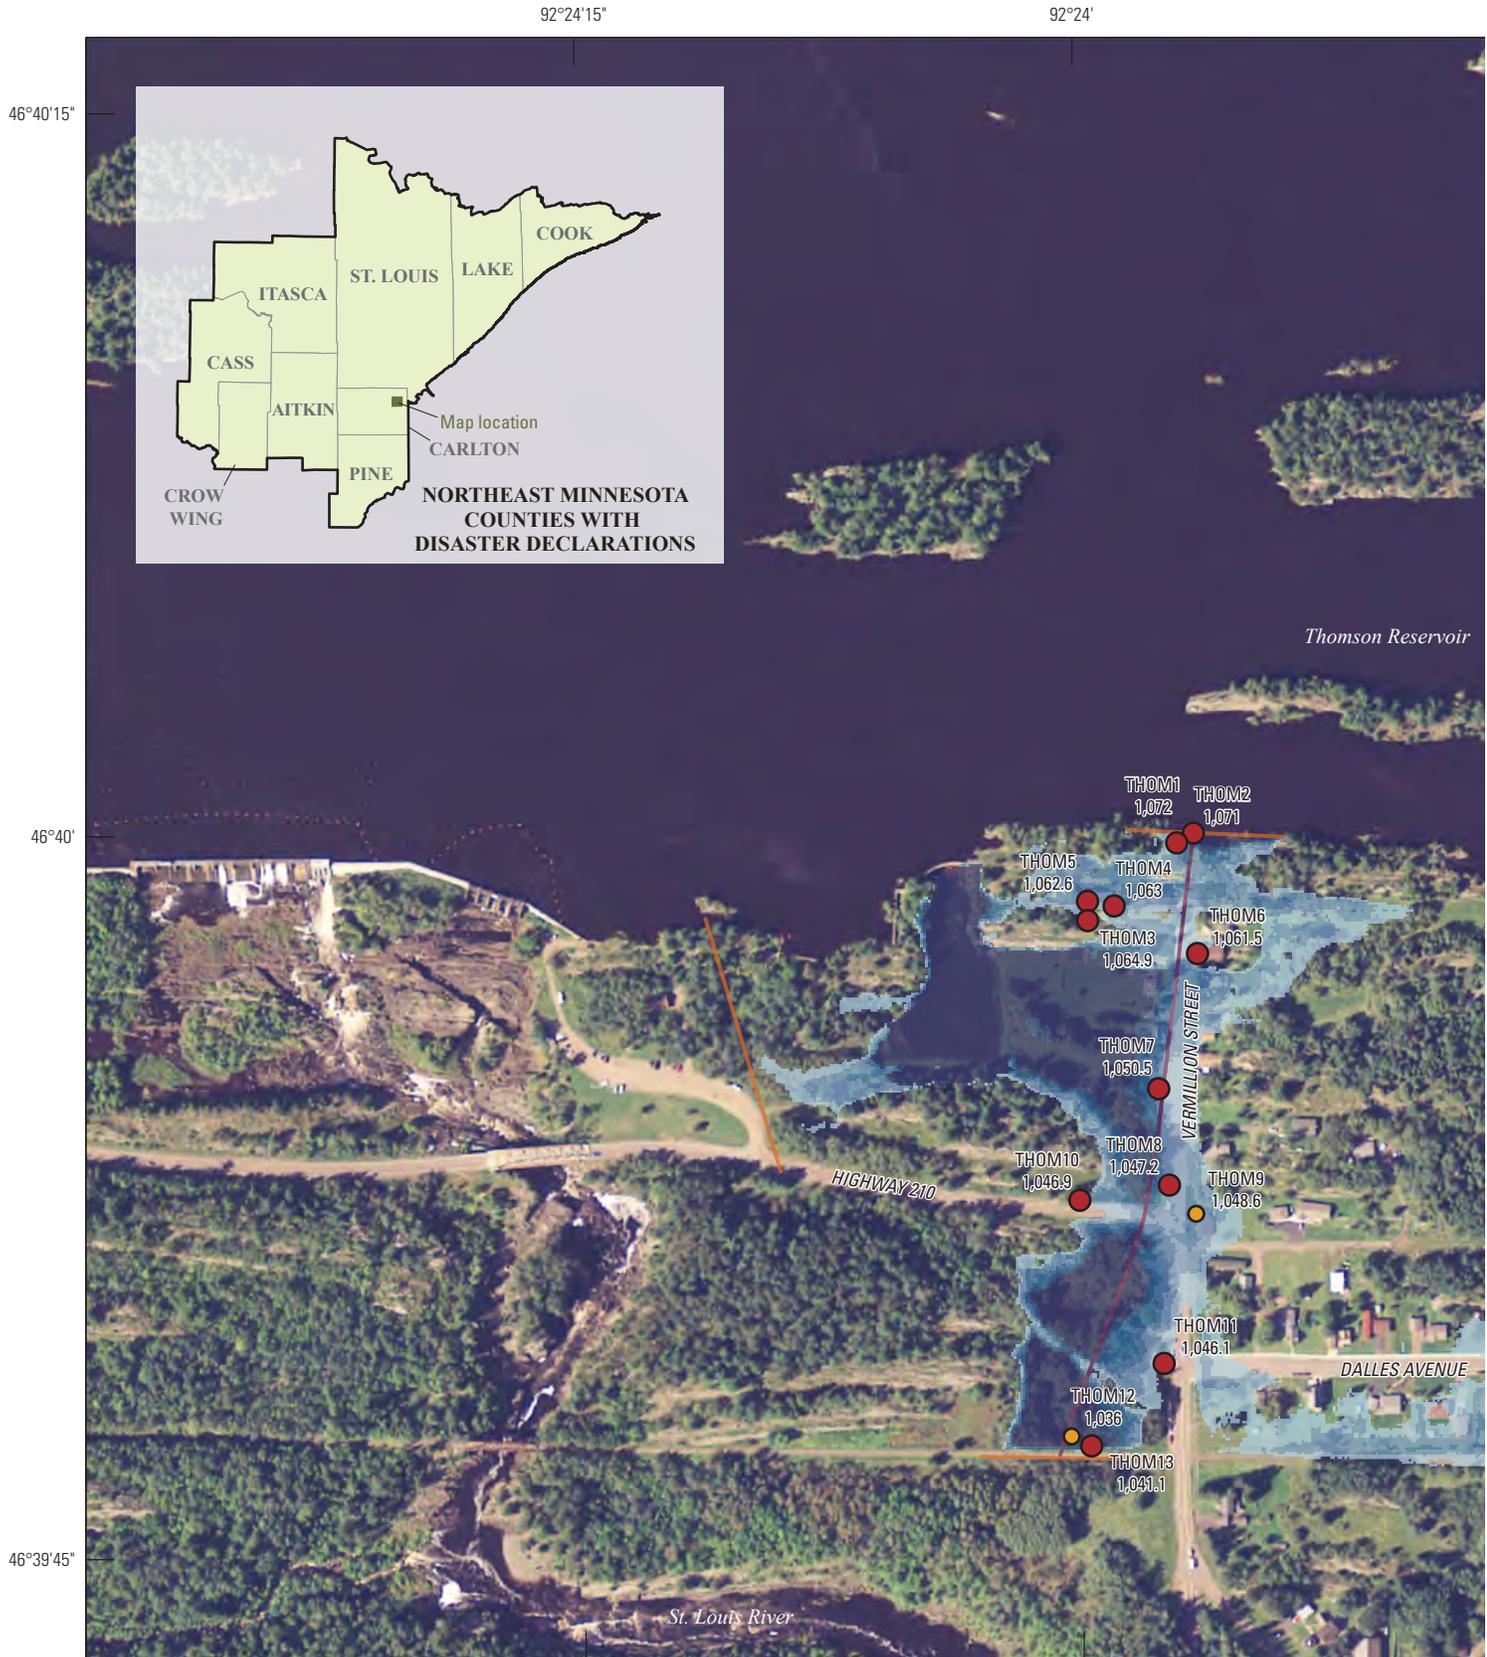
Figure 2-6. Approximate extent and depth of flood-peak inundation, flood of June 2012, for the Thomson Reservoir outflow near the St. Louis River at Thomson, Minnesota.

The St. Louis River exits Thomson Reservoir (fig. 2–6) at the dam west of the town of Thompson. Although the flooding along the St. Louis River washed out part of the Highway 210 roadway, this area was not in the study area for inundation mapping. Floodwaters spilled out of Thomson Reservoir at several small dam structures and flowed overland into the town of Thomson. The more destructive floodwaters flowed overland and south along Vermillion Street, flooding houses and causing substantial damage to the street. This water continued to flow southeast across Highway 210 and joined the St. Louis River south of the study limit (fig. 2–6). On the eastern side of Thomson, the floodwaters flowed down the forested hill from the reservoir and flooded houses along Dalles Avenue. Two culverts at the study boundary (indicated by the deeper inundation depths at the southern study boundary on fig. 2–6) could not pass all the flow to the south, which backed up water and caused it to flow west along Dalles Avenue and join with the floodwaters from Vermillion Street. Farther to the east, a diversion canal that conveys water from Thomson Reservoir downstream to Minnesota Power facilities also was beyond the study limit.

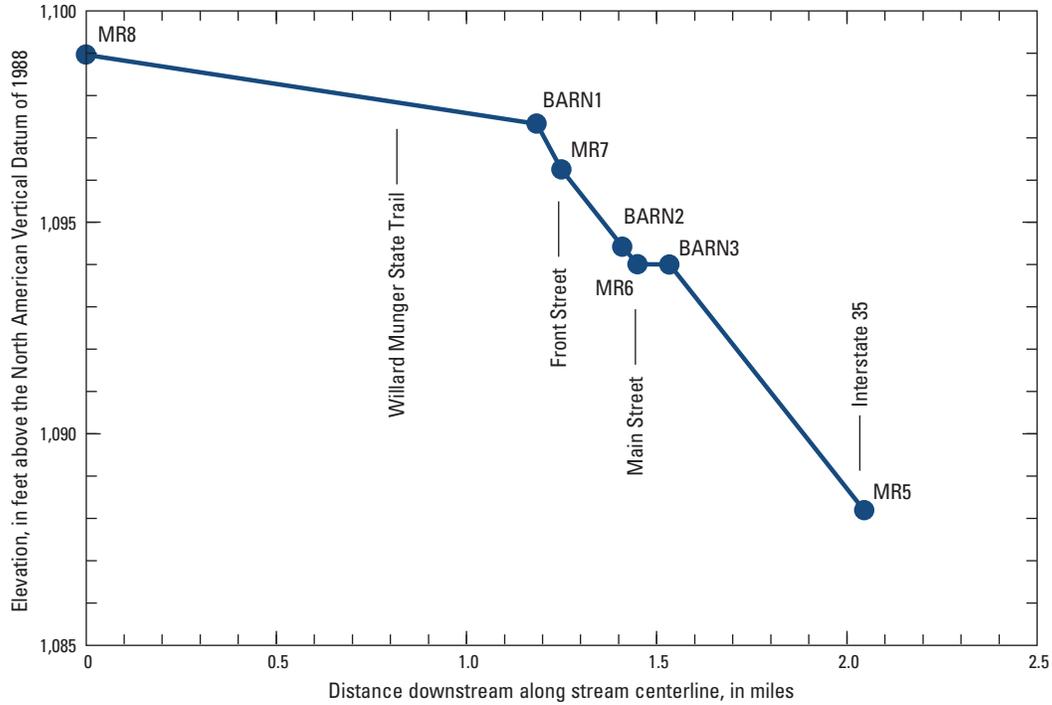
Figure 3-1. Flood-peak water-surface profile with selected high-water marks for the Moose Horn River at Barnum, Minnesota, for the flood of June 2012.

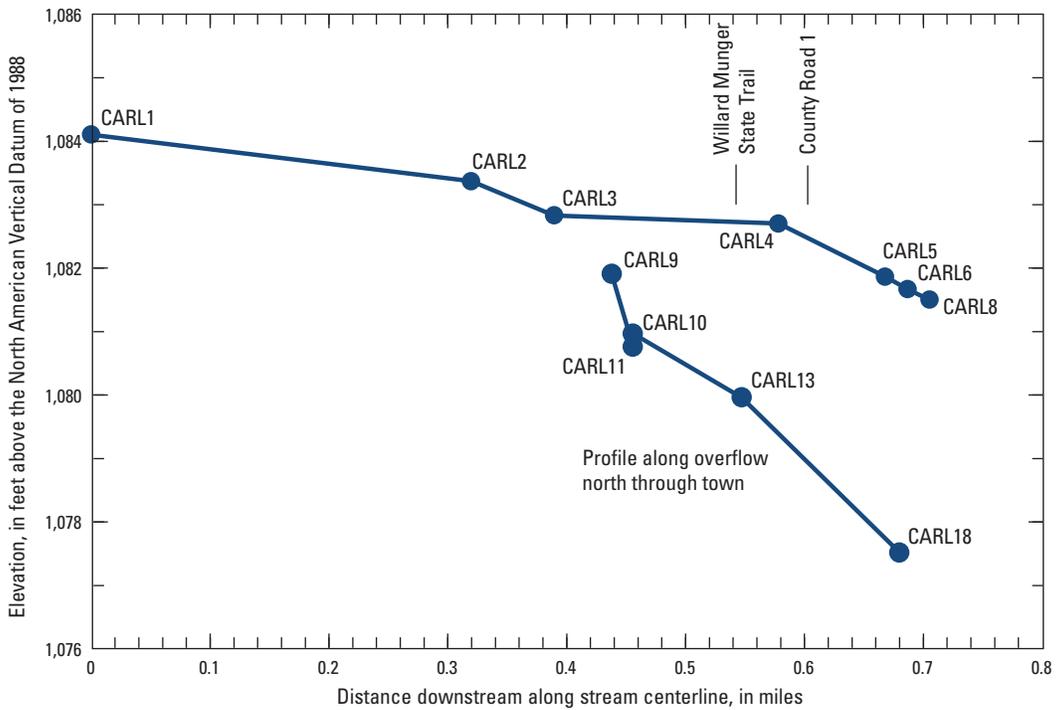
Figure 3-2. Flood-peak water-surface profile with selected high-water marks for Otter Creek at Carlton, Minnesota, for the flood of June 2012.

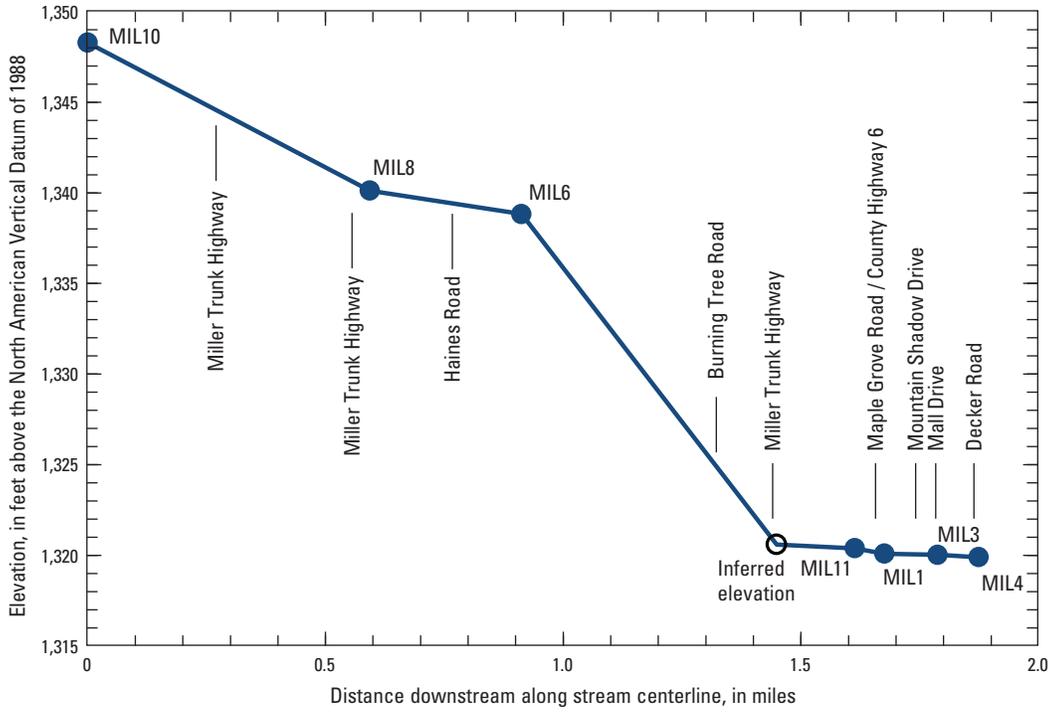
Figure 3-3. Flood-peak water-surface profile with selected high-water marks for Miller Creek at the Duluth Heights neighborhood, Duluth, Minnesota, for the flood of June 2012.
