Floods of June 2012 in Northeastern Minnesota

Scientific Investigations Report 2012–5283

By Christiana R. Czuba, James D. Fallon, and Erich W. Kessler

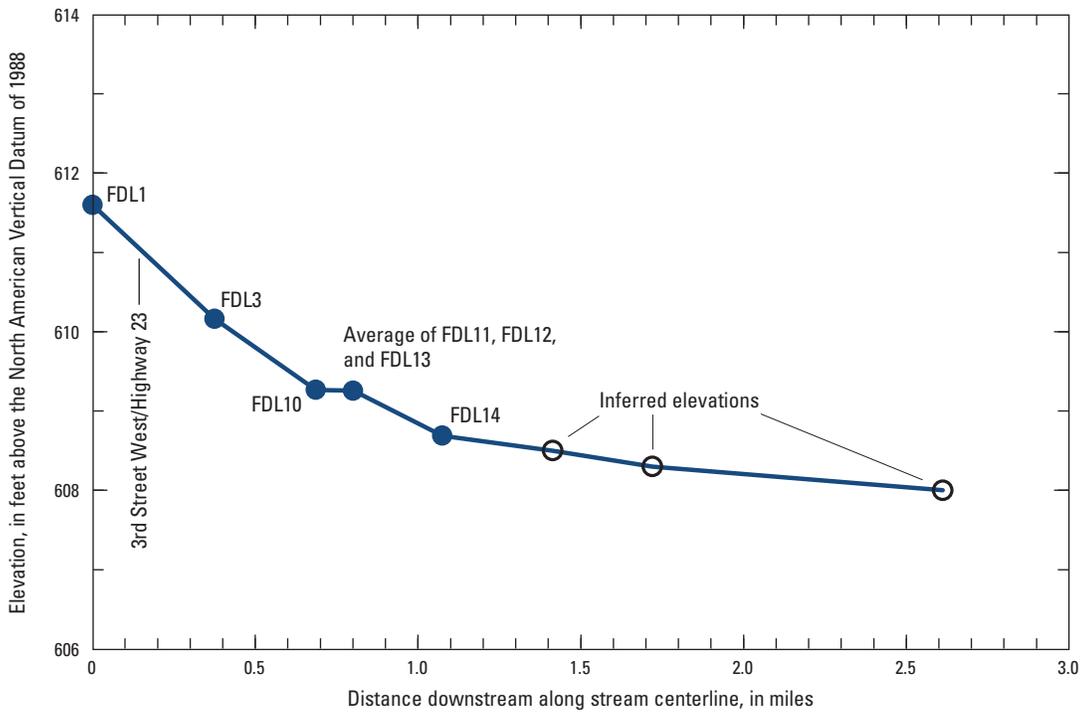
Figure 3-4. Flood-peak water-surface profile with selected high-water marks for the St. Louis River at the Fond du Lac neighborhood, Duluth, Minnesota, for the flood of June 2012.

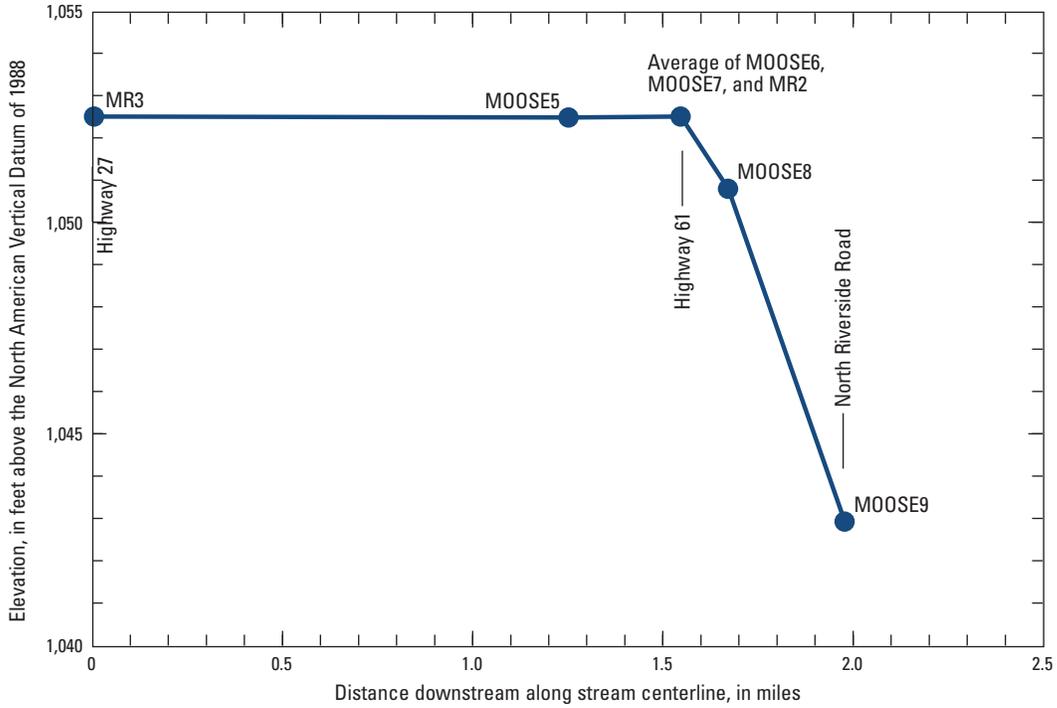
Figure 3-5. Flood-peak water-surface profile with selected high-water marks for the Moose Horn River and Moosehead Lake at Moose Lake, Minnesota, for the flood of June 2012.

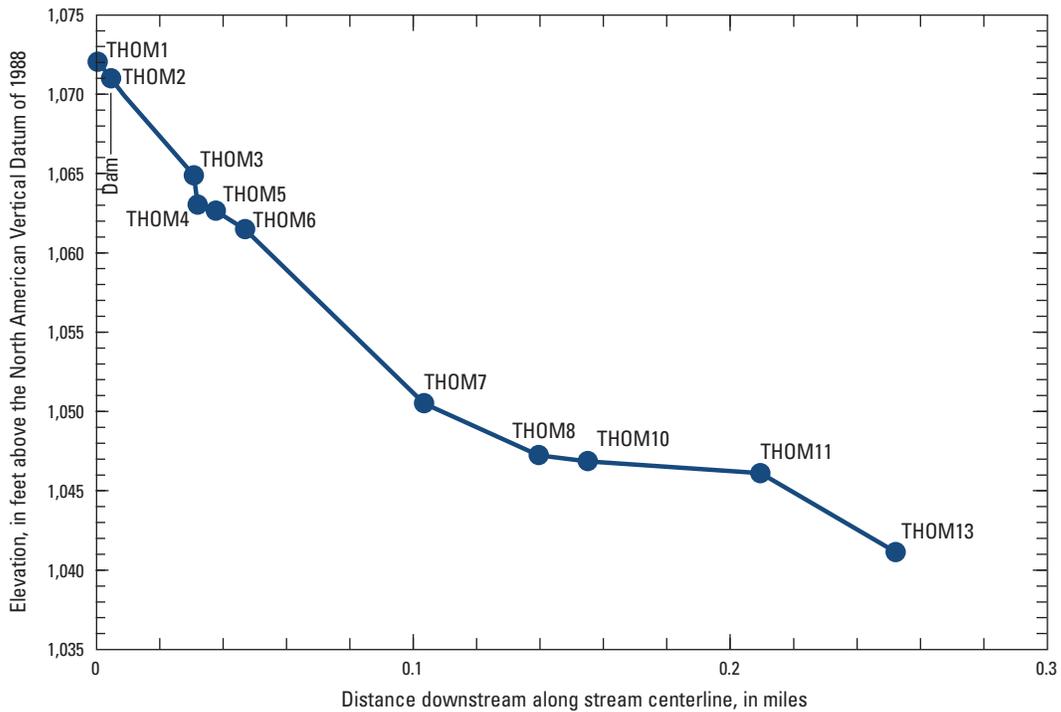
Figure 3-6. Flood-peak water-surface profile with selected high-water marks for the Thomson Reservoir outflow near the St. Louis River at Thomson, Minnesota, for the flood of June 2012.
