COST, PERFORMANCE, AND ESTHETIC IMPACTS OF AN EXPERIMENTAL FOREST ROAD IN MONTANA

USDA Forest Service
Research Paper INT-203
April 1978

A study on the Coram Experimental Forest in Montana was designed to assess the environmental impacts of harvesting and attendant road construction. The objective of the road portion of the study was to locate, design, and construct a road with reduced impacts (compared to standard practice) on the environment that would still serve the near-minimum needs of the projected traffic volumes, vehicle sizes, and logging equipment (skyline logging), and to evaluate the costs and impacts.

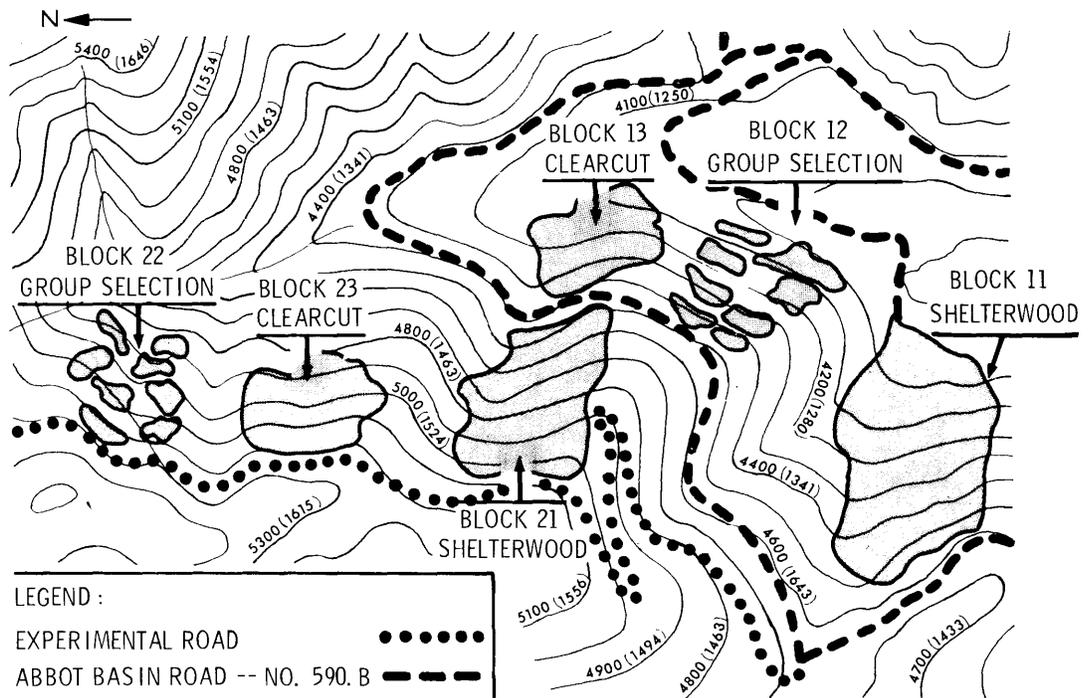
Figure 1.--Location and layout of experimental logging road on Coram Experimental Forest, Montana.

Information is seriously lacking to evaluate trade-offs related to social, environmental, and economic values associated with different road standards. Because of the paucity of information on which to base decisions, many research projects are now underway or are planned. This paper reports one such study on the Coram Experimental Forest in Montana (fig. 1).

The areas to be harvested and the new road constructed to provide access are shown in figure 1. Three cutting blocks 11, 12, and 13 were accessible from an existing road (Flathead NF road 590-B). The experimental road, an extension of road 590-B, was built to provide access to the other three blocks 21, 22, and 23.

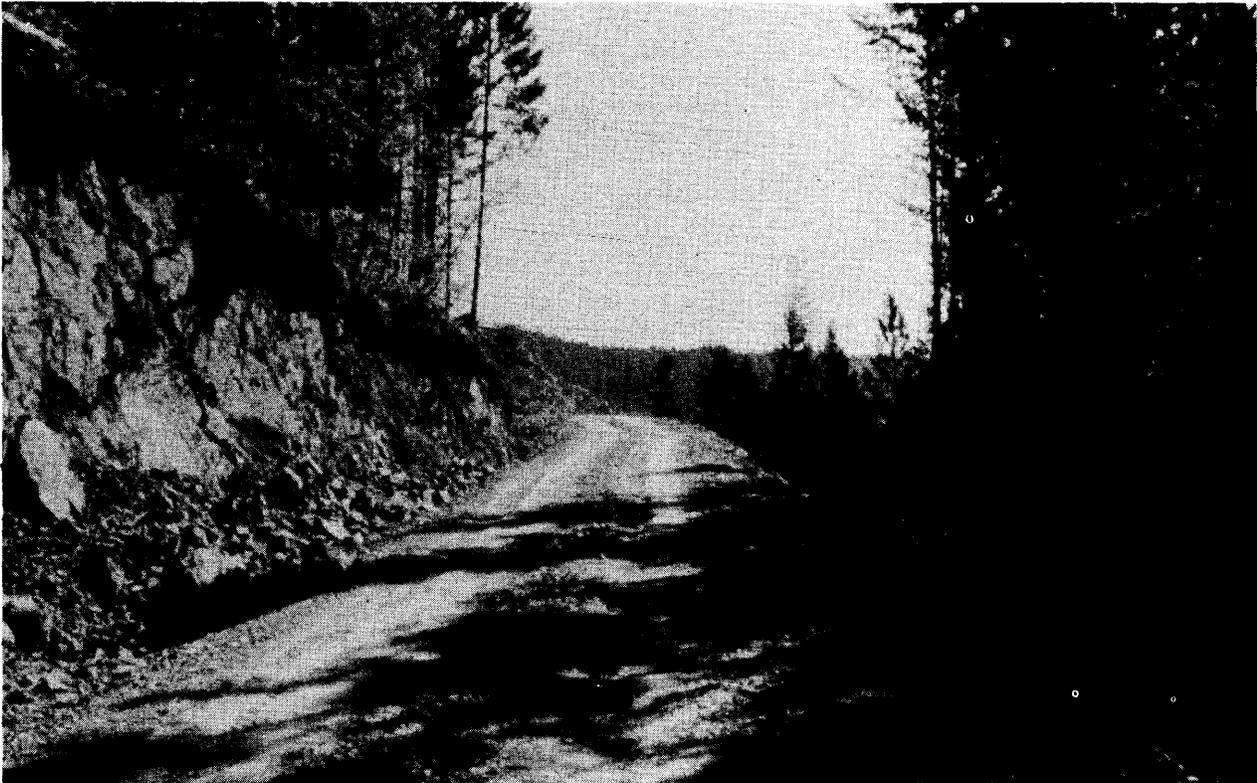
Figure 2.--Near station 54+00--view of 1/10:1 backslopes before final grading.

1/10:1 backslopes.--Two photos taken from approximately station 54+00, after the first winter and after final grading, tell the story. Figure 2 shows two or three sections where 1/2 to 1 cubic yard (0.13-0.26 m³) of rock sloughed off the cut bank. Figure 3 shows the same section of road after final grading and how it appeared the balance of the year. Only minor sloughing is likely in the future.

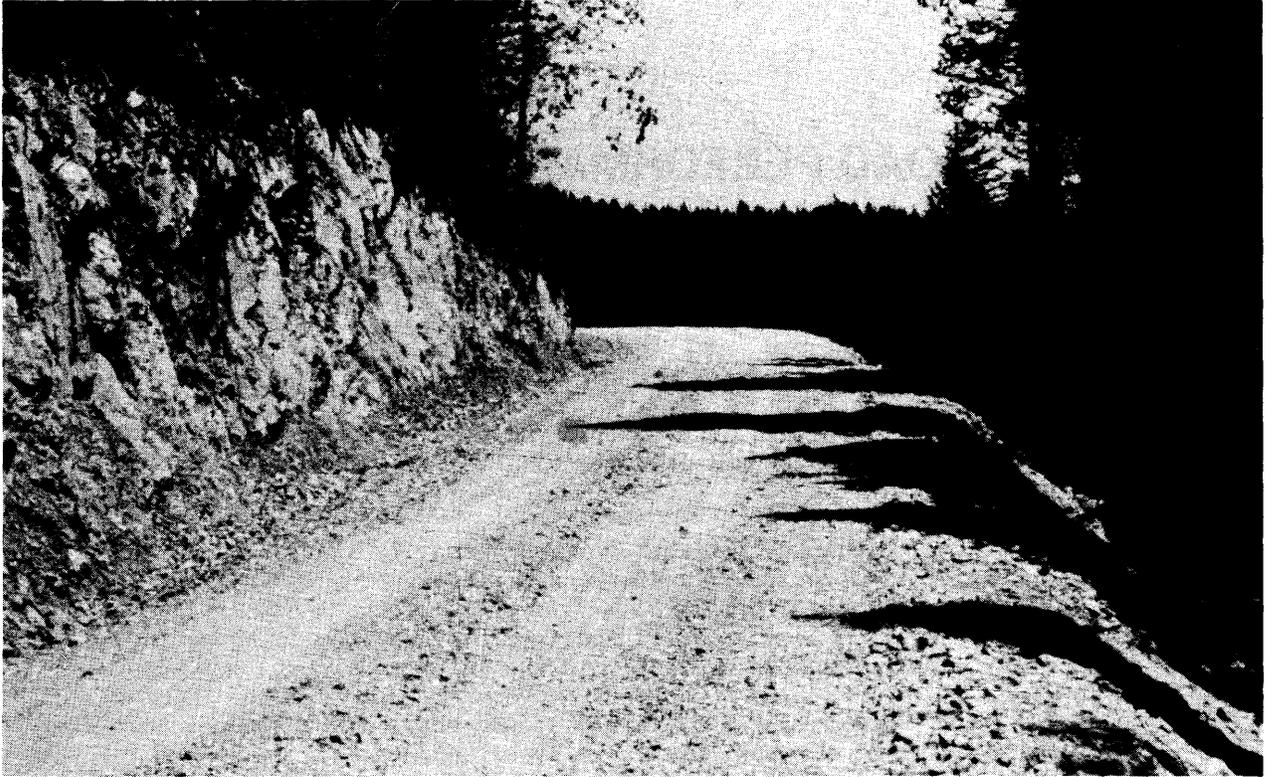
Figure 3.--Near station 54+00--view 1/10:1 backslopes after final grading.

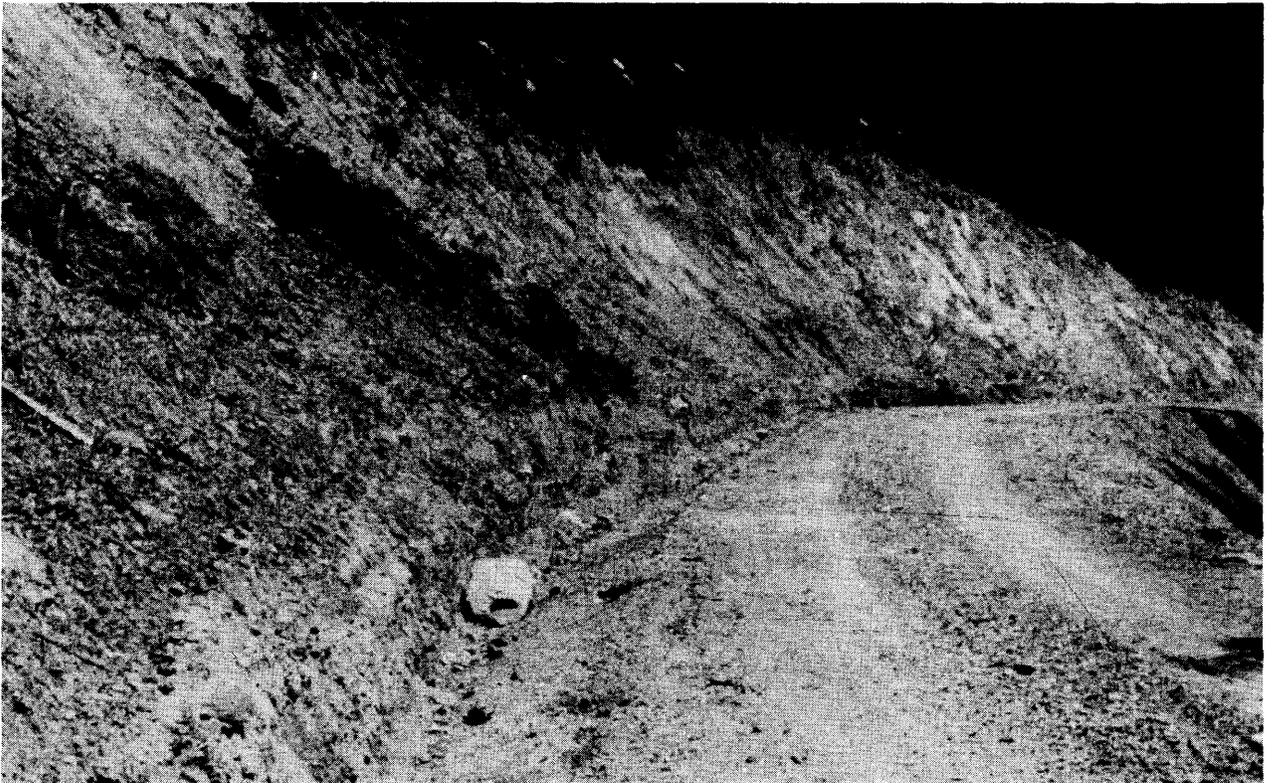
Figure 4.--Slumping cut slope near station 37+20.

3/4:1 backslopes.--Two areas of 3/4:1 backslopes showed some sloughing or slumping after the first winter, but are now relatively stable and no major failures are anticipated. Figure 4 shows minor slumping at station 37+20 on a relatively long slope in the deepest soil mantle found on the entire road. Some minor sloughing or slumping could be expected on 3/4:1 backslopes in this material.

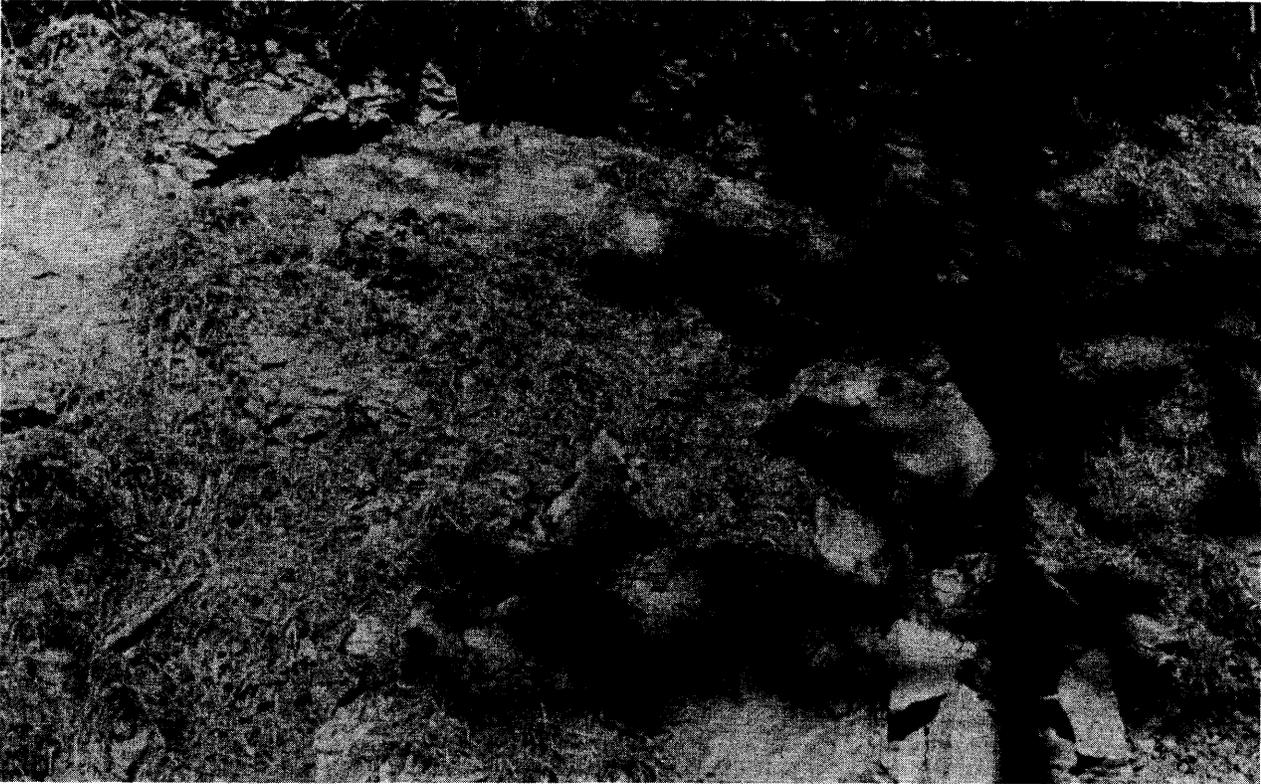
Figure 5.--Minor settlement in rock fracture at station 64+34.

A minor U-shaped settlement occurred in the cut bank at station 64+34 (fig. 5) because of rock fracturing.

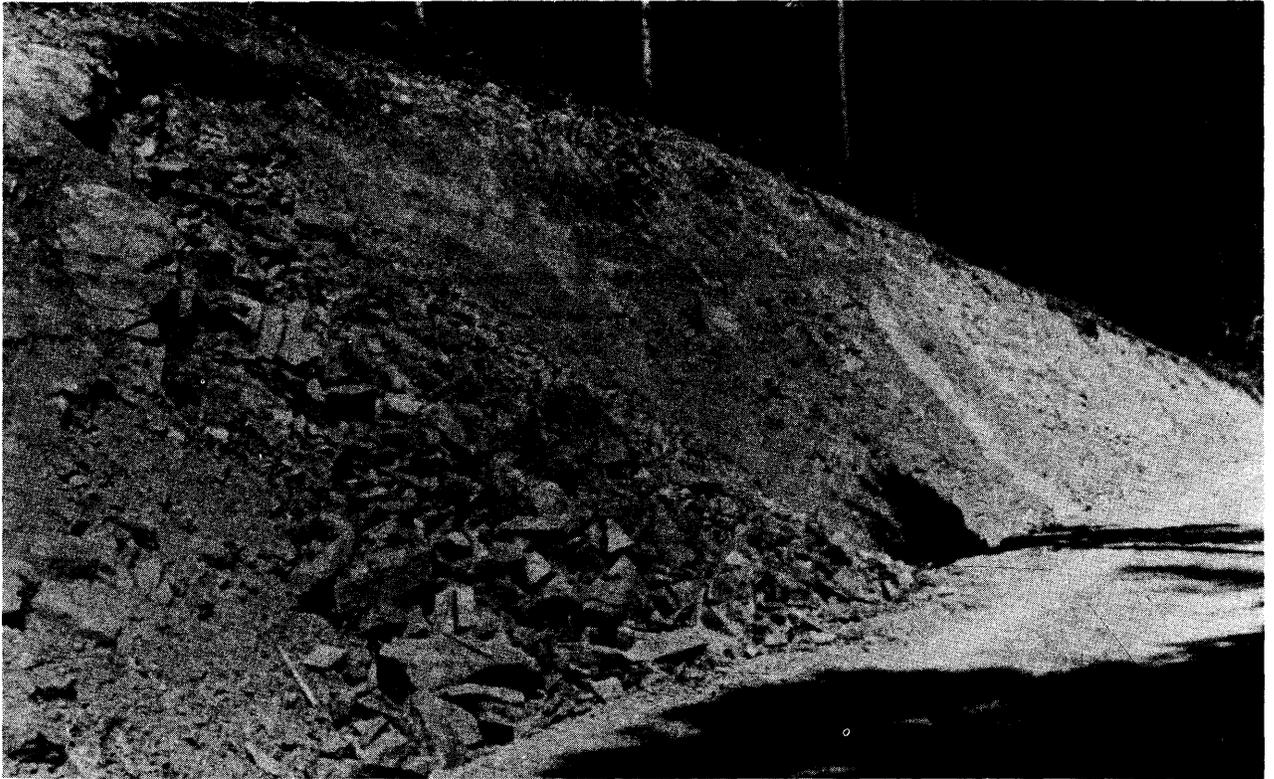
Figure 6.--Rock slab spalling due to dip and fracture at station 76+20.

In figure 6, several yards of rock slabbed off the cut bank at station 76+20 because of dip and fracture in the bedrock. No further sloughing of any extent is expected here.

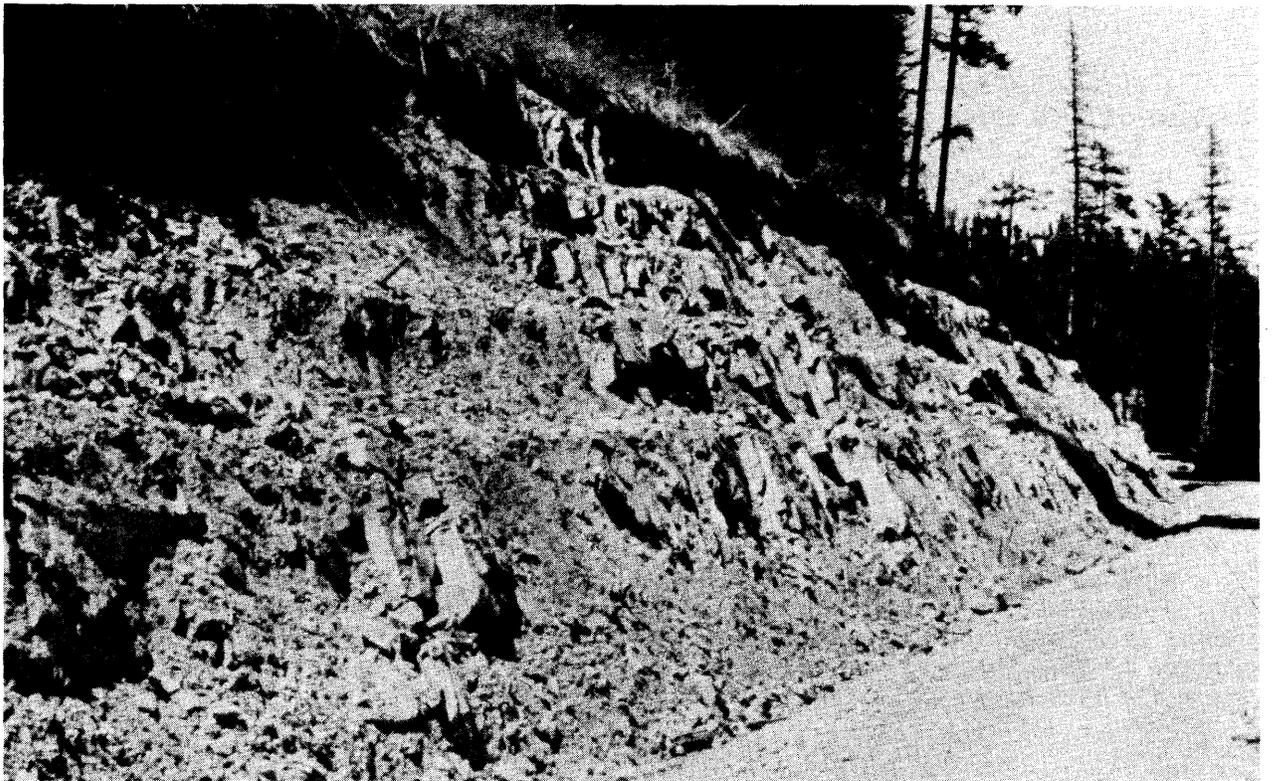
Figure 7.--Stepped backslopes in rock cut near station 82+50.

Stepped or serrated backslopes.--An experimental section of approximately 450 feet (137 m) of backslope was stepped to test growth of grass and shrubs and to evaluate esthetics and stability. This area has relatively high precipitation and a favorable aspect. Revegetation success was generally good. Figure 7 shows a completed section of serrated backslope. The dip and strike of the rock formations made stepping difficult and resulted in the steps being not quite as wide as planned. The steps have been planted, and it is believed that most of the sloughing expected has taken place. Sloughing eventually leaves less pronounced steps, but provides a seedbed and more moisture to the plants.

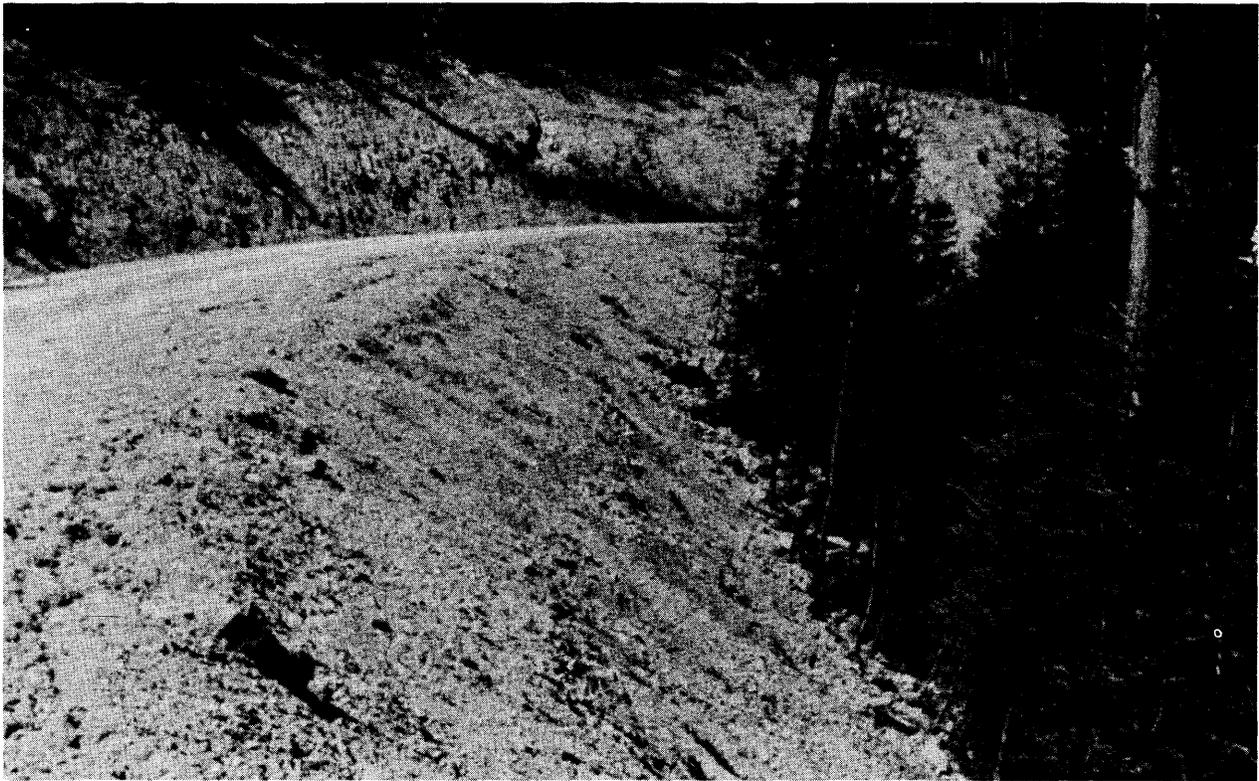
Figure 9.--Fill containing some fine colloidal material that produced a slightly uneven but stable slope at station 93+00.

Fill slopes.--Fills were designed on either a 1 1/2:1 or 1 1/4:1 slope, depending on the material. Many sections contained enough rock to support 1 1/4:1 slopes. Fill slopes were compacted by the earth moving equipment. Figure 8 shows a typical fill at station 87+75. The material in the area of station 93+00 produced the only section where the fill slope was slightly undulating, shown in figure 9.

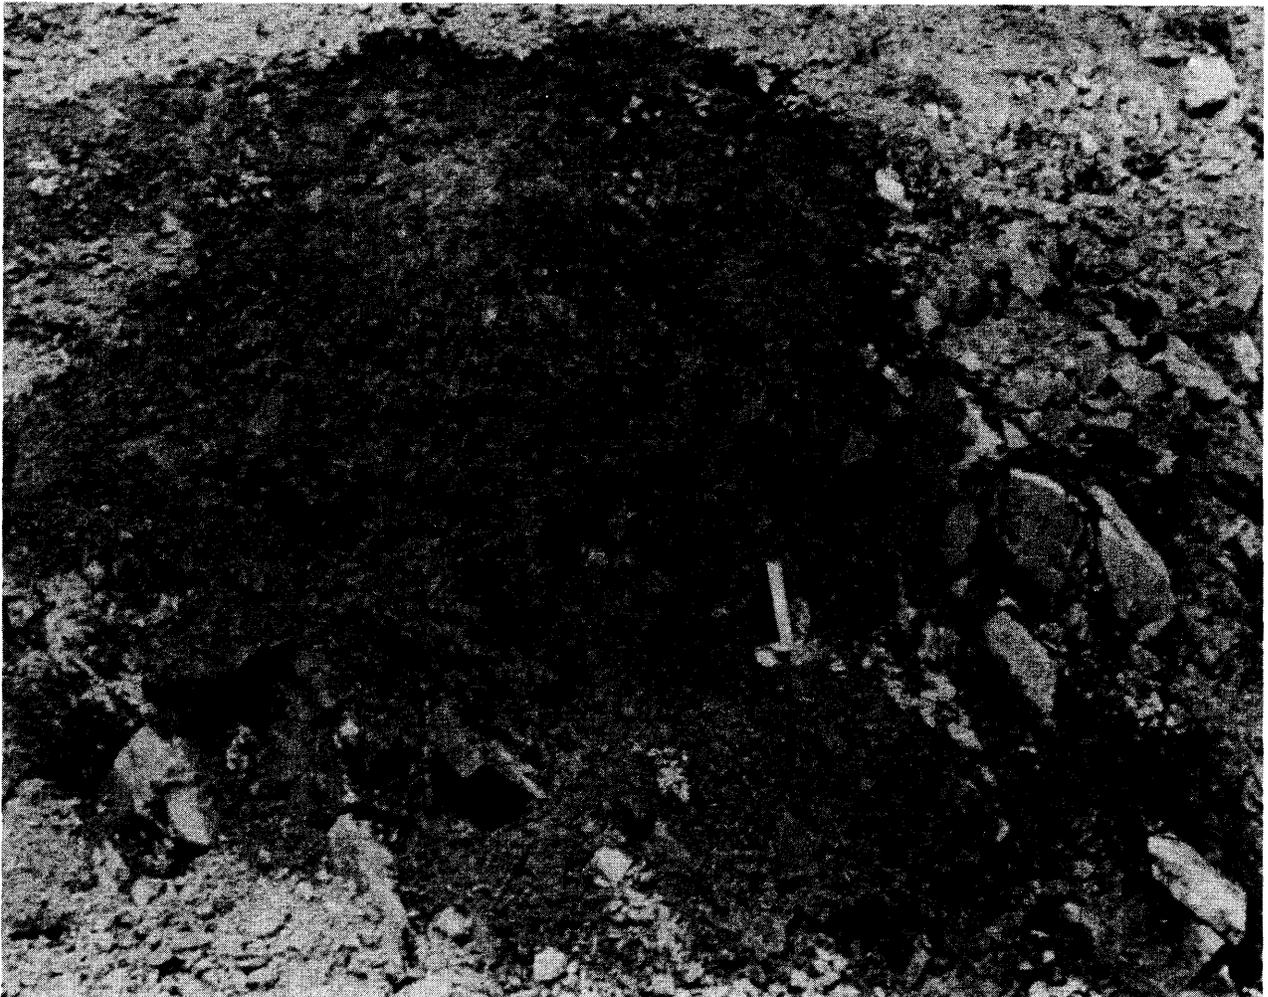
Figure 10.--Typical minor seepage at station 41+00.

Minor seepage was recorded in April from four cut bank sections at stations 12+40, 21+75, 41+00, and 55+00. The seepage at the first two locations continued throughout the year, but no damage resulted from the seepage. A typical area of seepage is station 41+00, shown in figure 10.

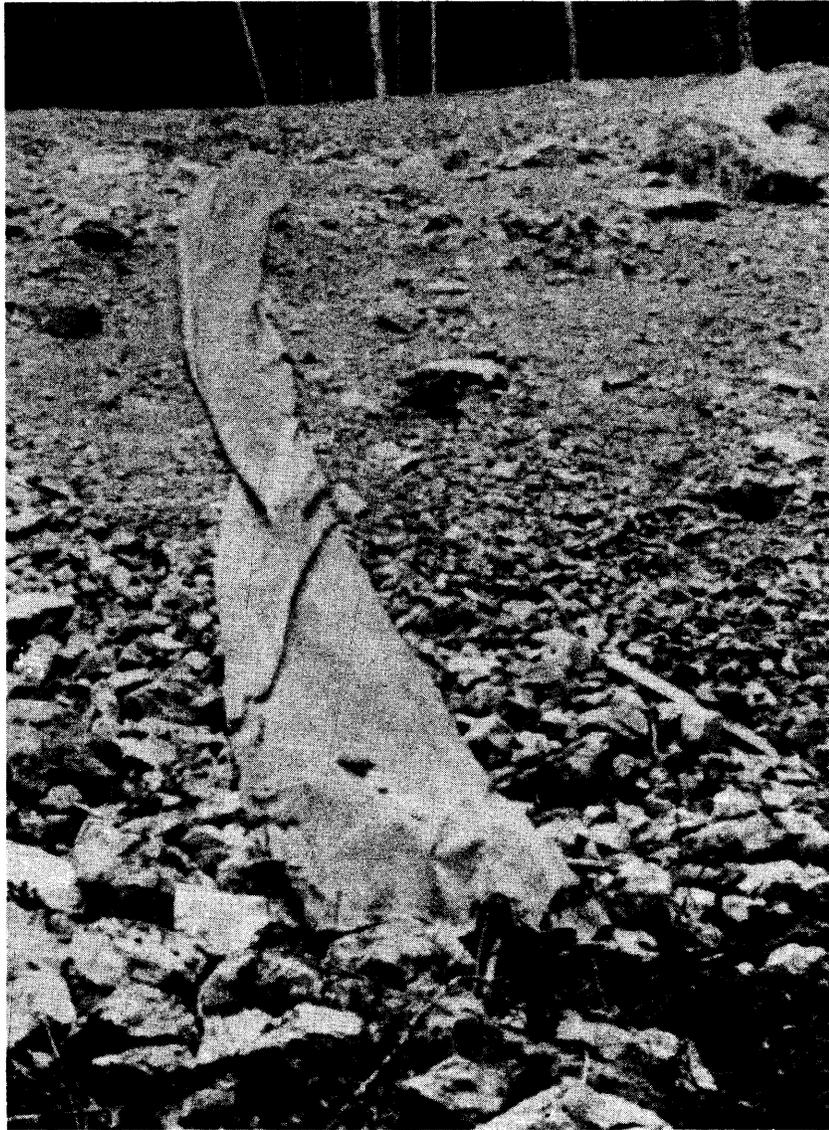
Figure 11.--Neoprene down-spout laid on top of fill at station 57+50.

Neoprene downspouts were used because of their greater stability on fill slopes and effectiveness in dissipating part of the energy under conditions of flow. The installation at station 57+50 is shown in figure 11.

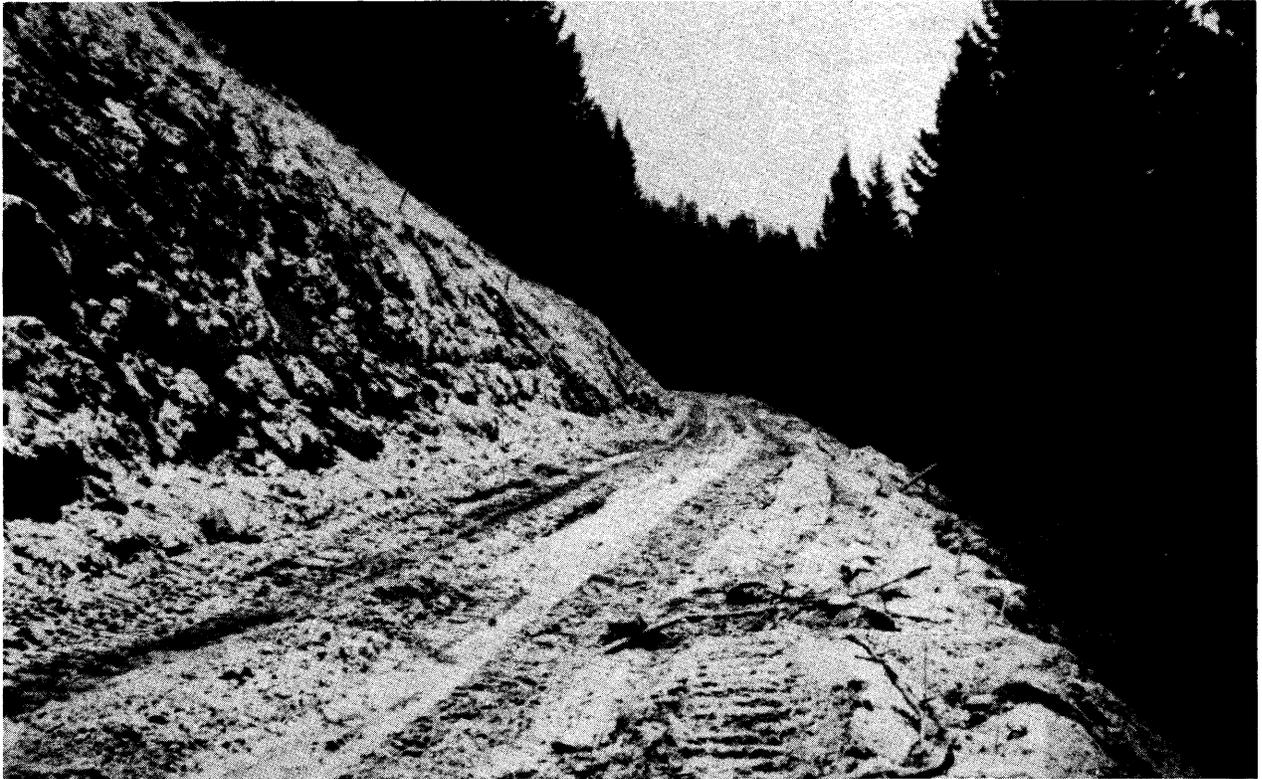
Figure 12.--Road section, conventional clearing.

The difference in overall appearance between the standard and reduced clearing widths can be seen in figures 12 and 13. As previously discussed, reduced clearing widths generally reduce esthetic impacts.

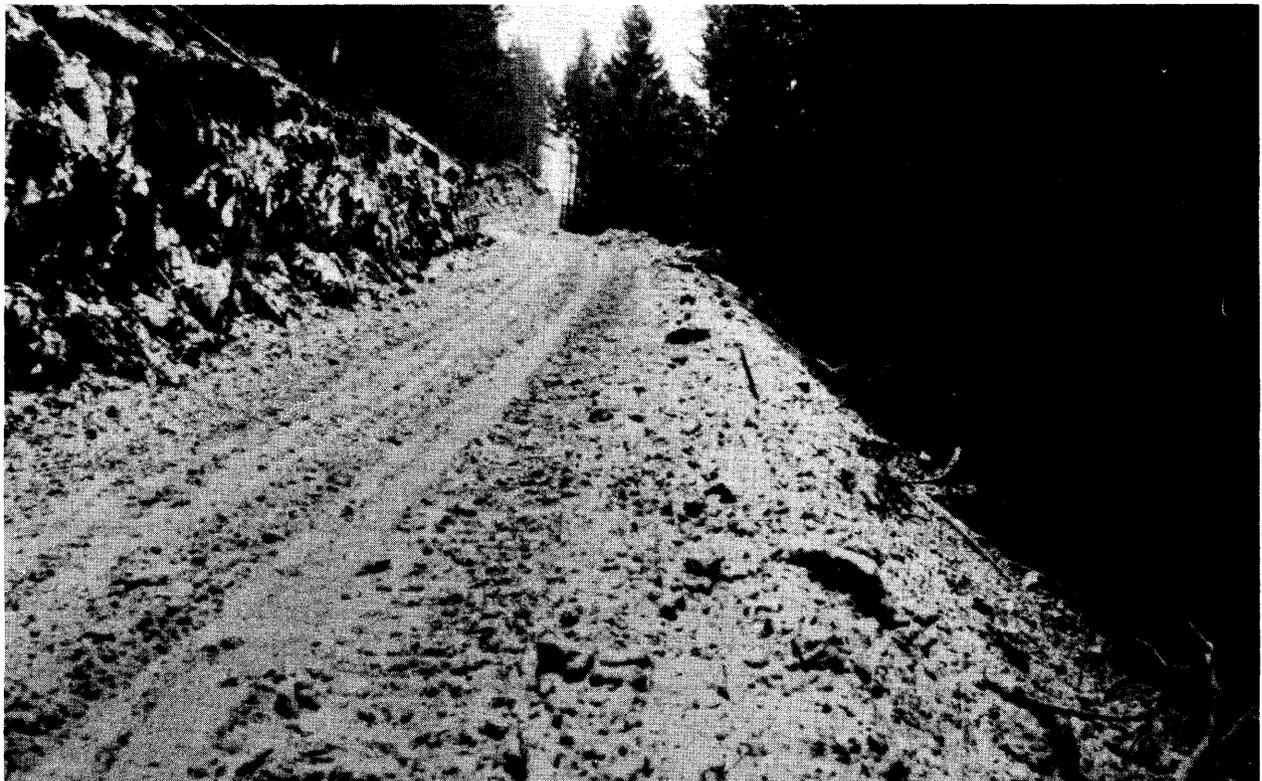
Figure 13.--Road section with vertical cut and reduced clearing width.

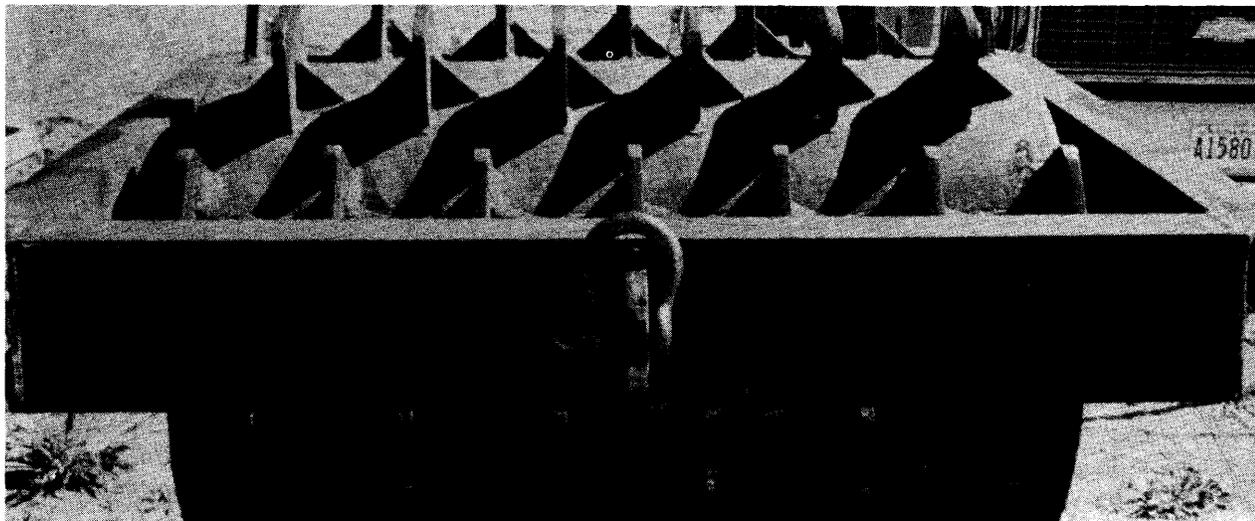
Figure 14.--Angeles N.F. roller-compactor.

Fill slopes that are difficult to revegetate have generally been most successfully treated by applying a mulch held in place by netting or impregnation. The sheep's foot-type roller, designed by the Angeles National Forest (fig. 14), has been proven effective in compacting the top 6 to 8 inches (15-20 cm) of soil, while at the same time impregnating straw mulch well into the soil. The roller was used on several fill sections; results will be reported when data have been analyzed. (The experimental seeding and planting were done by research personnel and were not a part of the road contract.)

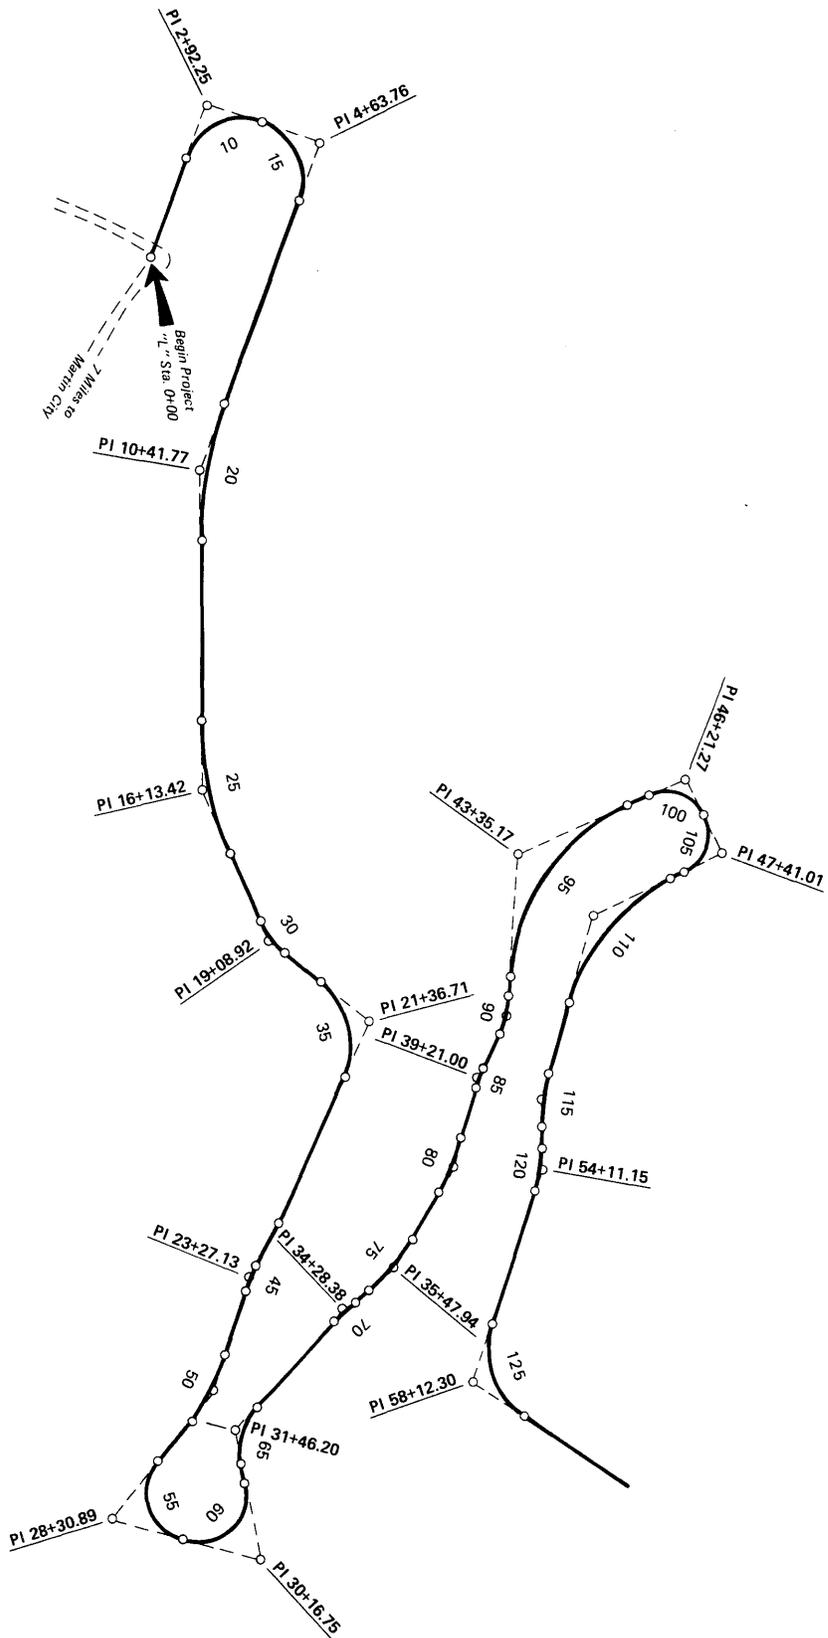
Figure 17. ---Alignment---experimental section Abbot Basin road 590-B, stn. 0+00 to PI 58+12.30.

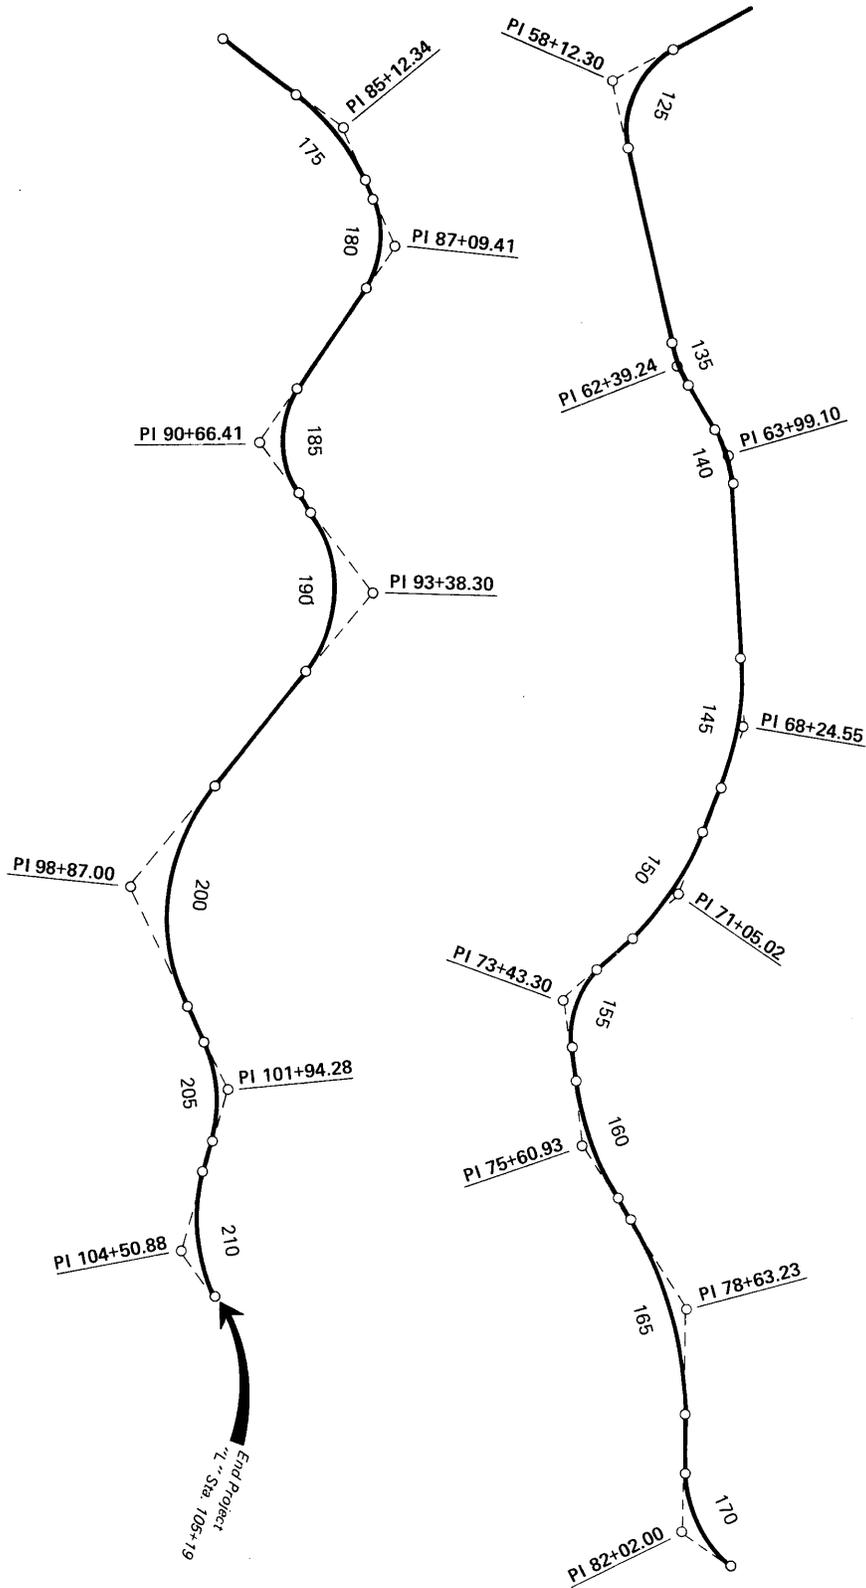
Figure 18. ---Alignment---experimental section Abbots road 590-B, 58+12.30 to stn. 105+19.

To minimize miles of road, one must use logging systems that require few roads. The research on the Coram site was to demonstrate the effects of logging systems that require fewer miles of road and produce less impact than conventional methods. Instead of the traditional Idaho jammer that required road spacings of 300-600 feet, (91-182 m) a skyline system was selected that had the potential to increase road spacing to about 2,000 feet (610 m). In steep country (>50 percent slopes), if road spacings are decreased, it generally means the road will require switchbacks to gain elevation. This was the case for the experimental portion of Abbot Basin road 590-B, as seen in figure 2 and appendix figures 18 and 19.

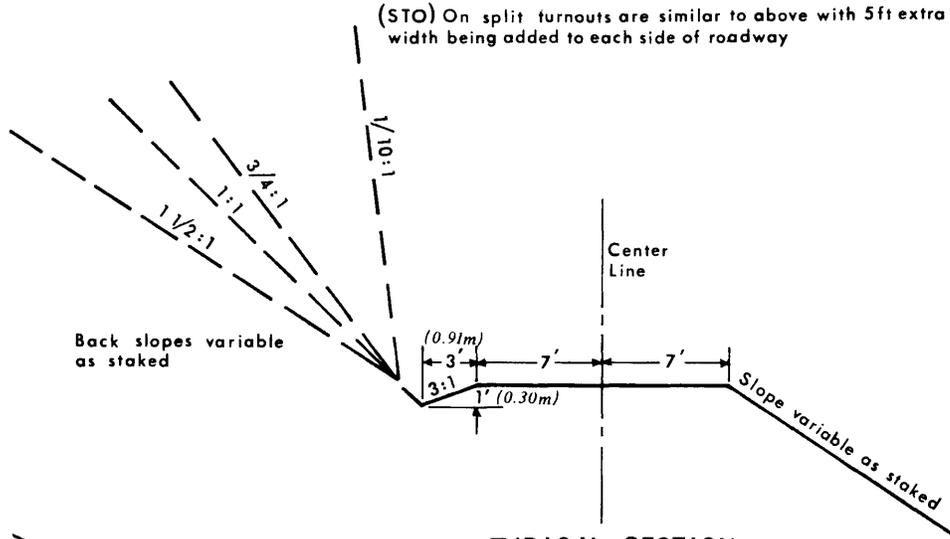
TYPICAL SECTION

(STO) On split turnouts are similar to above with 5ft extra width being added to each side of roadway

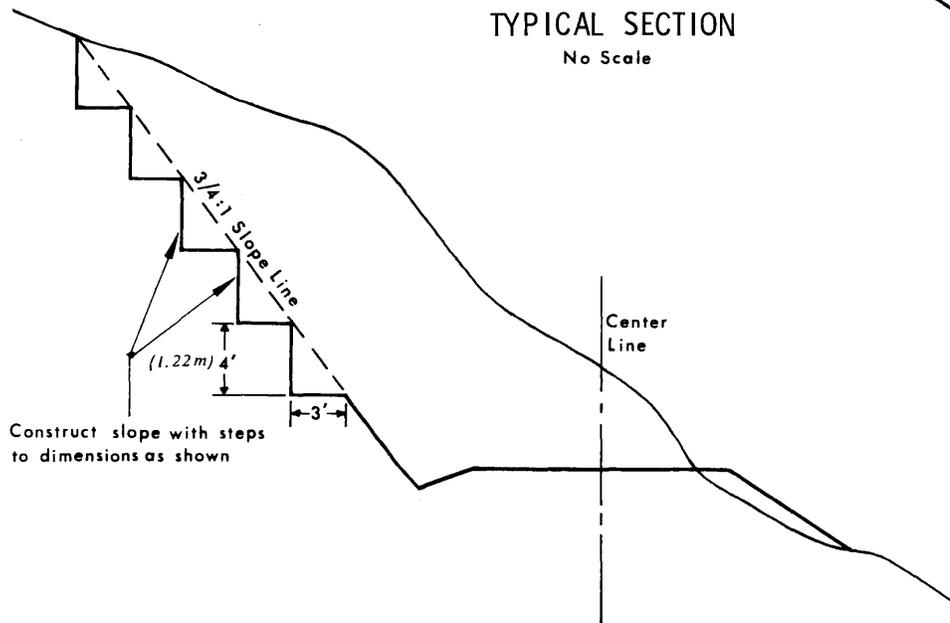
STEPPED BACKSLOPE

Sta 79 + 09 to Sta 83 + 53

Seismic velocities here (station 79+09 to 83+53) showed that the bedrock was competent to experiment with the stepped backslopes shown in appendix figure 19. When good fill or surface material is needed in a road and, for reasons of overall economy it can be obtained from a cut slope in a favorable location, then some treatment to dampen the appearance of the cut should be utilized. Shrubs were planted in this section to evaluate this treatment.
