CULTURAL LANDSCAPE REPORT
FOR RAPIDAN CAMP
SHENANDOAH NATIONAL PARK

MADISON COUNTY, VIRGINIA

National Park Service, Boston, Massachusetts, 2014

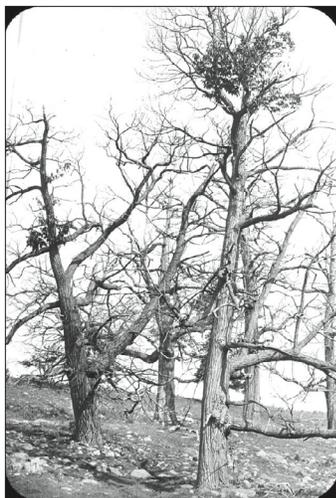
Figure 1.2. Historic photograph of chestnut trees killed by the chestnut blight , circa 1920s. (University of Chicago Library)

The fungus, identified as *Cryphonectria parasitica*, attacks the bark and cambium of healthy twigs, branches, and limbs of the tree, quickly encircling the limb and killing the tissue. As the infected branch dies, the fungus produces pin-head-sized spore bearers, which are carried by wind and rain to other branches and nearby trees. The rapid mortality of the trees and short reproduction cycle of the fungus make it particularly virulent, able to quickly destroy large populations of trees. The root systems of the trees remain viable, sending up shoots that grow as small understory trees before eventually succumbing to the blight. This understory provides a continuous host for the fungus and perpetuates the impacts on the forest.

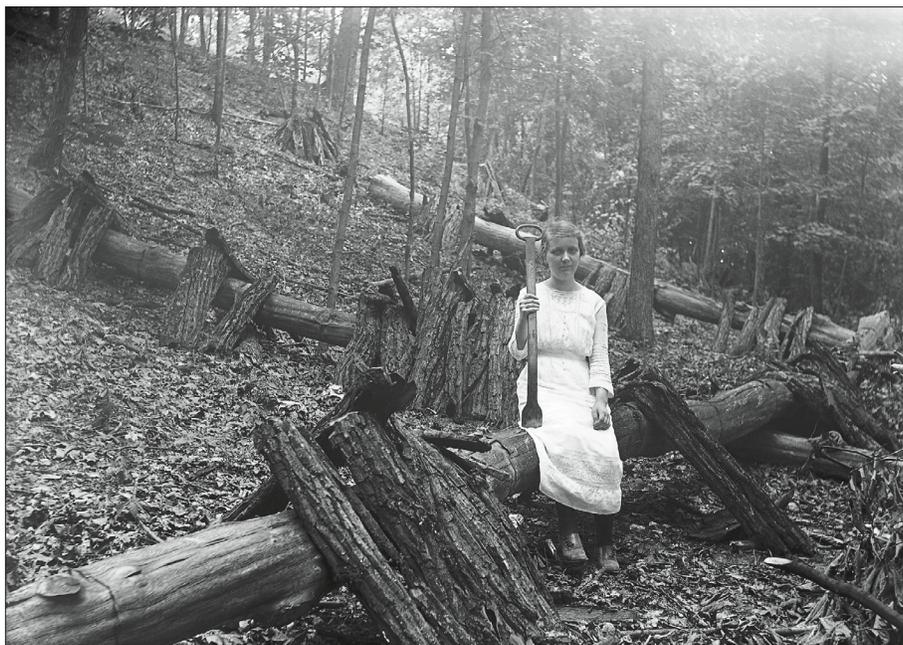
Figure 1.3. Photo of a girl holding a tool called a bark spud and chestnut trees stripped of their bark, 1916. In the late nineteenth and early twentieth centuries, chestnut bark was an important source of tannins for tanning leather. Felled trees were stripped of bark and often left on the forest floor. (Ohio State University)

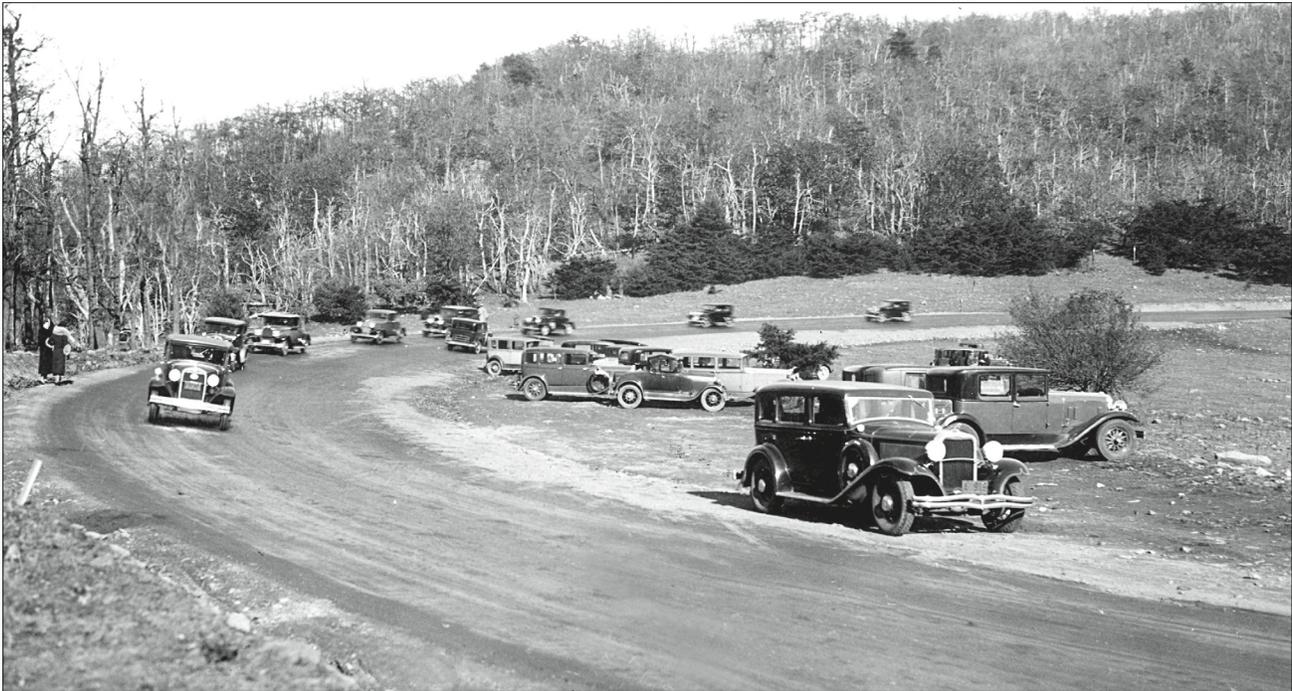
Figure 1.4. Opening of Skyline Drive, 1932. Extensive stands of dead chestnut trees and young conifers cover the hillsides in the background. (SHEN)

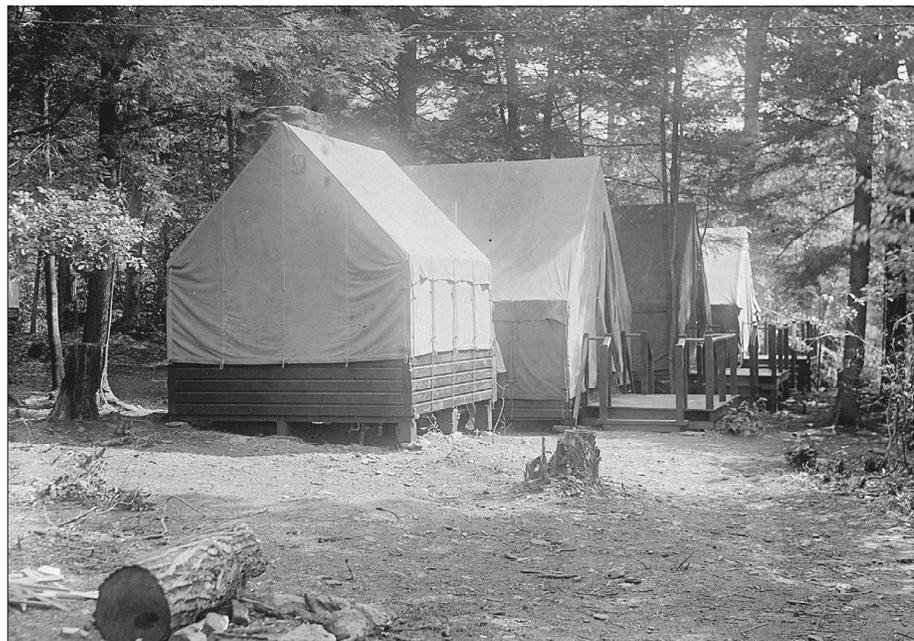
Figure 1.14. Tent cabins at Rapidan Camp, circa 1929. Early tent cabins at Rapidan Camp were constructed on wood platforms with wood half-walls. The roof and upper portion of the walls were constructed of wood frames covered in canvas. The canvas could be rolled up on the sides, maximizing ventilation and the connection with the outdoors. (LOC)

- Figure 1.14. Tent cabins at Rapidan Camp, circa 1929. Early tent cabins at Rapidan Camp were constructed on wood platforms with wood half-walls. The roof and upper portion of the walls were constructed of wood frames covered in canvas. The canvas could be rolled up on the sides, maximizing ventilation and the connection with the outdoors. (Library of Congress Prints and Photographs Division) 30

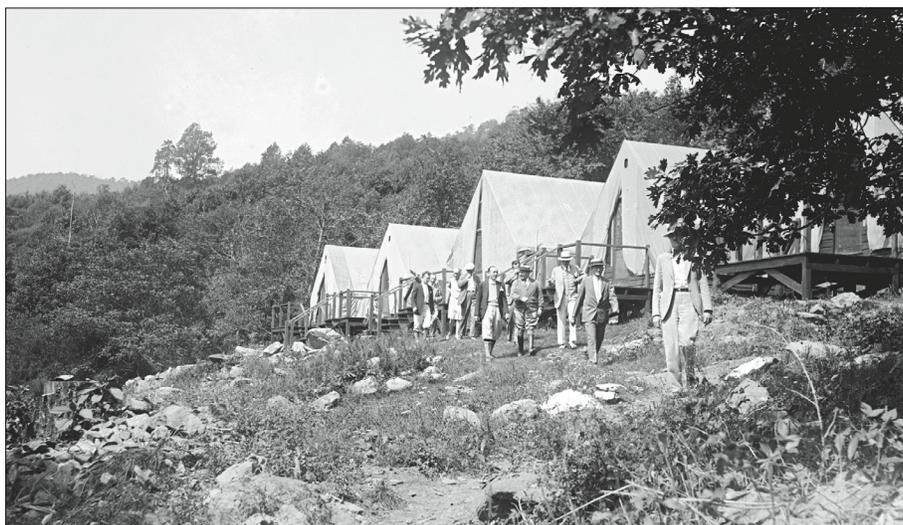
Figure 1.16. Historic photograph showing the Five Tents cabin, circa early 1930s. The building that replaced the original five tents was a 120-by-30-foot wood frame structure with a large stone fireplace. The front of the building appears to have been landscaped with native plants (SHEN).

- Figure 1.16. Historic photograph showing the Five Tents cabin, circa early 1930s. The building that replaced the original five tents was a 120-by-30-foot wood frame structure with a large stone fireplace. The front of the building appears to have been landscaped with native plants. (SHEN 22060 4001.009.005.01672/ neg. 110-41) 31

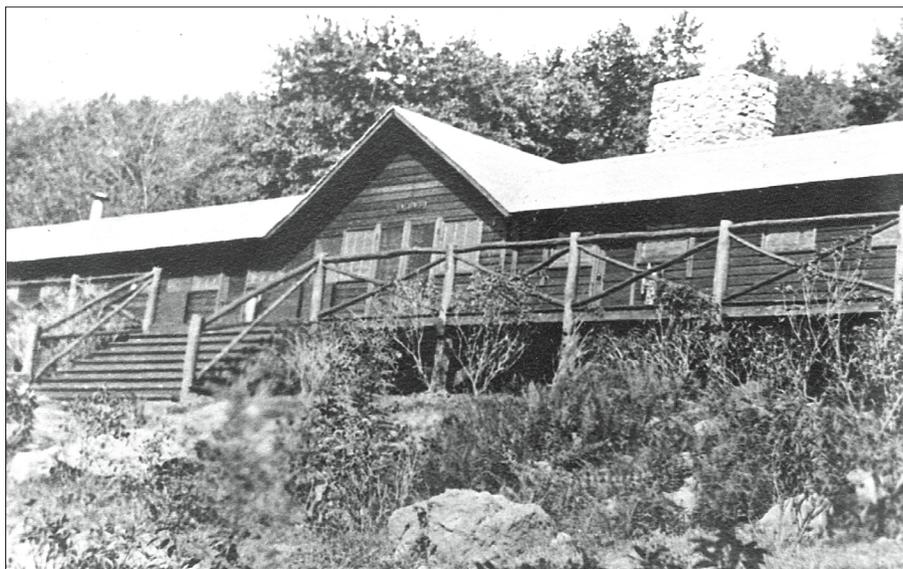
Figure 1.17. Historic photo of Town Hall taken during a press tour of the camp in August 1929 before the camp was complete. Marines can be seen on the porch of the cabin constructing the stone chimney. (LOC)

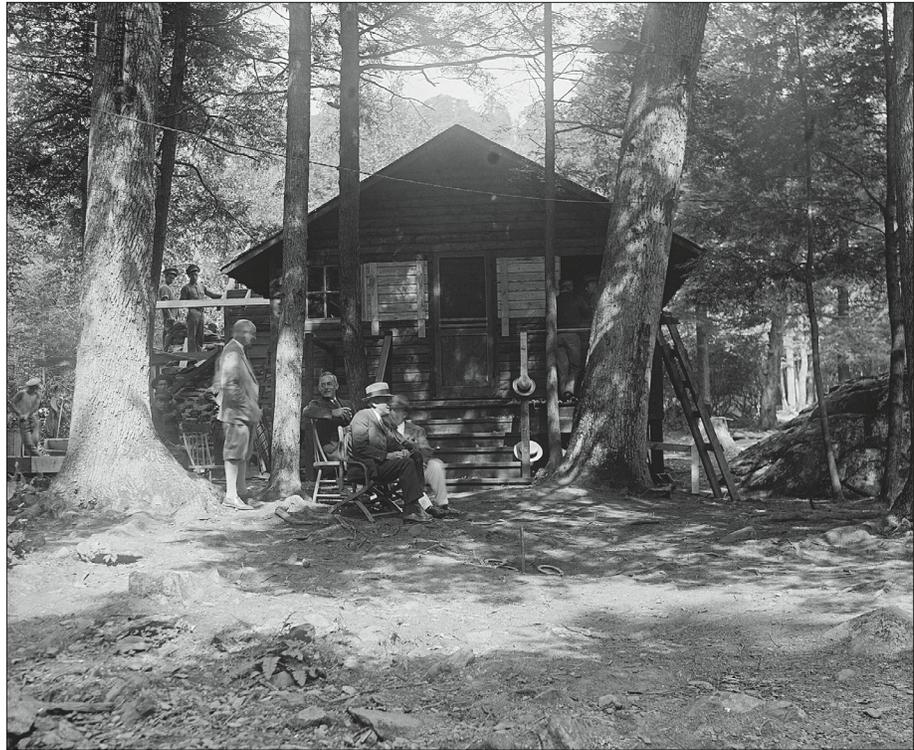
Figure 1.18. A view of the President's Cabin from Mill Prong taken in August 1929. The wooden bridge on which the men are standing was a temporary bridge that was later replaced with a rustic bridge made of rough tree branches. (LOC)

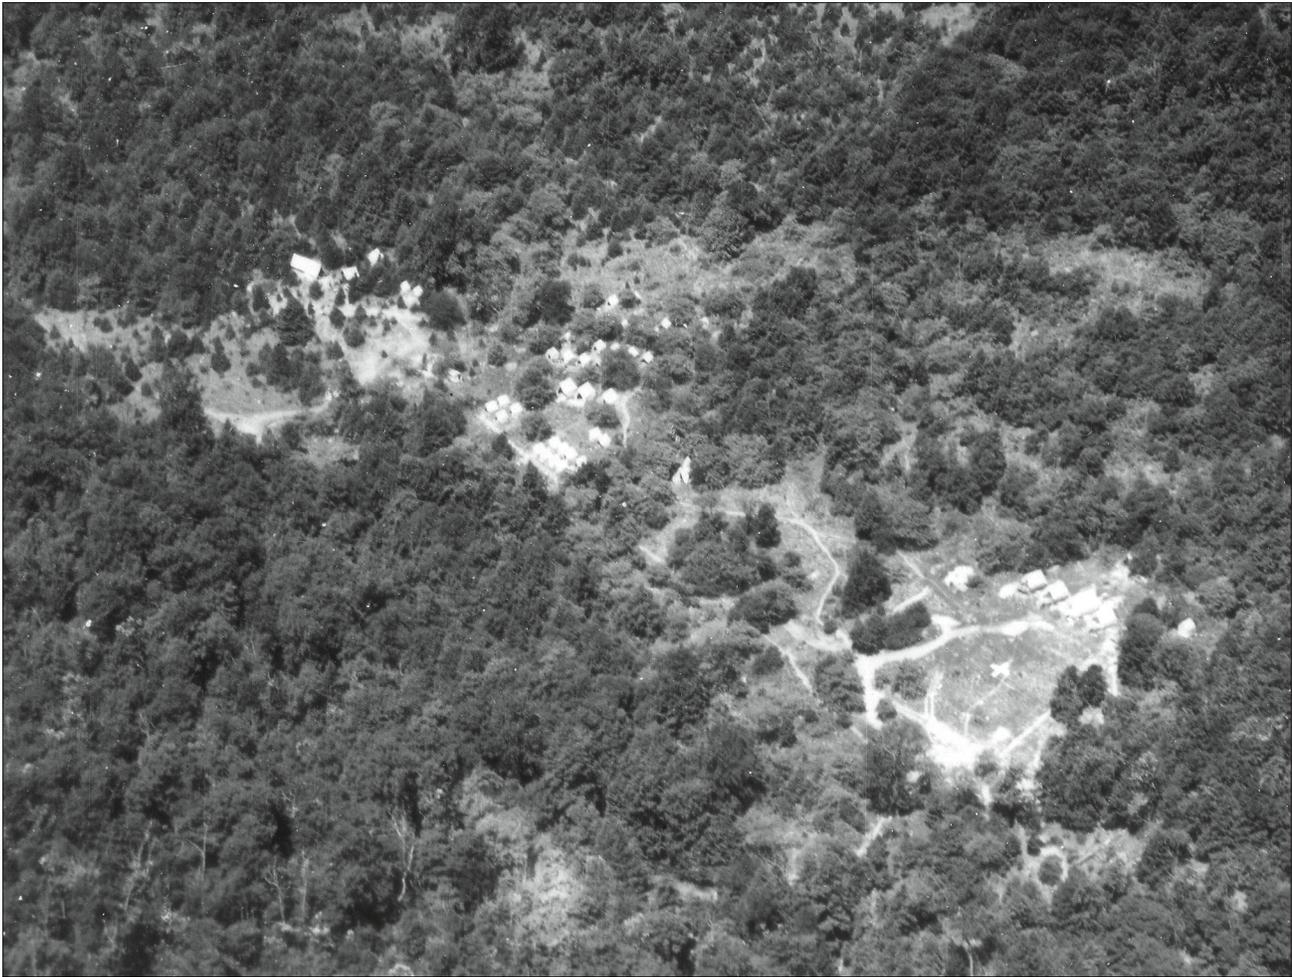
Figure 1.20. Aerial view of Rapidan Camp under construction in July 1929. The rows of tents in the upper left of the image are temporary quarters for Marines constructing the camp and were removed before the camp was occupied in the fall of that year. The row of five tents on the right were eventually replaced by the Five Tents cabin. Below the five tents is an open area with a cross target for air dropping materials and mail. (NARA)

- Figure 1.20. Aerial view of Rapidan Camp under construction in July 1929. The rows of tents in the upper left of the image are temporary quarters for Marines constructing the camp and were removed before the camp was occupied in the fall of that year. The row of five tents on the right were eventually replaced by the Five Tents cabin. Below the five tents is an open area with a cross target for air dropping materials and mail. (U.S. Army Air Corps Airscapes, NARA) 34

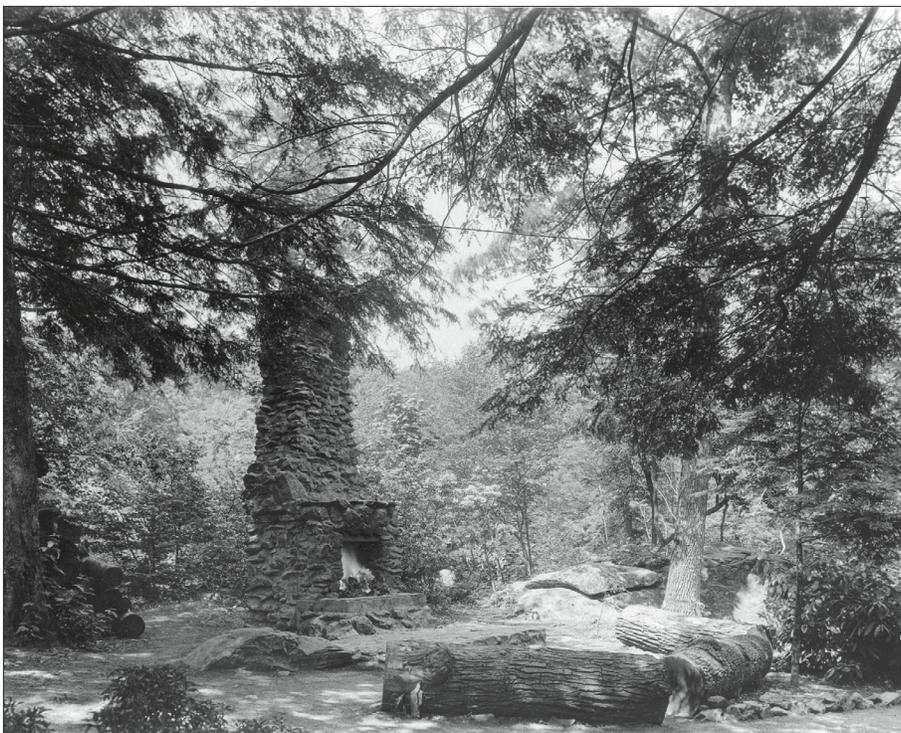
Figure 1.21. Historic photograph showing the outdoor fireplace with fire burning. Large logs are arranged around the fireplace for seating and extra firewood is stacked to the left. Constructed features such as the fire place were integrated into the natural rock outcrops of the site. (Herbert Hoover Presidential Library)

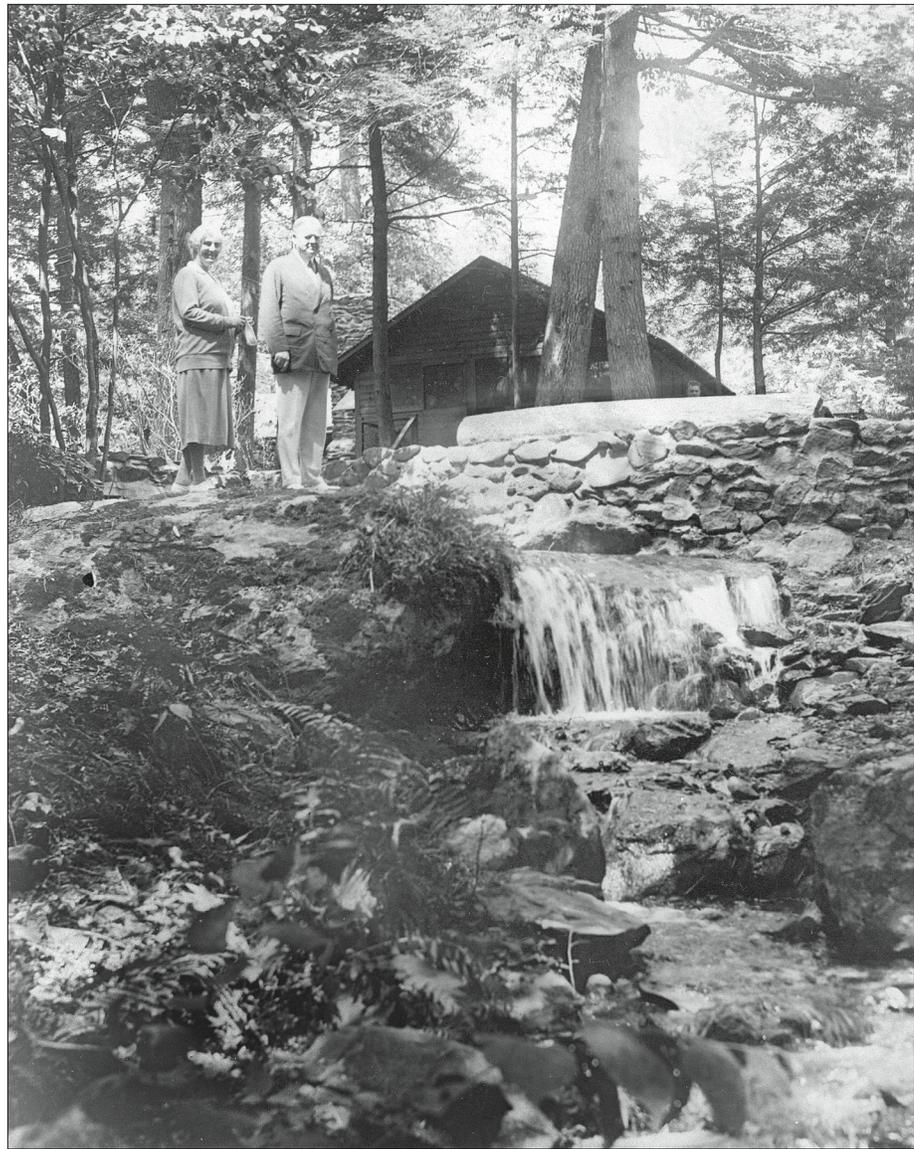
Figure 1.24. Mr. and Mrs. Hoover standing at the Hemlock Run waterfall, circa 1930. Also visible in the photograph are the Prime Minister's cabin and one of the stone footbridges. (Herbert Hoover Presidential Library)

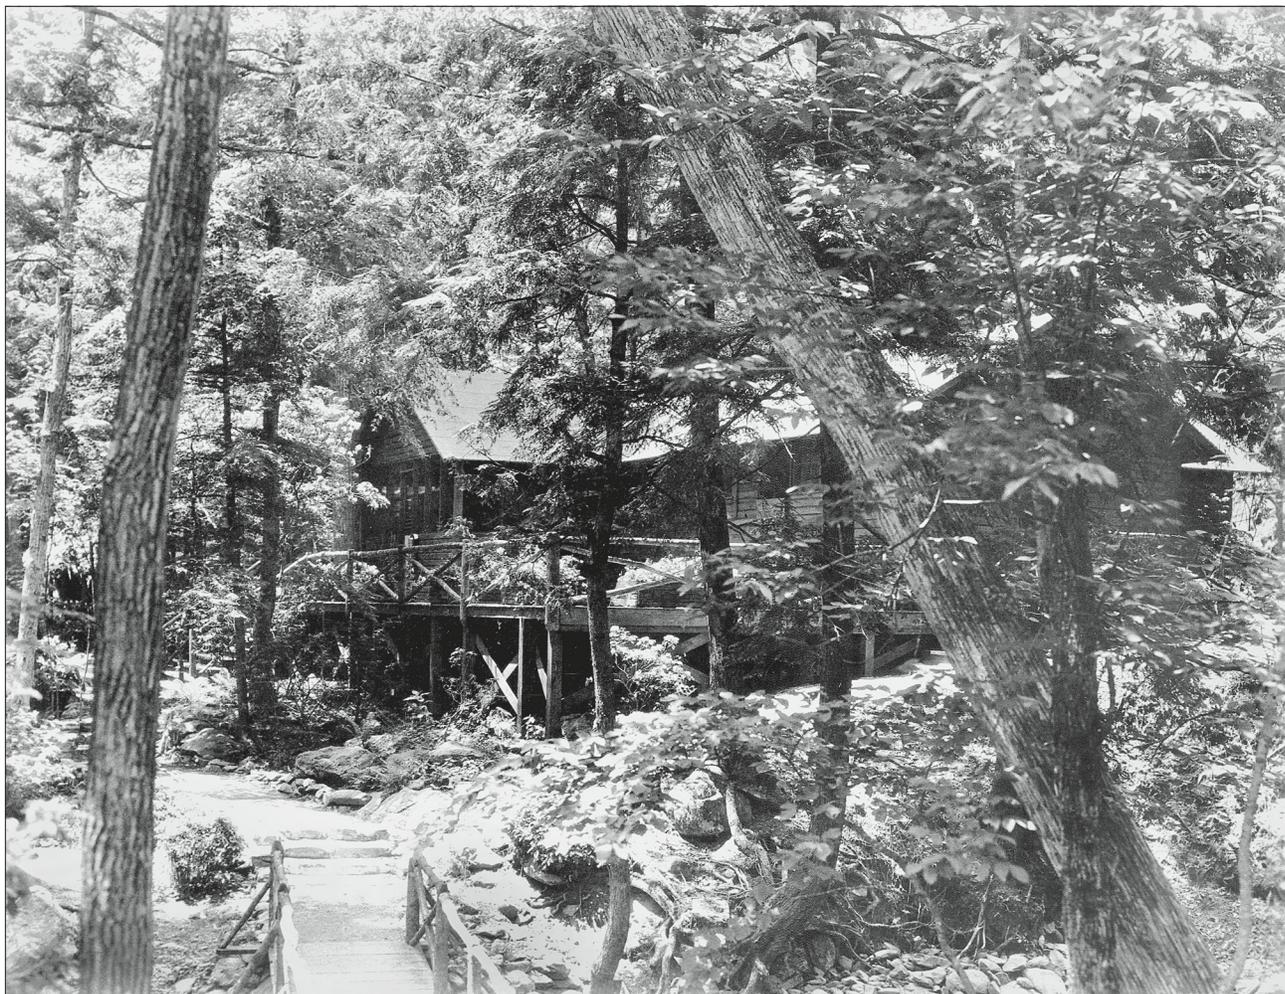
Figure 1.25. The President's Cabin, circa 1931. Ornamental plantings in the camp included shrubs, ferns, and flowers planted along the paths and around the cabins, as well as potted plants on the porches. (Herbert Hoover Presidential Library)

gardener, and was responsible for the flower boxes that brightened the cabins. Throughout the grounds she made naturalistic flower pots of rocks and logs. A seven page document of directions, called "Flowers and Shrubs for the President's Camp," outlined her wishes: new plantings were to be identical to those growing within twenty-five miles of the camp, or hardy species that might be cultivated but similar to the natives, and all plants should not seem out of place among the woody setting. "The President is very fond of color in gardens, so where possible, and appropriate to the species arrange flowering shrubs and flowers so as to give the mass effects of color."⁵⁰

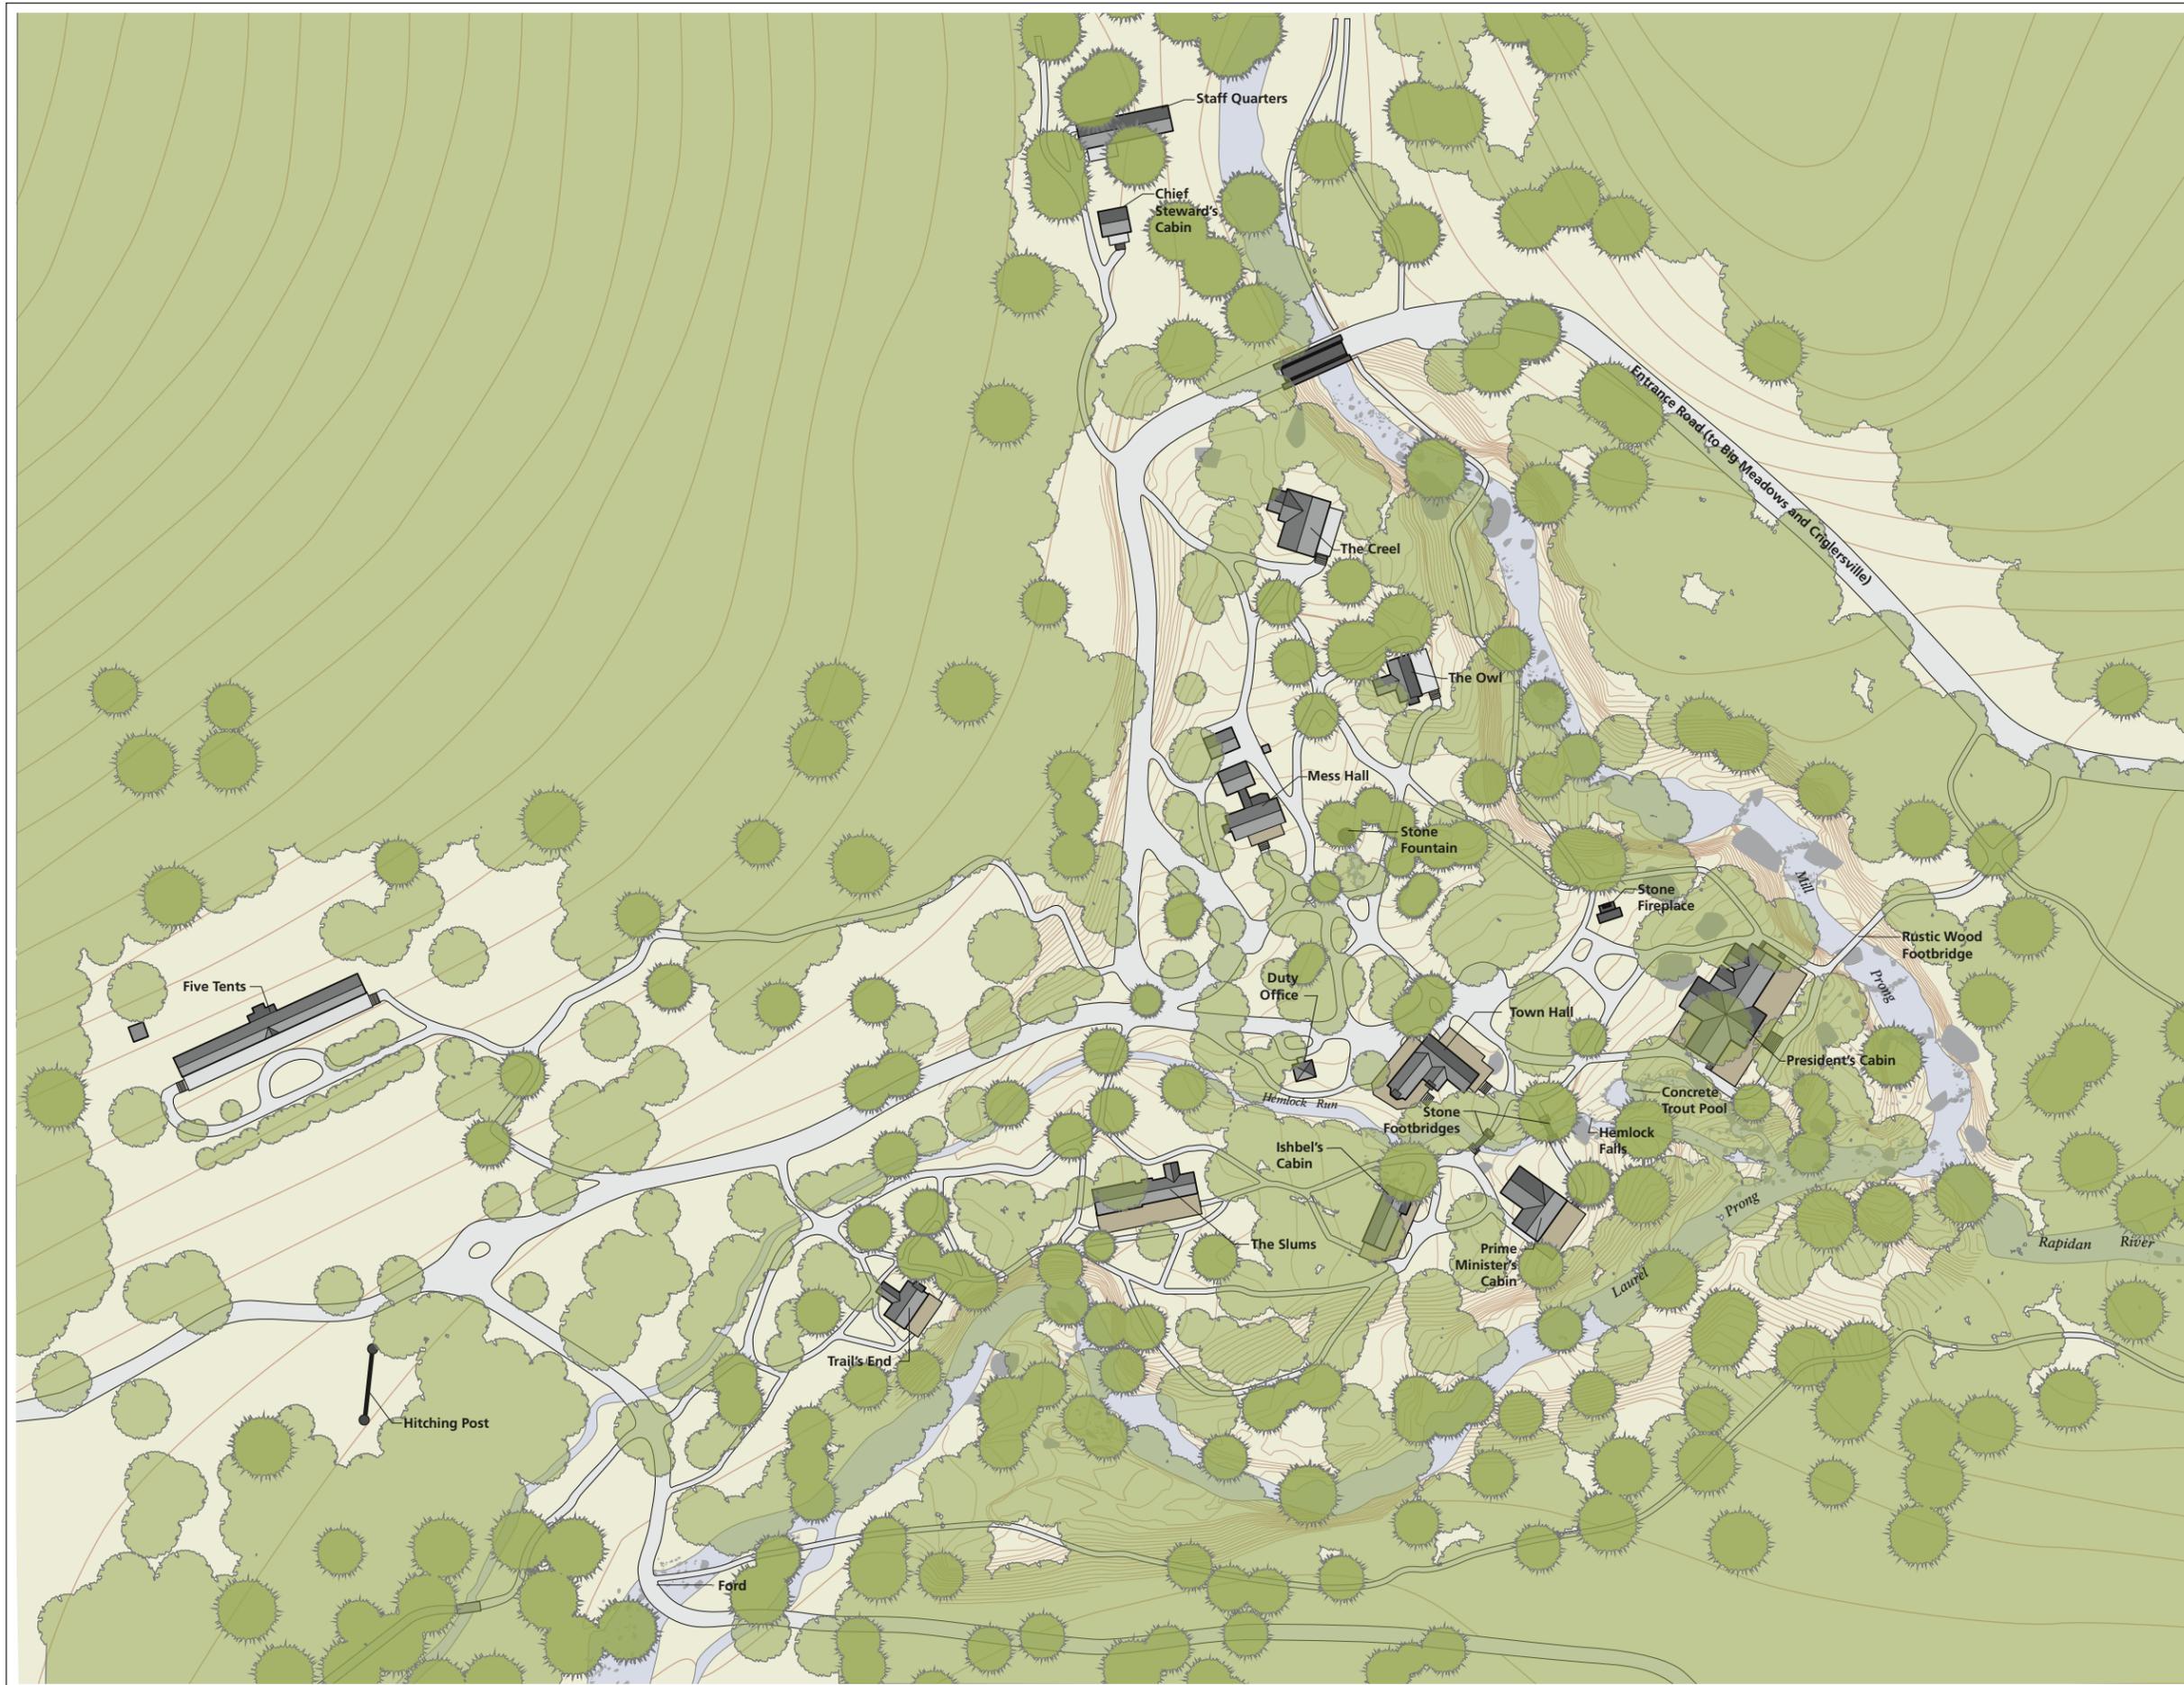
Drawing 1

Cultural Landscape Report
 Rapidan Camp
 Shenandoah National Park
 Rapidan Area
 1932 Period Plan

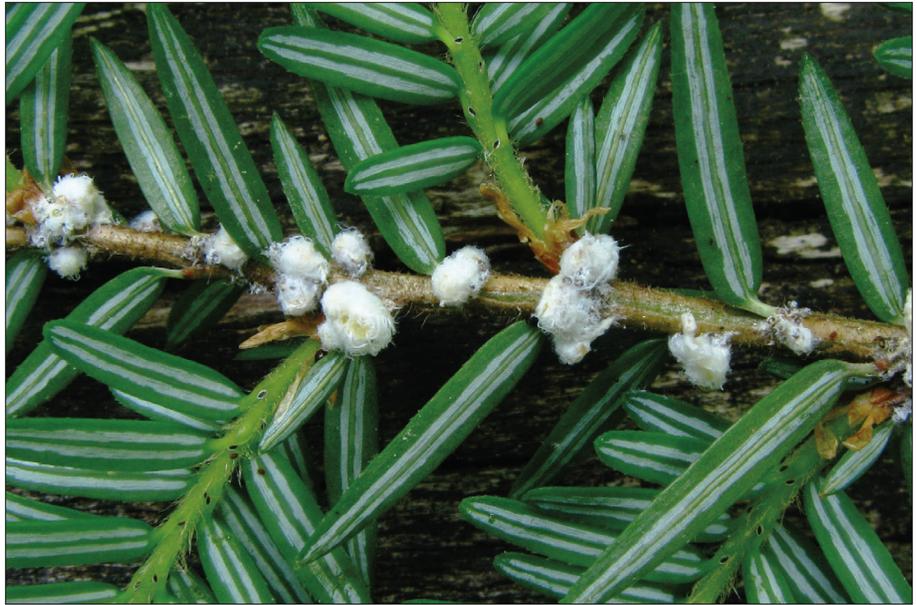
Figure 2.7. Close-up of a hemlock branch infested with hemlock woolly adelgids. (Courtesy of Alan Cressler)

the site today, and those that do are primarily saplings and young trees. While control of large-scale infestations is difficult, targeted control with systemic insecticide has shown significant success in improving the health of individual tree species. The park has treated some of the remaining hemlock trees within Rapidan Camp with the systemic insecticide Merit (imidacloprid). These trees appear to have responded well to the treatment, with the visible infestations decreasing and the health and vigor of the trees improving. The hemlock woolly adelgid infestation, however, remains in the forest at large and could re-infest the Rapidan trees in the future if treatment is discontinued.

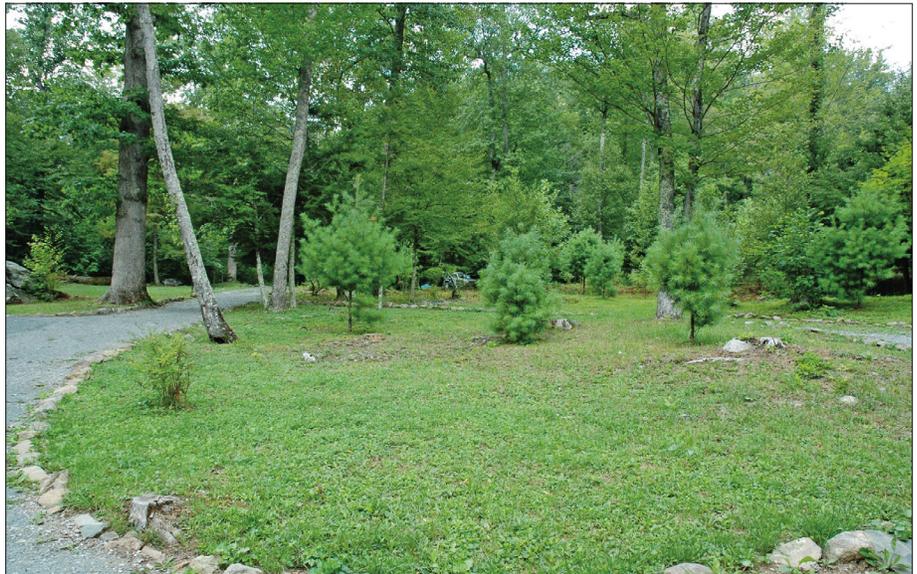
Figure 2.8. White pine saplings, planted to reestablish the canopy, grow within the core of the camp. Also visible in the photograph are large hardwoods and remnant hemlocks that have so far survived the hemlock woolly adelgid infestation. (OCLP)

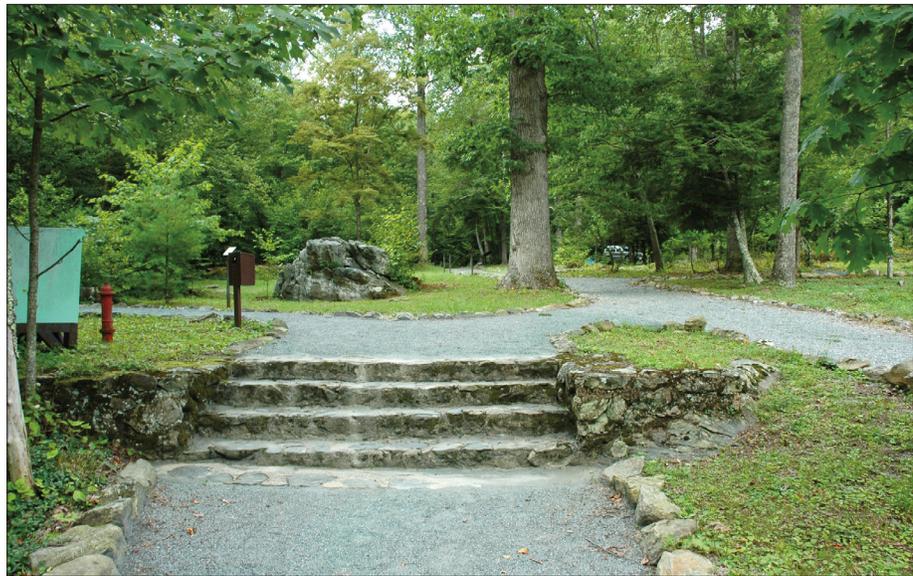
Figure 2.9. View looking west showing the steps near the site of the Town Hall (behind the large boulder in the center of the photograph). Also visible in the photograph are the hose cabinet, fire hydrant, and interpretive sign (see Small-scale Features). (OCLP)

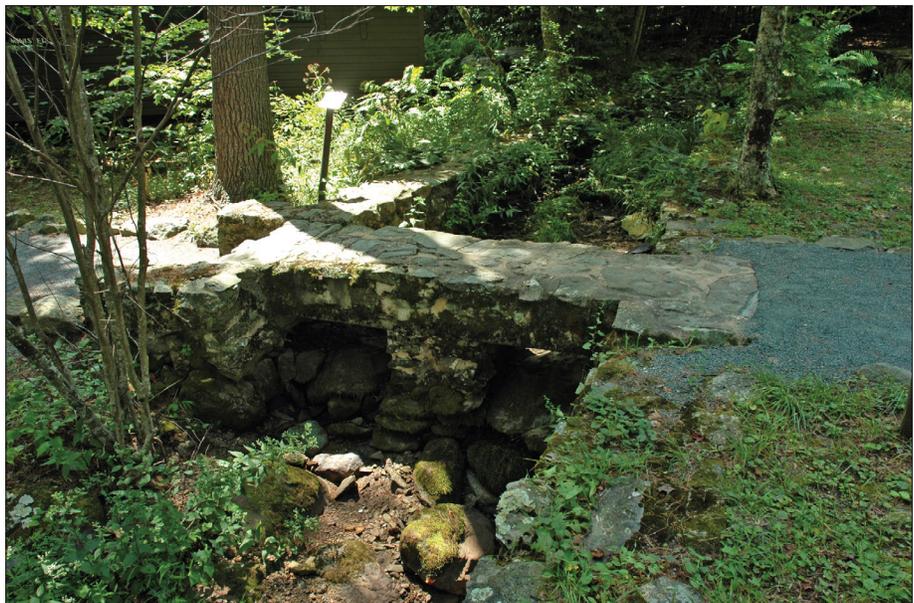
Figure 2.10. View looking west showing one of the stone footbridges over Hemlock Run. (OCLP)

Hemlock Run is a narrow water channel, only three to six feet wide in most places and varies in depth from less than one foot to about two feet. The channel extends approximately 1,600 feet from the remnants of a loose stone dam and sluice gate on Laurel Prong upstream from the camp. It runs along the north side of Laurel Prong through the heart of camp before rejoining the stream just upstream from the confluence with Mill Prong. For much of its length, it is little more than a ditch designed to bring water into the camp. As it passes through the heart of camp, however, the channel was developed to maximize its aesthetic value. A 200-foot section of the channel is lined with mortared stone, with sections further upstream reinforced with un-mortared stone. Four stone footbridges remain of what was once eight channel crossings. The channel was directed over a large, flat rock just east of the President's Cabin to create a waterfall and pool called Hemlock Run Falls. The combination of the stone footbridges, channel walls, and waterfall create a picturesque stream channel.

Figure 3.48. View looking south showing the westernmost of the two Hemlock Run stone footbridges. The easternmost stone footbridge is shown in Figure 2.10. (OCLP)

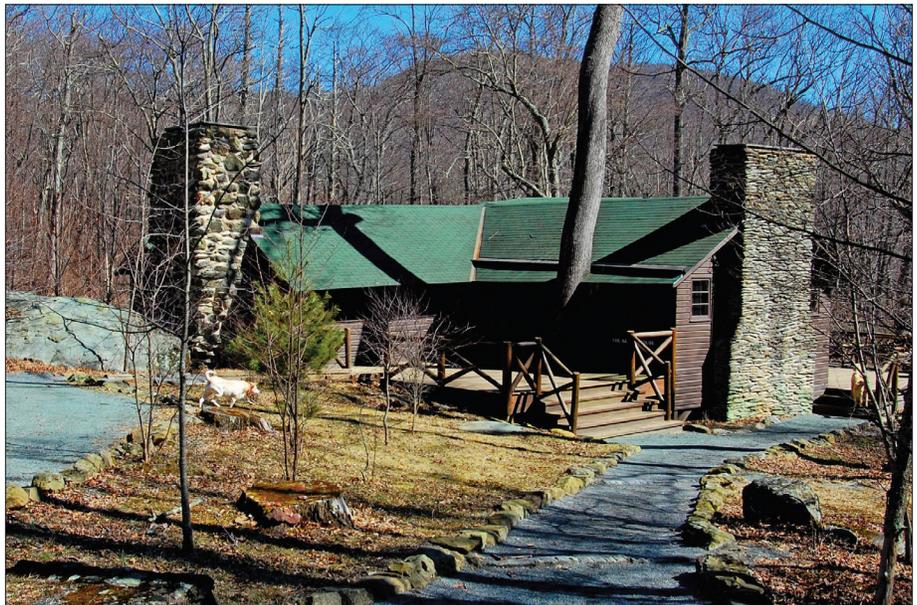
Figure 2.11. View looking south showing the President's Cabin. (OCLP)

bathrooms, an enclosed sun porch, and open decks in the front and rear. The cabin was restored to period conditions and furnished with a combination of original, period, and reproduction furniture based on historic photos from 1930 and 1931. Post-historic alterations, such as the conversion of one of the bathrooms into a kitchen, have been reversed, so that today the cabin closely resembles historic conditions. The cabin serves as a museum and is open for guided tours from Memorial Day through early fall.

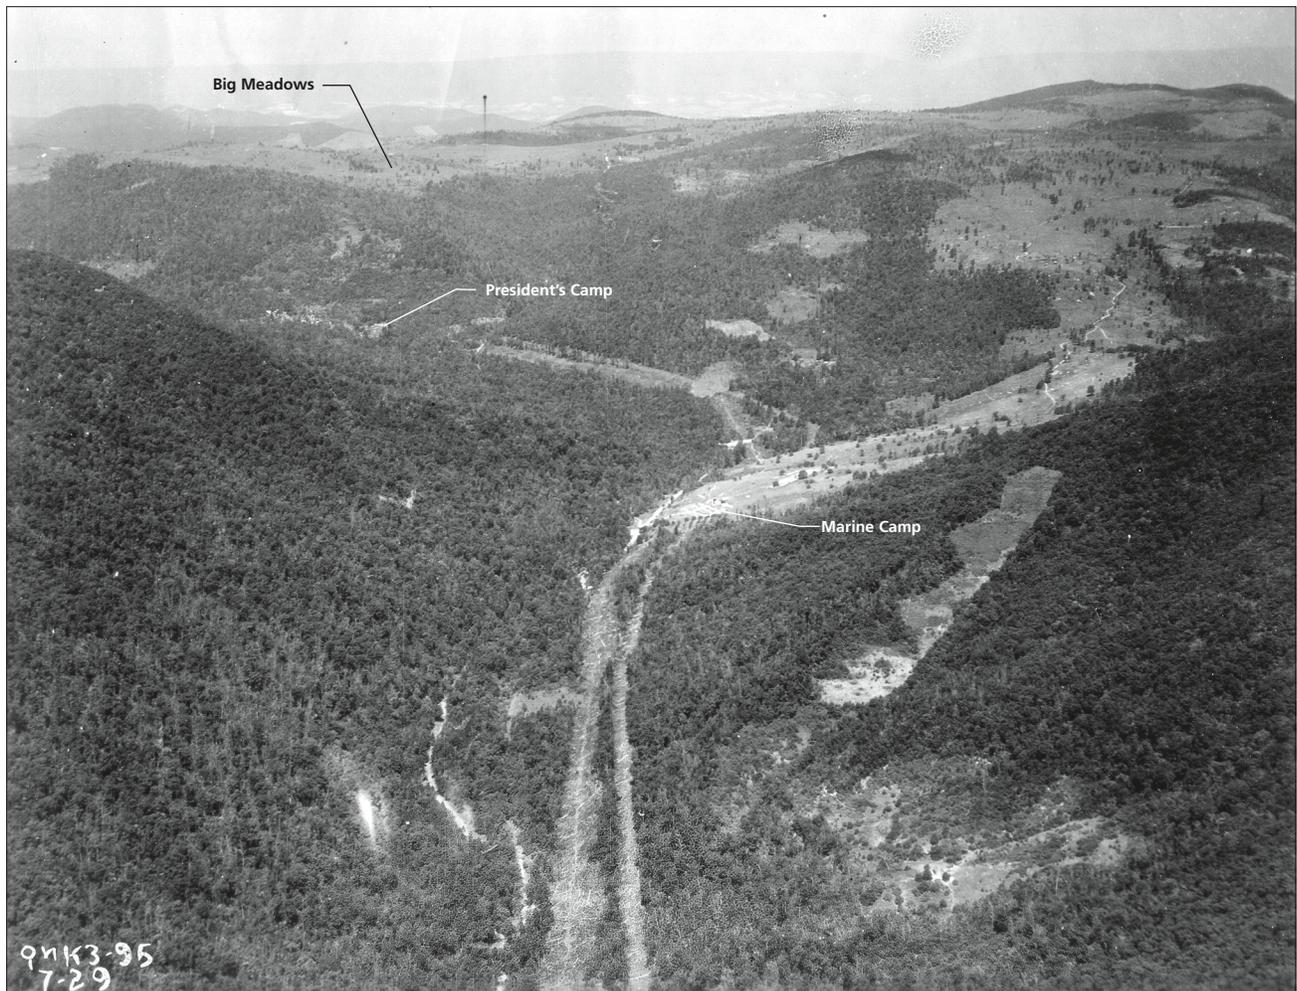
Figure 3.3. Aerial view of Rapidan Camp under construction in July 1929. Marine camp is in the foreground and the President's Camp is visible in the upper left. Also visible are the roads and utility lines that service the camps. The image shows the more open character of some of the surrounding areas at the time the camp was built. (U.S. Army Air Corps Airscapes)

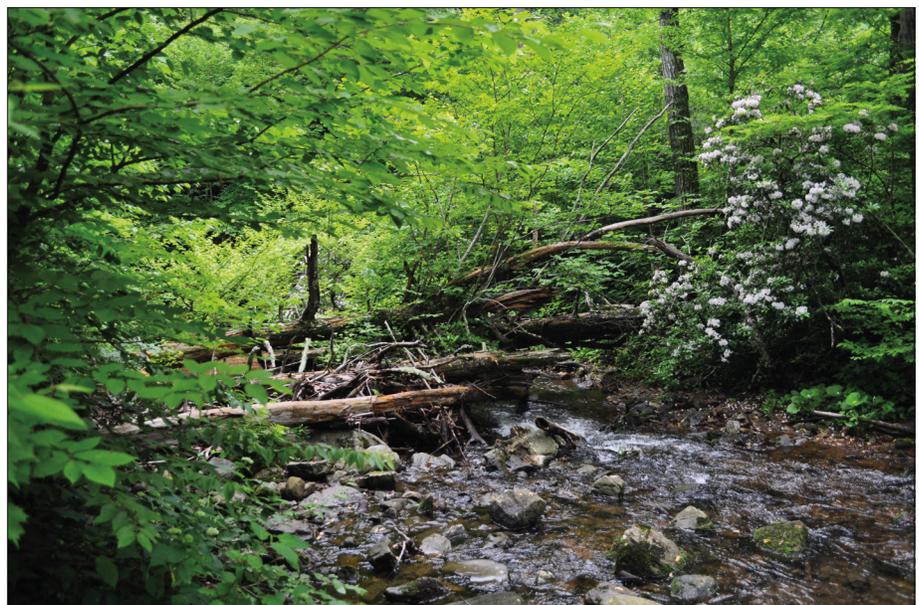
Figure 3.4. View of Laurel Prong looking east from Laurel Dam showing large woody debris across the channel. (OCLP)

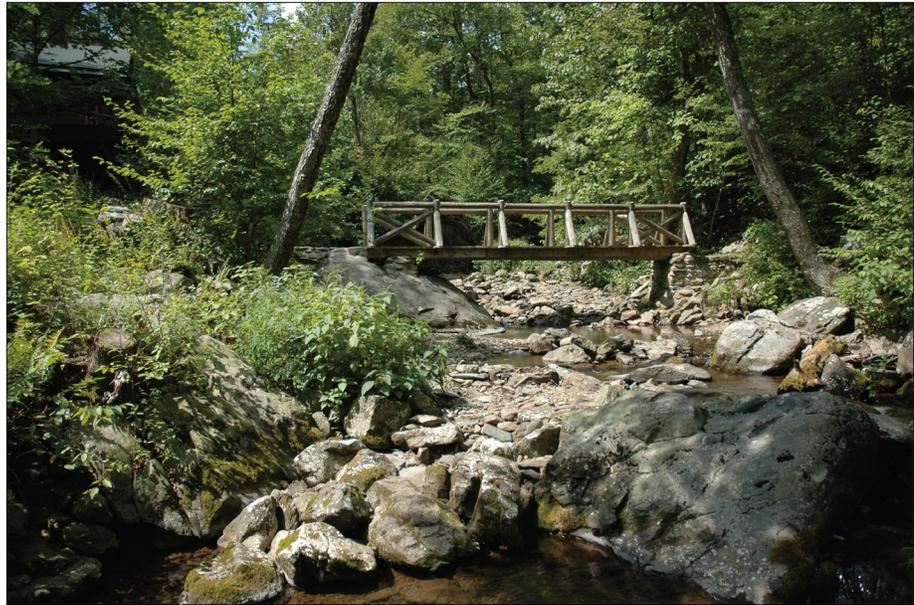
Figure 3.5. View of Mill Prong looking north from the confluence with Laurel Prong, showing the character of the streams at Rapidan Camp. (OCLP)

Mill Prong, which runs northwest to southeast along the eastern edge of camp, is similar to Laurel Prong in size, structure, and character. Because of its proximity to the President's Cabin and the timber bridge that crosses the channel to the east of the cabin, Mill Prong is a slightly more prominent feature in camp. Several photos from the historic period show the Mill Prong channel and its stacked stone dams and trout pools. Today, some of these dams are discernible as concentrations of stones across the channel.

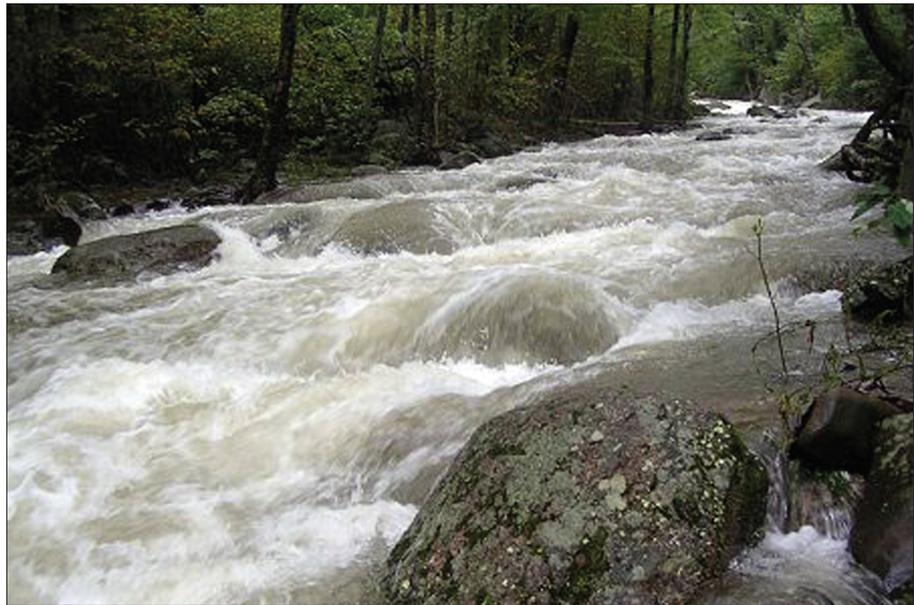
Figure 3.6. The Rapidan River south of Rapidan Camp during Hurricane Isabel in 2003 showing extreme water volumes during a flood event. (Courtesy of Brian Franz)

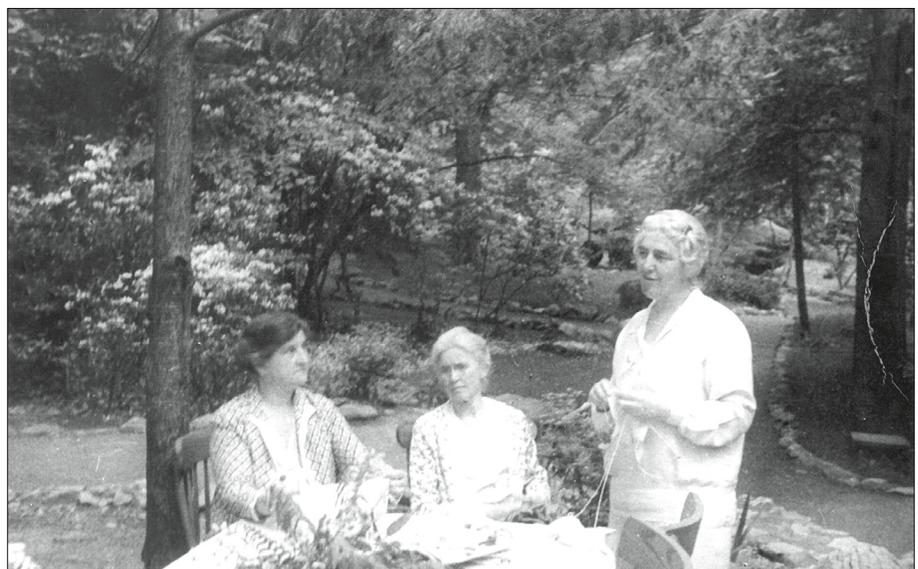
Figure 3.10. Mrs. Hoover and camp guests at Rapidan Camp. The ornamental nature and tidy character of the understory vegetation is evident in the photo's background. (Herbert Hoover Presidential Library)

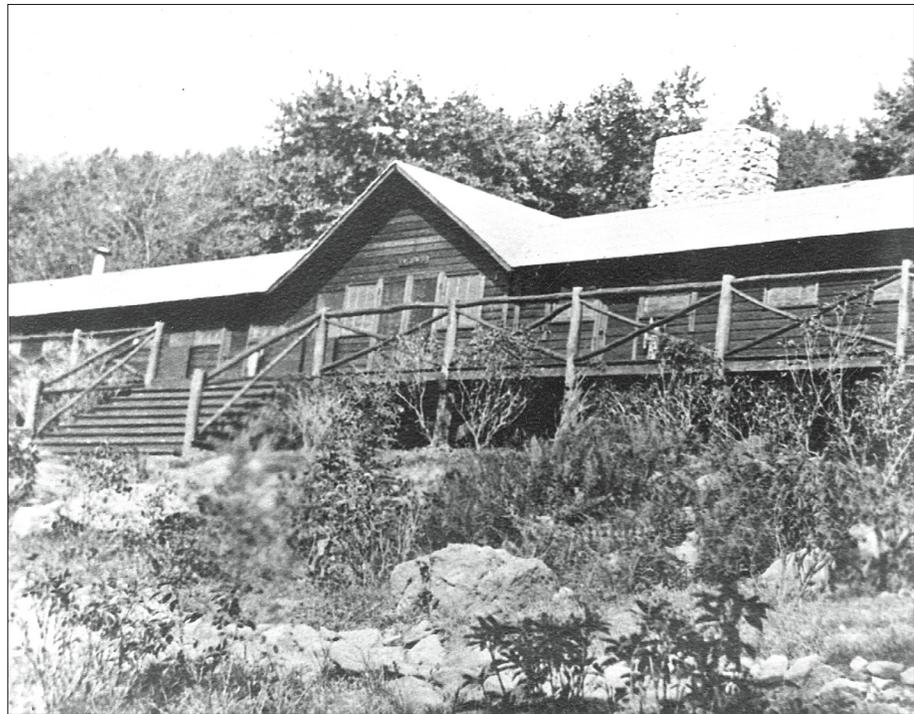
Figure 3.11. Five Tents cabin, circa early 1930s. The photograph shows the large clearing in front of the cabin and some of the planted shrubs and small trees. (SHEN)

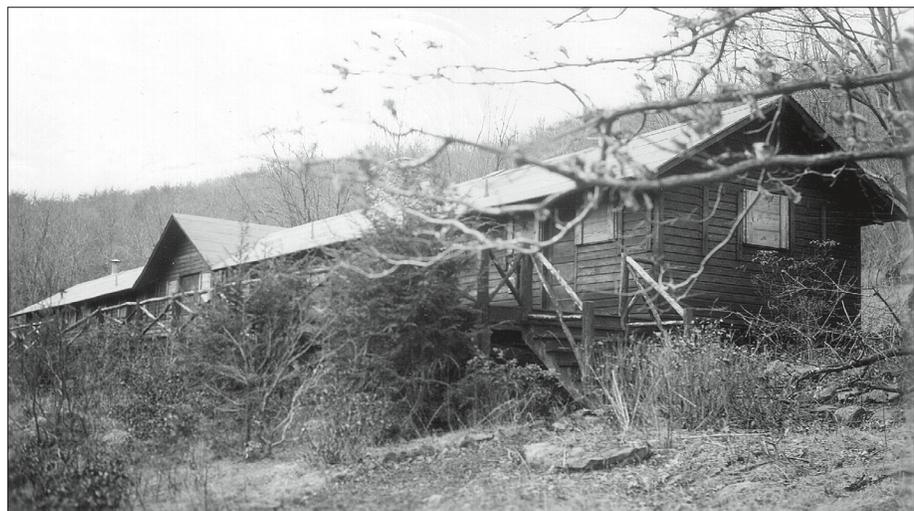
Figure 3.12. Five Tents cabin, circa late 1930s or early 1940s. The photograph, taken several years after the end of Hoover's presidency, shows overgrown vegetation around the cabin. (SHEN)

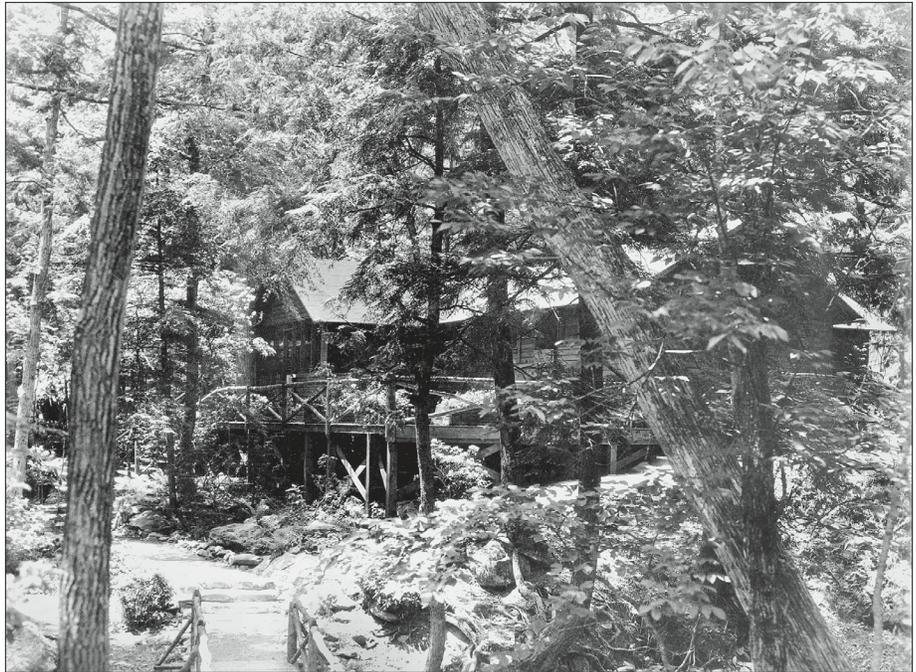
Figure 3.14. A contemporary photograph showing the same view as above, taken in 2011. Woodland shrubs and tree seedlings can be seen growing around the bridge and along the paths. (OCLP)
