CULTURAL LANDSCAPE REPORT
FOR RAPIDAN CAMP
SHENANDOAH NATIONAL PARK

MADISON COUNTY, VIRGINIA

National Park Service, Boston, Massachusetts, 2014

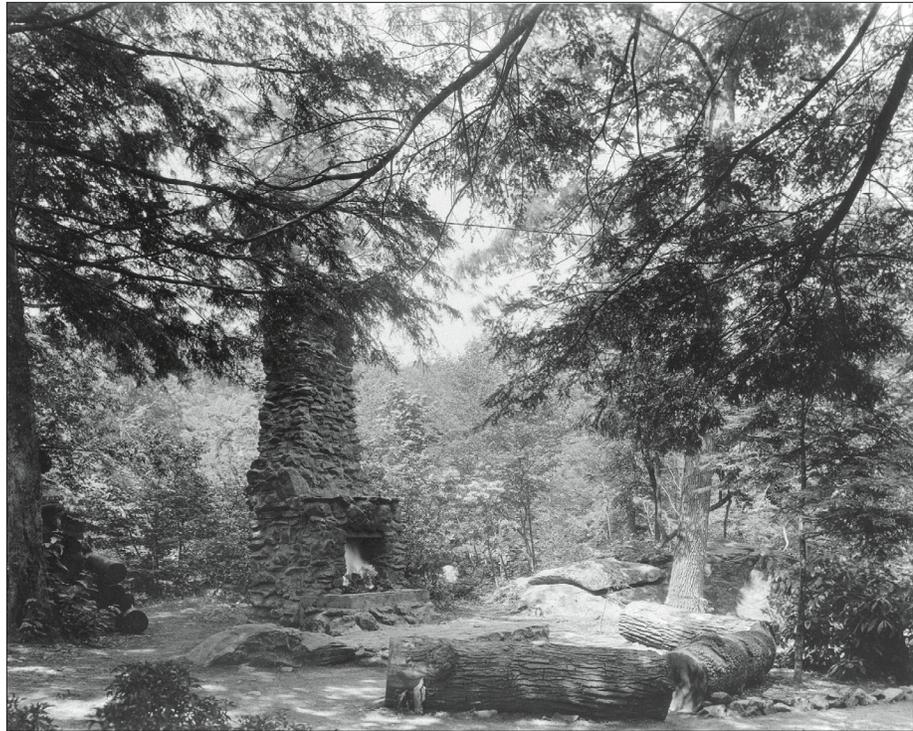
Figure 3.15. Historic photograph showing the outdoor fireplace during the historic period. (Herbert Hoover Presidential Library)

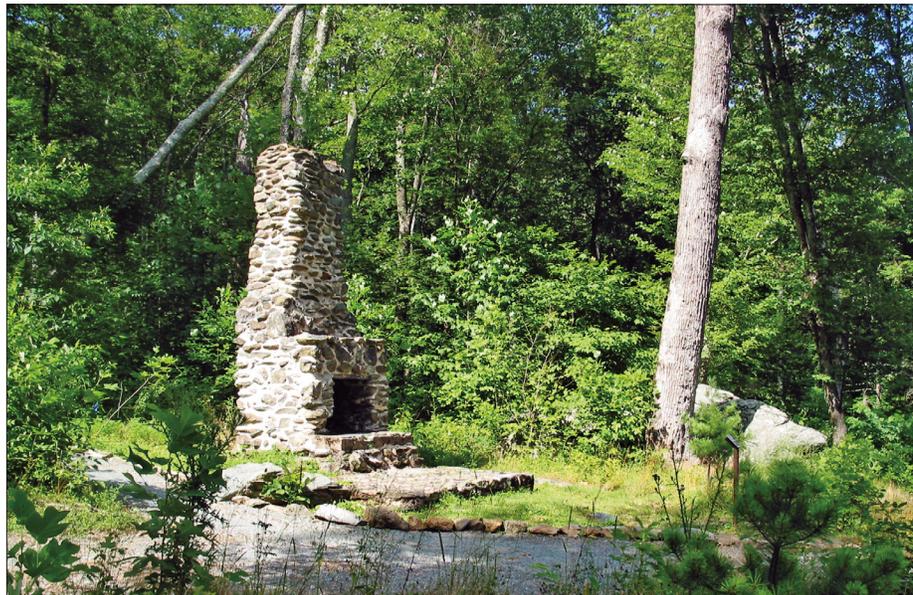
Figure 3.16. Comparing a contemporary view of the outdoor fireplace to the historic photograph above shows an overall reduction of canopy trees and an increase in small scrubby trees and shrubs. (OCLP)

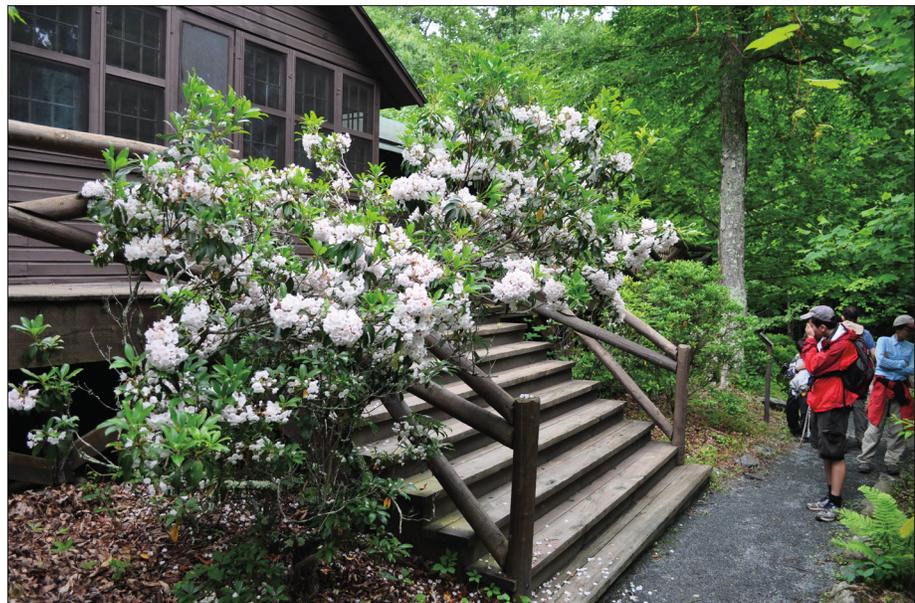
Figure 3.17. One of the several laurel bushes that grow in Rapidan Camp. The size and location of many of the laurels suggest that they were planted during the historic period. (OCLP)

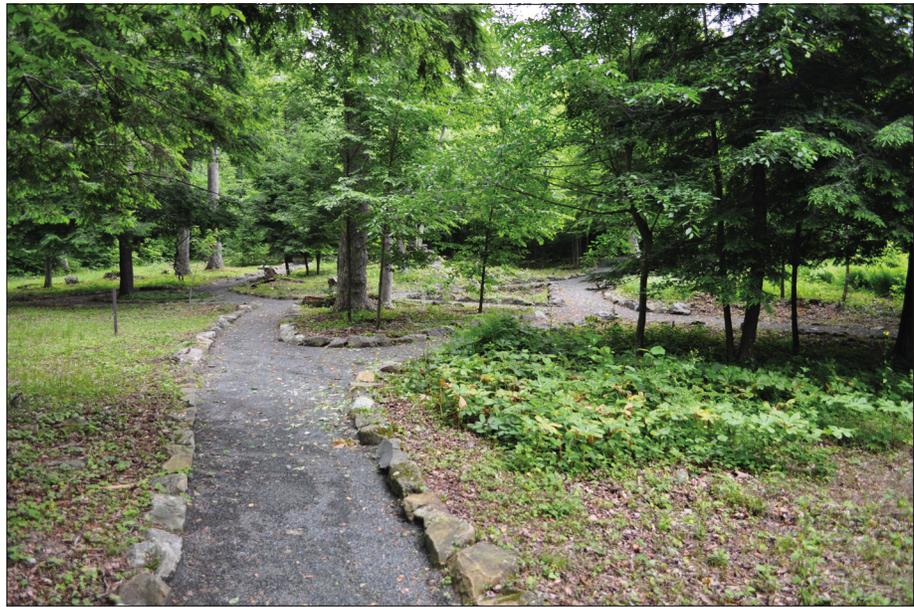
Figure 3.18. Several young hemlock trees grow between the footpaths of Rapidan Camp. (OCLP)

For several decades after the historic period, the hemlock trees remained a characteristic feature of Rapidan Camp. The trees first became infested with the hemlock woolly adelgid in the late 1990s, and within a few years the tiny insects had killed hundreds of centuries-old trees. Many of the trees remained standing dead

for a number of years before falling and becoming a tangle of massive trunks in and around the camp. While the park quickly removed the trees that died within the camp core, numerous dead and fallen trees remained along the periphery of the camp and in the forest surrounding it. Tree trunks close to the stream channels were periodically picked up by flood events and became destructive debris pushed along by the rushing water.

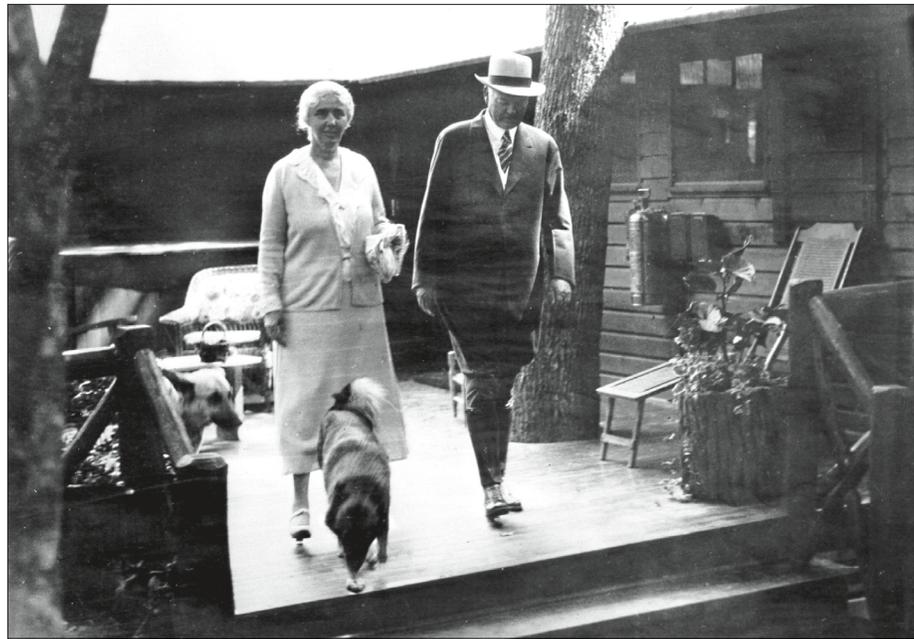
Figure 3.19. Historic photograph of Mr. and Mrs. Hoover on the north porch of the President's Cabin during the historic period. A large oak tree is seen protruding from the porch. (Herbert Hoover Presidential Library)

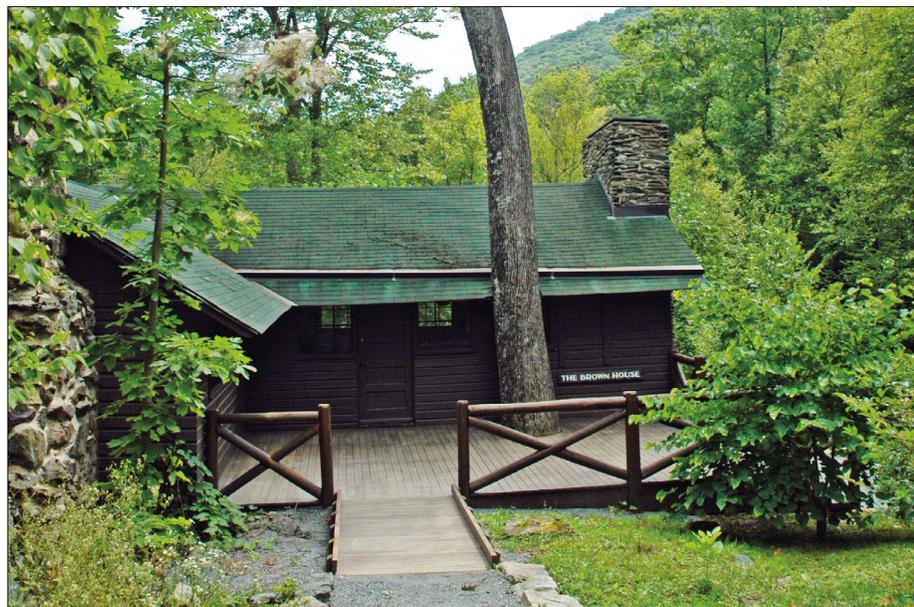
Figure 3.20. A contemporary view of the President's Cabin shows the same oak tree growing from the porch. (OCLP)

By the early twenty-first century, the oak tree in the front porch of the President's Cabin had begun to impact the structure, shifting and buckling the roof and other structural elements. In order to protect the cabin from further damage, the oak tree was removed in 2014. The hole in the porch was closed with planking placed perpendicular to the existing planking to indicate the tree's location.

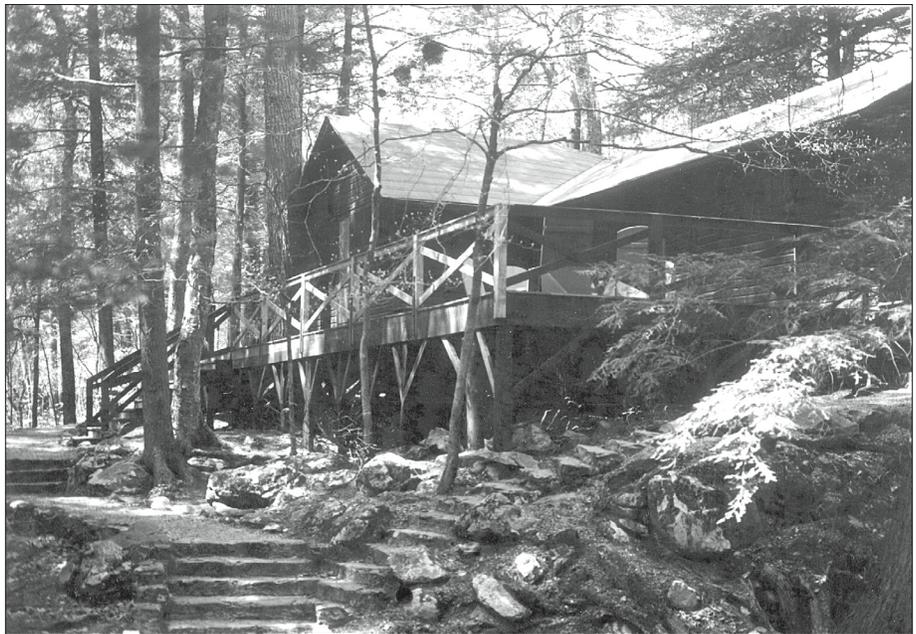
Figure 3.21. Historic photograph showing the President's Cabin, as well as the vegetation and the character and arrangement of the paths and steps. (SHEN)

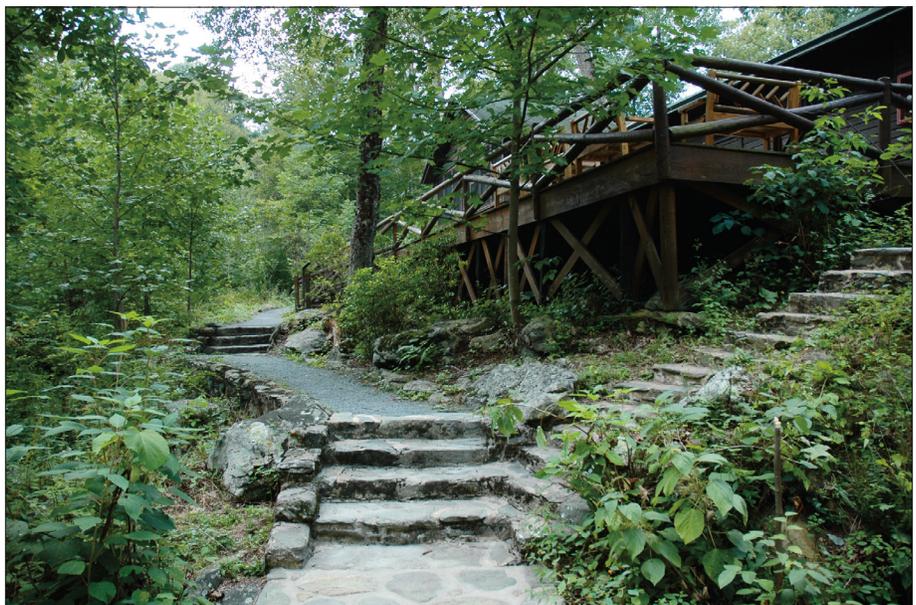
Figure 3.22. Current photograph showing the condition and character of the circulation features around the President's Cabin. (OCLP)

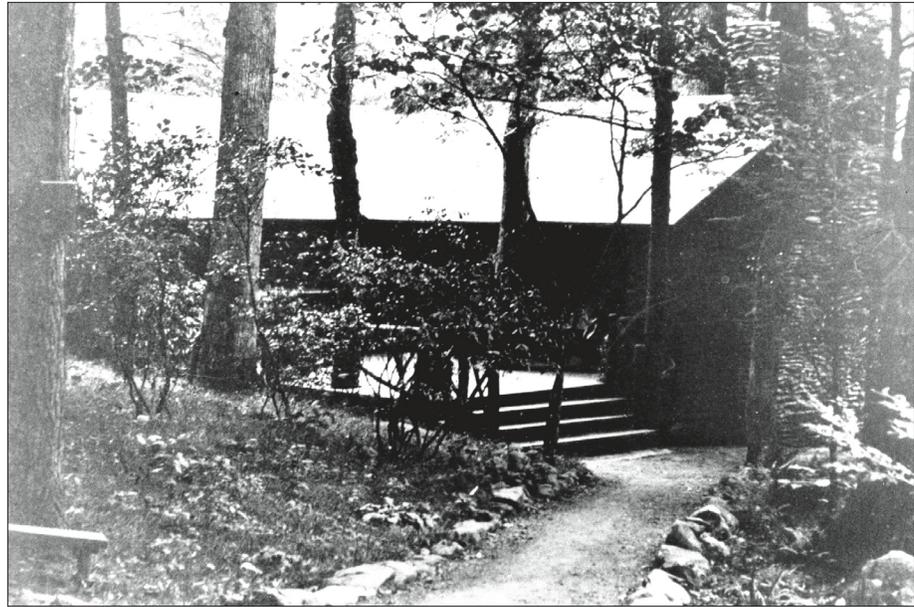
Figure 3.23. Historic photograph showing the stone-lined path and the northwest facade and porch of the President's Cabin. (Herbert Hoover Presidential Library)

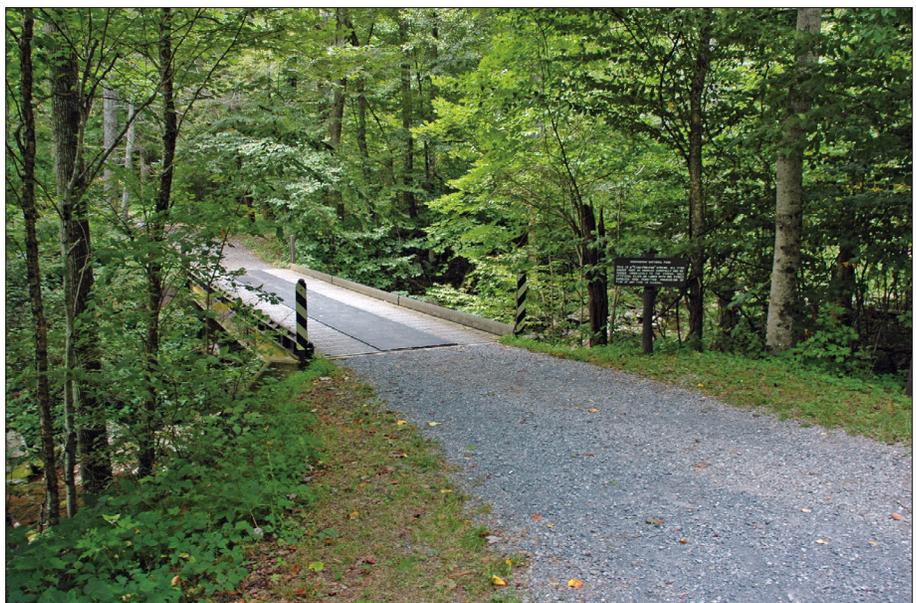
Figure 3.25. View looking west showing the entrance road and the steel bridge at the north edge of the camp. (OCLP)

The entrance road has received regular maintenance efforts over the years and remains in good condition.

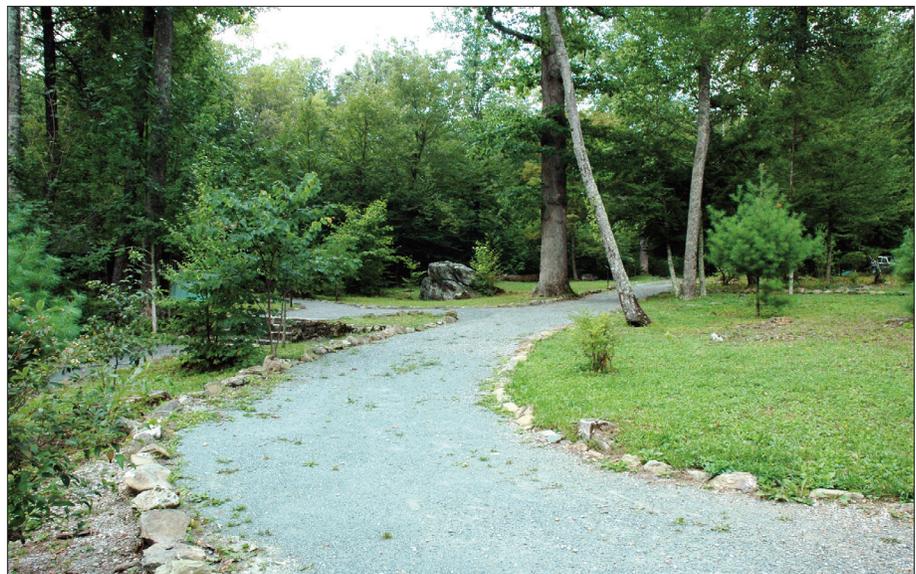
Figure 3.26. View looking west showing the circulation drive loop near the President's Cabin. Like the footpaths, the circulation drive is surfaced with crushed gravel and bordered with stones. (OCLP)

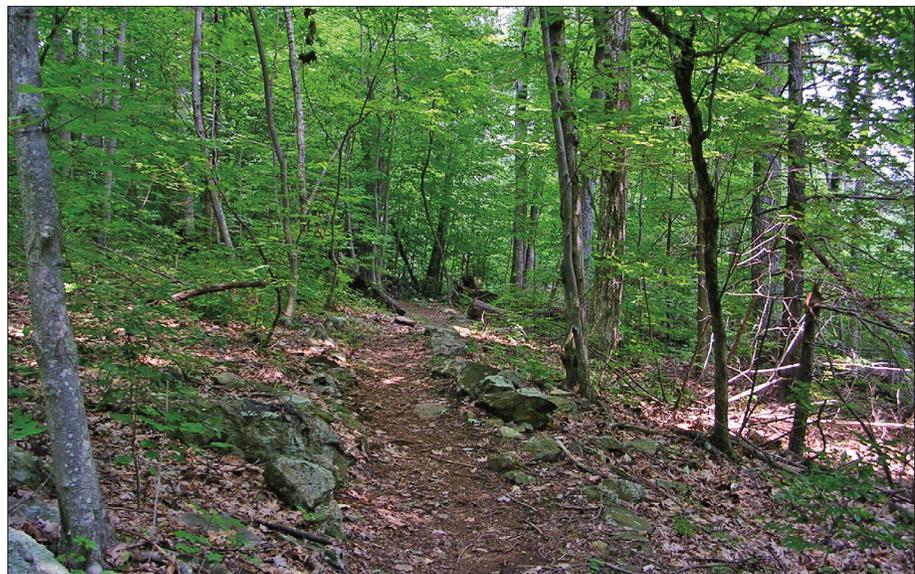
Figure 3.29. The trail to five tents, pictured here looking west, is less formal than the footpaths within the camp core. (OCLP)

The Five Tents Trail is intact, with the sets of stone steps and stone edging.

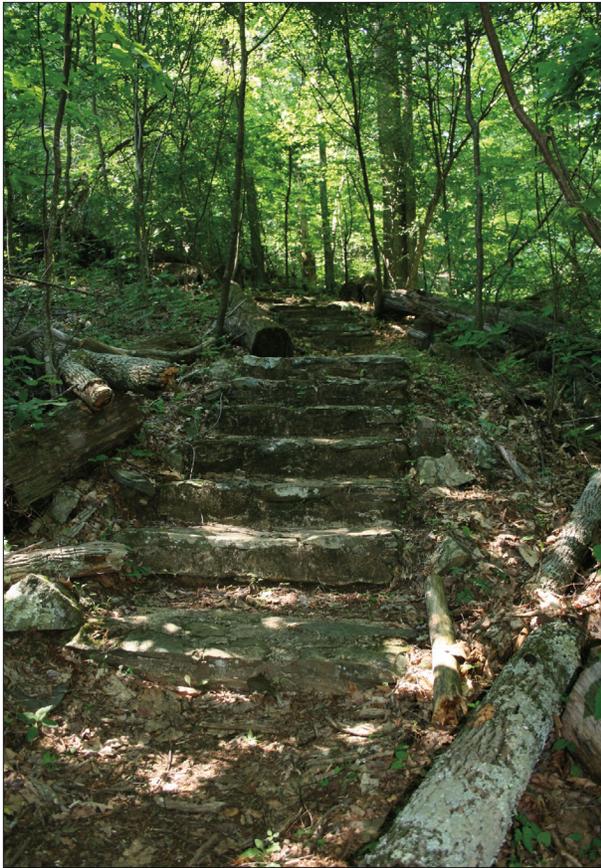
Figure 3.30. Two flights of mortared stone steps ascend the grade at the beginning of the trail to Five Tents. (OCLP)

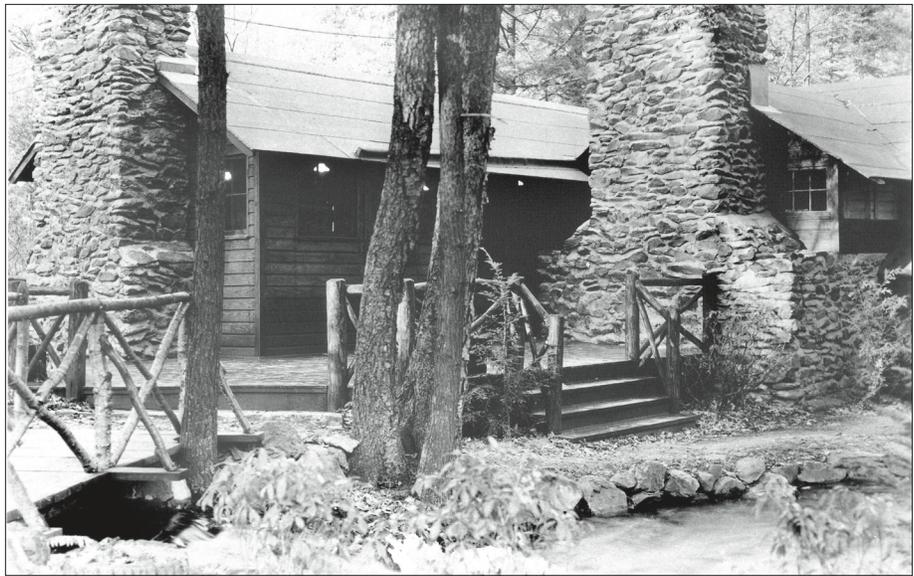
Figure 3.31. Hemlock run, seen here in the right-foreground, was a prominent feature in camp. (SHEN)

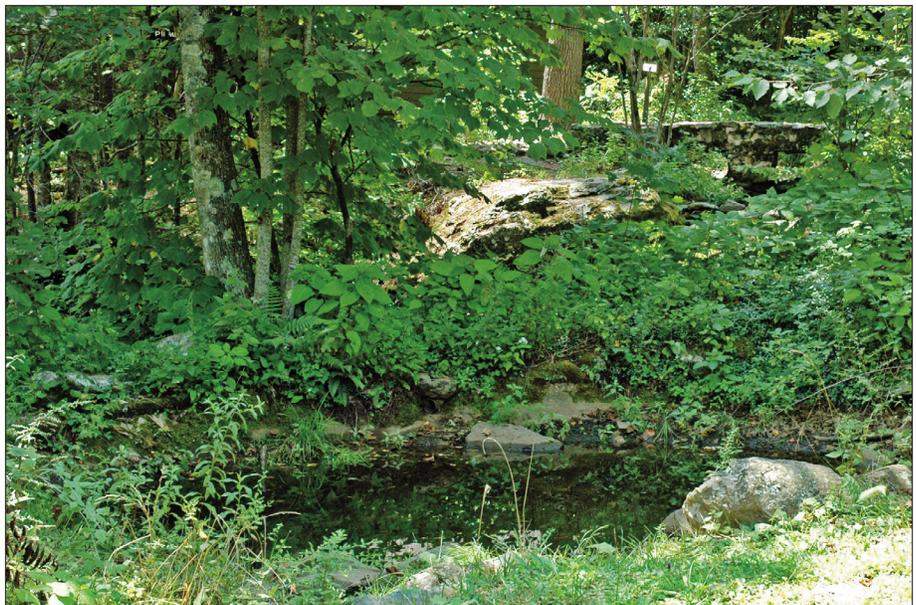
Figure 3.35. View looking south showing the concrete-lined trout pool. (OCLP)

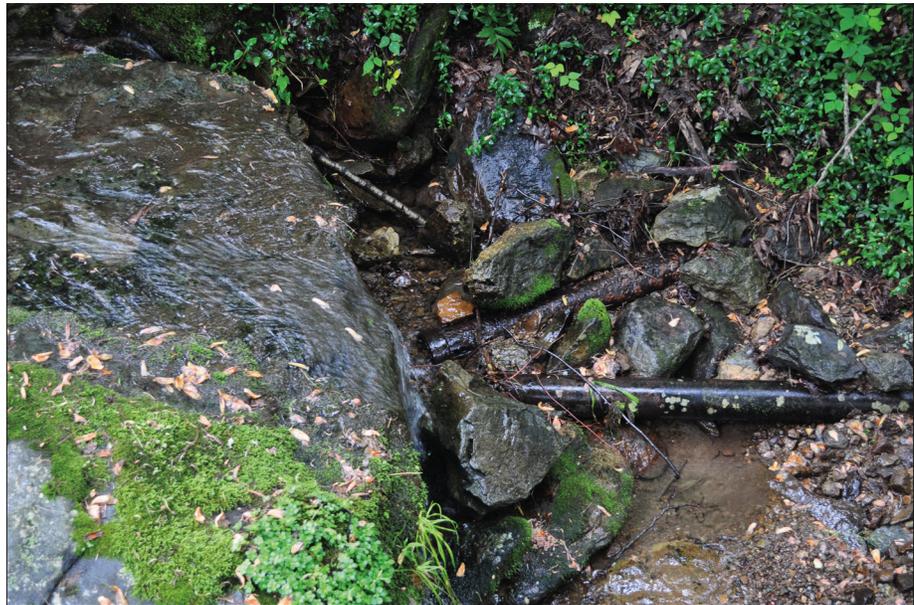
Figure 3.36. The concrete trout pool is fed by two iron pipes that originate immediately below Hemlock Falls. (OCLP)

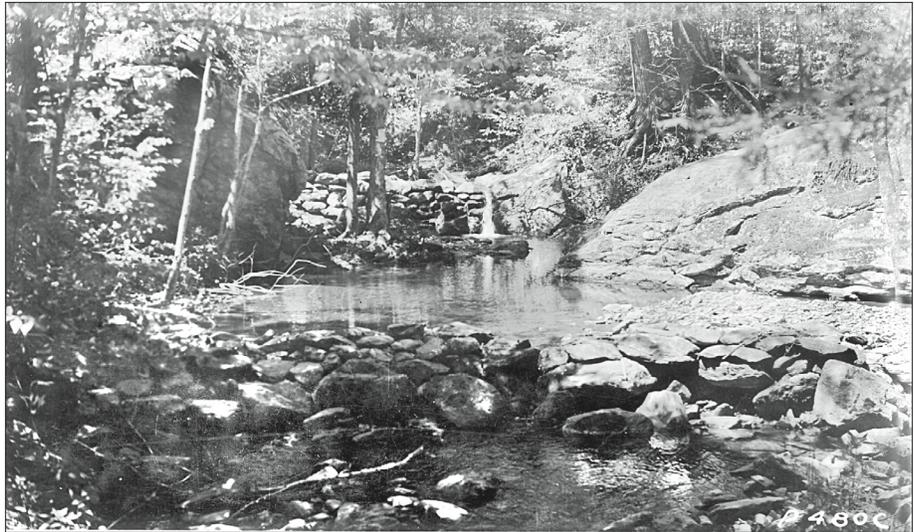
Figure 3.38. The same view today shows only scattered stones remain of the trout pools. (OCLP)

The trout pools along Mill Prong have deteriorated over the years due to the constant flow of the stream and high water events, but some portions of the old stone dams are still discernible upstream from the vehicular bridge. Hemlock Run itself still exists, but the flow of water has been significantly reduced since Hurricane Isabel severely damaged the sluice gate structure in 2003. Due to the diminished water flow, there is rarely enough water to create visible water falls over the large rocks at the site of Hemlock Run Falls. The channel's mortared stone walls have been restored and reconstructed and are in generally good condition. The unmortared stones lining the channel's edge farther upstream are present, but portions are overgrown. The trout pool next to the falls is in fair condition, although the pipes that once fed it are not functional and the water inside is stagnant. Mrs. Hoover's stone fountain does not currently function, and only a few of the recorded seven pools flowing from it are discernible.

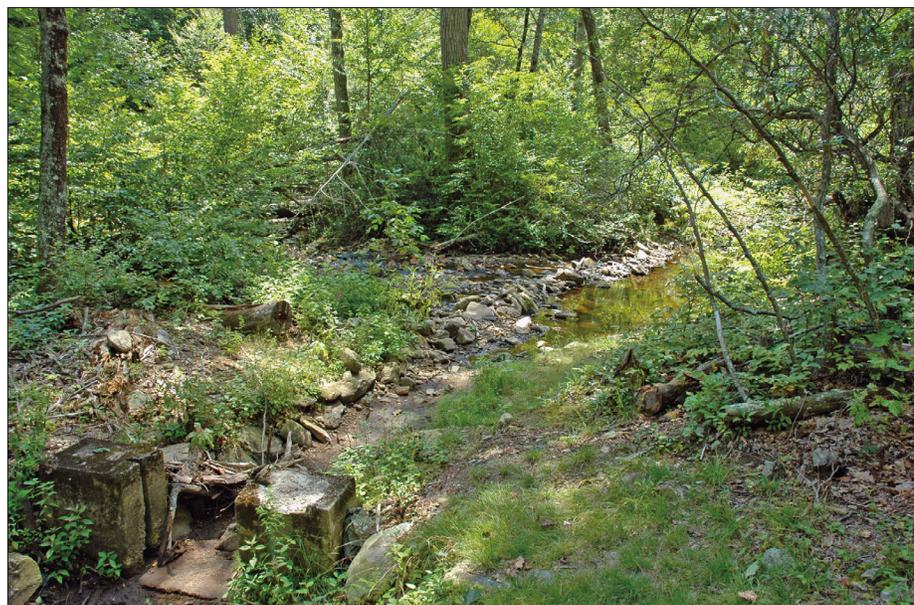
Figure 3.40. View looking east showing the sluice gate at the origin of Hemlock Run. At water levels typical of late summer (shown here in August), the water from Laurel Prong does not reach the sluice gate or enter Hemlock Run. (OCLP)

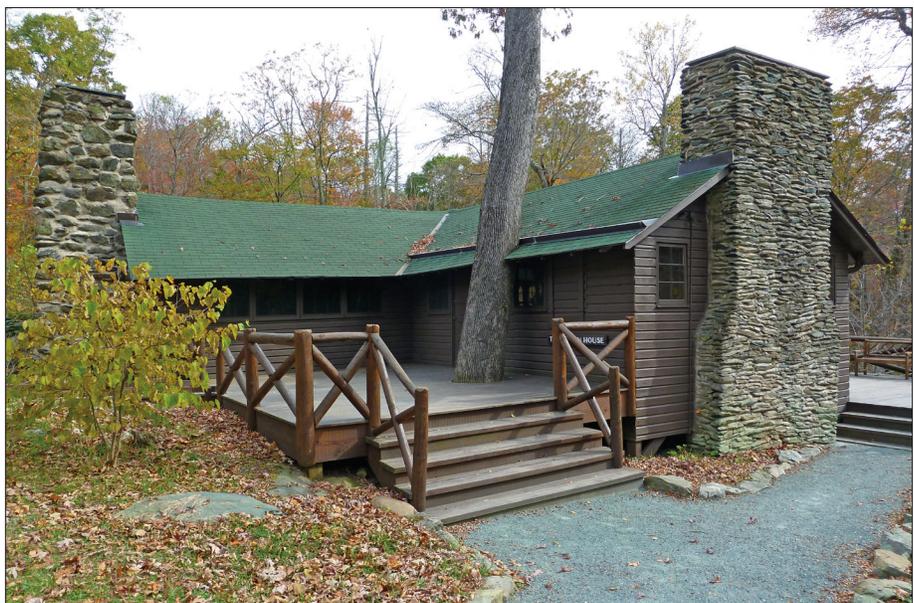
Figure 3.42. View of the President's Cabin looking southeast. (Courtesy of Amy Henschen)

With the removal of the Mess Hall and other cabins, The President's Cabin was remodeled between 1960 and 1963 to be more self-contained. One of the cabin's two bathrooms was eliminated to facilitate the addition of a kitchen, with the

northeast wall of the dining room altered to provide access to the kitchen. The deck on the cabin's southeast elevation was reduced in size from its 1932 configuration, while the southwest deck was eliminated entirely.

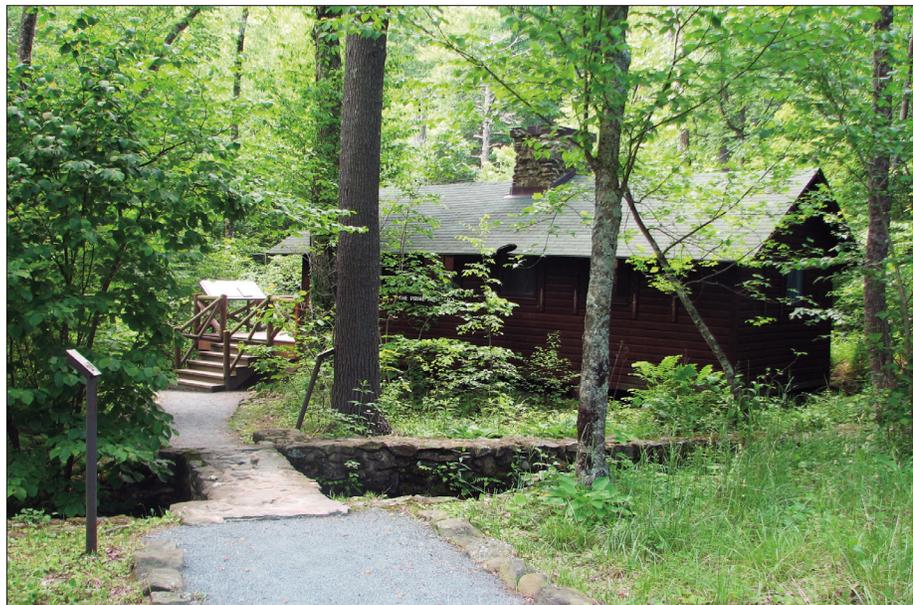
Figure 3.43. View looking south showing the Prime Minister's Cabin. (OCLP)

The Prime Minister's Cabin was constructed during the first phase of camp construction in 1929 and was complete by the summer of that year. The cabin was named in honor of a high-profile visit by British Prime Minister Ramsay MacDonald during disarmament talks between the two leaders. The single-story ell-shaped frame building included a thirty-two-foot by fourteen-foot main section and a thirteen-foot by fifteen-and-a-half-foot wing along the western elevation. The cabin had a prime location near the President's Cabin and Hemlock Run.

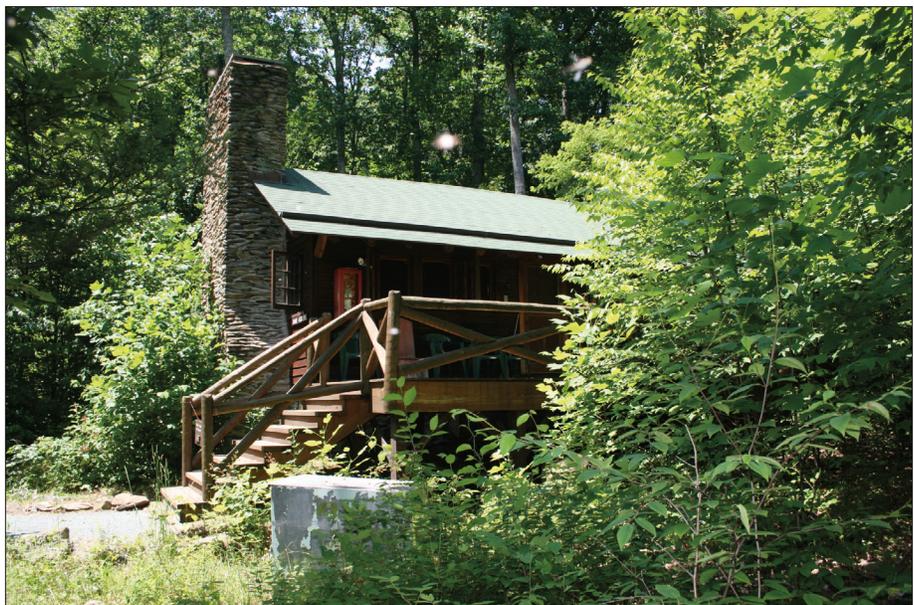
Figure 3.44. View looking northeast showing the Creel Cabin. (OCLP)

In 1969, in anticipation of a visit by President Richard Nixon, The Creel was equipped as a communications center. In the process, the cabin was insulated and the ceilings and walls paneled. That work has not damaged the historic structure and could be easily removed and restored to original appearance. In general, the exterior of this cabin has not changed over time, except for the original rustic rail-

ing being replaced by sawn members.

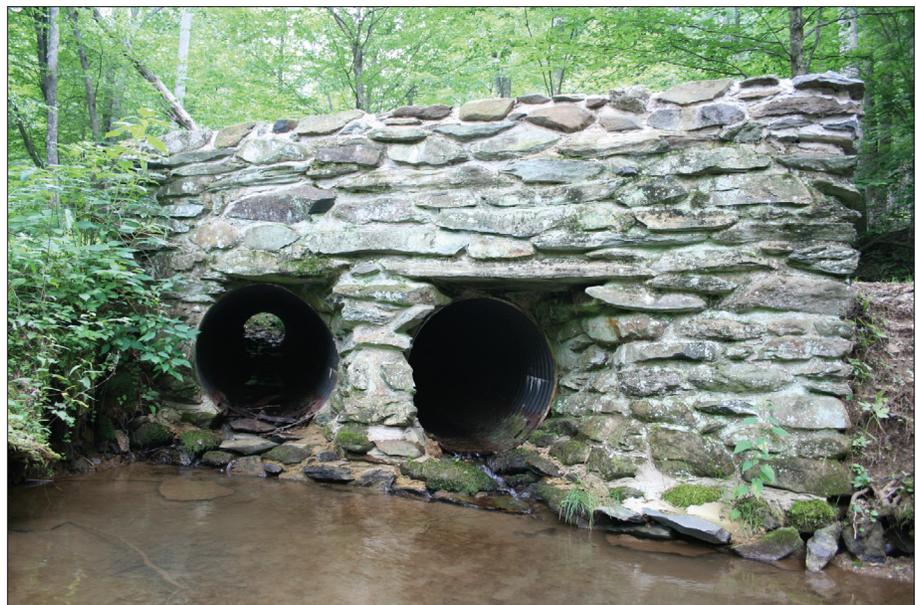
Figure 3.47. View of the steel culverts and stone headwall of the Entrance Road bridge. (OCLP 2008)

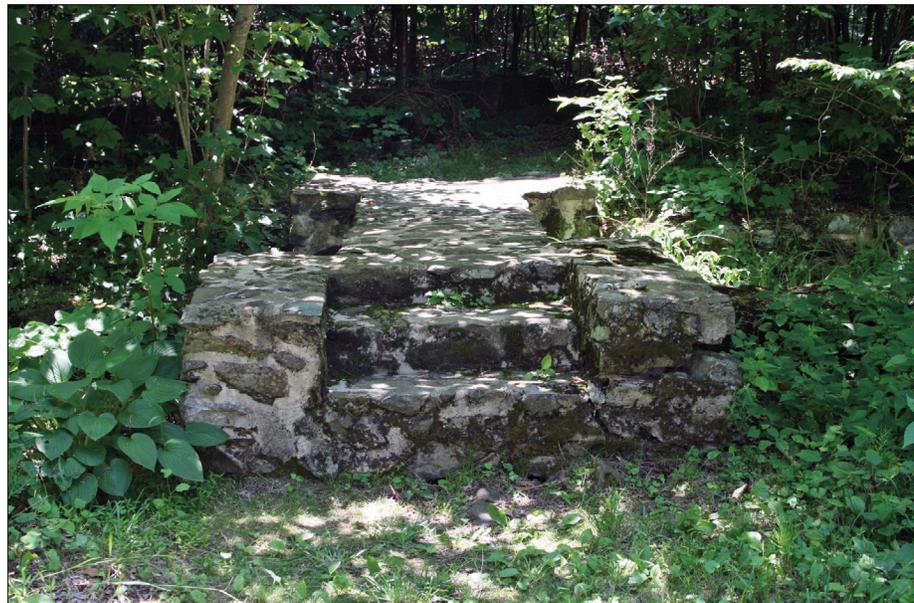
Figure 3.48. View looking south showing the westernmost of the two Hemlock Run stone footbridges. The easternmost stone footbridge is shown in Figure 2.10. (OCLP)

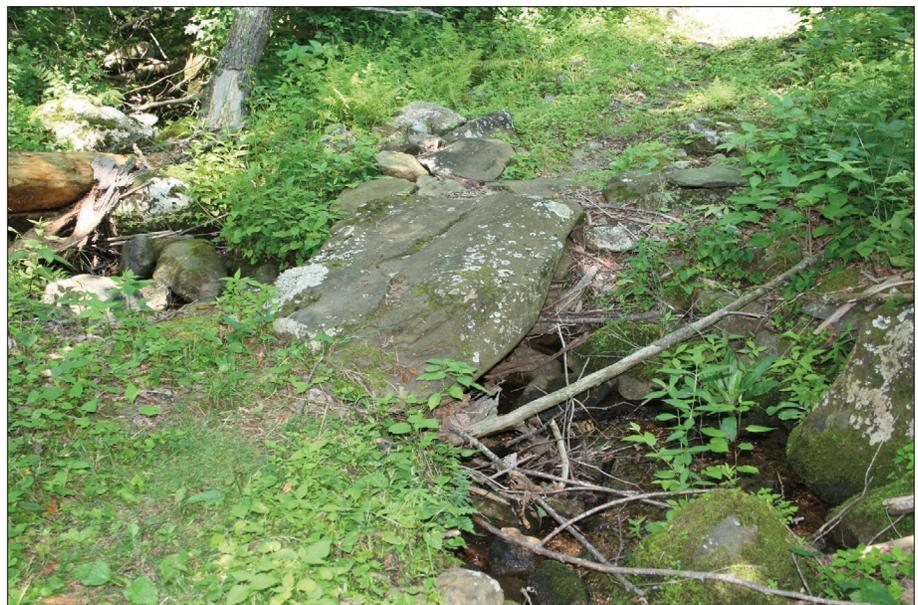
Figure 3.49. View of the stone slab footbridge over Hemlock Run. (OCLP)

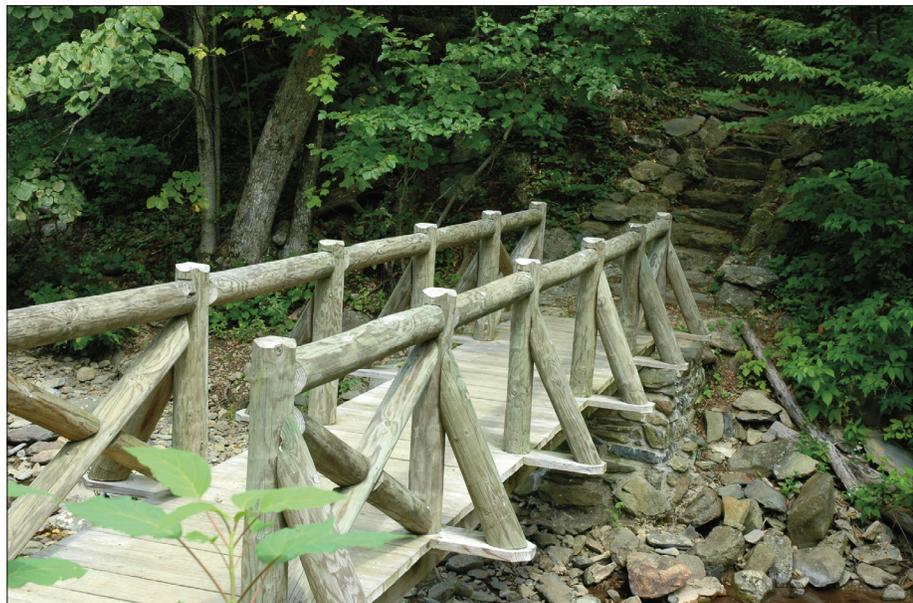
Figure 3.50. View looking east showing the wooden footbridge over Mill Prong. (OCLP)

of the President's Cabin. This was quickly replaced by a more permanent bridge, consisting of a timber-plank deck on log stringers with un-hewn log railings. The new bridge was supported by a large boulder on its west end and on a stacked stone foundation on the east end. This bridge is visible in other photos during the Hoover period (see cover photo).

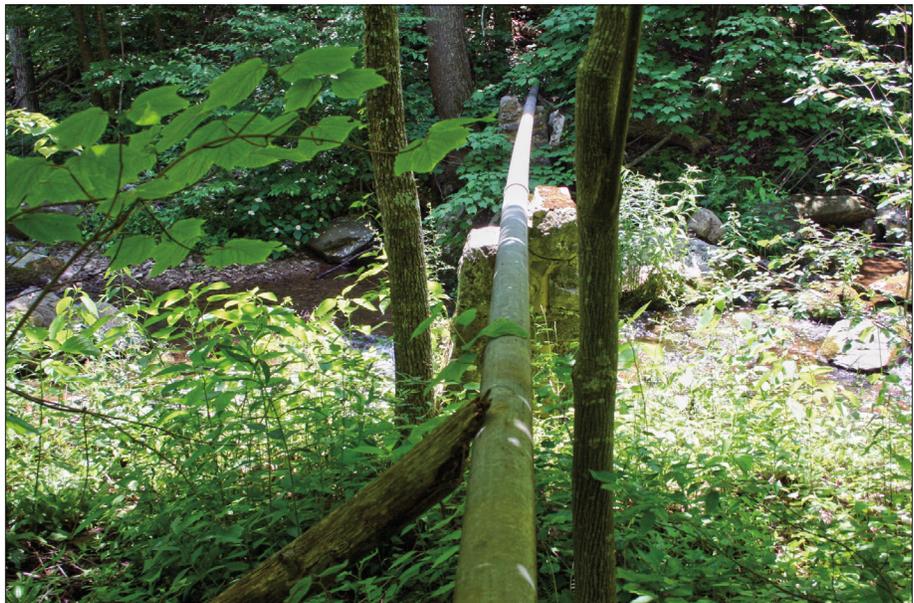
Figure 3.51. View looking south showing the septic pipe and stone piers. (OCLP)

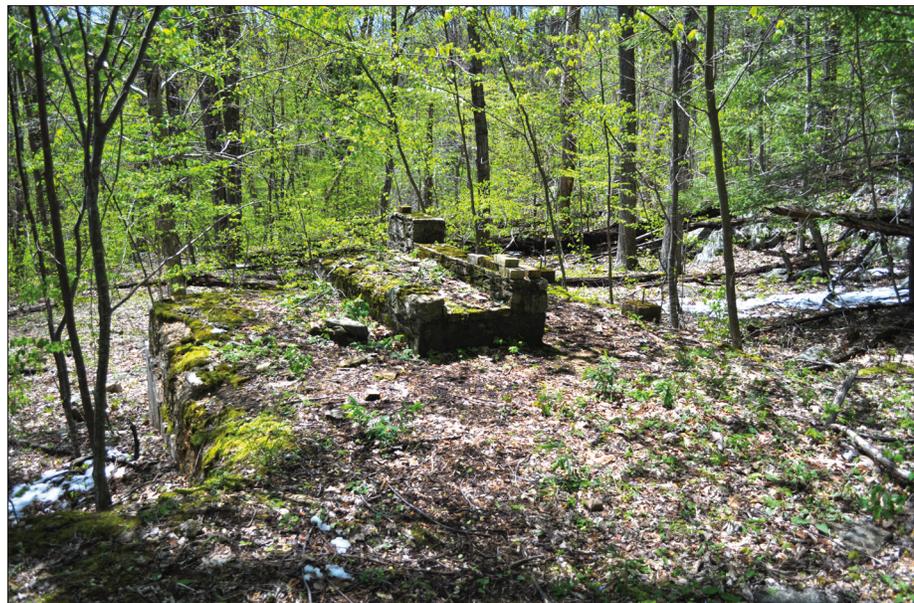
Figure 3.52. View of one of the unidentified stone structures conjectured to be part of the Boy Scout Camp. The pictured structure is located on the hillside northeast of the Five Tents site. (OCLP)

Obscured in the forested areas near Rapidan Camp are two stone structures that have not been positively identified. The structures consist of a rectangular stone foundation with the remnants of post attachments at the corners and along the sides. On top of each stone foundation is a raised stone structure, possibly a barbecue pit or fireplace. One of these structures is located along the entrance road near the junction of the trail from the President's Cabin. The other structure is located on the hillside above the trail to Five Tents. The structures appear to be of similar design and function.

The structures do not appear on any maps from the historic period, nor do they appear on a detailed park map created in 1954 during the period of use by the Boy Scouts. On the latter, the locations of both stone structures corresponds to areas indicated as "existing tent camp area." It has been speculated that these were picnic or barbecue shelters constructed during the Boy Scouts period, a theory supported by their apparent design and location. One former scout who camped at Rapidan, however, recalled the structures as in poor condition at the time, suggesting that they predate the Boy Scout period. The structures may have been a part of the water or other utility systems of the camp.

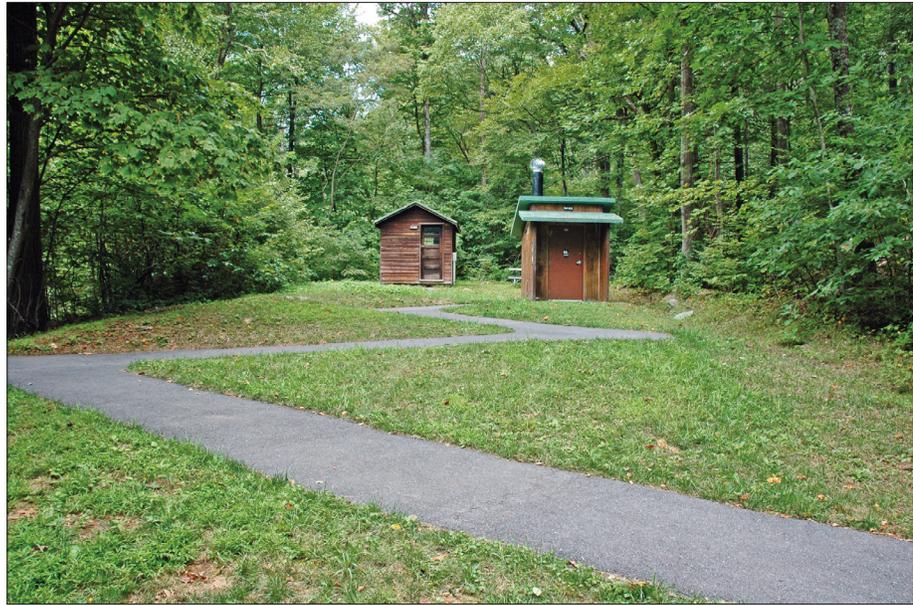
Figure 3.53. View looking north showing the vault toilet (right) and the storage shed. (OCLP)

Located near the vehicular entrance to camp just east of the steel bridge are two small, contemporary park structures, a shed and vault toilet. These structures are sited in an open turf area near the road with a zigzag accessible path leading to the vault toilet. The shed contains telephone equipment and is used for park storage, while the vault toilet is available for visitor use.

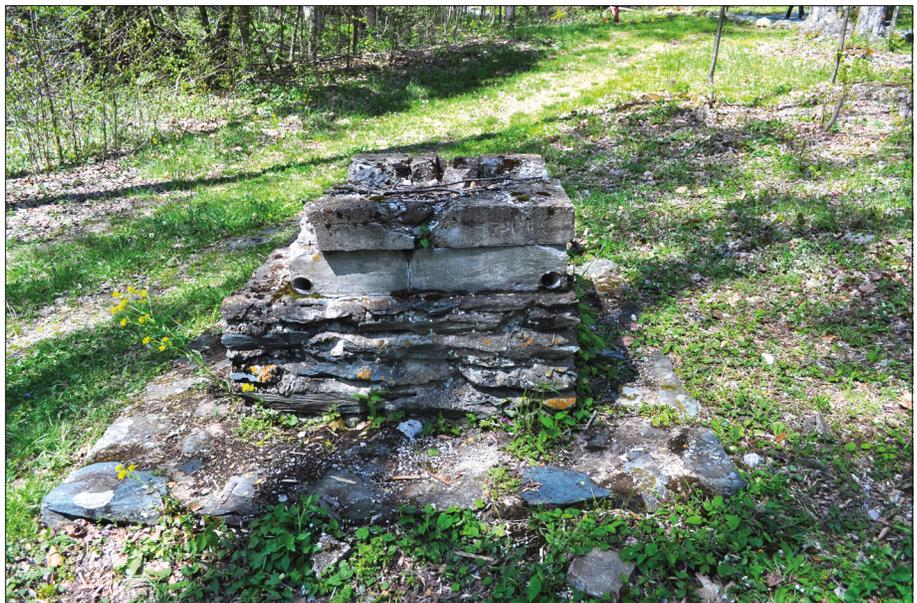
Figure 3.54. View of the stone barbecue. (OCLP)

The barbecue is the only remaining feature associated with the mess hall. The barbecue is in poor condition, with evident deterioration, particularly in the masonry block top. The stone base and stone platform are in fair condition with crumbling mortar and vegetation and moss growing on the rocks and in the cracks.

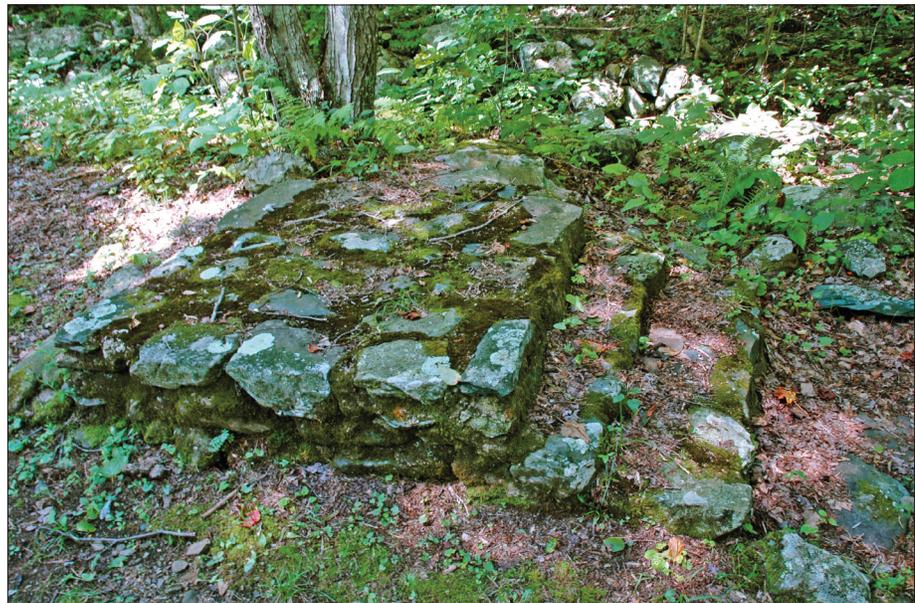
Figure 3.55. View of the stone mounting block on the Hemlock Run trail. (OCLP)

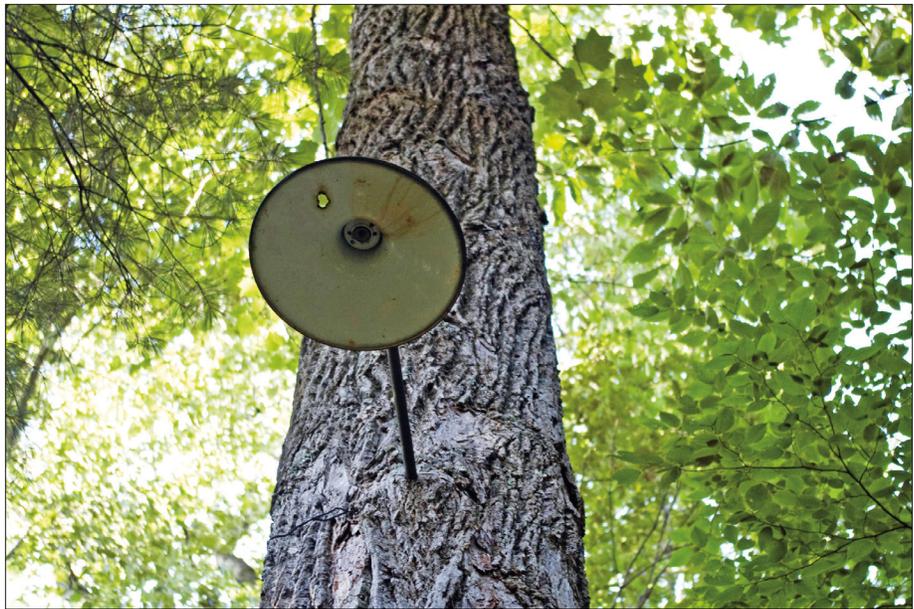
Figure 3.56. View of one of the remaining lights mounted in a tree along the trail to Five Tents. (OCLP)

Of the dozens of lights that were in camp originally, only two remain, located on trees along the trail to Five Tents. The lights currently consist of the metal shade and pipe mounting, with no electrical hardware remaining. The lights show signs of rust and deterioration, but are overall in fair condition.

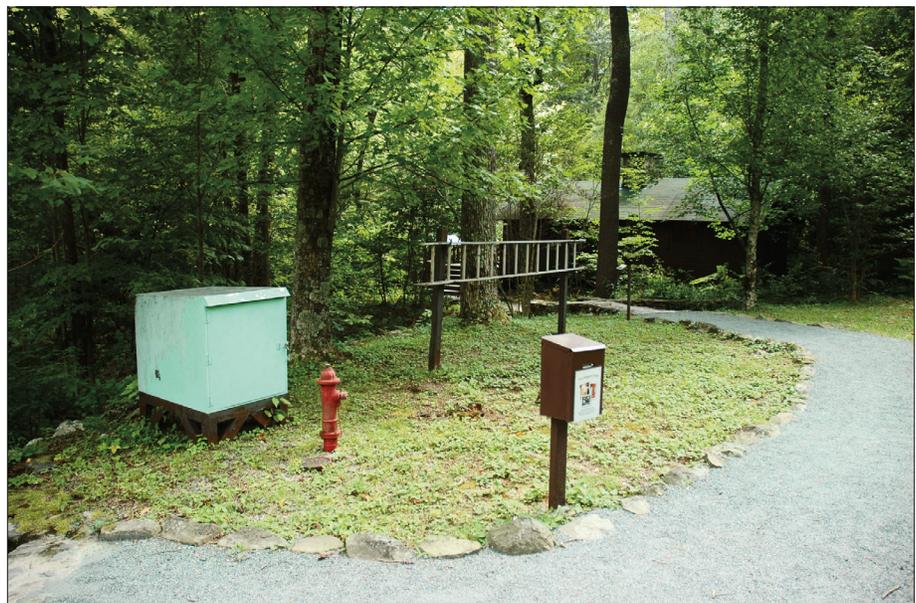
Figure 3.57. View looking southwest showing the hose cabinet, fire hydrant, ladder (since removed), and visitor donation box. The Prime Minister's Cabin is visible in the background. (OCLP)

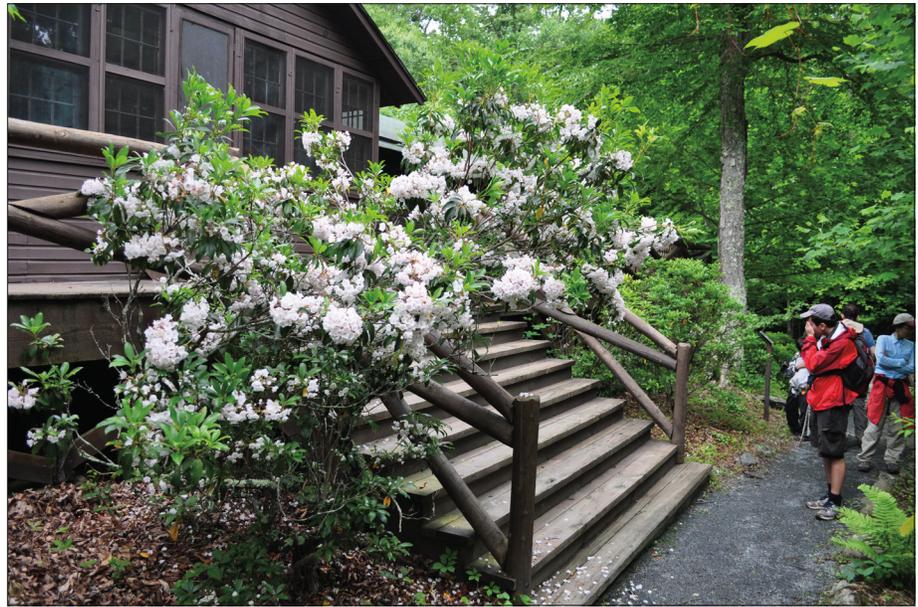
Figure 4.2. The desired character for Zone 1 is that of a woodland garden, with naturalistic arrangements of native woodland shrubs and an herbaceous ground cover of diverse native forest-floor ferns, forbs and grasses. Large mountain laurels, likely dating from the historic period, grow along with ferns and other ground covers at the south side of the President's Cabin. (OCLP)

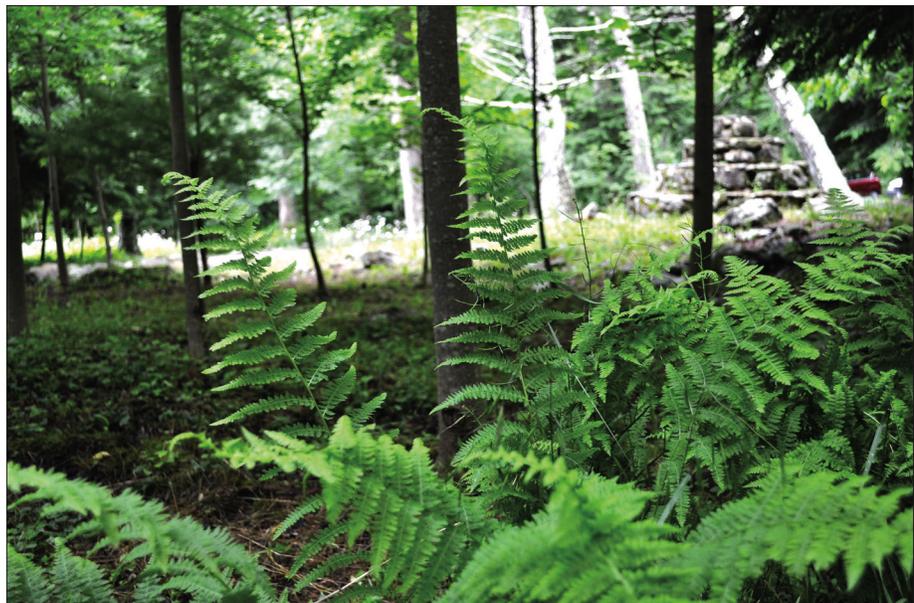
Figure 4.3. The desired character for Zone 2 is that of a natural forest floor with a lush green ground-cover layer of ferns, forbs, and grasses less than two feet high beneath a high tree canopy. This area is characterized by few shrubs and an almost complete lack of larger understory and midstory plants between five feet and twenty feet high. (OCLP)

- Figure 4.3. The desired character for Zone 2 is that of a natural forest floor with a lush green ground-cover layer of ferns, forbs, and grasses less than two feet high beneath a high tree canopy. This area is characterized by few shrubs and an almost complete lack of larger understory and midstory plants between five feet and twenty feet high. (OCLP) 168

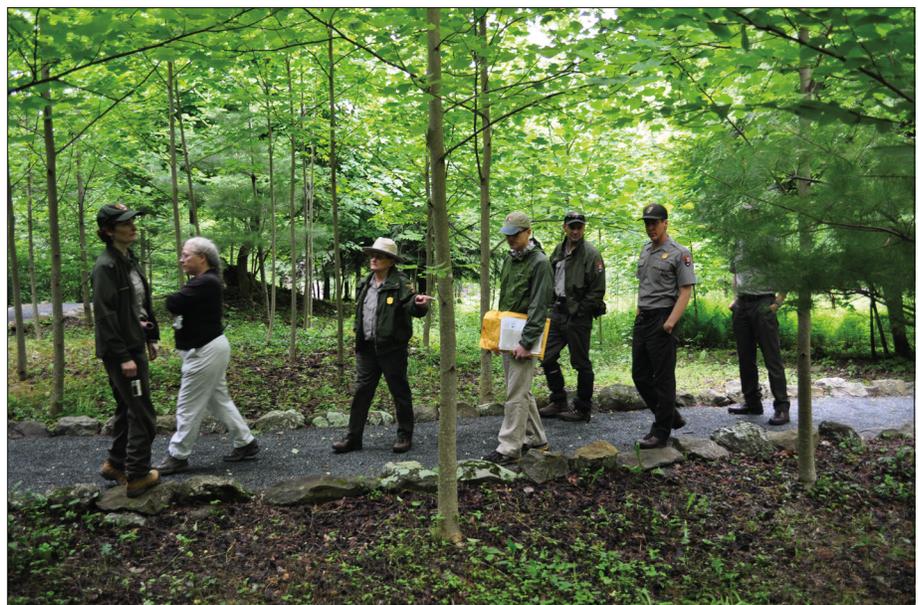
Figure 4.5. Manage existing tulip poplar trees. Stands of young tulip poplars have established themselves in portions of camp. These trees should be managed to create a high closed canopy. (OCLP)

- Figure 4.5. Manage existing tulip poplar trees. Stands of young tulip poplars have established themselves in portions of camp. These trees should be managed to create a high closed canopy. (OCLP) 173
