CULTURAL LANDSCAPE REPORT
FOR RAPIDAN CAMP
SHENANDOAH NATIONAL PARK

MADISON COUNTY, VIRGINIA

National Park Service, Boston, Massachusetts, 2014

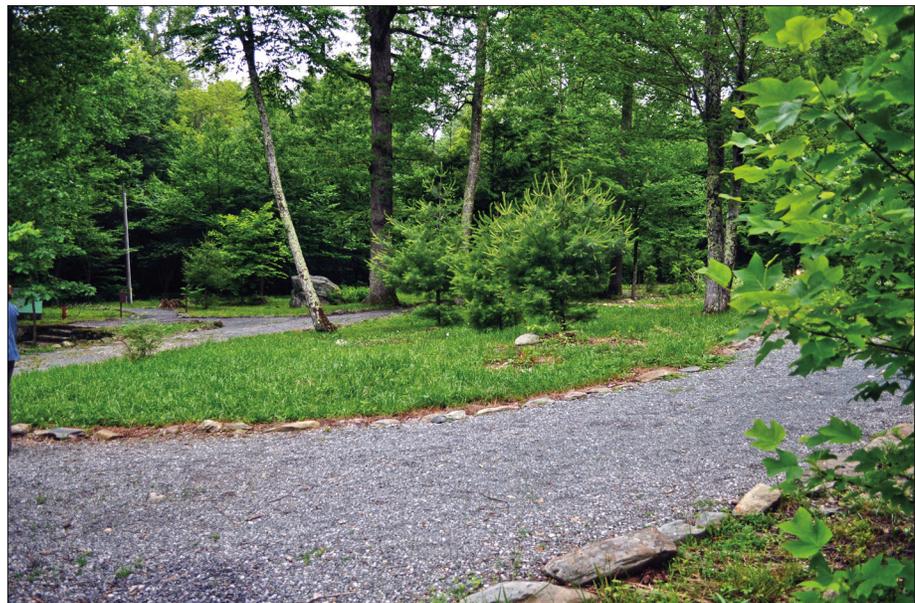
Figure 4.6. Transplant tulip poplars into clear areas. Portions of camp, such as the center of the circulation loop in front of the President's Cabin, lack sufficient regeneration of young trees to create a closed canopy. Tulip poplar seedlings should be transplanted from other areas of camp to create a shading canopy. (OCLP)

- Figure 4.6. Transplant tulip poplars into clear areas. Portions of camp, such as the center of the circulation loop in front of the President's Cabin, lack sufficient regeneration of young trees to create a closed canopy. Tulip poplar seedlings should be transplanted from other areas of camp to create a shading canopy. (OCLP) 174

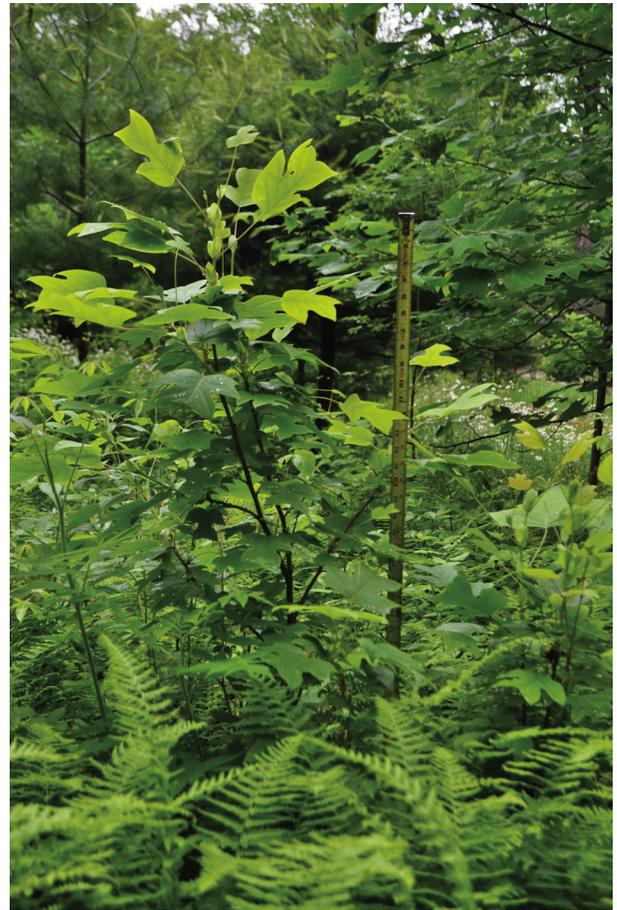
Figure 4.7. Several young tulip poplar trees growing in camp are suitable for transplantation. These should be transplanted into clear areas of camp before they are too big to move. (OCLP)

- Figure 4.7. Several young tulip poplar trees growing in camp are suitable for transplantation. These should be transplanted into clear areas of camp before they are too big to move. (OCLP) 175

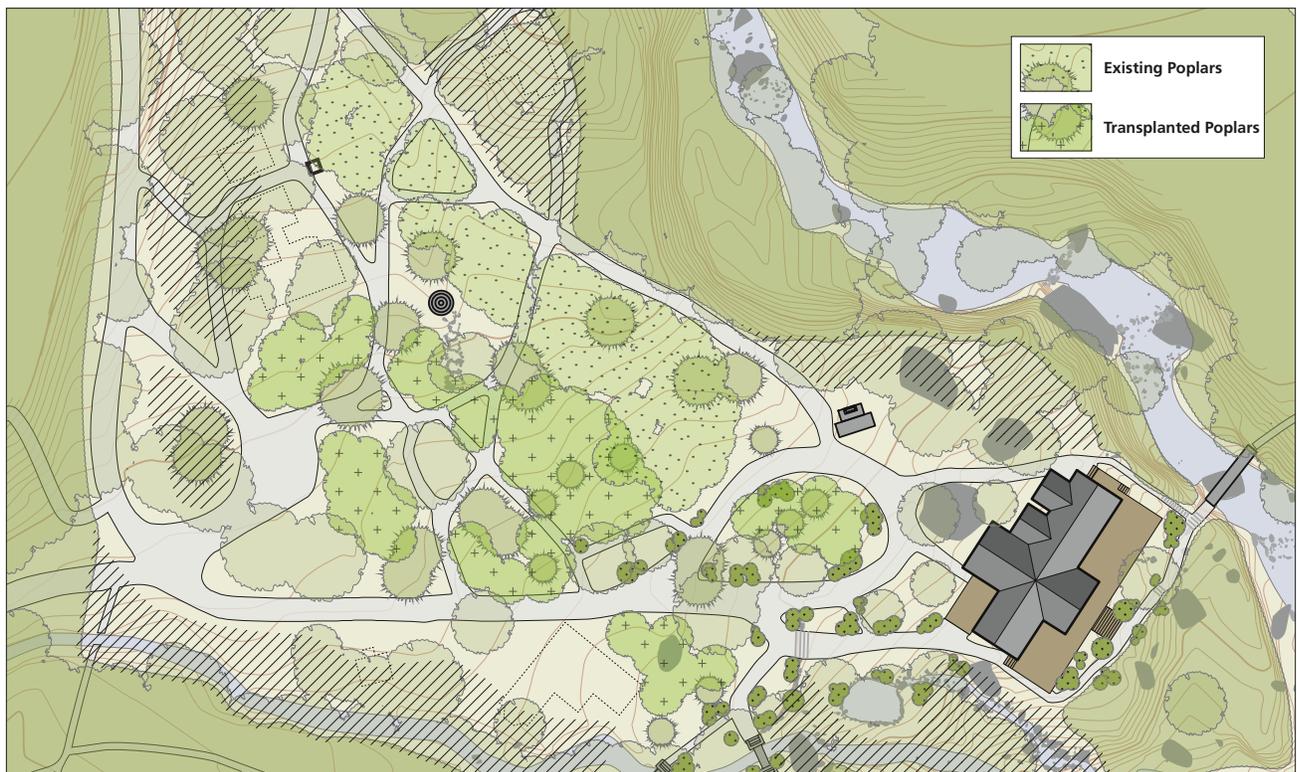
Figure 4.8. Diagram showing the approximate areas of tulip poplar management, indicating existing young tulip poplar stands and areas where transplanted trees should be established. For full treatment drawing, see Drawings 5 and 6. (OCLP)

- Figure 4.8. Diagram showing the approximate areas of tulip poplar management, indicating existing young tulip poplar stands and areas where transplanted trees should be established. For full treatment drawing, see Drawings 5 and 6. (OCLP) 175

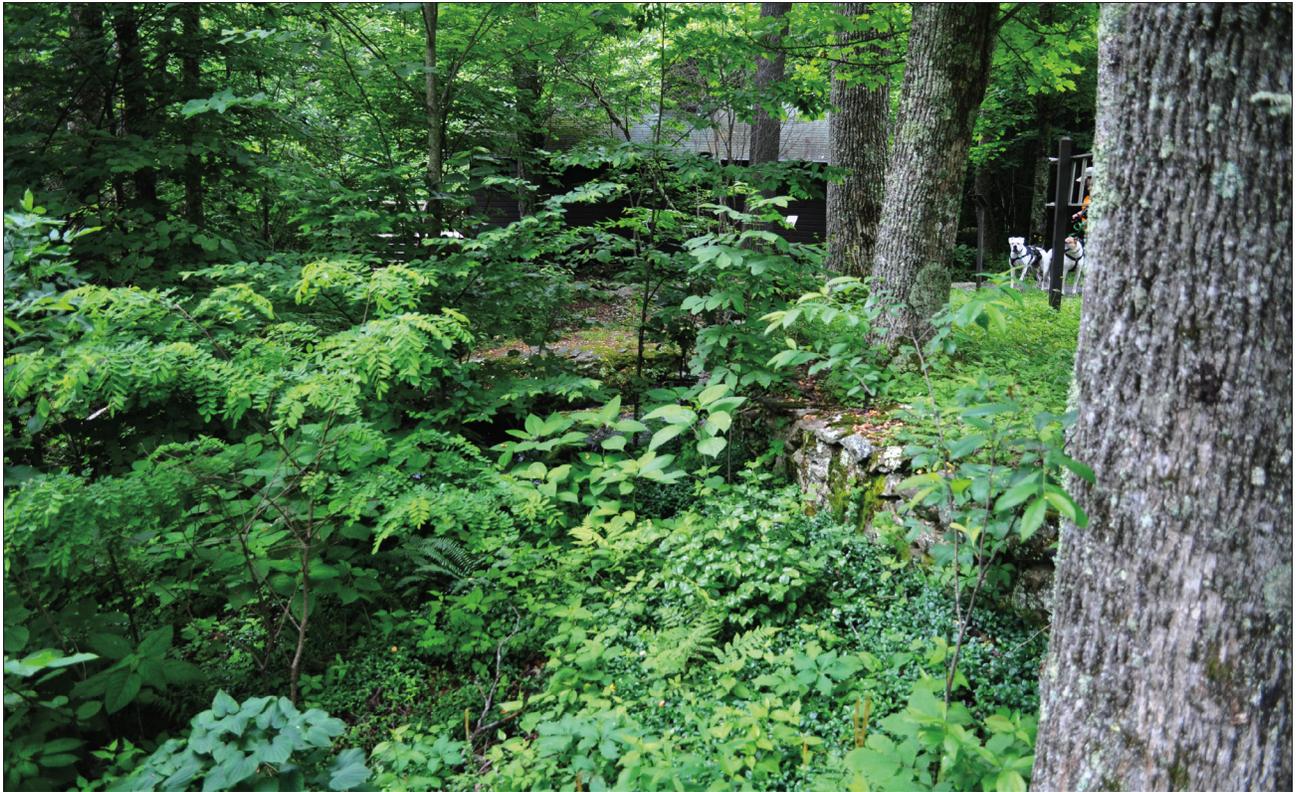
Figure 4.9. Reduce understory vegetation. Many of the features of Rapidan Camp are obscured by understory vegetation. In this view, looking south from the concrete trout pool, features like Hemlock Run and the Prime Minister's Cabin are largely obscured. (OCLP)

- Figure 4.9. Reduce understory vegetation. Many of the features of Rapidan Camp are obscured by understory vegetation. In this view, looking south from the concrete trout pool, features like Hemlock Run and the Prime Minister's Cabin are largely obscured. (OCLP) 177

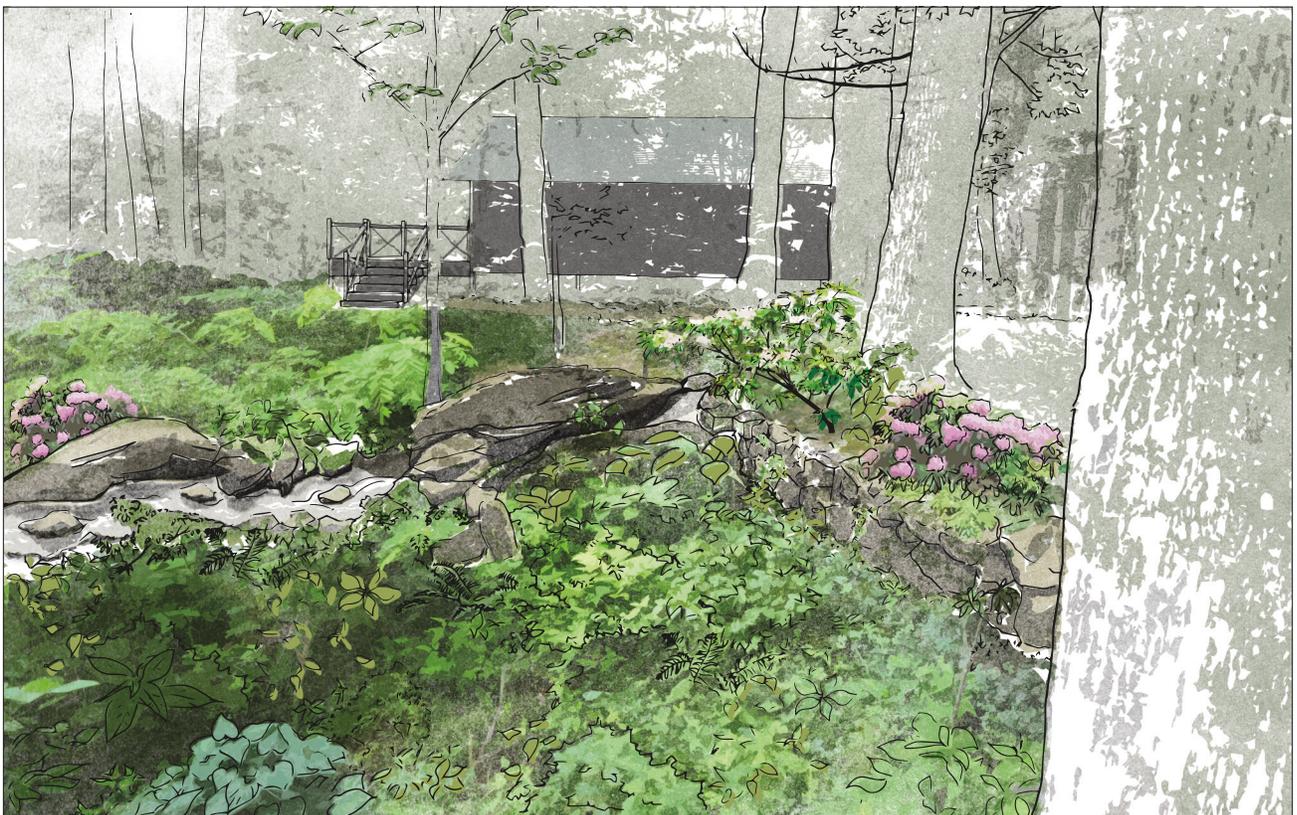
Figure 4.10. Remove shrubs, saplings, and small trees between about four feet and twelve feet, sufficient to maintain filtered views through the vegetated areas. Features such as Hemlock Run, footbridges, stone retaining walls, and the trout pool should be readily visible from nearby footpaths. (OCLP)

- Figure 4.10. Remove shrubs, saplings, and small trees between about four feet and twelve feet, sufficient to maintain filtered views through the vegetated areas. Features such as Hemlock Run, footbridges, stone retaining walls, and the trout pool should be readily visible from nearby footpaths. (OCLP) 177

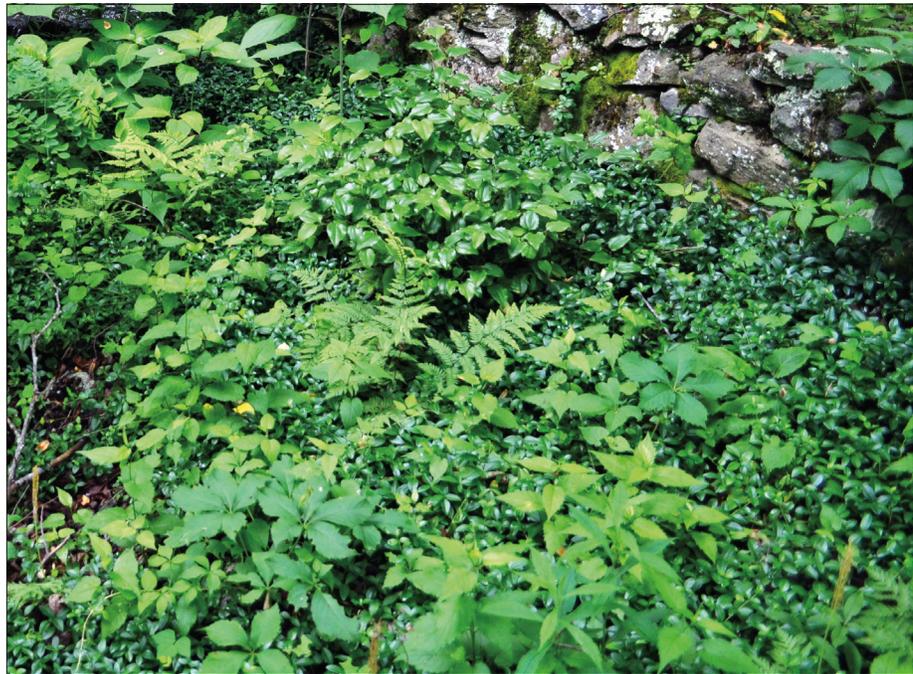
Figure 4.11. Cultivate a low, native herbaceous ground cover throughout the camp. Here, native ground cover species mix with non-natives, such as *Vinca minor*. Non-native species should be removed, retaining the natives. (OCLP)

- Figure 4.11. Cultivate a low, native herbaceous ground cover throughout the camp. Here, native ground cover species mix with non-natives, such as *Vinca minor*. Non-native species should be removed, retaining the natives. (OCLP) 178

ground covers. Non-native and undesirable vegetation should be removed by hand, and native forest-floor species transplanted into areas that have inadequate cover. Non-native turf grass should be removed and converted to native ground cover as shade is established, and native grasses should be planted in areas that receive more sun. Compacted areas should be aerated to promote growth. Appropriate species for ground cover and native grasses are listed in Table 4.1.

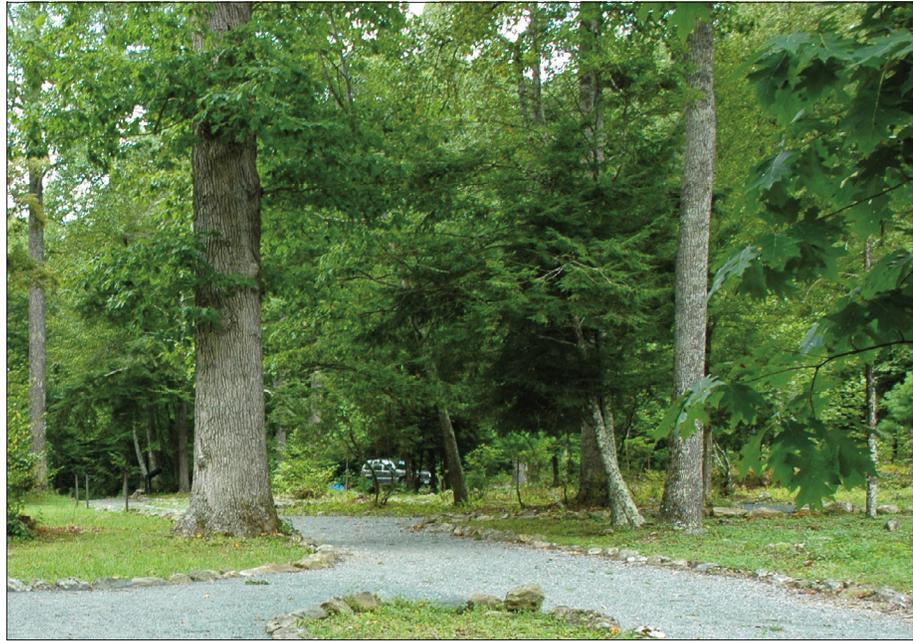
Figure 4.13. Retain existing native overstory trees. Large canopy trees from the historic period still grow throughout Rapidan Camp. While the missing component of the canopy should be reestablished with tulip poplars, mixed species existing trees should be retained. (OCLP)

- Figure 4.13. Retain existing native overstory trees. Large canopy trees from the historic period still grow throughout Rapidan Camp. While the missing component of the canopy should be reestablished with tulip poplars, mixed species existing trees should be retained. (OCLP) 180

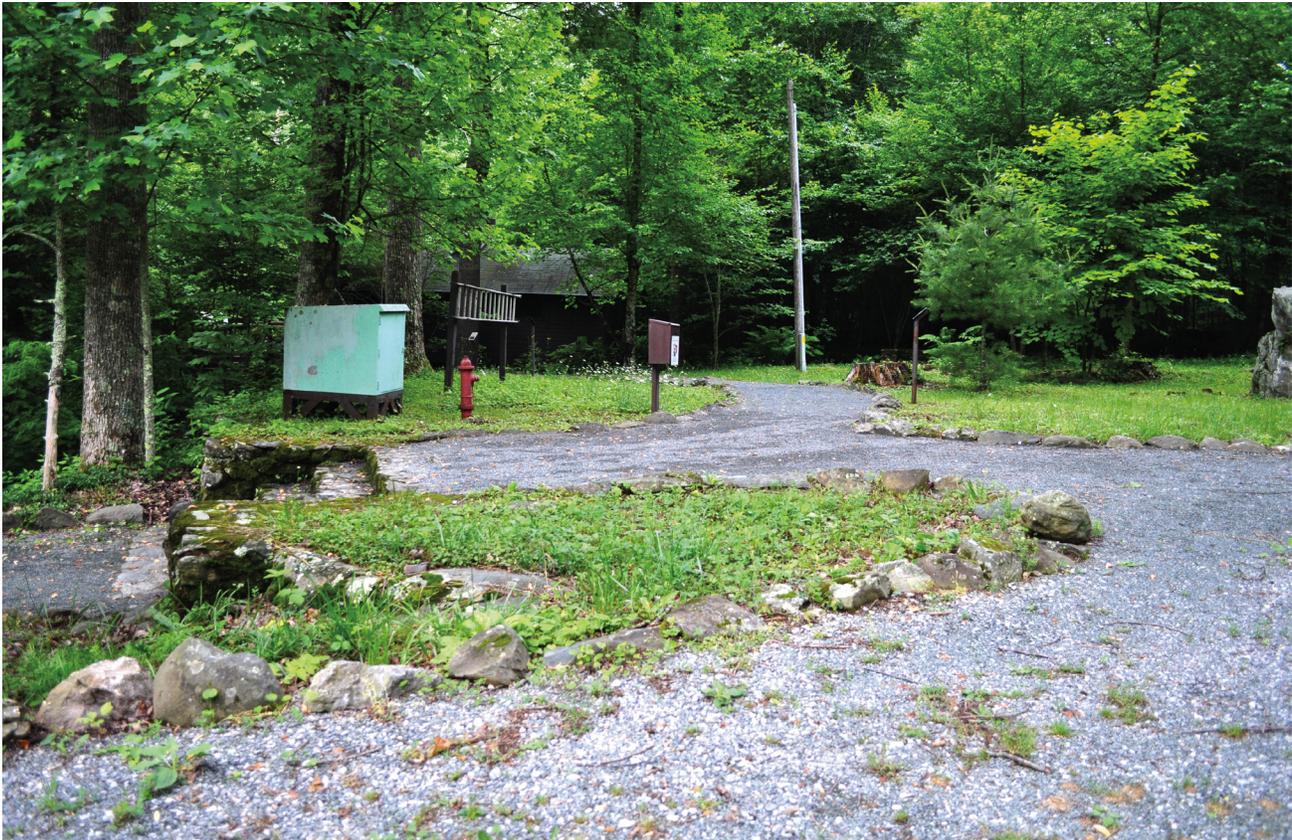
Figure 4.14. Areas of camp that are currently covered with turf grass should be planted with native ornamental understory vegetation. (OCLP)

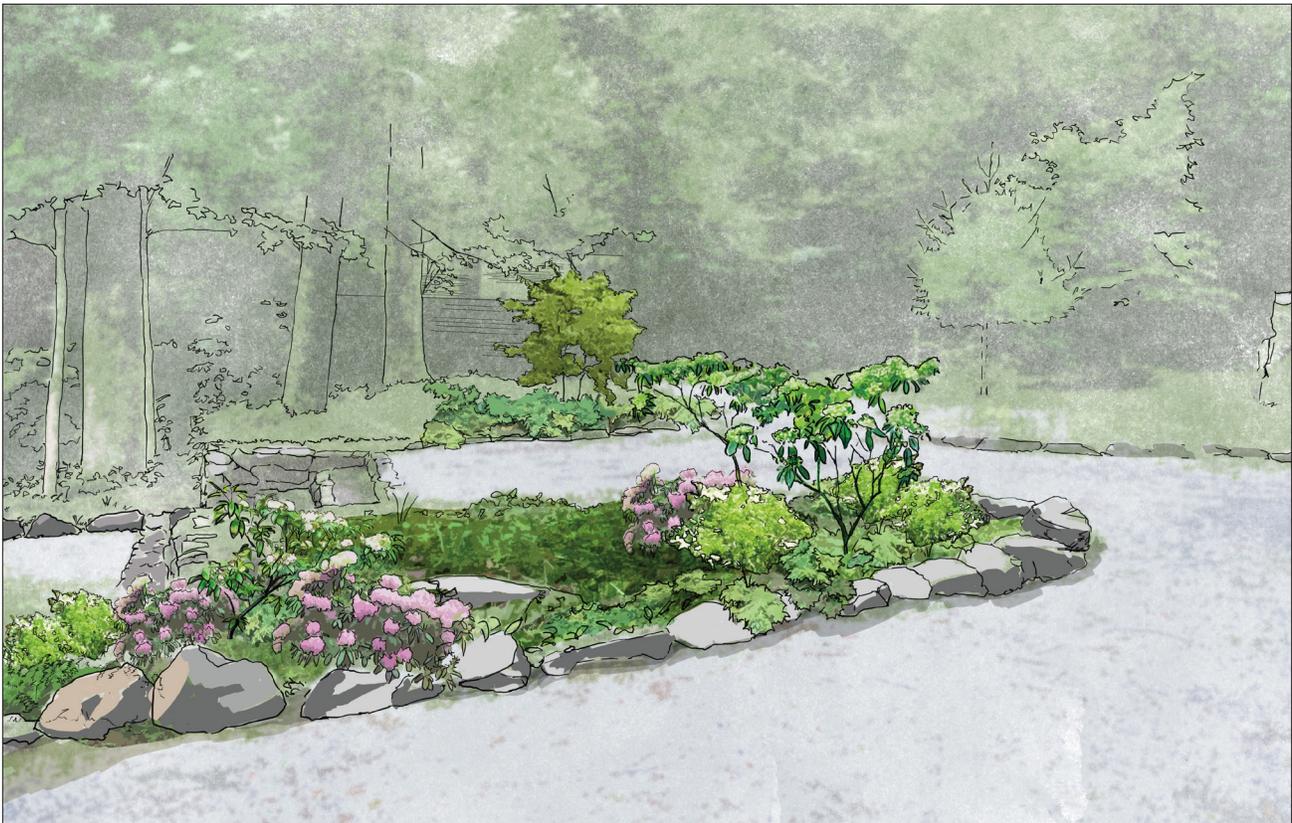
Figure 4.15. Plant native woodland shrubs, flowering perennials, and forest-floor ground covers along the edges of paths, particularly near key features and path intersections. Plant shrubs in naturalistic groupings. (OCLP)

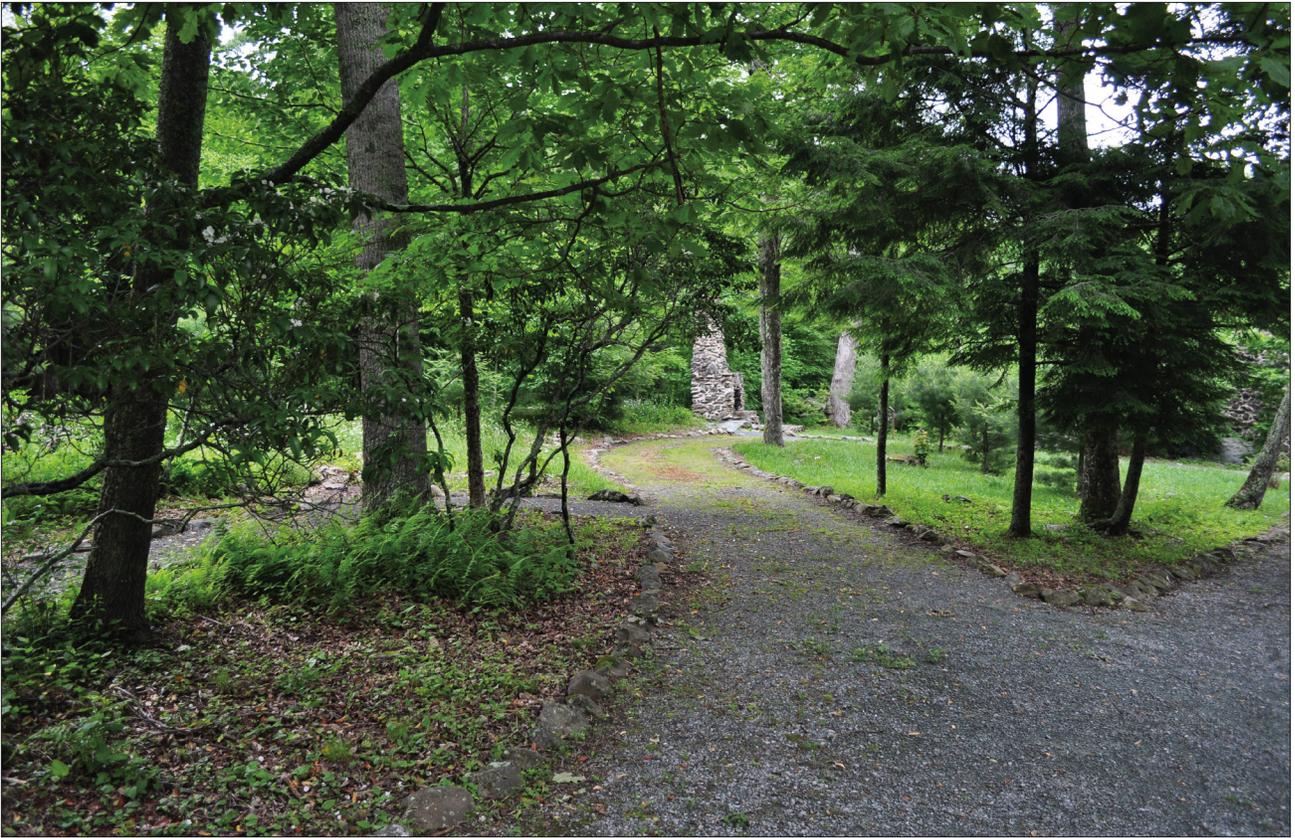
Figure 4.16. Native ferns, mountain laurels, and other native understory vegetation should be retained and supplemented with new plantings. (OCLP)

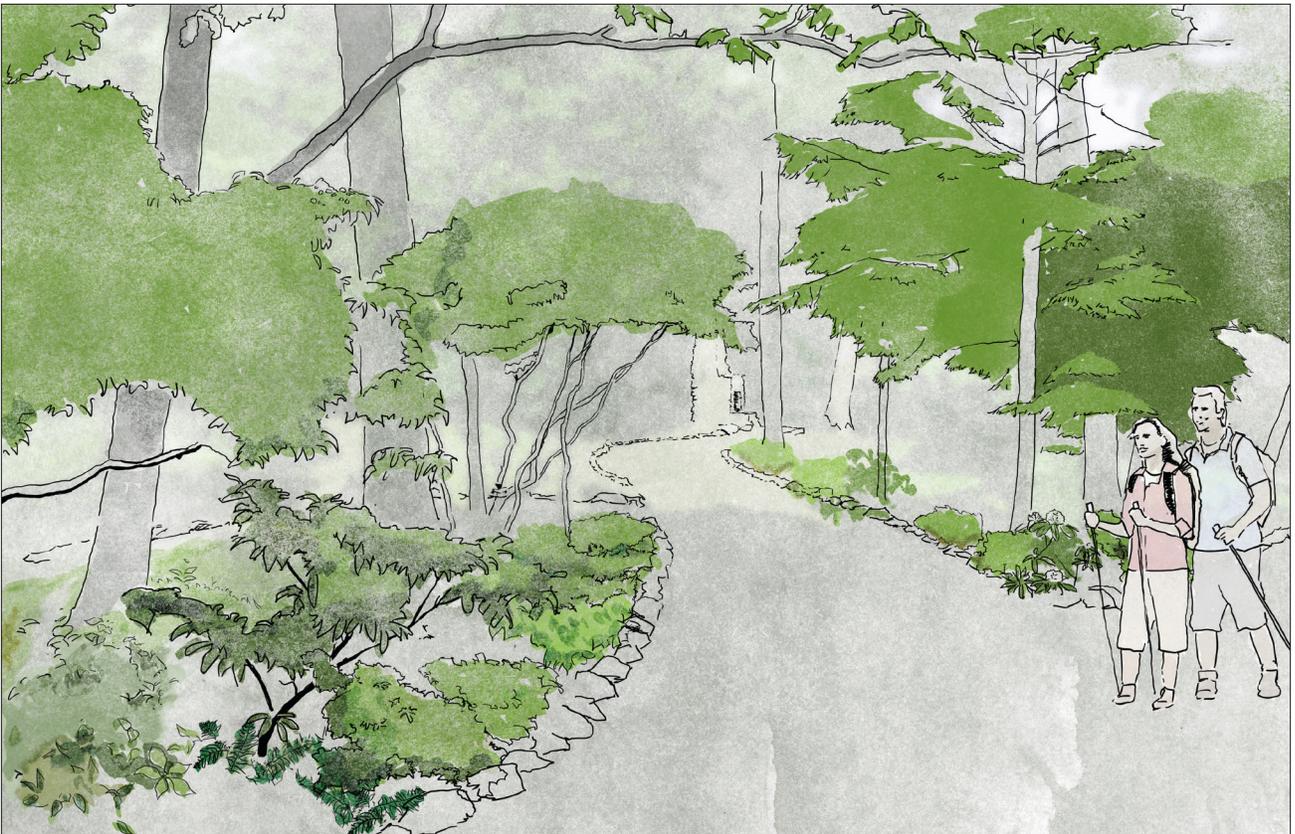
Figure 4.17. New plantings should have a low and tidy character and should mimic natural understory shrubs and ground cover. (OCLP)

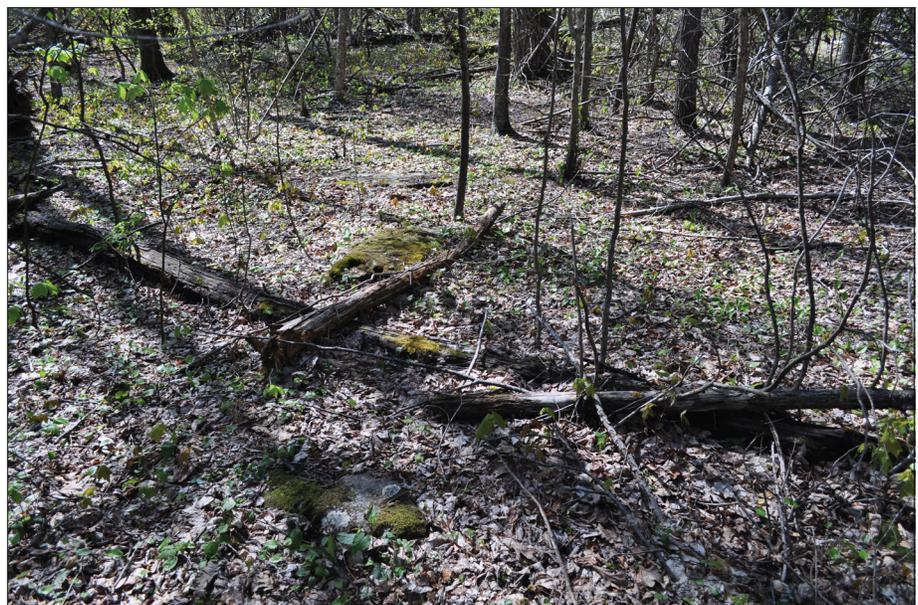
Figure 4.19. Clear trees and shrubs from building footprints and maintain as native ground cover. The locations of former cabins are indiscernible, due in part to vegetation that is growing within their footprints. Remove all woody vegetation from cabin footprints. (OCLP)

The locations of former cabins should be kept clear of trees and woody vegetation to ensure that the footprints are visible. At least once a year, all woody vegetation should be removed and the cut stems treated with herbicide to prevent sprouting. The cleared cabin footprints should be maintained with native forest floor vegetation. In conjunction with clearing the vegetation within the footprints, the locations of the cabins may be indicated by visible markers (see Task SP-2).

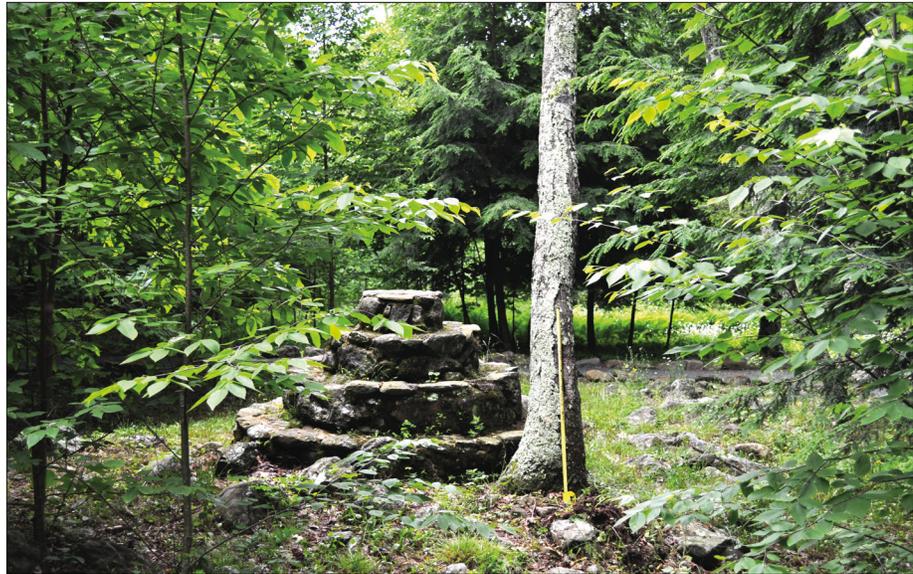
Figure 4.20. Remove woody vegetation growing on or near historic features. The tree growing adjacent to the stone fountain threatens the structure and should be removed. (OCLP)

Stonework and other features within camp may be impacted by adjacent vegetation. As trees grow, their roots and trunks may press against features and dislodge stones or otherwise damage them. Features may also be threatened by hazardous trees that could fall. Steps should be taken to prevent damage to these features.

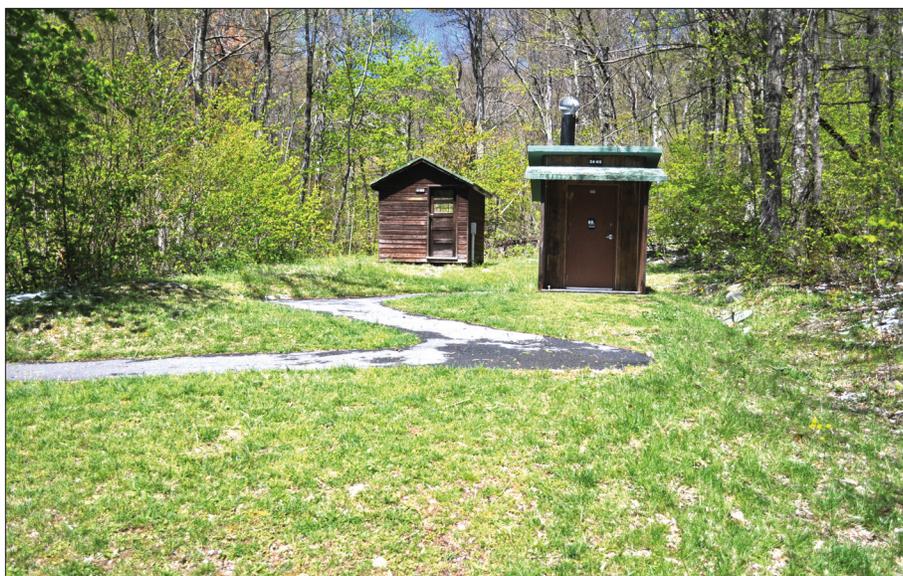
Figure 4.21. Plant screening vegetation. Non-historic features, like the pit toilet and storage shed, should be screened with vegetation to deemphasize their presence in the cultural landscape. (OCLP)

Non-historic structures should be screened and blended with the surrounding forest by planting native shrubs, trees, and ground covers. Planting guidelines should follow the guidance in Task VG-2 and VG-8, including the planting of shade trees and the use of mixed native ornamental shrubs in naturalistic arrangements. The structures should not be hidden completely from view, but framed and partially obscured by vegetation in the foreground.

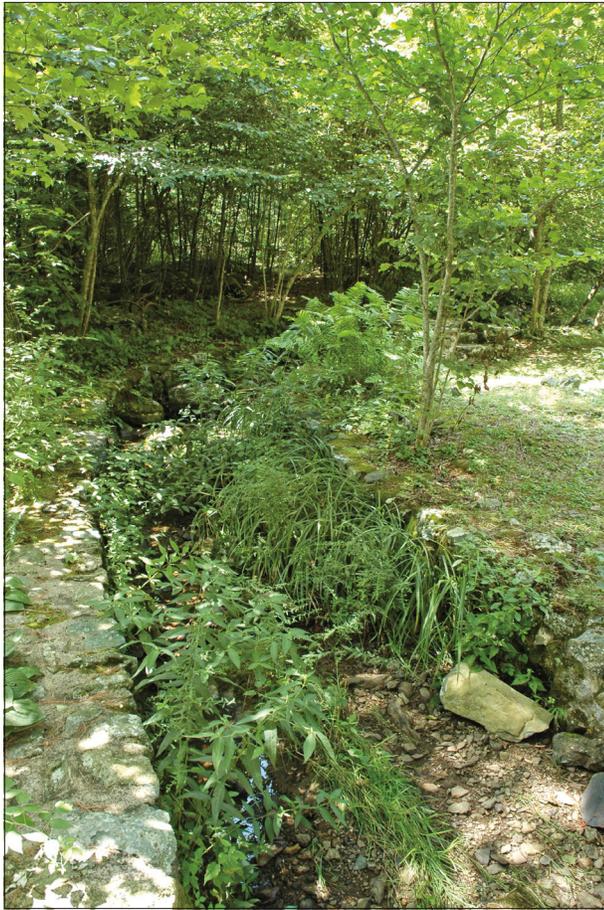
Figure 4.23. Portions of Hemlock Run that have mortared channel walls should be more carefully maintained and preserved. Remove sediment and gravel from the channel bed to ensure free flow of water and remove excess vegetation from channel. (OCLP)

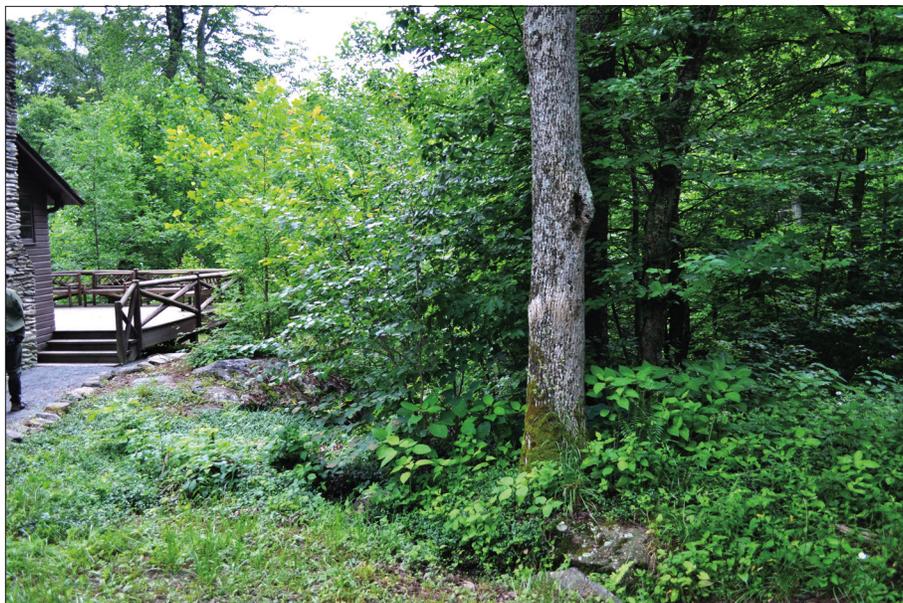
Figure 4.26. Rehabilitate stone fountain and rock garden. Make any necessary repairs to the fountain and remove vegetation and debris from the rock garden. (OCLP)

ed mortar or loose or missing stones and repairs made accordingly. Vegetation growing directly in the fountain should be removed, and the fountain should be maintained free of vegetation. The rock garden should be cleared of soil, debris, and vegetation.

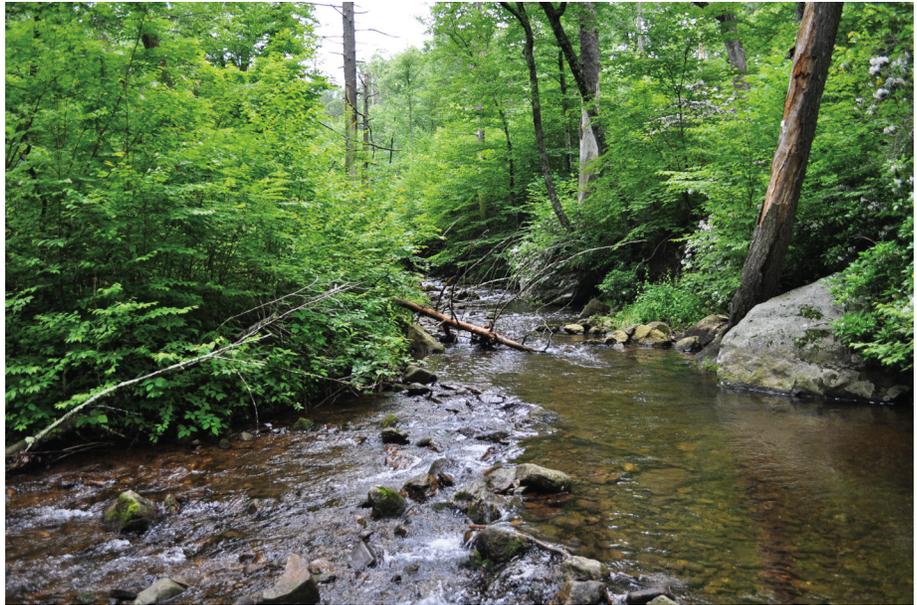
Figure 4.28. Repair the sluice gate to control the water flow to Hemlock Run. (OCLP)

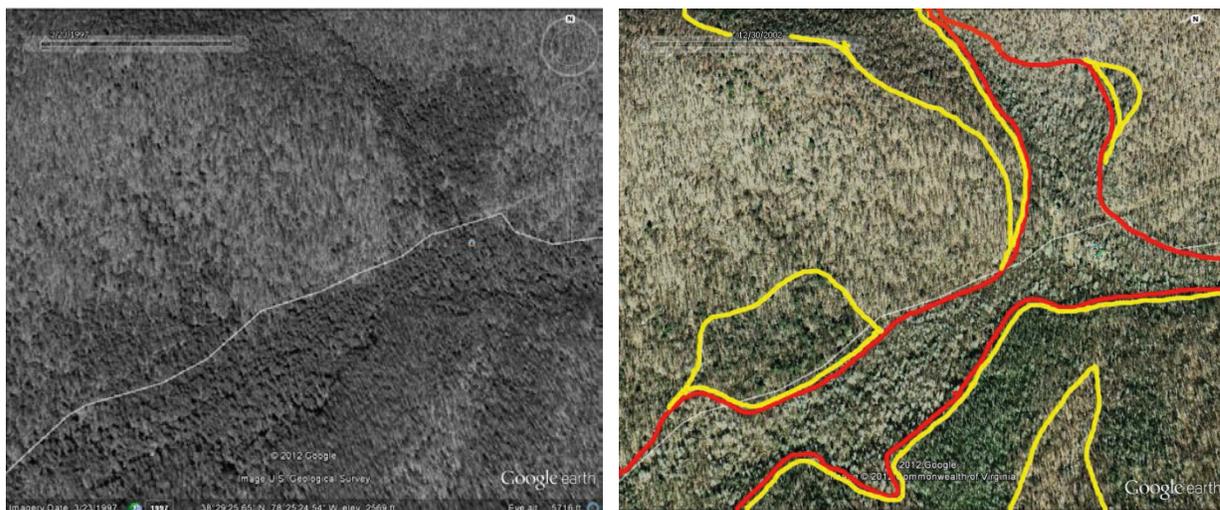
Figure 2.1.1 Satellite images of the Rapidan Camp area taken during the winter of 1997 (left) and winter of 2002 (right). Areas with evergreen vegetation are delineated as being primarily hemlock, appearing as a gray swath of dead trees in 2002 (in red), and other evergreen vegetation (in yellow).

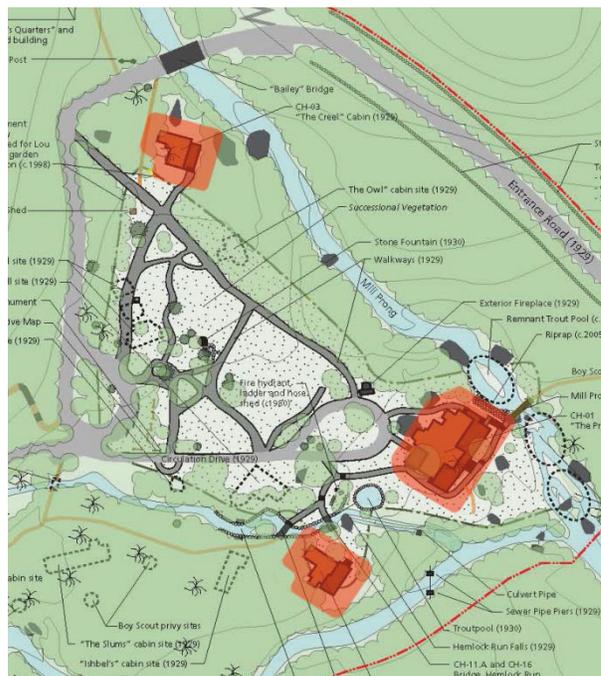
Fig. 3.0 Cabin area shown in red. Map from NPS Cultural Landscape Inventory of Rapidan Camp.

This is defined as a 15 foot zone surrounding the President's Cabin, Creel Cabin and Prime Minister Cabin, and also includes the parking lot and pathway between parking lot and President's Cabin (Figure 3.0). The primary factor in delineating this area is to provide a fire safety zone, and reduce building maintenance and damage risk due to falling tree limbs.

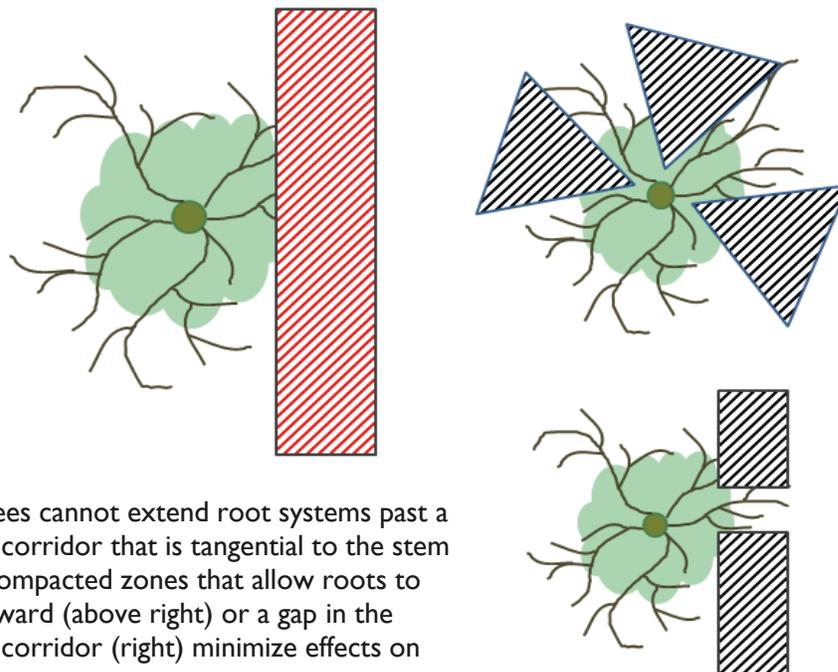
Fig. 3.3 Trees cannot extend root systems past a compacted corridor that is tangential to the stem (above). Compacted zones that allow roots to extend outward (above right) or a gap in the compacted corridor (right) minimize effects on existing trees.

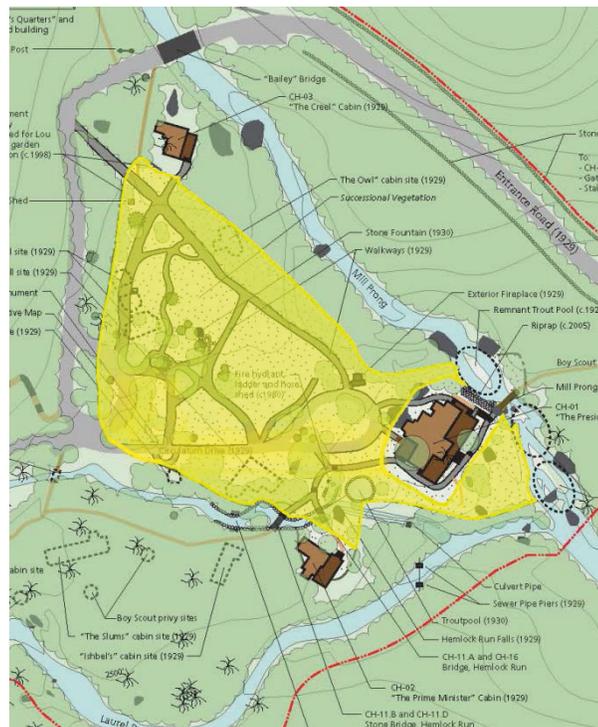
Fig. 4.0 Cabin proper area shown in yellow. Map from NPS Cultural Landscape Inventory of Rapidan Camp.

Camp proper is defined as the main area of Rapidan Camp, excluding areas already described as being immediately adjacent to the cabins and parking area. This area is delineated by the stippled area on the NPS Cultural Inventory Map, which is shown in Fig. 2.2 and Fig. 4.0.

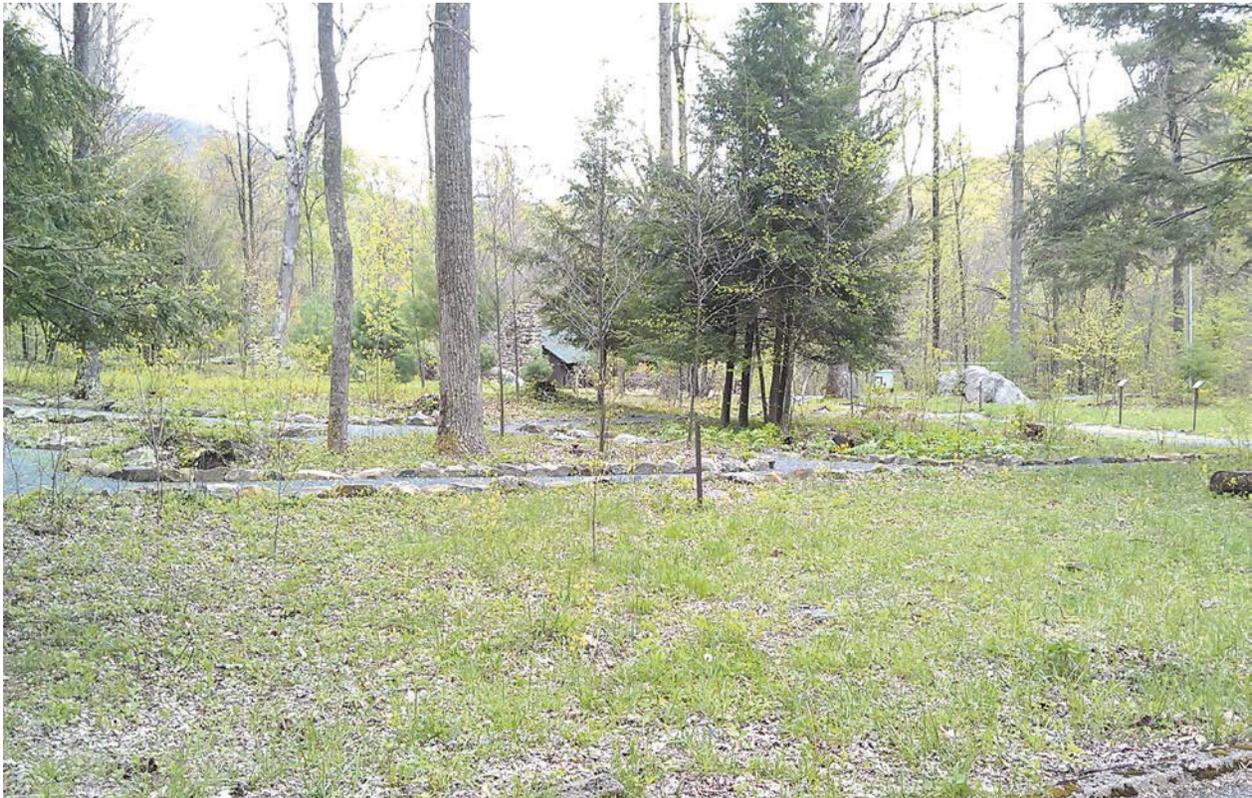
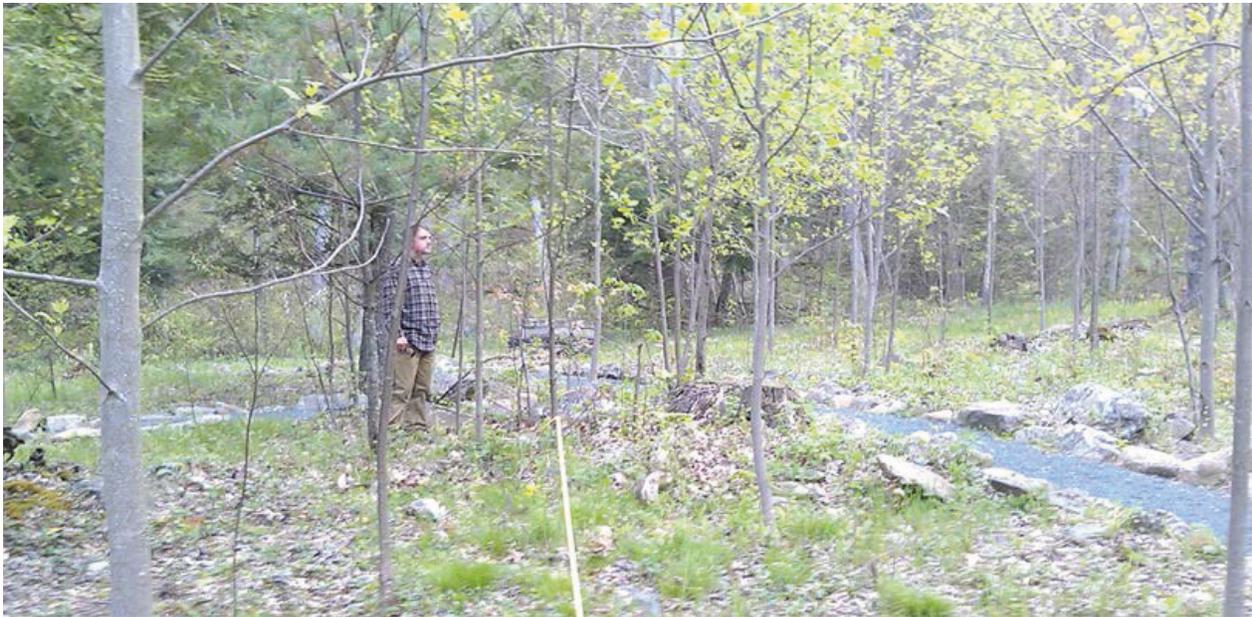
Figure 4.1. Current condition of the vegetation in the immediate vicinity of Rapidan Camp, taken in early spring of 2012. Top: view from the parking area looking toward the President's Cabin. Bottom: young stand of yellow poplar between the President's and Creel cabins.

Vegetation in this area can be characterized as a young hardwood forest. Numerous species are found as young seedlings, however trees surviving to sapling height are much less diverse (Table 4.1). The number of yellow birch and black cherry, and low survival of maple from the seedling to sapling stage, suggests deer browsing is affecting forest regeneration in this area. Both chestnut oak (*Quercus prinus*) and northern red oak (*Quercus rubra*) were present but not common, and did not survive into larger size classes. Eastern white pine has not established naturally, but have been planted along the main path between the parking lot and the President's

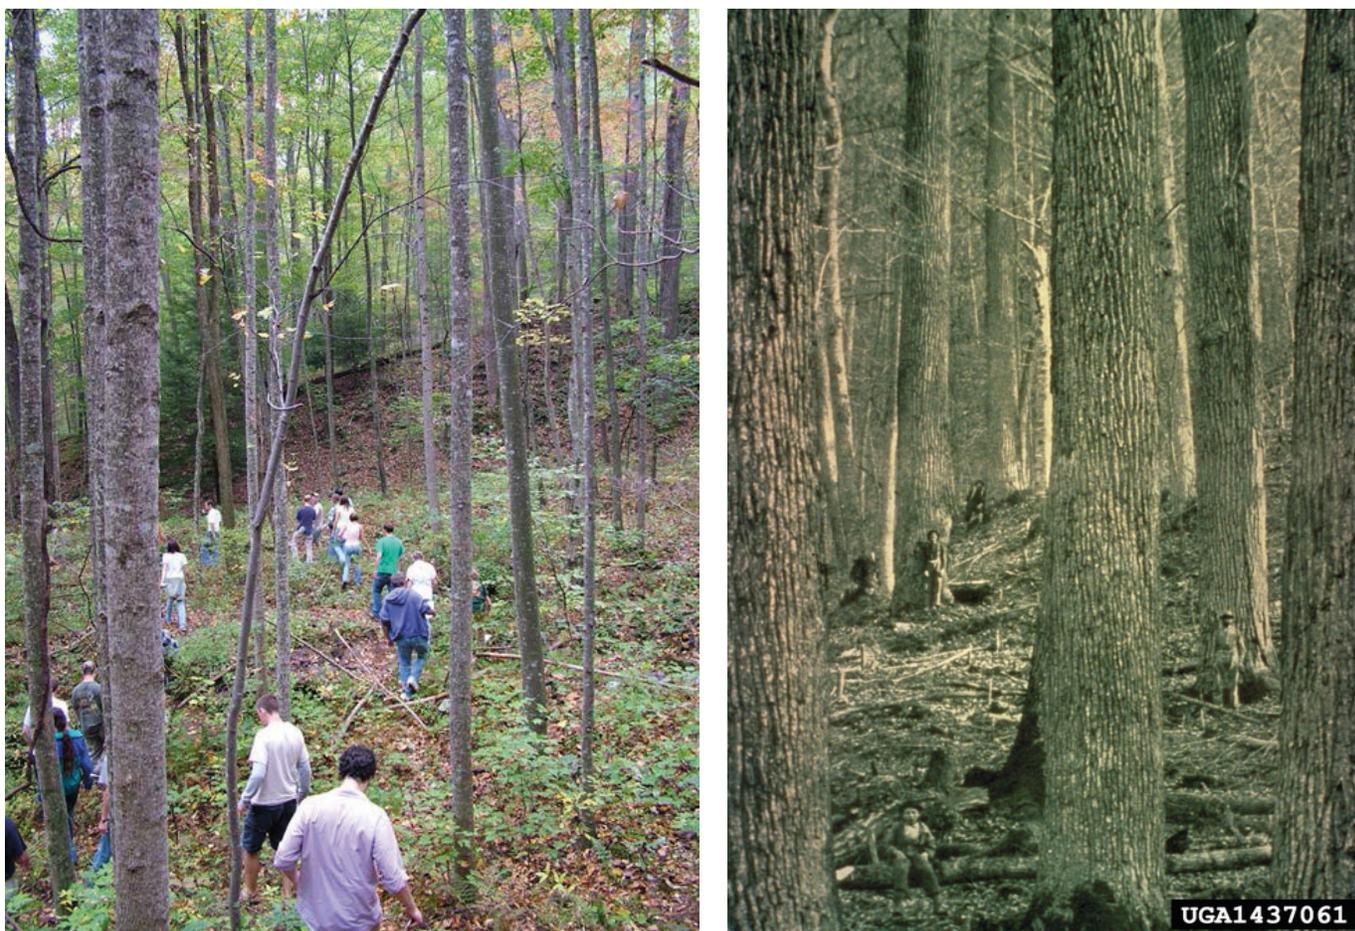
Fig. 4.2.1. Desired conditions in the Rapidan Camp area. Left: students walking in a 30-year-old pure stand of yellow poplar at the research forest at Bent Creek, NC. Right: a mature stand of pure yellow poplar, estimated at 120-150 years of age. National Park Service archival photo, Forestry Images. Note tree diameter in relation to figures in both photos.

The goal for this area is a closed canopy forest of large trees, with little mid-story. This type of forest is typical of many of the “destination forests” of the past and present, such as the “Limberlost” and the Redwood National Forest. Even-aged, closed canopy, and often single species forests with a low-diversity understory dominate the images in an internet search for the terms “beautiful forest”. These forests typically have a basal area of 80-150. The appearance of forests differing in basal area is shown in Appendix B. Based on tree counts, using a technique analogous to prism measurements of variable-radius plots, a basal area of 80-100 was estimated from historic images of Rapidan Camp (Fig. 4.2.2). A regular and dense canopy creates dense shade that inhibits the growth of plants on the ground. The result is often an understory dominated by one or several species. Ferns, moss, and clubmoss are common. Basal areas below 80 allow greater amounts of light to reach the ground, resulting in a dense mid-story and understory that restricts visibility, which is less desirable. Figure 4.2.1 shows an even-

aged yellow poplar forest at an age of 25 to 30 years, and at maturity. If the forest is composed of long-lived species, the general appearance will be maintained over many years unless struck by insects or disease. As the forest matures, basal area changes little but smaller diameter trees die, leaving fewer, but larger diameter trees.

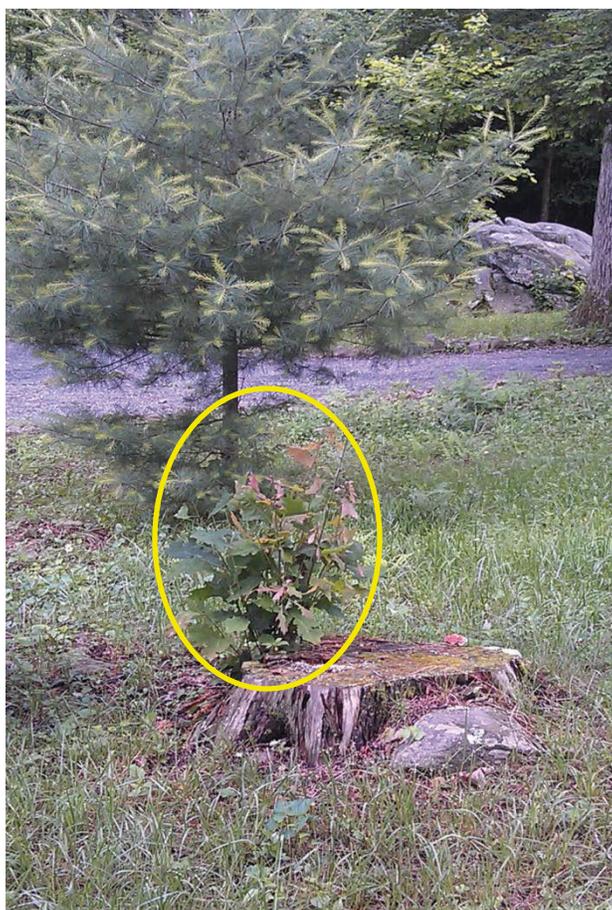
Fig. 4.3.1 Oak stump sprout in front of President's Cabin. Photo taken in summer of 2013.

Some areas currently have no saplings, probably the result of regular weeding. A bare area in front of the President's Cabin has a stump sprout that will grow quickly into a desirable tree, if protected from deer and maintenance workers. This will develop multiple stems, which should be allowed to develop for 3-6 years, at which time all but the largest stem should be removed. Young yellow poplar saplings can be transplanted into areas that are currently bare. To increase transplantation success, roots should be cut in the fall prior to transplanting, and phosphate fertilizer (P only, not NPK) applied inside the cut to stimulate the growth of roots inside the root ball that will be lifted.
