CULTURAL LANDSCAPE REPORT
FOR RAPIDAN CAMP
SHENANDOAH NATIONAL PARK

MADISON COUNTY, VIRGINIA

National Park Service, Boston, Massachusetts, 2014

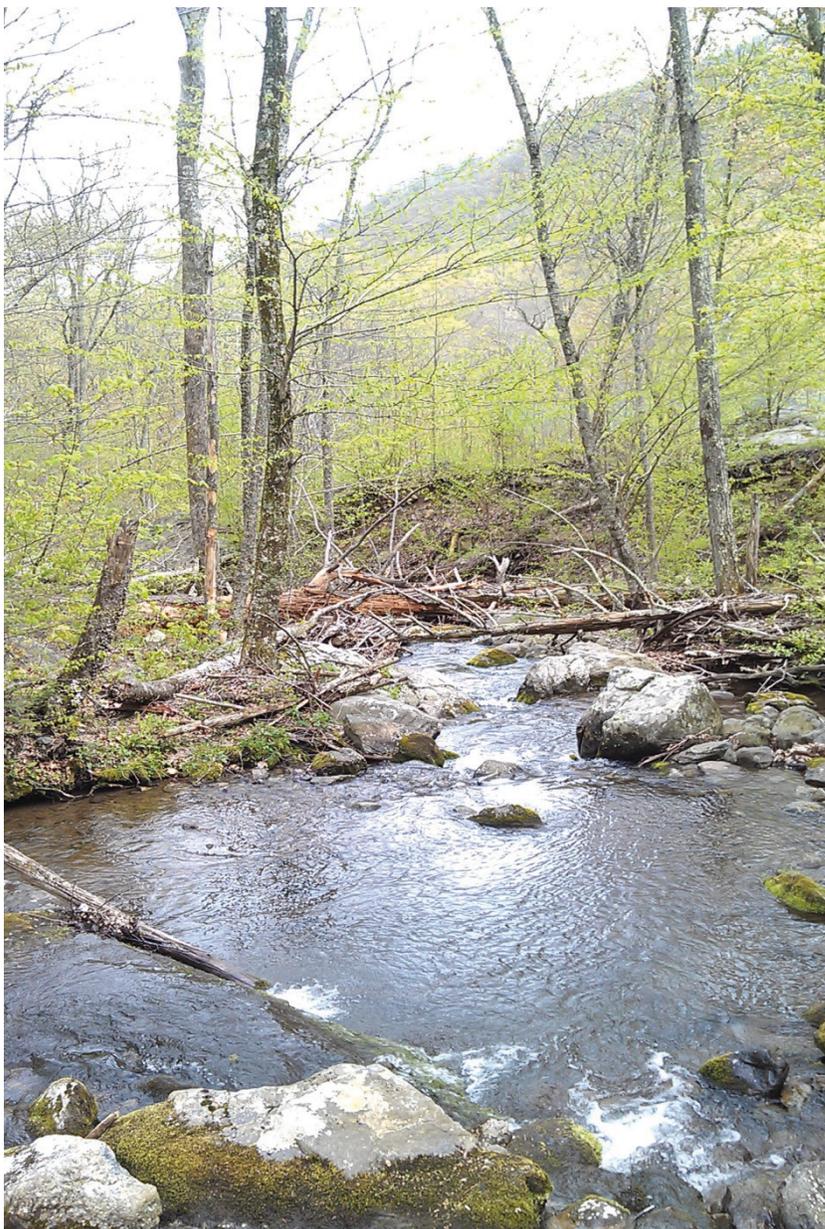
Fig. 5.2. Current conditions of Laurel Prong, showing a deep pool in the foreground with swiftly moving water beyond, and a debris pile crossing the stream in the background.

The remnants of hemlock forest that once stood in this area were apparent when surveying the stream. The majority of hemlock that once lined the stream banks have toppled, and many fell on or across the stream bed. The majority of the reaches surveyed contain at least one large debris pile composed of one or more large downed hemlock and accumulated debris. 52% of reaches contained at least one large log jam, 22% had a moderate amount of coarse woody debris, and 26% had fewer than three pieces of woody debris in the stream.

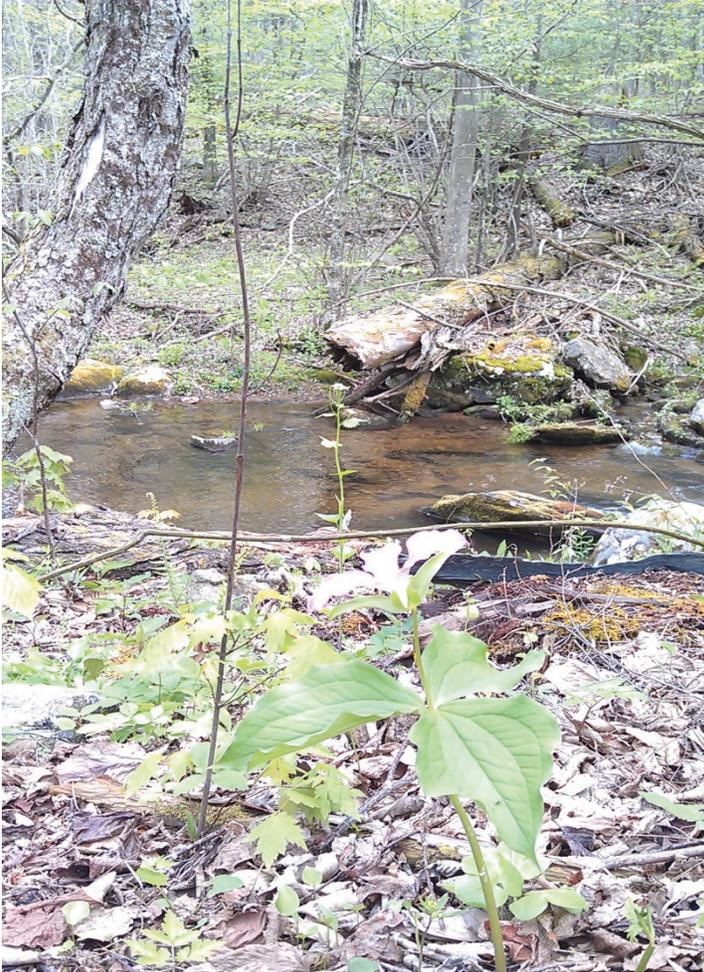
Fig. 6.1. A diverse young hardwood forest in the bottomland area along Hemlock Run. Native understory includes numerous wildflowers including *Trillium* species such as the one seen in the foreground.
