NASA/TM–2014-218543

# Evaluation of the First Transport Rotorcraft Airframe Crash Testbed (TRACT 1) Full-Scale Crash Test

In 2012, the NASA Rotary Wing Crashworthiness Program initiated the Transport Rotorcraft Airframe Crash Testbed (TRACT) research program by obtaining two CH-46E helicopters from the Navy CH-46E Program Office (PMA-226) at the Navy Flight Readiness Center in Cherry Point, North Carolina. Full-scale crash tests were planned to assess dynamic responses of transport-category rotorcraft under combined horizontal and vertical impact loading. The first crash test (TRACT 1) was performed at NASA Langley Research Center's Landing and Impact Research Facility (LandIR), which enables the study of critical interactions between the airframe, seat, and occupant during a controlled crash environment. The CH-46E fuselage is categorized as a medium-lift rotorcraft with fuselage dimensions comparable to a regional jet or business jet. The first TRACT test (TRACT 1) was conducted in August 2013. The primary objectives for TRACT 1 were to: (1) assess improvements to occupant loads and displacement with the use of crashworthy features such as pre-tensioning active restraints and e

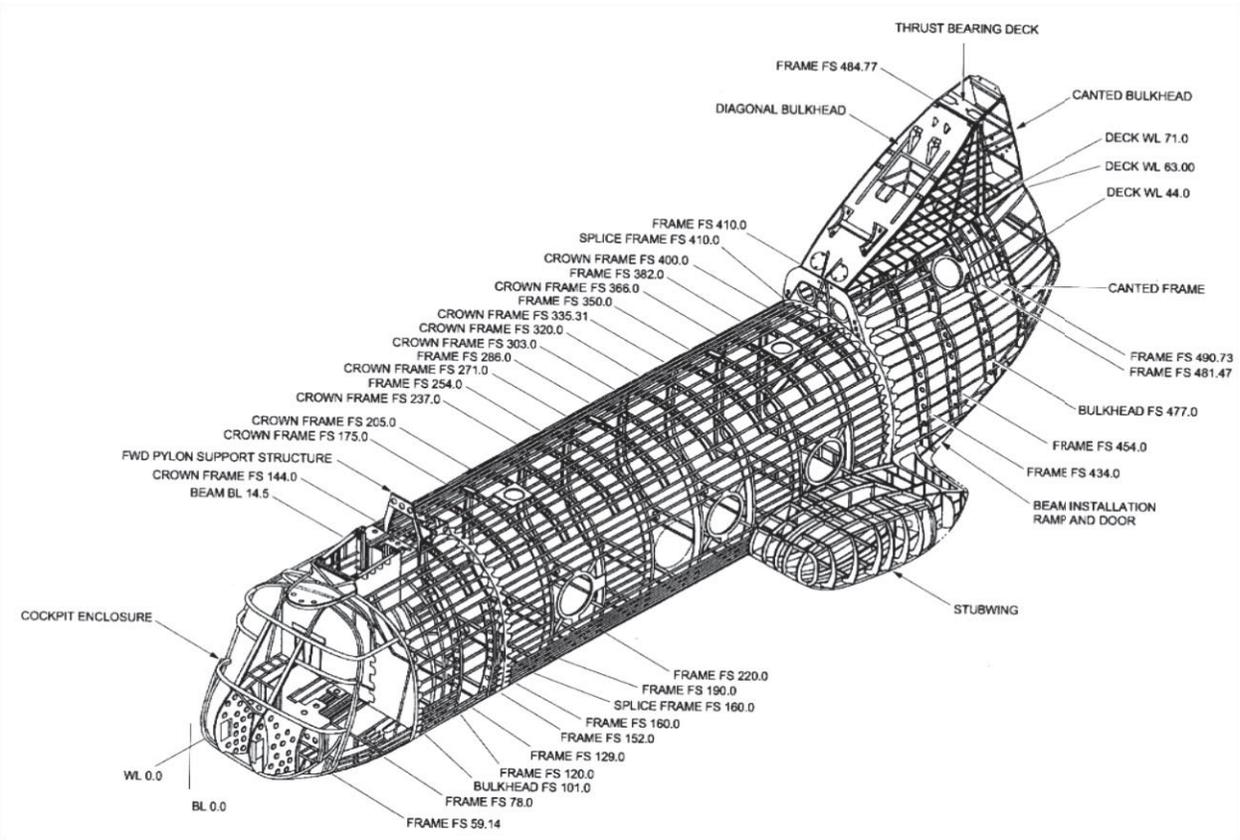
**Figure 2. CH-46E airframe schematic with FS, WL, and BL locations highlighted.**

The CH-46E Sea Knight is categorized as a medium-lift tandem rotor helicopter with length and width of nearly 45 ft. and 7 ft., respectively, and a capacity for 5 crew and 25 troops. A schematic drawing is shown in Figure 2 showing Fuselage Station (FS), Water Line (WL), and Butt Line (BL) locations. These dimensions are given in units of inches. The fuselage design is semi-monocoque with skin stiffeners and frame sections. The cabin fuselage cross section is nearly uniform and is composed primarily of Aluminum 2024 and 7075 alloys. Fuselage frames are spaced longitudinally approximately every 30 inches. Between FS120 and FS410, the fuselage section has a nearly uniform cross-section. The FS locations of major structural features are listed in Table 1.

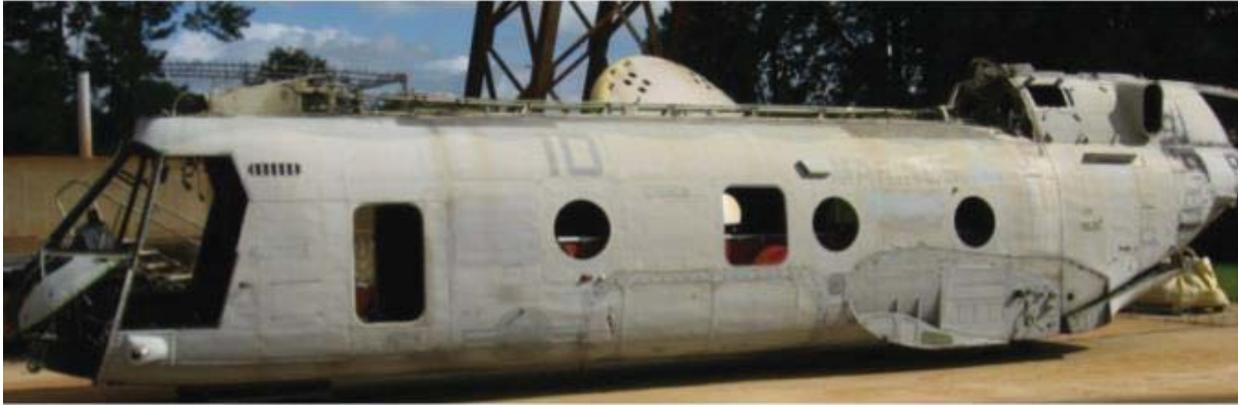
**Figure 3. TRACT 1 fuselage**

In 2012, NASA Langley obtained two CH-46E fuselages from the Navy CH-46E Program Office (PMA-226) that were located at the Navy Flight Readiness Center/Cherry Point. The stubwings which hold the main landing gear were removed for testing, along with the vertical tail and engine, rotor, and transmission components. The weight of these components was not replaced, because the fuselage was intended not to mimic the overall weight and center of gravity (CG) of the CH-46E. The main cabin from the cockpit aft bulkhead to the stubwing area contains five frame sections that are nearly identical in spacing and design to allow multiple occupant, seat, and crashworthy systems experiments to be evaluated. The as-delivered bare fuselage weight was approximately 2,500 lb. A photograph of the TRACT 1 airframe is shown in Figure 3.

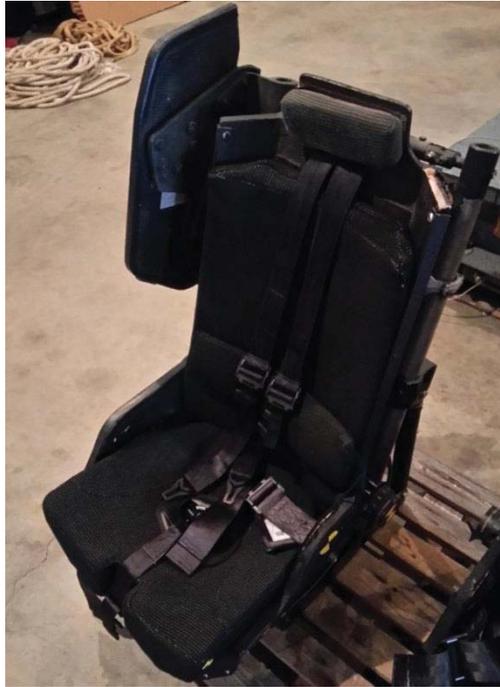
**Figure 4. CH-46E crew seat**

The CH-46E crew seat contains two pairs of energy absorbers (EAs). One pair of variable-load EAs, aligned aft of the seat back, is designed to stroke and limit the loads along the spinal direction. A second pair of fore/aft-oriented EAs limits the seat rail interface loads and prevents detachment of the seat during forward deceleration and occupant flail. The pilot seat is shown in Figure 4.

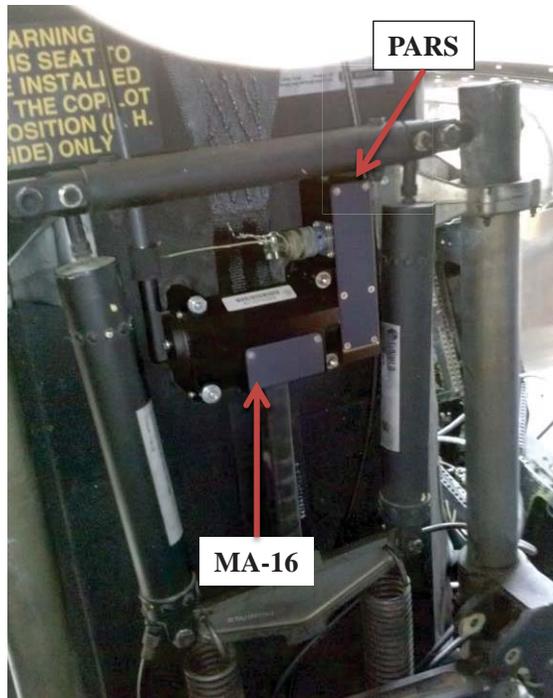
**Figure 5. MA-16 inertia reel with PARS**

Five-point restraints are used with the CH-46E seat. The shoulder webbings are spooled onto the MA-16 inertia reel, which locks passively under inertial loads. As much as 5 inches of extra webbing payout is possible due to pack-down on the spool and elongation due to flail, or forward body displacement. The Pre-Tensioning Aircrew Restraint System (PARS) system is intended to decrease the payout through pyrotechnically actuated spool retraction. Cobham Life Support provided the MA-16 reels, and the PARS pretensioning devices and control modules. The PARS system can be activated with customary crash sensors. For the TRACT 1 test, the PARS was activated at the point of impact with redundant contact switches mounted on the aft belly region. The MA-16 inertia reel and PARS system are located behind the seat back in between the vertical EAs, as shown in Figure 5.

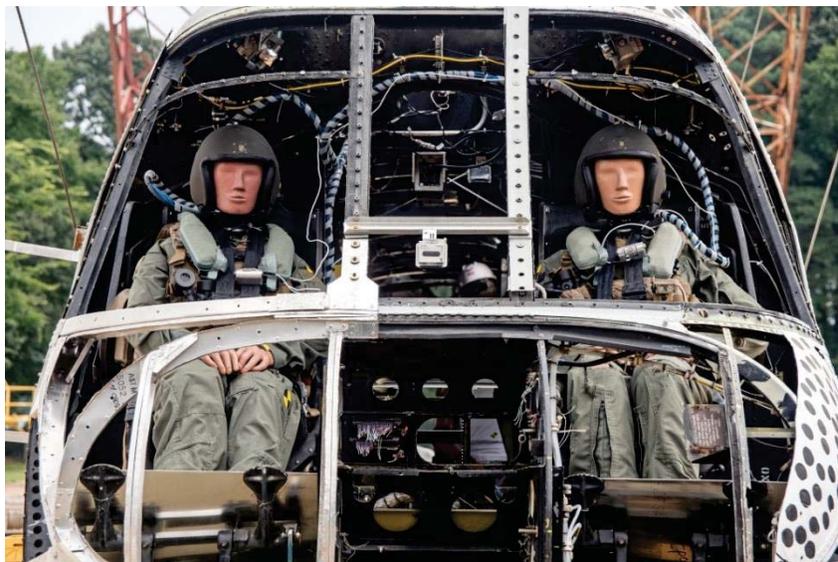
**Figure 6. Cockpit ATDs**

NAVAIR provided two fully instrumented 50<sup>th</sup> percentile Aerospace Hybrid III ATDs for the pilot and co-pilot seats. The ATDs were outfitted with standard flight suits, helmets, and flight gear. The test article did not have a cockpit enclosure forward of the directional pedals. Therefore, aluminum floor pans were added underneath the feet to ensure loads could be distributed through both the legs and the pelvis. The cockpit ATDs are shown in Figure 6.

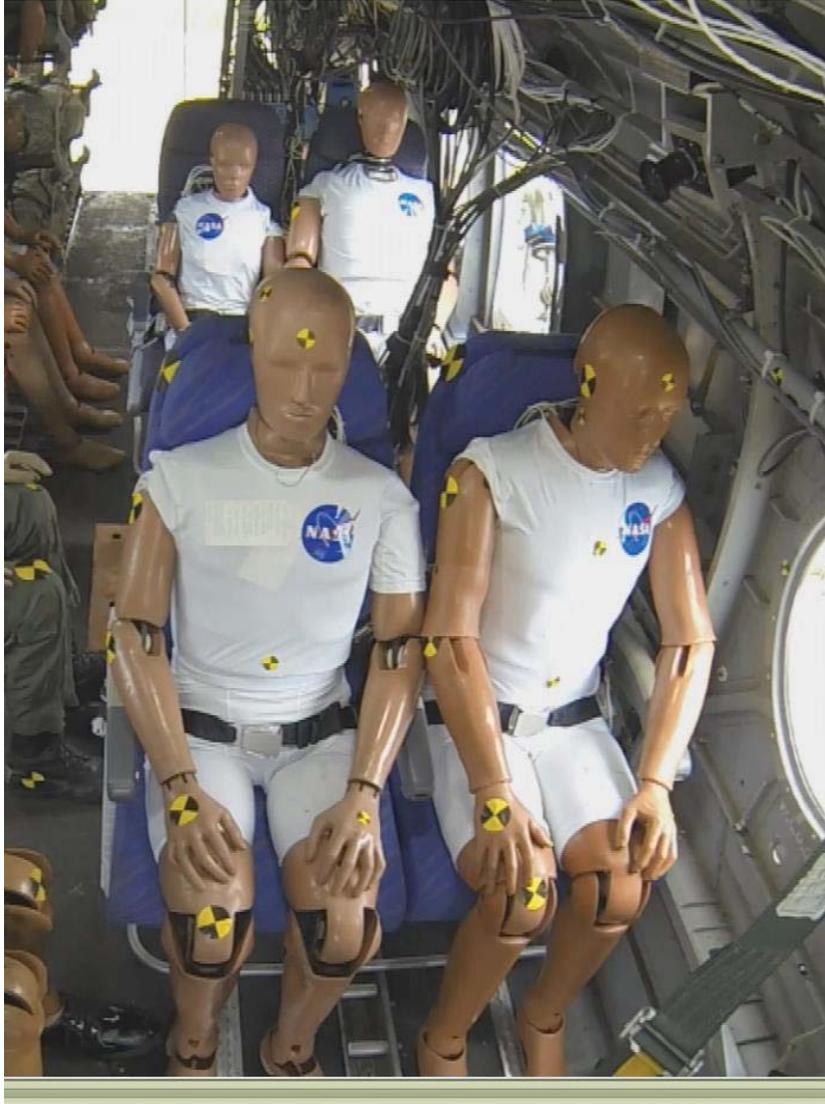
**Figure 7. Floor-mounted cabin seats with ATDs**

Two pairs of passenger aircraft seating systems certified to Part 25 standards (ref. 11) were donated by aircraft seat manufacturers. The first seat pair contained a diagonal strut to absorb loads. The second seat pair contained lightweight seat legs without dedicated energy absorbers. Seat legs were adjusted and centered to 23 inches of spacing to share a single pair of seat rails. Four LandIR ATDs were used for these seats. A 50<sup>th</sup> percentile Hybrid II and 50<sup>th</sup> percentile FAA Hybrid III were seated in the first pair. A 5<sup>th</sup> percentile female and a 95<sup>th</sup> percentile male were seated in the second pair. The floor mounted cabin seats with ATDs are shown in Figure 7. The floor at FS 254 was also loaded with 400 lb. of ballast mass to provide mass loading on the subfloor comparable to two pairs of seats.

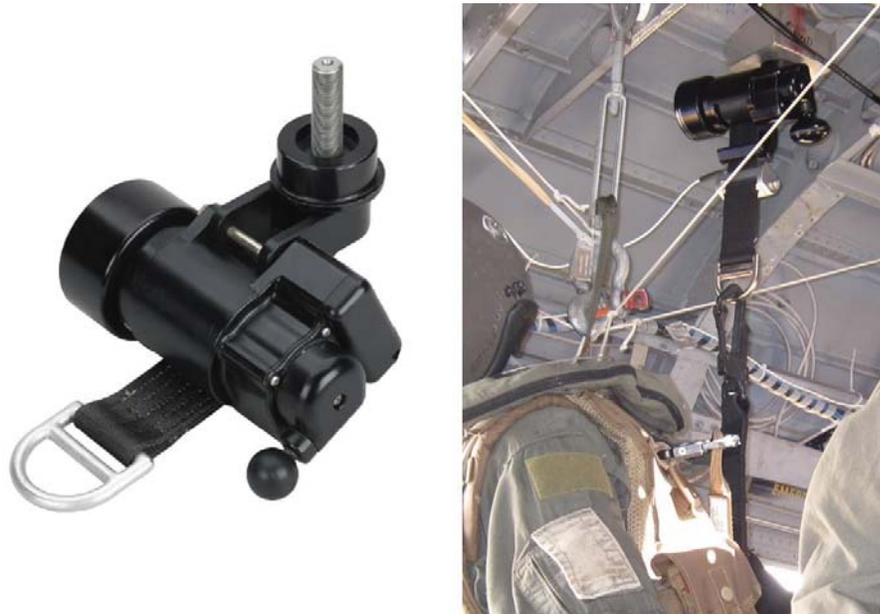
**Figure 8. MARS**

The MARS system was developed by Cobham Life Support as a variation on the MA-16 inertia reel (ref. 12). The MARS mounted in the TRACT test article is shown in Figure 8. The reel can be mounted along multiple cabin ceiling locations, and extends and retracts the webbing as the aircrew moves about the cabin. In a mishap, the retractor locks and slack is minimized. The MARS has been evaluated at the component and crash sled level under dynamic loads, and in flight tests, but not in a full-scale combined velocity impact environment.

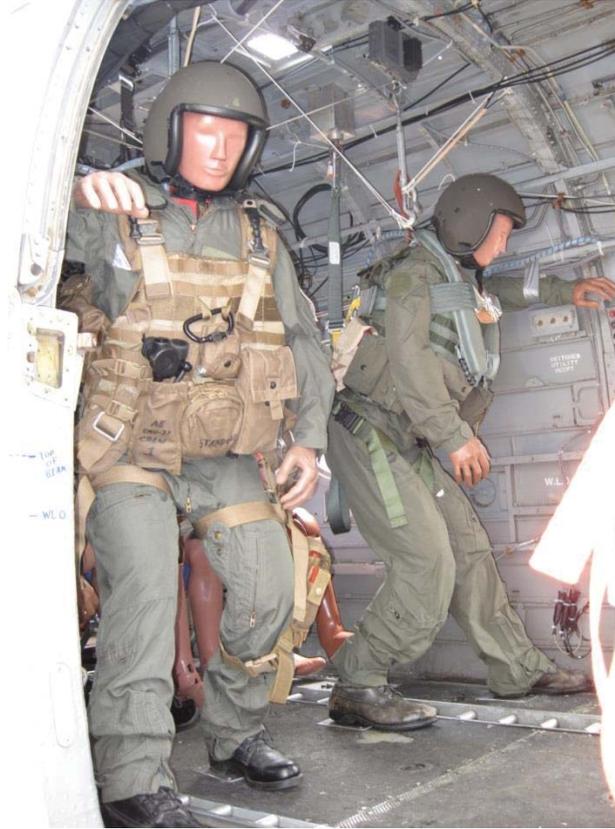
**Figure 9. Standing ATDs**

NAVAIR provided (2) fully instrumented 5<sup>th</sup> percentile male Aerospace Hybrid III ATDs, one attached to the MARS, and one attached to a standard gunner's belt. The smaller 5<sup>th</sup> percentile ATDs were used due to cabin height. To secure the standing ATDs in position during pullback and swing, the back of each neck was supported by thin steel cabling, and stabilized by parachute cords. A single pyrotechnic cable cutter was used to sever the steel cable at the point of impact. Hook and loop pads were used to hold boots in place. A photograph showing both standing ATDs is shown in Figure 9.

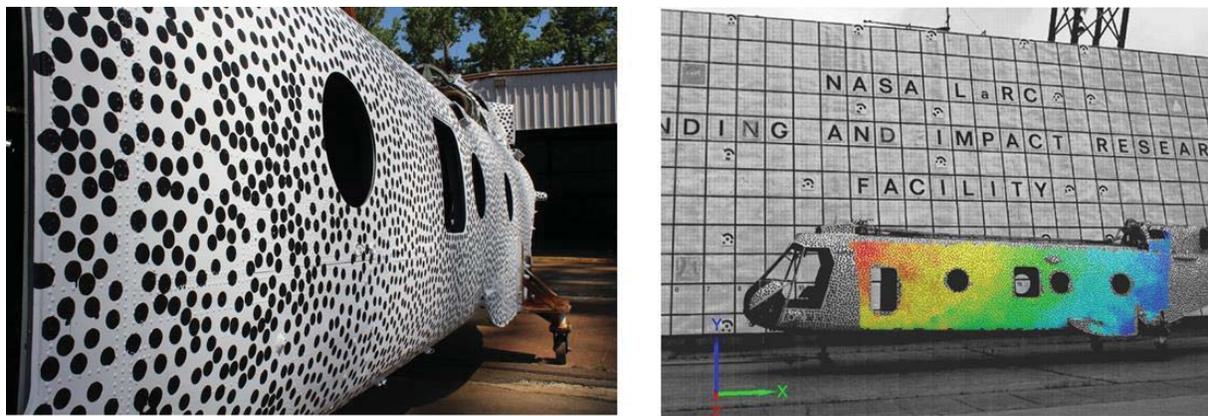
**Figure 10. Full-field photogrammetry, strain pattern**

impact. A random pattern of over 8,000 1-inch diameter dots was applied to the port airframe skin from the cockpit to the tail. After a camera calibration procedure is completed, the cameras are able to determine the position of each airframe dot in space. Pattern recognition algorithms sense relative deformation between dot groups and an entire deformation field is constructed. The dot pattern for the TRACT and an example of a fringe plot overlay is shown in Figure 10. During test preparation, the airframe was loaded onto a trailer and pulled across the gantry to calibrate the photogrammetry system. The colors in Figure 10 represent relative distance traveled based on a fixed camera location.

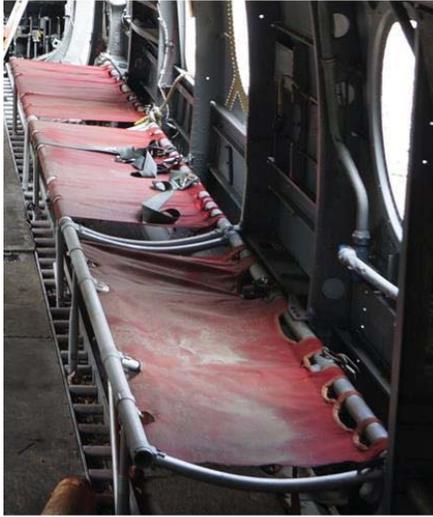
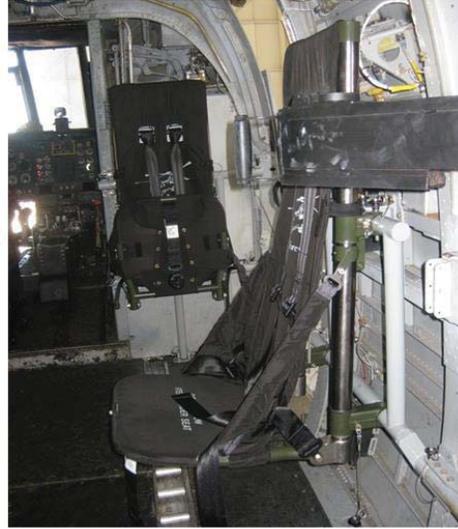
Troop Bench

CACS Seat in Crew Chief and  
troop position

The CH-46E troop seats are side-facing. The legacy CH-46E troop bench is an aluminum seat pan frame with canvas mesh overwrap and lap restraints. The CH-46E Crew Attenuating Crew seat (CACS) is an energy absorbing foldable seat with a five-point restraint. Two wire bender struts provide vertical load limiting capability for the restrained occupant. The typical troop bench and CACS configurations are illustrated in Figure 11.

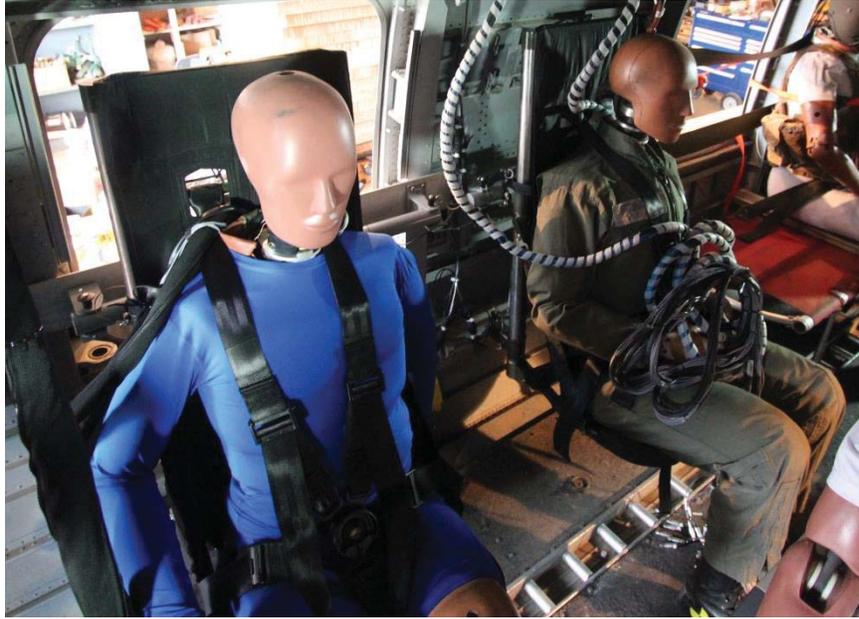
**Figure 12. CACS side-facing ATDs**

CAMI provided a fully instrumented FAA 50th percentile Hybrid III ATD with an ES-2re head and neck for use on one CACS seat. The FAA Hybrid III construction differs from the standard model by including components to permit accurate evaluation of injury risks due to vertical (through the spine) loads. The ES-2re head and neck components provide more biofidelic head/neck kinematics in the lateral direction and injury criteria are available to relate the neck loads measured to injury risk. NAVAIR provided a fully instrumented 50th Aerospace Hybrid III ATD in a second CACS seat for comparison to the CAMI ATD. The Aerospace Hybrid III can also evaluate injury risk from vertical loading. It uses a “pedestrian” pelvis assembly that provides more freedom of motion for the lower legs than provided by the “sitting” pelvis design of the FAA Hybrid III. Both Hybrid III models have shoulder and hip construction that provide consistent belt interaction. Figure 12 shows the CACS side-facing ATDs. Two 50th percentile Hybrid II LandIR ATDs were seated on the troop bench and restrained with lap belts (Figure 13). It was anticipated the troop bench would not survive the impact undamaged. Therefore, the troop bench experiment functioned mostly as a performance benchmark when evaluating the response of side-facing occupants.

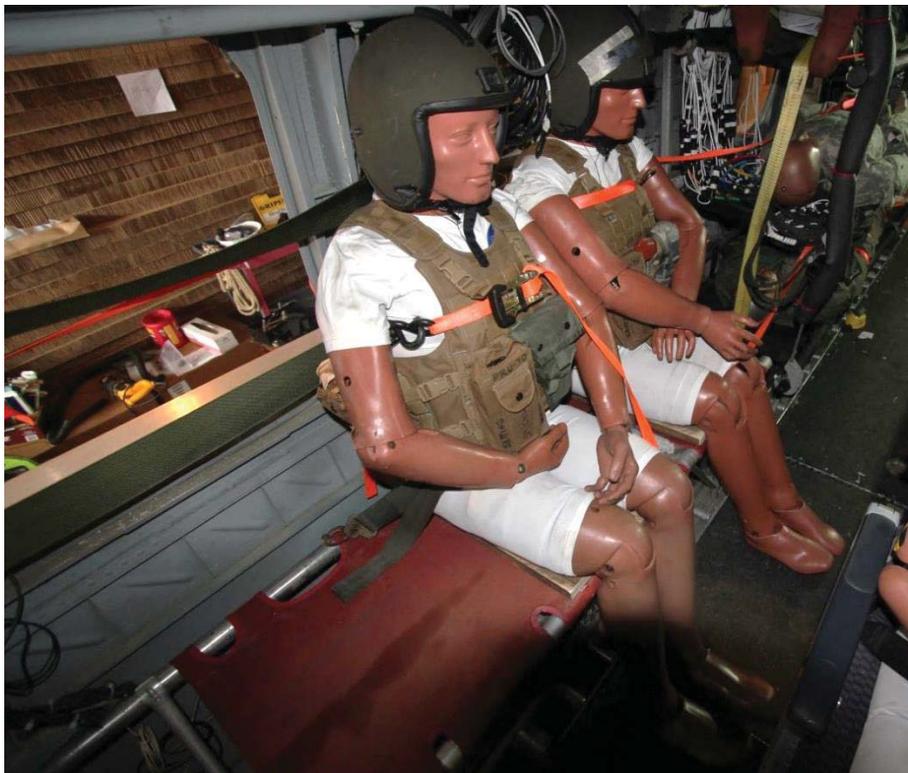
**Figure 13. Troop bench ATDs**

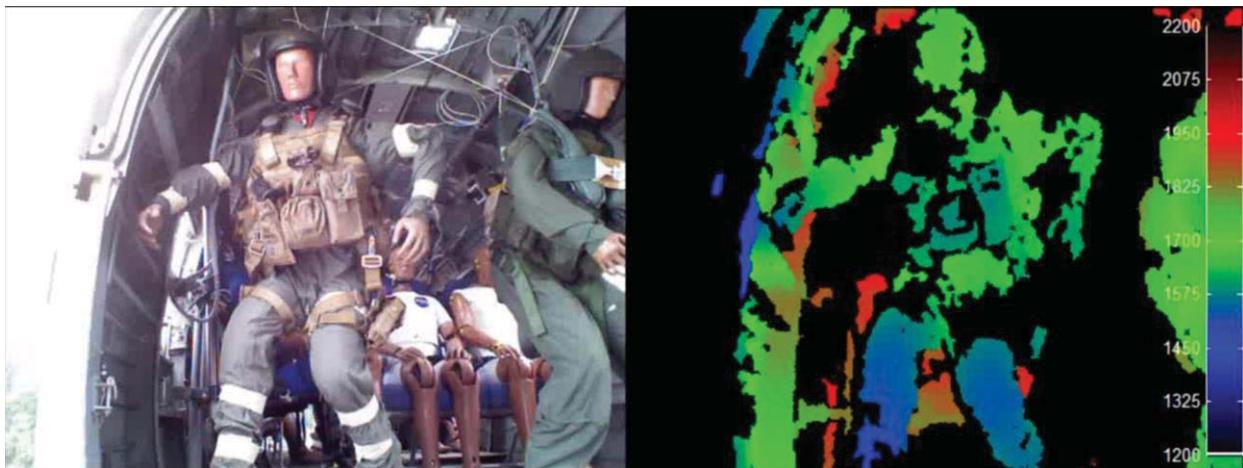
**Figure 14. Markerless Tracking**

An experiment to utilize commercial markerless tracking hardware within a dynamic impact environment was proposed. The standing ATD with the MARS restraint provided a suitable target for tracking. The commercial hardware consisted of a color digital video camera, along with a depth sensor/camera and an infrared projector combined in one package. The depth sensor and infrared projector worked in conjunction to obtain depth measurements in the field of view via a projection/comparison system. The infrared projector projected an infrared dot grid into the field of view, while the depth sensor measured the distance between all of the individual projected dots. The sensor then compared the calculated distances to a calibrated value. The difference between these two values was the measured depth of the projected dots under interrogation. When measured over the entire field of view, a full field depth field was generated. Internal logic preprogrammed with the sensor further examined the depth field and determined the presence of a human by employing various edge detection and area centroid algorithms. If a human shape was detected, a “best fit” three-dimensional skeletal wireframe could then be computed. The wireframe data can be manipulated to give three-dimensional positional time histories of 19 individual joint locations present in the body. From time histories of the joint locations, joint forces could be related to conventional ATD injury criteria. Figure 14 shows the camera field of view and depth fringe plot.

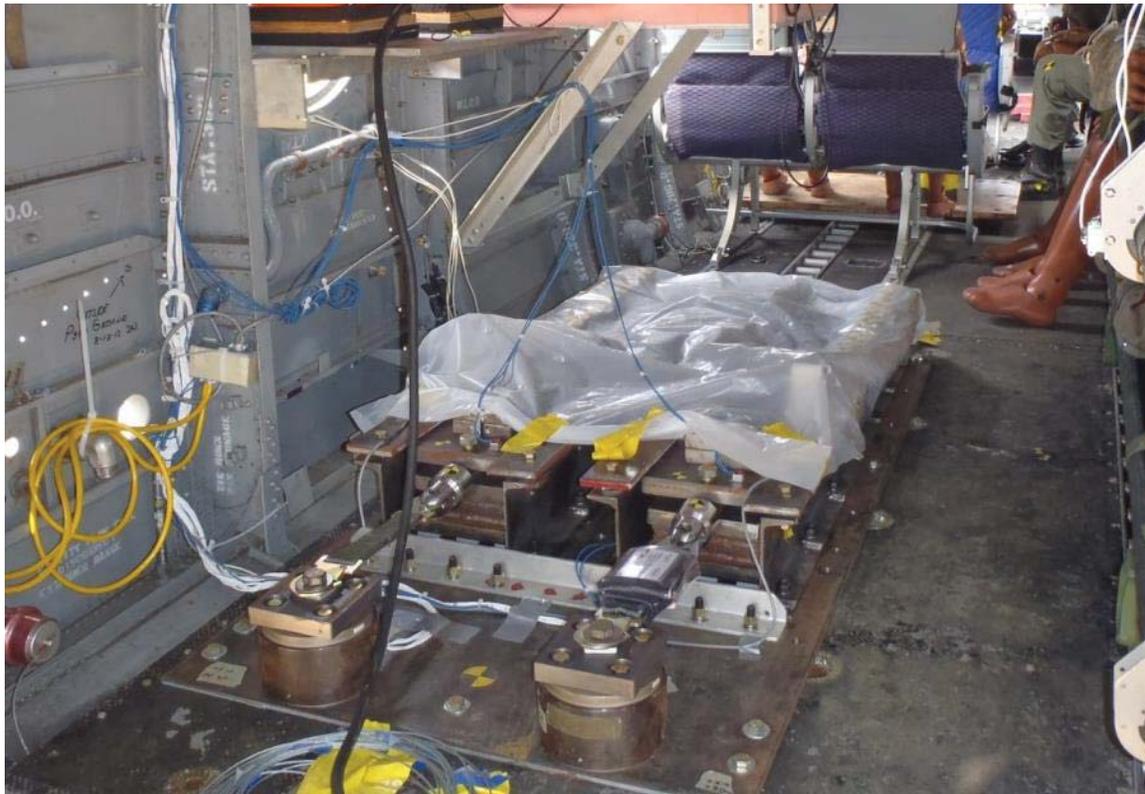
**Figure 15. Cargo Restraint Experiment**

A load-limiting cargo restraint was developed by Penn State University that uses a stitch ripping device (SRD). Energy is absorbed by webbing extension, thread rupture and stitch slippage. The restraint was attached to a breakaway fitting rated for 5,000 lb. failure load. The fitting was then connected to a 500 lb. sliding mass. A standard nylon webbing restraint was also evaluated alongside the SRD restraint with the same breakaway fitting and sliding mass. With 10 g deceleration, the loads would be exceeded in the standard restraint, causing detachment of the mass. The load-limiting restraint was designed to limit to 3,000 lb., and would therefore stroke without fitting detachment. The load-limiting experiment is shown in Figure 15. It was fabricated to be self-contained on a platform that could be bolted to the aft TRACT cabin floor. Housings were assembled around the masses for containment during deceleration.

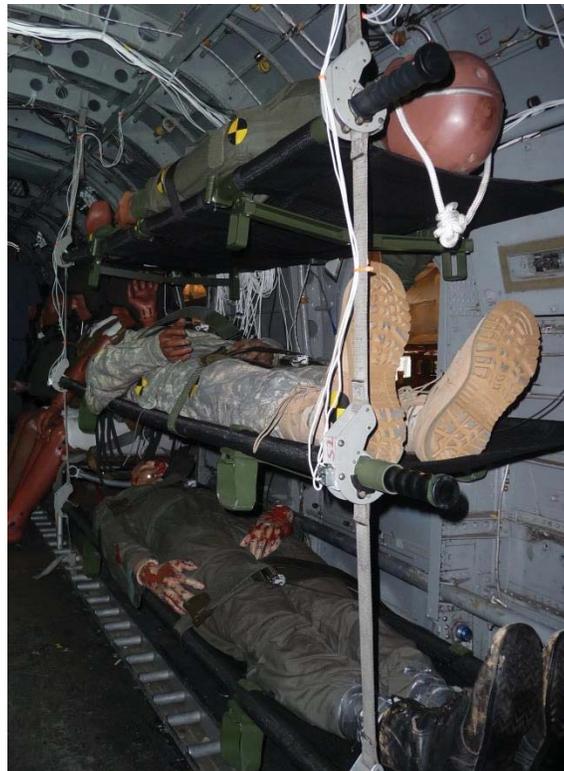
**Figure 16. Patient litter experiment**

The litter experiment involved a combination of DOD resources. USAARL supplied a three-tiered litter stanchion system compatible with the CH-46. The stanchion interfaces with existing sidewall, ceiling, and cargo rail supports. Two litters, one instrumented 50<sup>th</sup> Aerospace Hybrid III ATD, and one 200 lb. Grumman-Alderson Research Dummy (GARD) manikin were provided by the USAARL. NAVAIR provided one litter and a second GARD manikin. The two GARD manikins provided the proper mass loading of the litter, which is depicted in Figure 16.

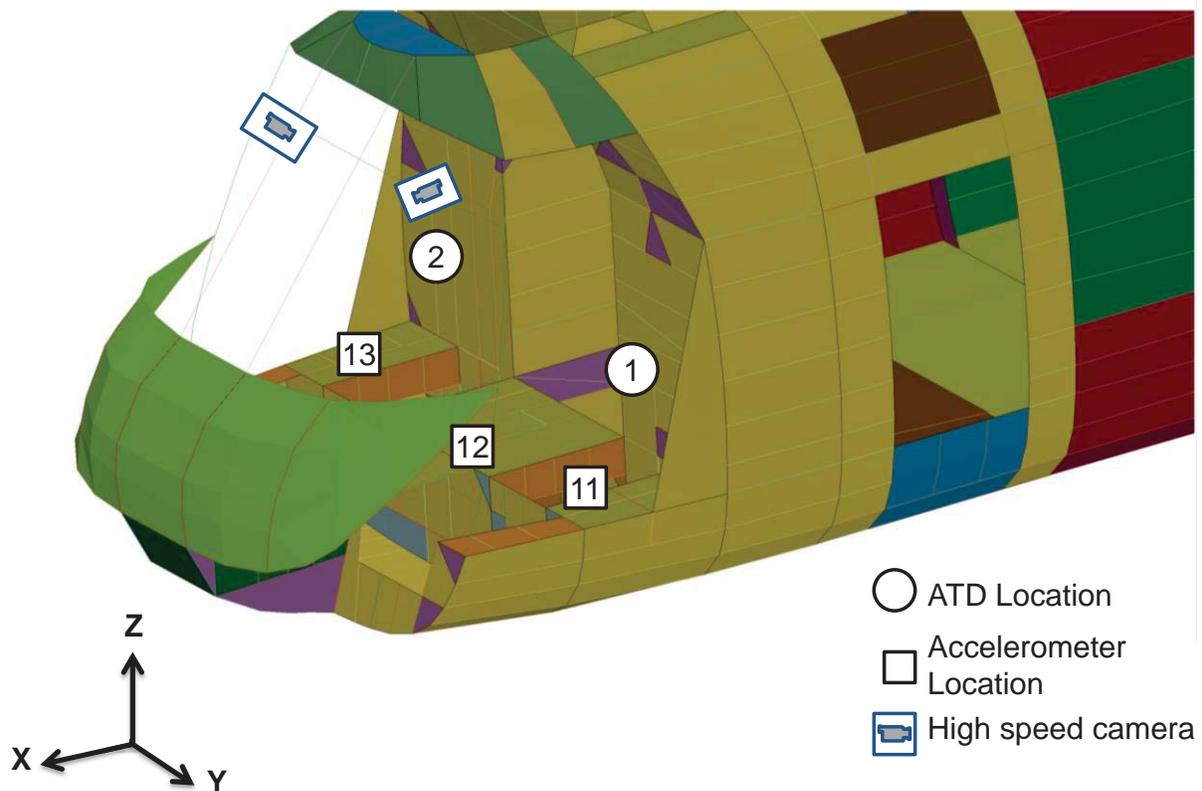
**Figure 17. Cockpit instrumentation**

CAMI provided a DAS rack that linked with the LandIR DAS system and would record all responses for their ATD. USAARL provided DAS racks that were also linked with the LandIR DAS system and would record litter instrumentation along with other sensors located in the aft cabin. The LandIR, CAMI, and USAARL DAS racks were connected in series to receive common trigger, onboard battery power, and DAS software control. NAVAIR supplied a separate DAS that was compatible with the NAVAIR ATD instrumentation. The NAVAIR DAS was independently controlled and powered with onboard batteries. The DAS racks were installed at two locations on the cockpit bulkhead and on a sidewall-mounted shelf aft of the second forward facing seat pair.

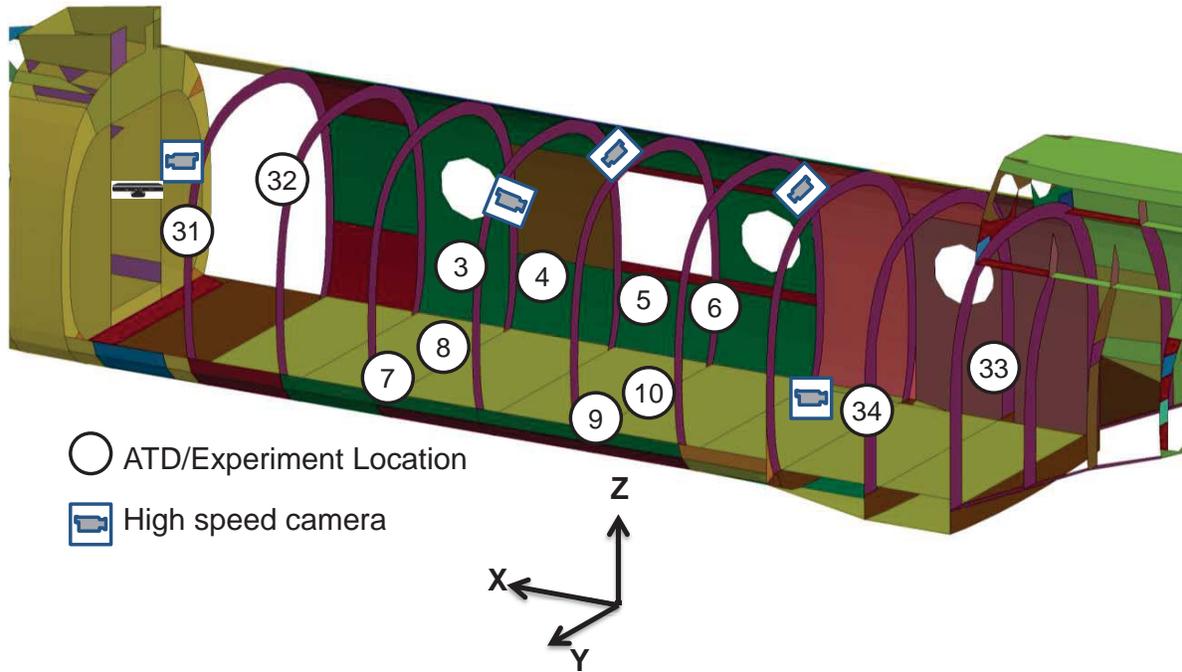
Figure 18. Cabin instrumentation- ATD and high speed camera, isometric view

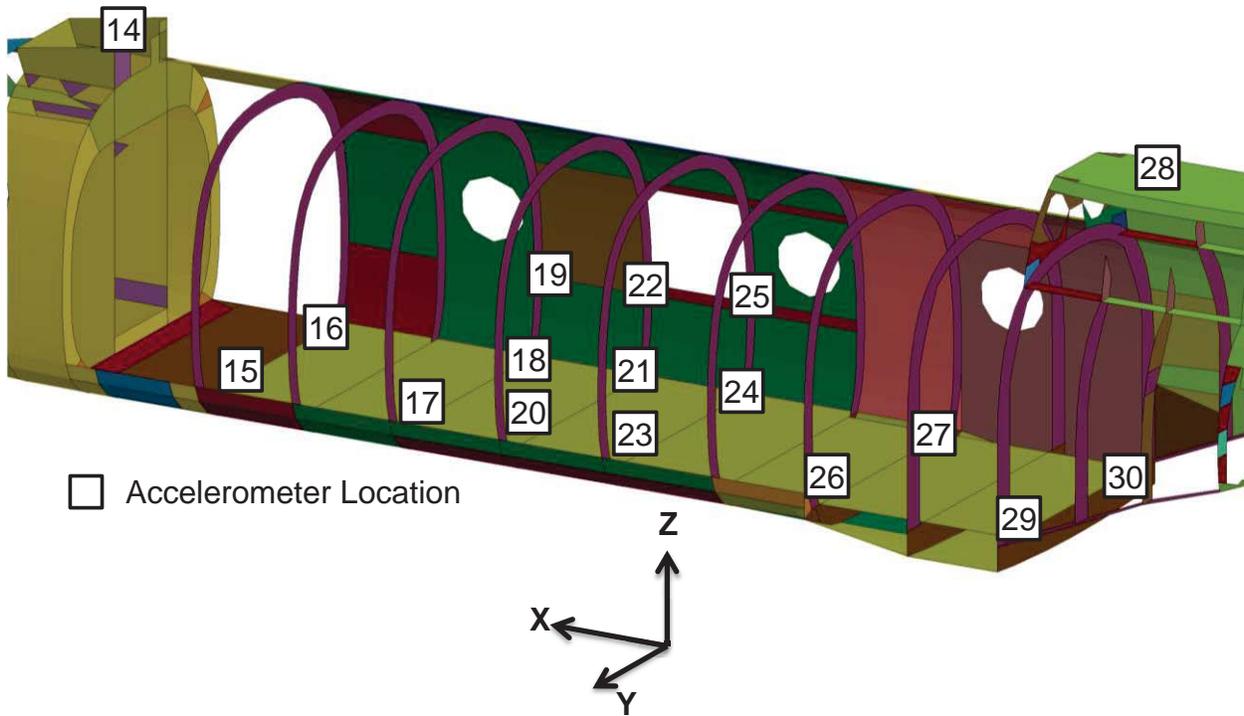
Figure 19. Cabin instrumentation- accelerometers

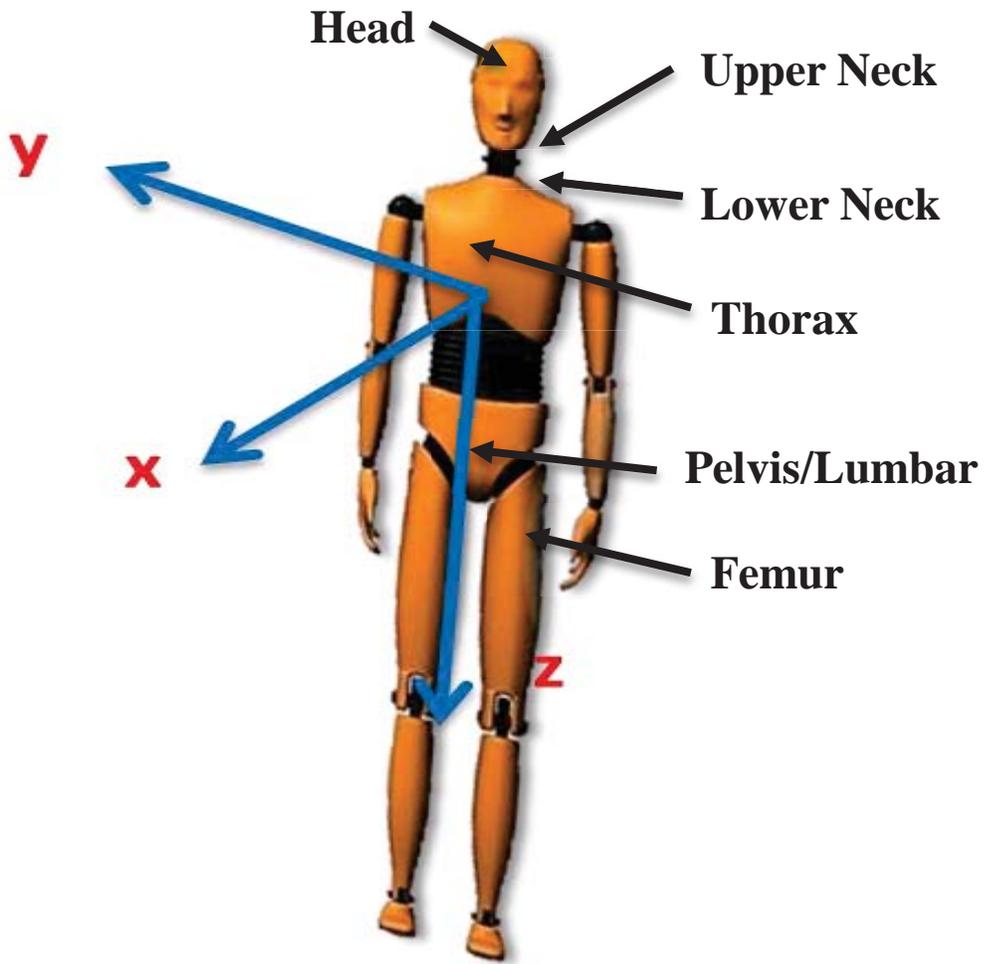
Figure 20. ATD Coordinate System and instrumentation Location

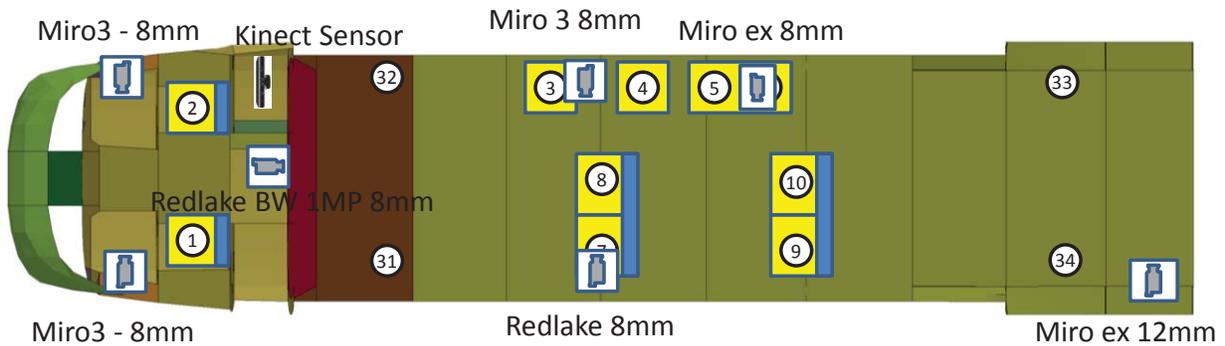
Figure 21. Cabin instrumentation- ATD and high speed camera, top view

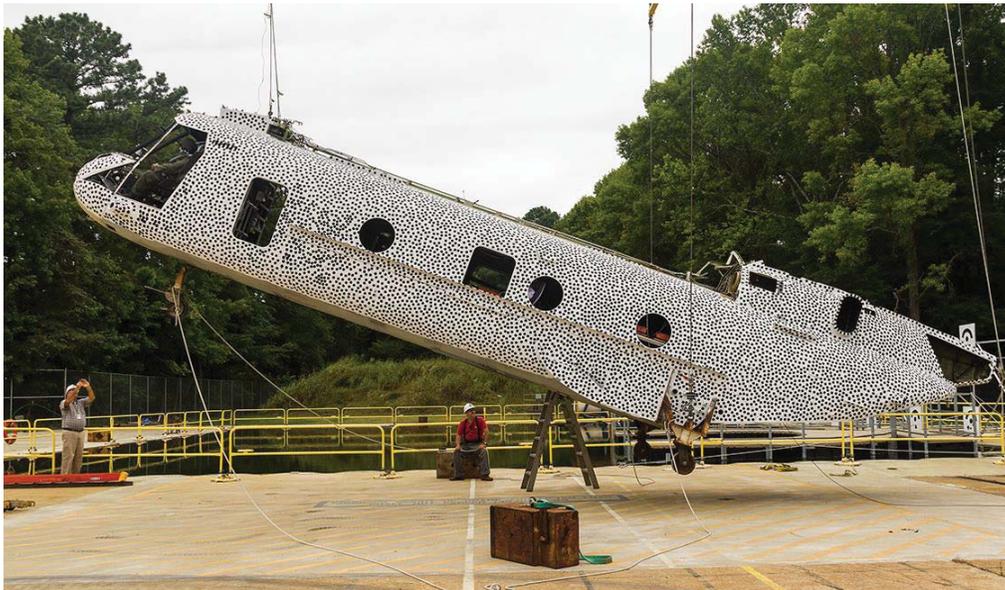
**Figure 24. Photograph taken during weight and balance testing**

The locations of the four swing cable and two pullback cable interfaces to the TRACT test article were dependent on the location of the CG. Any misalignment of the cables relative to the CG would cause the test article to pitch and roll upon release, causing a deviation from the intended impact attitude. To verify the predicted weight and balance estimates, the test article was suspended from three cables and pitched up to determine the CG in all three axes, as shown in Figure 24. The fully-loaded, fully-instrumented test article weighed 10,300-lb. The vertical CG was 3 inches above the swing cable and 6 inches above the waterline. The lateral CG was less than 1 inch from the centerline. The longitudinal CG was near FS 260.0. The actual weight and CG location matched well with the estimates.

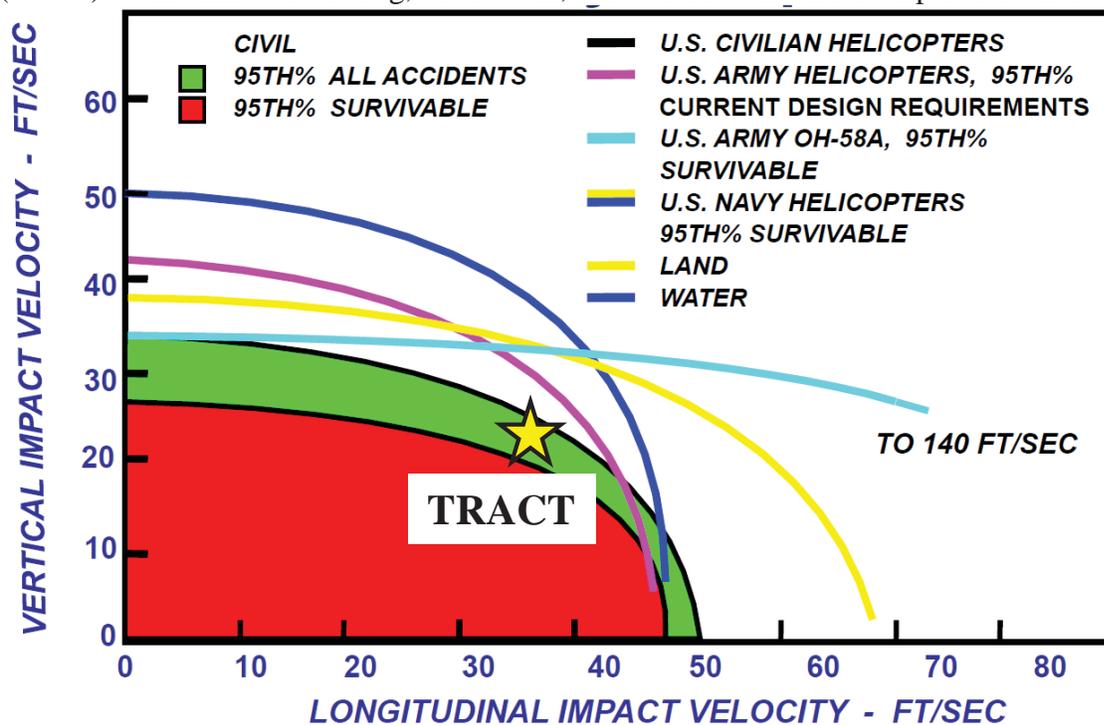
Figure 25. Comparison of civil and military survivable velocities

The impact conditions that were defined for the TRACT 1 test are considered to be severe but survivable, based on a survey of mishap data. Figure 25 shows a plot of the 95<sup>th</sup> percentile velocity change distributions for both civilian and military rotorcraft. The shaded regions pertain to civilian rotorcraft, while the solid lines show boundaries for military design requirements and mishap data. The velocity profiles for military aircraft are much higher than civilian with the inclusion of MIL-STD-1290 qualified rotorcraft. A velocity was chosen that would not extend beyond the civilian envelope. By also taking into account the achievable swing velocities of the LandIR, the vertical and horizontal velocities selected were 26 ft./sec and 35 ft./sec, respectively. A pitch attitude was chosen that would guarantee the test article would impact the surface at a nearly flat or slightly nose-up attitude. The accuracy of the pitch attitude for LandIR full-scale swing testing is  $\pm 1$  degree. A nose-up attitude of 2 degrees was selected.

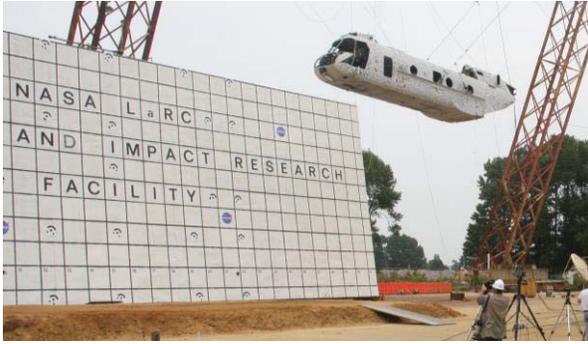
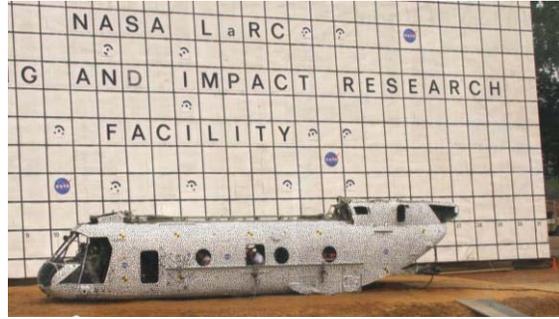
(a) Pre-test photograph.

(b) Post-test photograph.

Photographs of the TRACT 1 airframe in the release position and just following impact are shown in Figure 26. All external and onboard high speed video cameras properly triggered and recorded data through the swing and impact phase. The actual impact conditions are listed in Table 7. A photo time lapse from an external high-speed camera is shown in Figure 27 and Figure 28. The airframe impacted the soft soil with a 2.5° nose-up pitch attitude, causing the aft frames to impact initially. Next, the airframe rotated allowing the forward cabin to impact the soil. The duration of the point of impact to cockpit contact was approximately 0.020-sec. At 0.1-sec, the helicopter rebounded slightly, while maintaining a slight nose-down pitch and rolling towards the starboard side. A secondary impact occurred at 0.55-seconds, and the test article came to rest at 0.9-sec. The test article slide out was 8 ft.

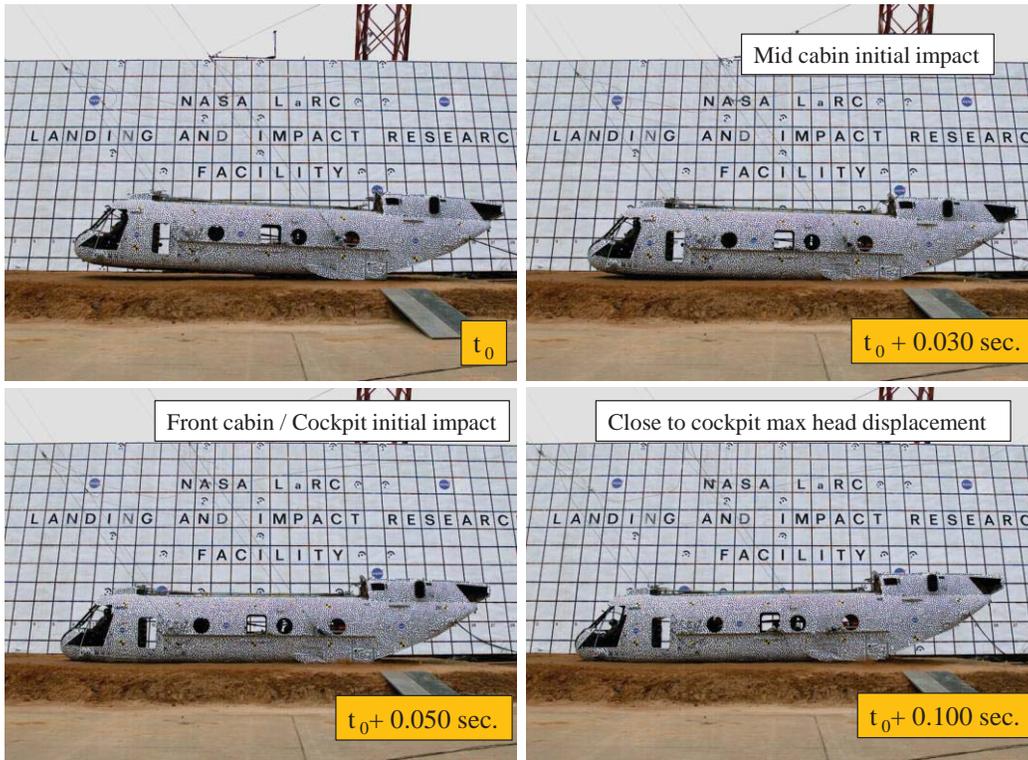
**Figure 27. Impact sequence of TRACT I test- 0-0.200 seconds**

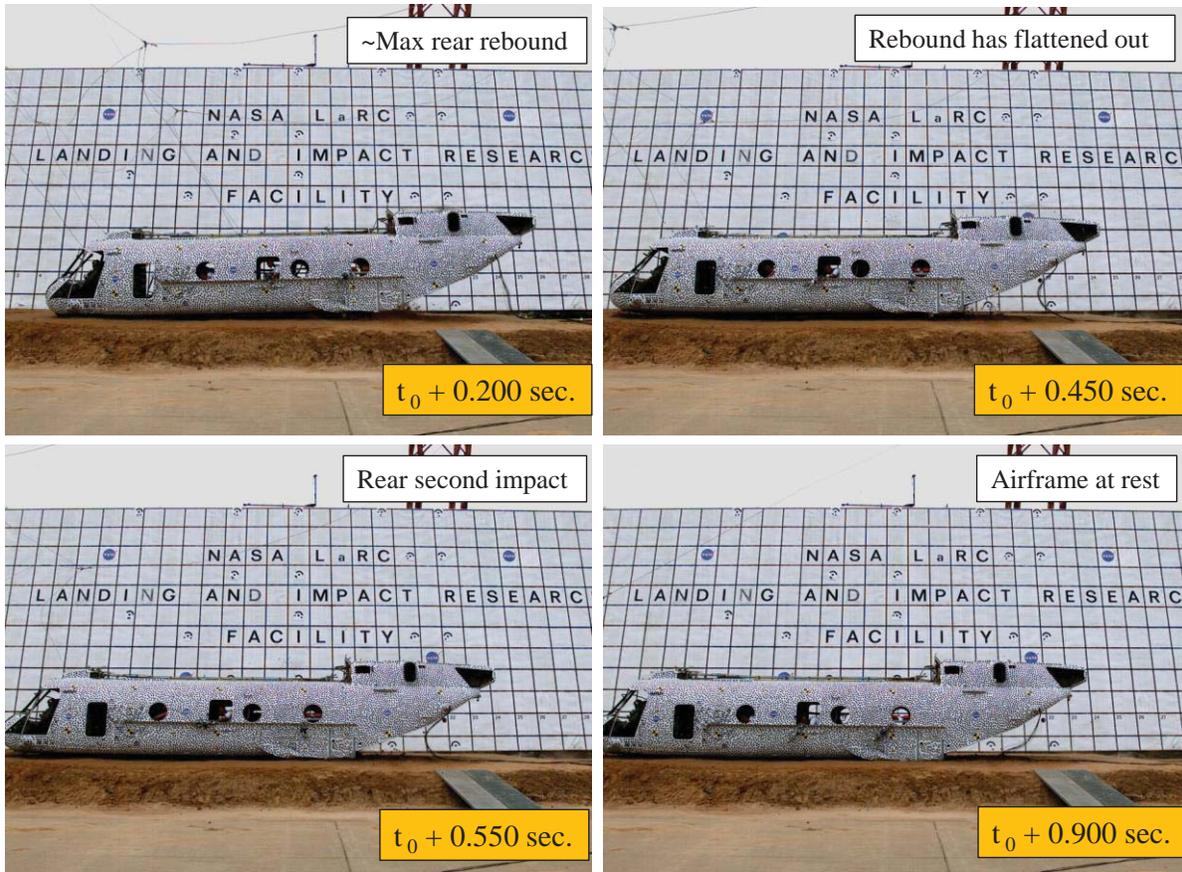
**Figure 28. Impact sequence of TRACT I test- 0.200-0.9 seconds**

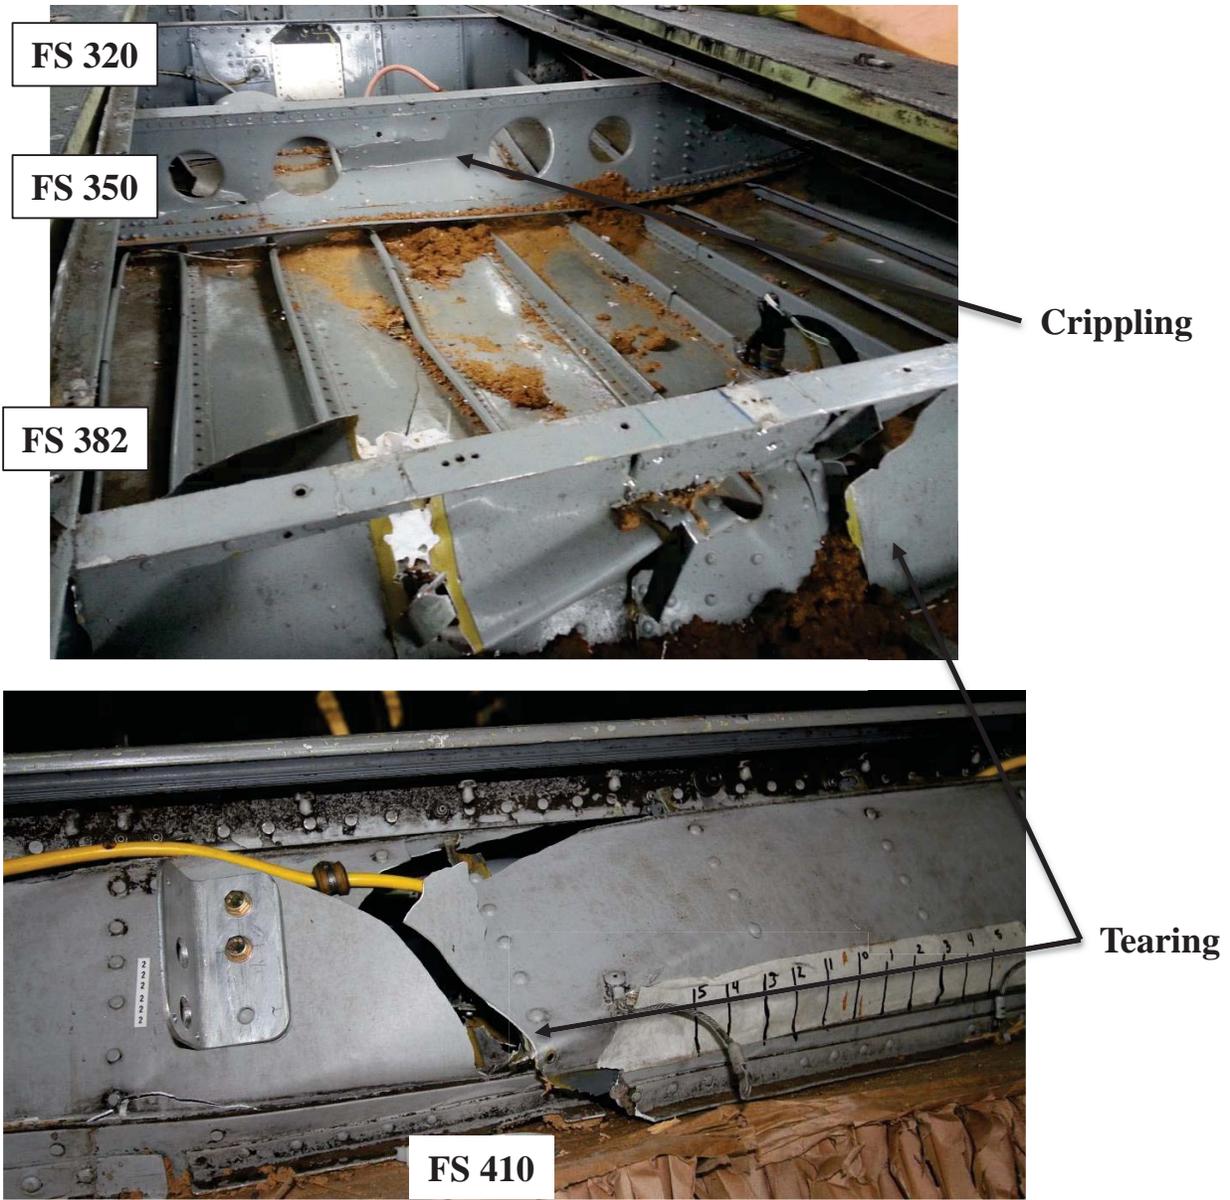
Figure 29. Photograph illustrating failure in rear cabin shear panels

Structural damage to the helicopter was observed in the shear panels located beneath the floor at discrete FS locations. Damage to these panels was more severe near the rear of the aircraft, which is the location of first ground contact. The rear shear panel deformations from FS 320 to FS 410 are shown in Figure 29. Failure modes consisted of plastic deformation, crippling, and tearing. Minor deformation due to longitudinal shear was observed in the shear panels from FS 190 to FS 286 (Figure 30). In addition, some tearing of the material was noted adjacent to rivet lines between the outer skin and fuselage frames. Wrinkling of the outer skin was also observed, as shown in Figure 31, of the skin underneath the cockpit. Minor deformation was evident on the frame sections above the floor aft of FS 286. No damage was evident on the cabin floor.
