NASA/TM–2014-218543

# Evaluation of the First Transport Rotorcraft Airframe Crash Testbed (TRACT 1) Full-Scale Crash Test

In 2012, the NASA Rotary Wing Crashworthiness Program initiated the Transport Rotorcraft Airframe Crash Testbed (TRACT) research program by obtaining two CH-46E helicopters from the Navy CH-46E Program Office (PMA-226) at the Navy Flight Readiness Center in Cherry Point, North Carolina. Full-scale crash tests were planned to assess dynamic responses of transport-category rotorcraft under combined horizontal and vertical impact loading. The first crash test (TRACT 1) was performed at NASA Langley Research Center's Landing and Impact Research Facility (LandIR), which enables the study of critical interactions between the airframe, seat, and occupant during a controlled crash environment. The CH-46E fuselage is categorized as a medium-lift rotorcraft with fuselage dimensions comparable to a regional jet or business jet. The first TRACT test (TRACT 1) was conducted in August 2013. The primary objectives for TRACT 1 were to: (1) assess improvements to occupant loads and displacement with the use of crashworthy features such as pre-tensioning active restraints and e

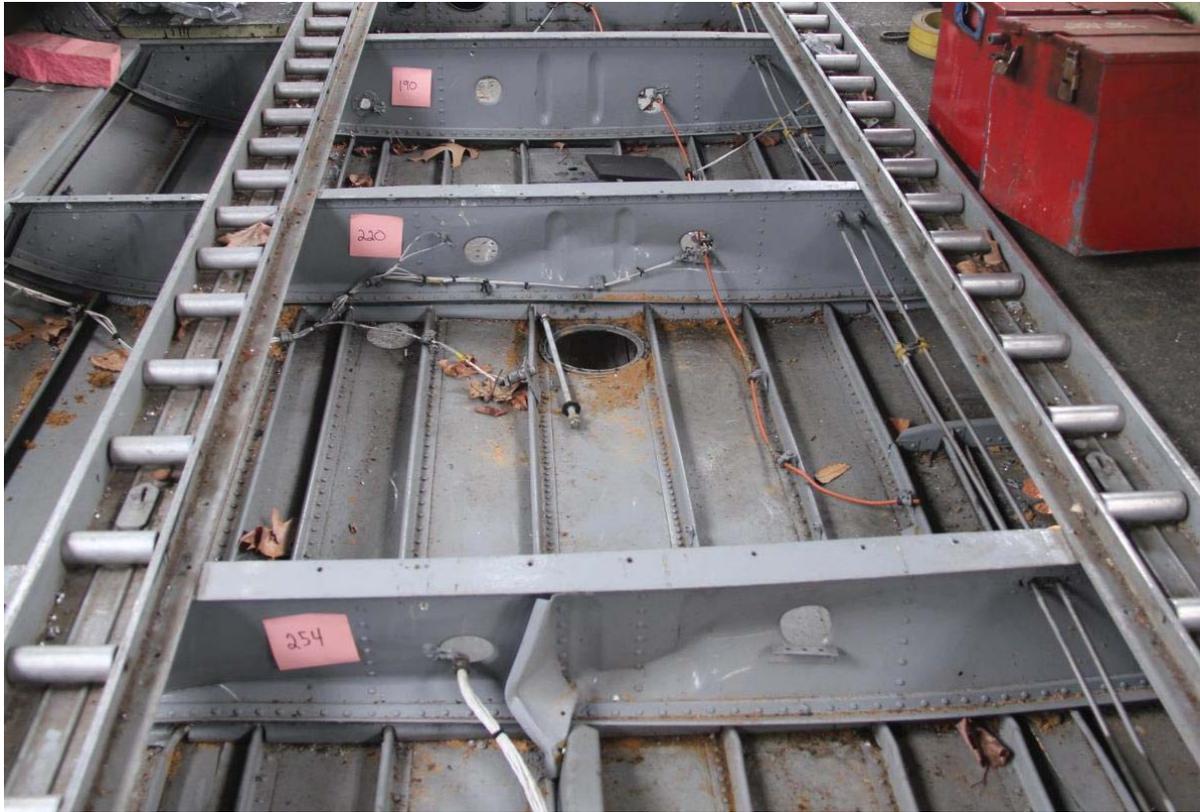
**Figure 30. Photograph illustrating failure in mid-cabin shear panels**

Structural damage to the helicopter was observed in the shear panels located beneath the floor at discrete FS locations. Damage to these panels was more severe near the rear of the aircraft, which is the location of first ground contact. The rear shear panel deformations from FS 320 to FS 410 are shown in Figure 29. Failure modes consisted of plastic deformation, crippling, and tearing. Minor deformation due to longitudinal shear was observed in the shear panels from FS 190 to FS 286 (Figure 30). In addition, some tearing of the material was noted adjacent to rivet lines between the outer skin and fuselage frames. Wrinkling of the outer skin was also observed, as shown in Figure 31, of the skin underneath the cockpit. Minor deformation was evident on the frame sections above the floor aft of FS 286. No damage was evident on the cabin floor.

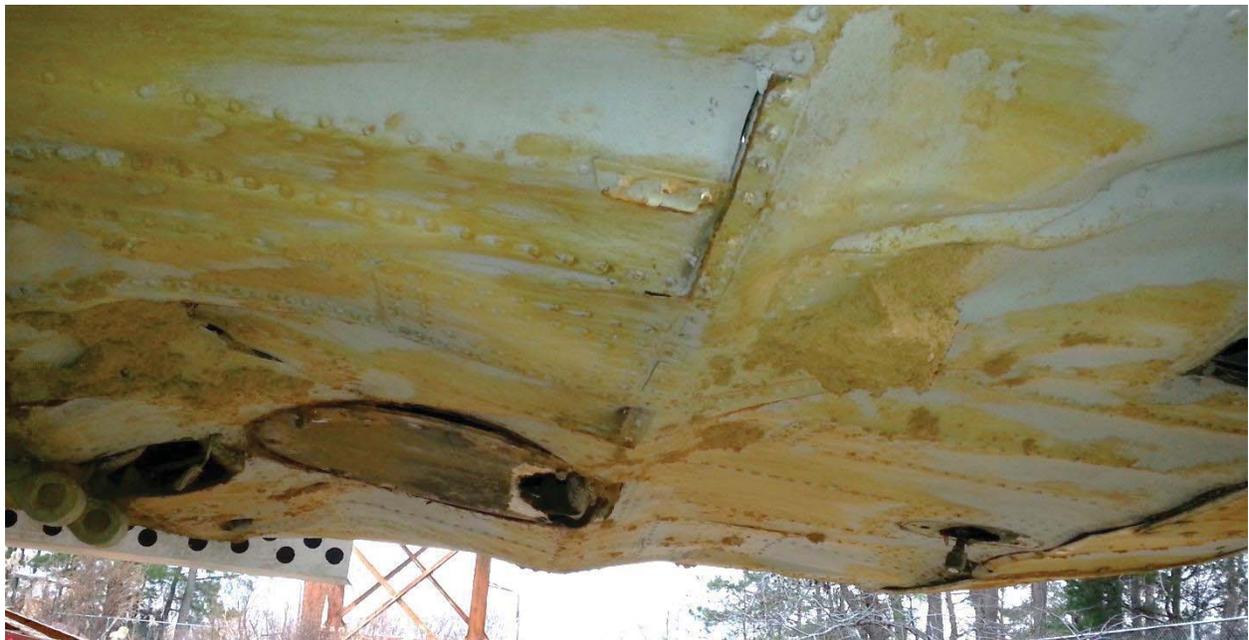
**Figure 31. Photograph illustrating skin wrinkling underneath cockpit**

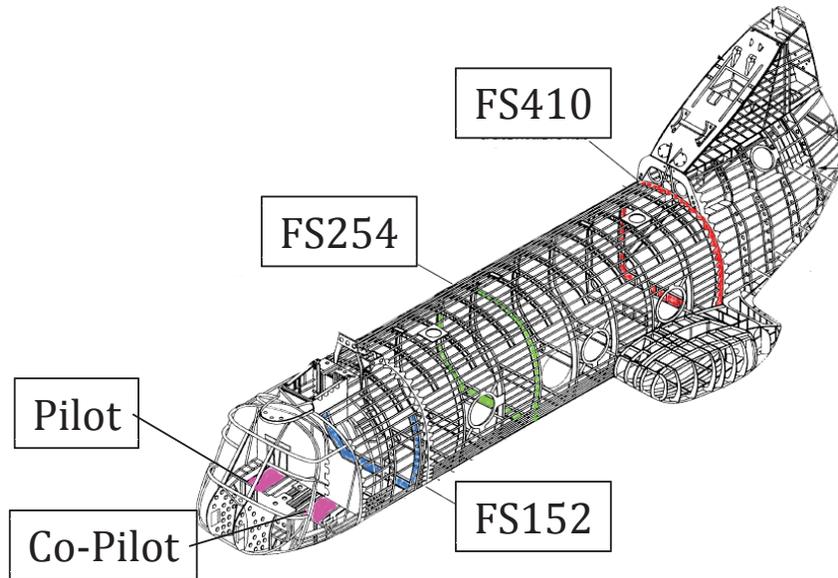
**Figure 32. Schematic of helicopter showing instrumentation locations**

A schematic of the fuselage highlighting airframe FS locations is shown in Figure 32. All airframe acceleration traces are filtered using an SAE CFC60 filter (ref. 14). It is important to note that FS 410 is located at the aft cabin/tail splice frame, FS 254 is located at mid-cabin, and FS 152 is located at the cockpit/forward cabin splice frame. The pilot and co-pilot responses are recorded on the floor supporting the seat rails.

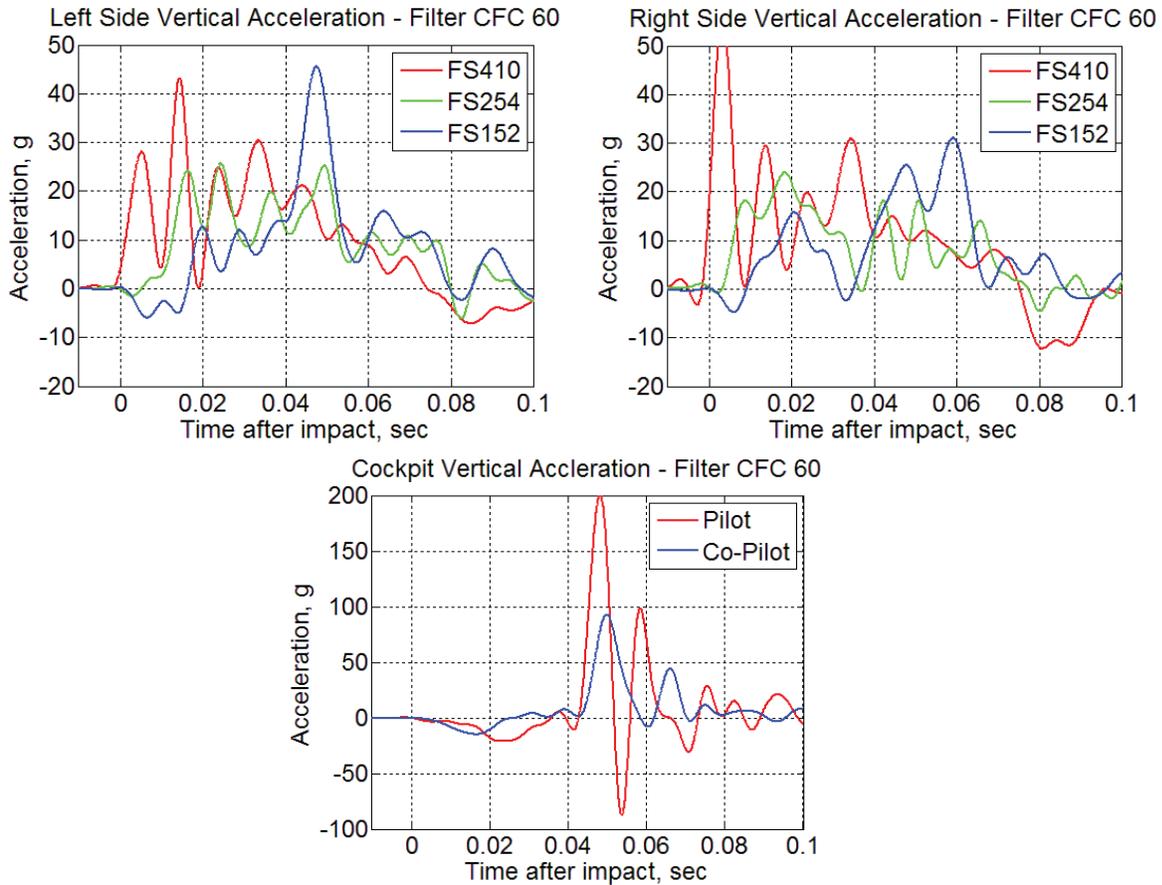
**Figure 33. Vertical floor-level acceleration results for the left and right sides of the cabin and the cockpit**

Given the nose-up pitch attitude at impact, it is expected that the onset of acceleration would occur first for FS 410, next for FS 254, and last from FS 152. The data shown in Figure 33 confirm this expectation. The left side acceleration responses range in peak magnitude between 25- and 45-g with durations of approximately 0.08 seconds. The right side responses range in peak magnitude between 22- and 55-g with a duration of approximately 0.08 seconds. The difference in responses between left and right are attributed to the seat m. At FS 152, there is a noticeable negative component of acceleration before 0.03 seconds as the test article pitches down. The behavior is more pronounced in the pilot and co-pilot responses. The co-pilot and pilot responses have very high magnitude oscillations after slam down at 0.04 seconds. There is a high different between the co-pilot and the pilot responses because of the locations of the accelerometer blocks on the thin-walled floor.

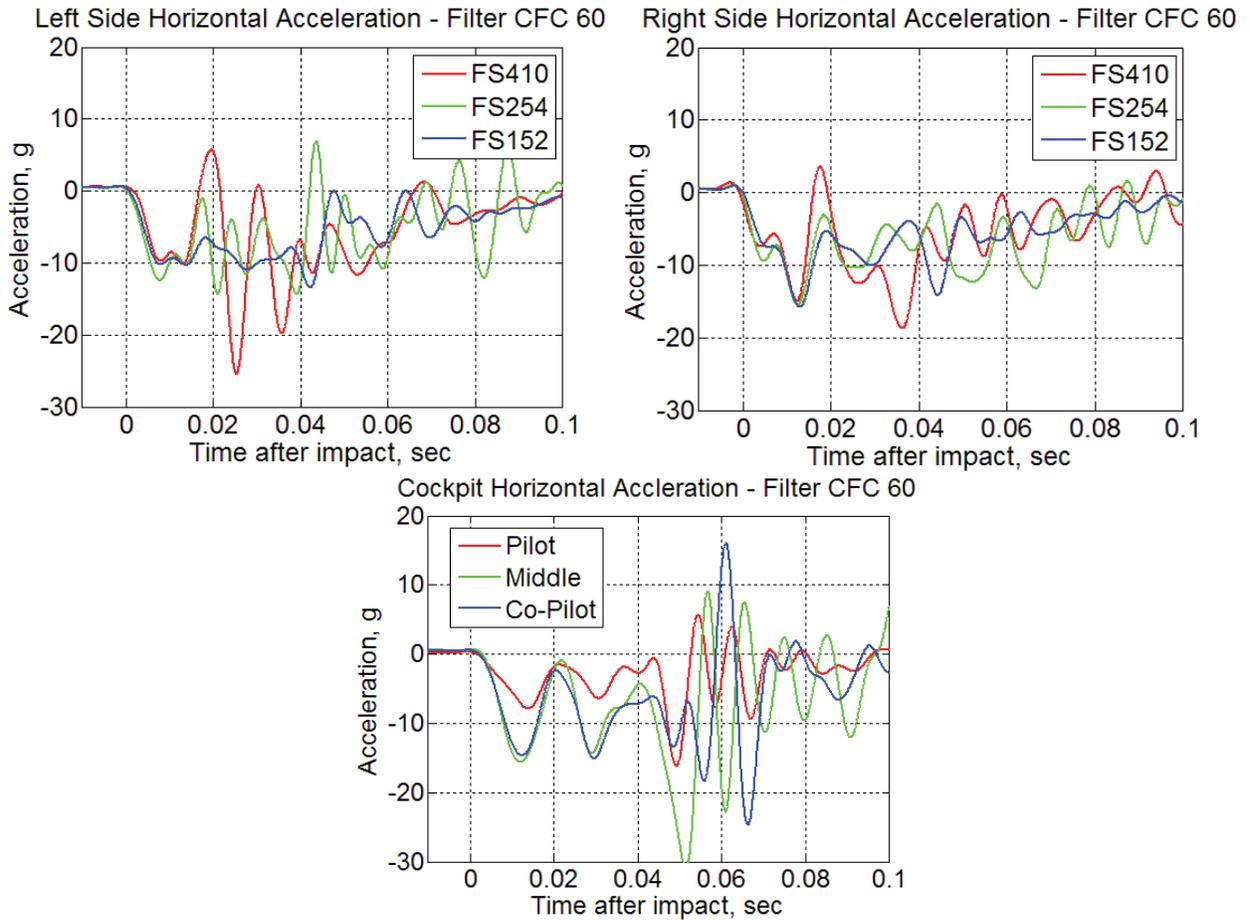
Figure 34. Horizontal floor-level acceleration responses

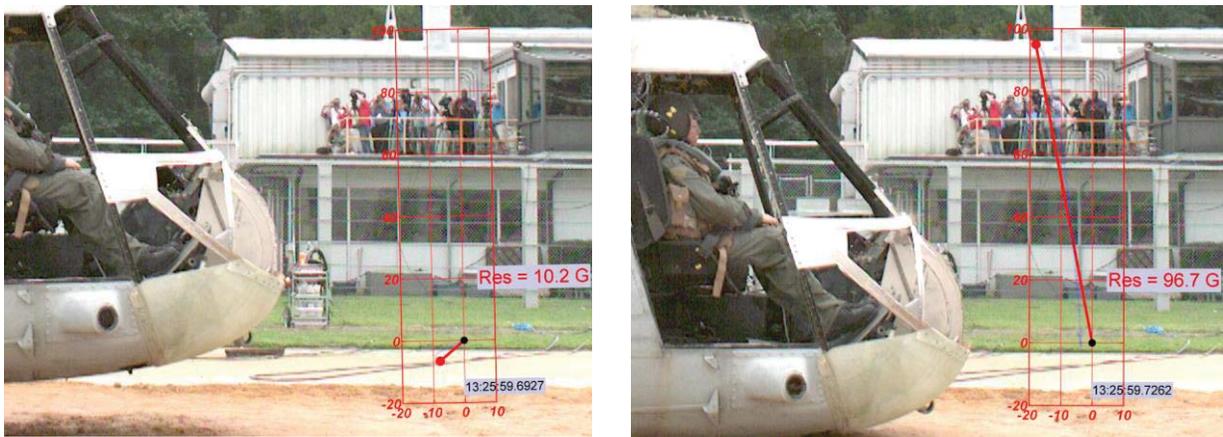
Figure 35. Cockpit resultant acceleration

The orientations and magnitudes of the resultant accelerations just before and after cockpit belly impact are illustrated in Figure 35. In Figure 35a, the orientation of the airframe deceleration is pointed to the aft and down. The pilot and co-pilot excursions are in the opposite direction, upward and forward. The magnitude of the negative component is approximately 10-g during nose over. In Figure 35b, after cockpit belly impact, the acceleration is directed up and slightly aft with a magnitude greater than 95-g.

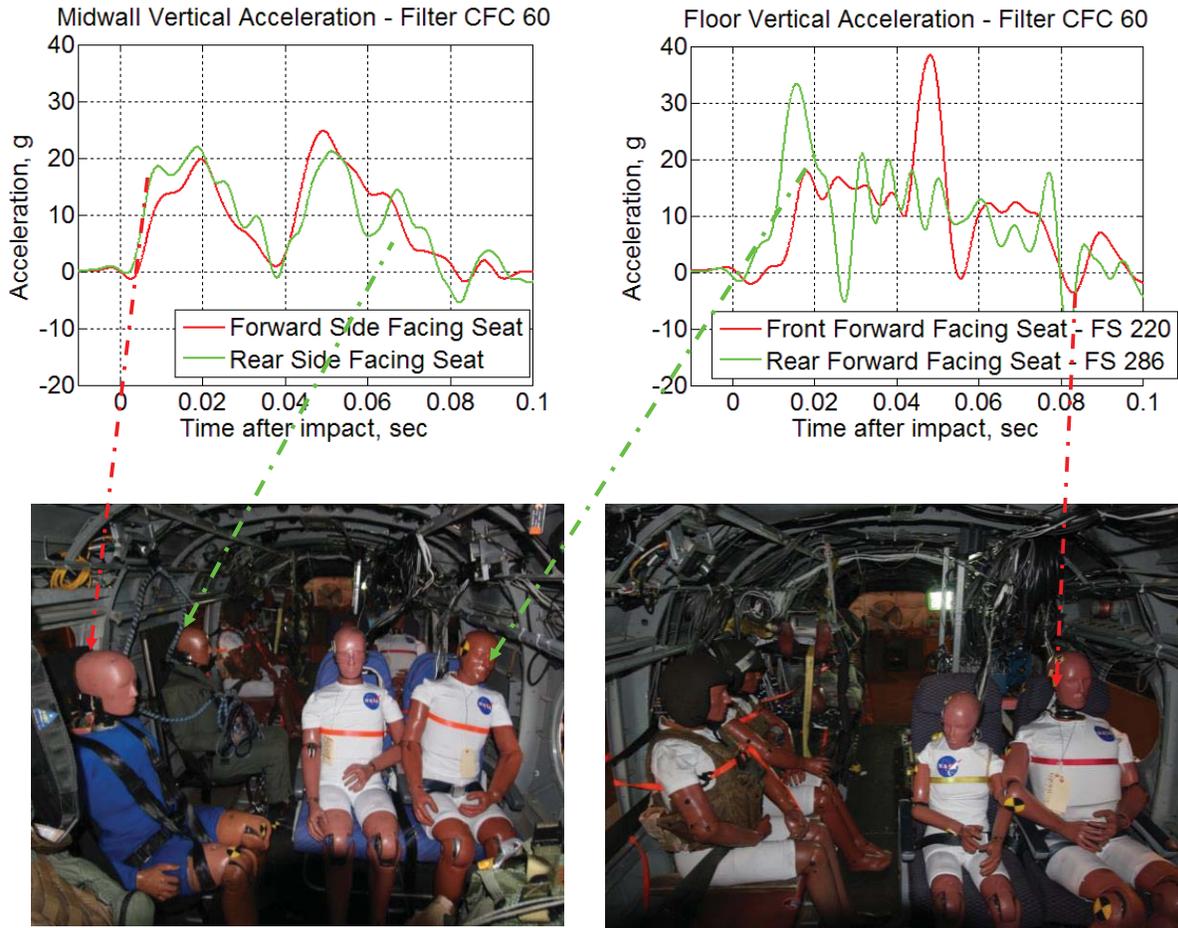
**Figure 36. Cabin vertical acceleration responses at seat attachment locations**

very similar, the floor traces are opposite to one another. The forward seat exhibits a 15-g uniform acceleration response, which suddenly increases near the end of the pulse to a peak of 38-g. Conversely, the rear seat exhibits an initial peak of 34-g, which is reduced to a relatively uniform 15-g response that decays near the end of the pulse. Both responses have durations of approximately 0.08 seconds.

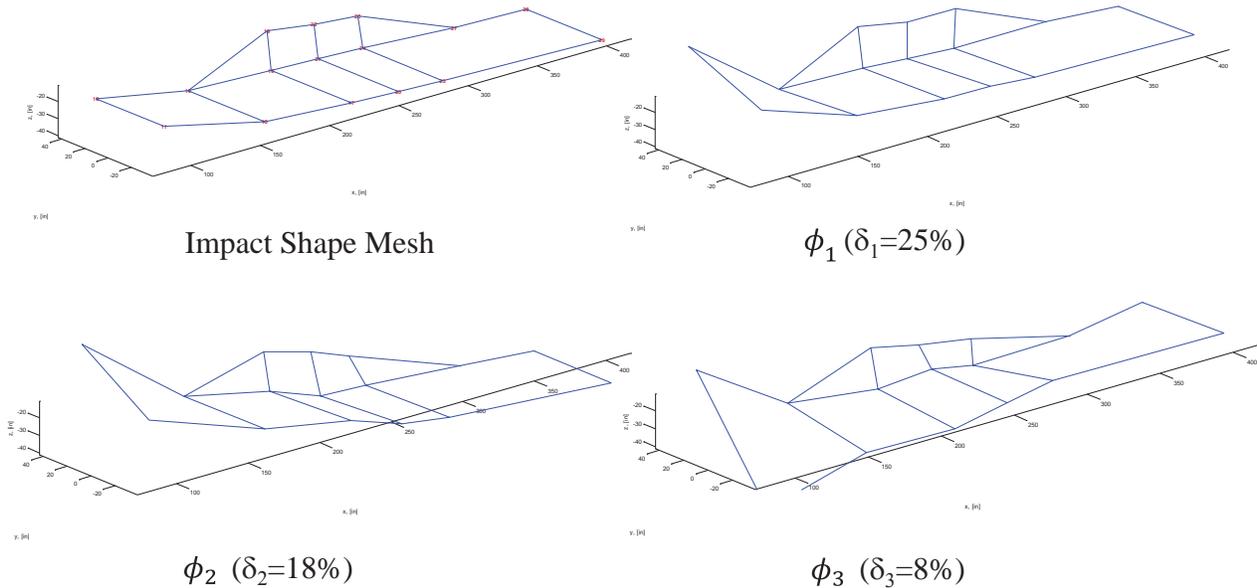
**Figure 37. Impact shapes from test data**

When visualized, the impact shape vectors are also helpful in identifying responses that may be erroneous due to signal corruption, polarity, or sensor mount failure. The impact shapes are plotted by connecting each sensor location with a wireframe. The impact shape mesh and the first three impact shapes are plotted in Figure 37. The first two impact shapes are dominated by cockpit response. The first 10 impact shapes provide 80% of the overall contribution of the response.

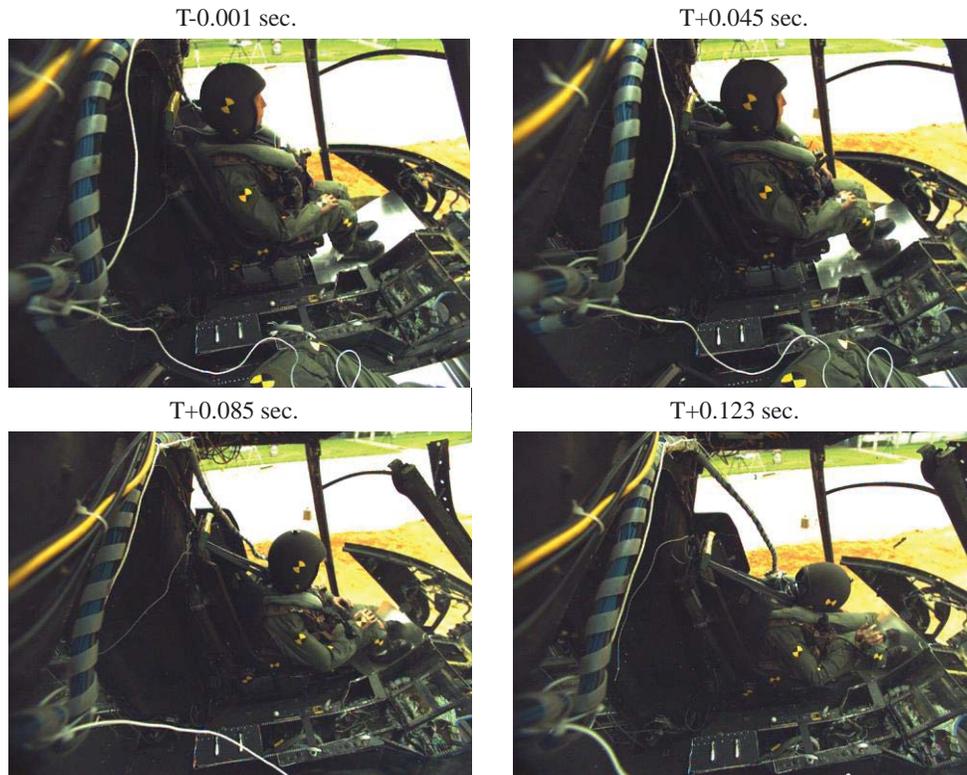
**Figure 38. Co-Pilot ATD response**

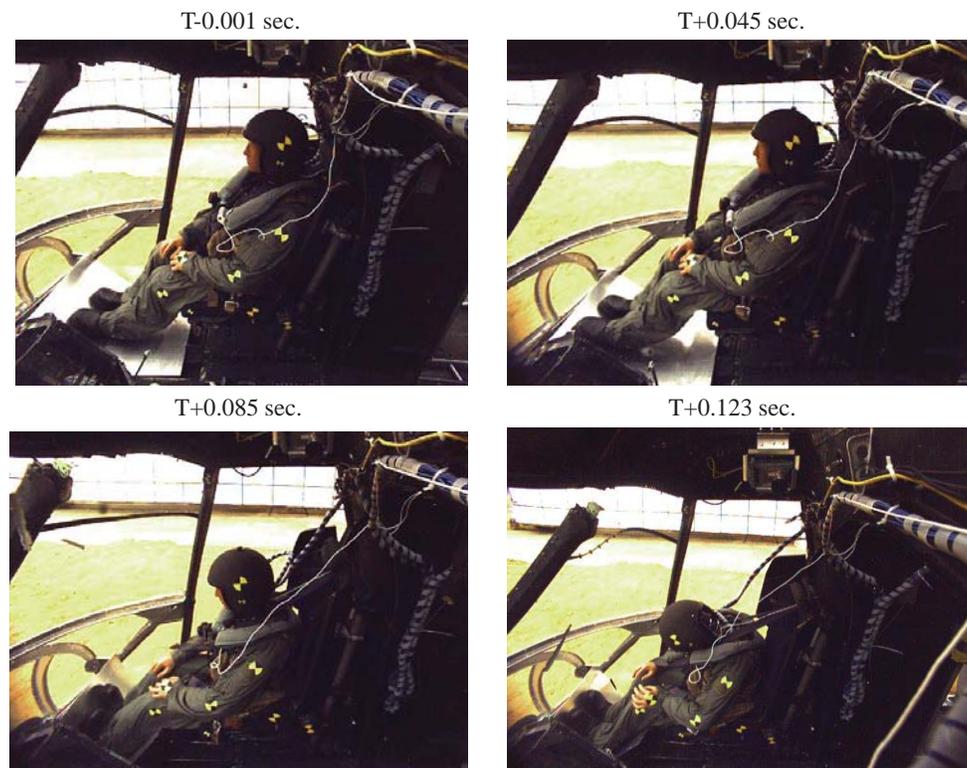
**Figure 39. Pilot ATD response**

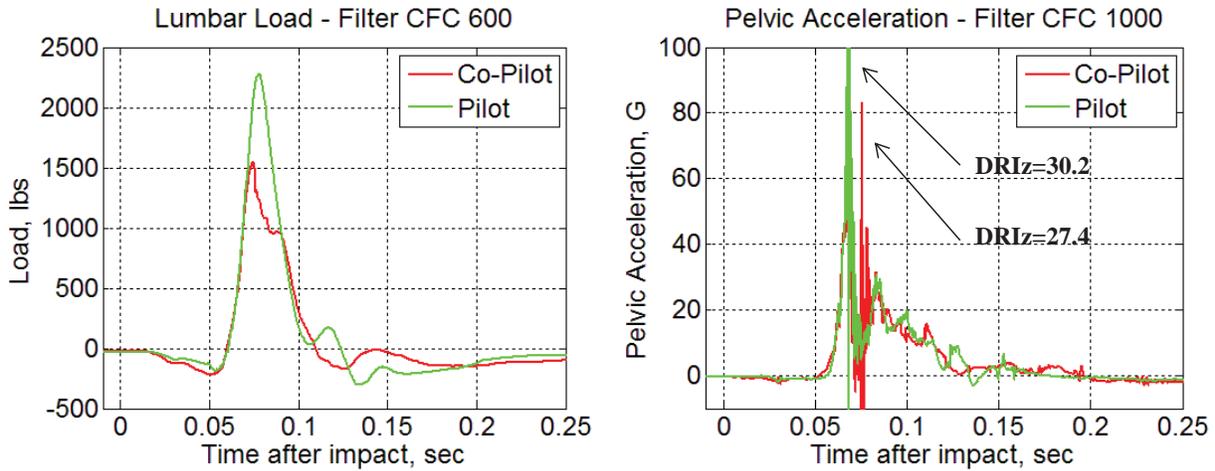
Figure 40. Pilot/Co-pilot ATD lumbar load and vertical pelvic acceleration

The pelvic acceleration waveforms track the lumbar load similarly. Magnitudes do not track linearly with lumbar load, with magnitude spikes above 70 g for the co-pilot and 100-g for the pilot. These abrupt peaks are caused by the ATD re-contacting the seat pan, and therefore not evident as the load path is damped into the lumbar. The relative velocities between the ATD and seat at the time of re-contact are different from the PARS retraction, causing different dynamic overshoot effects. These accelerations well exceed human acceleration tolerance limits for eyeballs down (+25 g) and would be categorized using Eiband curves as severe (ref. 17). The Dynamic Response Index in the spinal direction (DRIZ) is 27.4 for the co-pilot and 30.2 for the pilot, indicating a >50% risk of AIS 2+ injury (ref. 18). These criteria are no longer recognized requirements, and have been superseded by lumbar criteria when evaluating crash loads specifically, but underscore the severe response of the pilot and co-pilot.

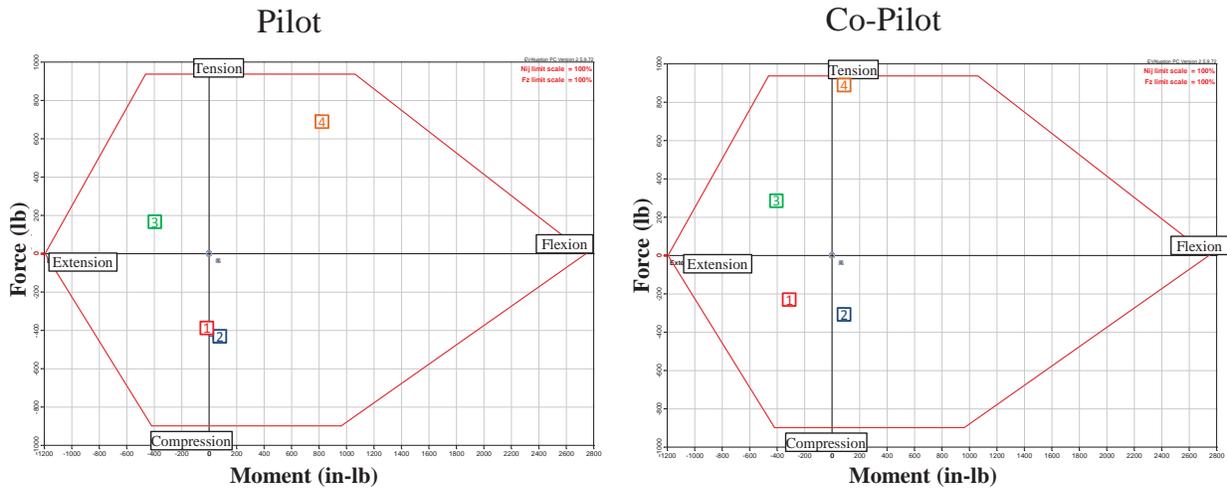
Figure 41. Pilot/ Co-pilot Nij

The potential for significant neck injury due to axial tension and compression and flexion and extension bending are evaluated by plotting the upper neck axial forces ( $F_z$ ) and moments ( $M_y$ ). Maximum neck flexion occurs at approximately 0.120 seconds. The Neck Injury Criteria ( $N_{ij}$ ) is used to determine the combined effect of axial and bending loads (ref. 19). Kite graphs showing the acceptable limits for force and moment are shown in Figure 41. The time of maximum axial load and bending loads often do not coincide, so  $N_{ij}$  is computed for multiple instances during impact.  $N_{ij}$  is calculated for four select times for both pilot and co-pilot. For the pilot, all forces and moments are within acceptable limits, while there is one case for the co-pilot where the axial tension is marginal.

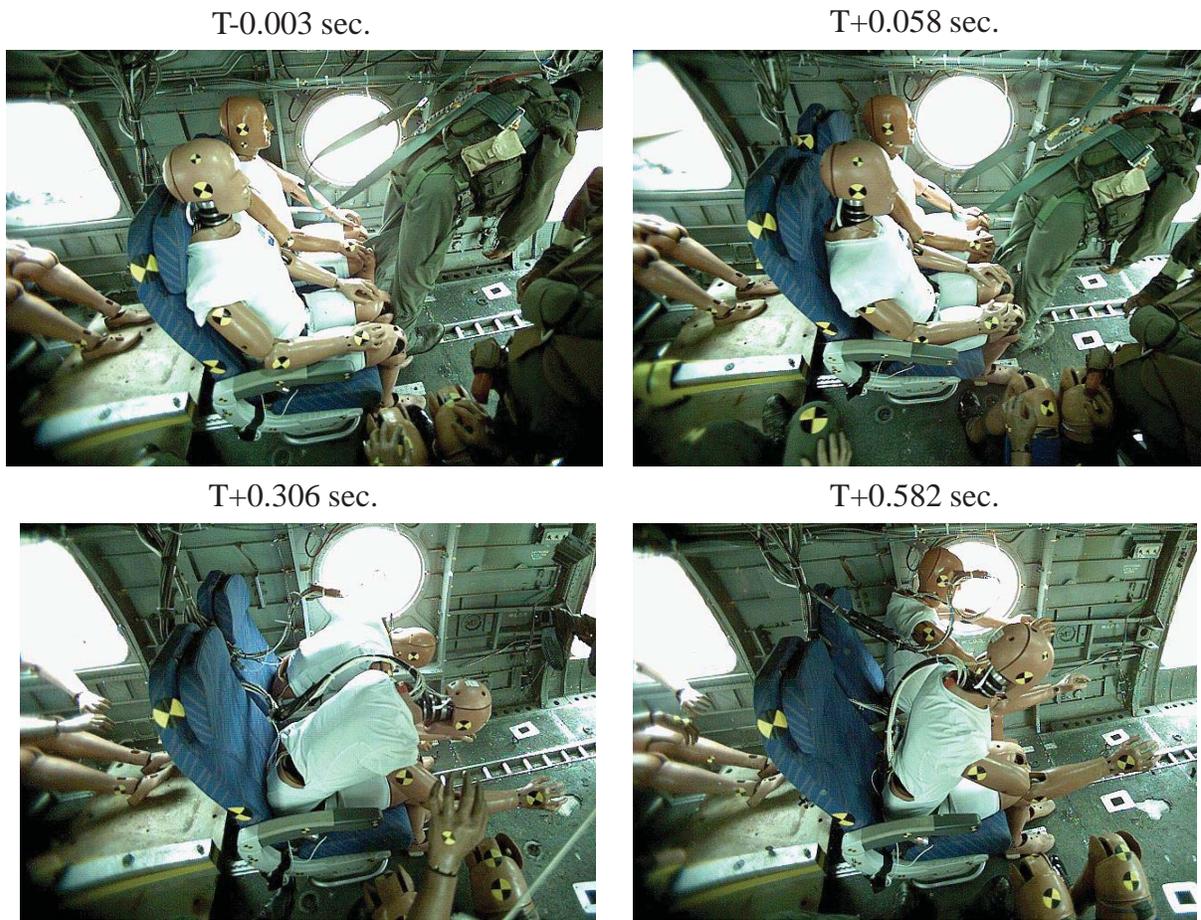
**Figure 42. 50<sup>th</sup> ATDs response**

similarity in hardware. The peak lumbar load was 2,900 lb. for the 50<sup>th</sup> FAA Hybrid III and 2,550 lb. for the 50<sup>th</sup> Hybrid II. The duration of the loading was approximately 0.060 seconds. These lumbar loads are well above the 1,500 lb. FAA limit, and would suggest a high likelihood of severe spinal injury. The peak lumbar load was approximately 1,600 lb. for the 5<sup>th</sup> Hybrid III and 2,500 lb. for the 95<sup>th</sup> Hybrid III. The lumbar load for the 5<sup>th</sup> female is an estimate from the waveform that appears to have saturated. This saturation is actually a scaling error identified post-test that limited the output range for that channel. The peak load of 1,600 lb. was determined through extrapolation. There is not a specific FAA requirement defined for the 5<sup>th</sup> and 95<sup>th</sup> ATDs. However, the DOD has recommended injury limits of 1,281 lb. for the 5<sup>th</sup> female and 2,534 lb. for the 95<sup>th</sup> male (ref. 14). The DOD recommendations for the 50<sup>th</sup> ATD are scaled up relative to the FAA requirement. Therefore, equivalent civilian requirements for the 5<sup>th</sup> and 95<sup>th</sup> would likely be lower. It is evident that lumbar loads for the 5<sup>th</sup> female and 95<sup>th</sup> male are near or above injury tolerance levels as well.

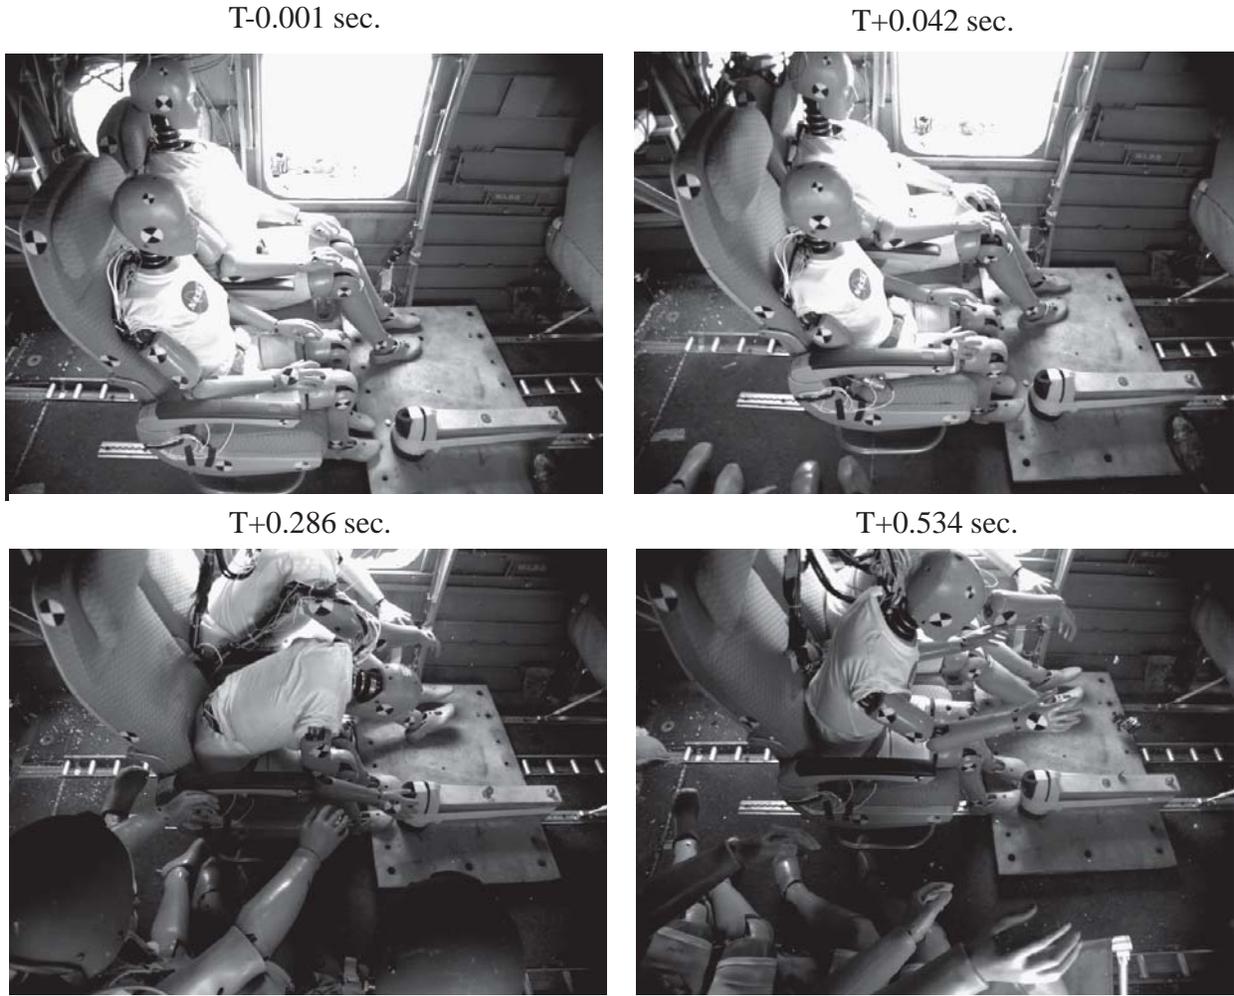
Figure 43. 5<sup>th</sup> and 95<sup>th</sup> ATD response

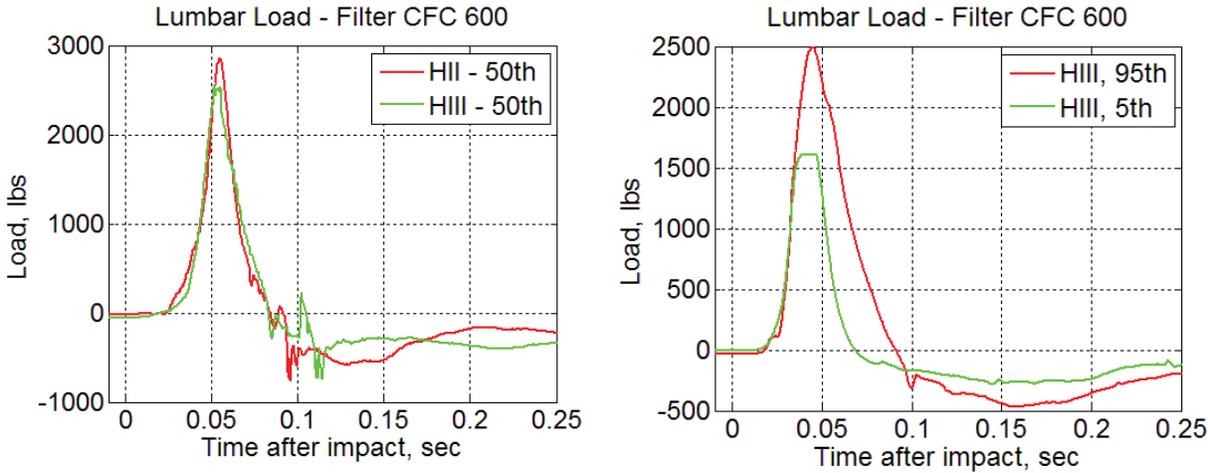
Figure 44. Forward facing ATDs, lumbar load

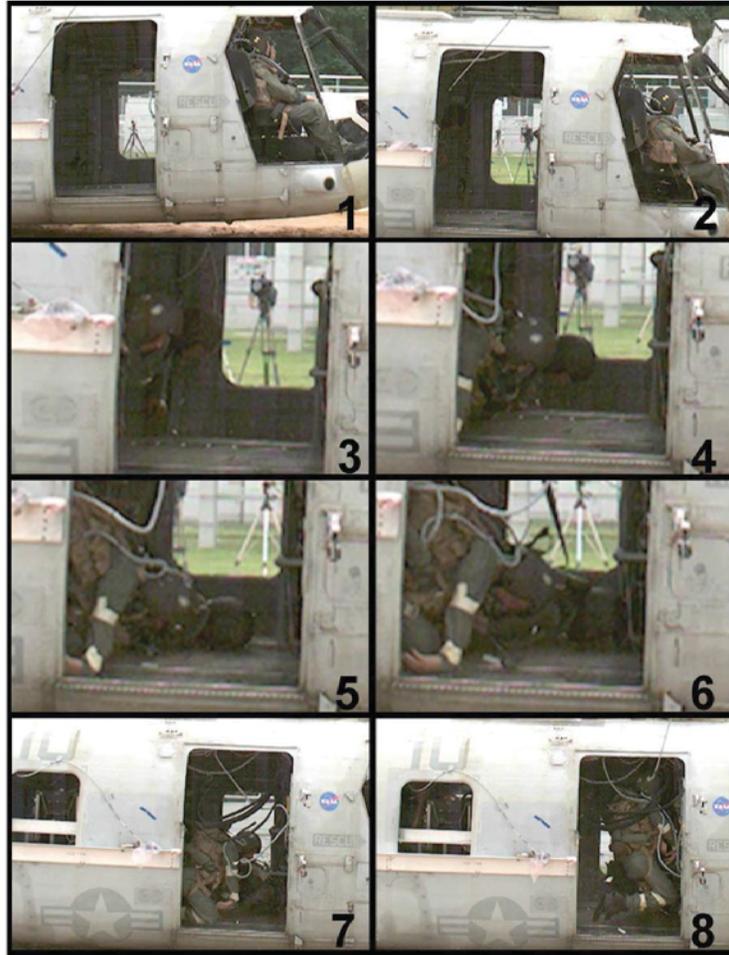
**Figure 45. Sequence of mobile aircrew motion during CH-46 airframe crash test.**

The two mobile aircrew surrogates both released simultaneously from their temporary restraints and followed a symmetric trajectory during airframe deceleration to create relative velocity between the ATDs and the airframe. This continued until the ATDs were nearly in a “hands and knees” position on the floor of the airframe. Between steel cable release and the hands and knees position, the MARS locked and webbing payout was restricted. By the time the MARS ATD was in a hands and knees position, the MARS had arrested his vertical excursion toward the fuselage floor and he began to swing forward and up. At the same time, the gunner’s belt on the gunner’s belt ATD was still slack. The gunner’s belt ATD moved right past the hands and knees position to impact the cabin floor followed by a forward slide along the floor. Figure 45 contains a high speed video sequence from the outside of the aircraft showing key points during the crash sequence. Frame 1 is at the time the standing ATDs are released from their steel cable loops. At this point, the aft fuselage has contacted the soil, but the forward fuselage is still pitching down. In Frame 2, the head of the gunner’s belt ATD is visible inside the crew door. Frame 2 also represents the initiation of seat stroke for the cockpit occupants. Frame 3 clearly indicates a symmetric response between the gunner’s belt and MARS ATDs. The MARS reel has locked at a point between Frames 2 and 3. Also at the time of Frame 3, the cockpit crew seats continue stroking. Frame 4 represents the time of the end of seat stroke for the cockpit occupants. The mobile aircrew ATDs in Frame 4 have symmetrically moved to the ‘hands and knees’ position. The MARS ATD has continued to move while pulling webbing off of the MARS reel by film spooling (approximately 8- 10 inches.). Frame 4 also indicates that the MARS ATD has started to slow relative to the airframe. Frame 5 depicts a severe contact between the head of the gunner’s belt ATD and the floor of the airframe. No such contact has happened with the MARS ATD. Frame 6 shows the gunner’s belt ATD sliding forward on the floor and the MARS ATD pulling up away from the floor. Frames 7 and 8 depict the motion of the MARS ATD as he pivots about the MARS.

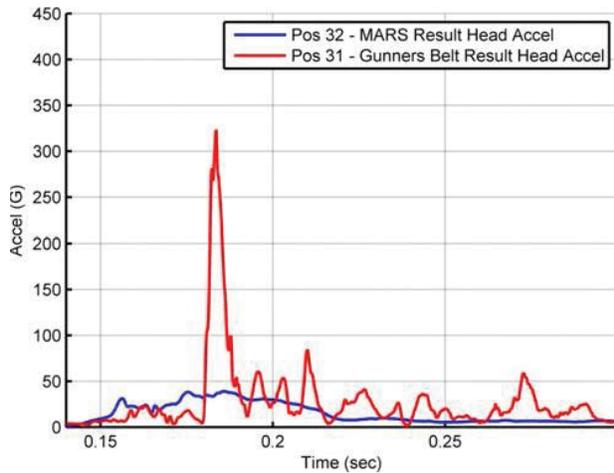
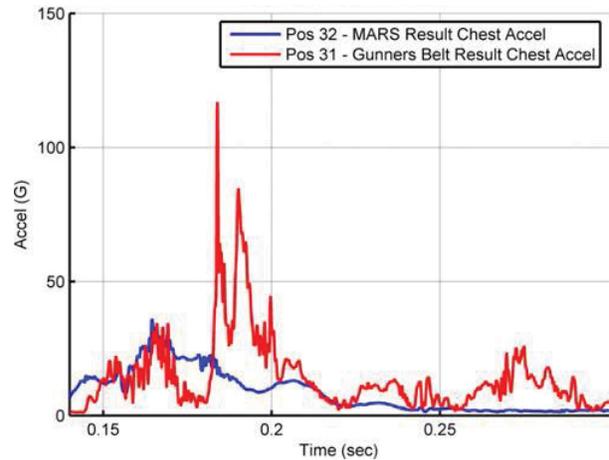
(a) Resultant Head Acceleration

(b) Resultant Chest Acceleration

**Figure 46. Resultant Acceleration for Mobile Aircrew ATDs**

Figure 46a shows the resultant head acceleration time-histories for both ATDs. The head strike against the floor is clearly identifiable in the acceleration data. Both the magnitude and duration of this head strike are far in excess of human tolerance. With the MARS unit, the strike was prevented and head accelerations are substantially lower and sustained over a much longer duration. Head acceleration measurements indicate the head impact for the ATD with the gunner's belt was a lethal impact. The calculated Head Injury Criterion (HIC) for the gunner's belt ATD was 4,539. Correspondingly, the HIC for the MARS ATD was 248. For reference, HIC values of 1,000 are used as an injury threshold for frontal automotive crash certification, FAA seat performance standards, and Navy qualification test requirements. Figure 46b contains resultant chest acceleration time-histories for the two ATD's. Based on the typical 60-g critical chest acceleration limit, there is again an injurious situation with the gunner's belt ATD and a non-injurious situation with the MARS ATD. Figure 47 shows measured neck forces and moments. Key in these graphs is the remarkable difference between the two ATD's. For all neck forces and moments, the ATD with the MARS experienced less severe loading.

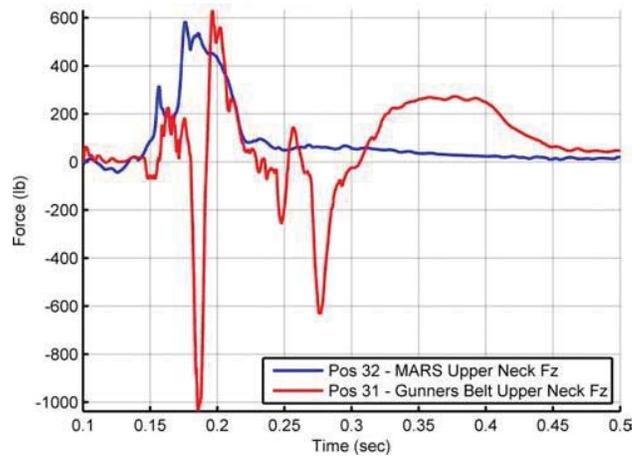
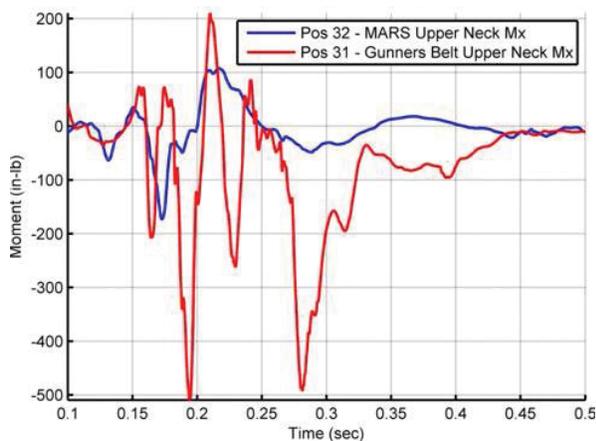
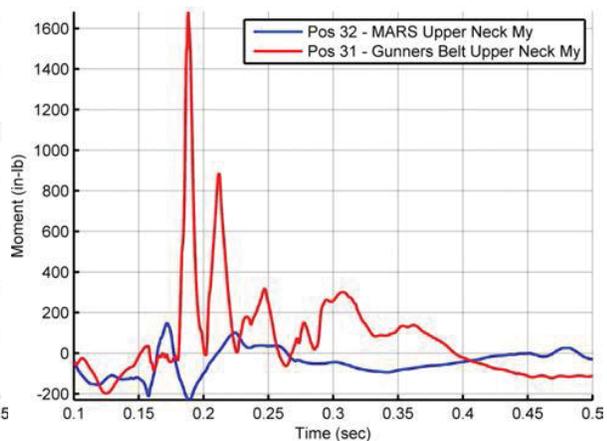
(a) Upper Neck Fz

(b) Upper Neck Mx

(c) Upper Neck My

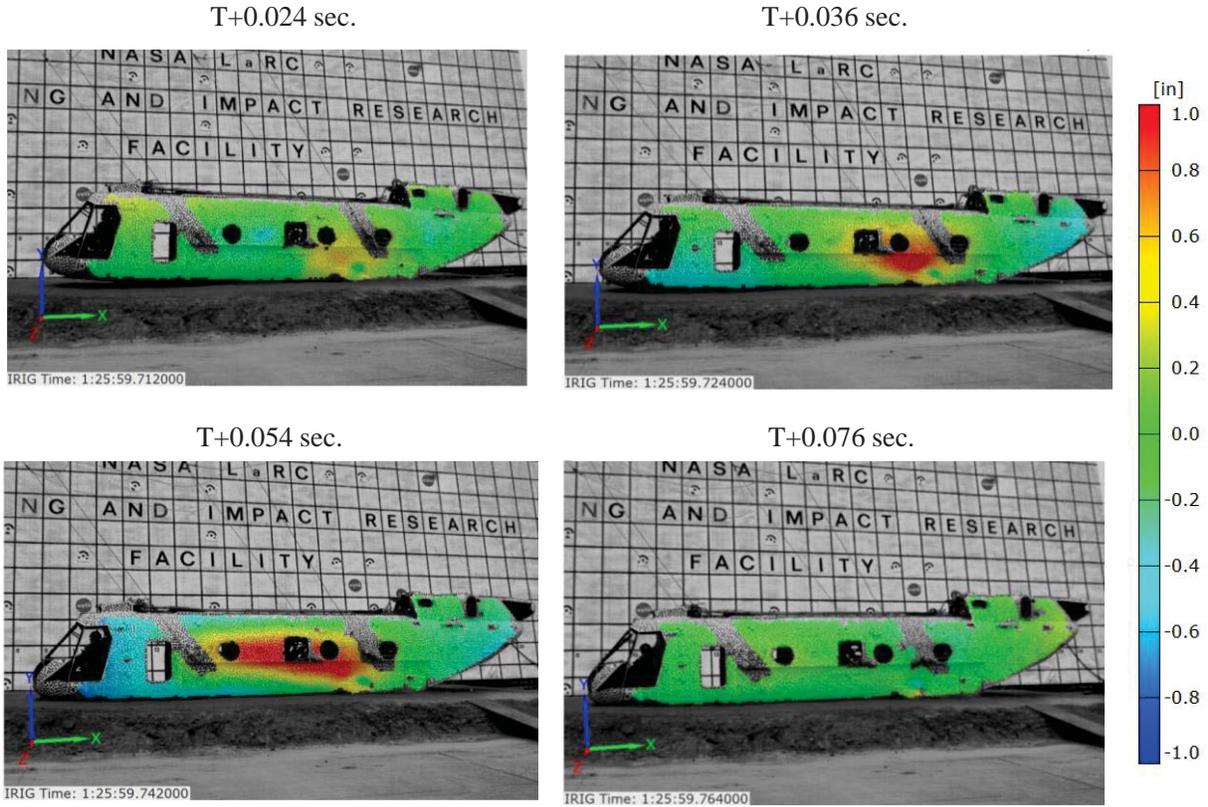
Figure 48. Measured out of plane displacement photogrammetry data

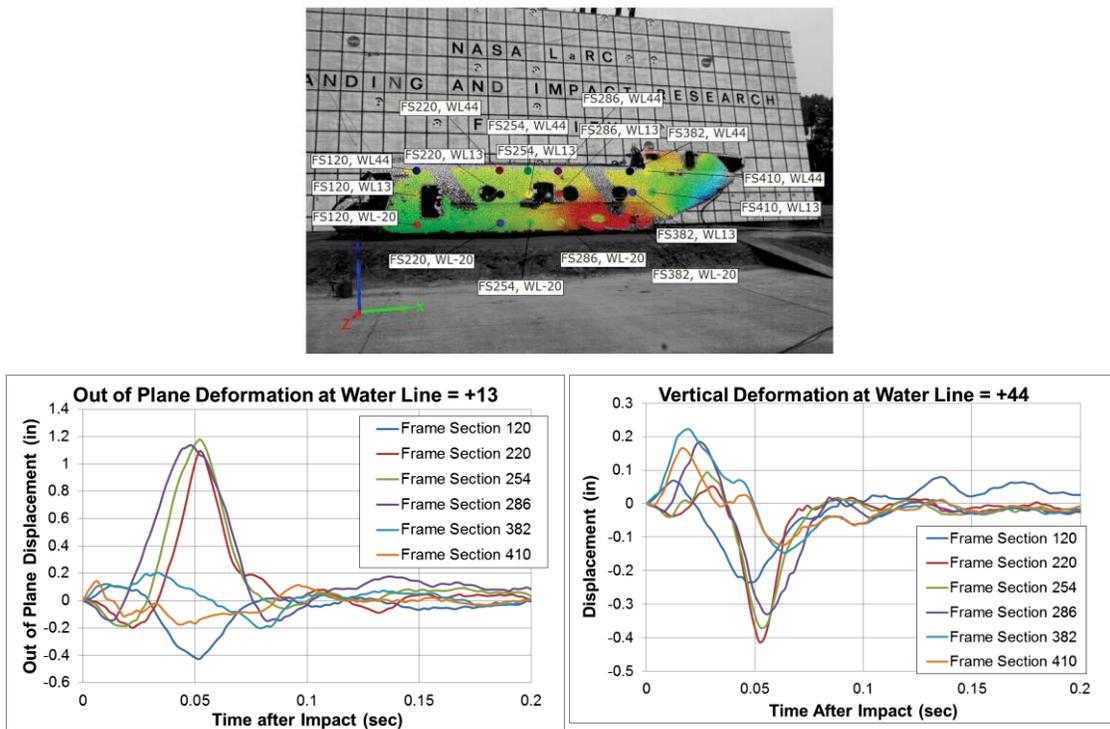
Figure 49. Discrete point time-histories

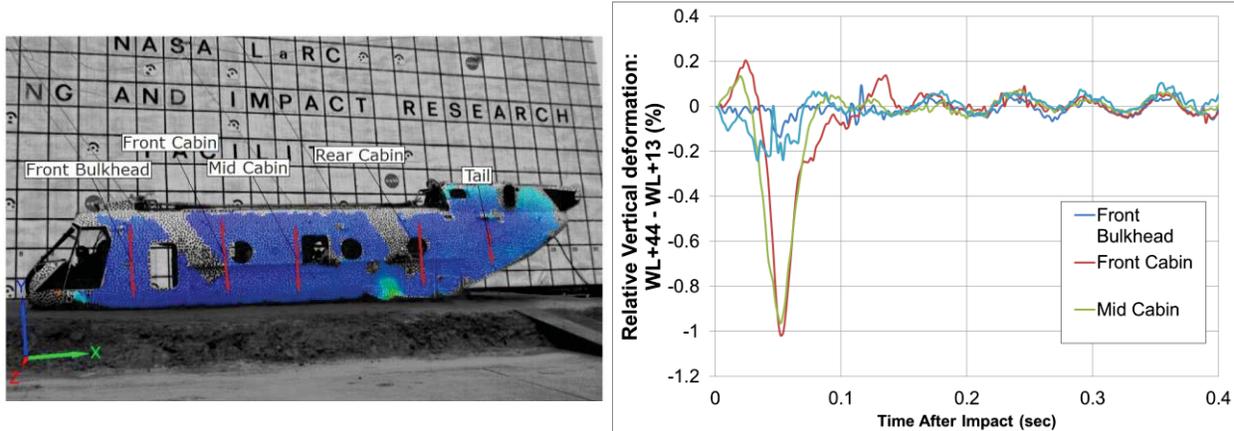
**Figure 50. Relative vertical deformation photogrammetry data**

Further evidence of this flexing is demonstrated in Figure 50. Vertical relative deformation is evaluated by interrogating relative position change between discrete points along the length of the cabin at the frame locations. Five locations were investigated further using this technique. The analysis calculates the maximum change in length of a created line endpoint positions, divided by the original undeformed line length, and reported as a percentage similar to strain calculations. The maximum relative deformation occurs in the front and mid cabin suggesting that the largest unsupported test article locations are those with the highest deformation.

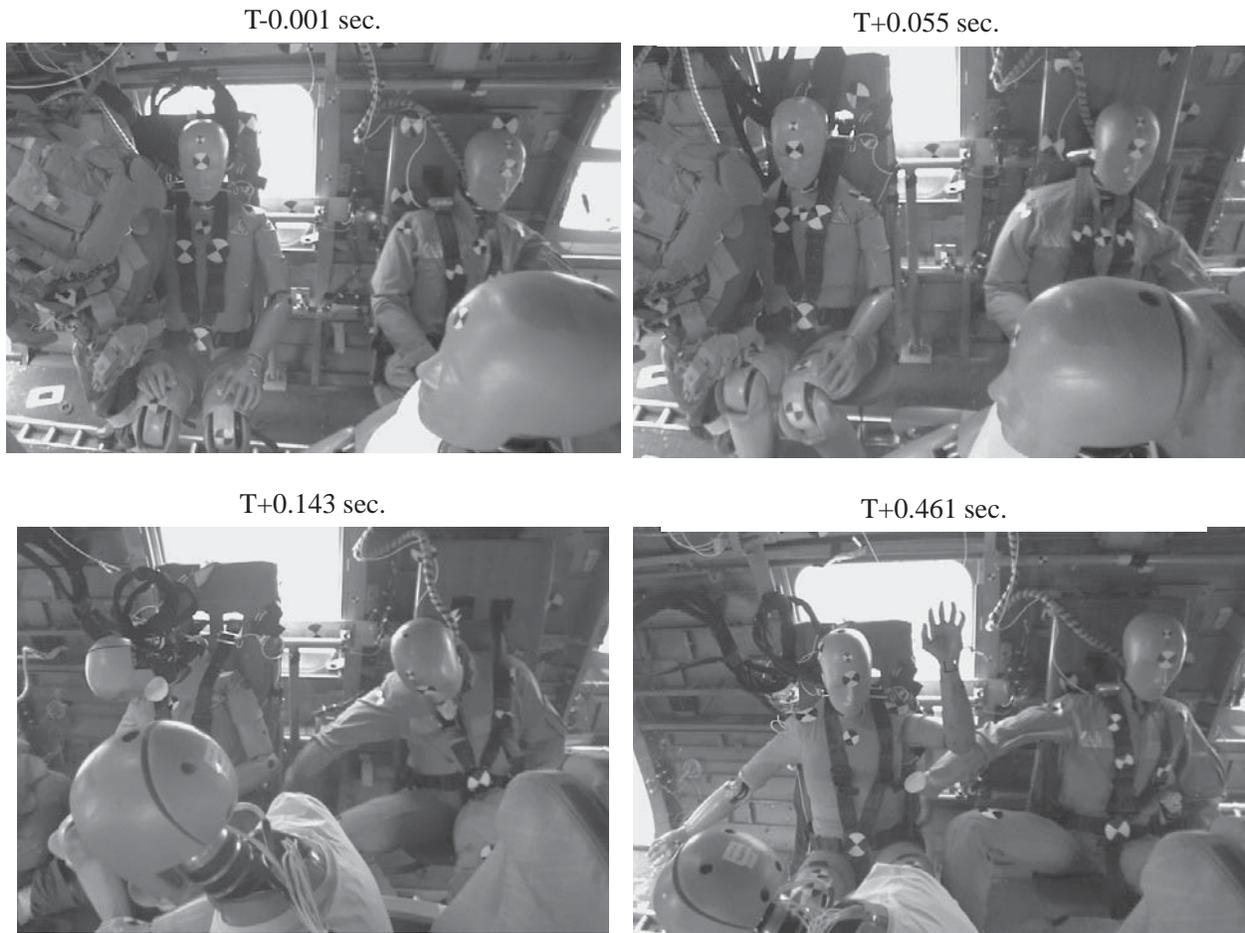
**Figure 51. Response of side facing ATDs on CACS**

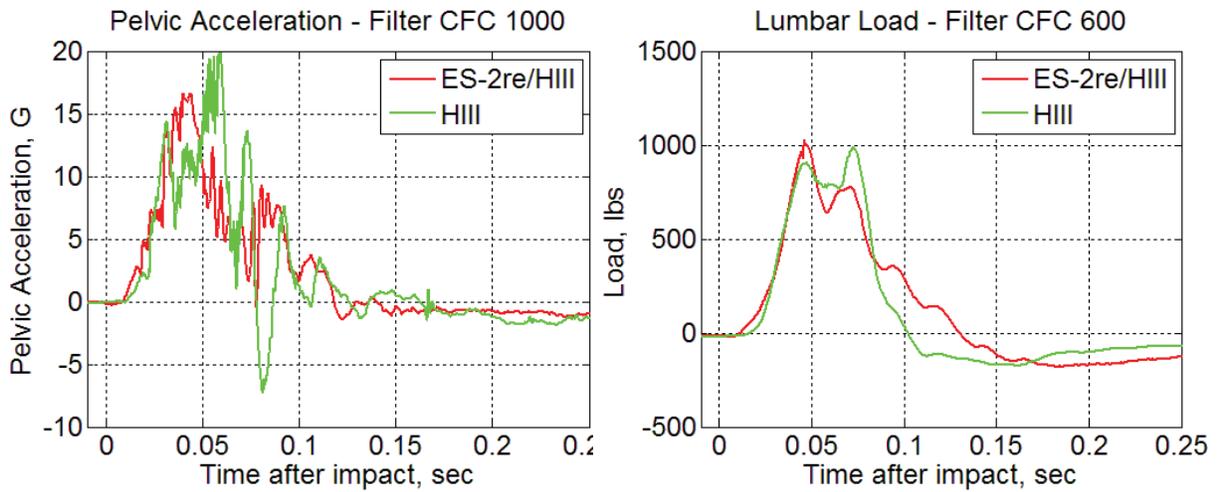
**Figure 52. Side facing ATDs on CACS, pelvic acceleration and lumbar load (HIII offset by 0.010 seconds)**

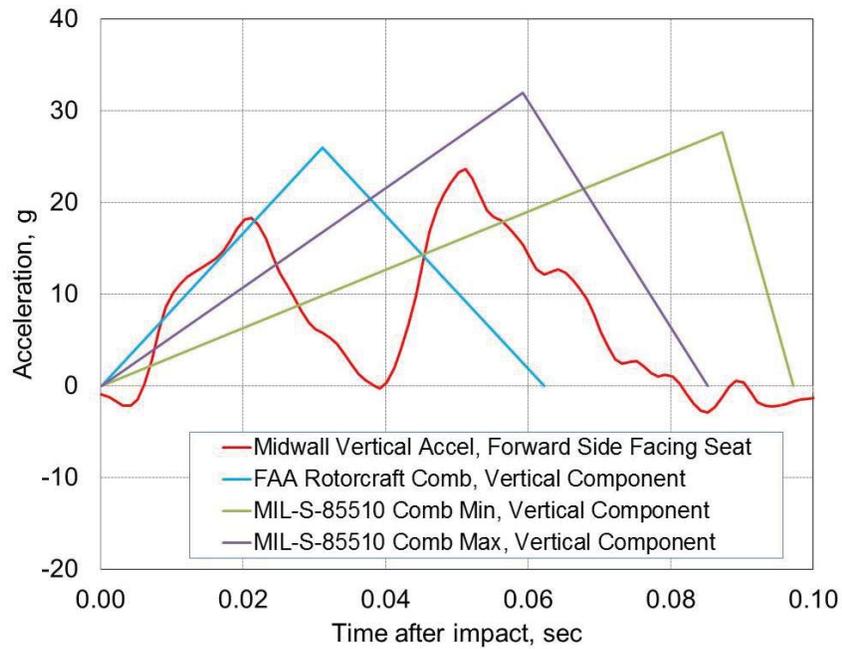
**Figure 53. Comparison of sidewall acceleration pulses**
