NASA/TM–2014-218543

# Evaluation of the First Transport Rotorcraft Airframe Crash Testbed (TRACT 1) Full-Scale Crash Test

In 2012, the NASA Rotary Wing Crashworthiness Program initiated the Transport Rotorcraft Airframe Crash Testbed (TRACT) research program by obtaining two CH-46E helicopters from the Navy CH-46E Program Office (PMA-226) at the Navy Flight Readiness Center in Cherry Point, North Carolina. Full-scale crash tests were planned to assess dynamic responses of transport-category rotorcraft under combined horizontal and vertical impact loading. The first crash test (TRACT 1) was performed at NASA Langley Research Center's Landing and Impact Research Facility (LandIR), which enables the study of critical interactions between the airframe, seat, and occupant during a controlled crash environment. The CH-46E fuselage is categorized as a medium-lift rotorcraft with fuselage dimensions comparable to a regional jet or business jet. The first TRACT test (TRACT 1) was conducted in August 2013. The primary objectives for TRACT 1 were to: (1) assess improvements to occupant loads and displacement with the use of crashworthy features such as pre-tensioning active restraints and e

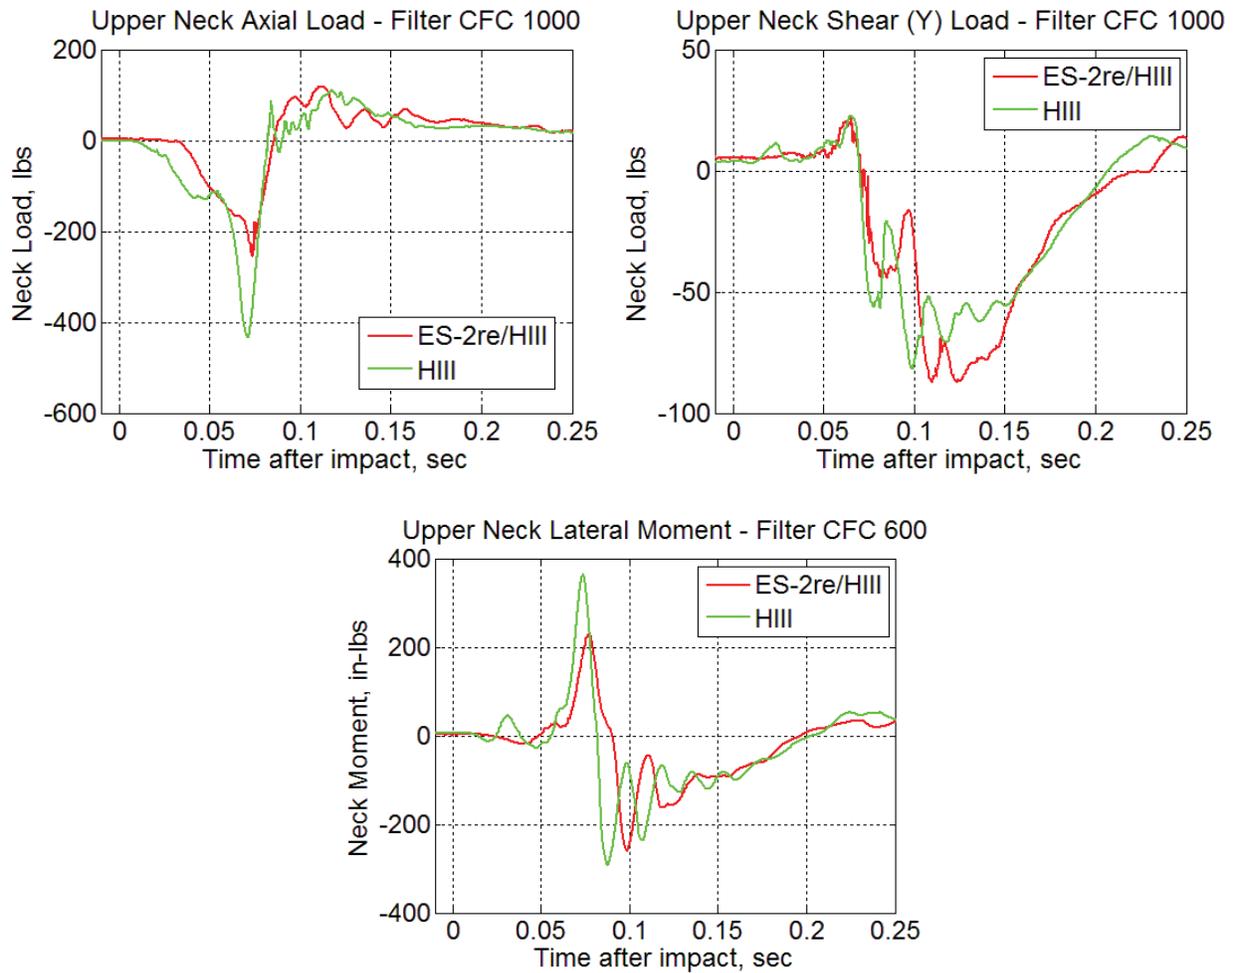
**Figure 54. Side facing ATDs on CACS, upper neck forces and moments**

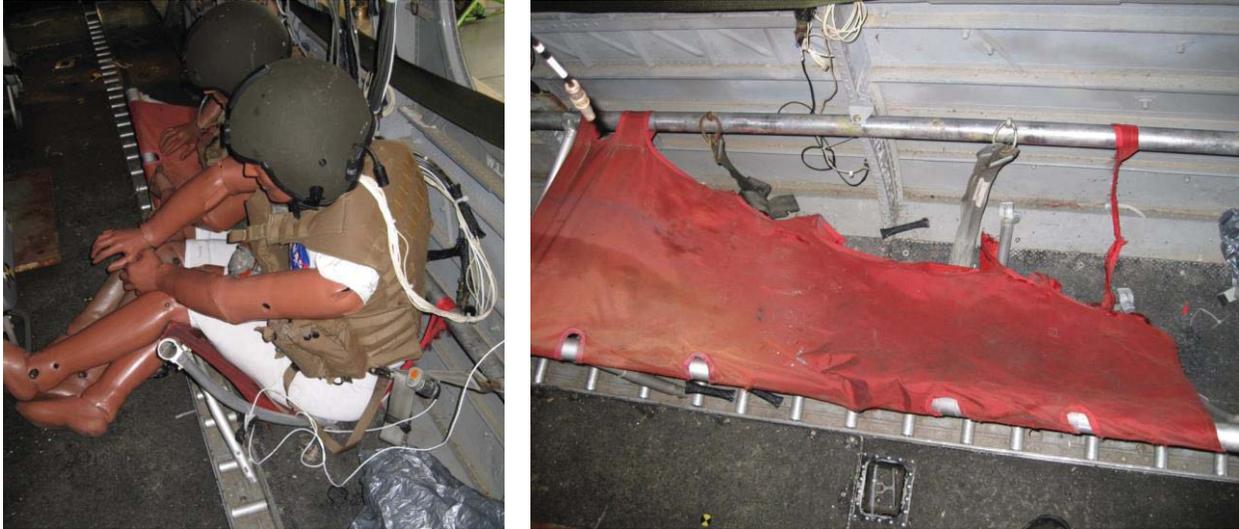
**Figure 55. Side Facing ATDs on troop bench**

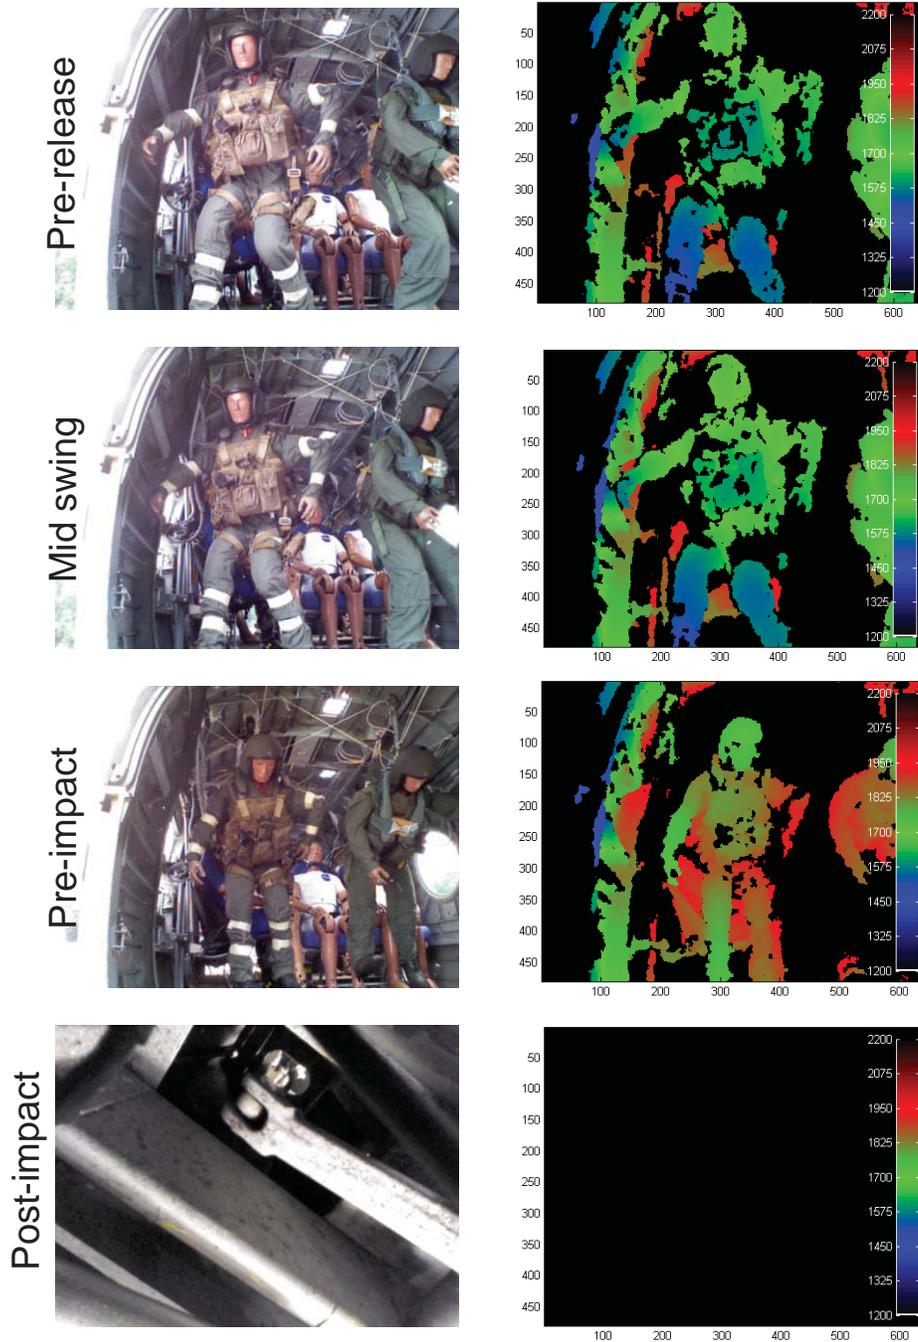
**Figure 56. Markerless tracking time history-color image (left) and depth fringe plot (right)**

A limited number of frames of ATD motion were captured using the markerless tracking system. This result is partially due to its low acquisition rate of 30 frames per second, but primarily due to the foot of the standing ATD impacting and dislodging the sensor from its mount during the impact. This impact caused the sensor to break free of its mounted location and become settled on the floor of the airframe, pointed down toward a linkage. However, approximately 62 frames of color and depth images were captured during the free fall prior to impact. The time history in Figure 56 shows a summary of the data captured during the test. Each pair of images contains data from the color sensor, which is presented on the left, and a fringe plot reconstruction of the depth data, which is presented on the right. Since data were unavailable post-impact, the data presented occurs at four different states prior to impact. The depth data shows a graphic representation of ATD distance from the sensor, displayed in units of millimeters (mm). At pre-release, the majority of the ATD is colored green and blue, which represents 1,300 (blue) to 1,700 (green) mm position away from the sensor. The frame prior to impact, labeled pre-impact, shows the ATD is partly green, but primarily red in color. This data suggests that the ATD is between 1,700 and 2,200 mm away from the sensor, representing a half meter change in position away from the sensor from release to impact.

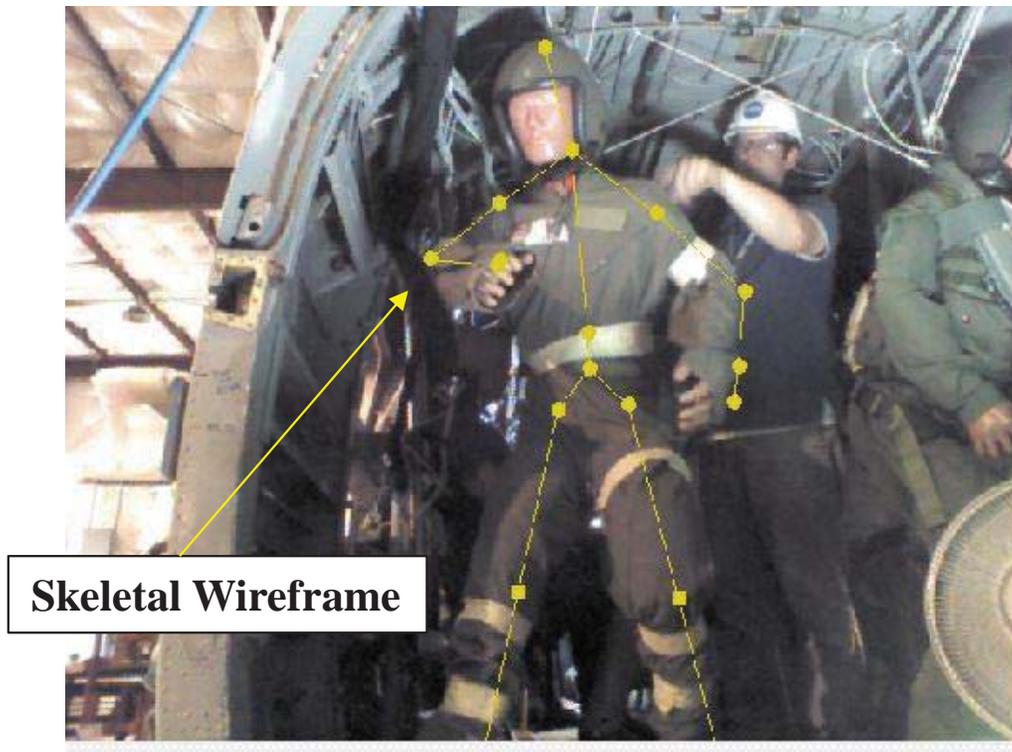
**Figure 57. Preliminary ATD wireframe tracking**

The skeletal tracking algorithms did not associate with the depth data, and therefore, skeletal data was not acquired. Two potential reasons are presented to explain the lack of skeletal capture. The first reason was the shape of the standing ATD. The standing ATD contained a helmet, flight vest, and other various straps and articles which would cause confusion in the tracking algorithms. This theory was proven, when, during a preliminary test, this equipment was removed and the sensor was able to associate a skeletal wireframe with the standing ATD, as shown in yellow in Figure

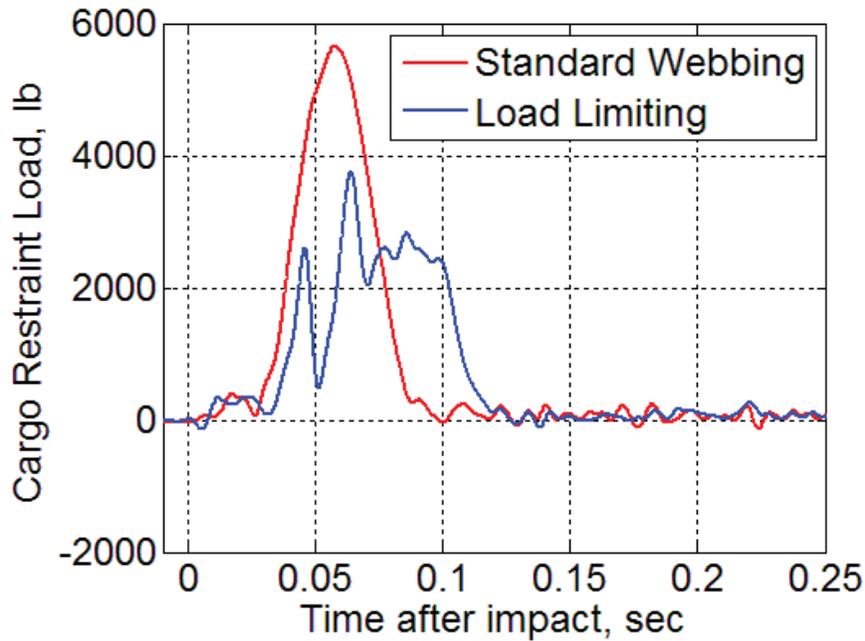
Figure 58. Cargo Restraint Load

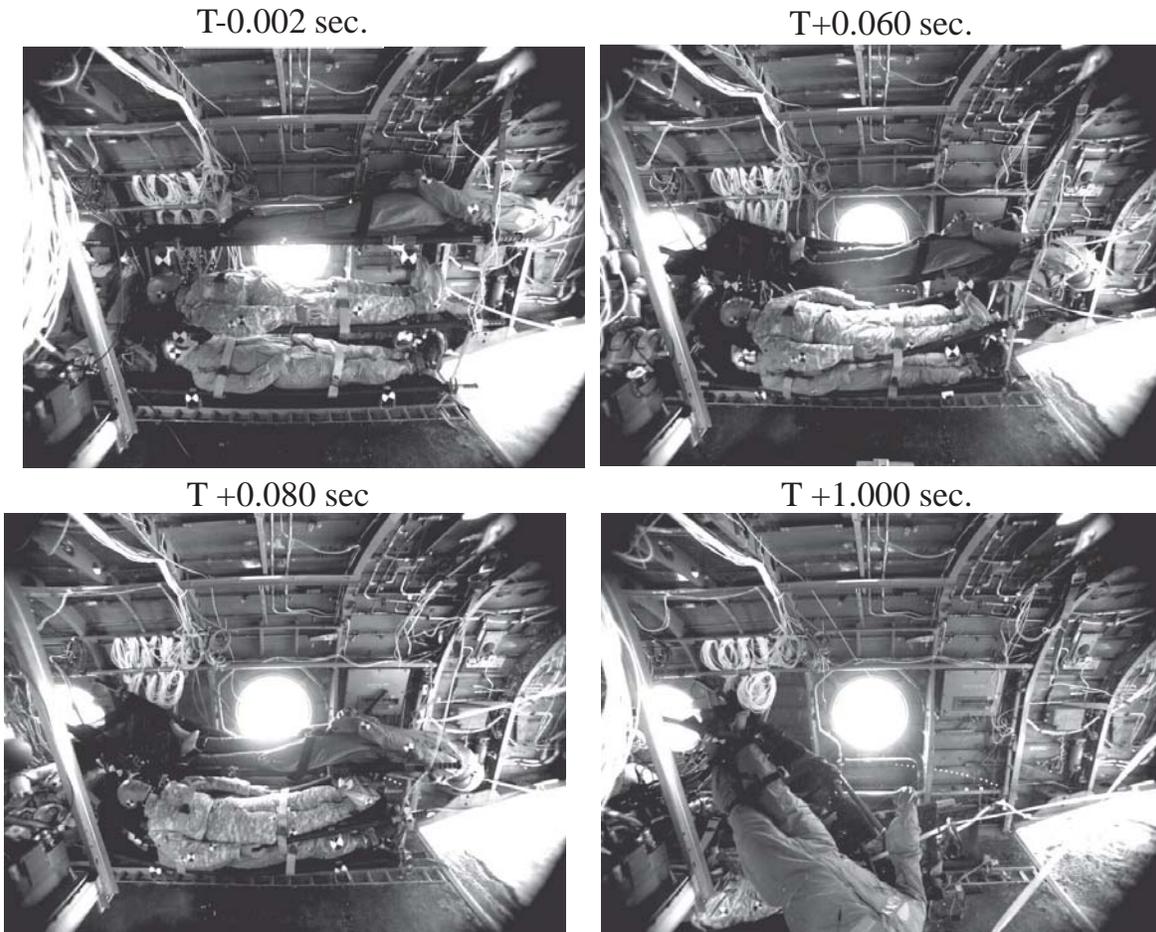
**Figure 59. Patient Litter Sequence**
