# Electricity Supply Infrastructure Improvements

## Final Technical Status Report December 2010

Daniel Piekarski and Dana Brad  
*Northern Indiana Public Service Company  
Merrillville, Indiana*

**Subcontract Report**  
NREL/SR-5500-49793  
February 2011

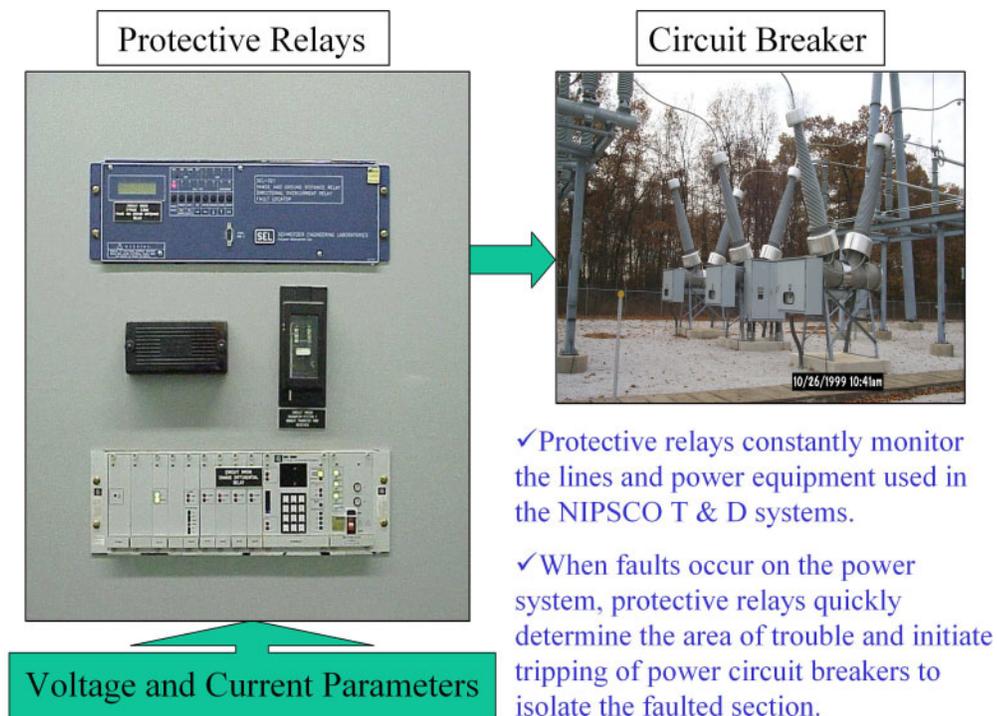
**Figure 1**

As figure 1 illustrates, relaying components monitor circuit voltage and current parameters and are designed to operate automatically to disconnect the protected elements from the transmission system. Protective relay outputs initiate power circuit breaker tripping to isolate electrical faults (typically in 2 – 5 cycles) and protect power equipment from damage due to voltage, current, and/or frequency excursions outside the design capabilities.

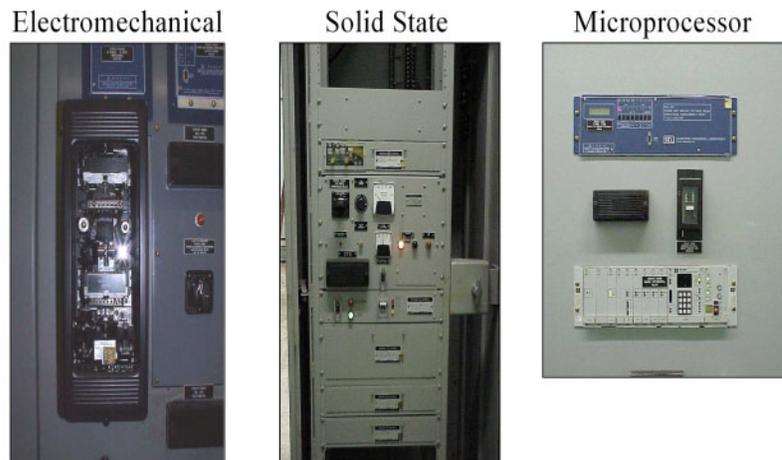
**Figure 2**

#### 3 Eras of Protection Equipment

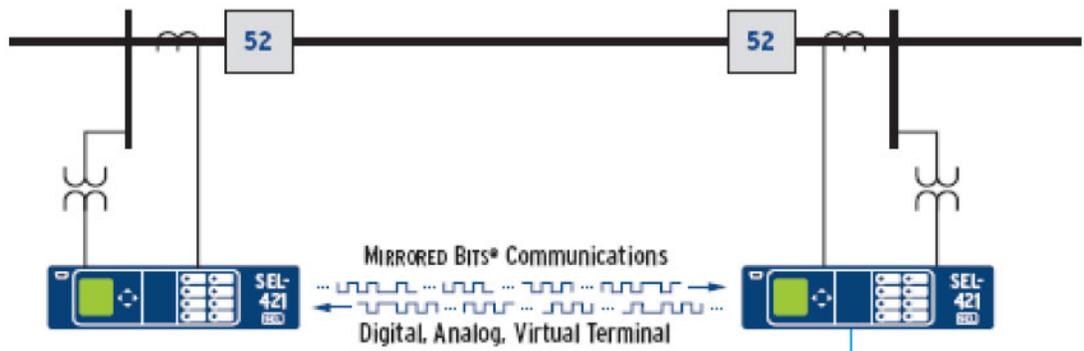
Figure 3

Communication between the relays at each end of the circuit will be done over digital microwave. This channel will facilitate Permissive Overreaching Transfer Trip (POTT) as well as a Direct Transfer Trip (DTT) scheme that is used for breaker failure protection.

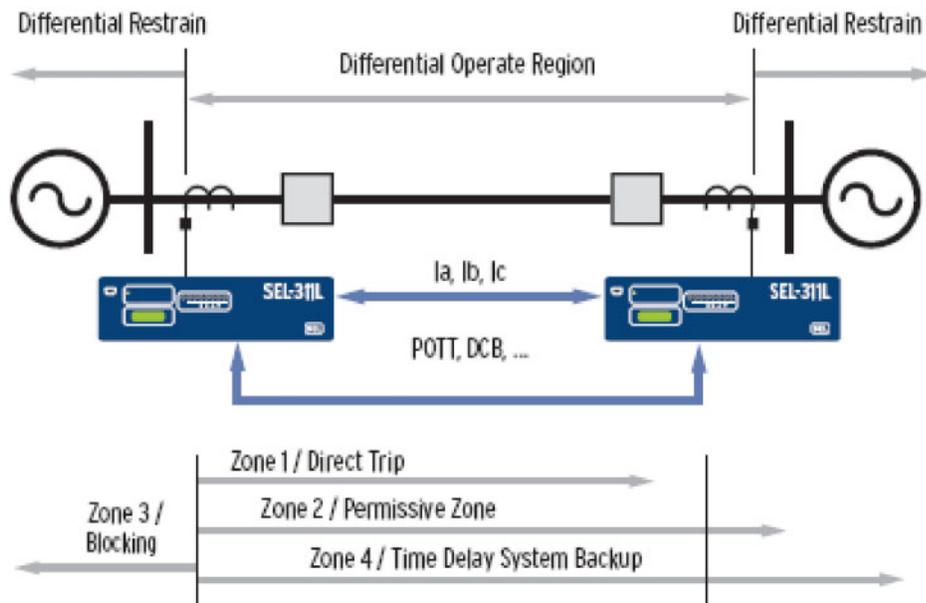
**Figure 4**

The secondary protection for the 345KV circuits will be performed by SEL-311L relays. The SEL-311L relay uses a vector ratio of the local and remote phase and sequence currents to provide high speed current differential protection. The SEL-311L relay also includes complete step zone distance protection with directional overcurrents serving as backup. POTT and DTT schemes are integrated in the protection.

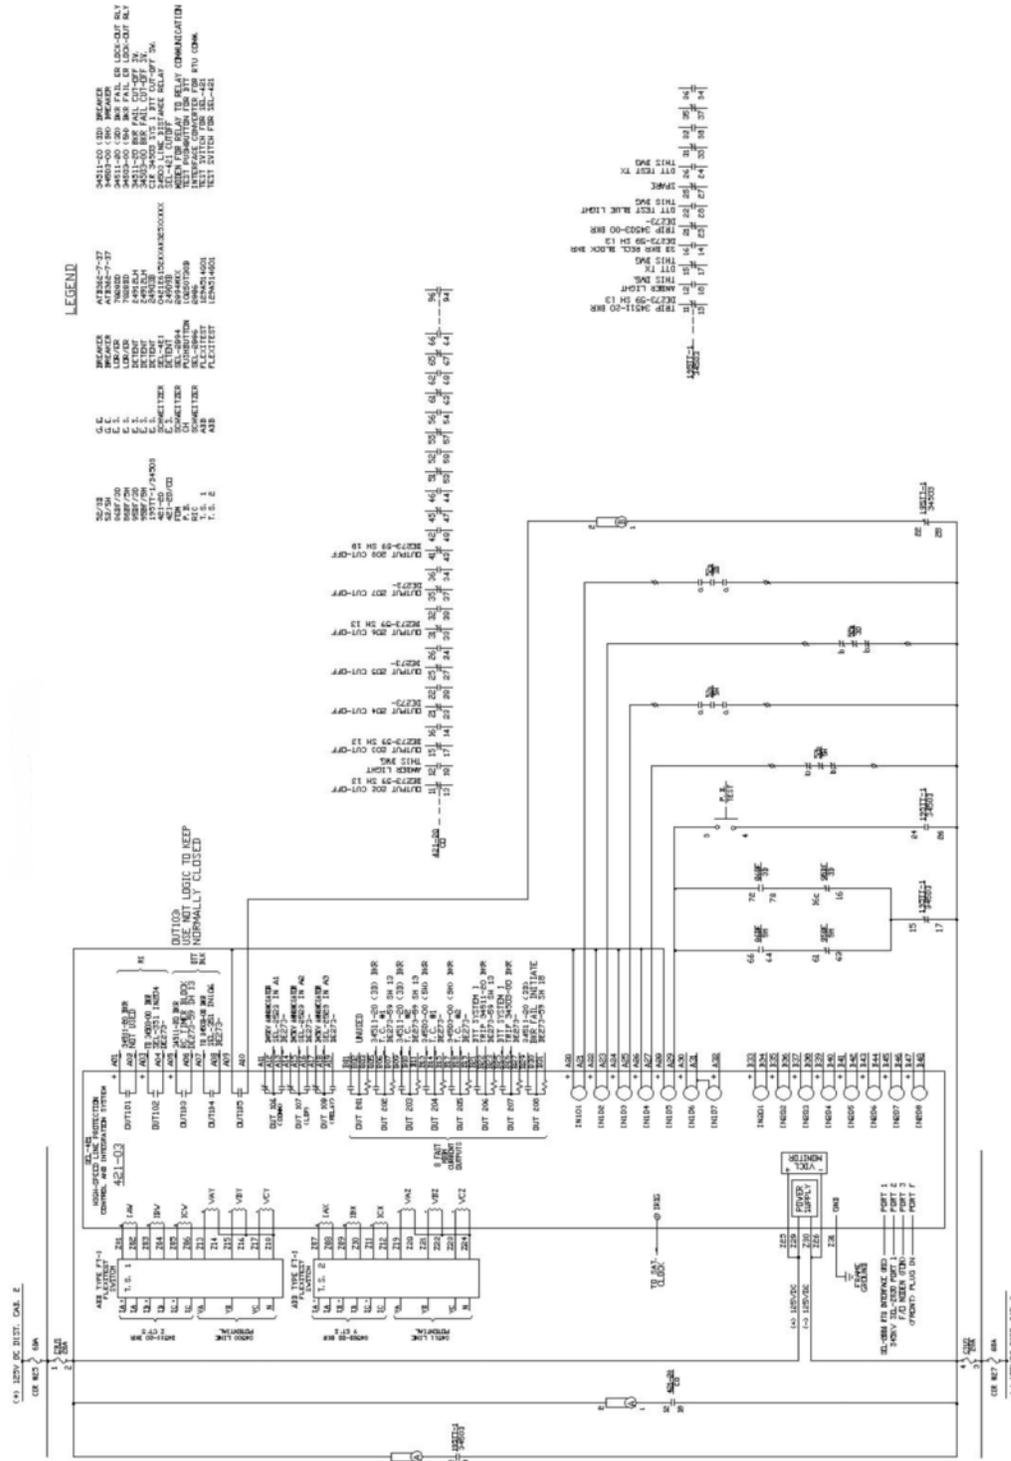
System 1 - SEL-421 Schematic

A sample of DC Schematics for the 345KV line protection schemes associated with this project are shown in Figure 5 and 6 on the following pages:

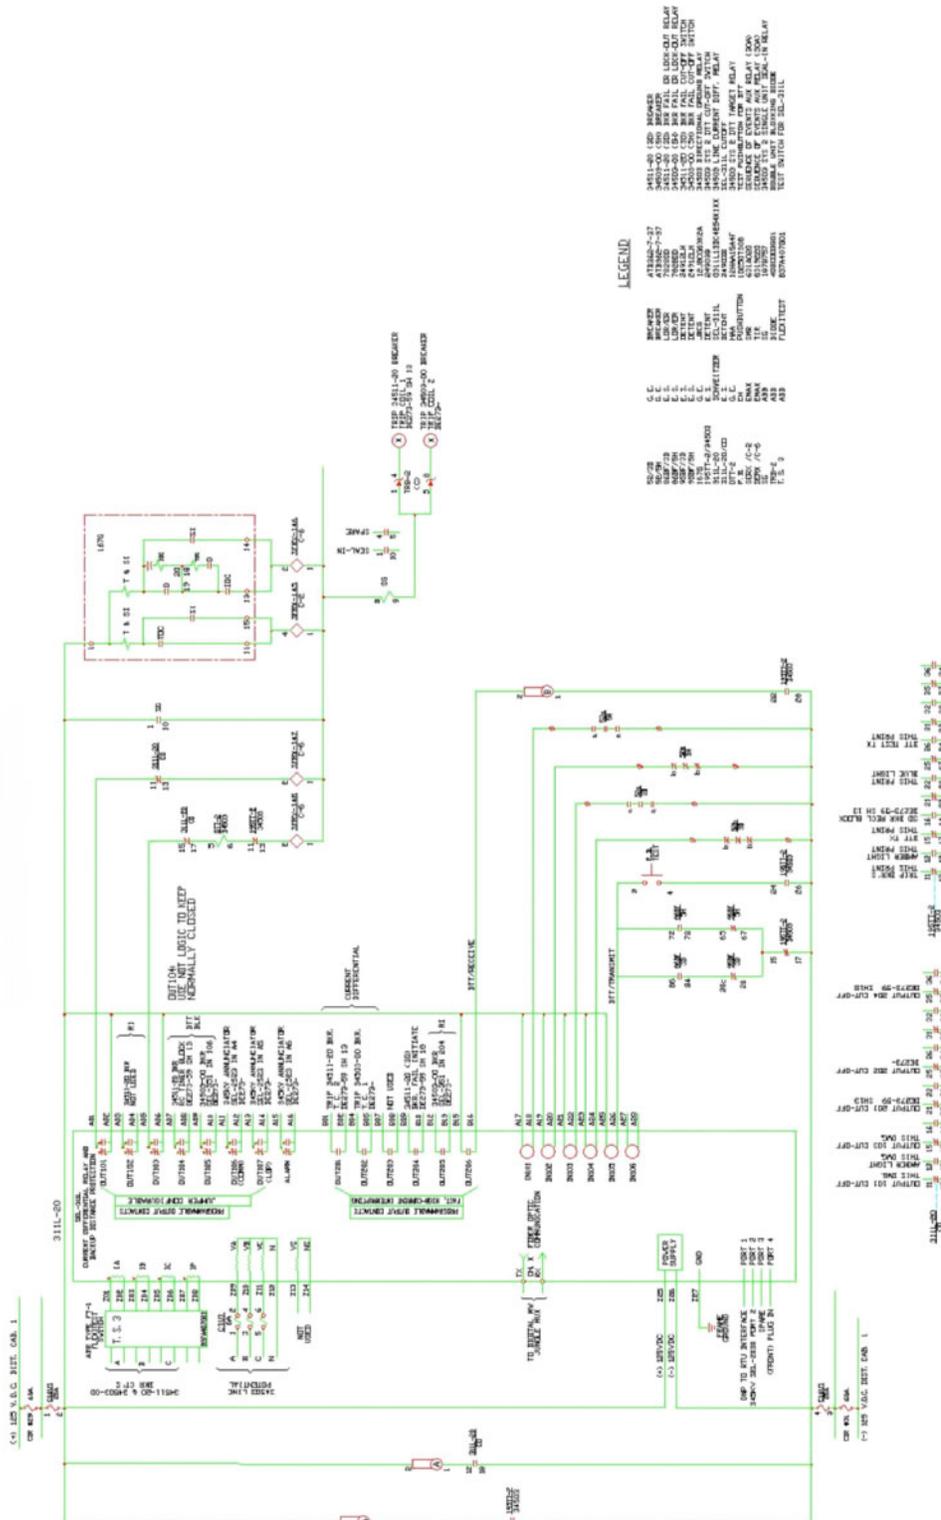
Figure 6

System 2 – SEL-311L and Backup Directional Ground Overcurrent Schematic

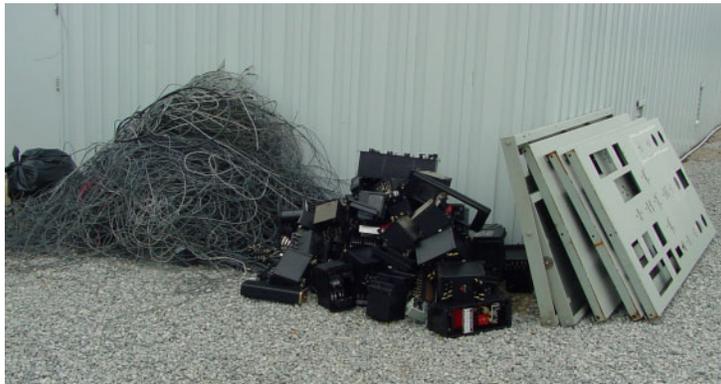
Babcock – Wiring and Relay Panel Removals

345KV protective relay modernization projects typically require extended circuit outages (3-4 weeks). To minimize the system impact, such projects are often scheduled when moderate weather is anticipated (Spring and Fall). When project timing is not advantageous, NIPSCO employ's the use of temporary relaying panels to limit circuit clearances to only two days: one day at the beginning and one day at the end of the project. While this practice has proven to be extremely valuable under adverse conditions, utilizing temporary panels increases the complexity and duration of the project. While adequate, the circuit protection provided by the temporary panels is also less than ideal. For the modernization associated with this project, timing allowed for 3 week outages, therefore the temporary panels were not required. For each circuit, the proper line and breaker clearances were acquired. The protection and control circuits were de-energized and the old relay panels were unwired and removed from service. Relay modernization projects entail a tremendous amount of wiring changes. For the Babcock project there were 43 pages of wiring removals. Five panels and more than 30 electromechanical relays were retired from service.

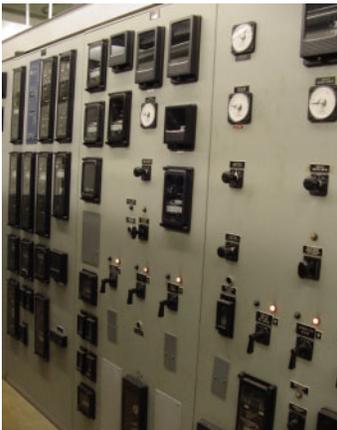
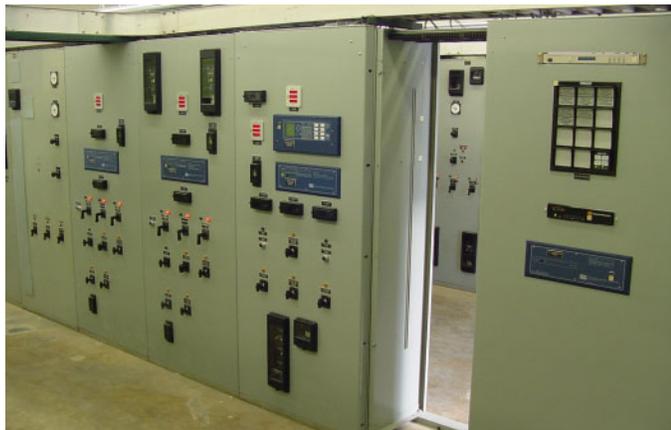
Old Babcock Relay Panels

New Babcock Relay Panels

The prior pictures illustrate one of the many advantages of the modern microprocessor relays. They are multifunctional, i.e. one SEL relay performs the functionality of an entire panel of electromechanical relays. As a result, new panels contain fewer relays (fewer points of failure), while providing more advanced and redundant levels of protection.

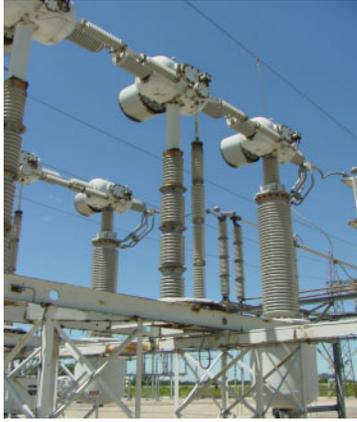
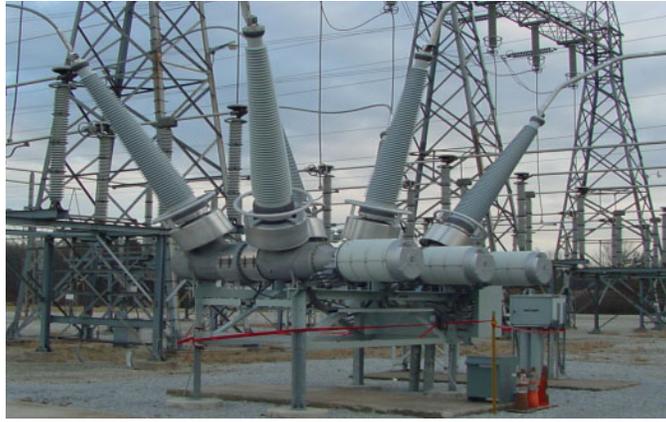
Old Air Blast Breaker

New SF-6 Breaker

Coinciding with the relay modernization project at Babcock was the replacement of a 345KV Breaker.

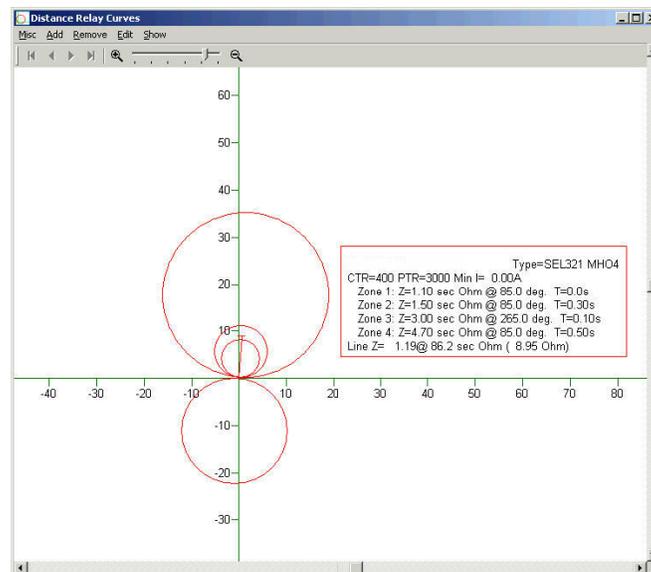
Figure 7

The NIPSCO Transmission Planning and System Protection group is responsible for maintaining the T&D system model. Short circuit analysis is performed using Aspen Oneliner to develop impedance and overcurrent settings for the protective relays.

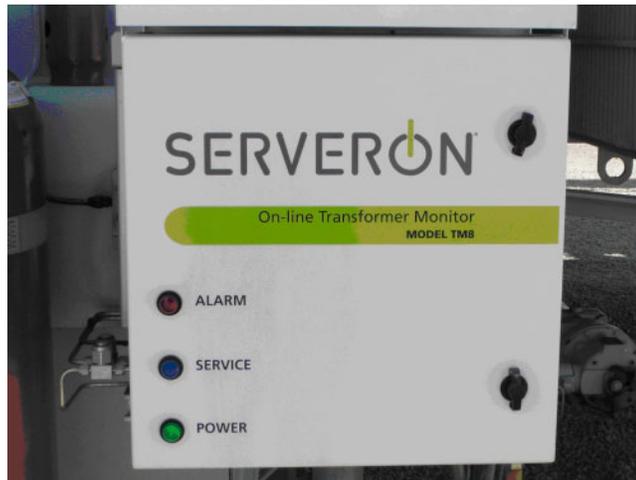
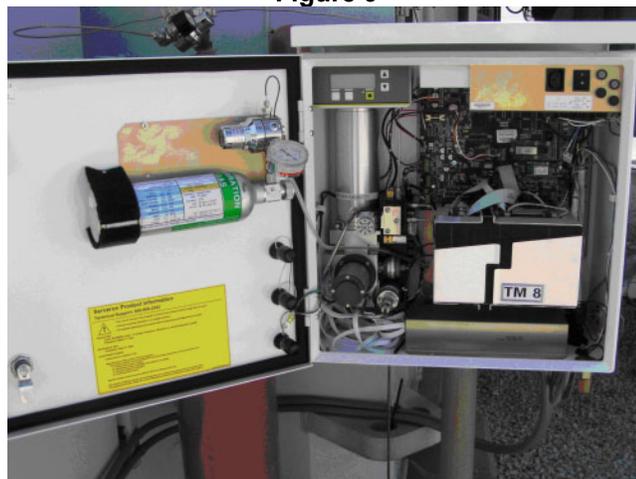
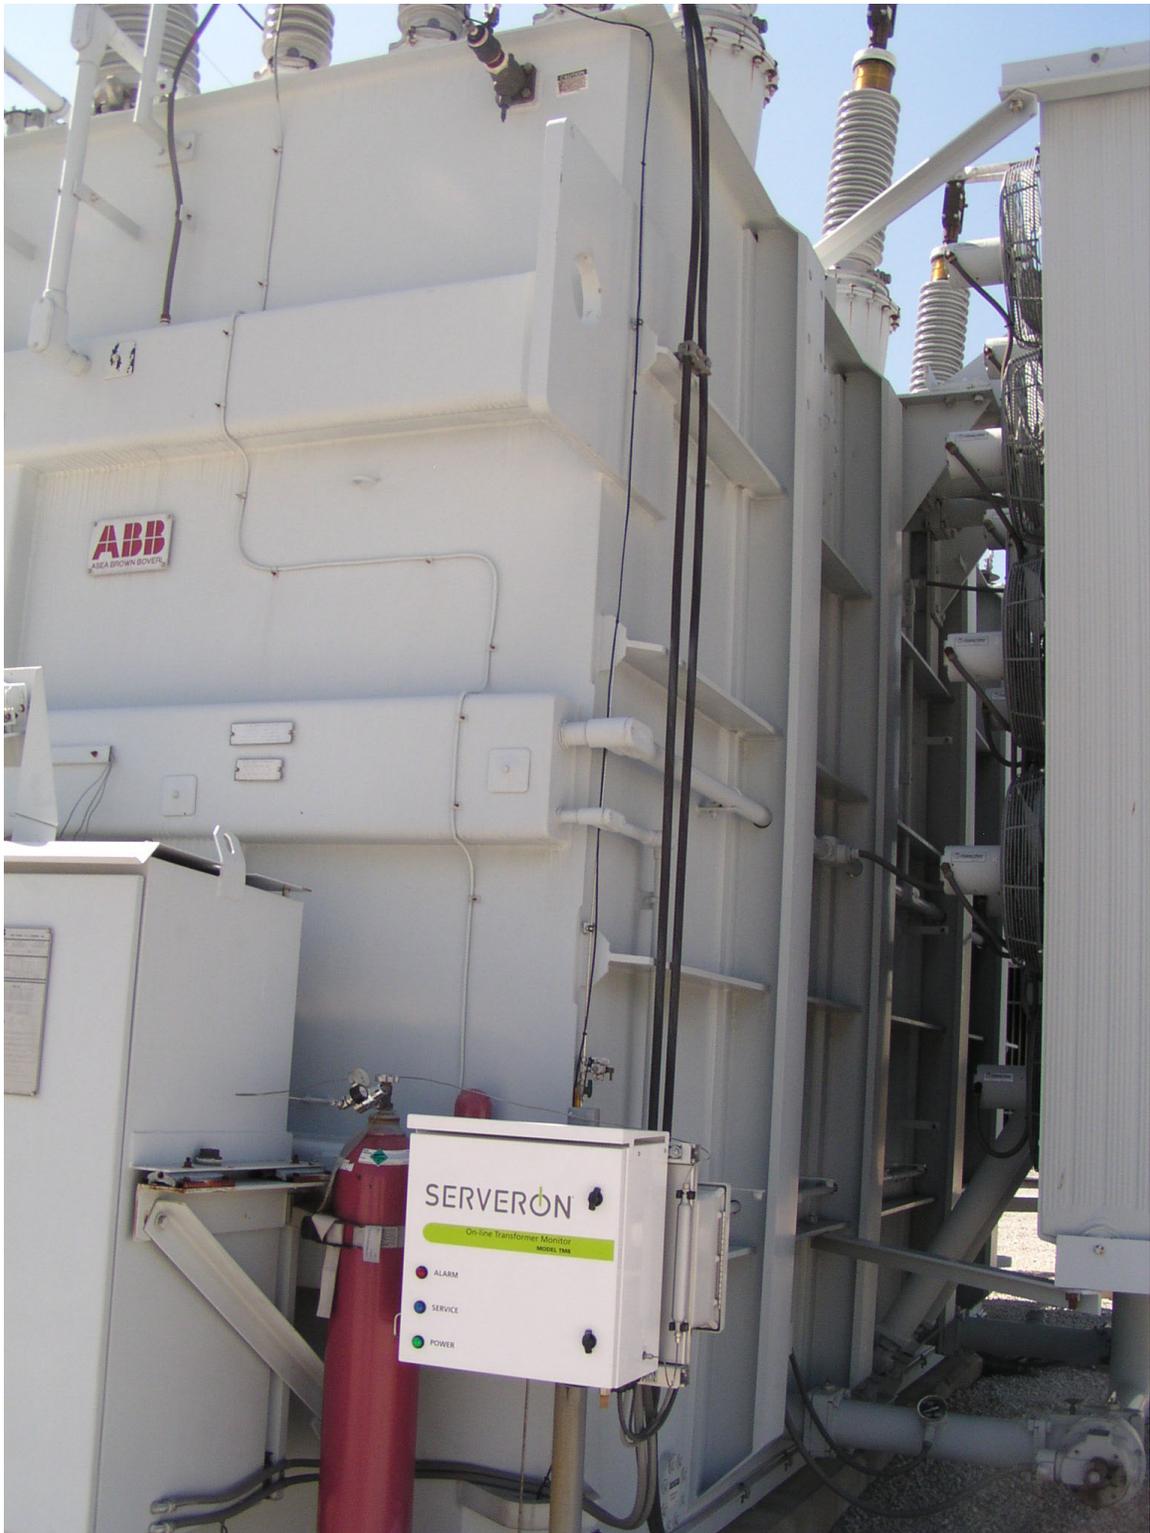
A typical Serveron monitor installation is shown in figures 9,10 and 11. Figure 9 is the transformer monitor mounted on brackets to the side of the transformer case. Figure 10 is the monitor with its swing cover open to show an internal electrical panel containing the electronics to monitor the gas levels and for interfacing AC power and communications to the monitor. Figure 11 details the oil supply lines from the oil moisture and temperature sensor connected to an existing oil port near the top of the transformer to the monitor.

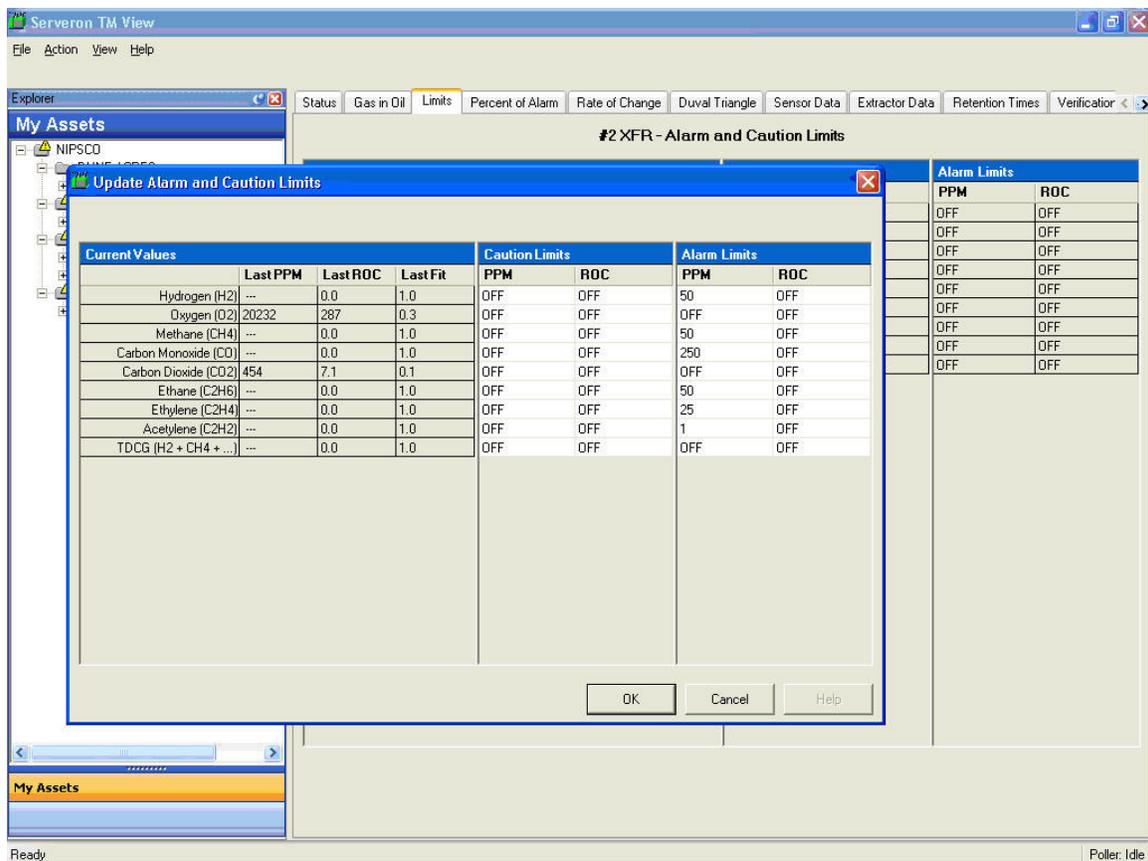
Figure 12

Caution and alarm limits are set manually in the Serveron TM View software (Figure 12)

View from the Serveron TM View software limits setting tab

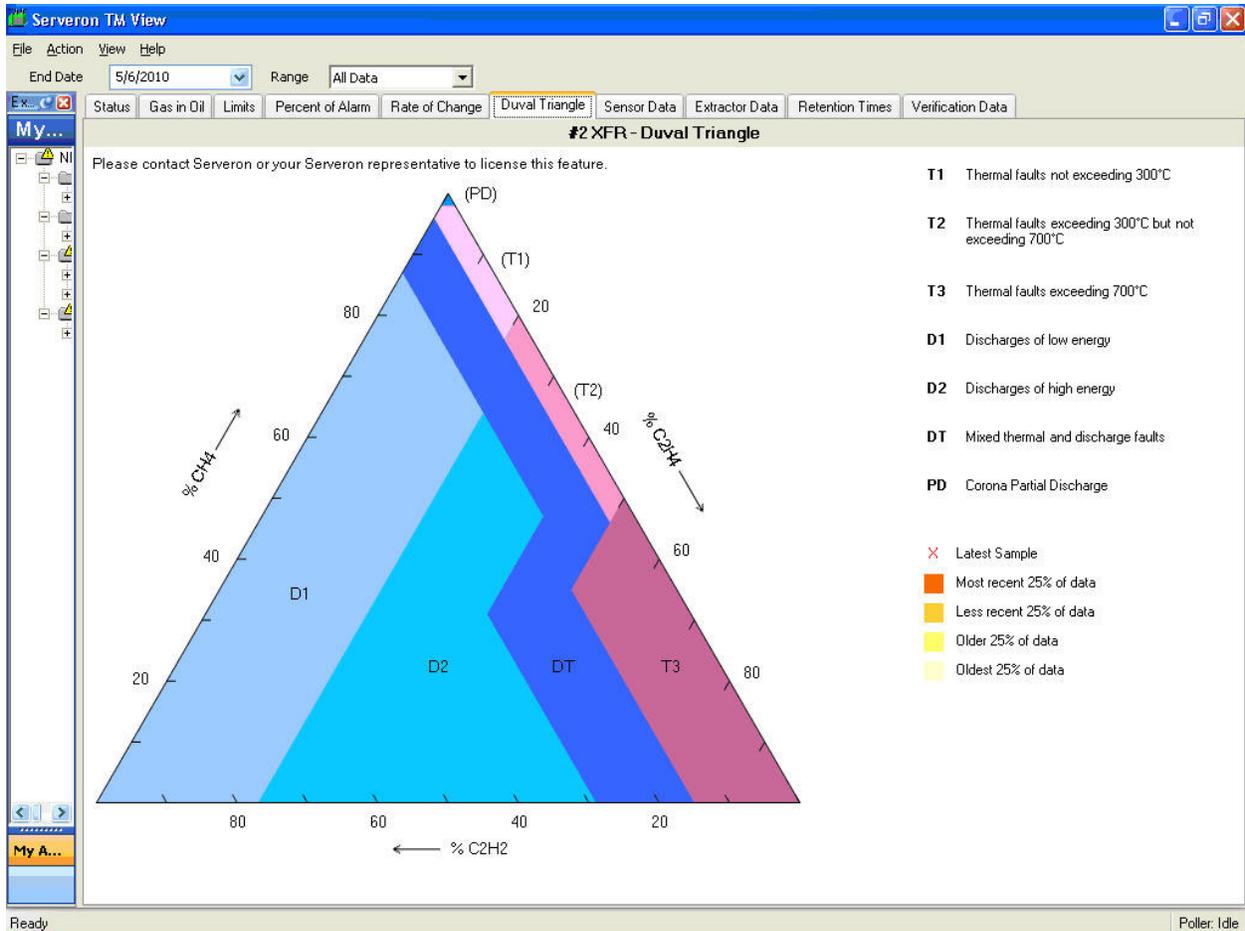
Figure 13

Serveron TM8 utilizes the Duval Triangle gas relationship of Acetylene ( $C_2H_2$ ), Methane ( $CH_4$ ) and Ethylene ( $C_2H_4$ ). If a condition exists that has the three mentioned gasses present, the levels of each gas is weighted to each other and an appropriate cause is identified. Here is a screen shot of the TM View software and Duval's triangle diagnostic feature.

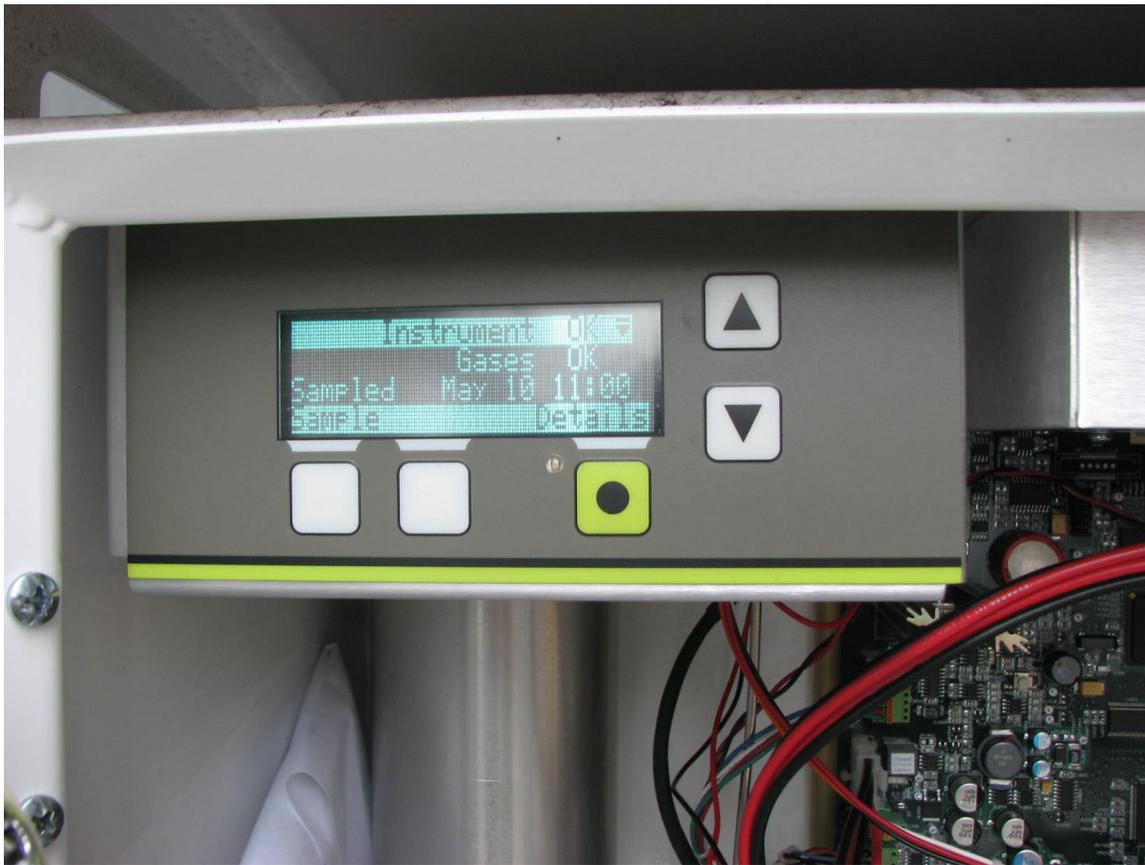
As we became more familiar with the Serveron units, we discovered several features that would improve the gas monitoring devices. The gas monitors did not have a user interface or display to view the gas levels without the use of a laptop computer. We worked with Serveron to incorporate a display to view the current gas levels and last sample date stamp. This feature would quickly identify any fault gasses and the last sample performed by our first responders in the case of a fault condition.

**Figure 14 - TM8 DISPLAY**

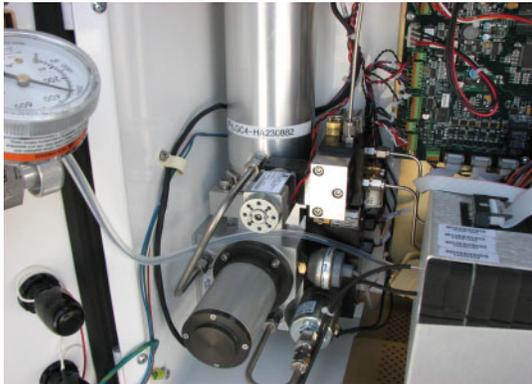
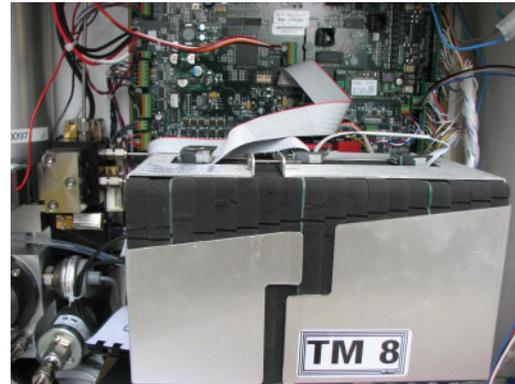
**Figure 15**  
**PUMP ASSEMBLY**

**Figure 16**  
**SLED ASSEMBLY WITH MAIN BOARD IN**  
**BACKGROUND**

We have had multiple sled issues, moisture transmitter problems, pump concerns and display malfunctions.

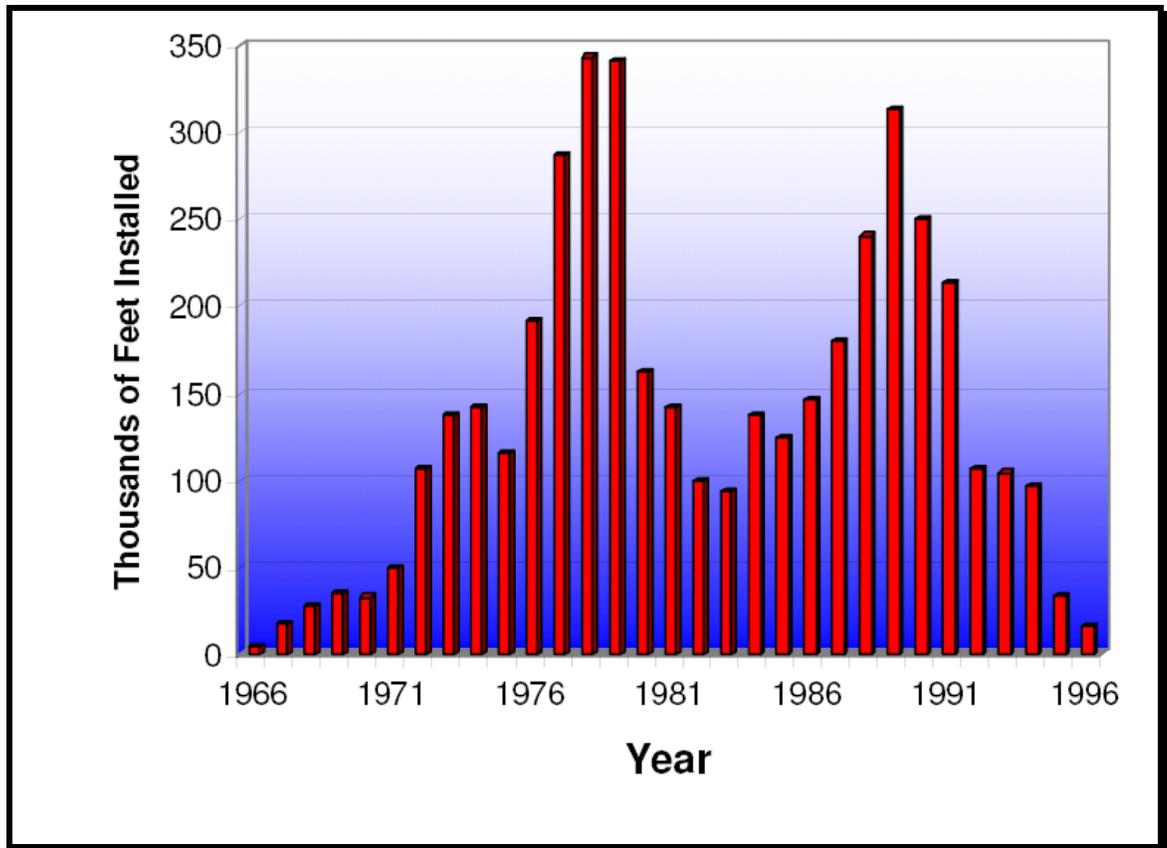
During the years from 1985 to 1990, NIPSCO changed their cable standards to the latest technology. Unjacketed cable with cross-linked polyethylene (XPLE) insulation was replaced with jacketed cable with tree retardant XLPE or (TRXLPE) and strand filled conductor.

**Figure 23 Length of Unjacketed Cable Installed per Year**

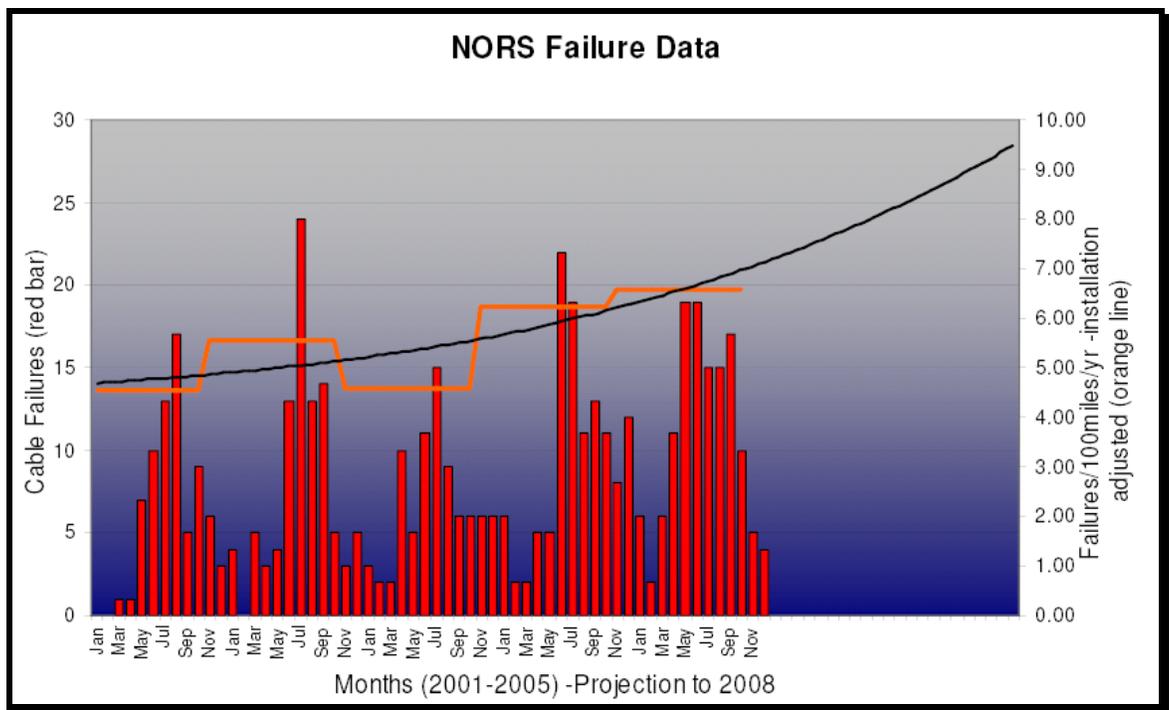
**Figure 24 Failures per month is plotted with the red bars and the yearly increase shown by the orange line.**

The graph shows that NORS tracked nearly 7 failures/100 miles/year in 2005. This is 13% above the national average of 6.2 failures/100 miles/year as reported by AEIC in 1994. However, a 5 utility survey on the basis of data presented at the 2004 Fall IEEE PES ICC Meeting shows that the NIPSCO failure rate is 23% lower

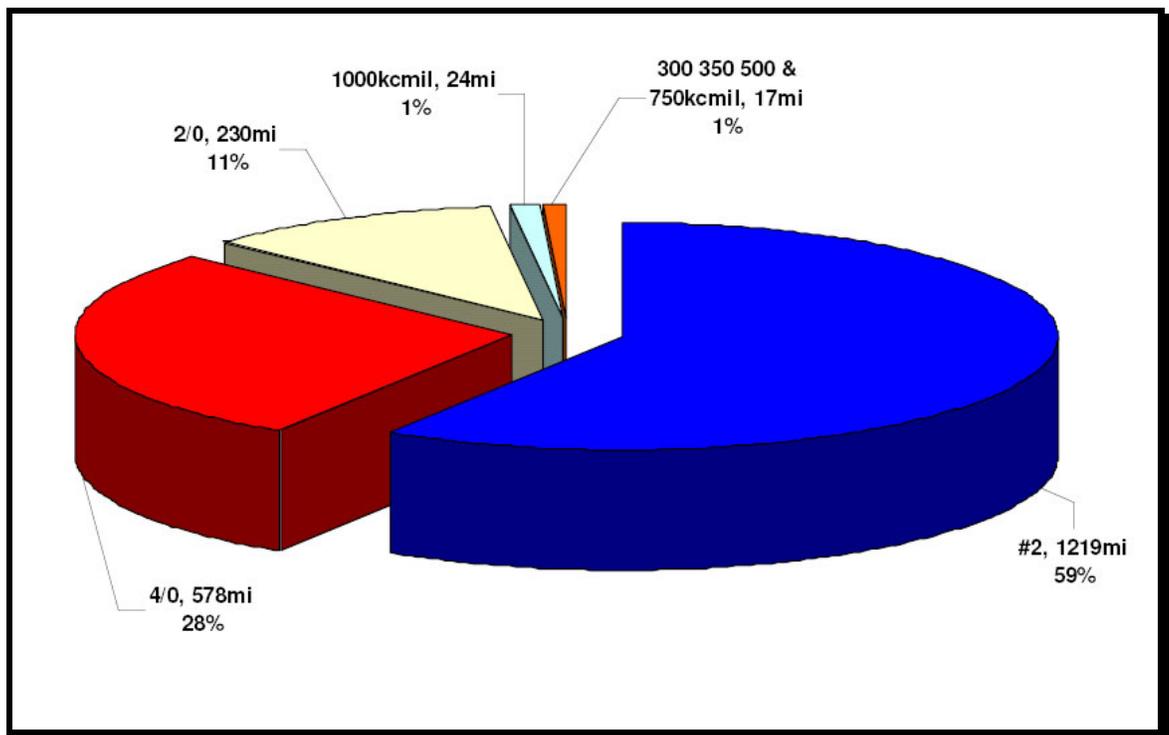
Figure 25 Percentage Installed Cable by Conductor Type (March 2006)

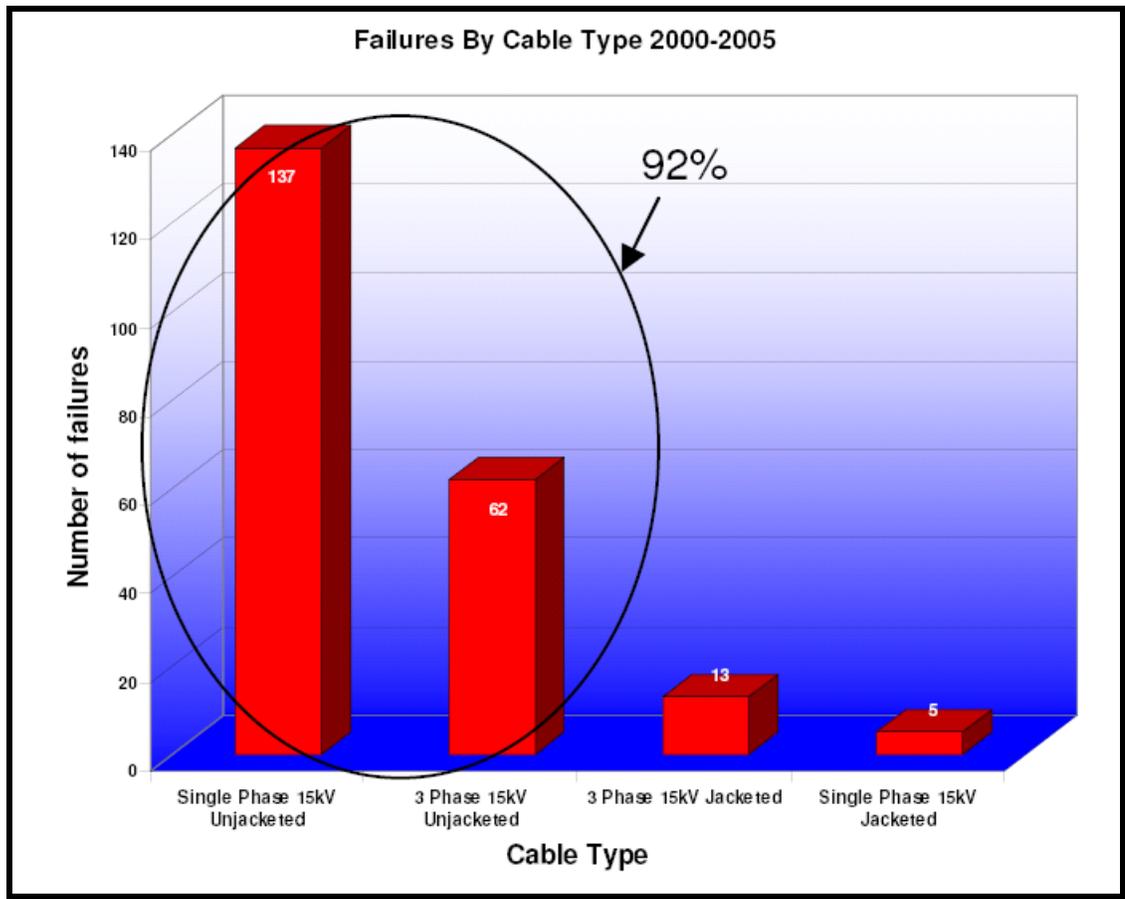
**Figure 26**  
**NORS Failure Data 2001-2005 by Cable Type**

The above graph indicates that 92% of the failures are emanating from the 15kV class unjacketed cable. The EDFS asset database indicates that 95% of the unjacketed cable, about 705 miles, was installed between 1970 and 1990. This means that 35% of the cable system is causing 92% of the failures.

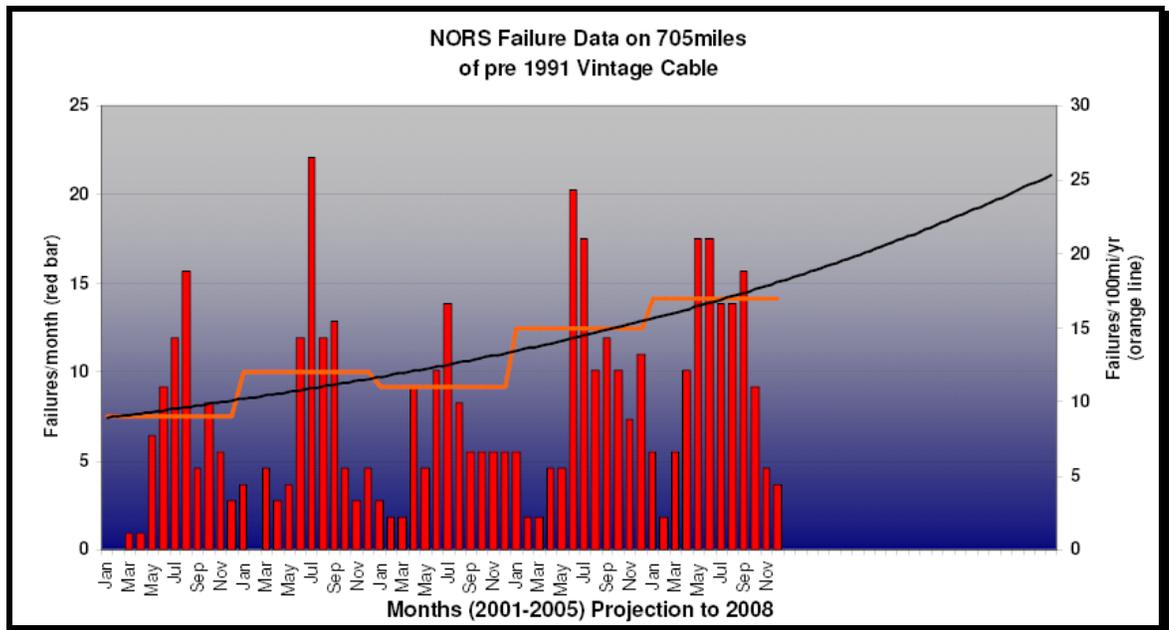
**Figure 27**  
**NORS Failure Data on 705 miles of pre-1991 Unjacketed Cable**

Comparing 92% of the failures caused by 705 miles unjacketed cable to the failures recorded by NORS from 2001 to 2005, the above graph is derived. The failure rate of the 705 miles of unjacketed cable in 2005 was 17 failures/100 miles/year, or nearly 3 times the national average for URD systems reported by the AEIC in 1994 (6.2 failures/100 miles/year) and nearly 2 times the 2004 ICC survey (9 failures/100 miles/year) mentioned above. Since 2001, the failure rate has been increasing by an average of 18% per year.

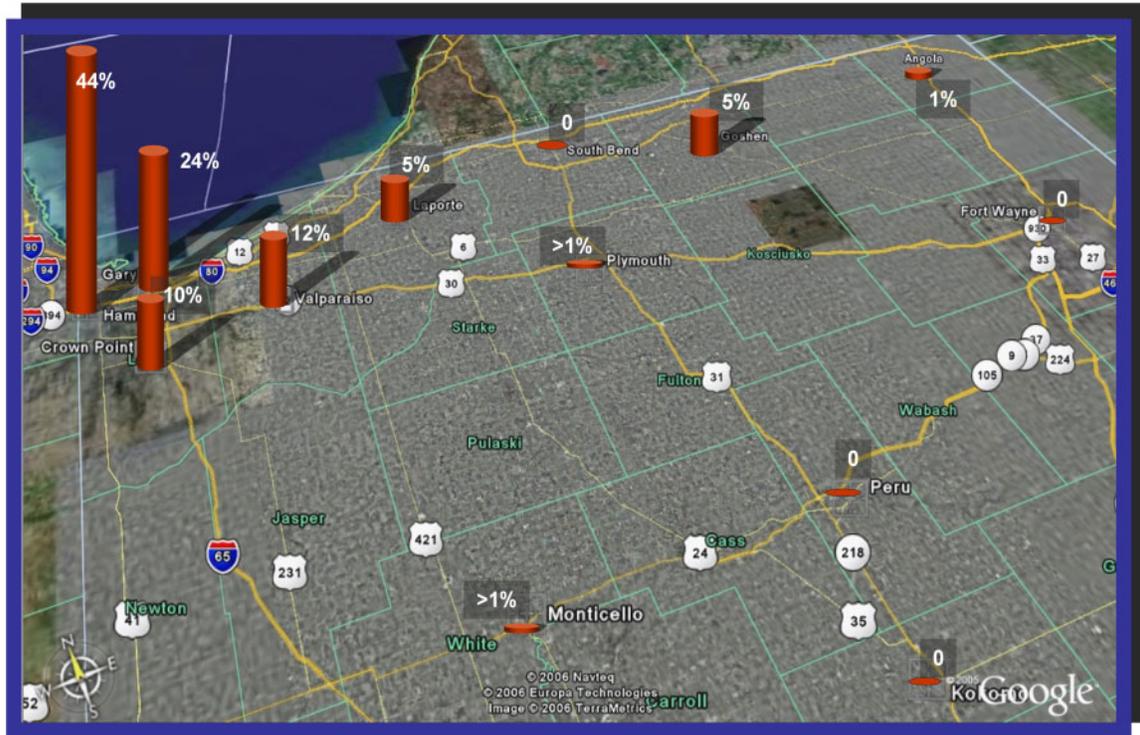
**Figure 28**  
**Google Earth Overlay of LOAs with 90% of Failures from 2001-2005**

As shown in Figure 28, a goal is to focus on the Hammond, Crown Point, Gary, and Valparaiso local operating areas. According to NORS, these 4 LOAs have sustained 90% of the failures on 114 circuits in the last 5 years and have the highest percentage of target unjacketed cable population.

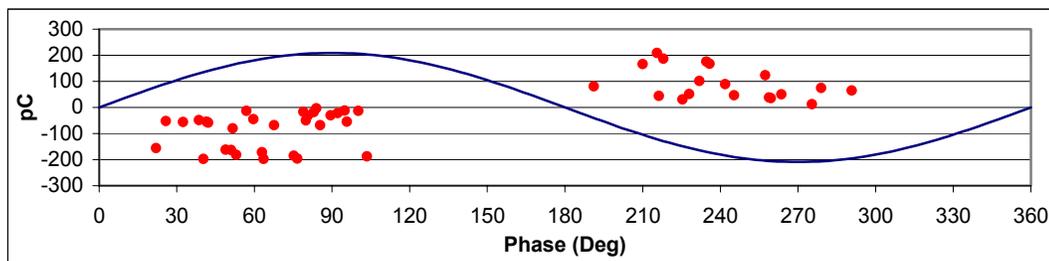
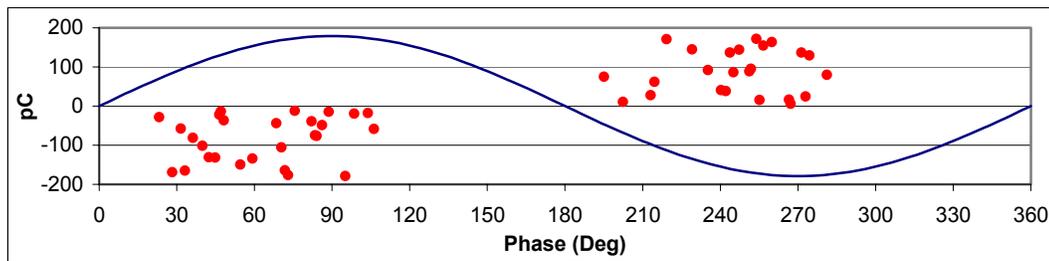
**Figure 31 Partial Discharge Detail**

The detail in figure 31 above is an example of an information level reviewed by the IMCORP, and in this case, the partial discharges are from the end termination and are mitigated in the field. This level of detail is included in the customer documentation.

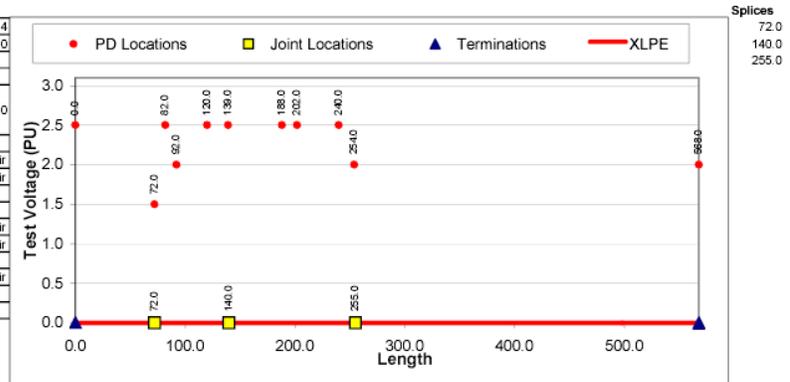
Comments: Far End was re-terminated with new elbows before testing. Semi-con cutback measurements were incorrect. Recommend repairing cable section between splices 72ft and 255ft, if practical and cost effective. Considering the length of the cable, it may be more realistic to replace the section.

**Figure 32 Simplified Profile of Cable Segment with recommendation**

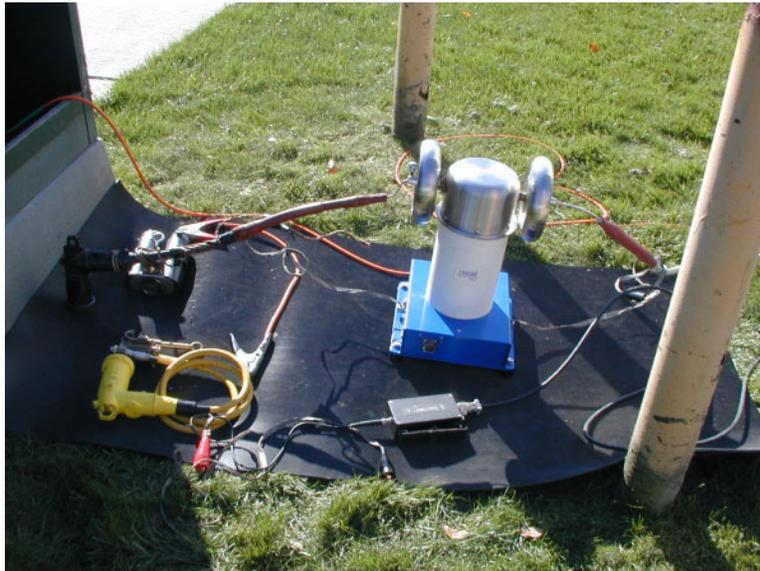
- i. Customer assist crew starts by selecting a point in the circuit where one or more cables can be tested without having to shift the location of test truck.
- ii. Assist crew prepares the first cable before the arrival of IMCORP crew.
- iii. As the first cable is tested the assist crew is preparing a second cable
- iv. As the second cable is being tested, the first cable will be reassembled and the next cable is being prepared.
- v. The assist crew moves to a second location on the circuit where one or more cables can be tested.
- vi. The process is repeated from step (ii).

**Figure 33 Typical Equipment Setup**

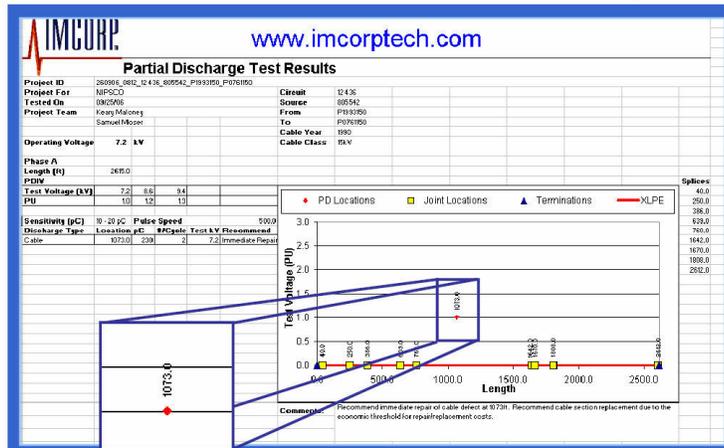
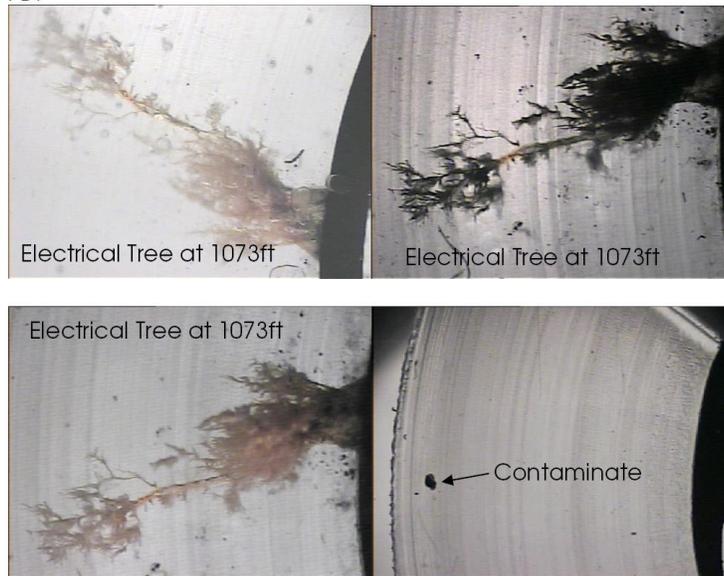
Figure 35 Dissection Analysis Report

**Background:** On 9/25/06 the cable parallel to Connecticut Dr in Merrillville, IN was tested for partial discharge activity and location. As the 60Hz voltage was increased to simulate voltage transients, a partial discharge site was located very close to nominal voltage of the cable. As a result, the defect was located using a location matching system and removed by NIPSCO crews. The sample was sent to the IMCORP sample laboratory and dissected finding the following defects, the most significant being the electrical tree the source of the PD.

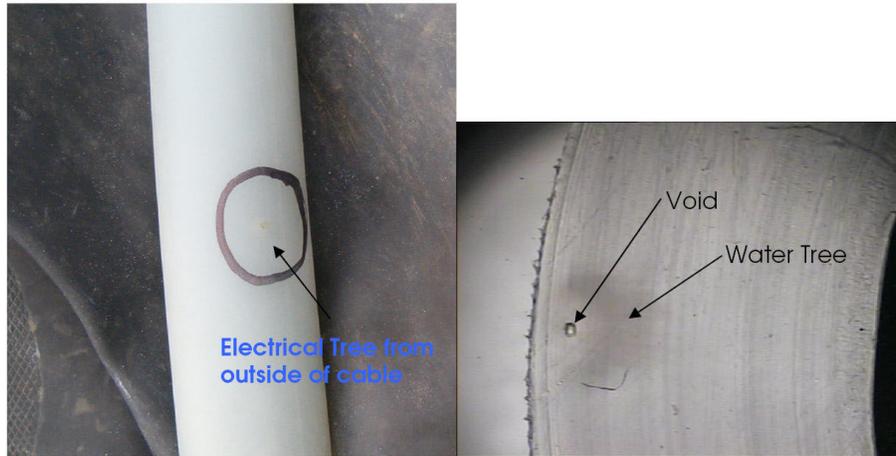
**Figure 36 Additional Electrical Tree Example**

Since this was near the start of the Condition Assessment Survey, early dissection analysis was helpful to relate the technology and reports to the actual defect that is detected and in this case, removed.
