Laser Scanning Technology as Part of a Comprehensive Condition Assessment for Covered Bridges

June 2015

Brashaw, Brian K.; Anderson, Samuel; Ross, Robert J. 2015. Laser scanning technology as part of a comprehensive condition assessment for covered bridges. Research Note FPL-RN-0335. Madison, WI: U.S. Department of Agriculture, Forest Service, Forest Products Laboratory. 10 p.

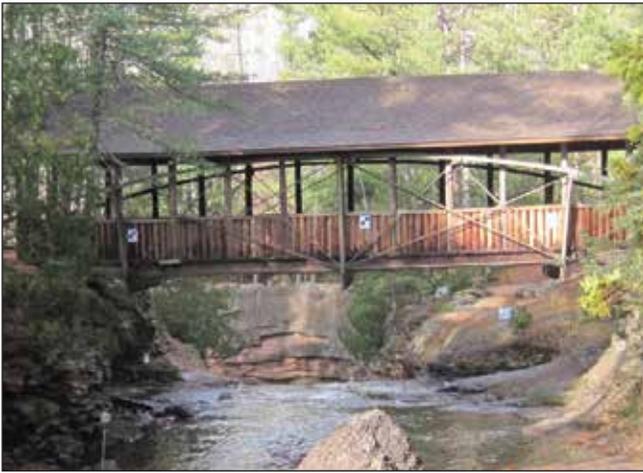
Figure 1—Amnicon River Bridge photograph from upstream.

This bridge was moved to its current location from a nearby site over the Amnicon River in 1930. A roof was added to it around 1939. The bridge is a bowstring pony truss design. It is considered to be historically significant as a consequence of its age and unusual construction details. Designed and constructed by Mr. Charles Horton, the bowstrings were unique in that no holes were drilled in the truss members and they were held together with a unique system of clips. His design allowed quick assembly without expensive machinery or tools and minimal labor. The construction method called for using arched beams secured with hooks and clips rather than rivets and bolts (Wisconsin Department of Natural Resources 2013). The roof was replaced in 1941 after collapsing from heavy snow and again in 1971 when destroyed by a fire set by vandals. Figures 1–3 are photographs of the Amnicon River Bridge in October 2011.

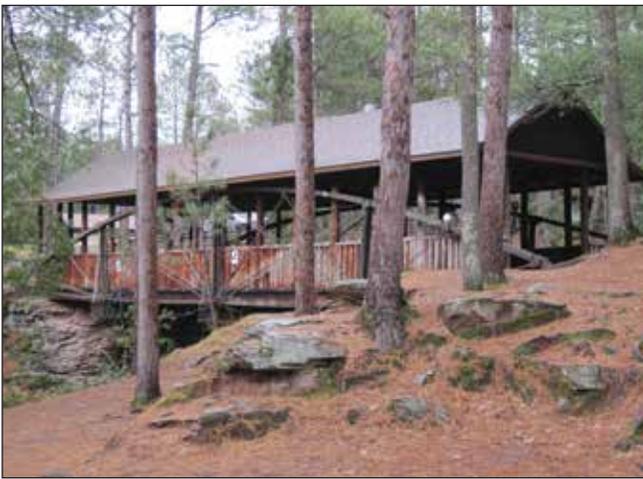
Figure 2—Amnicon River Bridge profile showing bowstring trusses and timber components.

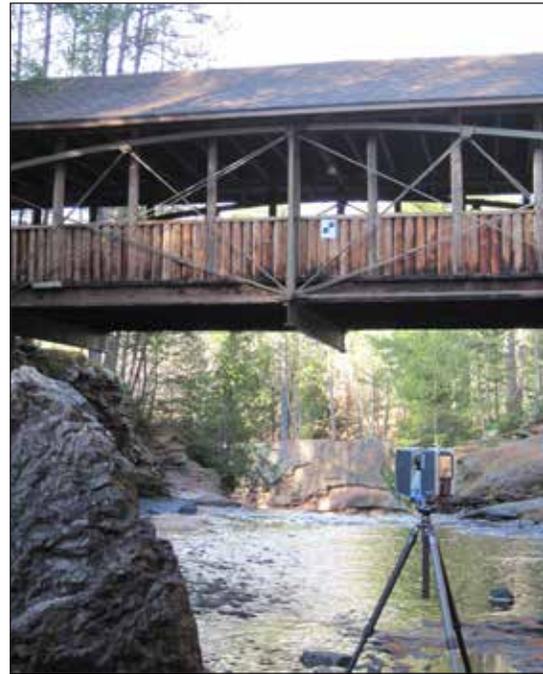
Figure 4—A FARO Focus 3D 120 laser scanner was used to scan the Amnicon River Bridge.

Laser scanning was completed by staff from UMD using a FARO 3D Focus 120 scanner. Approximately 18 scans were completed of the bridge from a variety of angles. Figure 4 shows a FARO laser scanner in use.

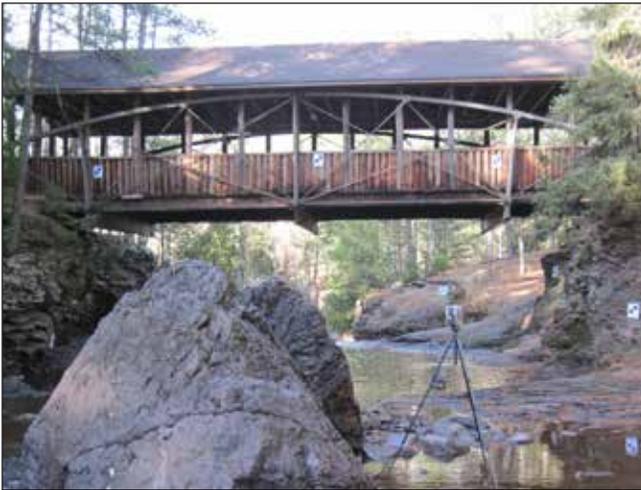
Figure 5—Paper reference targets used during the inspection process.

as visible references. Each scan requires a minimum of three visible references, however, four or more references are recommended. These targets are used to register or “connect” multiple scans, each on their own coordinate system into a single, aligned coordinate system. Figures 5 and 6 show the use of paper targets and spherical globes we used in this study.

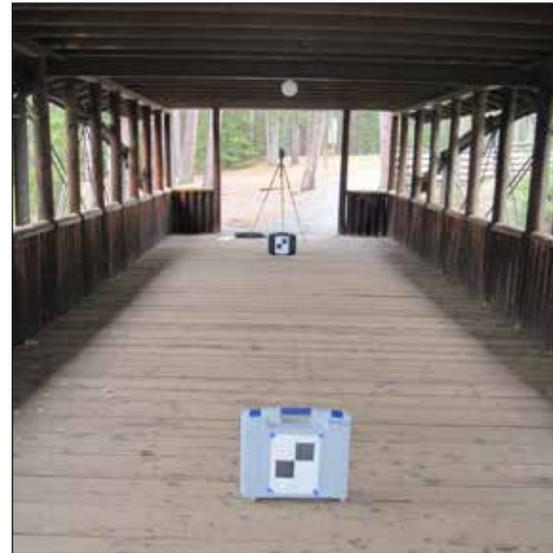
Figure 7—Laser scanner test setup, inside bridge.

2. A 3D laser scanner (FARO Focus 3D 120, FARO 2013) was used to conduct the scan. The scanner was placed at 18 unique vantage points inside and outside the bridge, such that all visible surfaces of the bridge would be documented. This included upstream, under the bridge and downstream locations. Individual scans were completed in approximately 10 minutes. When a single scan was completed, it was saved to a flash memory card on the unit as an .ls file. Because Figures 7–9 show example locations that were scanned for the Amnicon Bridge.

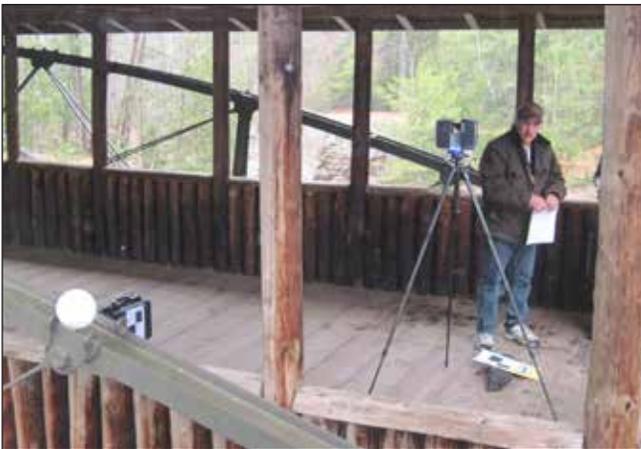
Figure 6—Spherical globes are often used in combination with paper targets as references for laser scanning.

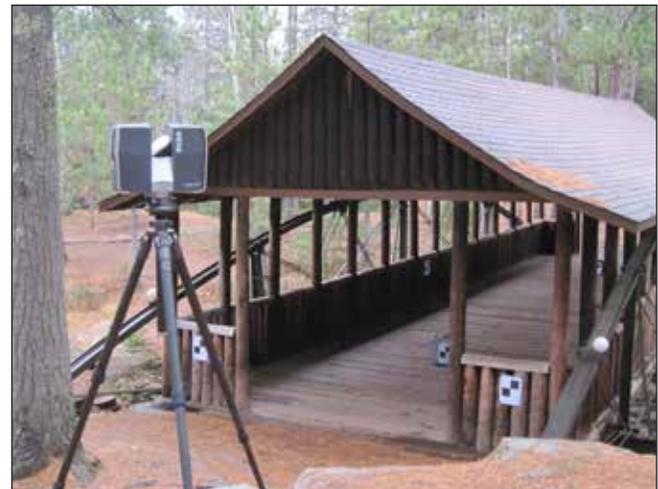
Figure 8—Scanner test setup, bridge entrance.

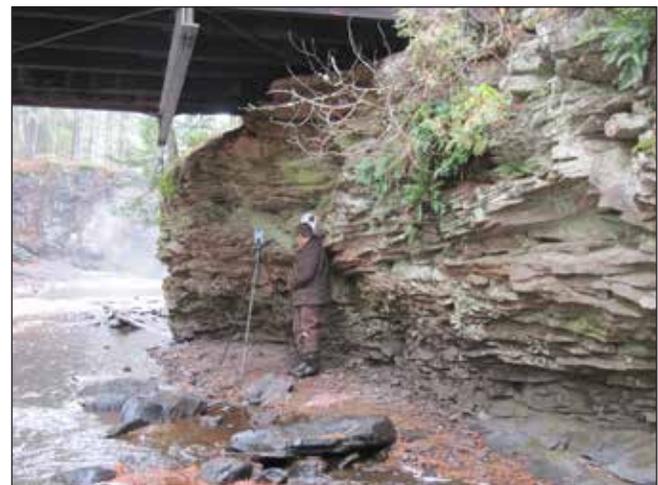
Figure 9—Scanner test setup, under bridge.

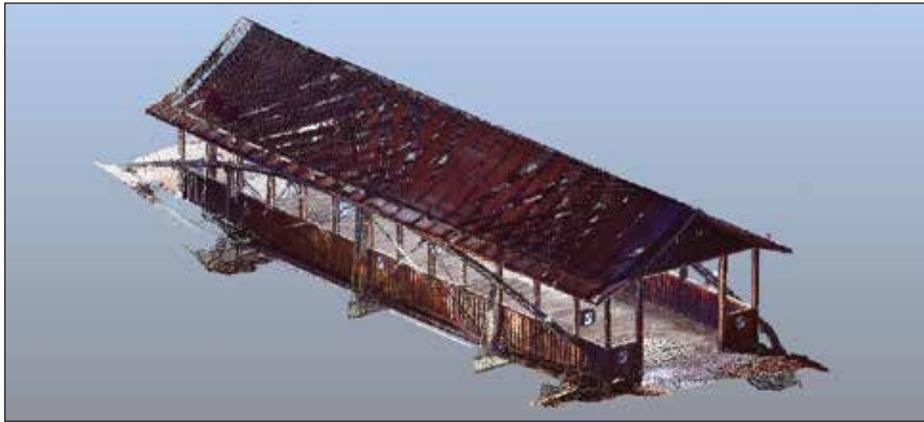
Figure 10—All scans have been connected to create a point cloud by using a process called registration. Point clouds depicting all visible aspects and actual dimensions of the bridge.

to link or attach one scan to another. The process of linking two individual scans was repeated several times until all scans were compiled into one large scan depicting the entire bridge. Figures 10–12 are point cloud images of the multiple scans that were completed for the Amnicon River Bridge.

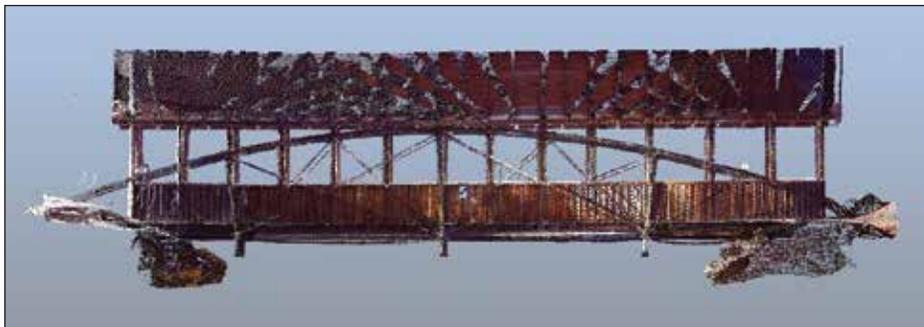
Figure 11—A point cloud image can be rotated to look at other views, such as this landscape image of the Amnicon Bridge.

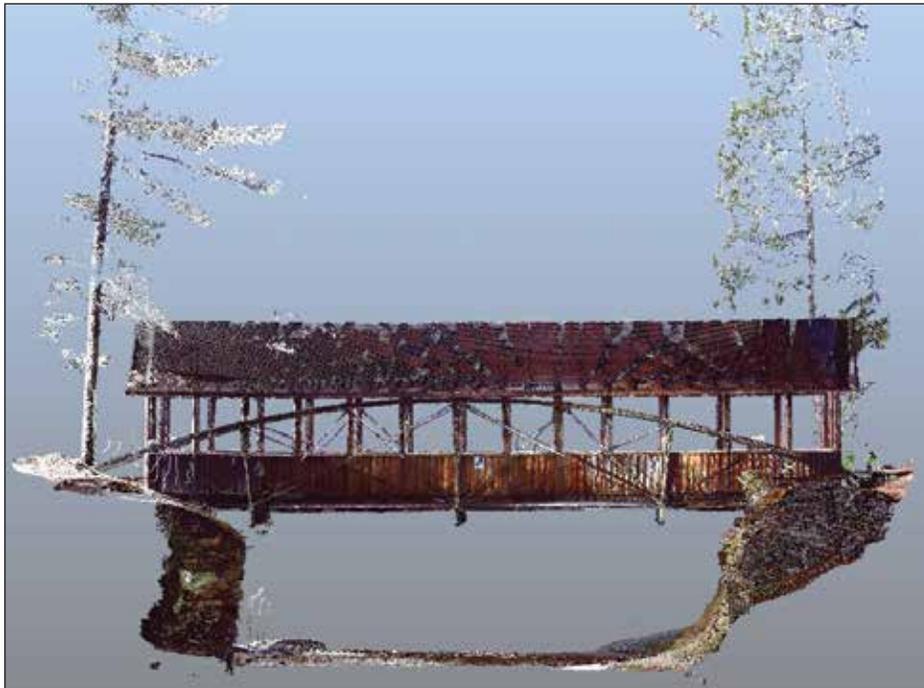
Figure 12—Point cloud images collect a wide range of data points from reflective surfaces such as vegetation and land. This image shows the white pine located near the bridge and the cross section of the river valley.

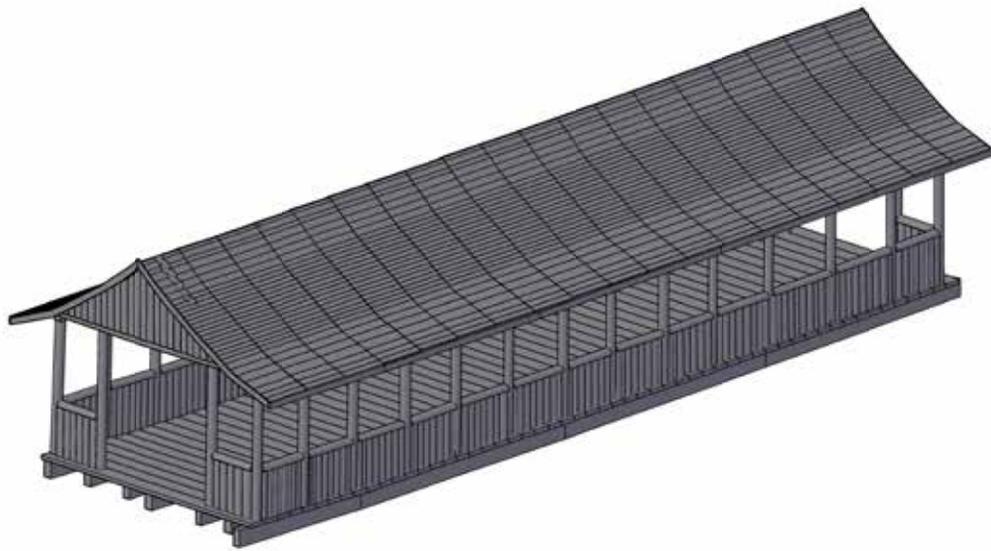
Figure 13—An isometric view of the Amnicon River Bridge.

Once the Amnicon Bridge was completely assembled using all of the individual scans, it was exported into AutoCAD using an add-in provided by Kubit USA. This add-in enabled us to import point cloud files in addition to the ones inherently recognized by AutoCAD and has additional modeling tools for working directly with point cloud data in AutoCAD. Once a point cloud has been exported into AutoCAD, it can be divided into multiple cross-sections. This is done so that specific components of the bridge can be seen more clearly. From this point, two and three-dimensional (2D and 3D) models of the bridge can be generated. Figures 13–16 show AutoCAD images of the Amnicon Bridge. The steel floor beams and bowstring members were omitted from the AutoCAD images.

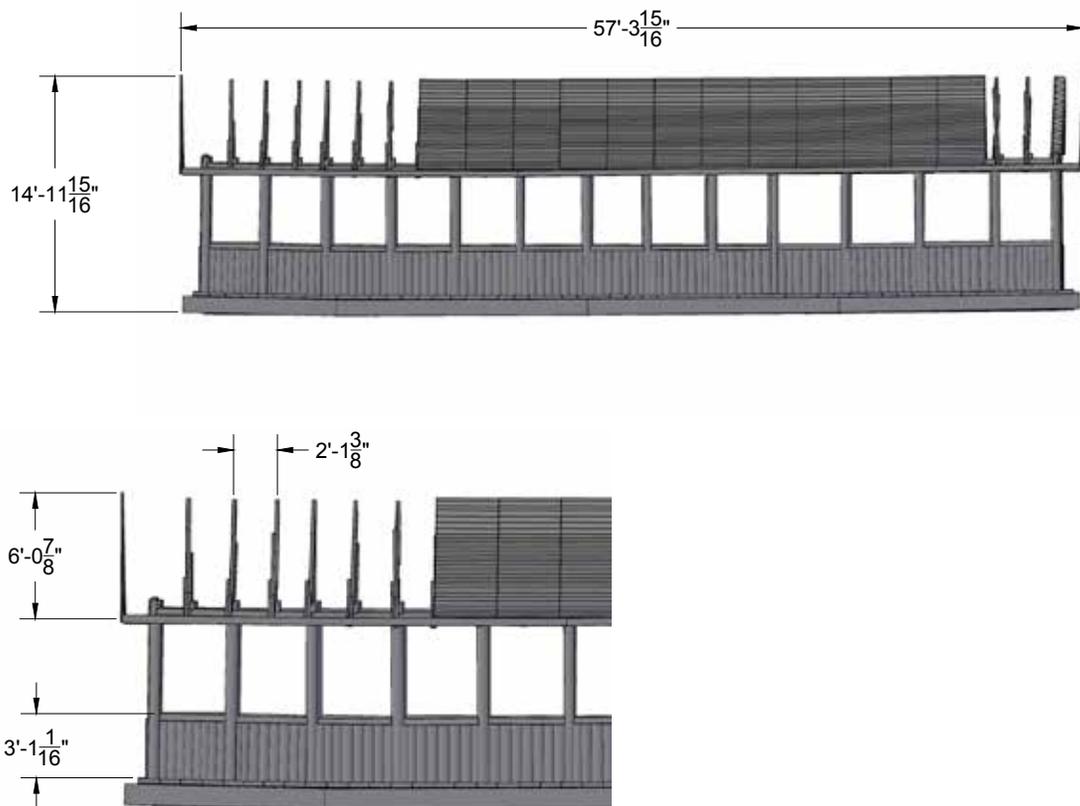
Figure 14—AutoCAD cross-section of the Amnicon River Bridge.

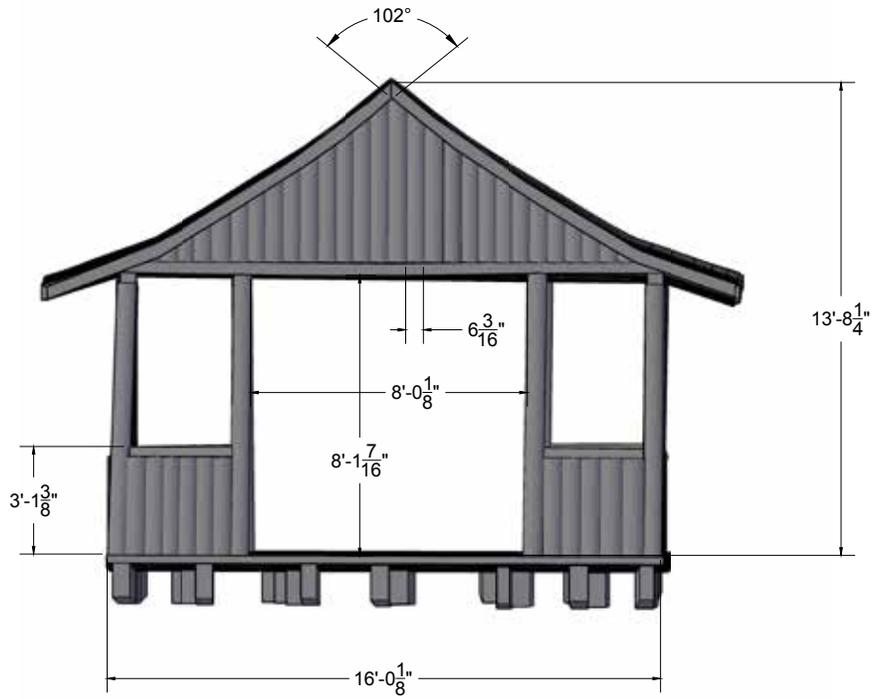
Figure 15—End view of the Amnicon River Bridge.

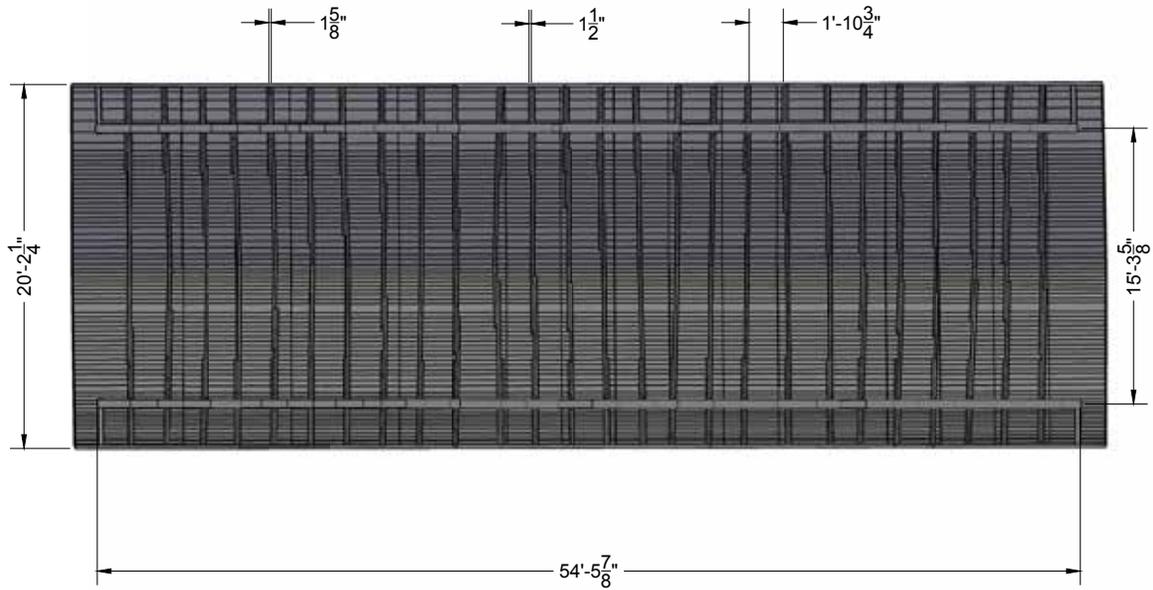
Figure 16—View of the underside of the Amnicon River Bridge roof system.
