*NIST Technical Note 1540*

**Propagation and Detection of Radio  
Signals Before, During, and After the  
Implosion of a 13-Story Apartment  
Building**

May 2005

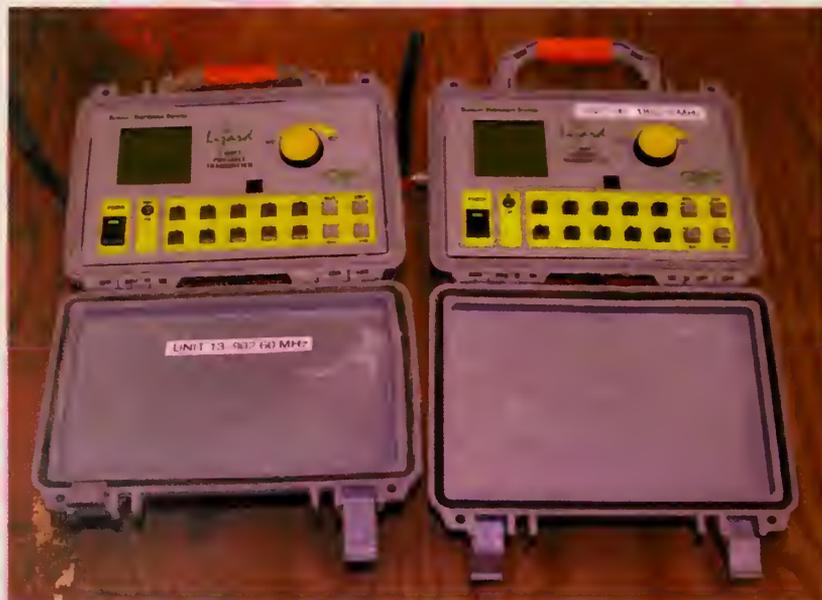
Figure 6. Transmitters used for the two higher frequency bands.

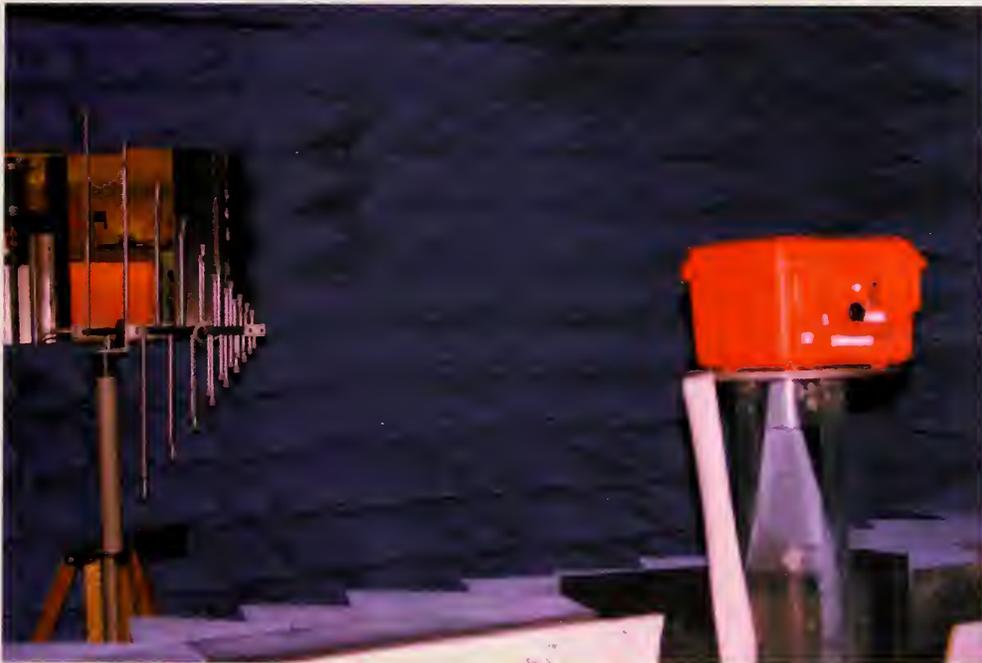
Figure 7. Transmitter in the NIST Boulder anechoic chamber.

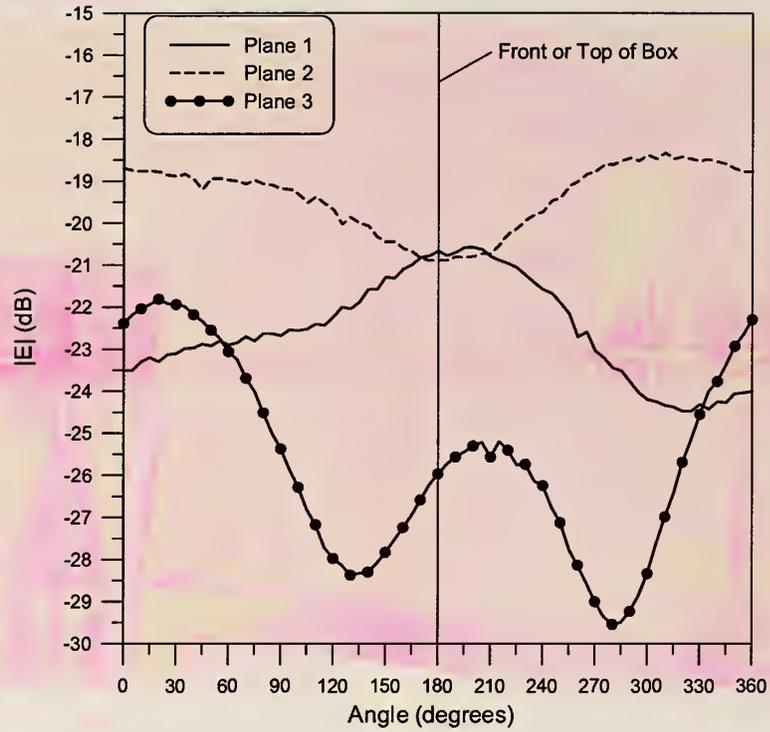
Figure 8. Radiation pattern of a 164 MHz transmitter in a protective case.

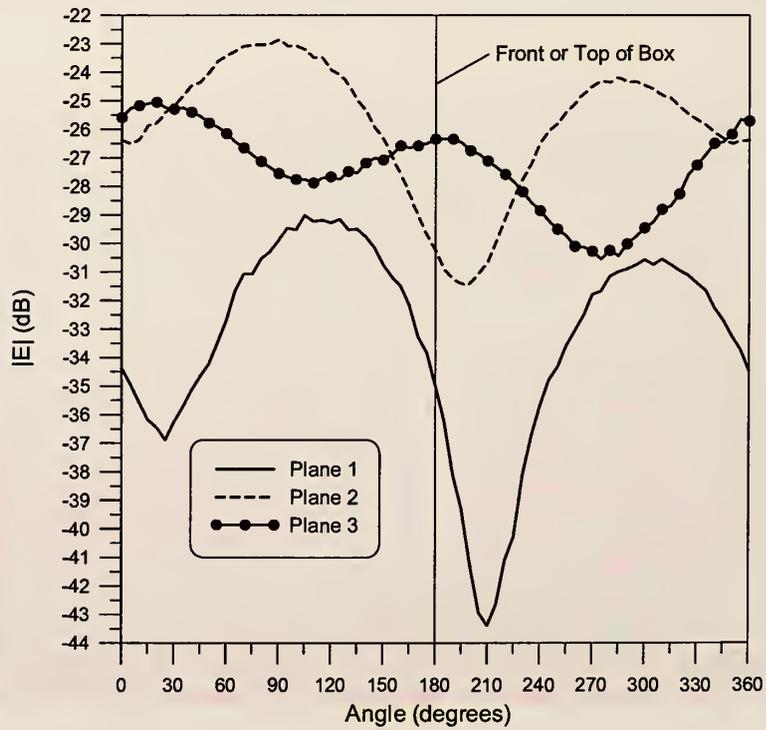
Figure 9. Radiation pattern of a 225 MHz transmitter in a protective case.

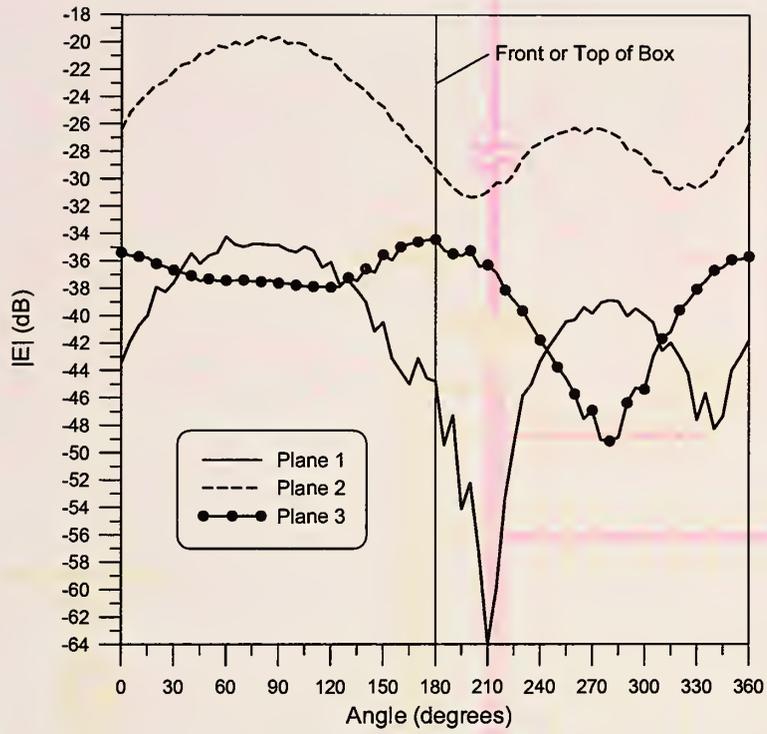
Figure 10. Radiation pattern of a 448 MHz transmitter in a protective case.

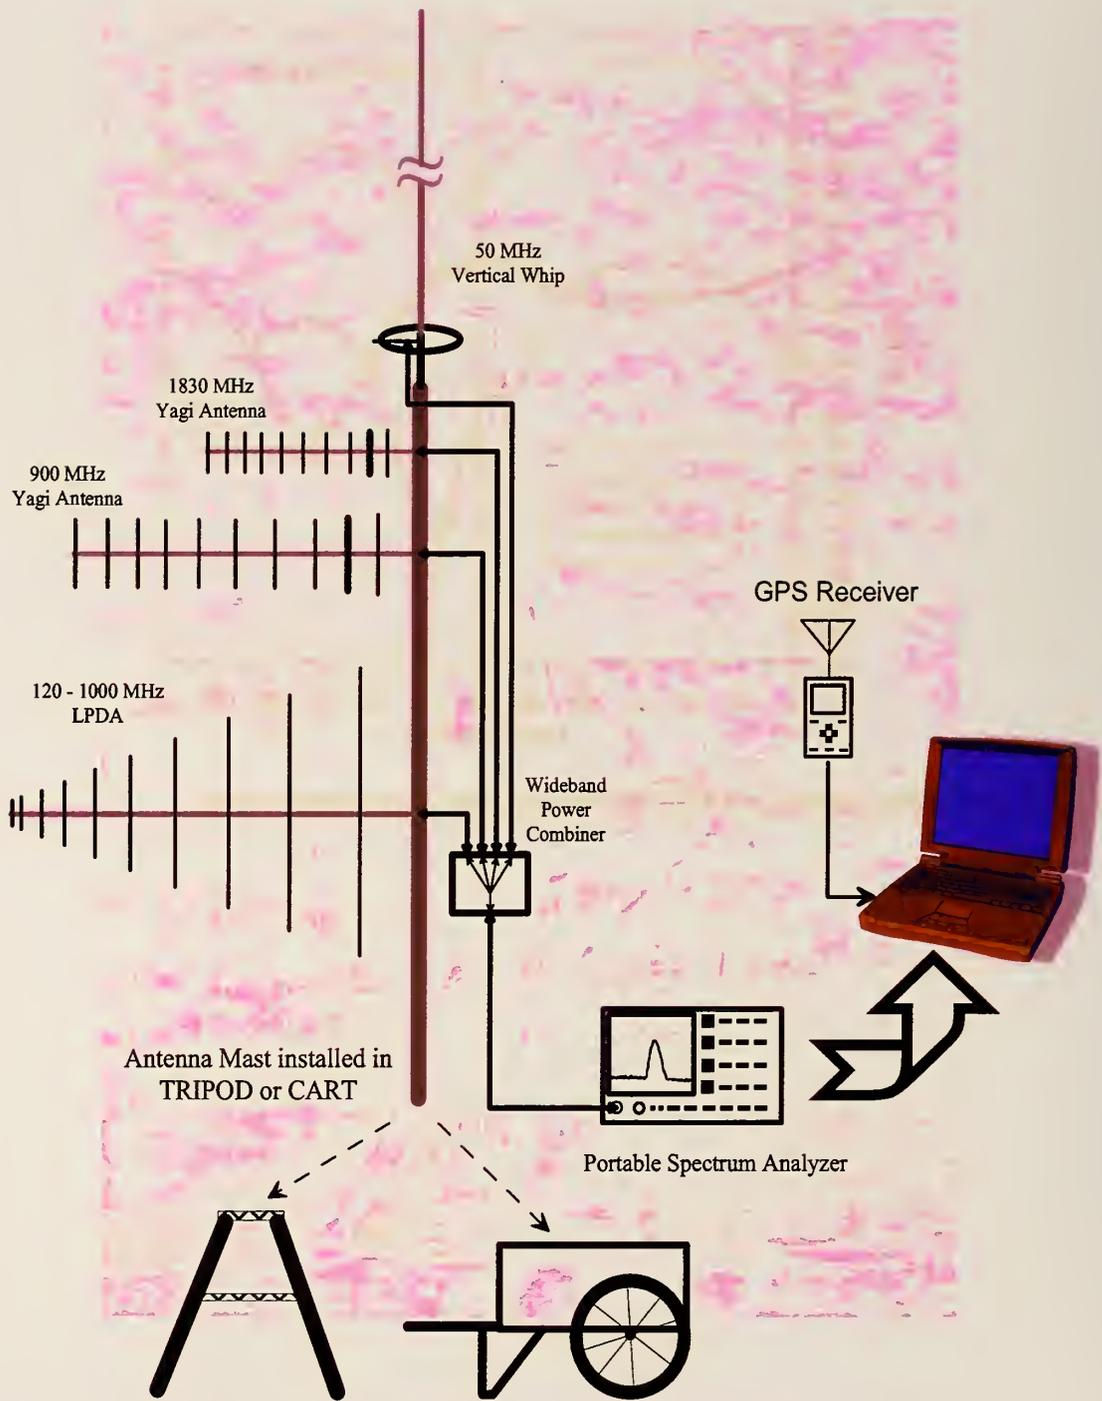
Figure 11. Schematic of the receiving system.

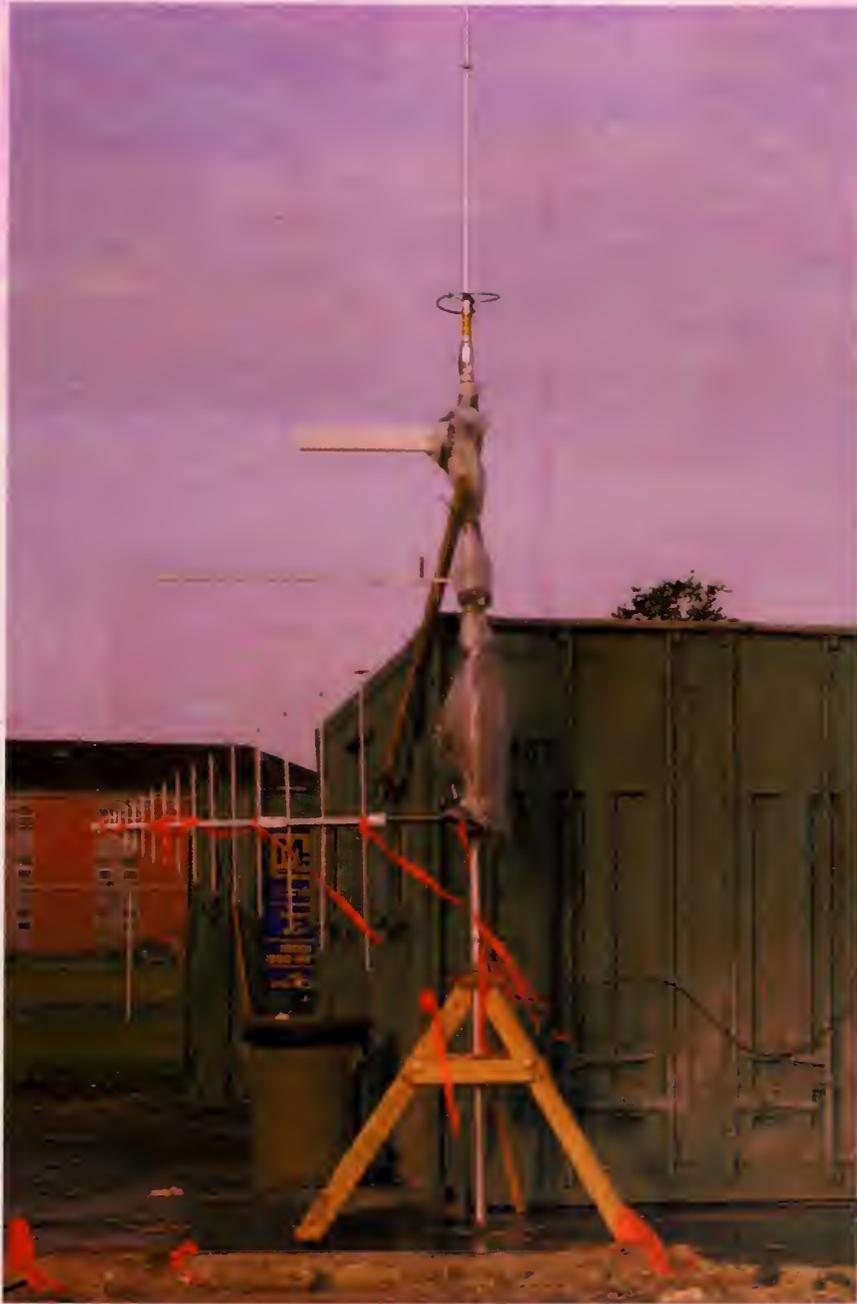
Figure 12. Photo of the weather-resistant antenna system mounted on a tripod and secured to a storage container to prevent tipping during the implosion. The receiving instruments are protected inside the container.

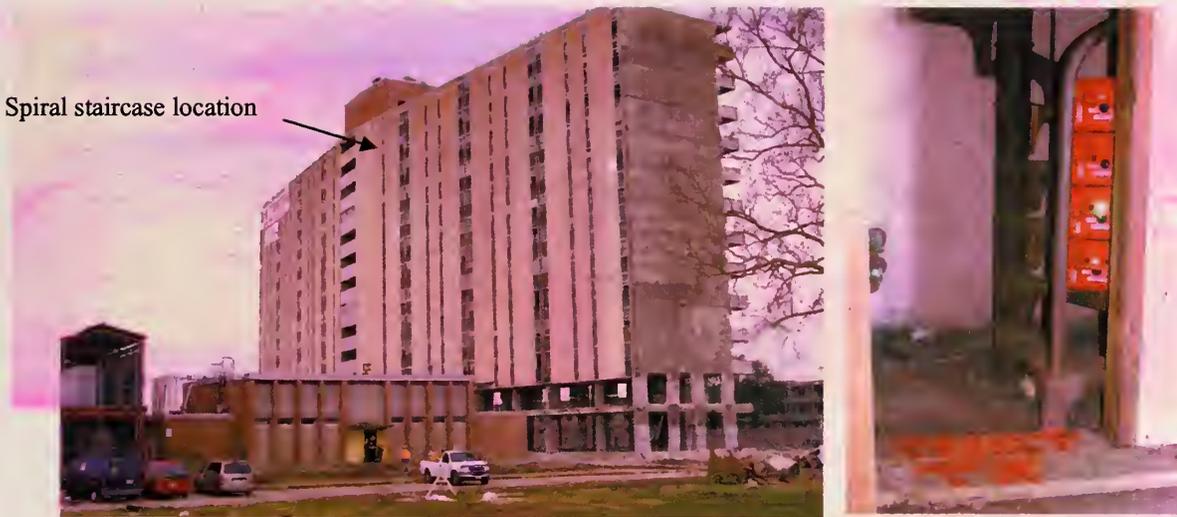
Figure 16. Fixed transmitter location on fourteenth floor.

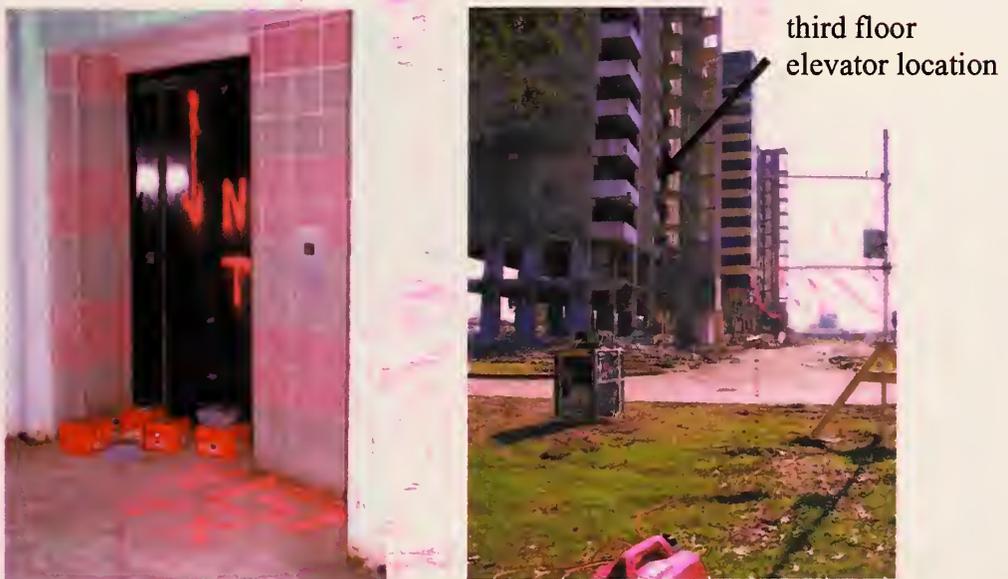
Figure 17. Fixed transmitter location on third floor at elevator.

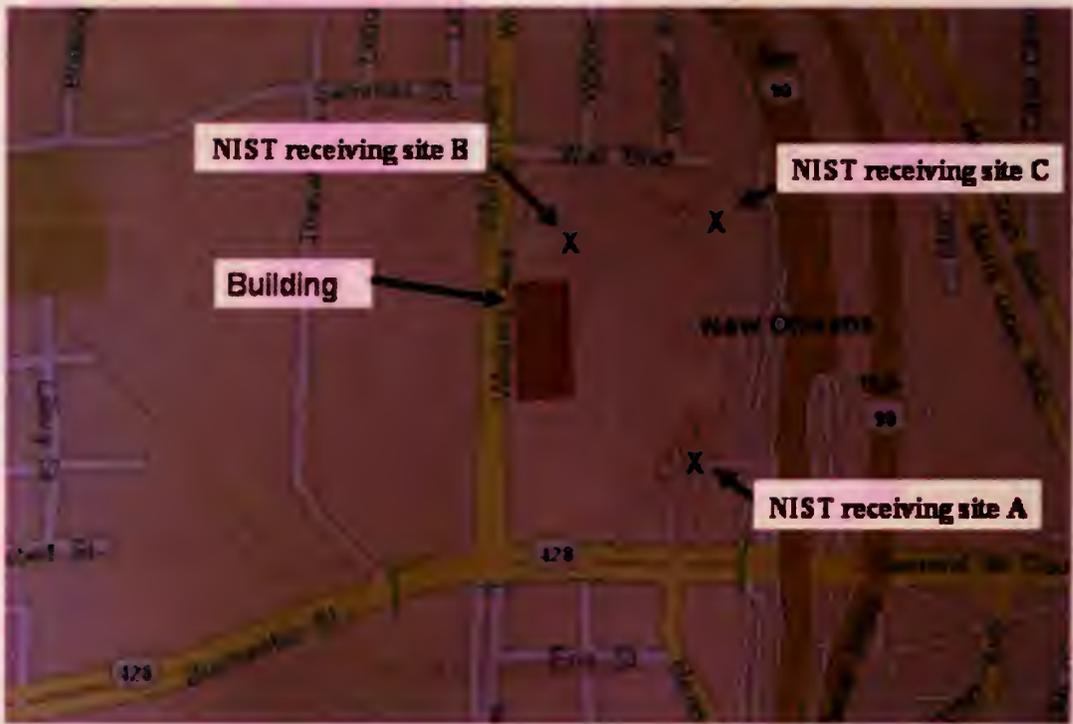
Figure 20. Location of the three fixed receiving sites.

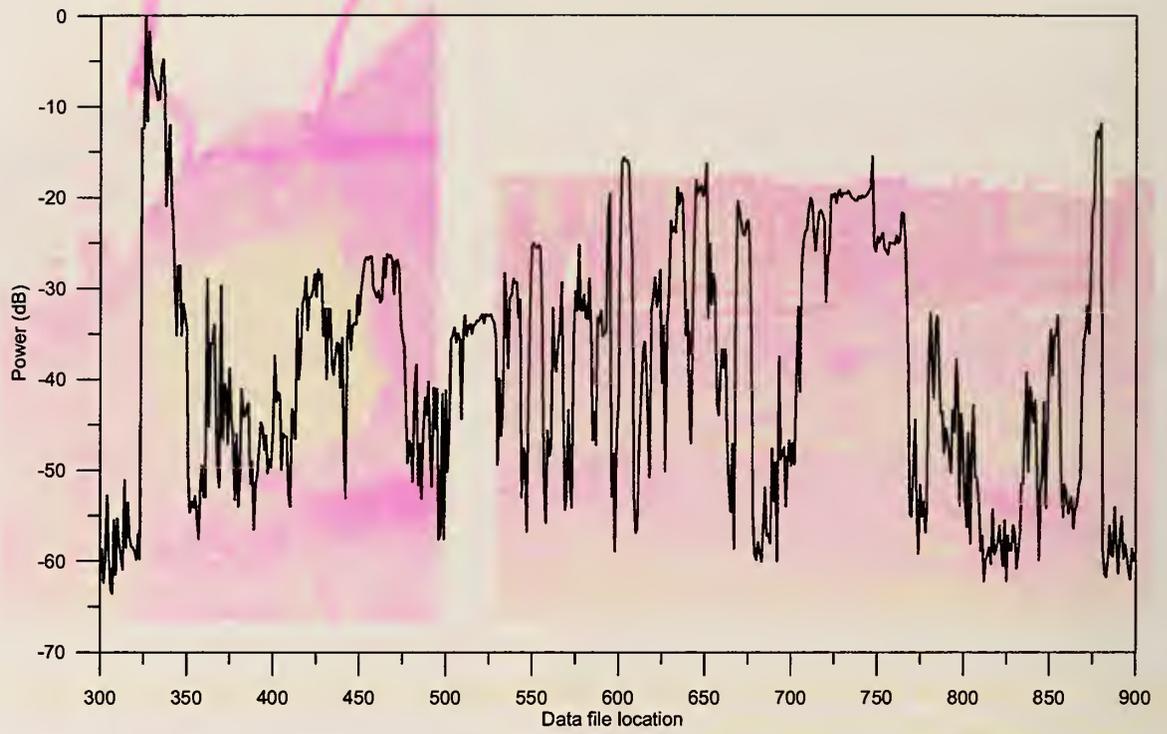
Figure 25. Building walk-through at 49.6 MHz.

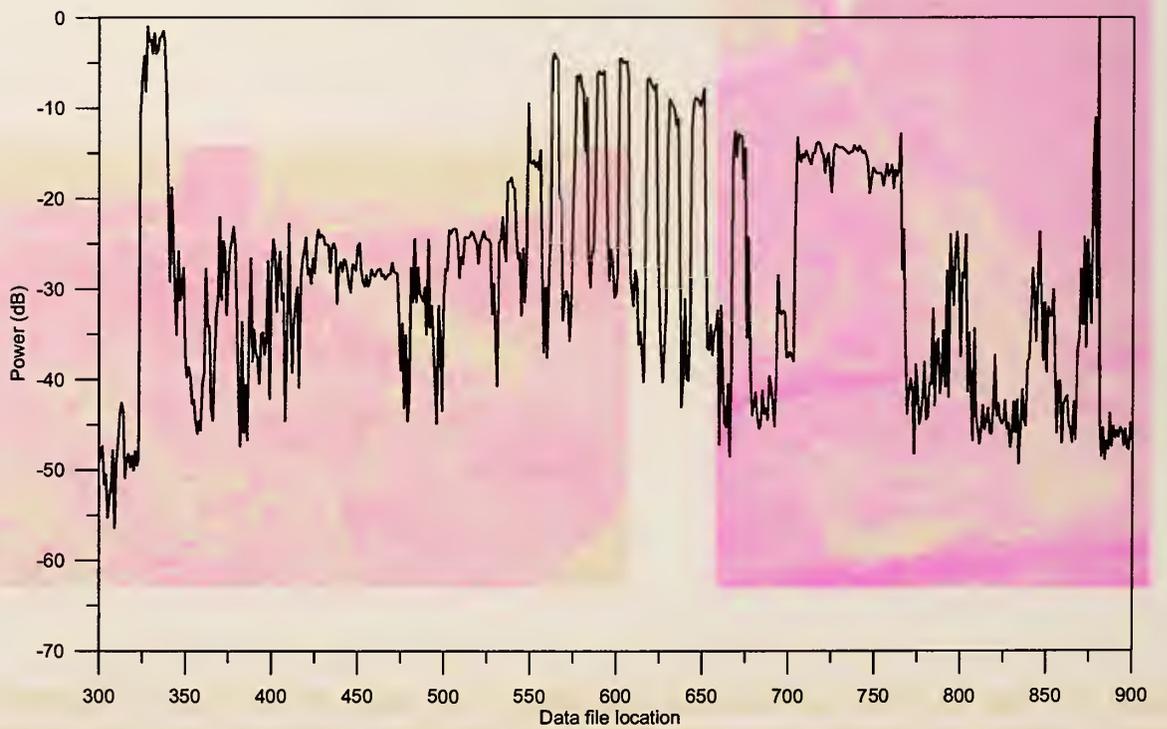
Figure 26. Building walk-through at 162.0 MHz.

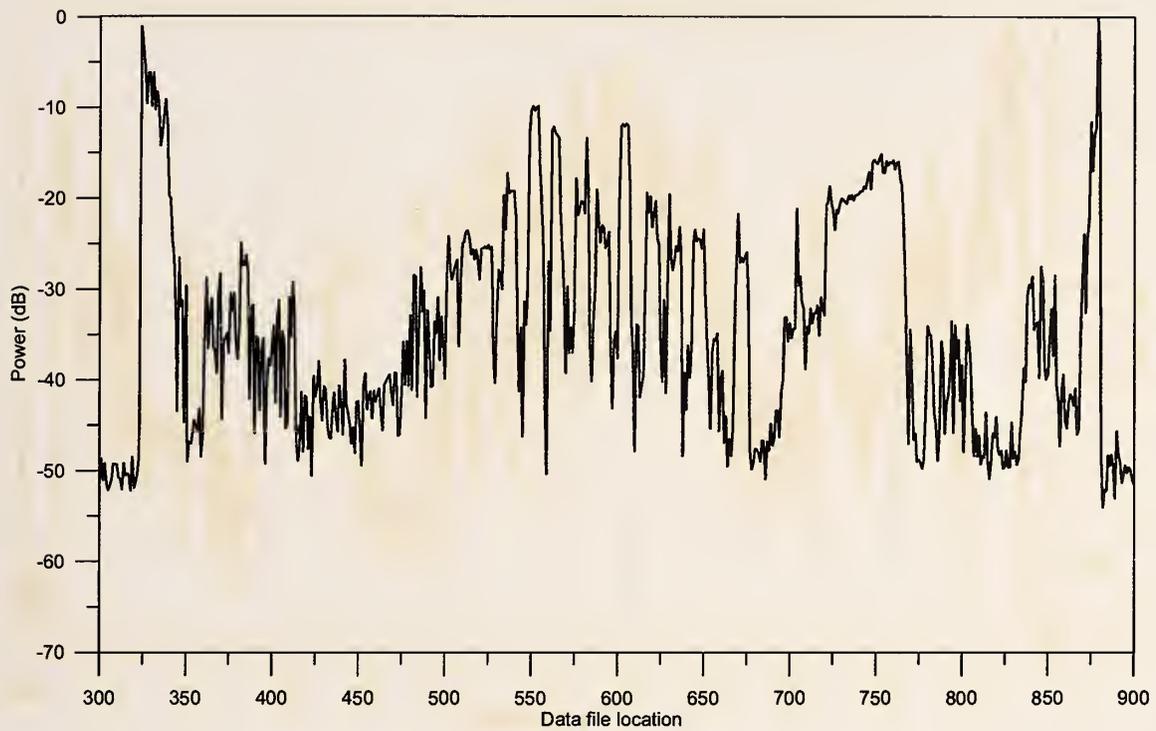
Figure 27. Building walk-through at 225.375 MHz.

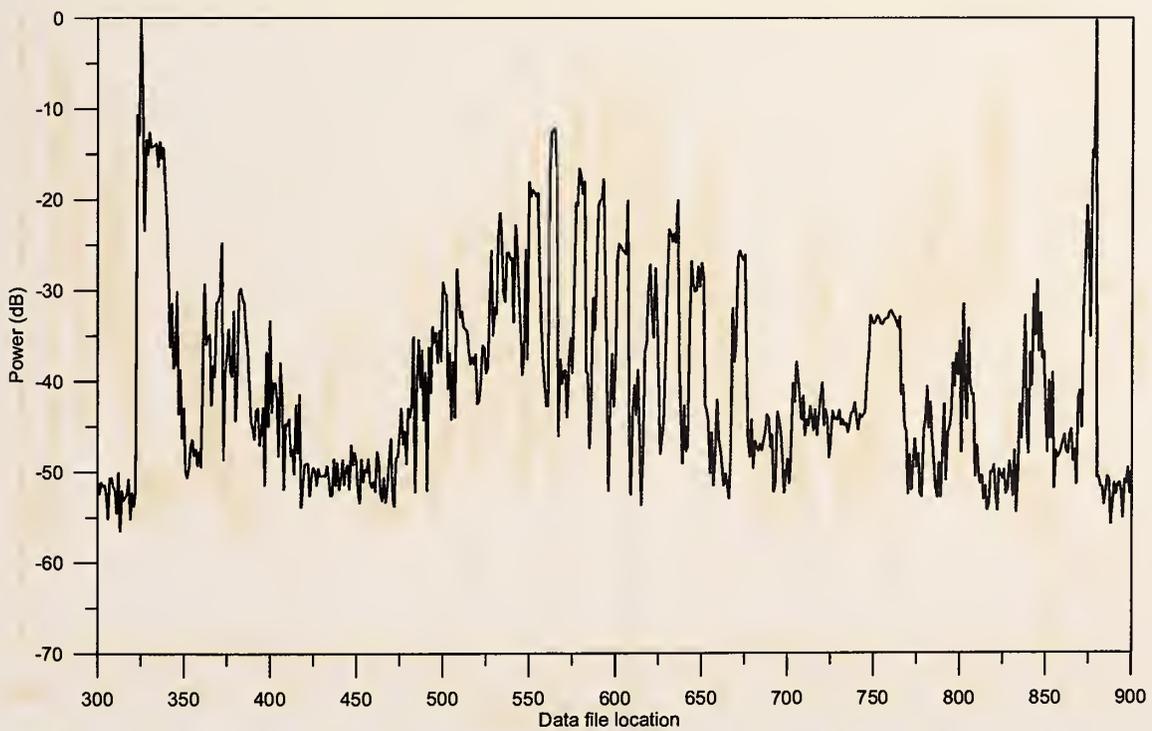
Figure 28. Building walk-through at 448.6 MHz.

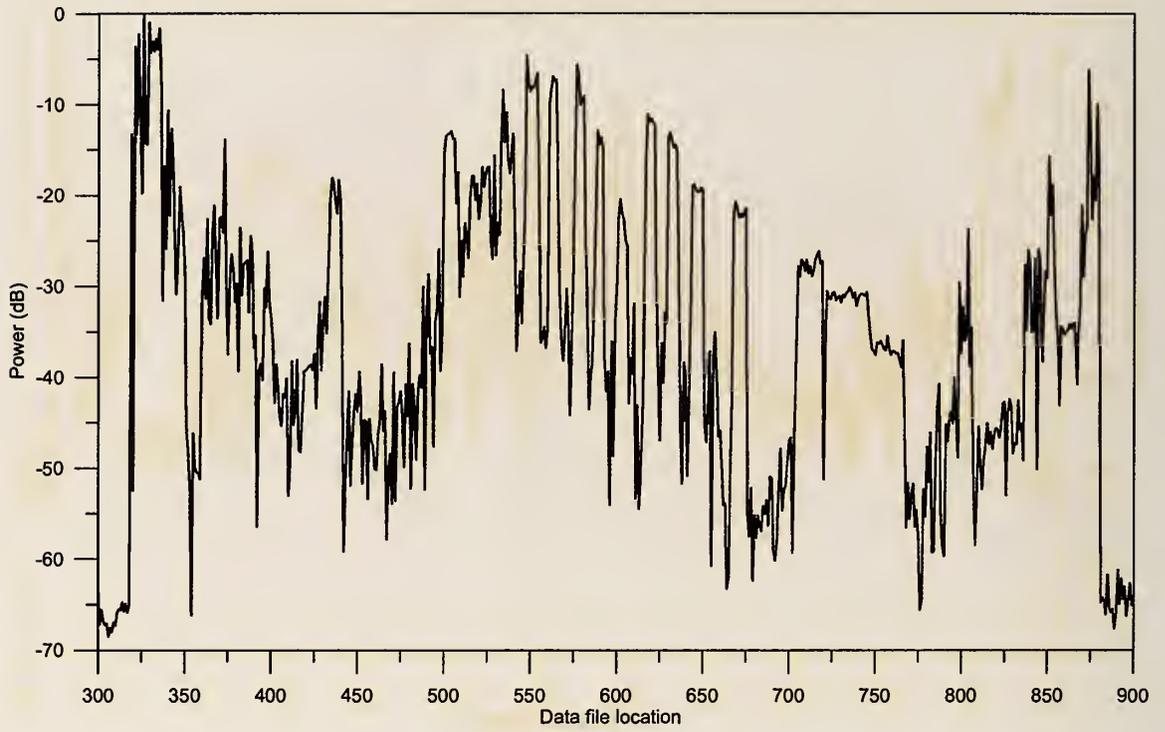
Figure 29. Building walk-through at 902.6 MHz.

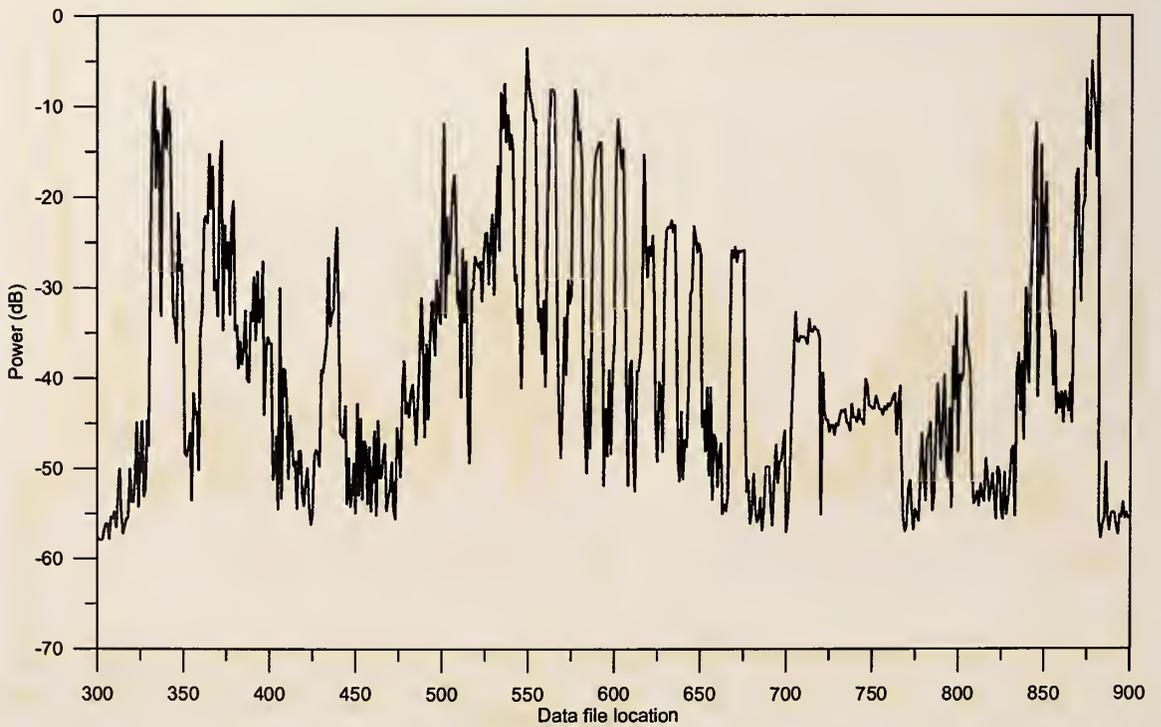
Figure 30. Building walk-through at 1832.5 MHz.

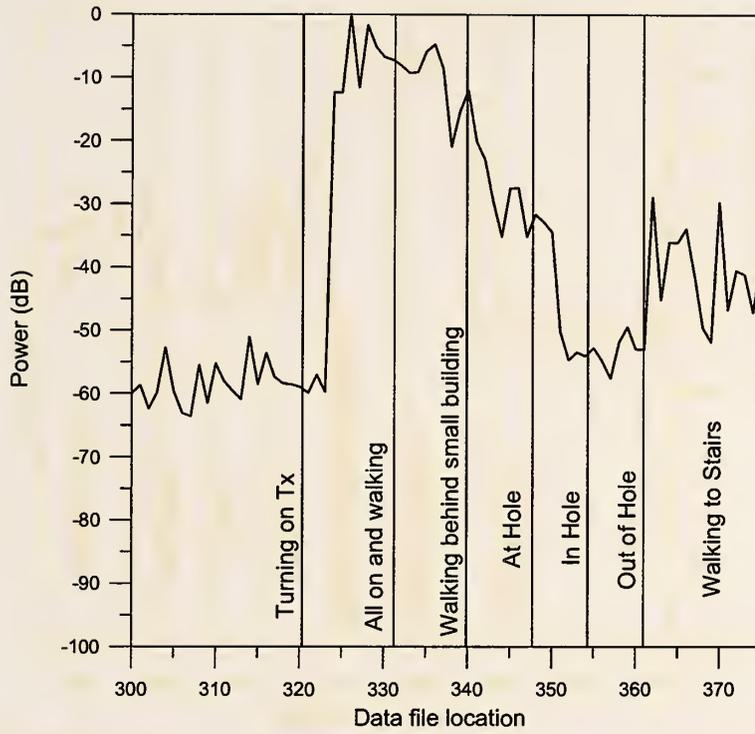
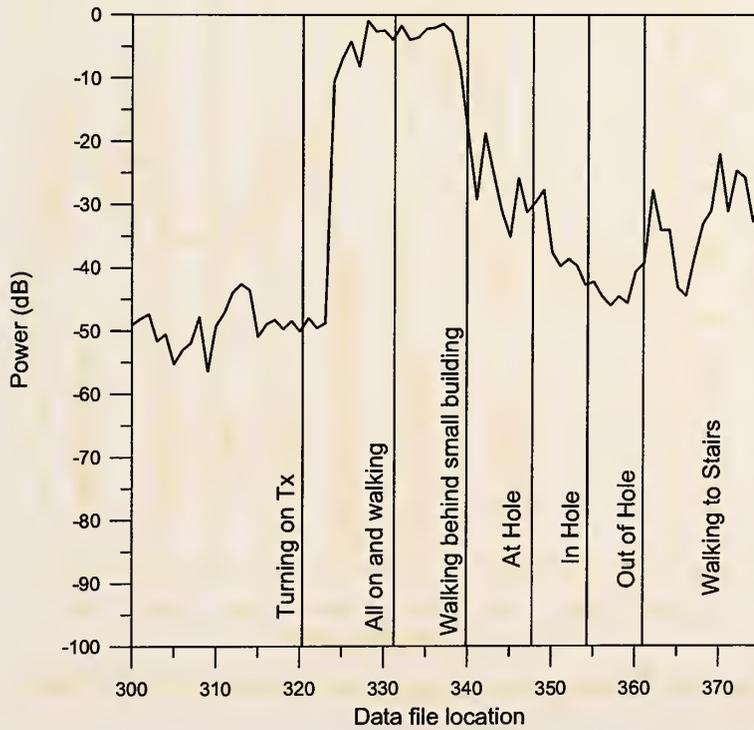
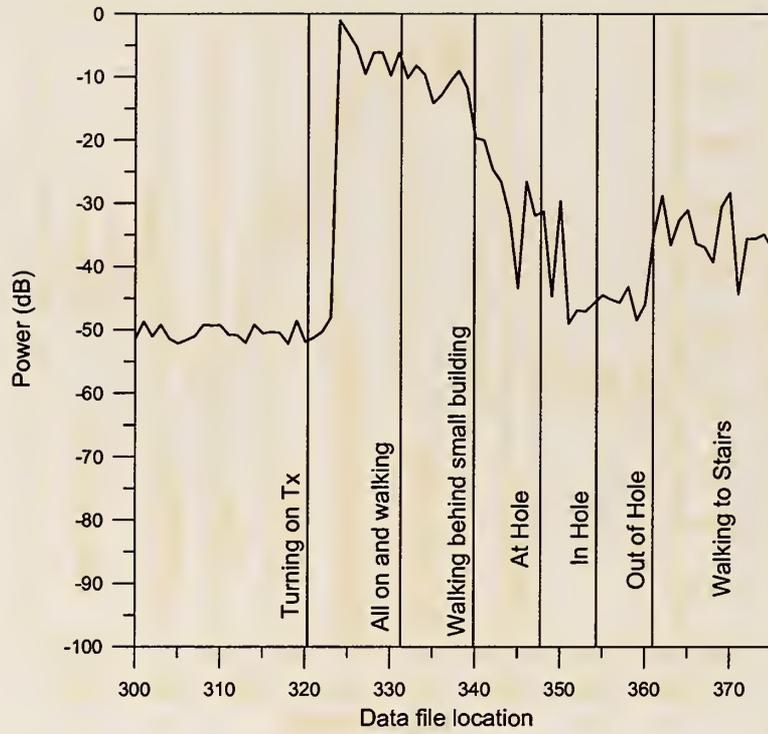
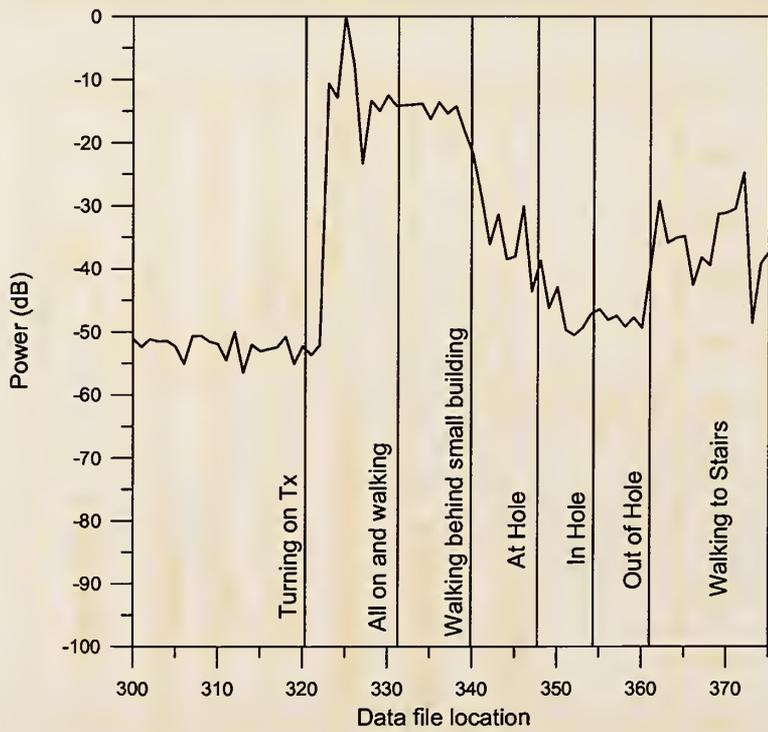
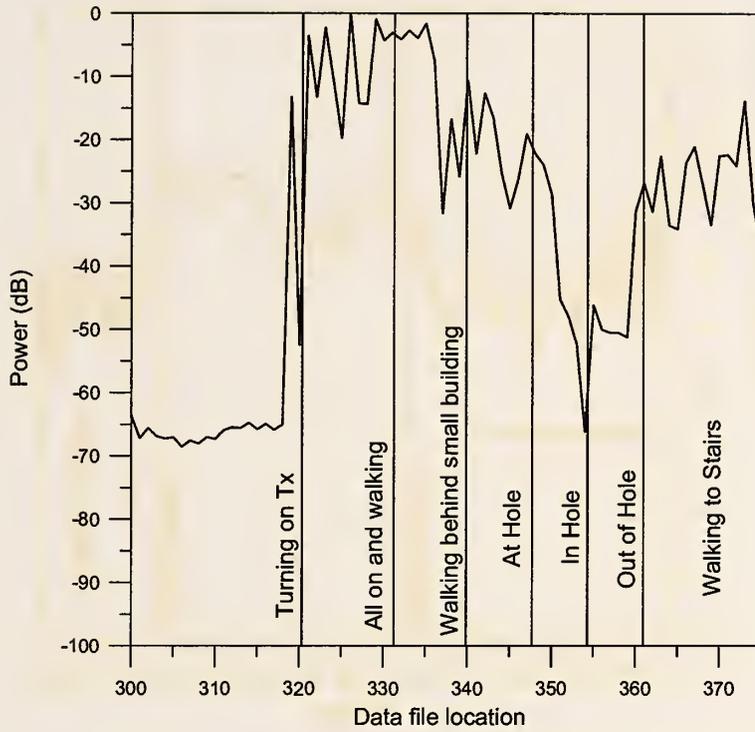
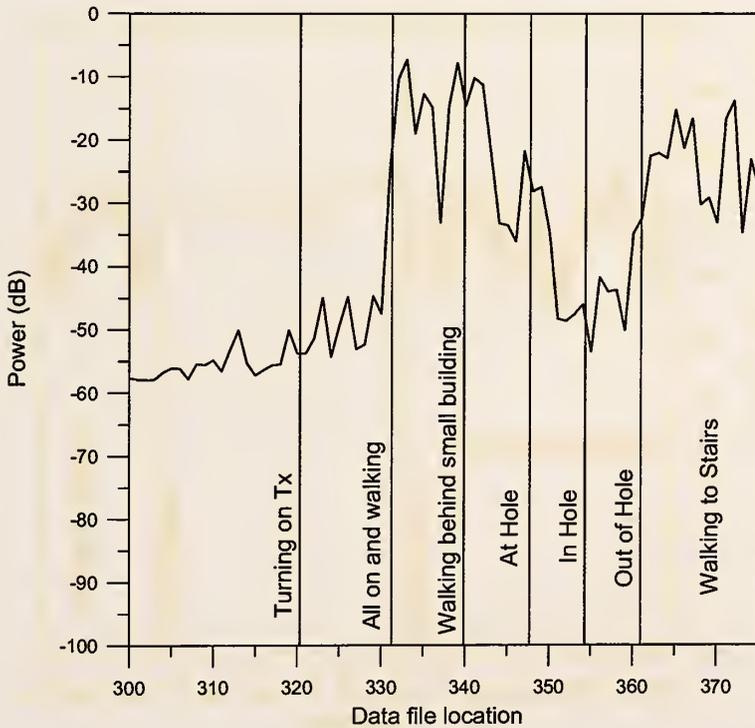
Figure 31. Starting walk-through and hole data at 49.6 MHz.

Figure 32. Starting walk-through and hole data at 162.0 MHz.

Figure 33. Starting walk-through and hole data at 225.375 MHz.

Figure 34. Starting walk-through and hole data at 448.6 MHz.

Figure 35. Starting walk-through and hole data at 902.6 MHz.

Figure 36. Starting walk-through and hole data at 1832.5 MHz.

Since the locations of the transmitters were noted in the dataset during the walk-through, the variability in the received signal at various locations in the building can be investigated. Figures 31-36 show the start of the walk-through and show the effect of placing the transmitters in the hole in the concrete floor. While being taken to the hole in the floor, the transmitters were carried behind a small building (see Figure 13). The results in these figures show the effect of walking behind the building. The decrease in the signal in these figures illustrates the so-called “knife-edge diffraction” of building corners. These figures also show that a reduction of 15 to 20 dB in signal strength occurred when the transmitters were placed in the hole.

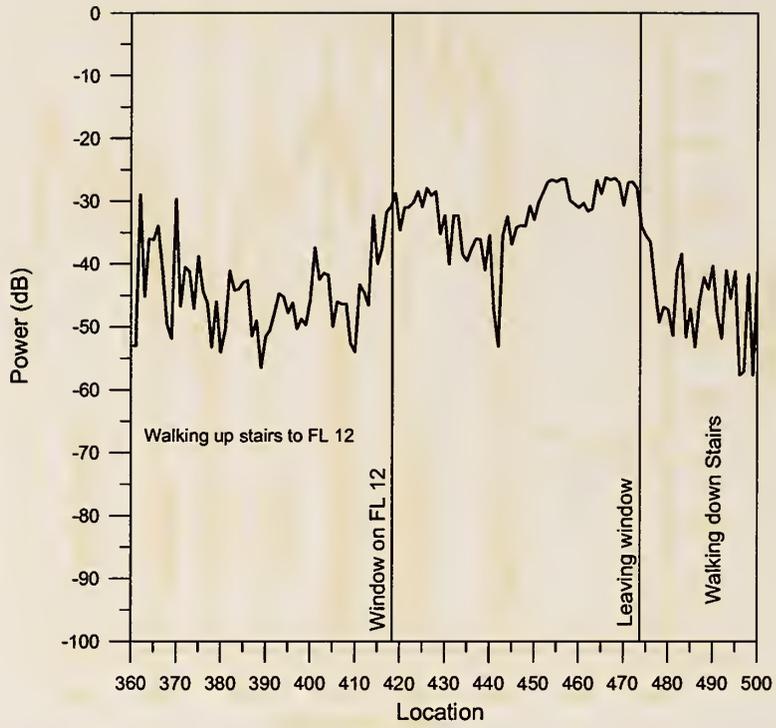
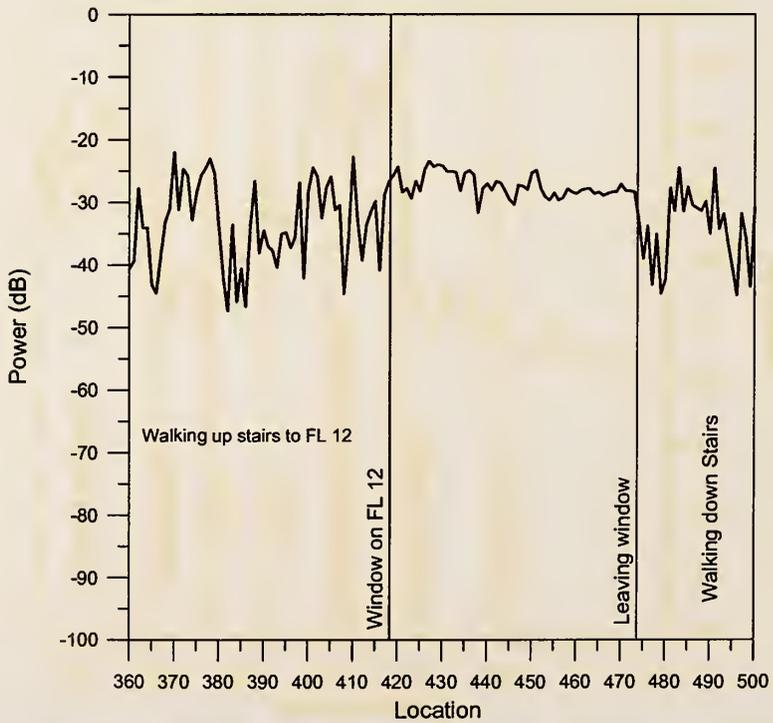
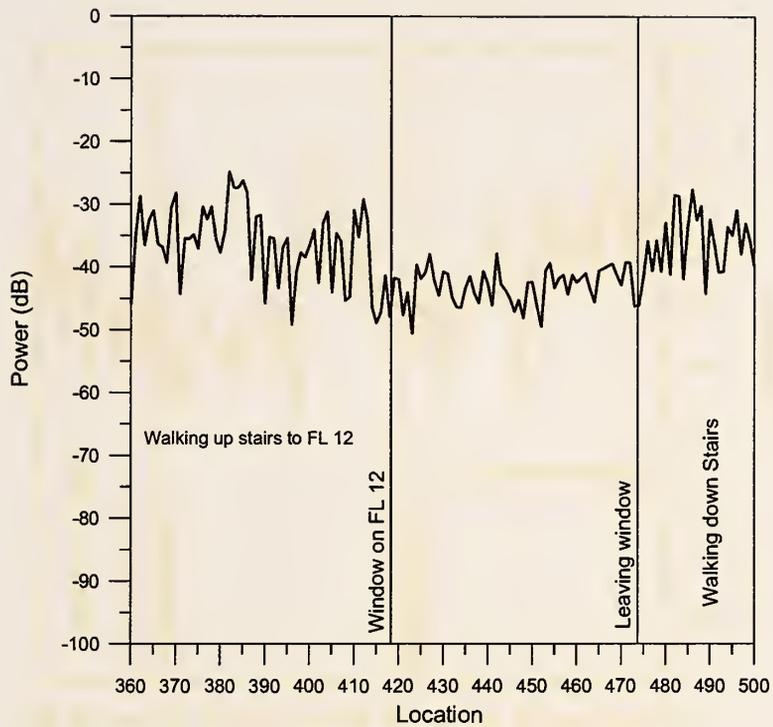
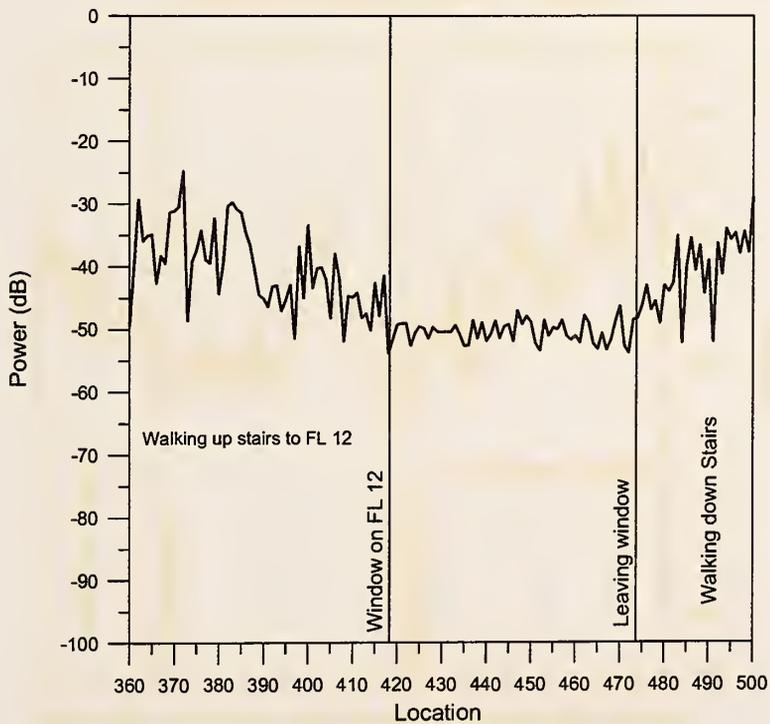
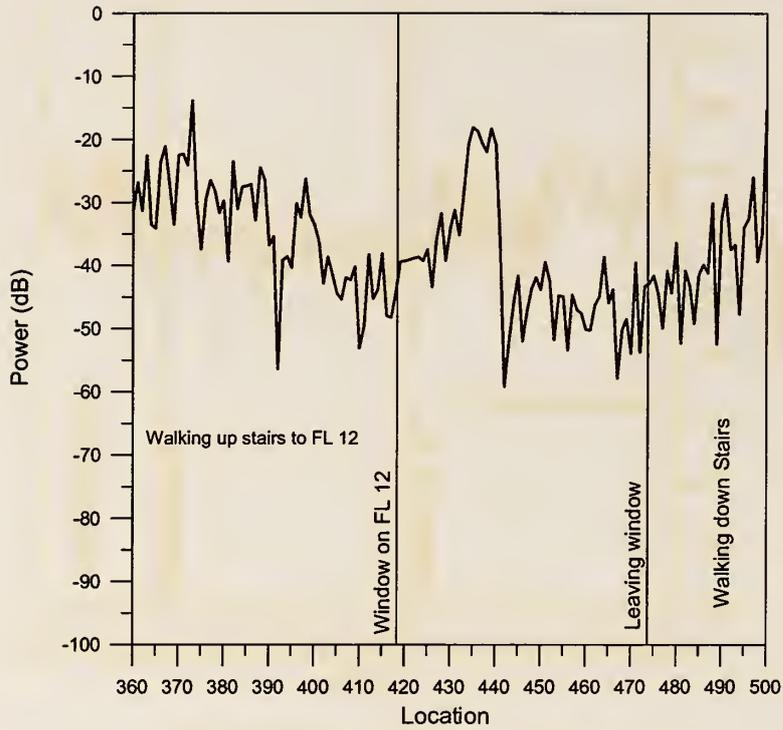
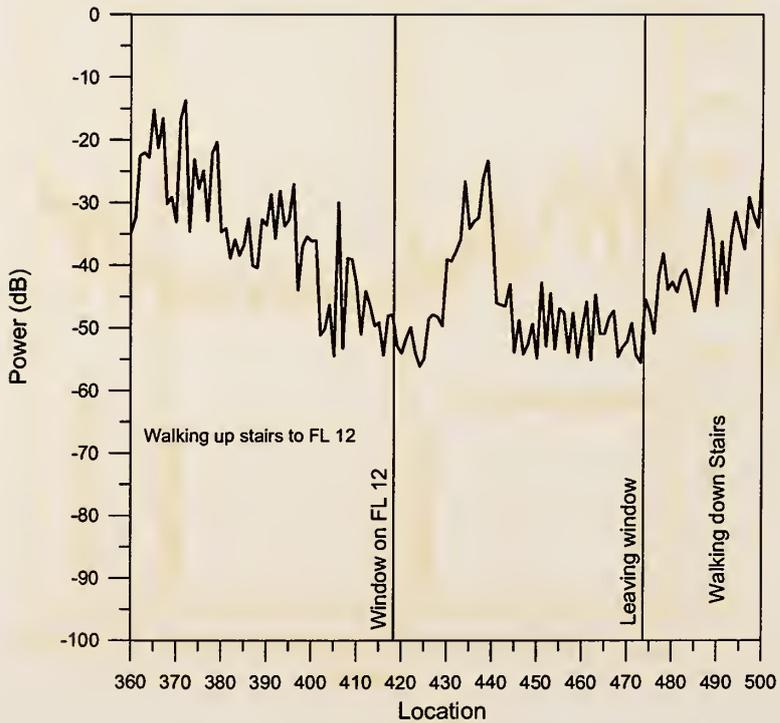
Figure 37. Stairwell data 49.6 MHz.

Figure 38. Stairwell data 162.0 MHz.

Figure 39. Stairwell data 225.375 MHz.

Figure 40. Stairwell data 448.6 MHz.

Figure 41. Stairwell data 902.6 MHz.

Figure 42. Stairwell data 1832.5 MHz.
