*NIST Technical Note 1540*

**Propagation and Detection of Radio  
Signals Before, During, and After the  
Implosion of a 13-Story Apartment  
Building**

May 2005

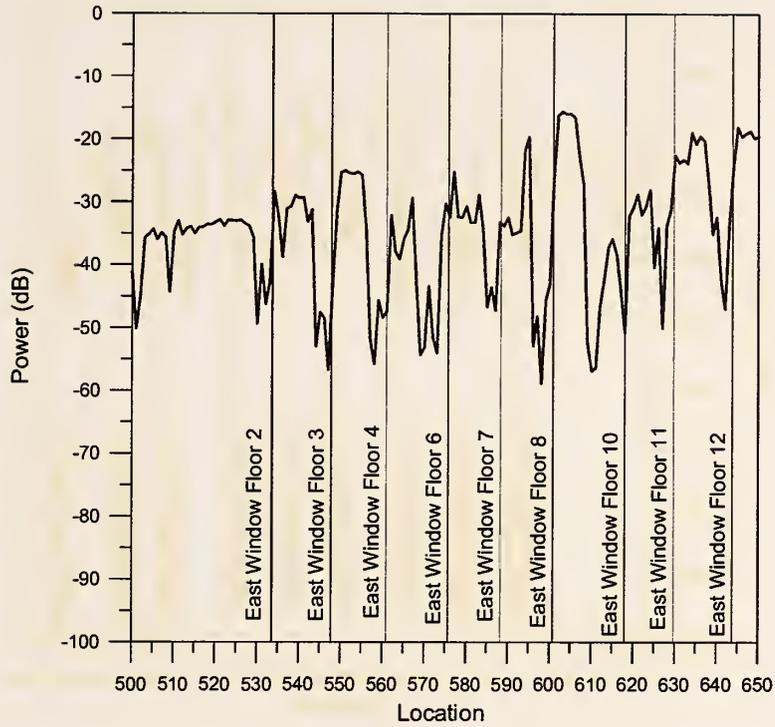
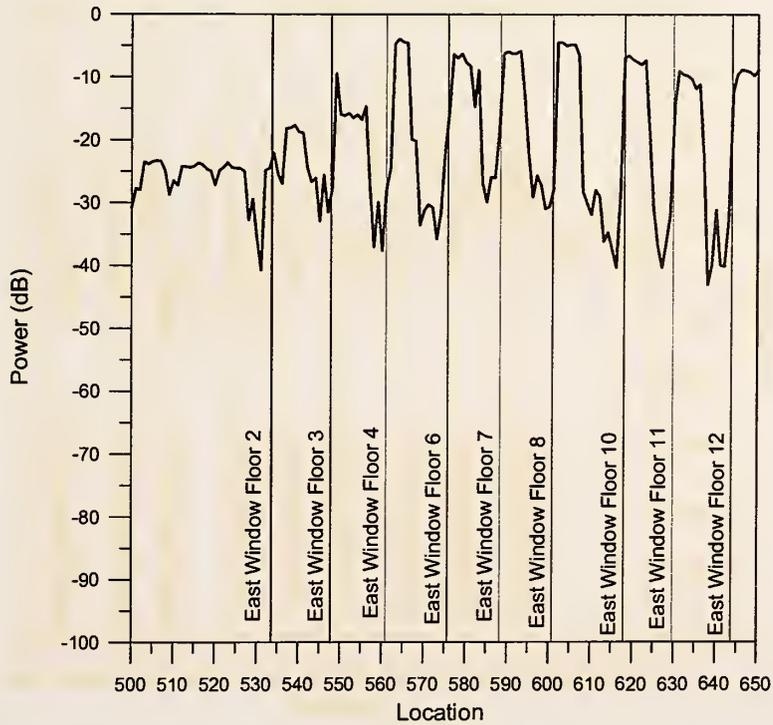
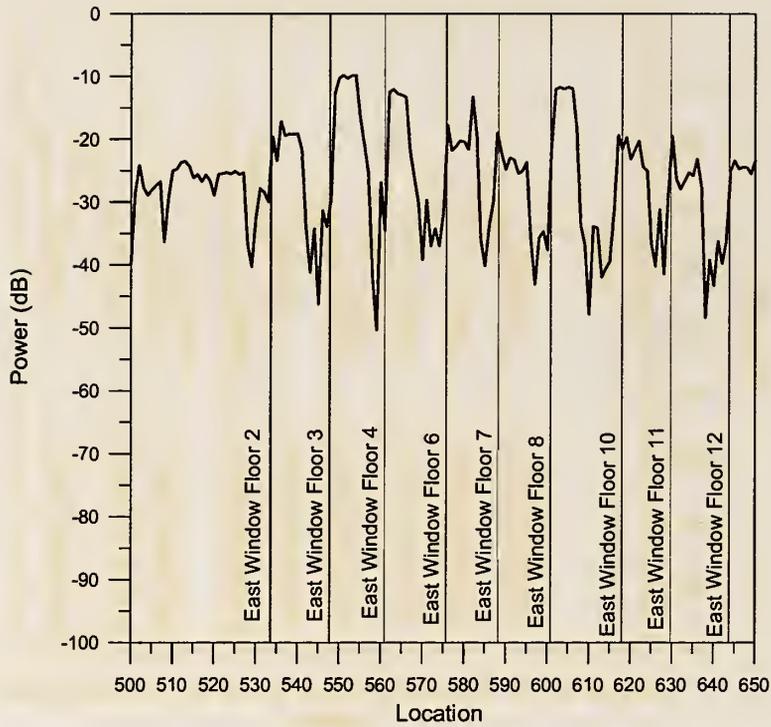
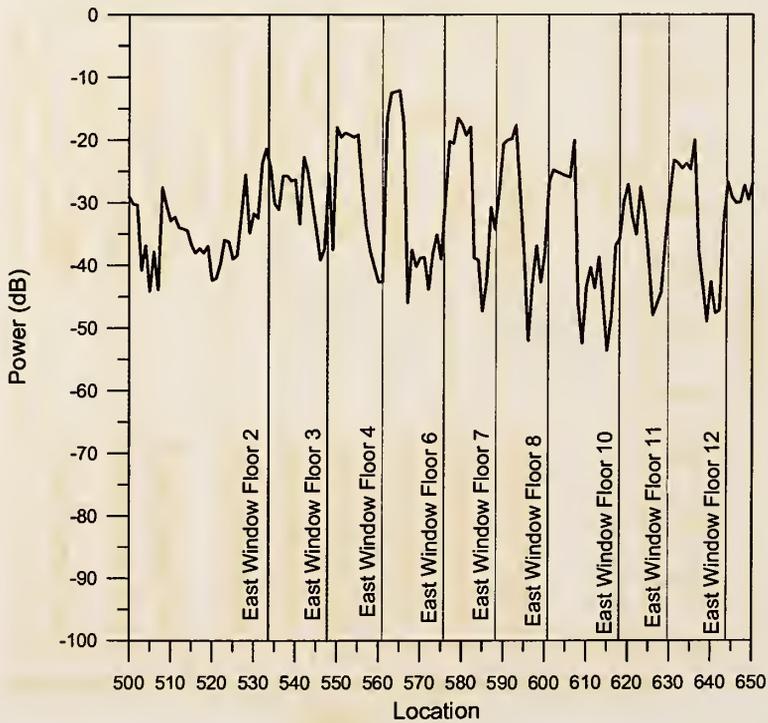
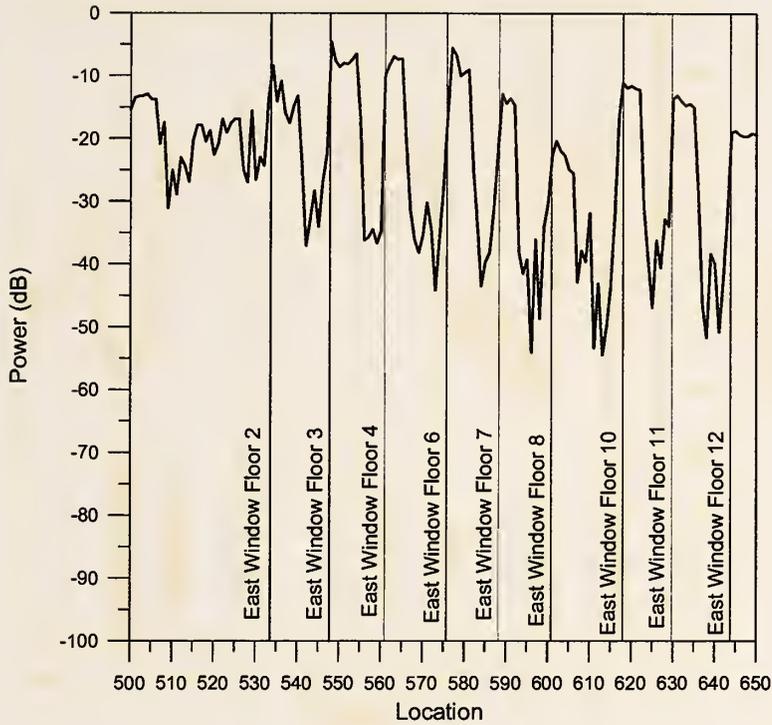
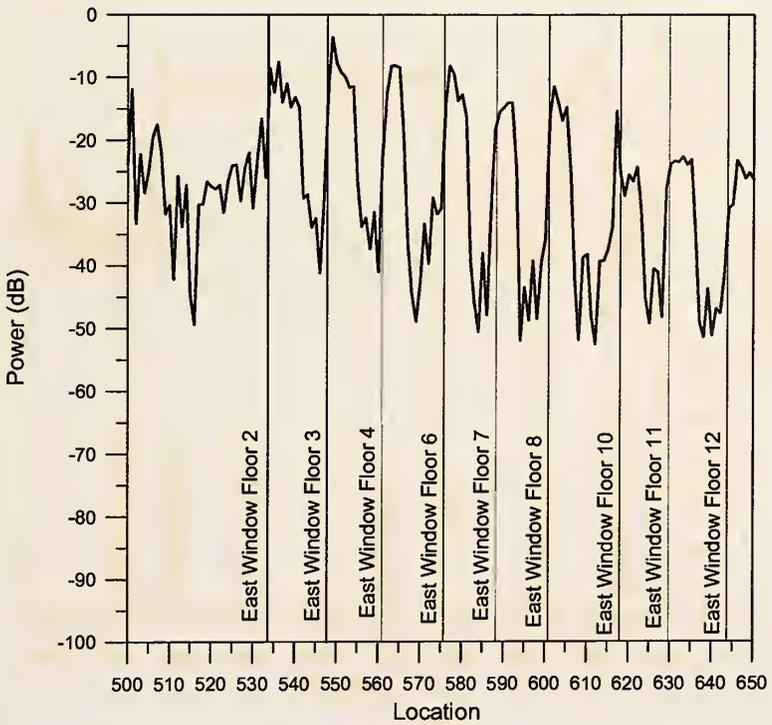
Figure 43. Building walk-through with transmitters at window (LOS to receiver) of each floor at 49.6 MHz.

Figure 44. Building walk-through with transmitters at window (LOS to receiver) of each floor at 162.0 MHz.

Figure 45. Building walk-through with transmitters at window (LOS to receiver) of each floor at 225.375 MHz.

Figure 46. Building walk-through with transmitters at window (LOS to receiver) of each floor at 448.6 MHz.

Figure 47. Building walk-through with transmitters at window (LOS to receiver) of each floor at 902.6 MHz.

Figure 48. Building walk-through with transmitters at window (LOS to receiver) of each floor at 1832.5 MHz.

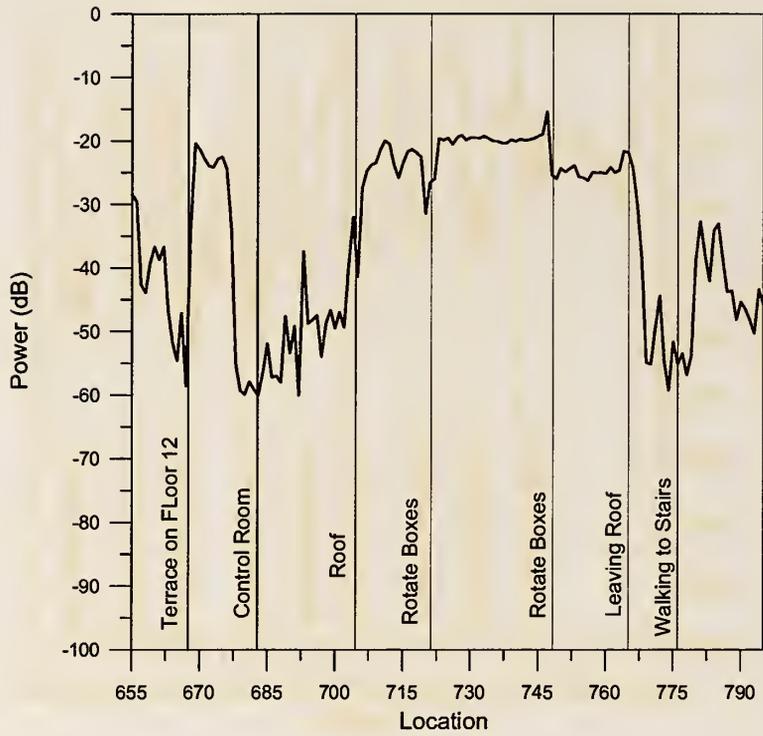
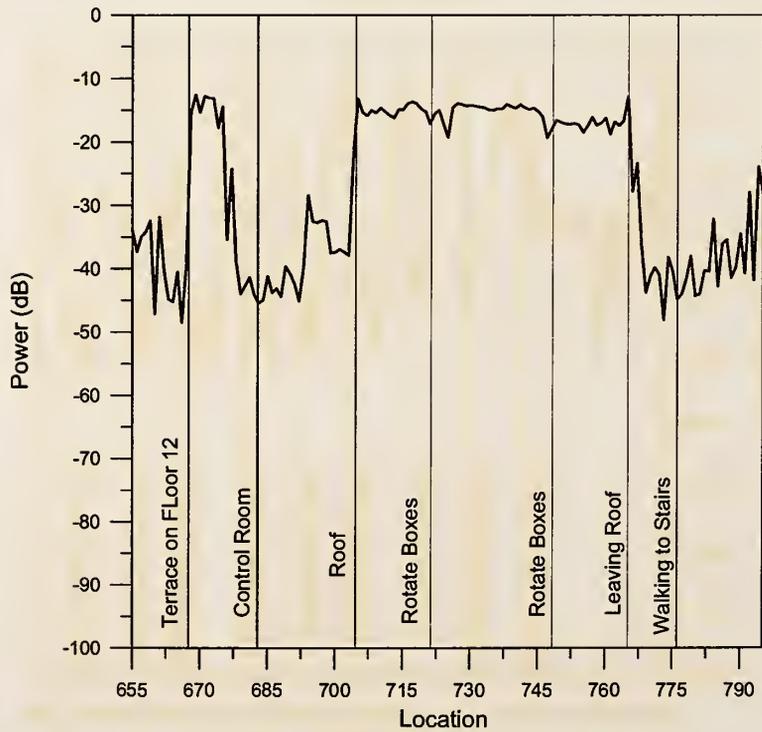
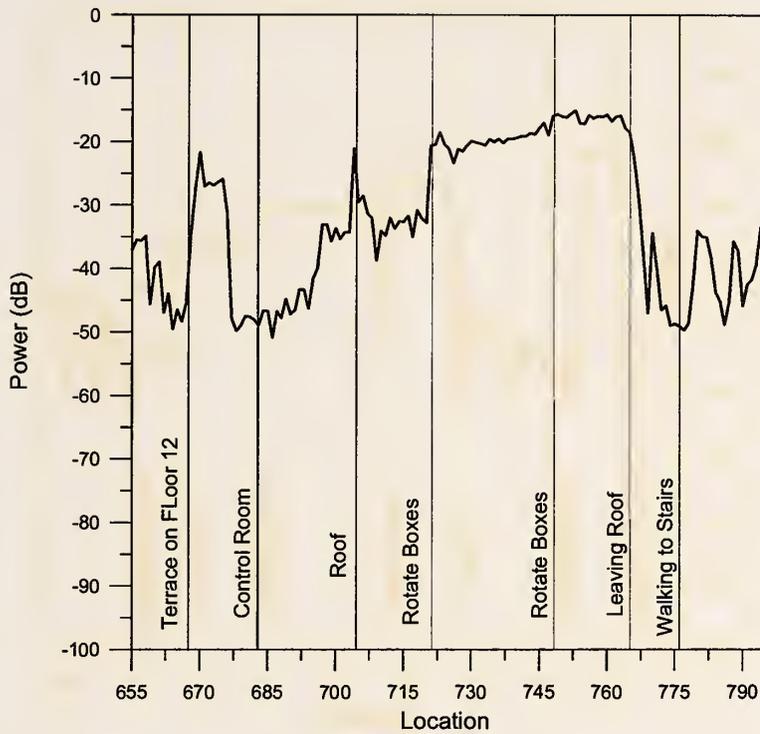
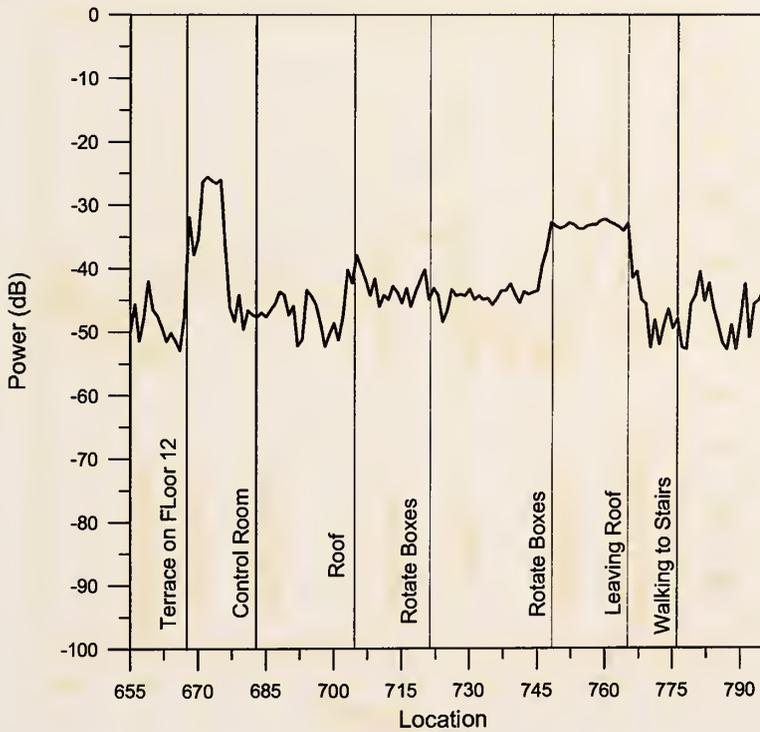
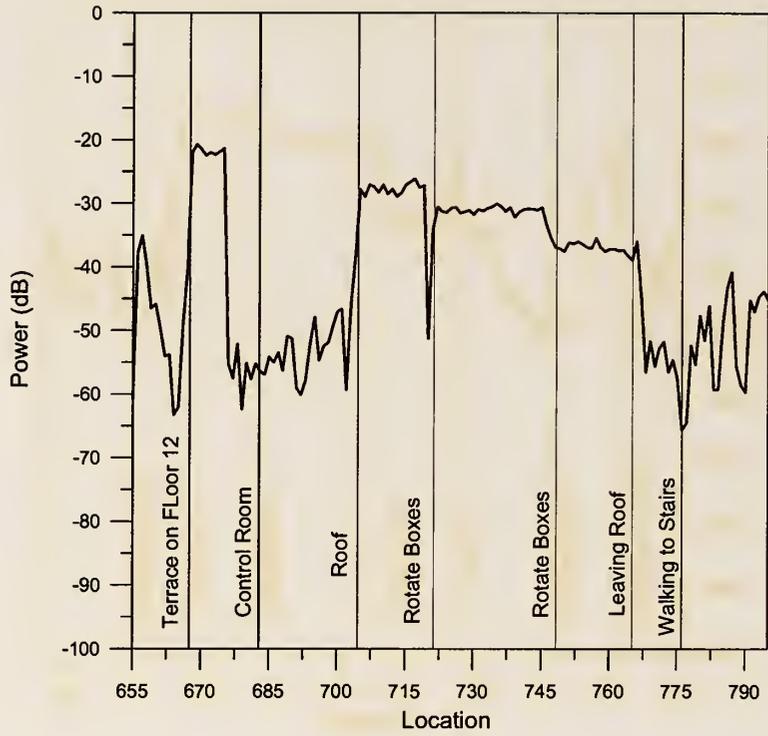
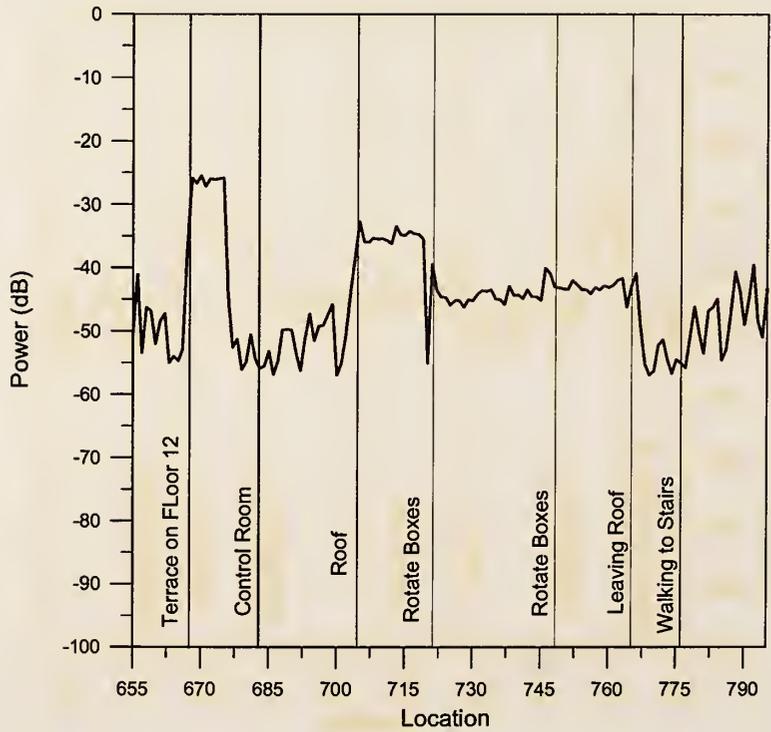
Figure 49. Control room and roof top at 49.6 MHz.

Figure 50. Control room and roof top at 162.0 MHz.

Figure 51. Control room and roof top at 225.375 MHz.

Figure 52. Control room and roof top at 448.6 MHz.

Figure 53. Control room and roof top at 902.6 MHz.

Figure 54. Control room and roof top at 1832.5 MHz.

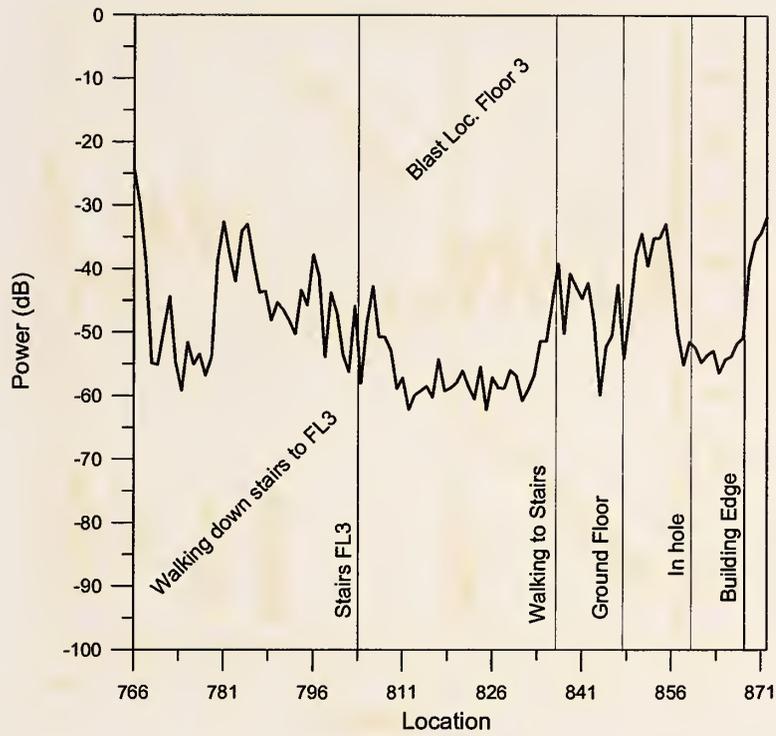
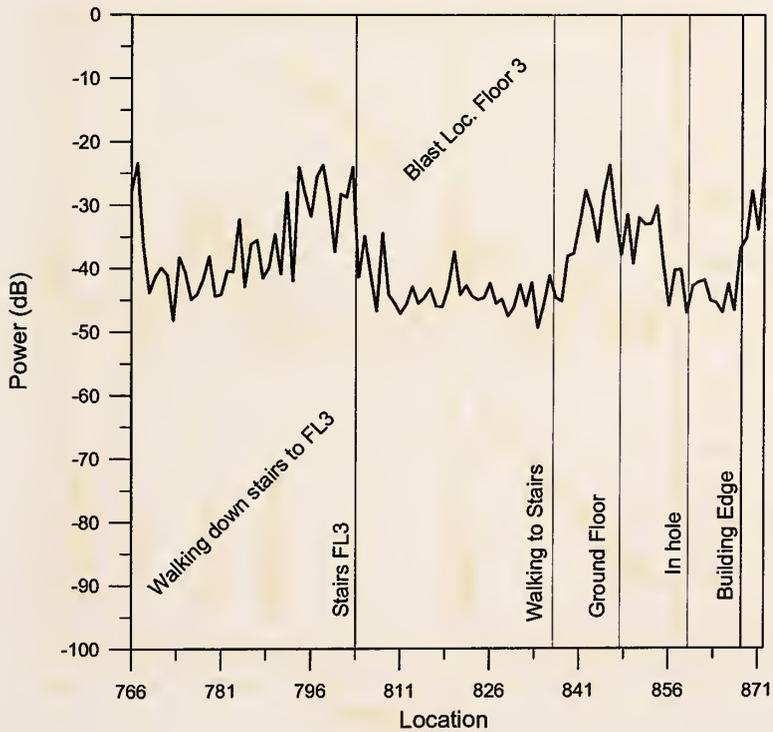
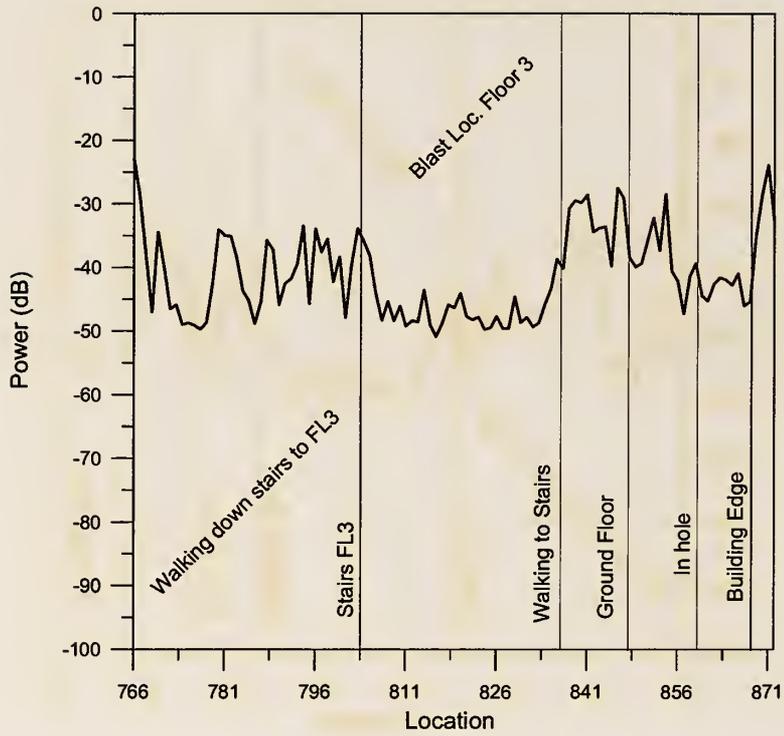
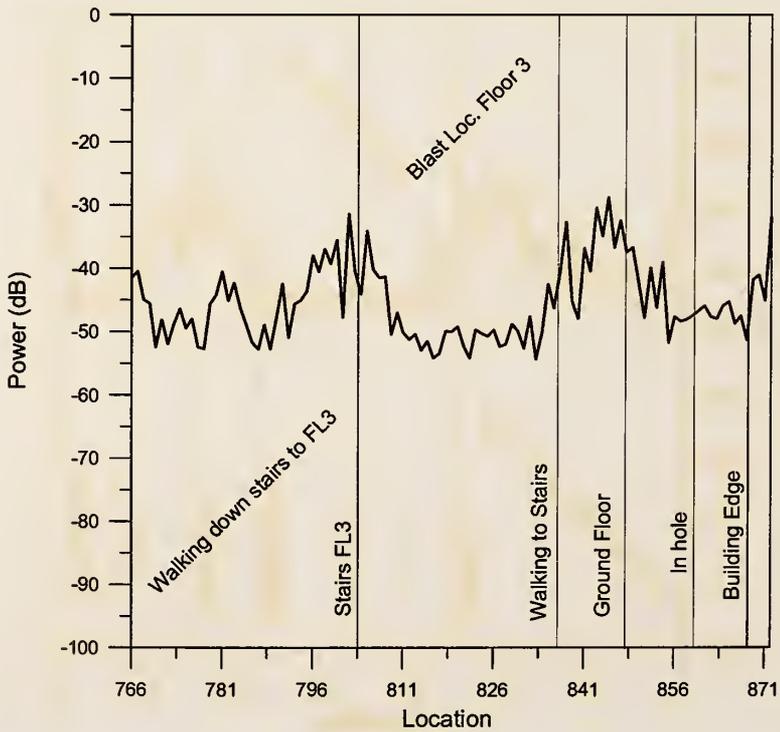
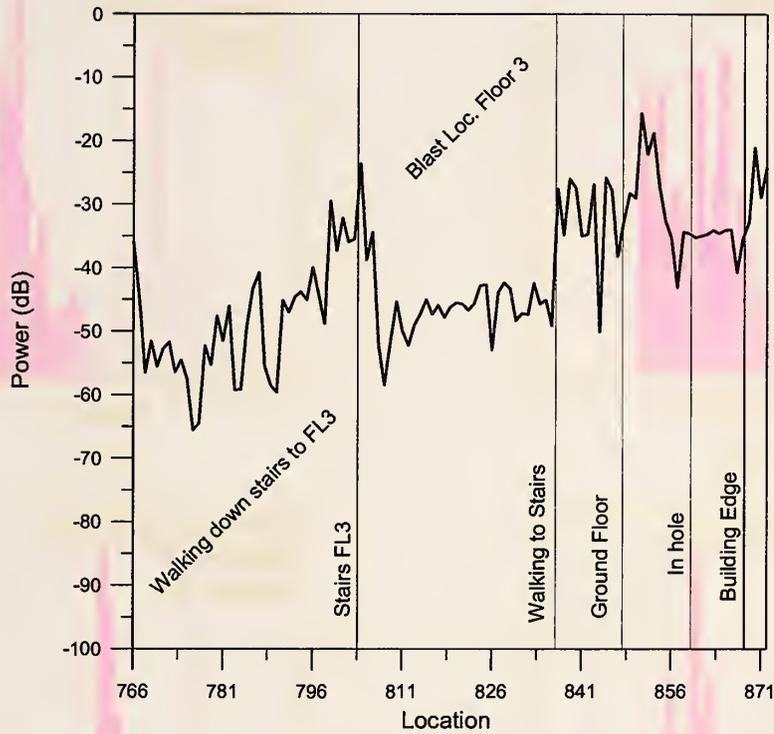
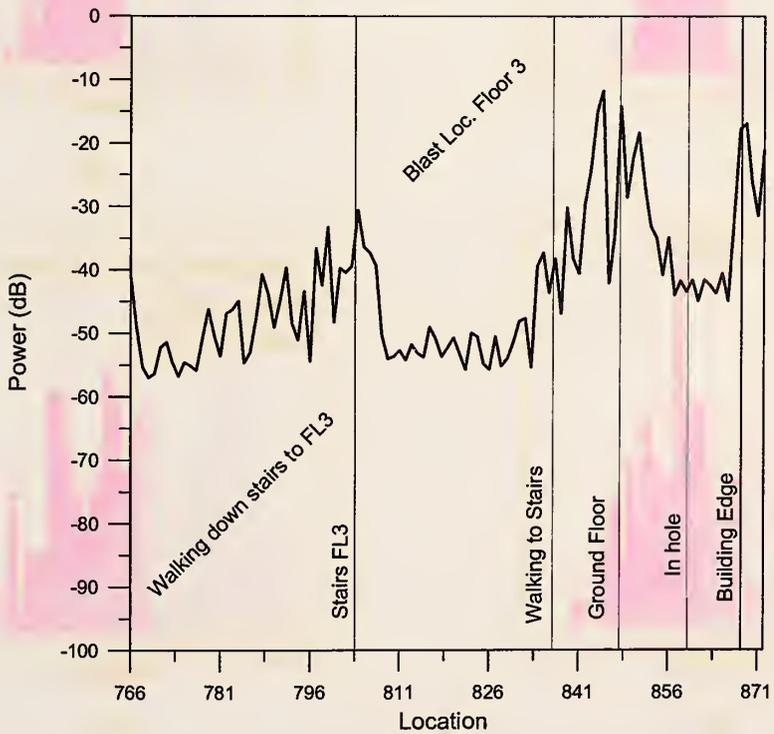
Figure 55. From the control room to exiting the building at 49.6 MHz.

Figure 56. From the control room to exiting the building at 162.0 MHz.

Figure 57. From the control room to exiting the building at 225.375 MHz.

Figure 58. From the control room to exiting the building at 448.6 MHz.

Figure 59. From the control room to exiting the building at 902.6 MHz.

Figure 60. From the control room to exiting the building at 1832.5 MHz.

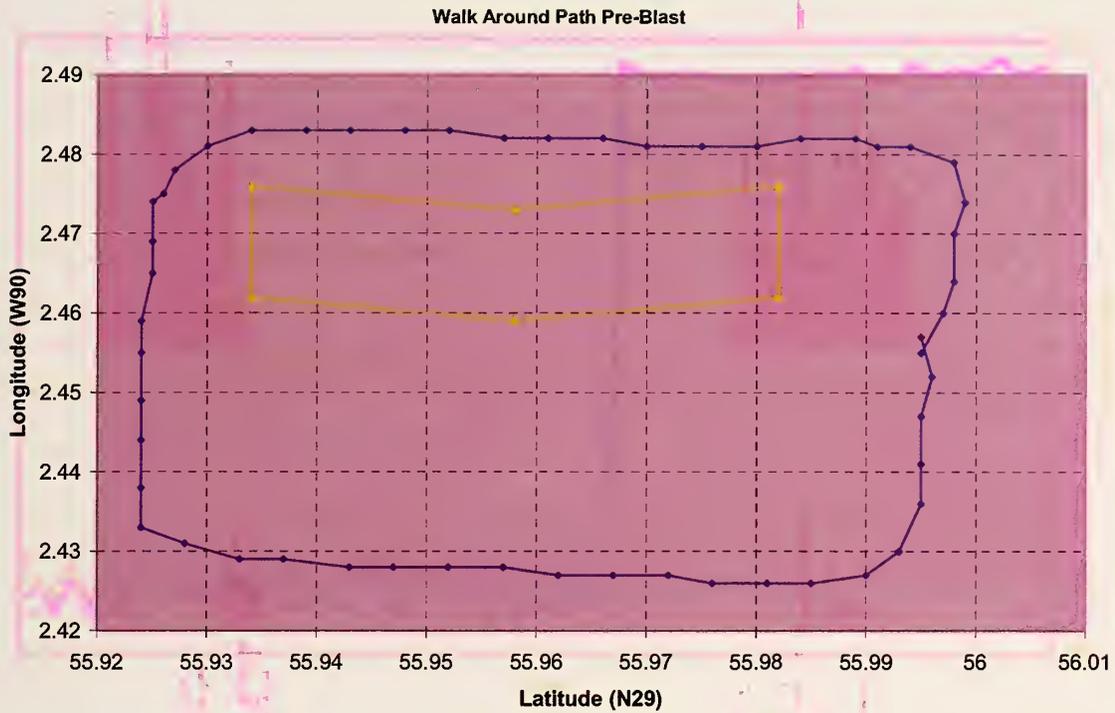
Figure 66. Coordinates of the building footprint (yellow) and cart location (blue).

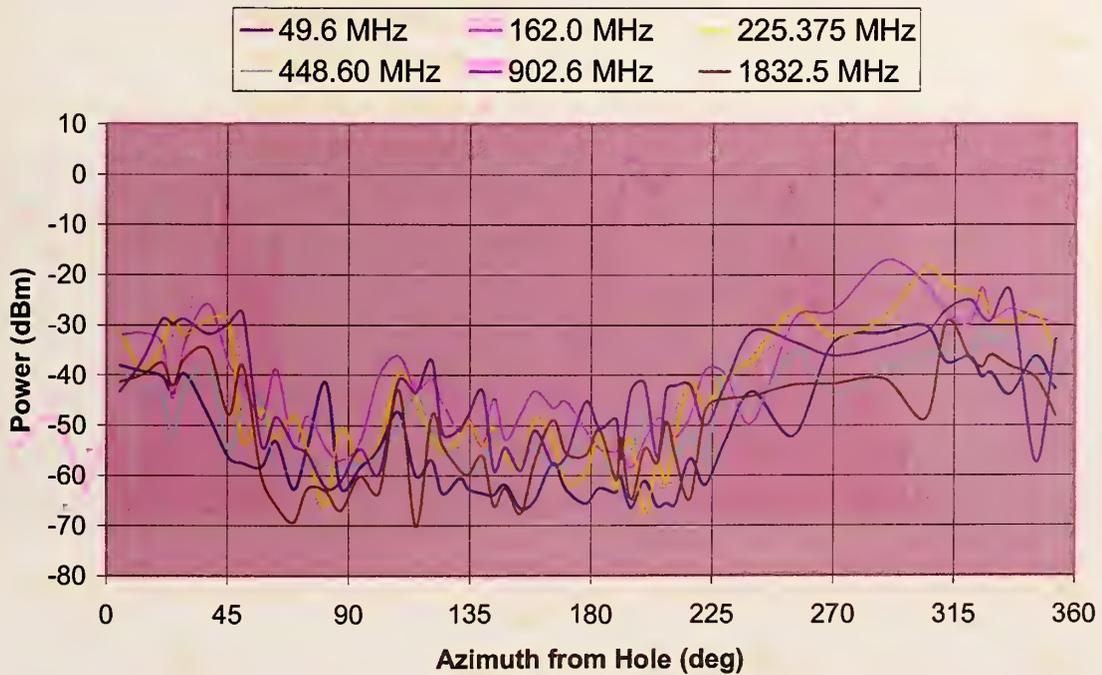
Figure 67. Pre-implosion data from the mobile cart for the transmitters in the hole.

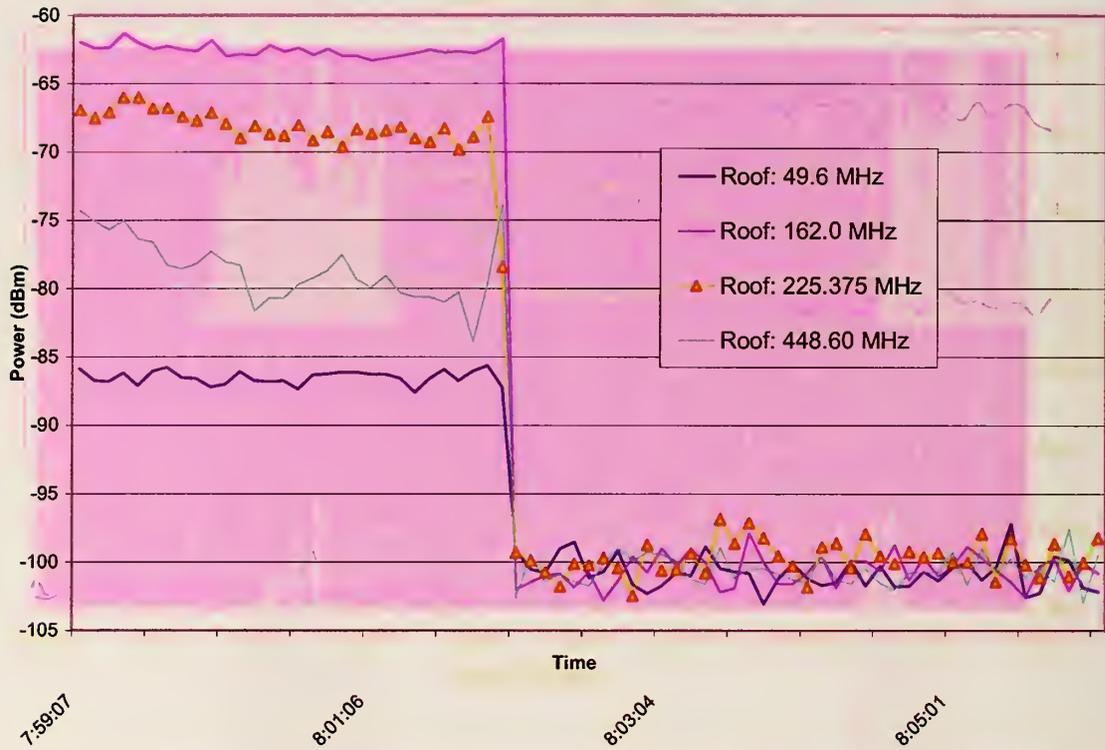
Figure 68. Pre- and post-implosion data collected from Receiver Site A for the transmitters in the control room.

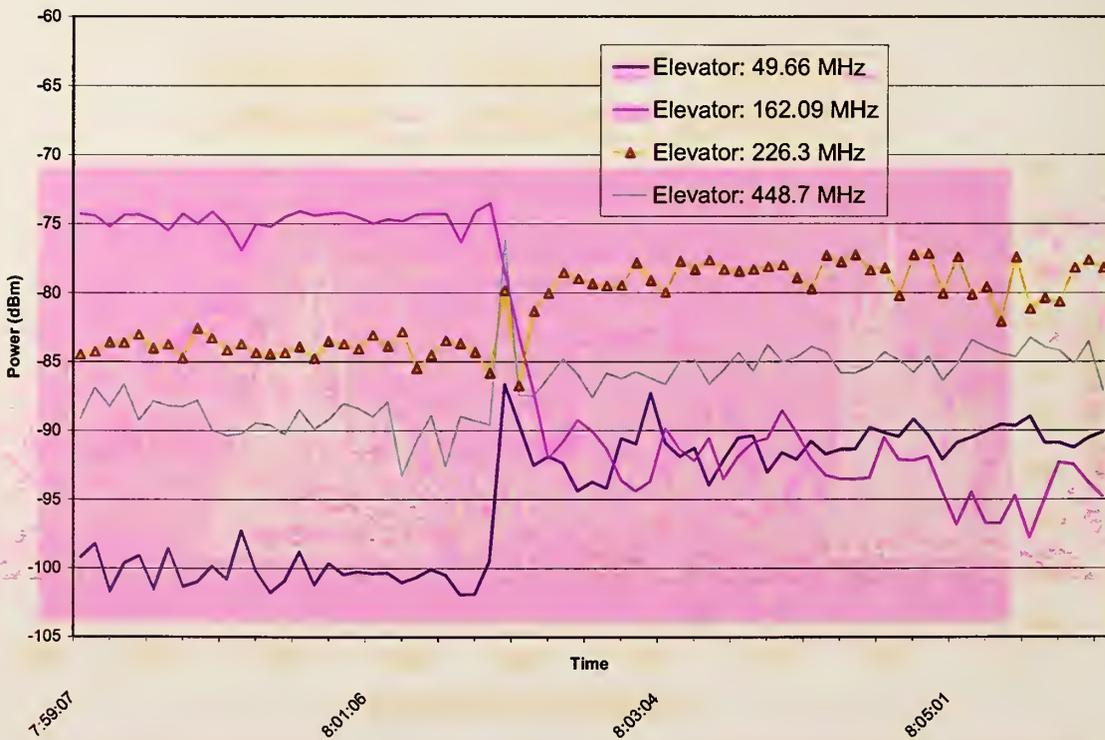
Figure 69. Pre- and post-implosion data collected from Receiver Site A for the transmitters at the third floor elevator.

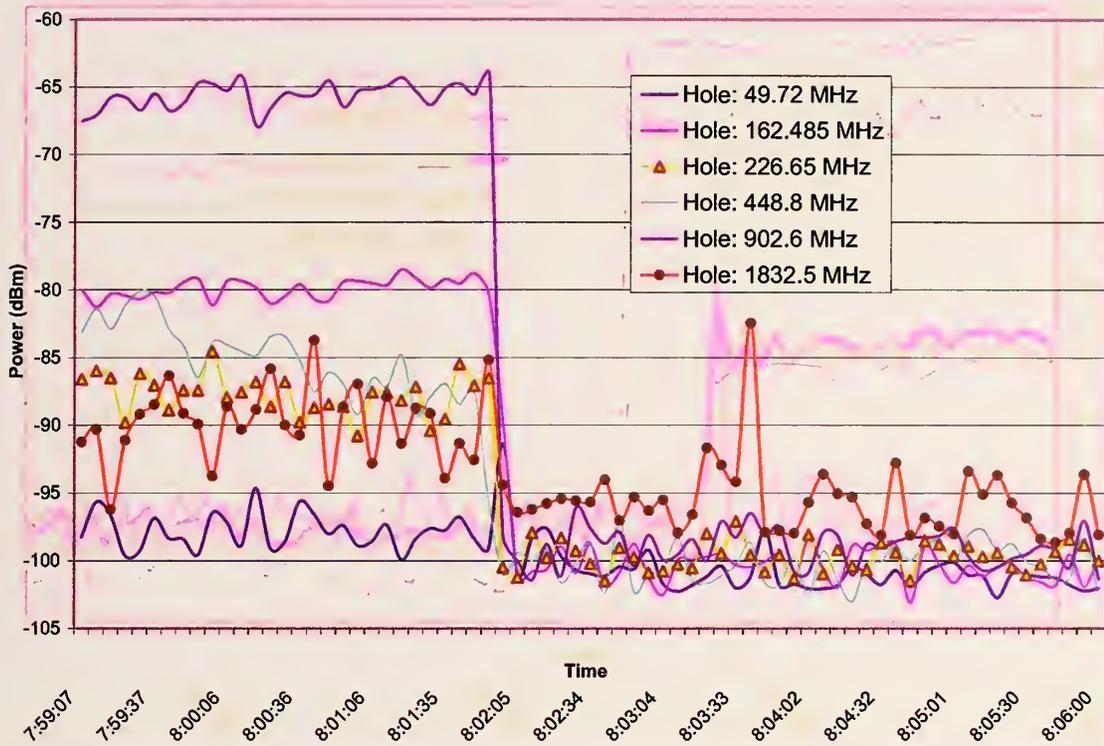
Figure 70. Pre- and post-implosion data collected from Receiver Site A for the transmitters in the hole.

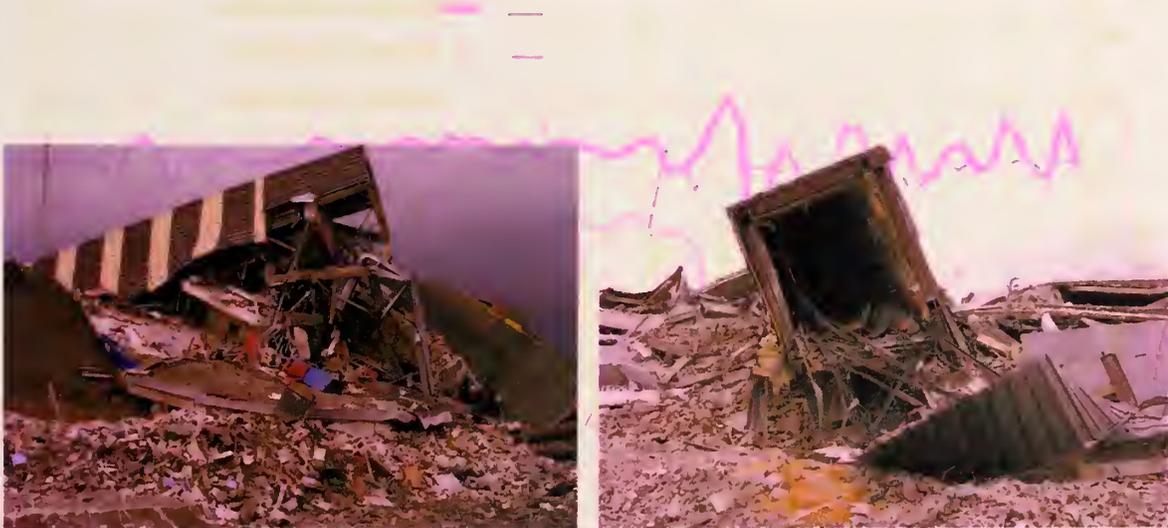
Figure 71. Location of the elevator shaft and transmitters after the implosion.

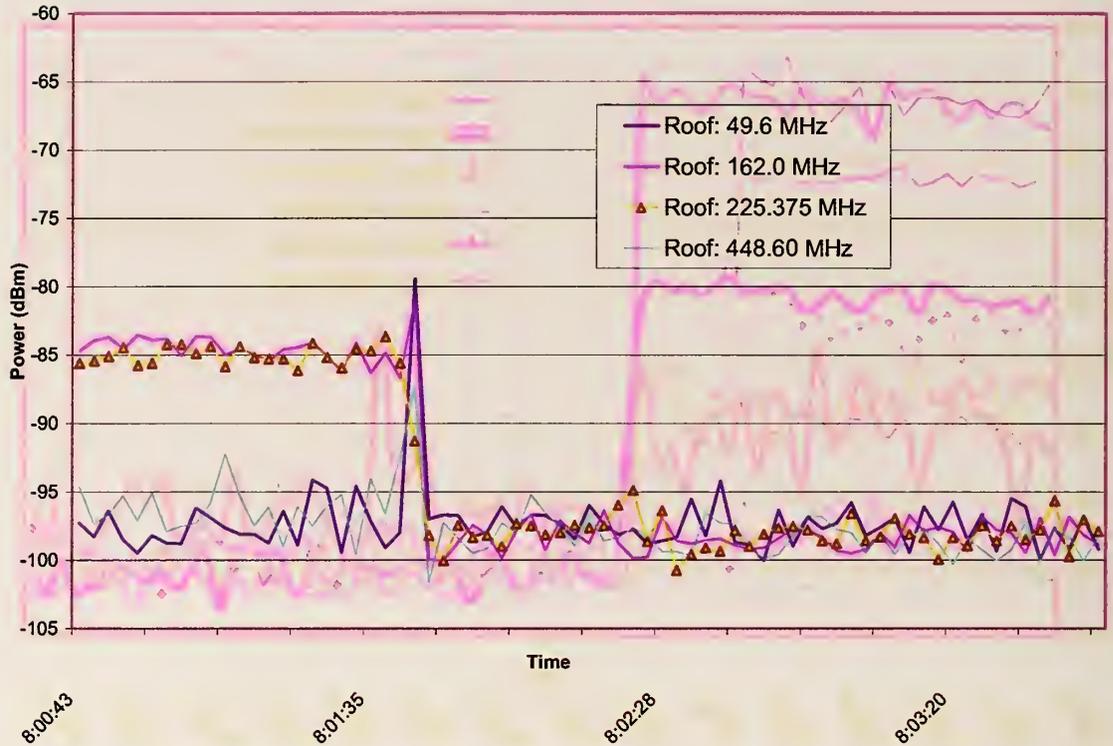
Figure 72. Pre- and post-implosion data collected from Receiver Site B for the transmitters in the control room.

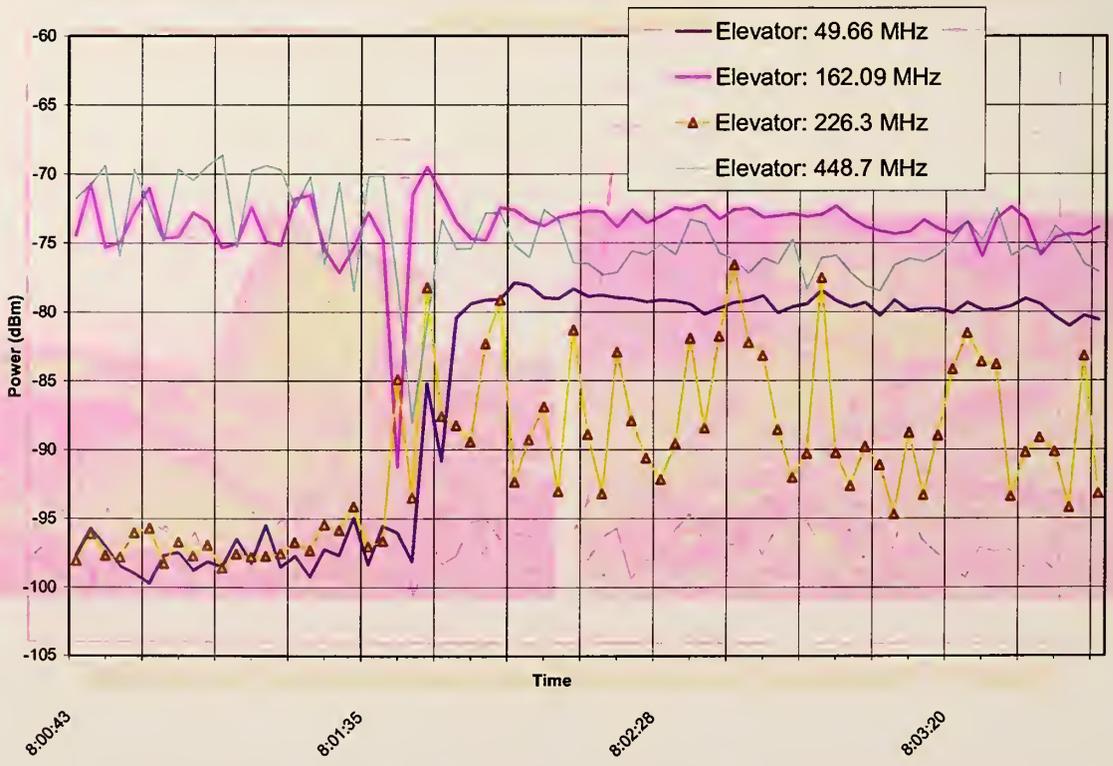
Figure 73. Pre- and post-implosion data collected from Receiver Site B for the transmitters at the third floor elevator.

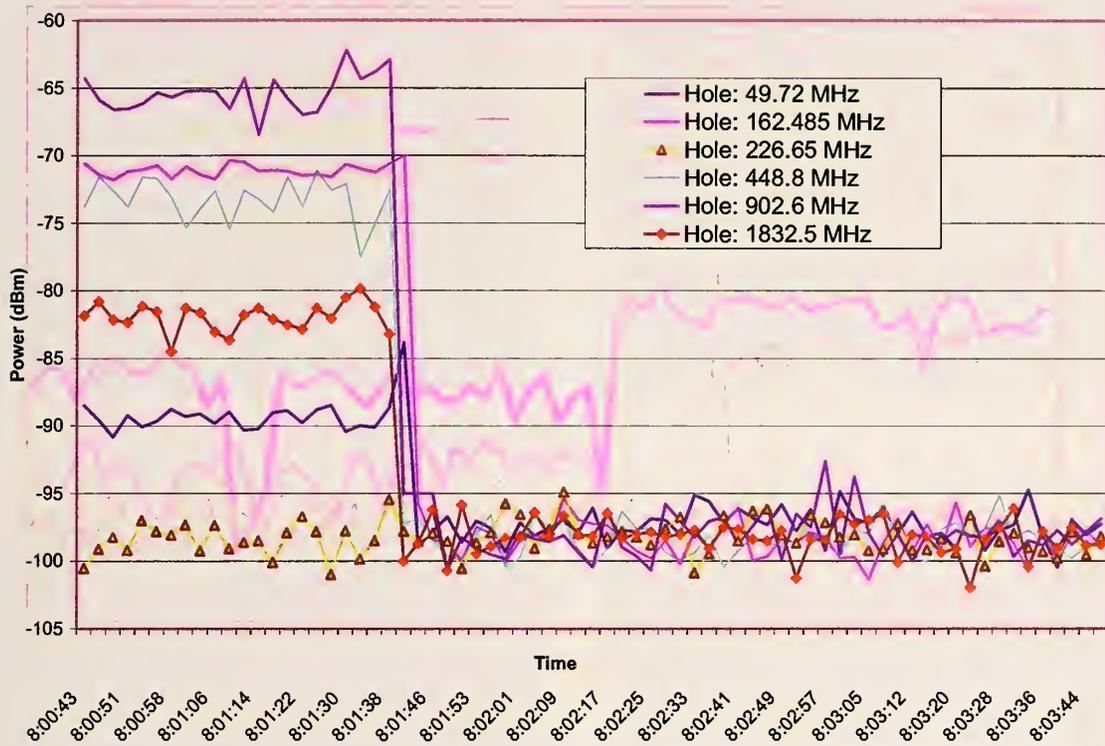
Figure 74. Pre- and post-implosion data collected from Receiver Site B for the transmitters in the hole.

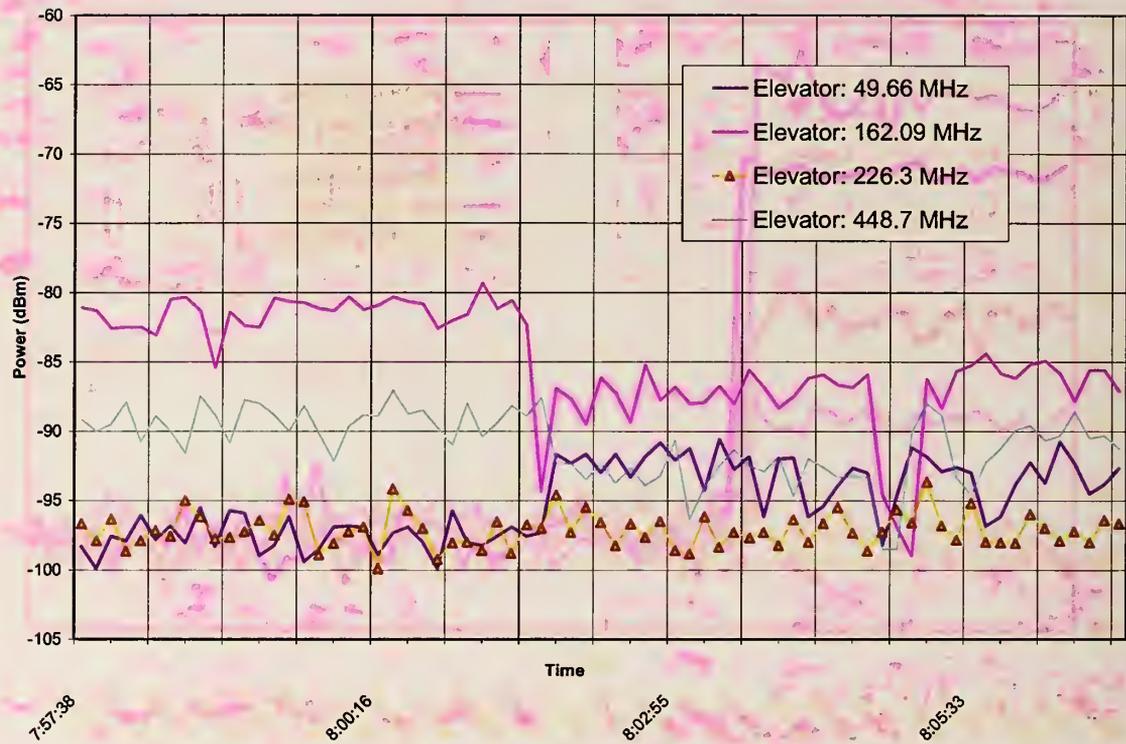
Figure 76. Pre- and post-implosion data collected from Receiver Site C for the transmitters at the third floor elevator.

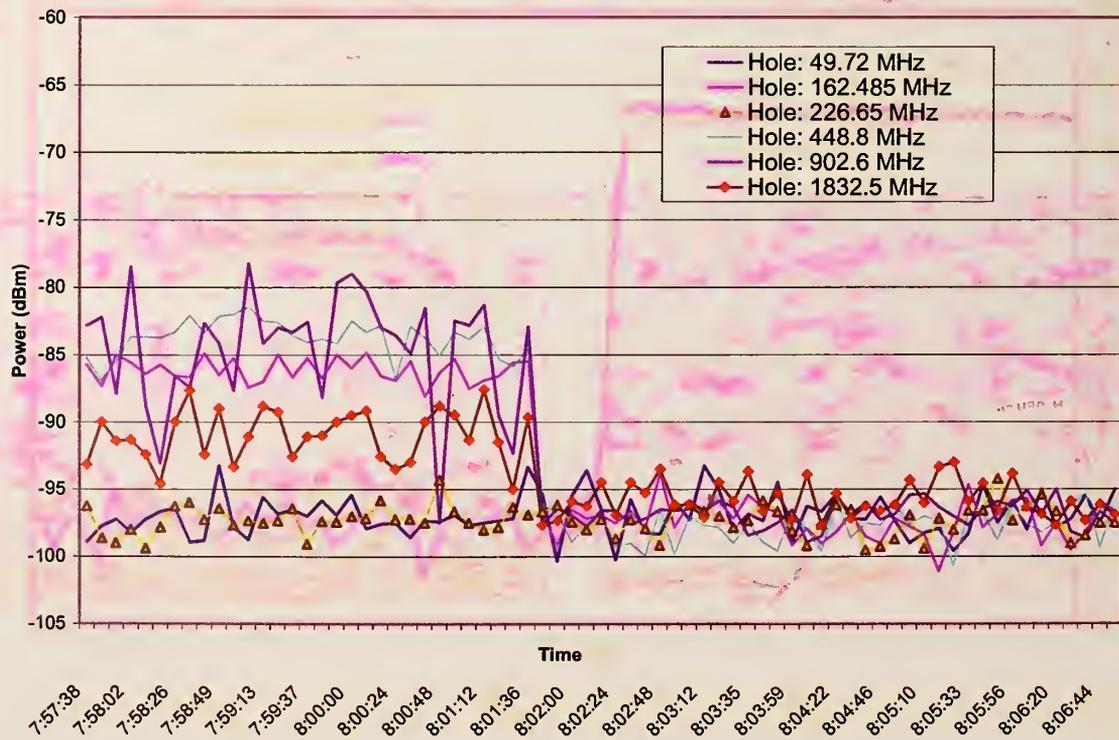
Figure 77. Pre- and post-implosion data collected from Receiver Site C for the transmitters in the hole.

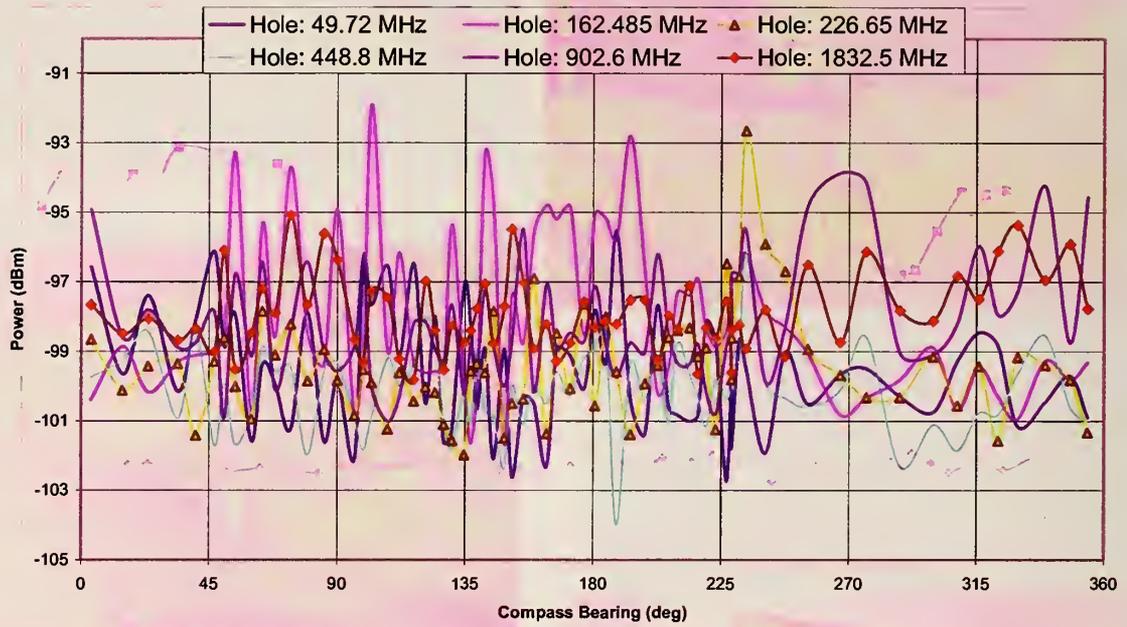
Figure 81. Post-implosion mobile cart measurements for the transmitters in the hole.

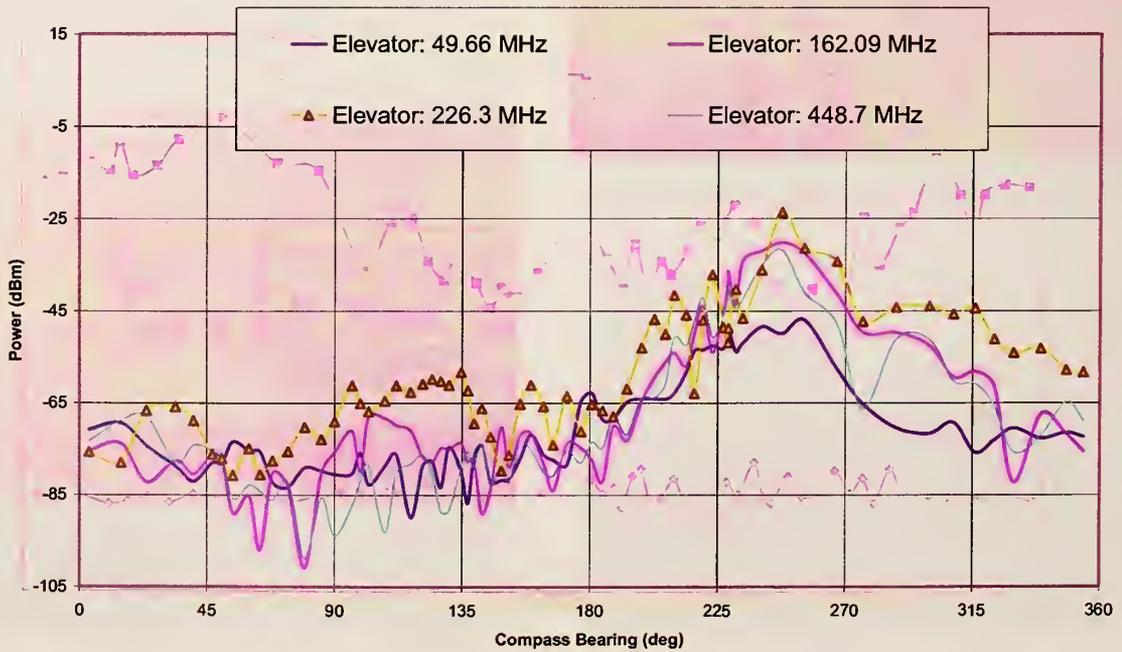
Figure 82. Post-implosion mobile cart measurements for the transmitters at the third floor elevator.
