*NIST Technical Note 1540*

**Propagation and Detection of Radio  
Signals Before, During, and After the  
Implosion of a 13-Story Apartment  
Building**

May 2005

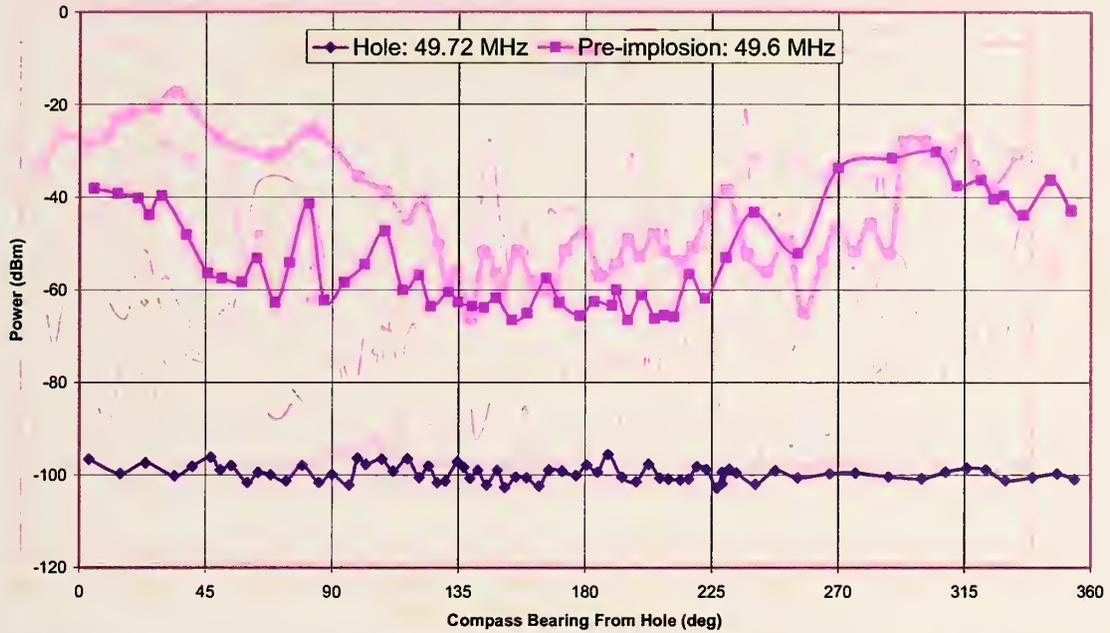
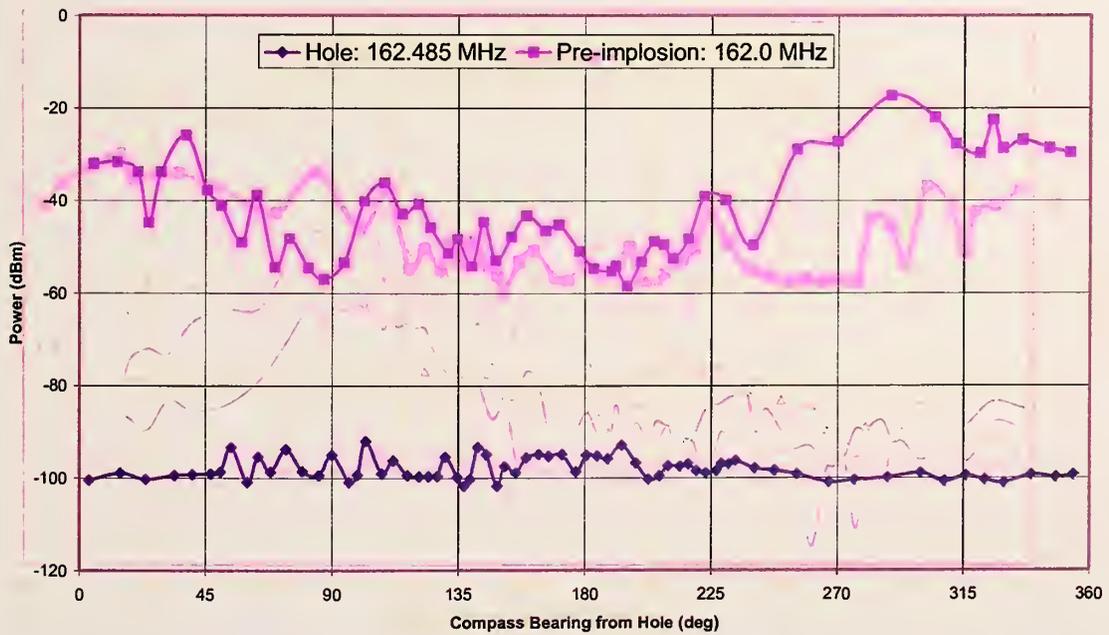
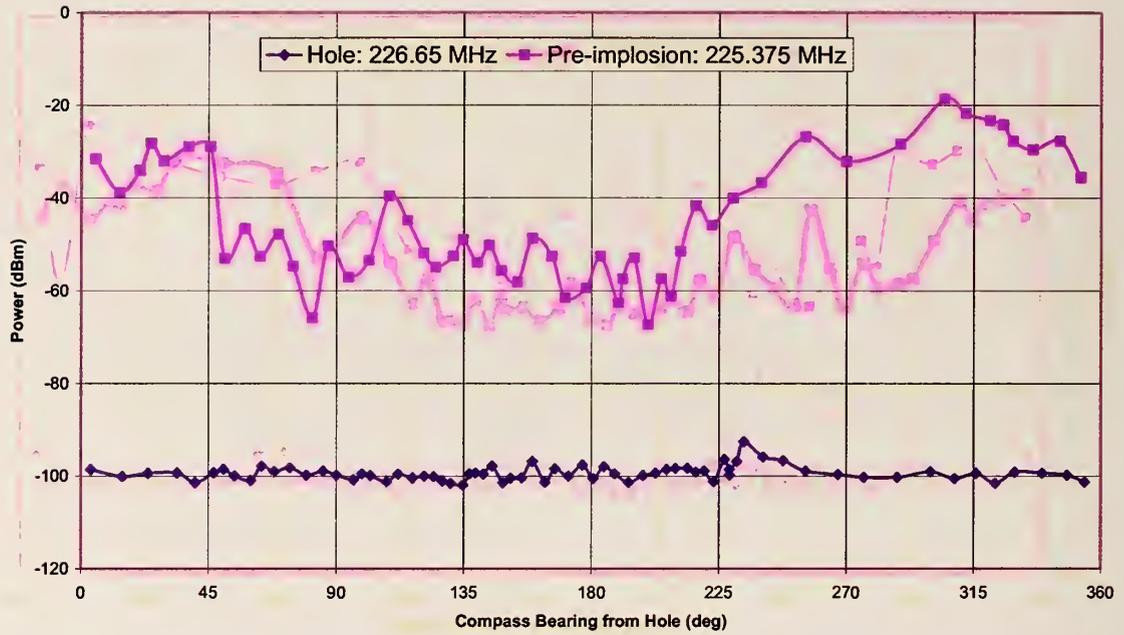
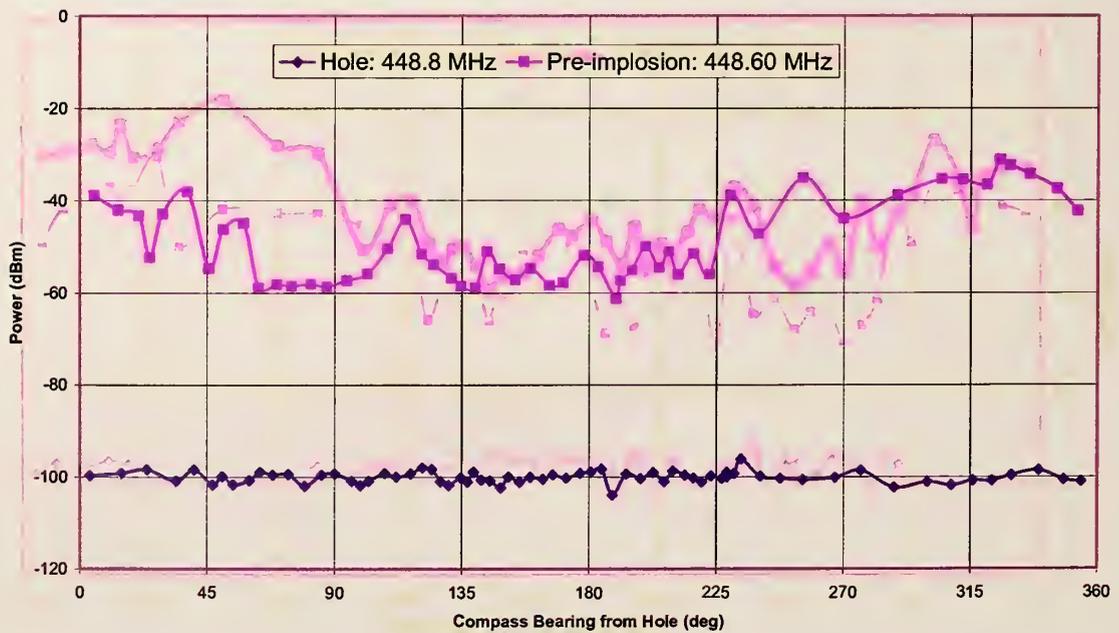
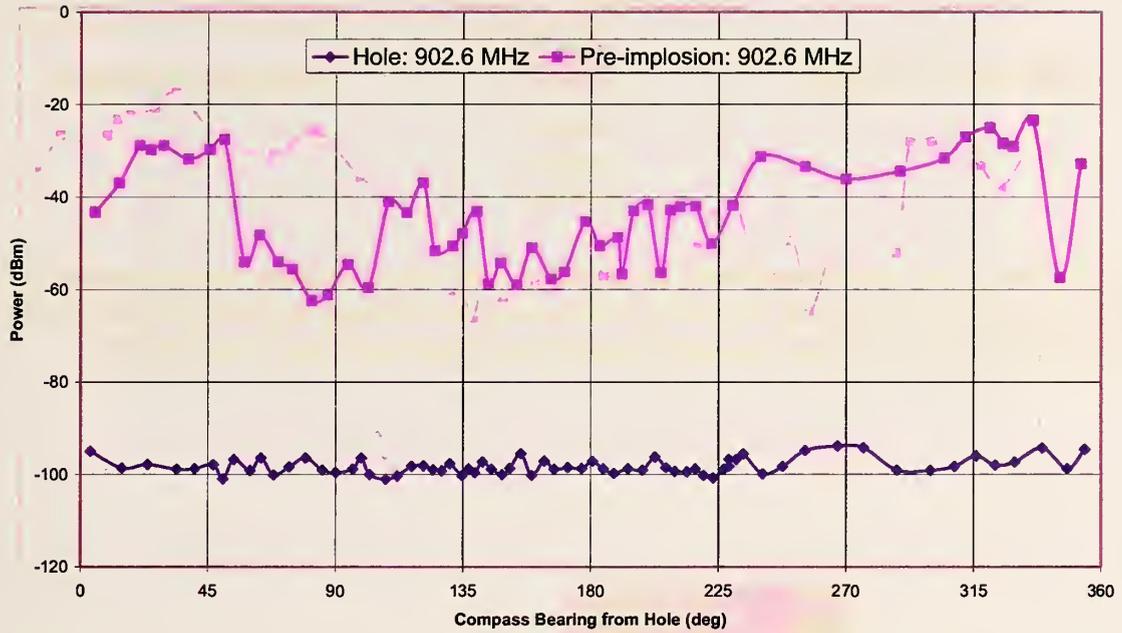
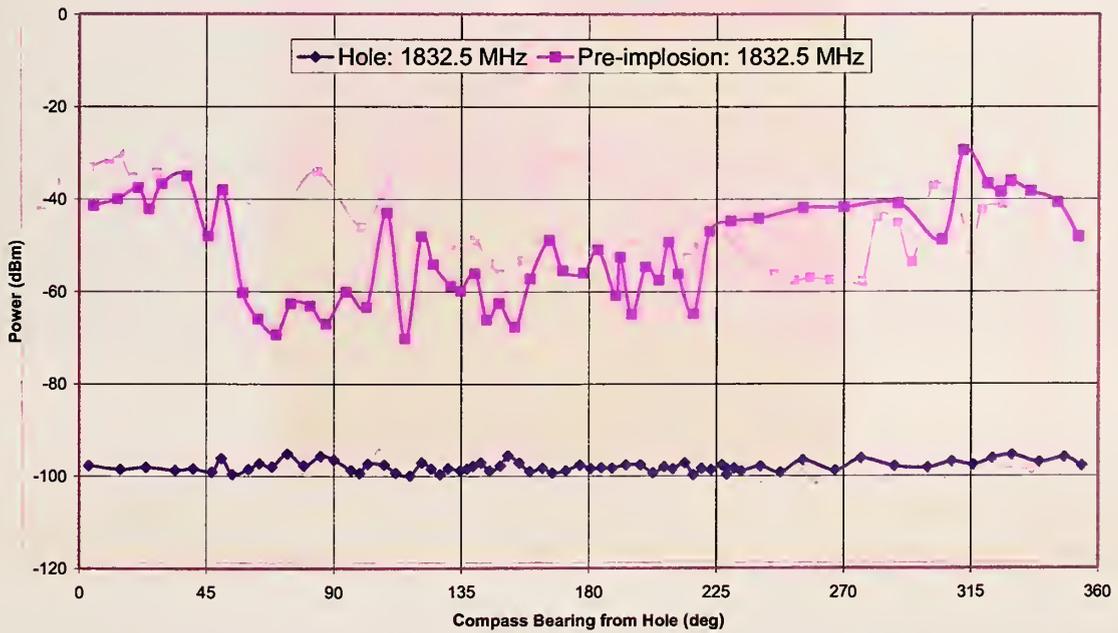
Figure 83. Comparison of pre- and post-implosion mobile cart measurements for the transmitters in the hole in 49 MHz band.

Figure 84. Comparison of pre- and post-implosion mobile cart measurements for the transmitters in the hole in 162 MHz band.

Figure 85. Comparison of pre- and post-implosion mobile cart measurements for the transmitters in the hole in 225 MHz band.

Figure 86. Comparison of pre- and post-implosion mobile cart measurements for the transmitters in the hole in 448 MHz band.

Figure 87. Comparison of pre- and post-implosion mobile cart measurements for the transmitters in the hole in 902 MHz band.

Figure 88. Comparison of pre- and post-implosion mobile cart measurements for the transmitters in the hole in 1832 MHz band.

Measurements for the transmitters in the hole were made before the implosion such that a pre- and post-signal strengths could be compared. These comparisons are shown in Figure 83-88. From these figures, it appears as if the post-implosion signals are either not transmitting or at the noise floor of the measurement instruments. With other measurements (see next section) it was confirmed that the transmitters in the hole were indeed transmitting. Thus, from the results in Figures 83-88, we see that the large amount of building rubble causes as much as 60 to 80 dB of attenuation of the signal. Thus, if someone is trapped under such a rubble pile and is trying to communicate with an emergency responder with a two-way radio or cell phone, their communication link would have to overcome 60 to 80 dB of attenuation.

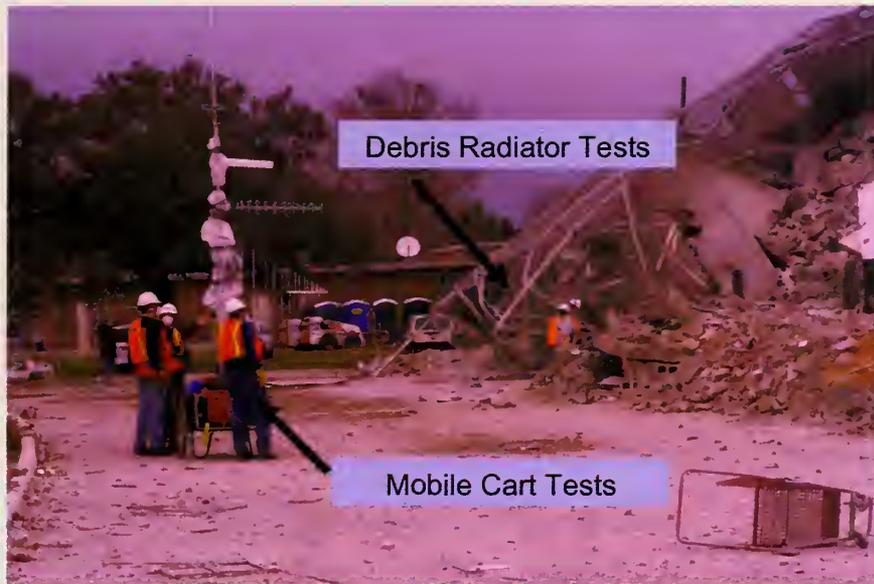
Figure 91. Post-implosion measurements. The mobile cart is in the foreground and the debris radiator tests are at right.
